# 291 Hills Road, Cambridge

## Archaeological Evaluation Report

March 2020

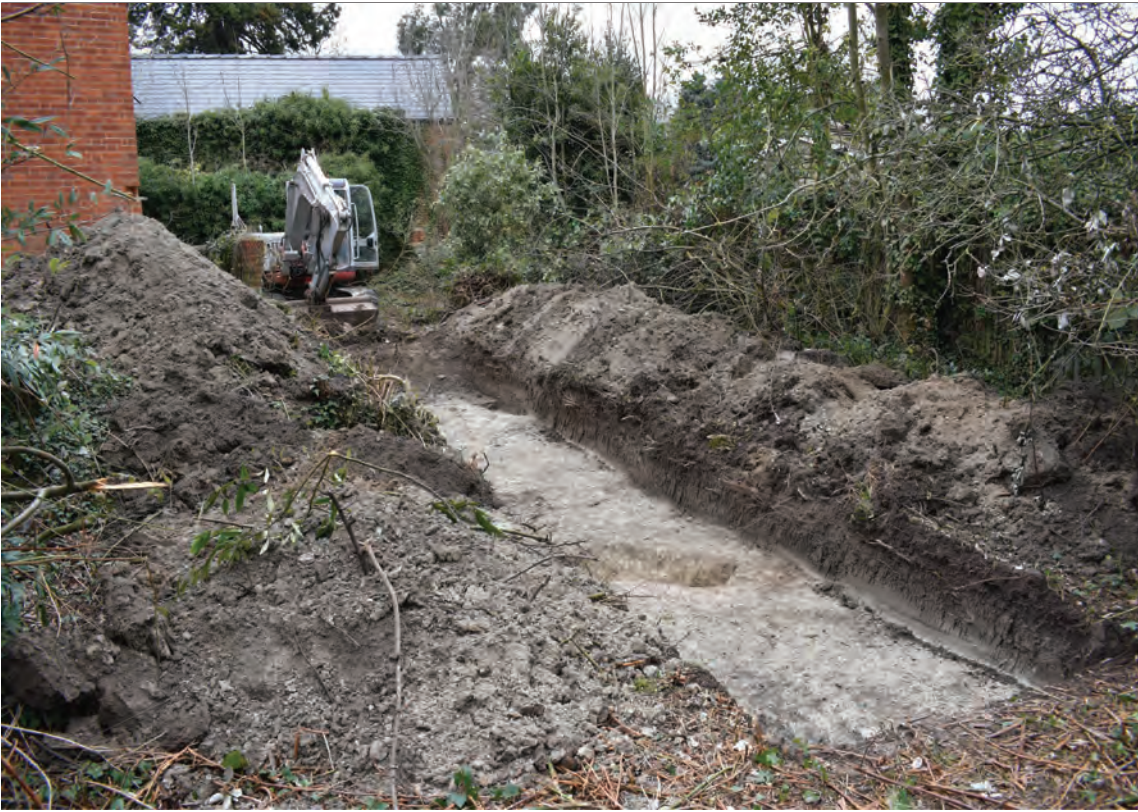
Plate 1: Site view, showing Trench 2 in the back garden of the house, looking north-east

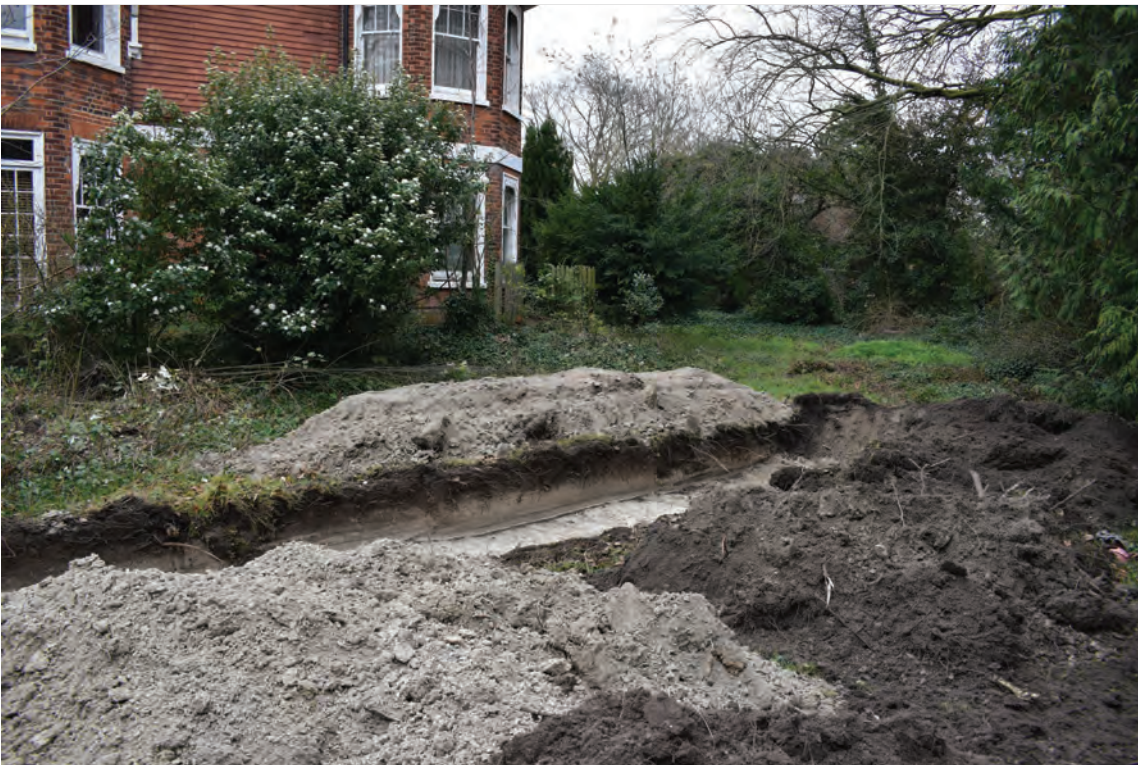
Plate 2: Site view, showing Trench 1 in the front garden of the house, looking east

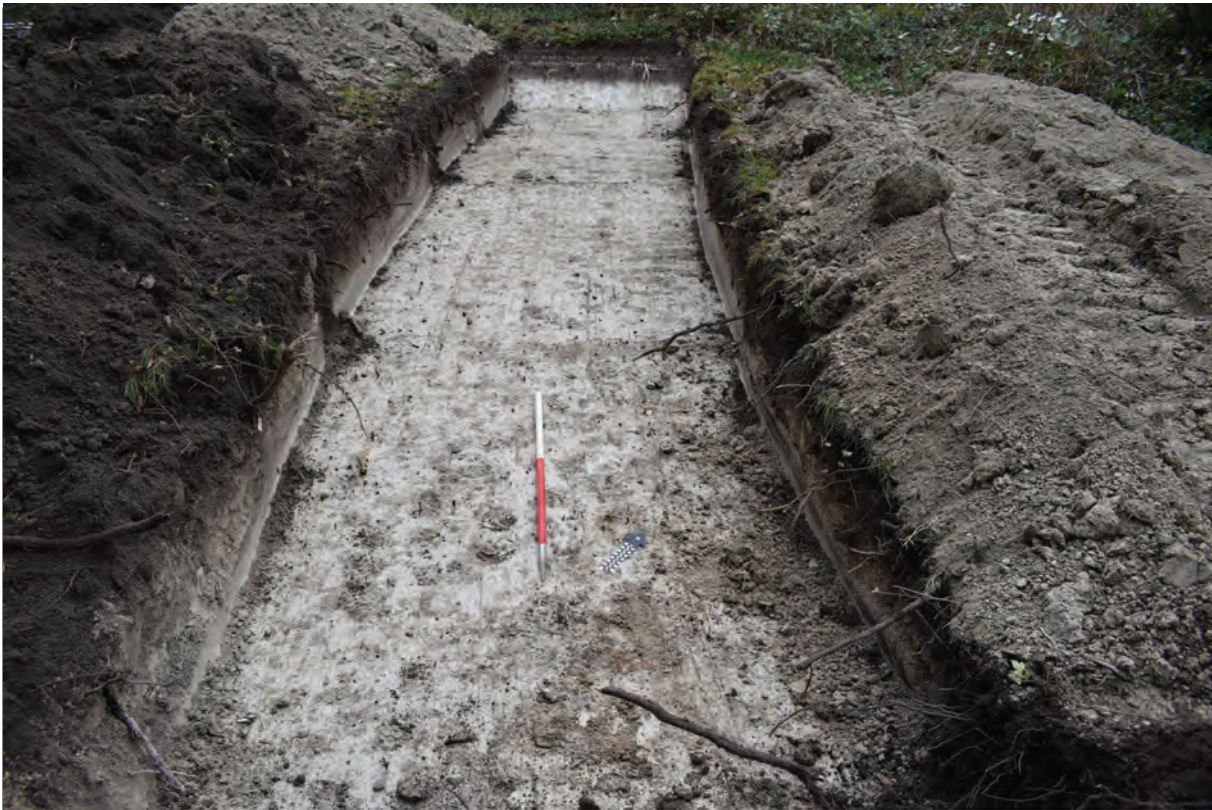
- 3.1.1 The results of the evaluation are presented below. Both trenches were located within the garden of the residential property (Plates 1 and 2); Trench 1 (Plate 3) was blank, and will not be discussed further, whereas, Trench 2 did reveal modern features/deposits (Plate 4). No features or finds of archaeological significance were found in either of the trenches.
- 3.1.2 Full details of both trenches with dimensions and depths of all deposits can be found in Appendix A.

Plate 3: Trench 1, looking north-east

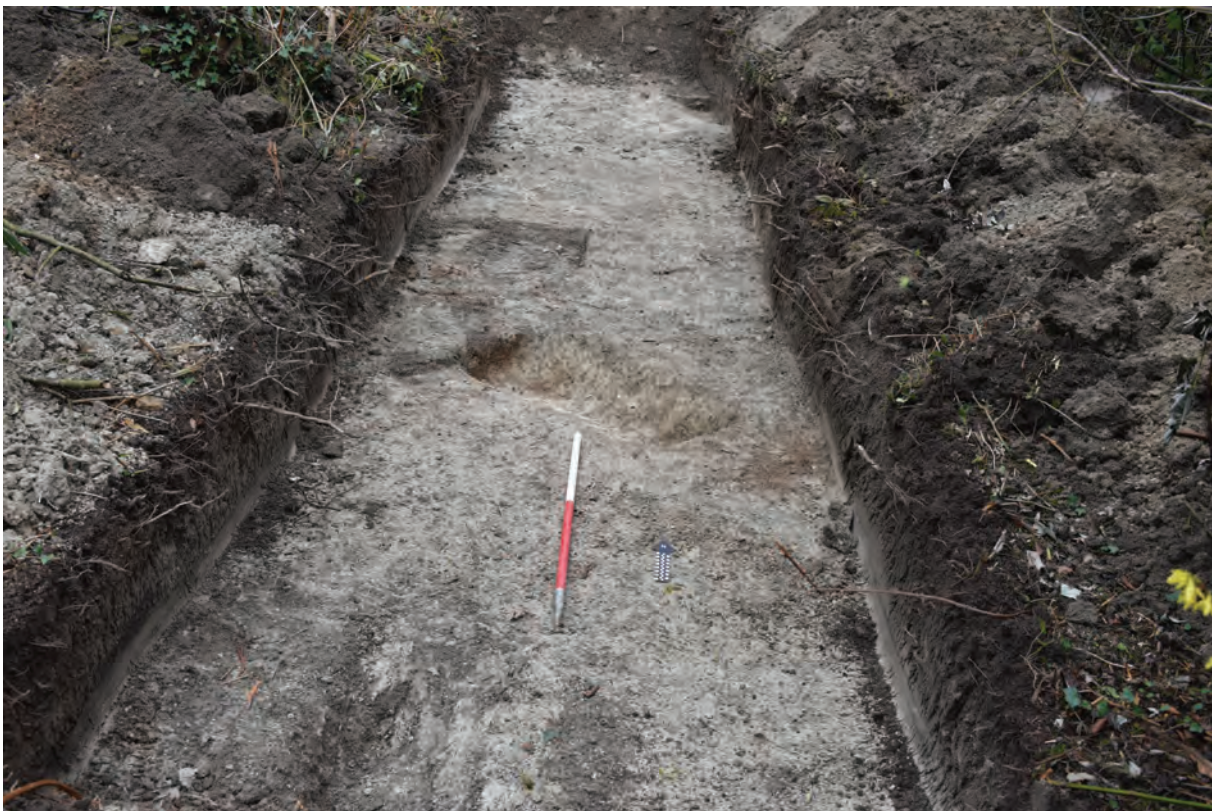
- 3.3.1 Trench 2 (Plate 4) was located on the east side of the residential property and was orientated north to south.
- 3.3.2 Across the whole trench, a layer of modern made ground ((3); Plate 5) was revealed underlying the topsoil (4) and overlying the natural geology (5). This was a mixed deposit of light, mid and very dark grey clayey silt, containing a significant amount of modern brick, mortar and concrete.

Plate 4: Trench 2, looking north

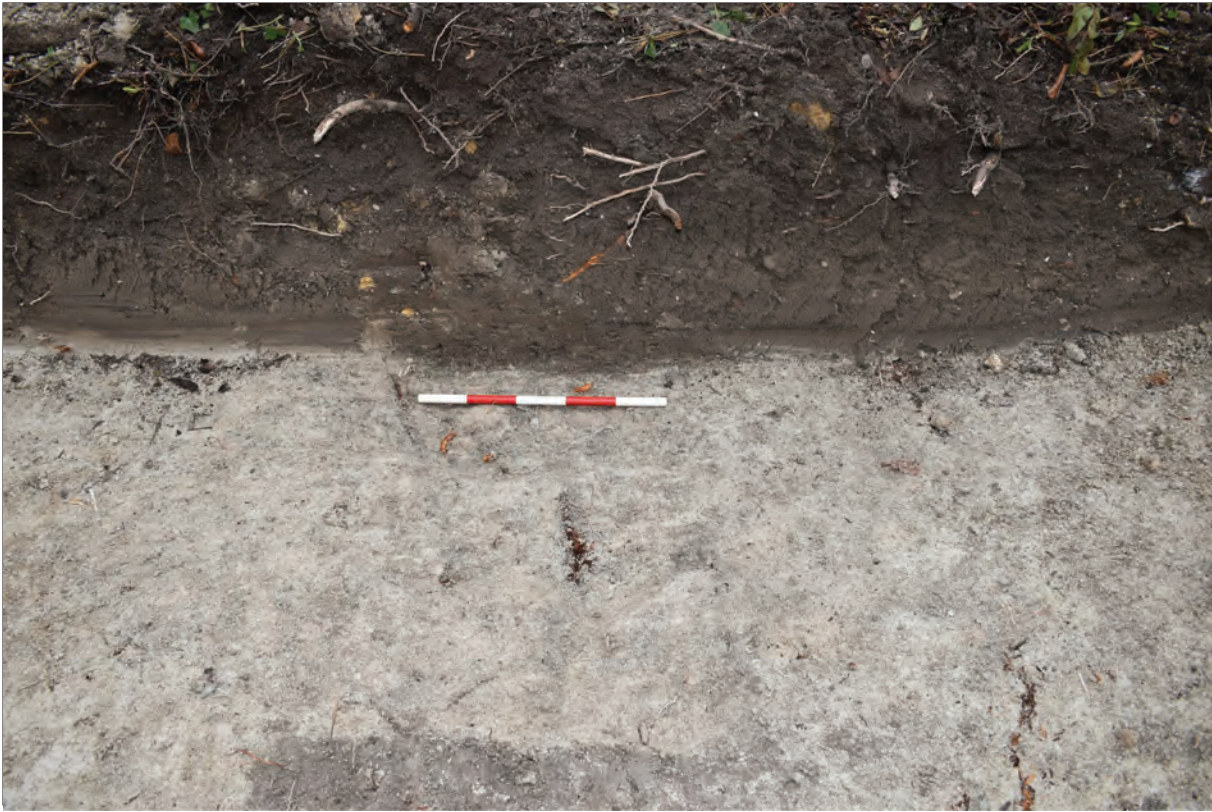
Plate 5: Section of Trench 2 showing made ground 3, looking east

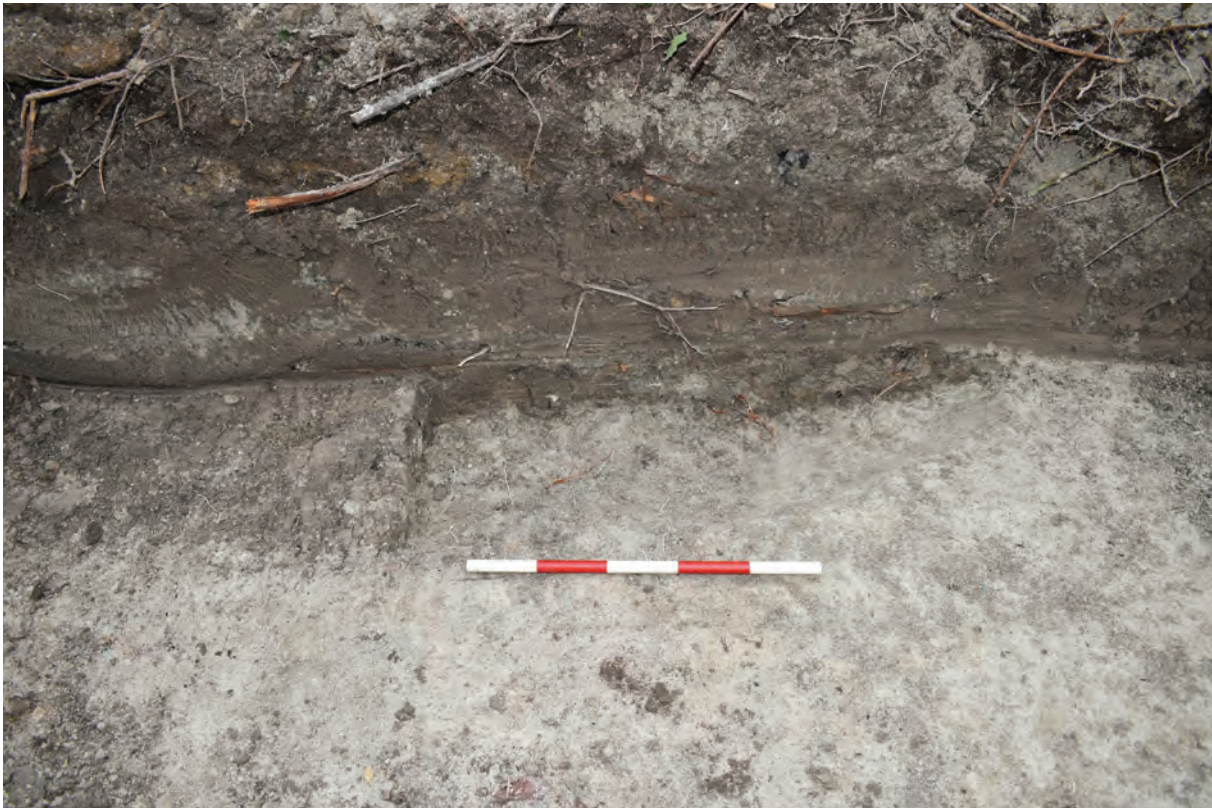
- 3.3.3 A modern feature (1), a very shallow pit or hollow cut into the natural geology, was revealed at the northern end of the trench (Plate 6). The shape and extent in plan were undetermined, but in profile it was shallow, steep sided with a gradual break in slope and flat-based. It was filled by a mixed deposit (2), that was very similar and probably the same as to the overlying made ground layer ground (3). This fill also contained modern brick and mortar.

Plate 6: Section of modern feature 1 in Trench 2, looking east

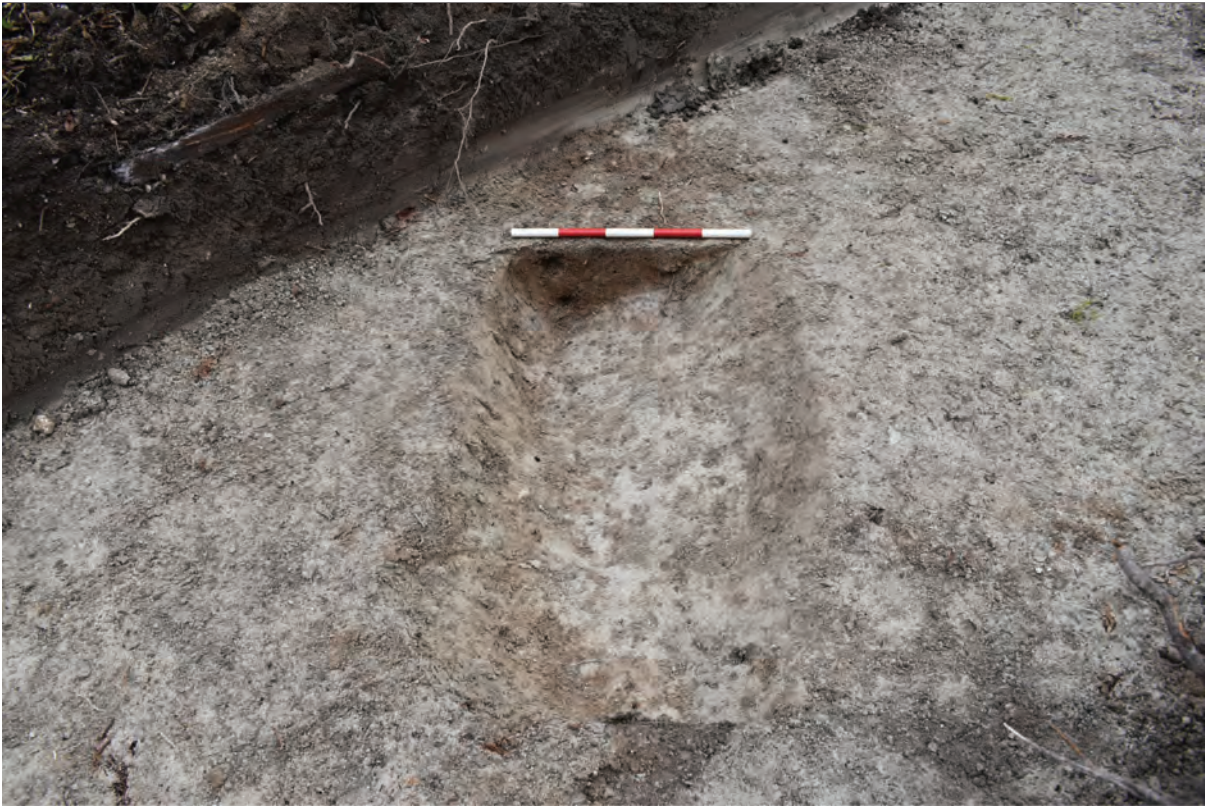
- 3.3.4 Irregular elongated/linear patches of bioturbation caused by tree roots were found at the southern end of the trench (Plate 7).

Plate 7: Section showing bioturbation in Trench 2, looking south-east
