The Provost's Garden Wall, The Queen's College, Oxford

Historic Wall Recording

The Provost's Garden Wall, Queens Lane

The Queen's College, Oxford

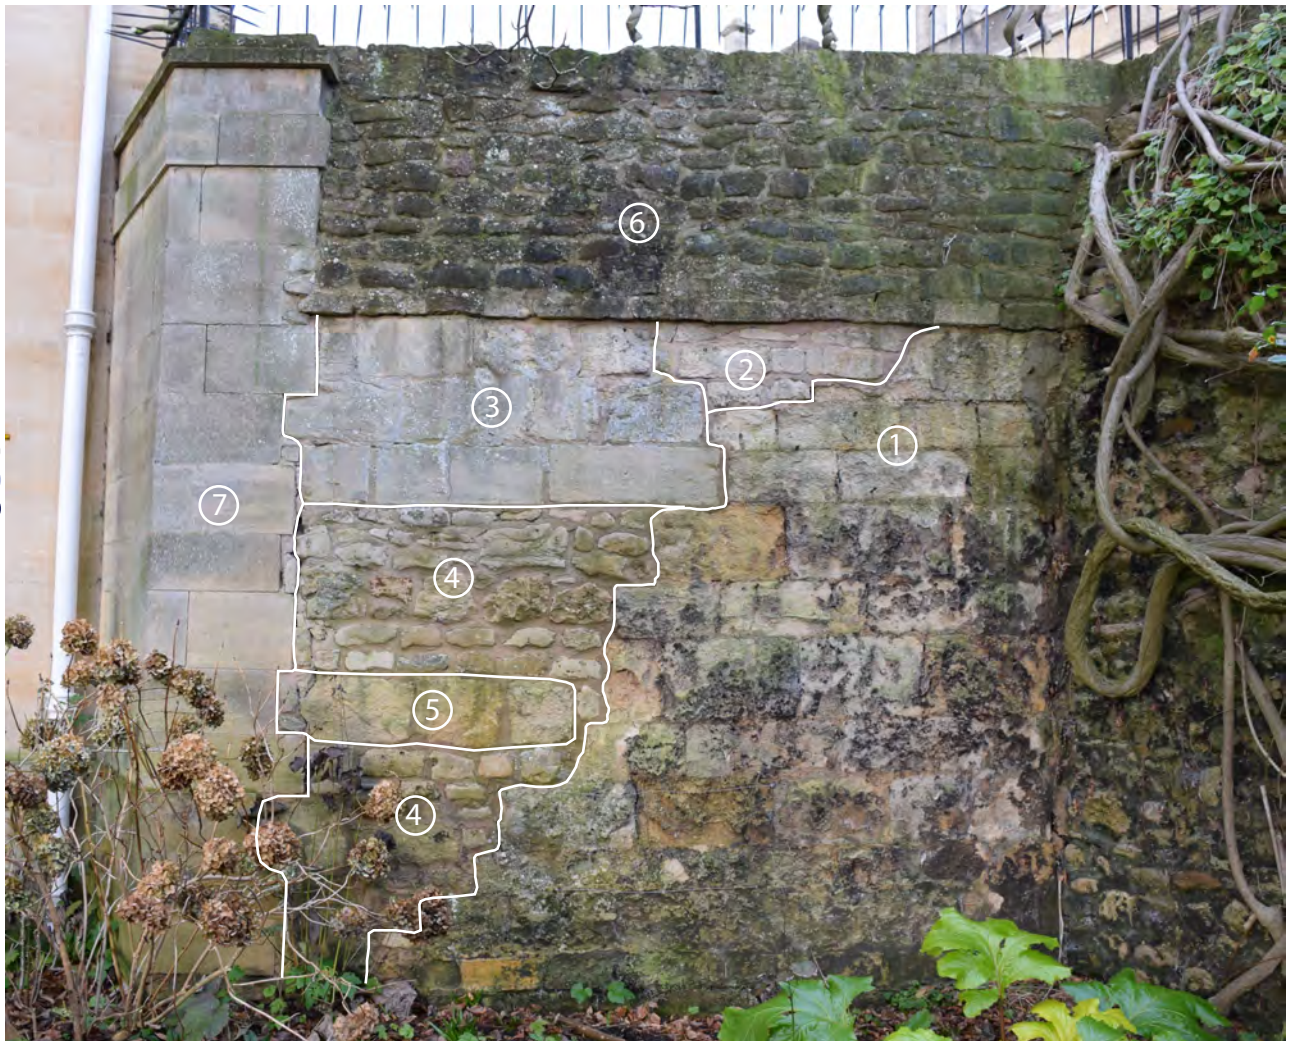
Figure 3: East face of wall showing phasing (see section 3 of text)

- 3.3.1 The east face of the wall comprises the following distinct sections (see Figures 3):
- 3.3.2 **[1]** this section appears to represent the main primary face of the wall probably constructed in the mid 18th century. It is formed from a relatively soft limestone (probably from the Headington quarries) and is heavily weathered in parts. The faces of many of the stones are blackened from pollution and in many areas are coming away from the main stone behind. The stonework is dressed and laid in regular courses with a soft lime mortar. The stone blocks are between 28 cm and 22 cm tall and although they vary in length they are generally c.40-60 cm long. The character of this section of wall is different to the main, adjacent east-to-west wall which fronts Queens Lane as it is formed from larger stones and at the junction between the two it appears that the south-westerly kinked wall abuts the main street-front wall. It may be that the wall originally continued right along Queens Lane and that the opening was created within it to allow access to the rear service yard.

- 3.3.3 **[2]** This is a small area of infill or patched repair formed from smaller stones than [1] and bonded with a relatively smooth salmon-coloured cement mortar. The larger stones measure c.30 cm by 10 cm while the smaller ones measure c.15 cm x 10 cm. This repair may be of the same date as other repairs (eg 4-5)

- 3.3.4 **[3]** This is a regular patch of coursed, dressed stone and although its character is quite different from the other areas of secondary repair (2, 4, 5) it is possible that it is from the same phase as them. It appears to use the same smooth cement mortar as the other areas of re-facing. The stones are large measuring from 23 by c.60 cm to c.30 x 23 cm.

- 3.3.5 **[4]** This context has two sections with each one formed from relatively small stones grouped together to form sections of similar stones. This context is partially coursed and it appears to be formed from stones similar to the sloped cap [6].

- 3.3.6 **[5]** This context is within [4] and is probably contemporary with it but it is formed from much larger stones with a different character. There are three stone blocks in this context measuring c. 25 cm tall by c.25-36 cm wide. It is possible that the blocks could be reused stones from the primary wall [1] but the coursing is different to that of the primary wall.

- 3.3.7 **[6]** The top of the wall is formed from a shallow sloping cap of roughly coursed and roughly squared stone. The character of the stone varies in different areas and there is likely to be areas of repair or rebuilding but the nature of the stonework means that it is difficult to identify these with certainty.

- 3.3.8 **[7]** Regular ashlar stonework constructed in c.1958-60 when the adjacent Provost's Lodging was added. This wall would have been constructed to cap the truncated section of NE-SW wall when it was shortened.
