Corpus Christi College, Oxford

Archaeological Watching Brief Report

May 2020

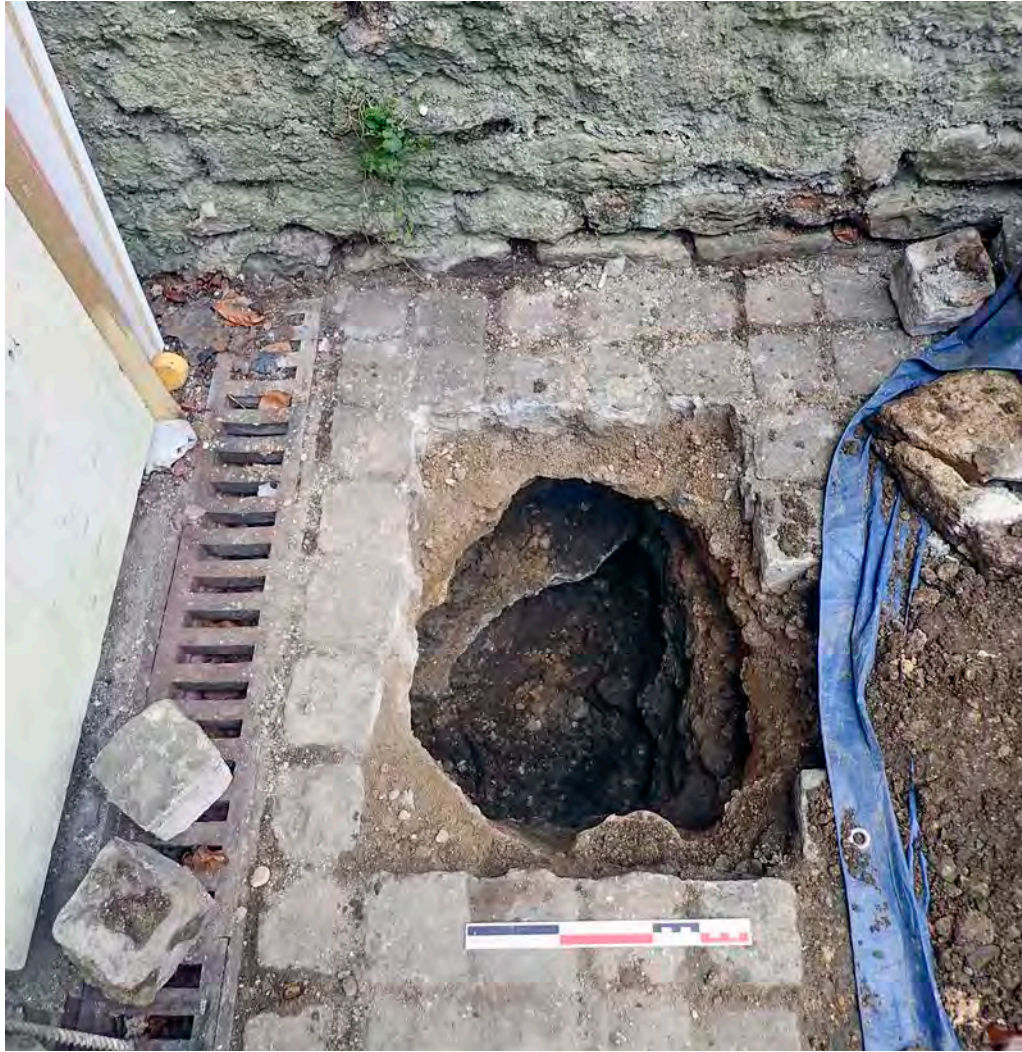
Plate 1: Test pit 1, view to N

3.4.1 Test-pit 1 was excavated to a depth of 1.24m BGL (Fig. 3). The test-pit was located against the wall which separates Corpus Christi and Christchurch Colleges (Fig. 2). It established that the walls foundations were constructed to a depth of 1.24m BGL.

3.4.2 The lowest deposit, 1005, comprised a loose, dark grey-brown sandy silt, 0.4m thick. This appeared to be a make-up layer for stone surface 1004. The stone surface was formed from large limestone slabs, 0.08m thick.

3.4.3 The limestone surface was overlain by a dark grey brown sandy/silty gravel with oyster shell and animal bone, 1003, 0.28m thick. This layer possibly represented a former garden soil, or a refuse deposit formed when the surface had gone out of use.

- 4.3.1 The stone surface recorded in Test-pit 1 was not associated with any datable artefacts, but is likely to correlate with the uppermost surface of the former Shidyerd Street uncovered by the previous evaluation trenches (OA 2015). The surface is thought to date from potentially as far back as the 14th century. Its presence within the test pit, adjacent to the boundary wall between Corpus Christi and Christchurch Colleges, would suggest that it was built to abut the precursor to the wall, which although 18th century in date, is thought to have been partially constructed on an earlier 14th century wall foundation. The lack of any of the preceding, more rudimentary surfaces within Test pit 1 suggests that these were removed by the 14th century wall's construction, although these would have been difficult to spot given their fragmentary nature and the small size of the test pit. Alternatively, the wall foundation could have been constructed against the side of the foundation trench from the Christchurch College side, so that there would have been little disturbance of the adjacent strata. Given the presence of the refuse deposit of potential 16th century date overlying the road surface, the latter is the more likely hypothesis.

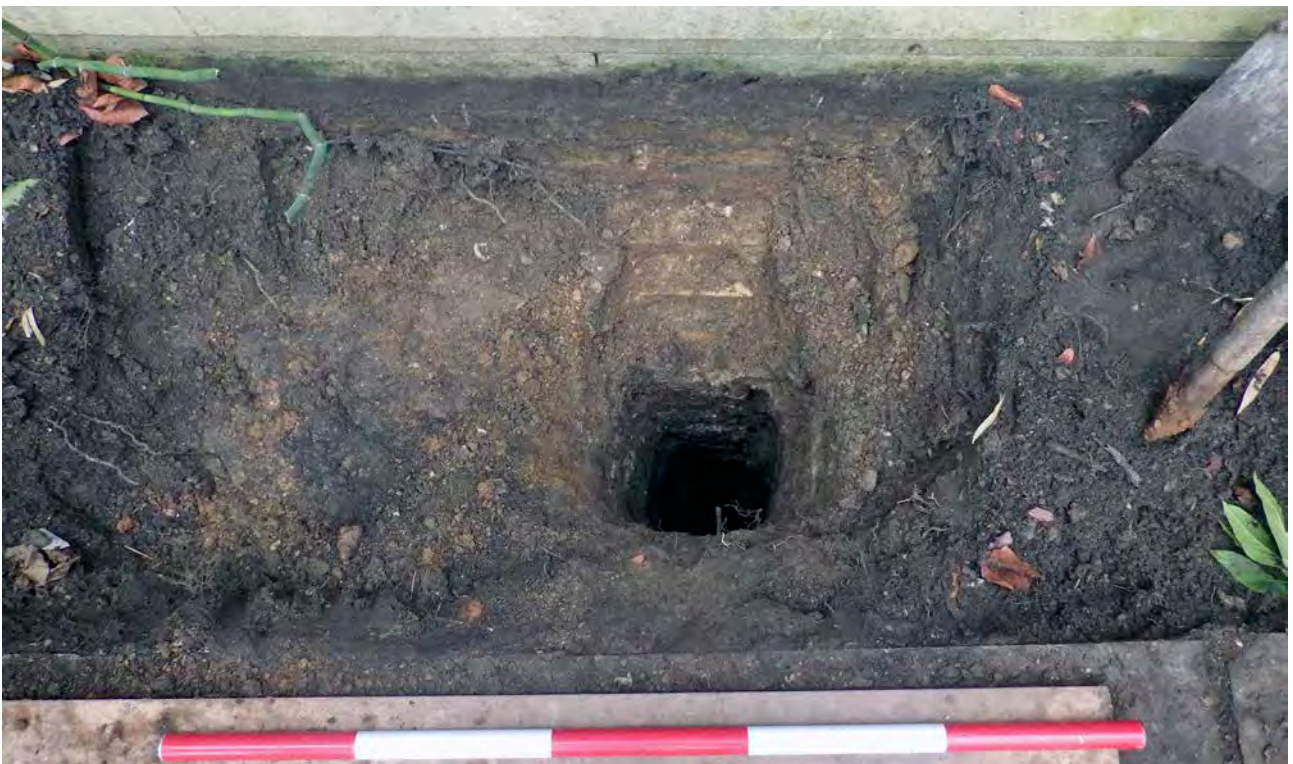
Plate 2: Test pit 2, view to W

3.5.1 Test-pit 2 was excavated to a depth of 2.16m BGL (Fig. 3). The test-pit was located on the external side of a wall on the west side of Main Quad (Fig. 2). It established that the walls foundations were constructed to a depth of 2.16m BGL. At between 0.4m

and 0.58m BGL the wall foundation stepped out three times, to a maximum width (within the test pit) of 0.3m.

- 3.5.2 The lowest deposit encountered, 2003, comprised moderately compact, dark grey clayey silt, 1.26m in depth. This deposit almost certainly represented the backfill of the construction trench for the wall, although the cut for this was not exposed within the test-pit.
- 3.5.3 Overlying 2003 was a mixed deposit, 2002, containing modern brick and 0.34m thick. This was overlain by a loose, light greyish yellow sandy gravel, 2001, 0.34m thick. This in turn was overlain by the current garden soil, 2000, which was 0.22m thick.
