Church Of St. Mary The Virgin Kintbury, Berkshire

Archaeological Watching Brief

ARCHAEOLOGICAL WATCHING BRIEF REPORT

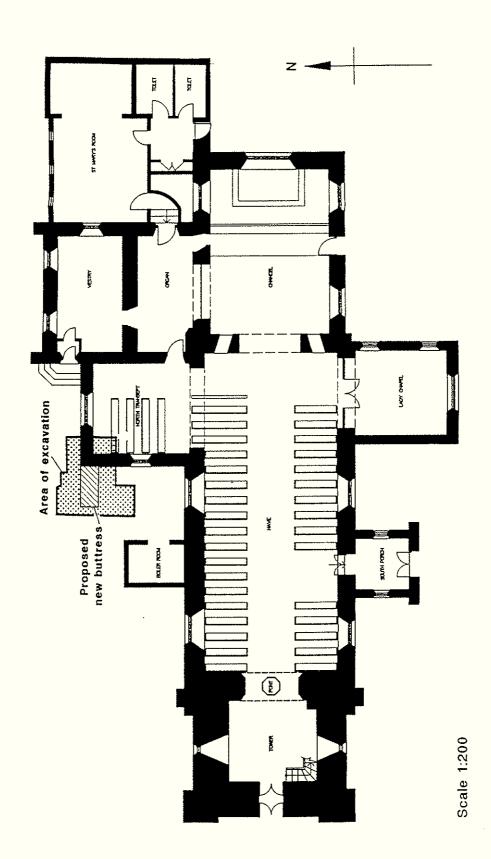
The operation initially required a area of approximately 12 sq m to be excavated to a depth of 2.0m against the W side of the transept, to provide for a concrete base for a new buttress (Fig 1). This phase of the operation was satisfactorily observed.

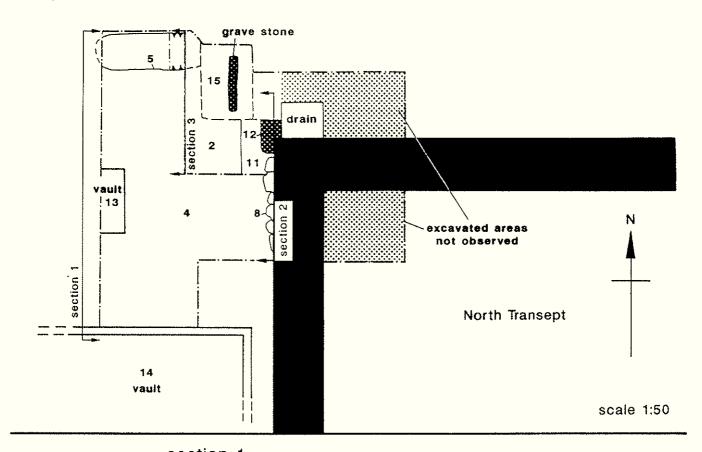
scale 1:50 figure 2

The buttress trench was hand excavated by the contractor to a mean depth of 2.1 m. The horizon of undisturbed natural chalk (4) was approximately 1.80 m below present ground level, tipping very slightly to the N. Where not disturbed by later features, this

was overlaid by a layer of mixed dark brown silty clay with 30% chalk fragments (3).

As seen in section 2, layer 9 which appears to correspond to (3), had been slightly truncated by the construction of the flint transept wall (7), and its footing (8) of flint in a silty clay matrix. No dating evidence was recovered from layers 3 or 9.

The exposed part of wall (7) revealed an area of brickwork (16) infilling an area 0.40 m deep and at least 0.50 m wide. This was finished flush with the wall face and set on the top of the footing layer (8).

Partly revealed under the ashlar blocks of the corner of wall (7) was a roughly worked sarsen slab (12). This was resting on a 0.20 m deep x 0.50 m wide layer of concrete (11) which extended along the side of the wall to the S.

Overlying the layers 3 and 9 was a 1.50 m deep layer of mixed silty loam and approximately 30% decayed chalk (2). Inclusions of stone and tile fragments, and redeposited human bone were noted.

Against the N side of the trench, layer 2 was cut by a W-E grave (5). A small sondage dug below the general excavation depth revealed the pelvic area of the burial (6). Sufficient was cleared to establish that the burial was probably that of an adult, supine, with the head to the W. Fragments of coffin fittings and a coffin plate were identified, although the latter was too badly corroded for any inscription to be discerned. Given that the burial was below the excavation depth, it was not disturbed further.

The sides of two 19th century brick vaults were revealed on the W and S sides of the trench (13), (14).

The brick infilling (16), and the concrete layer (11) could be interpreted as two earlier attempts to rectify subsidence problems in this area. The bricks appear to be similar in character to those in the S transept, which may indicate that this work was undertaken at the same time as the S transept's construction in the 18th century. The concrete slab (11) is a more recent attempt, probably 20th century.
