Cayton Park, Hurley, Berkshire

Archaeological Evaluation Report

June 2020

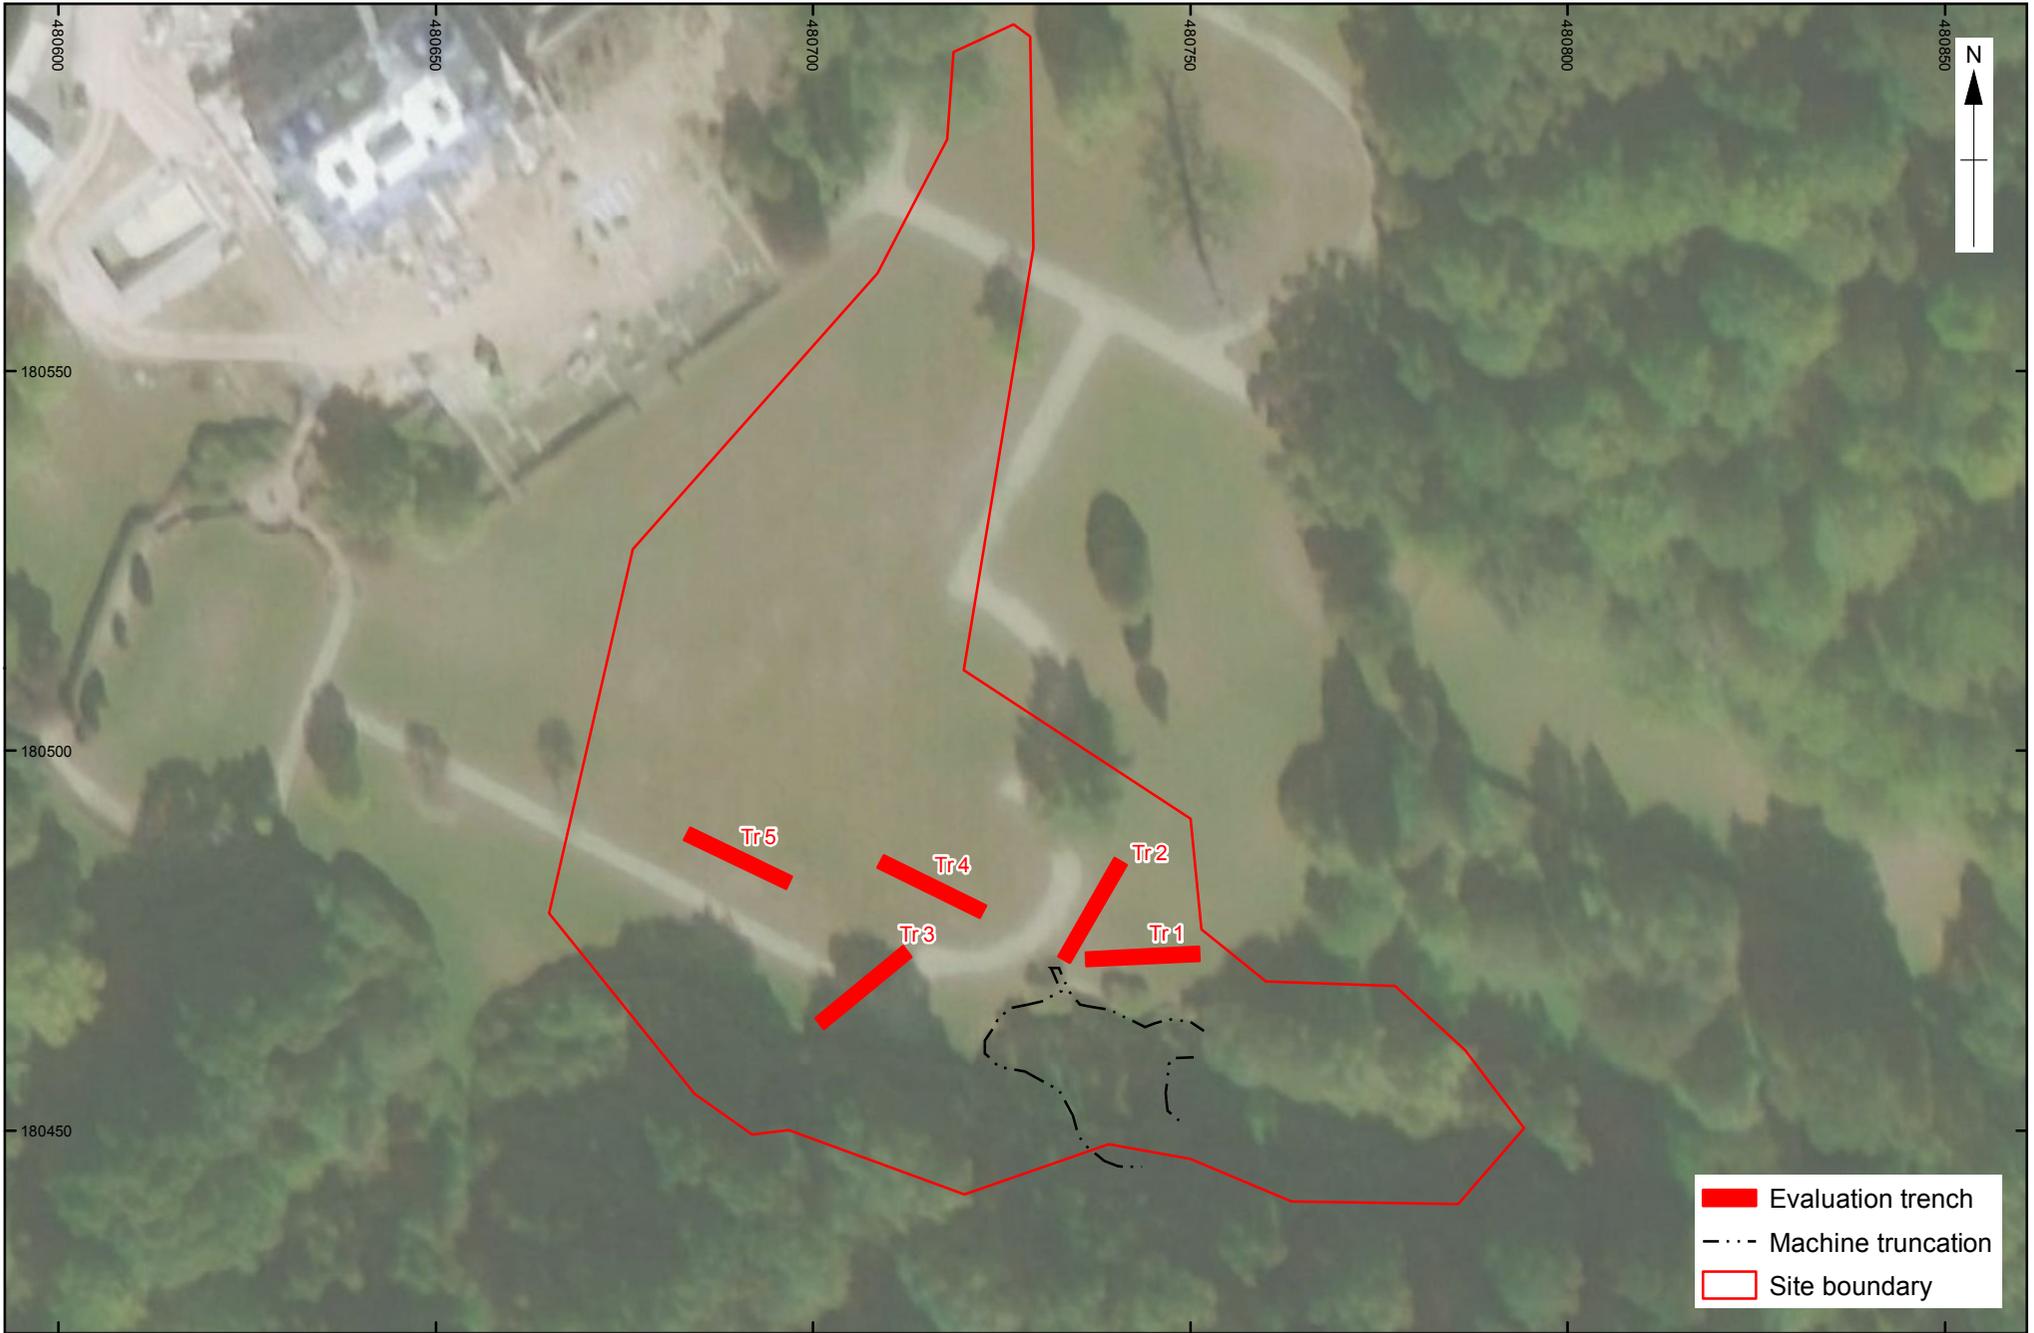
Figure 2: Trench location

2.3.1 Five evaluation trenches measuring 15m by 1.6m were excavated within the footprint of the proposed lake, equating to a 4% sample of the proposed development area (Figure 2). All works were undertaken in accordance with the methodology outlined in the WSI.

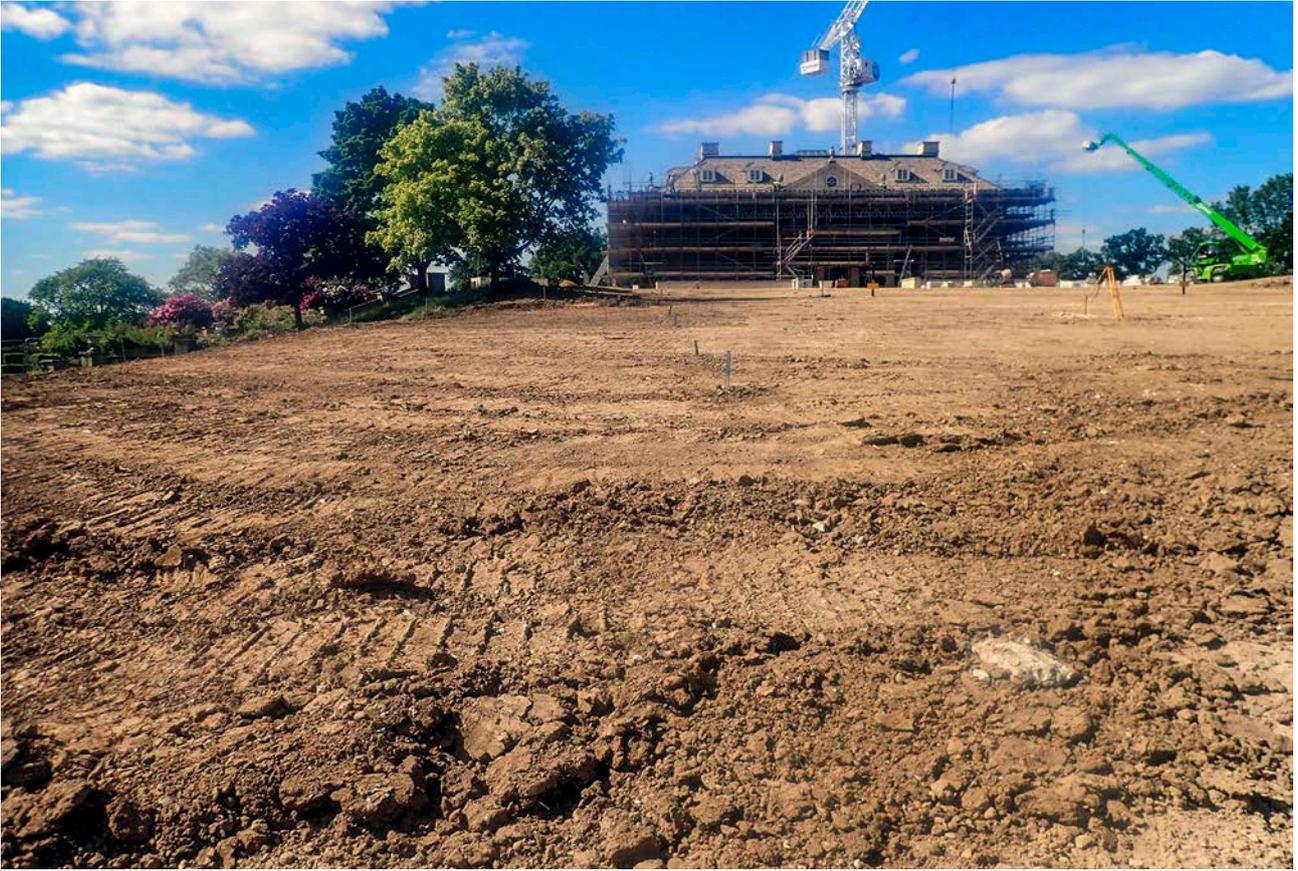
Plate 1: General shot of site

3.2.1 The soil sequence in the trenches was uniform. The natural geology of London Clay Formation was overlain by a layer of disturbed geology. The topsoil had been impacted by the contractors prior to the start of the evaluation in the locations of Trenches 1, 2, 4 and 5 which created this disturbed geological horizon (Plate 1). Topsoil was recorded in Trench 3 as directly overlying the natural geology.

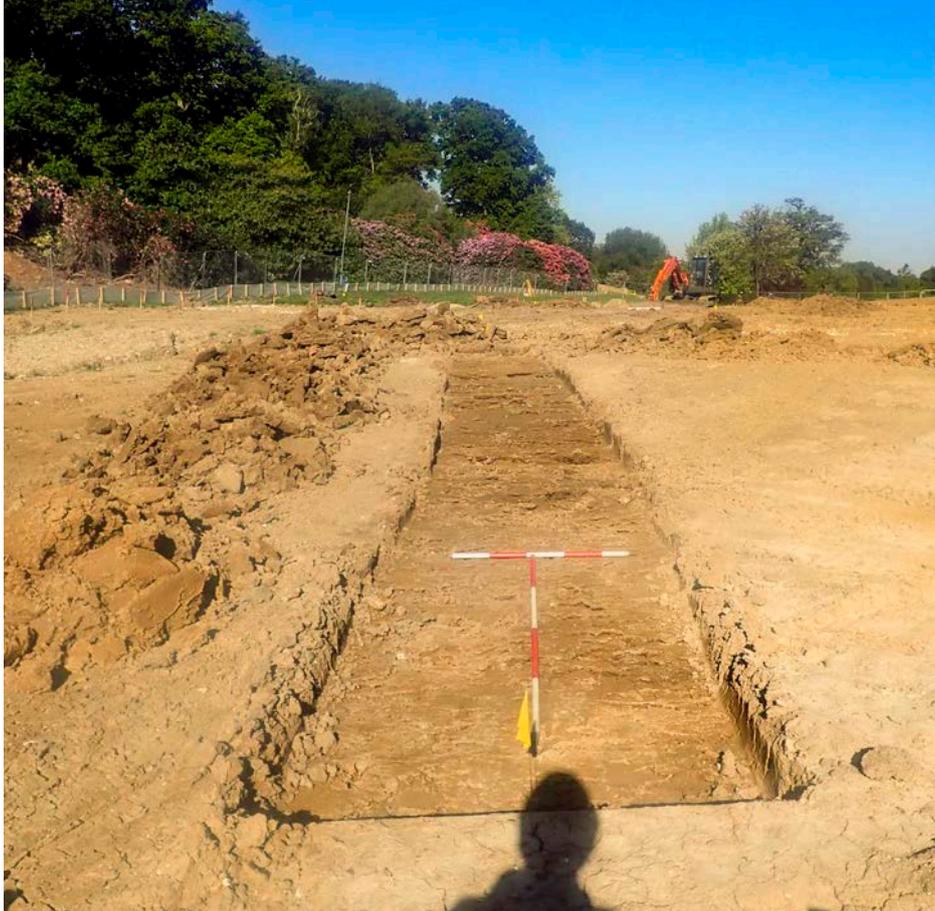
Plate 2: Trench 1

3.3.1 The evaluation did not record any archaeological deposits or features (Plates 2-6).

Trench 1						
General description					Orientation	NE-SW
Trench did not contain any archaeology.					Length (m)	15
					Width (m)	1.6
					Avg. depth (m)	0.13
Context No.	Type	Width (m)	Depth (m)	Description	Finds	Date
100	Layer	-	0.1	Disturbed soil horizon	-	-
101	Layer	-		Geology. Yellow brown clay	-	-

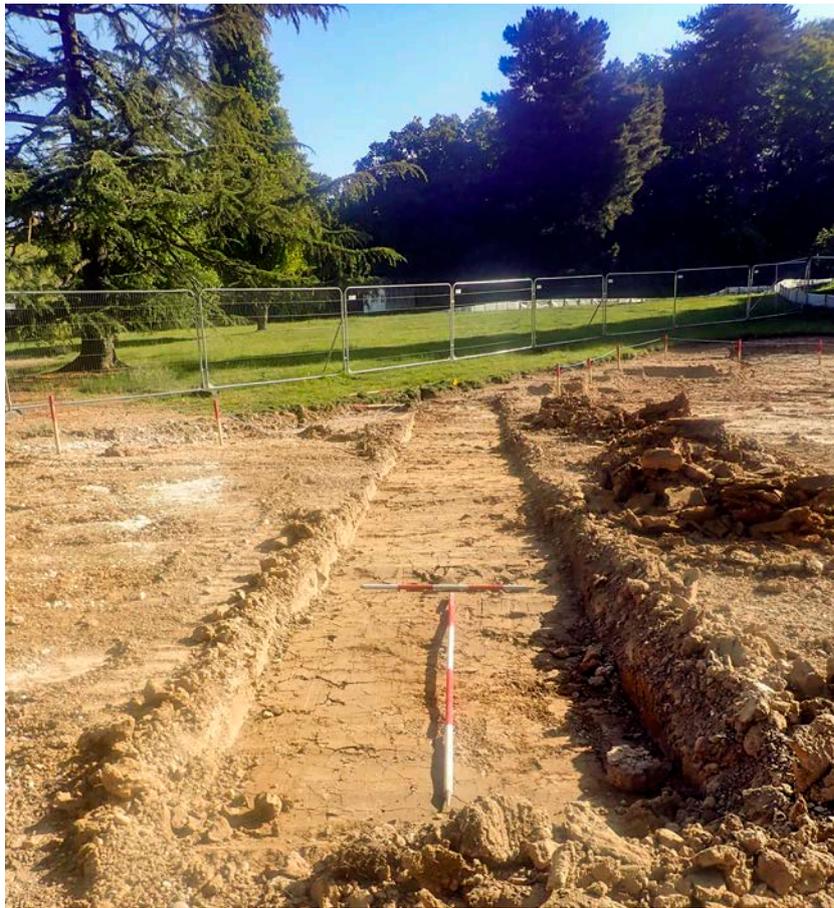
Plate 3: Trench 2

Trench 2						
General description					Orientation	N-S
Trench did not contain any archaeology.					Length (m)	15
					Width (m)	1.6
					Avg. depth (m)	0.15
Context No.	Type	Width (m)	Depth (m)	Description	Finds	Date
200	Layer	-	0.1	Disturbed soil horizon	-	-
201	Layer	-		Geology. Yellow brown clay	-	-

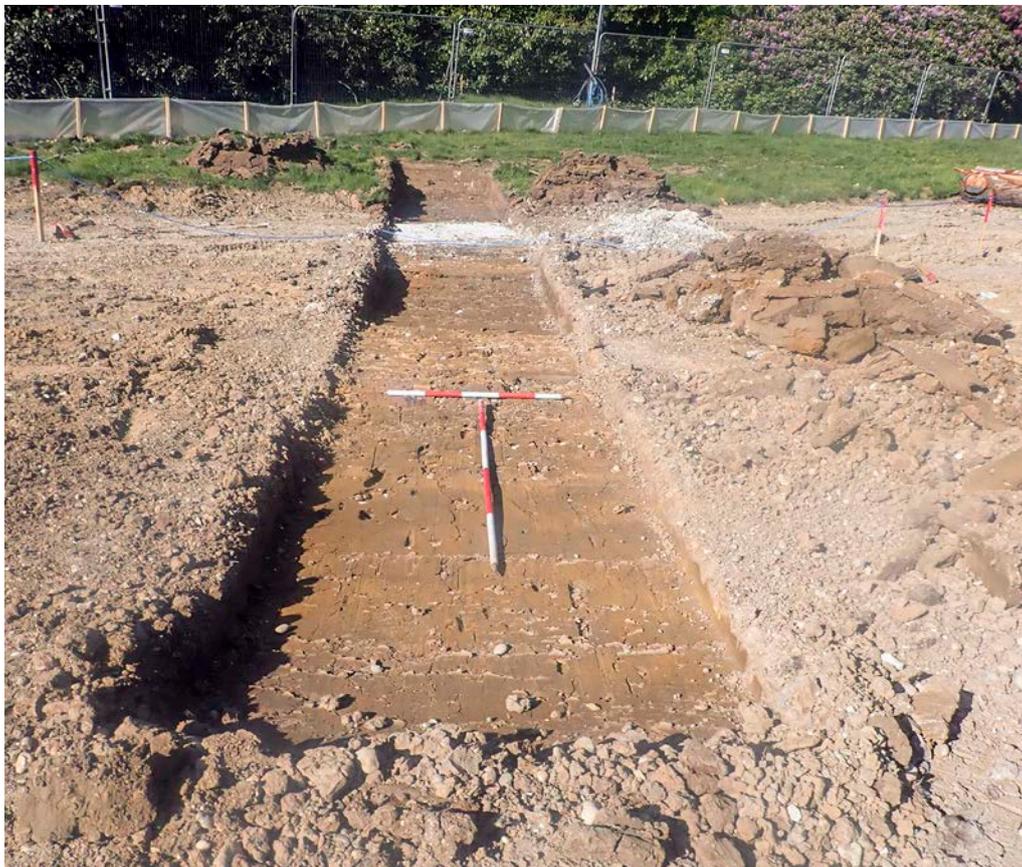
Plate 4: Trench 3

Trench 3						
General description					Orientation	NNE-SSW
Trench did not contain any archaeology.					Length (m)	15
					Width (m)	1.6
					Avg. depth (m)	0.17
Context No.	Type	Width (m)	Depth (m)	Description	Finds	Date
300	Layer	-	0.24	Topsoil	-	-
301	Layer	-		Geology. Yellow brown clay	-	-

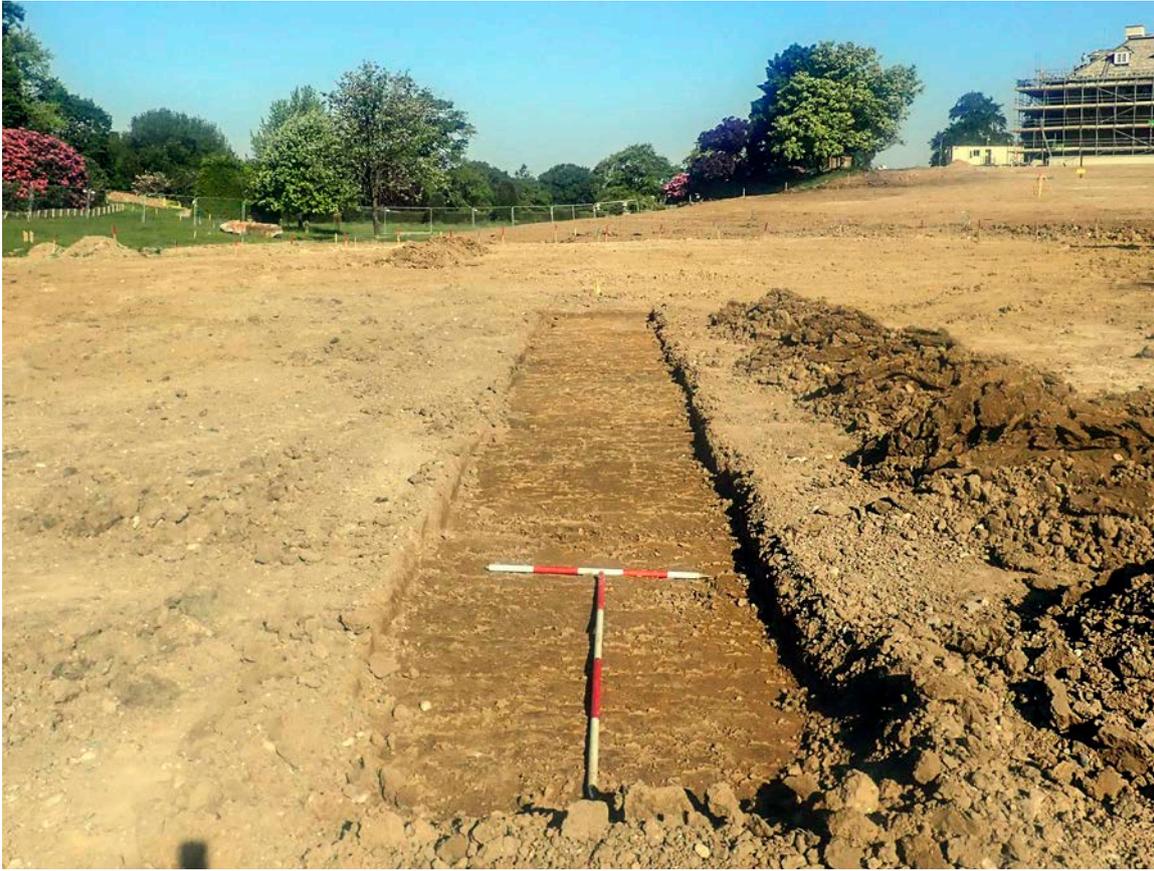
Plate 5: Trench 4

Trench 4						
General description					Orientation	E-W
Trench did not contain any archaeology					Length (m)	15
					Width (m)	1.6
					Avg. depth (m)	0.13
Context No.	Type	Width (m)	Depth (m)	Description	Finds	Date
400	Layer	-	0.1	Disturbed soil horizon	-	-
401	Layer	-		Geology. Yellow brown clay	-	-

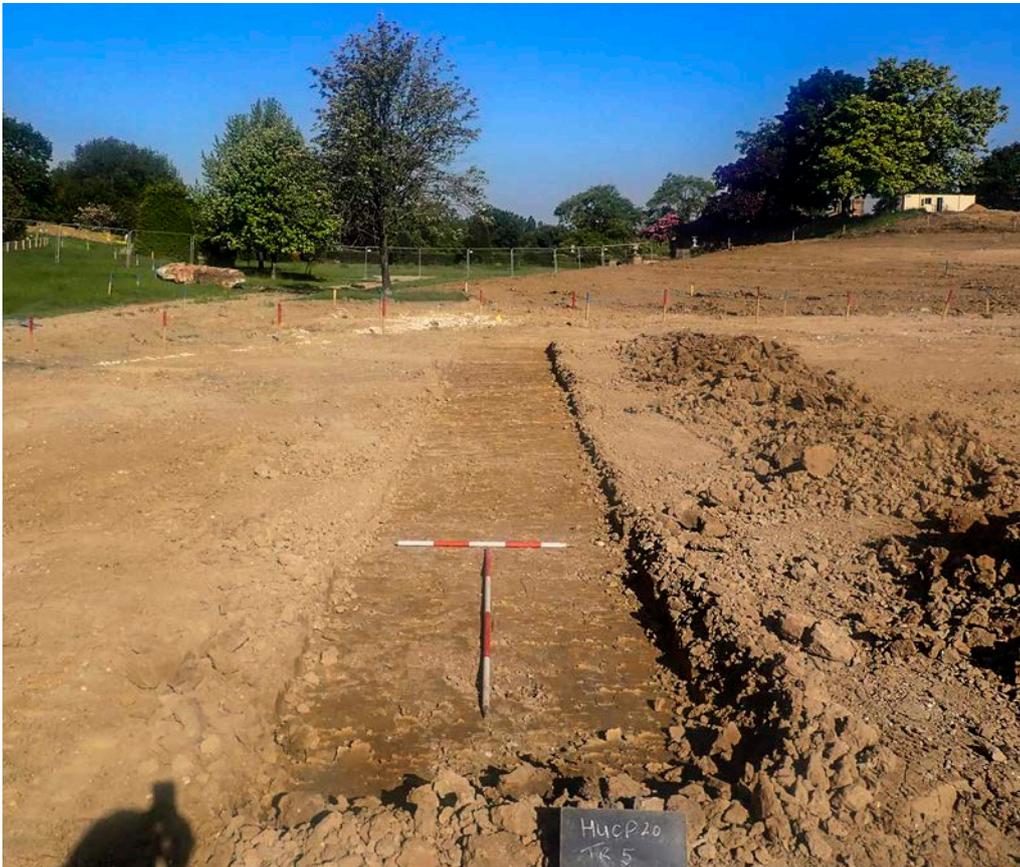
Plate 6: Trench 5

Trench 5						
General description					Orientation	E-W
Trench did not contain any archaeology					Length (m)	15

Width (m)	1.6
					Avg. depth (m)	0.13
Context No.	Type	Width (m)	Depth (m)	Description	Finds	Date
500	Layer	-	0.1	Disturbed soil horizon	-	-
501	Layer	-		Geology. Yellow brown clay	-	-
