Land at Maylands Avenue, Hemel Hempstead, Hertfordshire

Archaeological Evaluation Report

November 2020

Client: Prologis

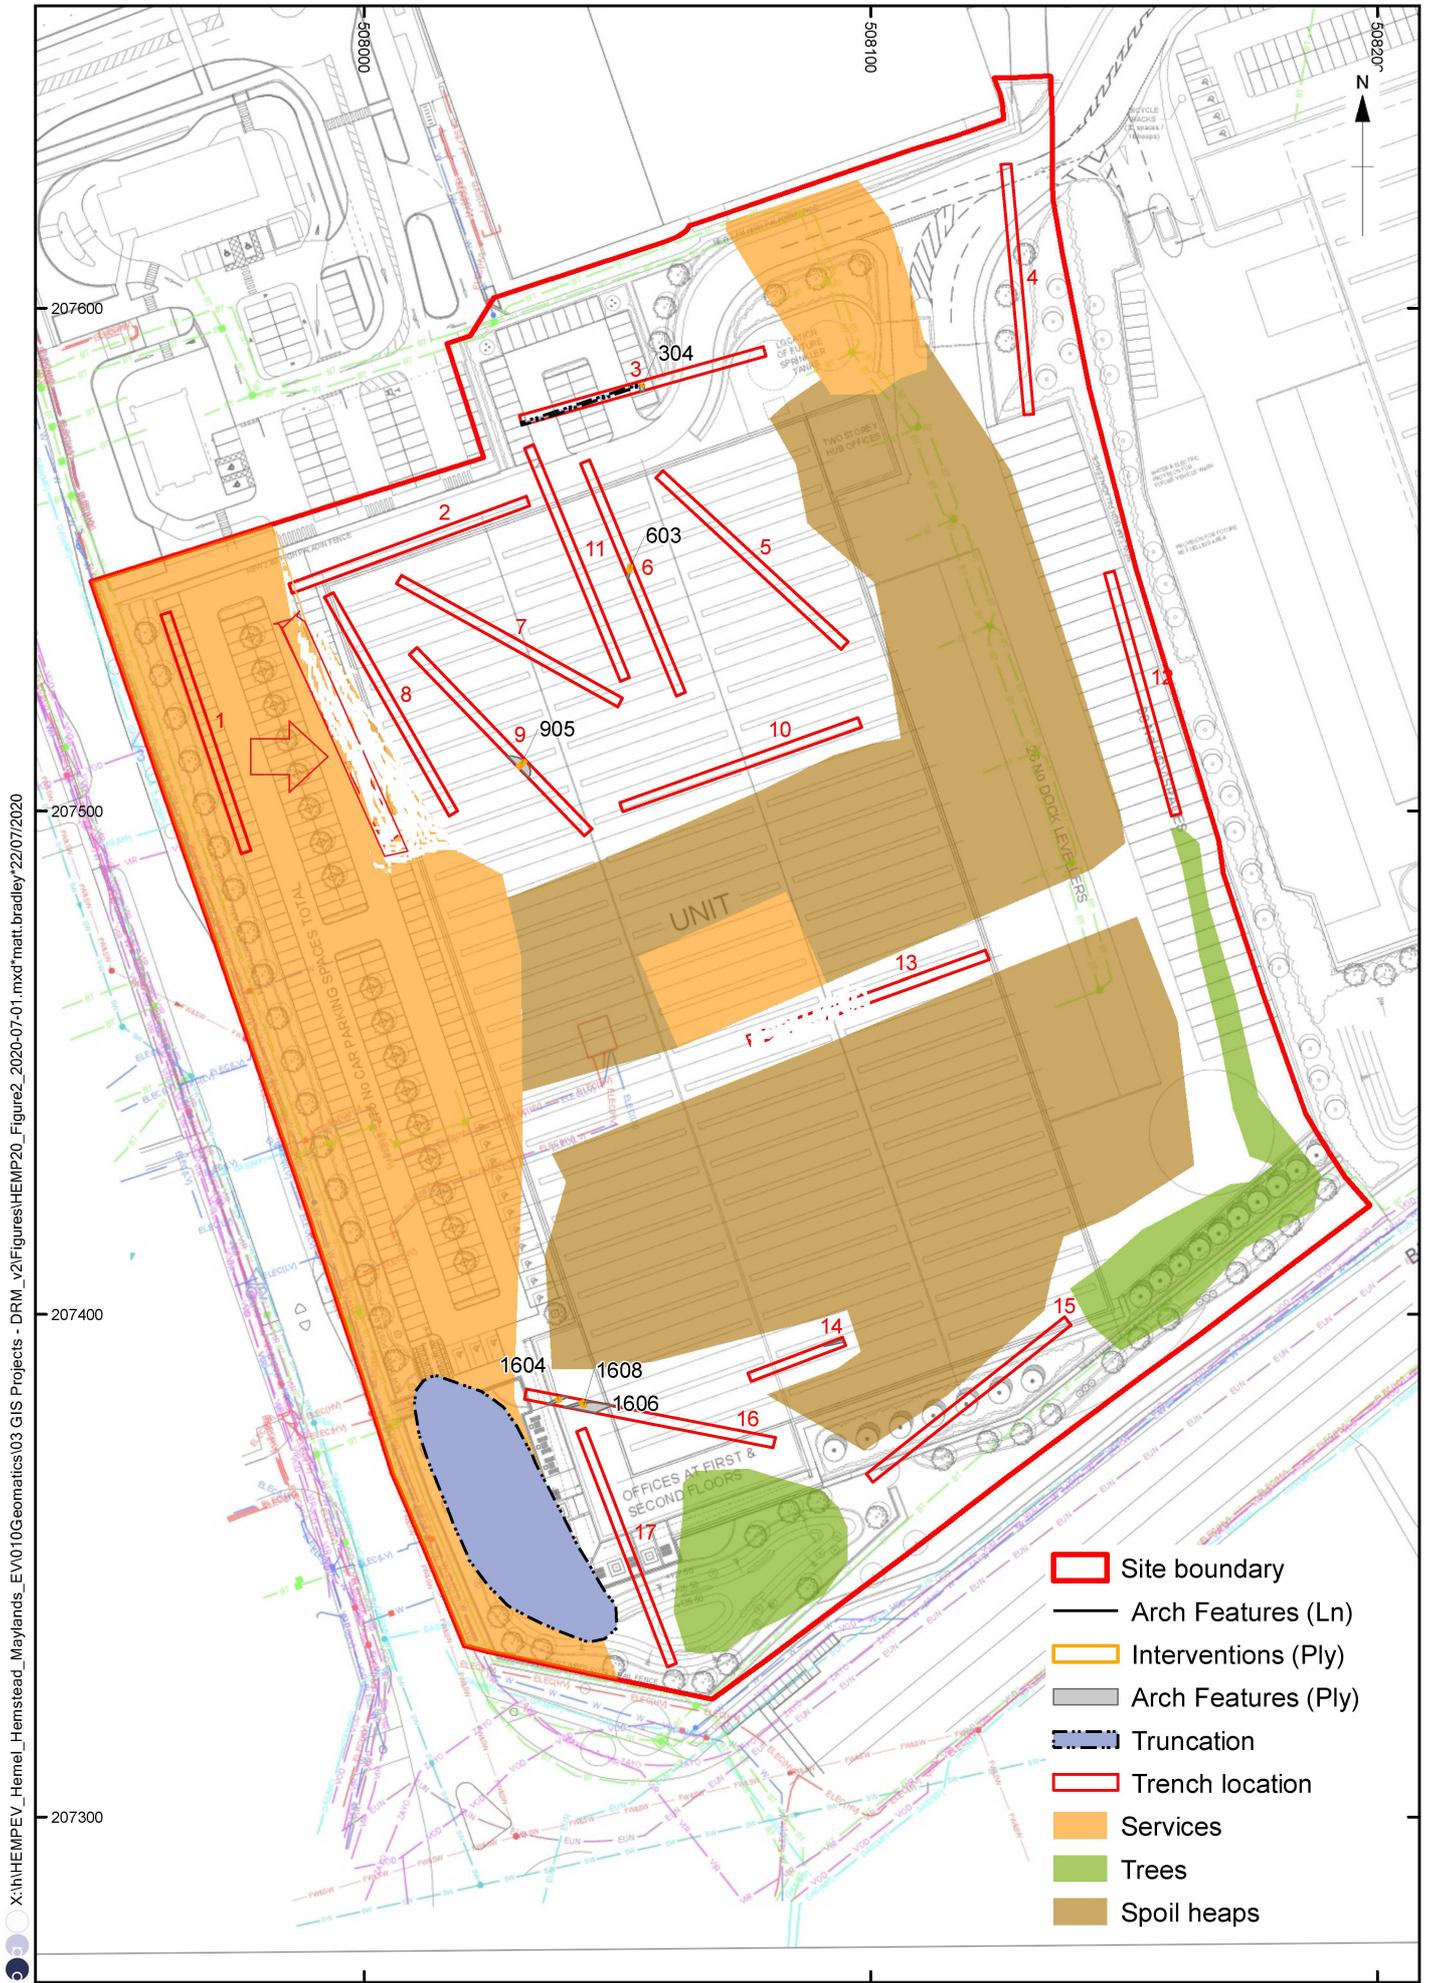
Figure 2 : Trench locations

2.2.1 A total of 17 trenches were excavated, each measuring 1.8m by 50m and representing a 4% sample of the development area. The location of some of the trenches had to be altered from their proposed position outlined in the WSI (RPS 2020) in the field owing the presence of services, modern structures, walls, spoil heaps and vegetation (Fig. 2).

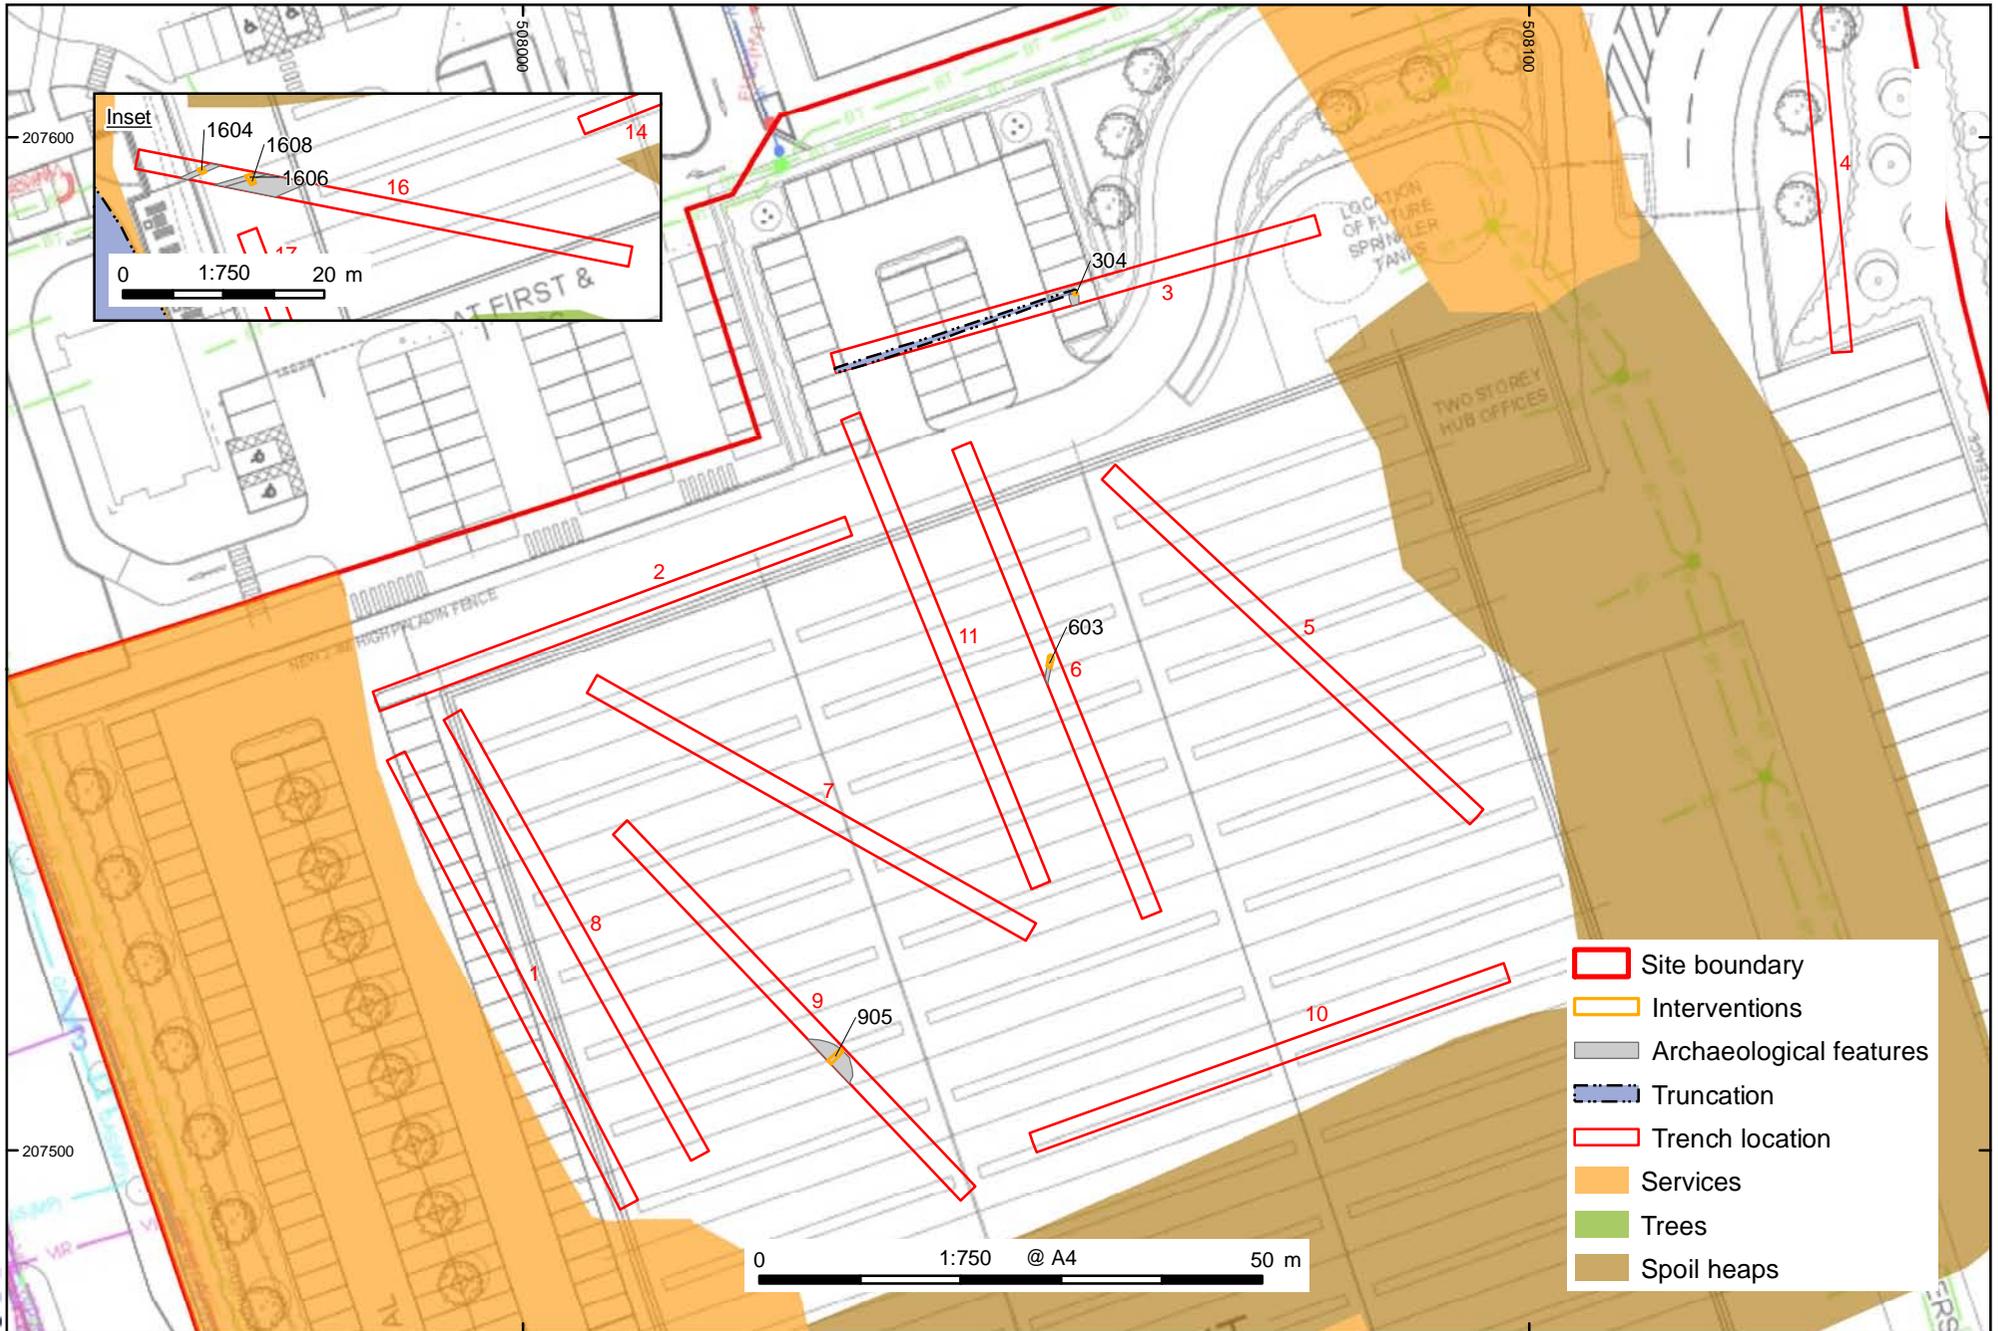
Figure 3 : Detailed plan of trenches 1-11 (with inset of trench 16)

- 3.4.2 A very small number of features of probable modern or natural origin were located in these trenches. Trench 6 contained a possible narrow ditch (603; Figures 3 and plate 8). This was aligned broadly N-S and had a V-shaped profile (Figure 4). It measured 0.77m in width and 0.33m in depth and was filled with a dark brown sandy clay with occasional flint pebbles.

- 3.4.3 A large, deep circular feature (905; Figure 3 and plate 19) was partially revealed by Trench 9. It measured 1.32m in width and at least 0.26m in depth; it was not bottomed owing to its location at the edge of the trench (Figure 4). It contained material in the

- 3.6.2 The only feature of possible archaeological origin in these trenches was a ditch (1604) in Trench 16 (Figures 3 and 4; Plate 22). There were no finds recovered from its brown silty clay fill, but two other similarly aligned features adjacent to it (1606 and 1608; Figure 4 and plates 23 and 24) were filled with modern material and tile of late 19th-century date and it is likely that feature 1604 is also of the same date. Ditch 1606 was seen extending through Trench 14, though was not numbered there. Trenches 15 and 17 were empty.

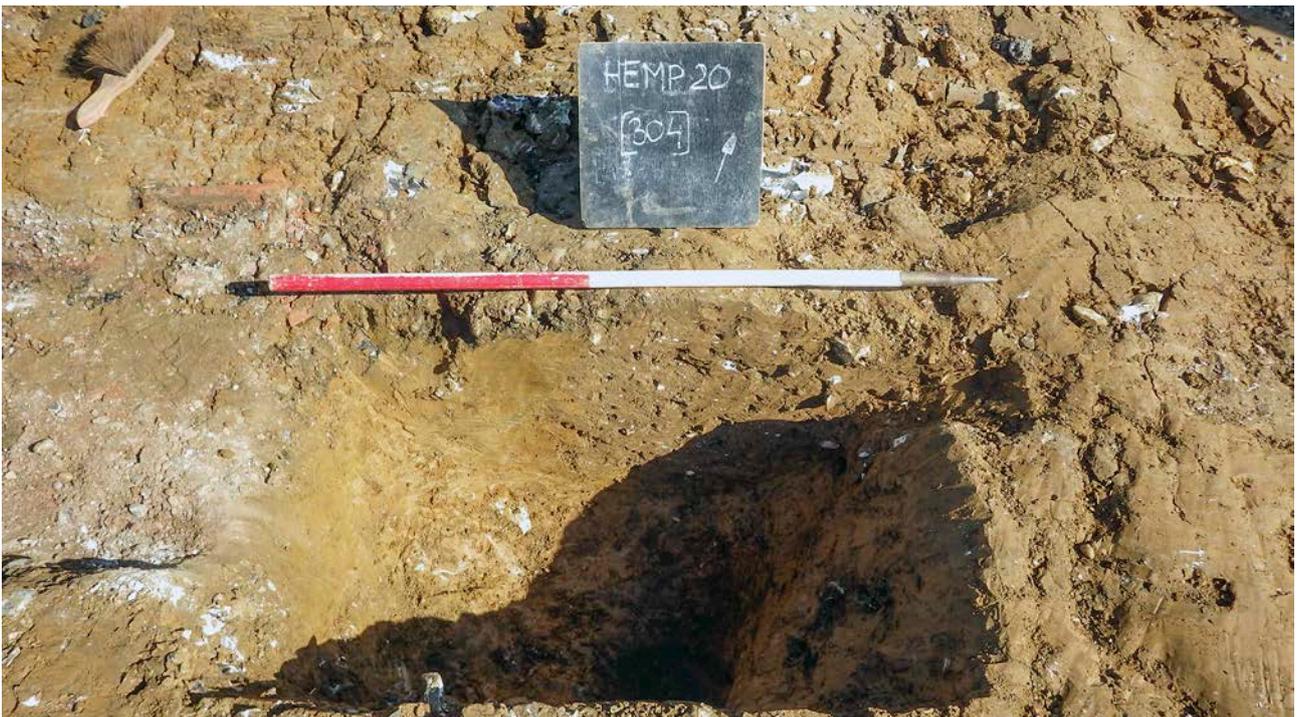
Plate 3: View to N, S. 300 of feature (304) 1x1m scale

Trench 3						
General description					Orientation	E-W
Trench devoid of archaeology. Brick lined service trench truncated a possible tree throw hole, two possible robber cuts for post medieval or modern foundations were present but not recorded in detail. Natural of yellow-orange clay.					Length (m)	50
					Width (m)	2.20
					Avg. depth (m)	0.65
Context No.	Type	Width (m)	Depth (m)	Description	Finds	Date
300	Layer	-	0.35-0.95	Levelling/ rubble overburden	-	-
301	Layer	-	-	Natural	-	-
302	Structure	0.11	0.07	Modern services		
303	Fill	-	0.53	Fill of possible natural feature	CBM (1 pc 11g)	L18-19C
304	Cut	1.2	0.53	Possible natural feature

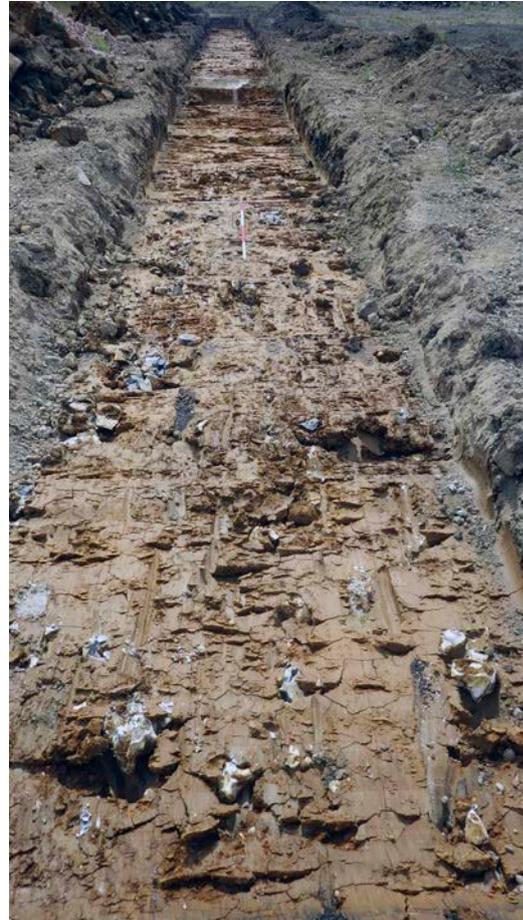
Plate 7: View to SE Trench 5, 1x2m scale

- 3.4.5 There were remnants of a concrete surface in Trench 5 and extant concrete structural blocks in Trenches 1, 7, 10 and 11. In Trench 7 there were two irregular non-archaeological features, probably areas of modern disturbance. Two intersecting brick drains were located in Trench 8, and there was also an undated sub-circular feature filled with a brownish orange clay in the same trench (Plate 11). This may be natural in origin. A narrow linear feature filled with tarmac and modern debris crossed Trench 12 and may be a service trench.

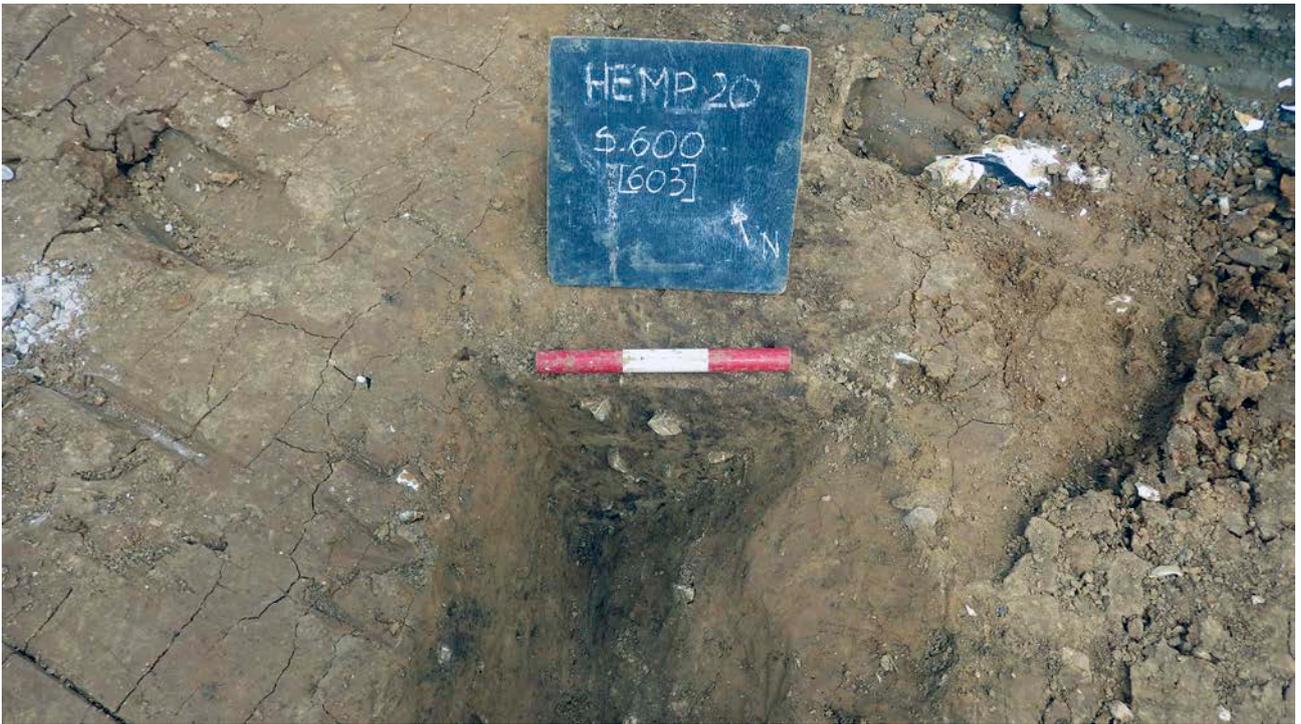
Plate 8: View to NE, S. 600 (603) 1x0.3m scale

Trench 6						
General description					Orientation	NW-SE
Trench devoid of archaeology. A single N-S aligned ditch contained no finds and was not dated.					Length (m)	50
					Width (m)	2.20
					Avg. depth (m)	0.35
Context No.	Type	Width (m)	Depth (m)	Description	Finds	Date
600	Layer	-	0.35	Levelling/ rubble overburden	-	-
601	Layer	-	-	Natural	-	-
602	Fill	-	0.33	Fill of ditch		
603	Cut	0.7	0.33	Ditch

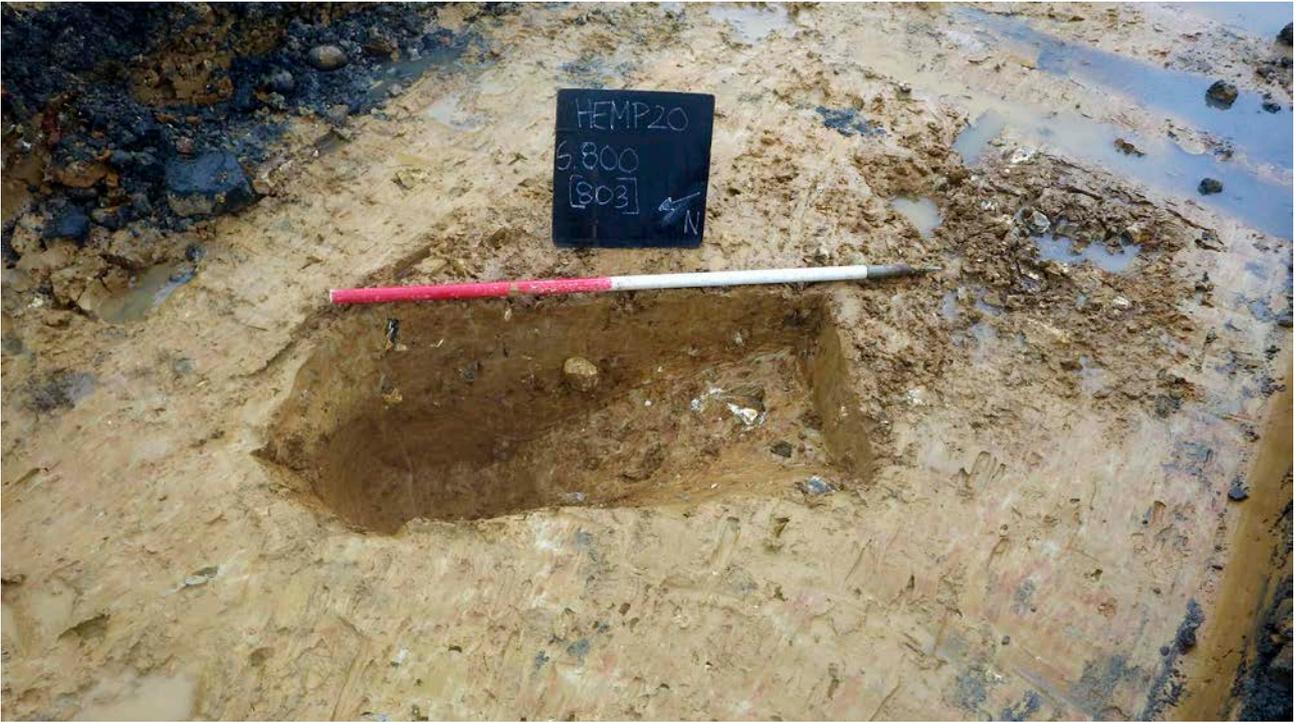
Plate 11: View to SE, S. 800 (803) 1x1m scale

Trench 8						
General description					Orientation	NW-SE
Trench devoid of archaeology. Two modern brick drains, possible pit or natural feature.					Length (m)	50
					Width (m)	2.20
					Avg. depth (m)	0.35
Context No.	Type	Width (m)	Depth (m)	Description	Finds	Date
800	Layer	-	0.35	Levelling/ rubble overburden	-	-
801	Layer	-	-	Natural	-	-
802	Fill	-	0.4	Fill of possible pit

803	Cut	0.77	0.4	Possible pit		
-----	-----	------	-----	--------------	--	--

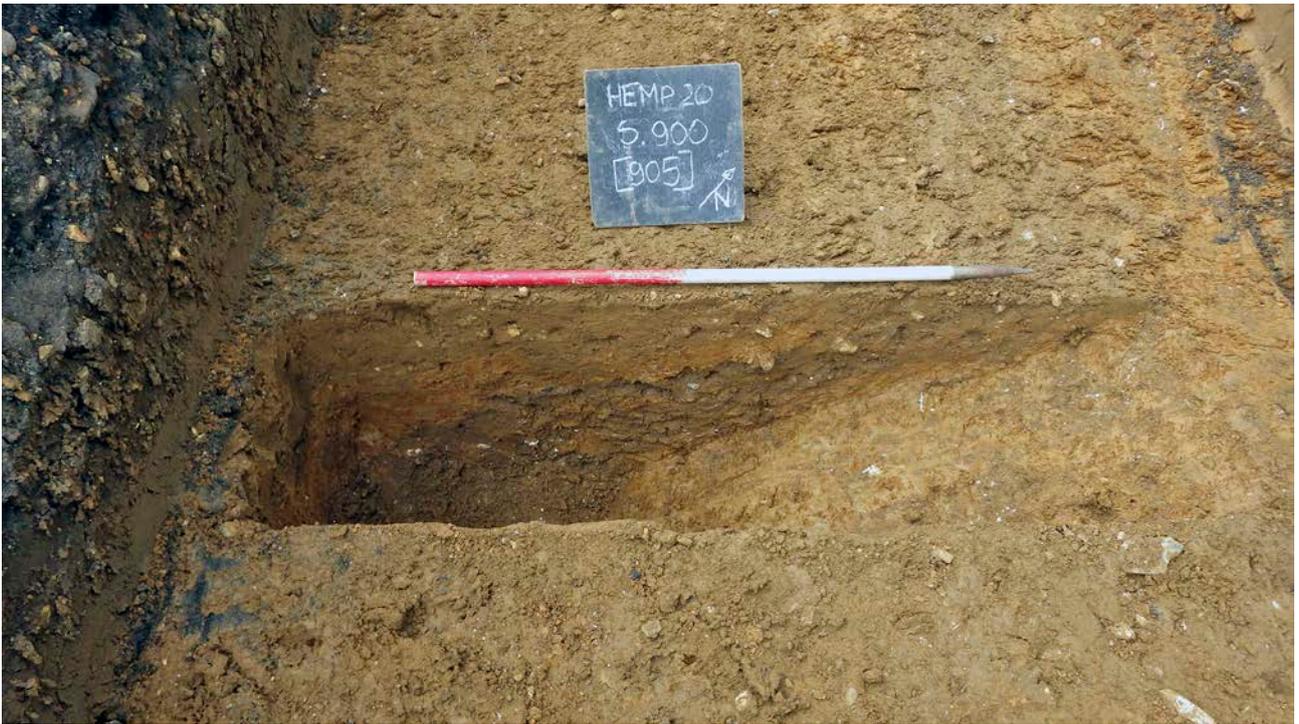
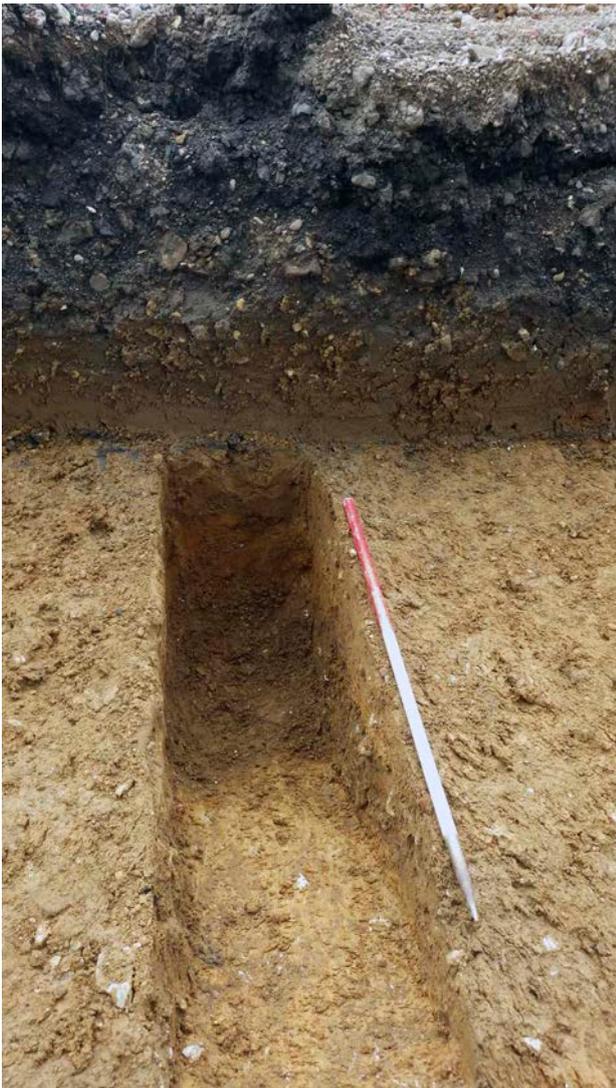
Plate 14: View to NW S. 900 (905) 1x1m scale

upper fill of clear post-medieval and probable modern date including brick, pottery of late 18th to 19th-century date and a modern white mug.

Trench 9						
General description					Orientation	E-W
Trench devoid of archaeology.					Length (m)	50
					Width (m)	2.20
					Avg. depth (m)	0.45
Context No.	Type	Width (m)	Depth (m)	Description	Finds	Date
900	Layer	-	0.3-0.6	Levelling/overburden rubble	-	-
901	Layer	-	-	Natural	-	-
902	Fill	-	0.26	Fill of pit	Pot (3 sherds 11g) CBM (10 pcs 195g)	1780-1840 L18-19C
903	Fill	-	0.26	Fill of pit		
904	Fill	-	0.36	Fill of pit		
905	Cut	1.64	0.64	Pit

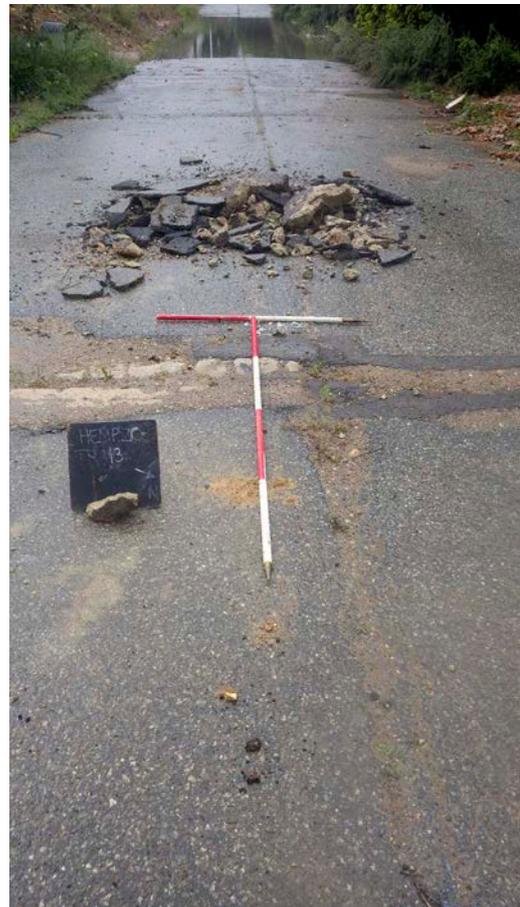
Plate 19: View to SW Trench 13 (unexcavated) 1x2m
1x1m scale

- 3.5.1 One trench was located in the central area of the site along the former tarmac access road (Trench 13). Excavation of the trench commenced, but had to be halted due to the presence of reinforced concrete located under the tarmac. No other trenches were possible in the central area due to the presence of services and upstanding concrete structures.

Trench 13						
General description				Orientation	NE-SW	
Trench could only be excavated to 0.5m, the tarmac surface was removed to reveal reinforced concrete below. The trench could not proceed beyond this point.				Length (m)	0.25	
				Width (m)	2.20	
				Avg. depth (m)	0.5	
Context No.	Type	Width (m)	Depth (m)	Description	Finds	Date

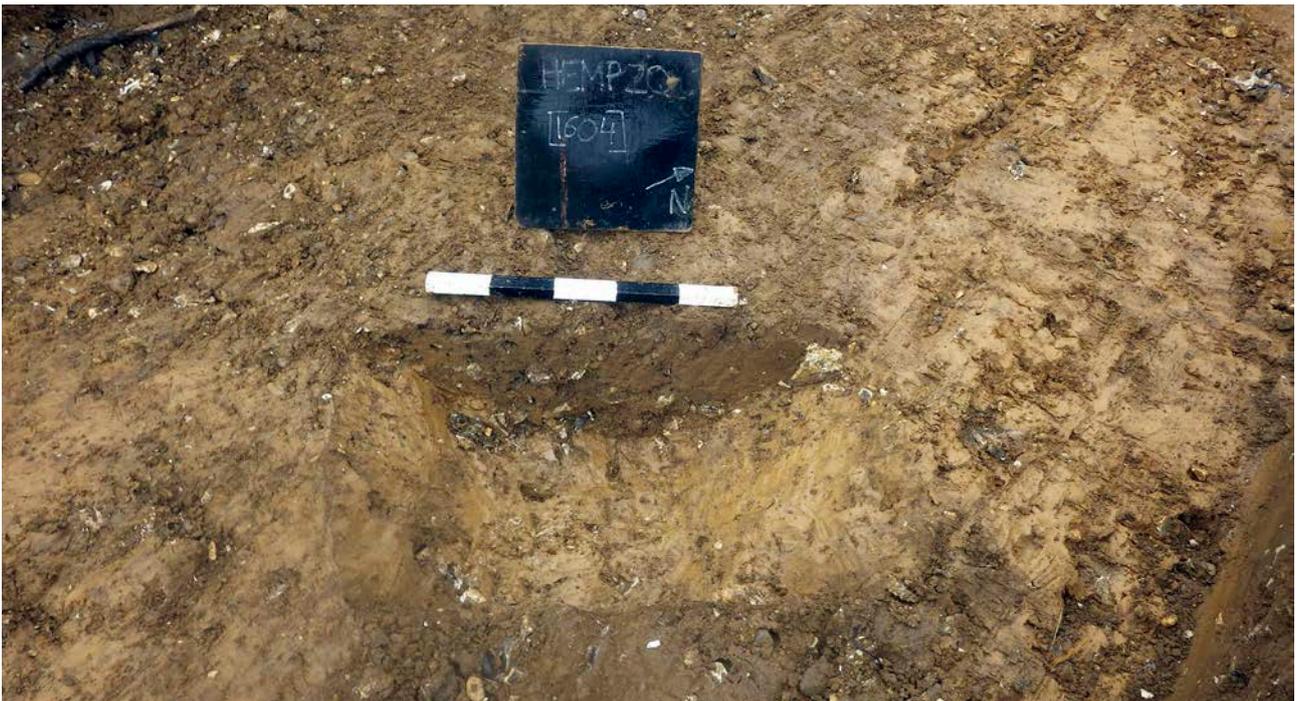
Plate 22: View to W, S.1600 (1604) 1x0.5m scale

1604	Cut	0.86	0.25	Modern ditch		
1605	Fill	-	0.22	Fill of modern ditch		
1606	Cut	0.59	0.22	Modern ditch		
1607	Fill	-	0.12	Fill of modern ditch		
1608	Cut	0.8	0.12	Modern ditch

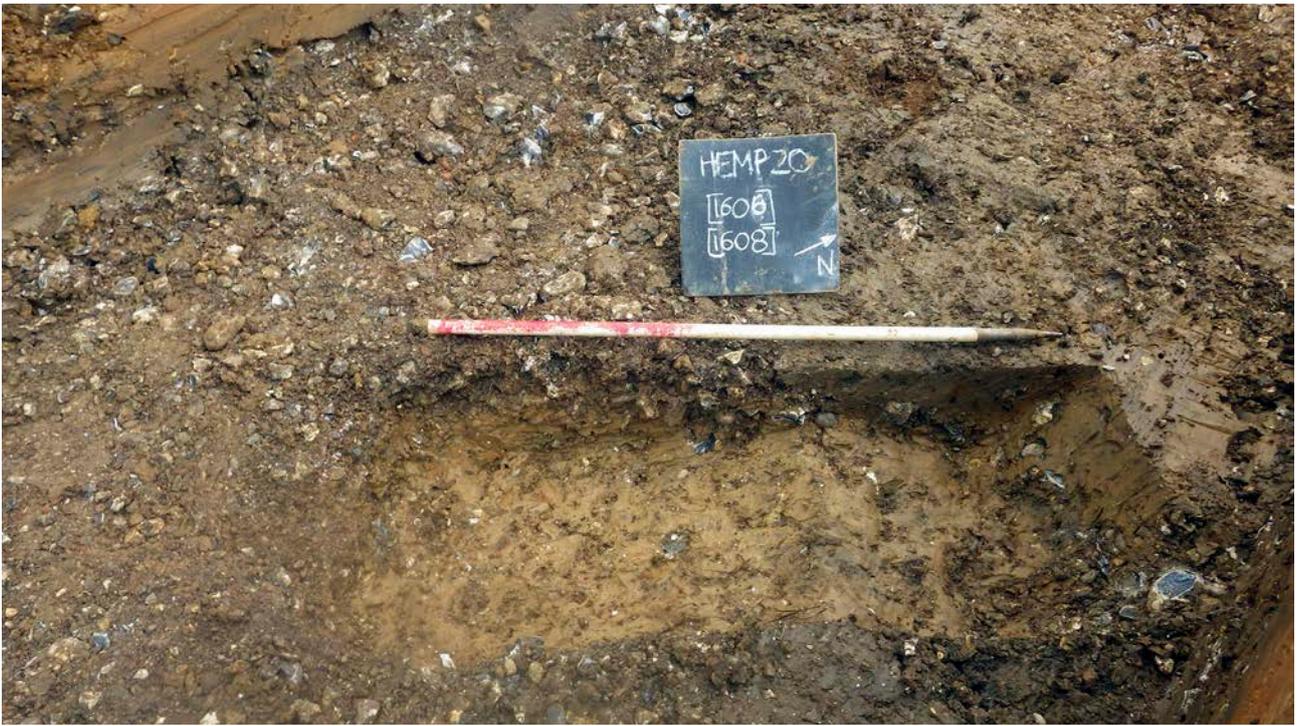
Plate 23: View to W, S.1601 (1606, 1608) 1x1m scale

pieces of encaustic decorated floor tile were recovered from context 1605, fill of ditch 1606. These dated to c 1850-1900. Fragments of roof tile were also recovered from context 1607, fill of ditch 1608.

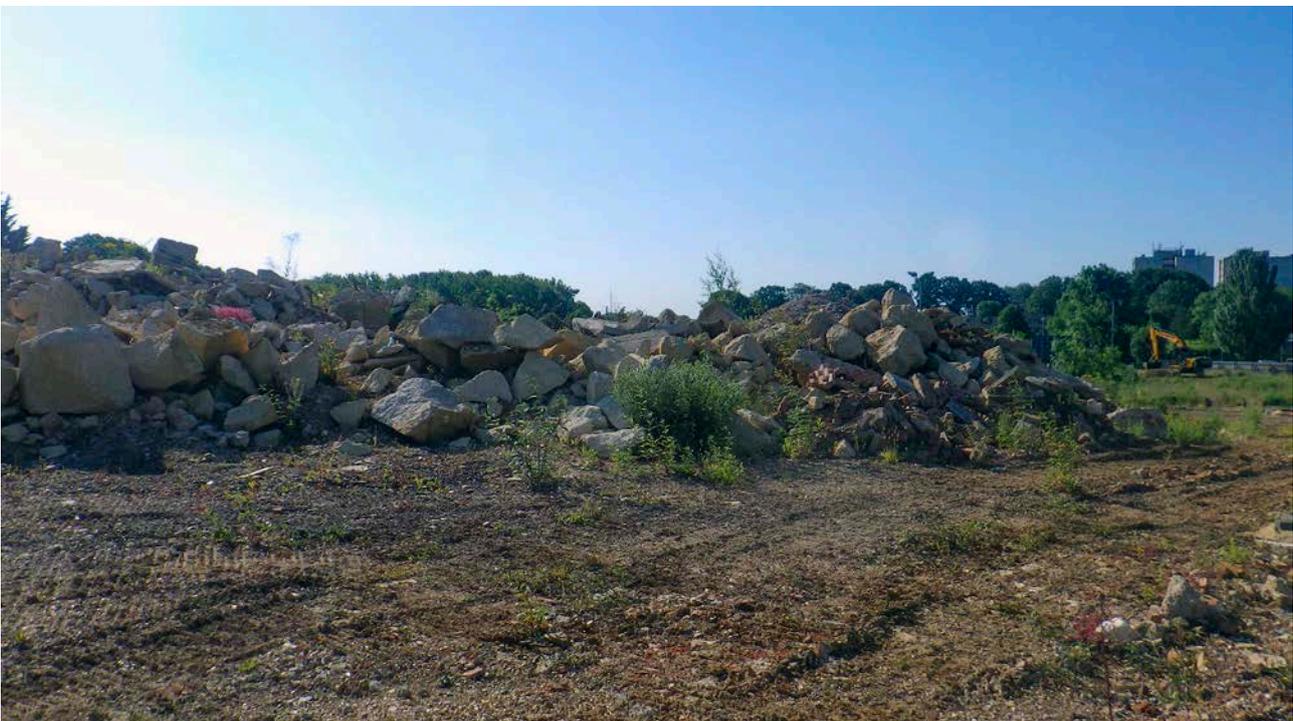
Plate 27: View to S, spoil and rubble heaps between Trenches 13 & 14

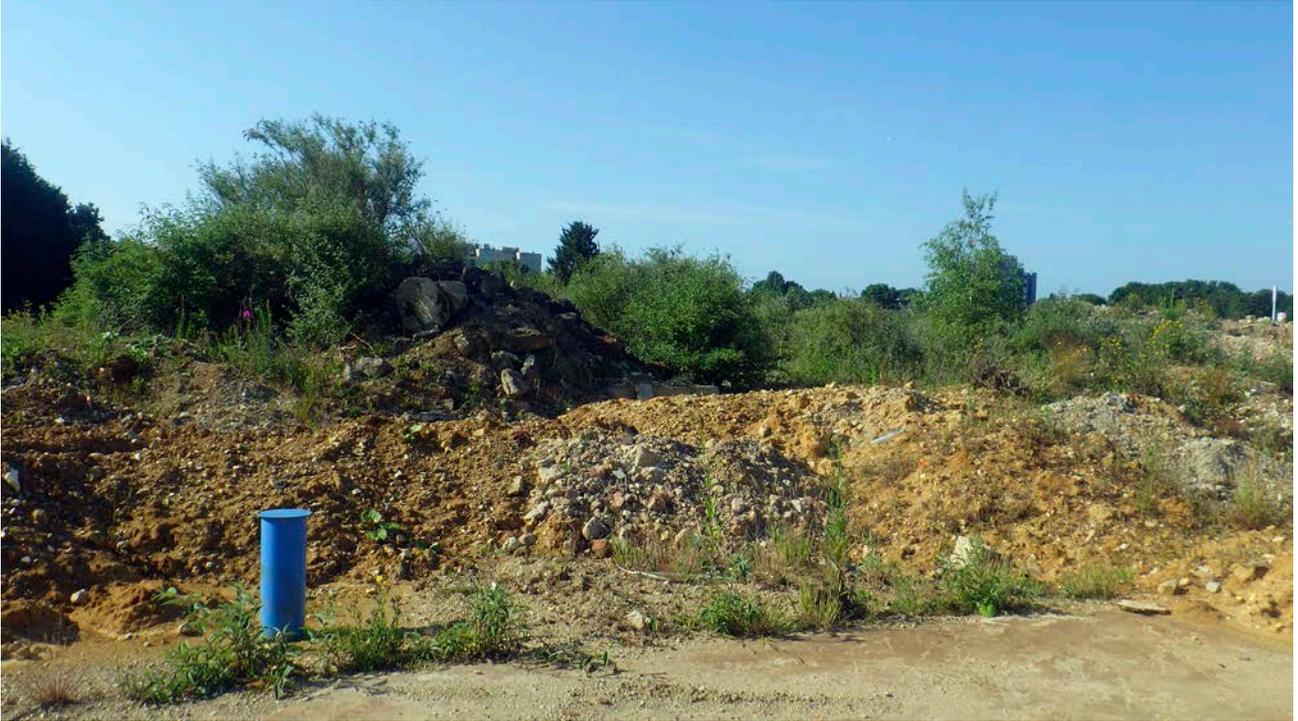
Plate 28: View to SE, rubble spoil heap near Trenches 4 & 5
