Tudor Road, Runcorn, Halton, Cheshire

Archaeological Evaluation and Watching Brief Report

April 2021

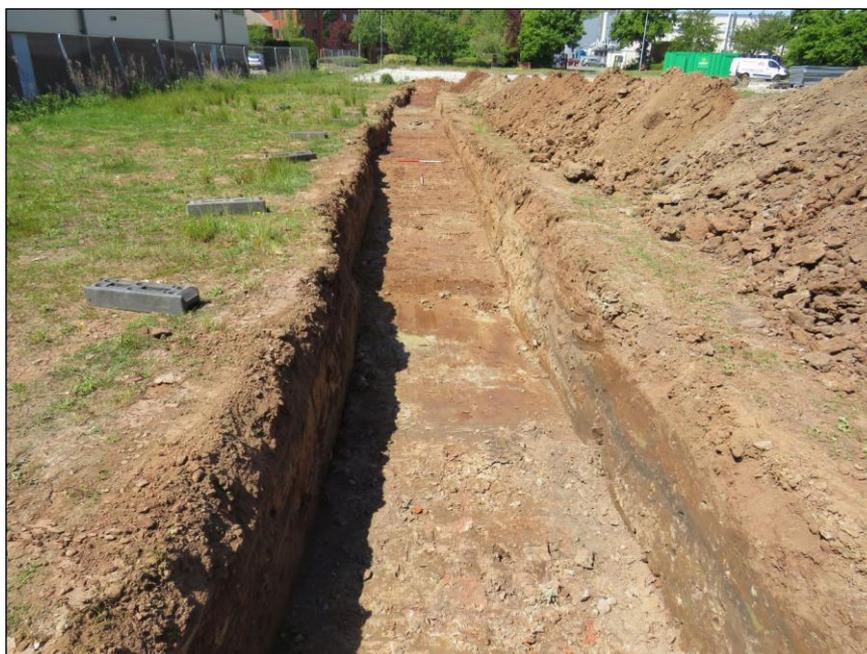
Plate 1: Evaluation trench looking north-west, moat 102 in the foreground (fill 106), scales 1m and 2m

- 3.3.2 Only part of moat **102** was encountered within the south-eastern end of the trench, with a maximum width of 2.8m being exposed, and surviving to a depth of 1.89m. Only the north-western half of the profile was exposed, which was seen to be gradually sloping, with a fairly flat base.

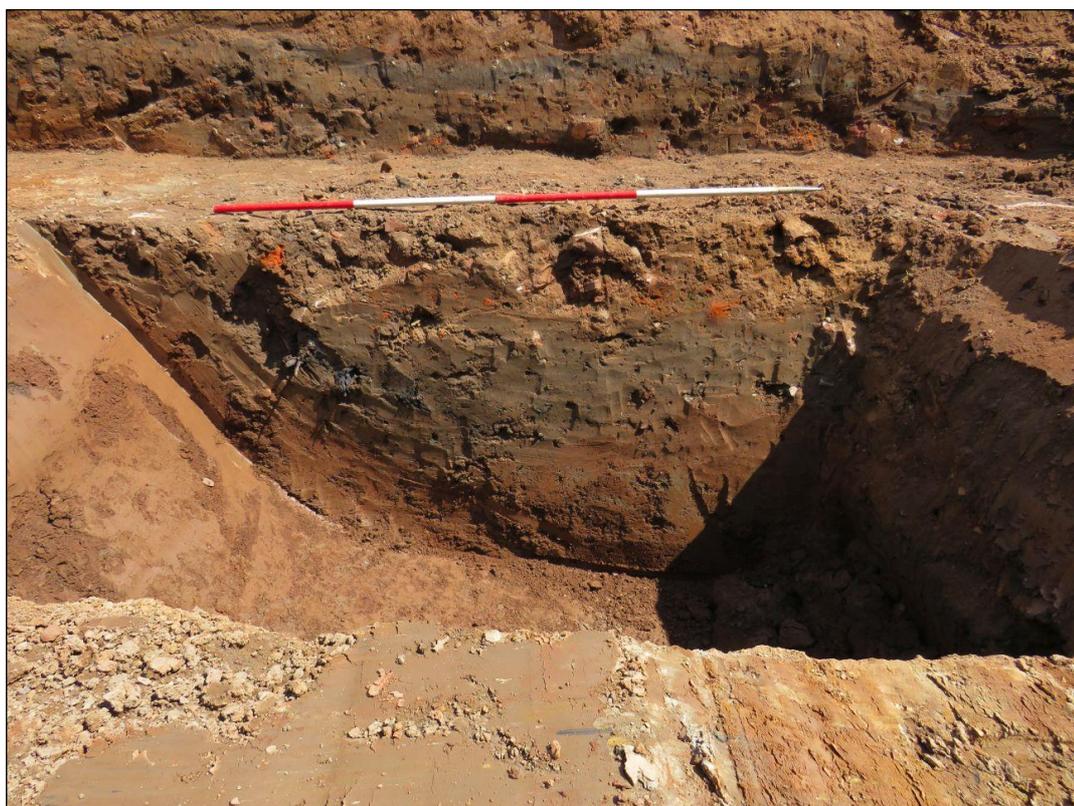
- 3.3.3 The earliest deposit encountered within moat **102** was reddish-grey silt clay **103**, which was 0.6m thick and appeared to be natural silting from open water, presumably after the feature had been abandoned for a period of time, as there was no evidence of the feature being cleaned out. Deposit **103** was overlain by reddish-grey compact silt clay **104**, 0.58m thick, potentially a slumping deposit from the south-eastern edge of the moat, again presumably from a period of disuse. Deposit **104** was, in turn, overlain by mid-brown-grey sandy silt **105**, 0.93m thick, which contained fairly substantial quantities of organic material and charred plant remains, suggesting that the feature had been left open, with leaf litter and vegetation collapsing into standing water for a period of time. The moat then appears to have been filled with redeposited natural **106**, mid-brown-grey and orange clayey sand, 0.38m thick, suggesting that the area had been levelled, seemingly during the post-medieval period, as the deposit contained some brick rubble and large amounts of stone. Deposit **106** appears to have left a slight depression, which was subsequently filled by **107**, a mid- to dark grey silty sand, approximately 0.15m thick. The feature was ultimately sealed by redeposited natural **100**, visible throughout the trench.

Plate 2: South-west-facing section of moat 102, scale 2m

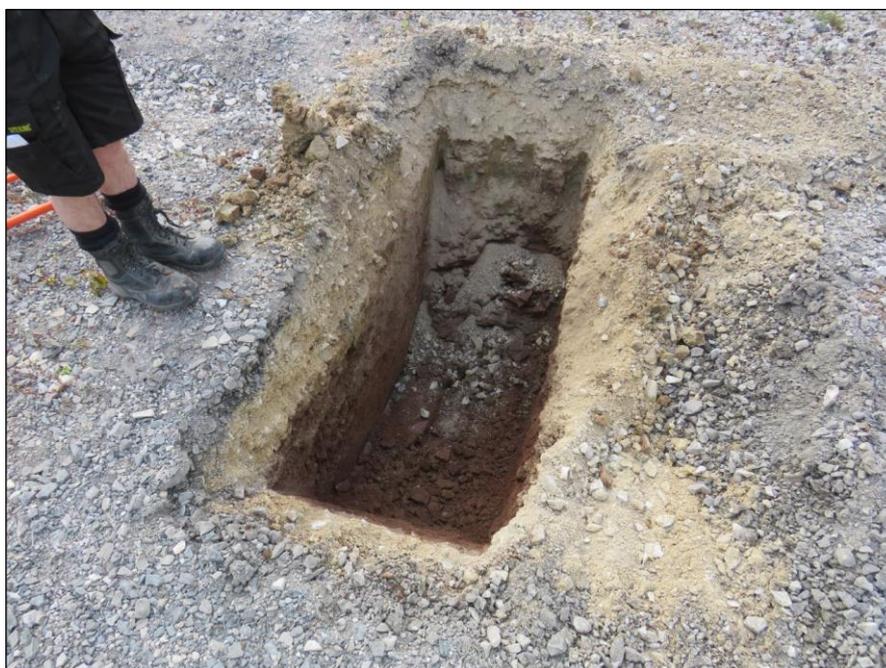
3.4.1 The watching brief was maintained over ten days, initially on 26th May 2020 and then between 2nd November 2020 and 6th January 2021. The initial monitoring on 26th May 2020 was during the excavation of test-pits to undertake permeability tests. These only measured 2m long by 1m wide and were excavated with a small five-ton mechanical excavator fitted with a toothed bucket. The northern test-pit was excavated in the north of the site and identified natural geology **1001** at 0.9m below the ground level, a red sandstone, overlain by made ground or redeposited natural **1000**, measuring 0.5m thick, which was in turn overlain by hardcore **1002**, 0.4m thick (Plate 3). The second test-pit was excavated in the middle of the site and identified natural **1001** at 0.4m below ground level, which was overlain by made ground or redeposited natural **1000** (Plate 4).

Plate 3: Northern test-pit looking north

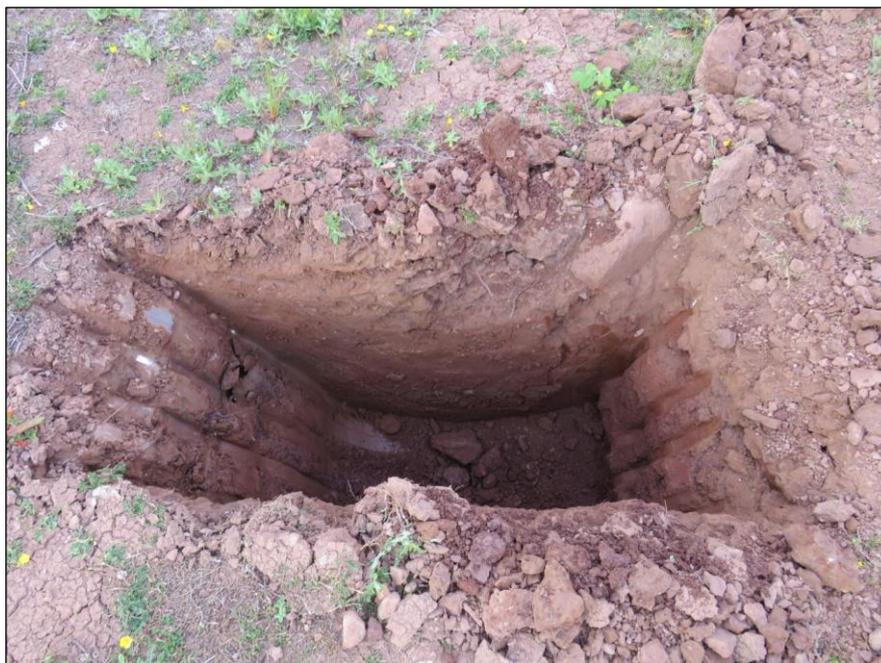
Plate 4: Second test-pit looking north

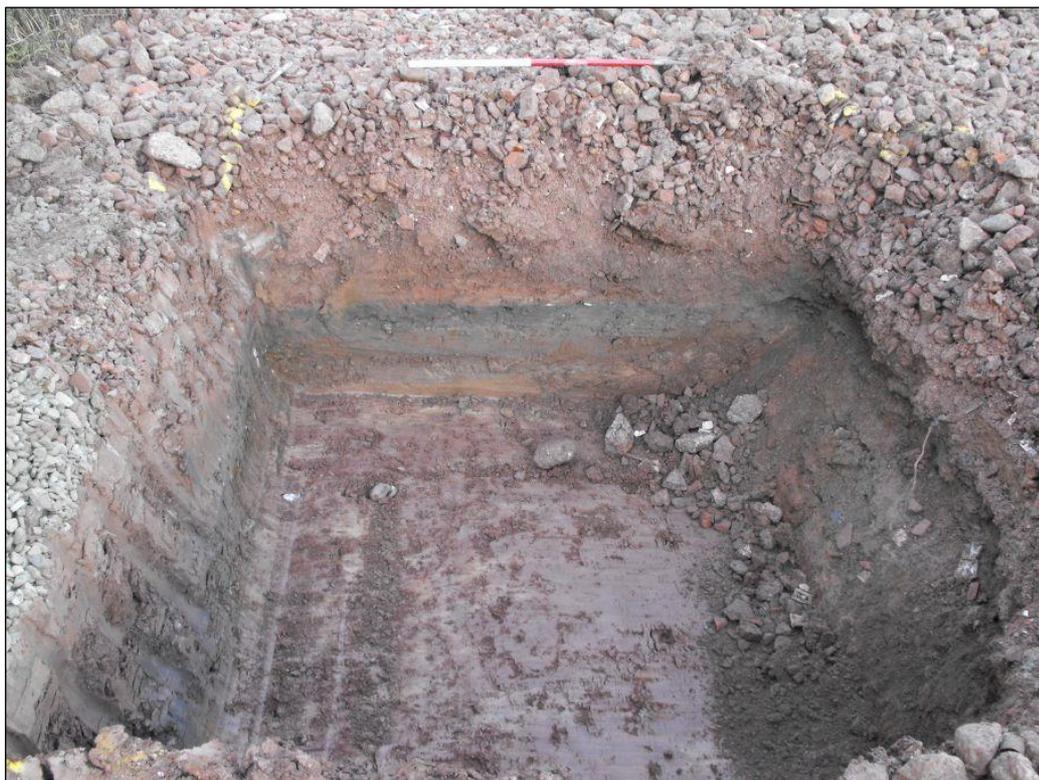
3.4.2 The watching brief then recommenced once construction started on the site in November 2020 and was completed in January 2021, being maintained during the excavation of foundation pads, drainage routes and attenuation (Fig 4). The foundation pads were all approximately 2m by 2m in area and were excavated to a maximum depth of 1.2m. The majority of the foundation pads contained the same deposits, natural material **1001** and made ground or redeposited natural **1000**. There was possible evidence of the upper deposits of moat **102** in the foundation pads in the south-western corner of the array (Plate 5), the earliest being deposit **1003**, a mid-brown-grey and orange clayey sand, approximately 0.3m thick, similar to deposit **106**, identified in the evaluation trench (*Section 3.3.3*). This was in turn overlain by **1004**, a mid- to dark grey sandy silt, approximately 0.15m thick, similar to deposit **107**, identified in the evaluation trench (*Section 3.3.3*). The cut of the feature was not visible within the foundation pad.

Plate 5: Foundation pad in the south-west corner of the development, scale 1m

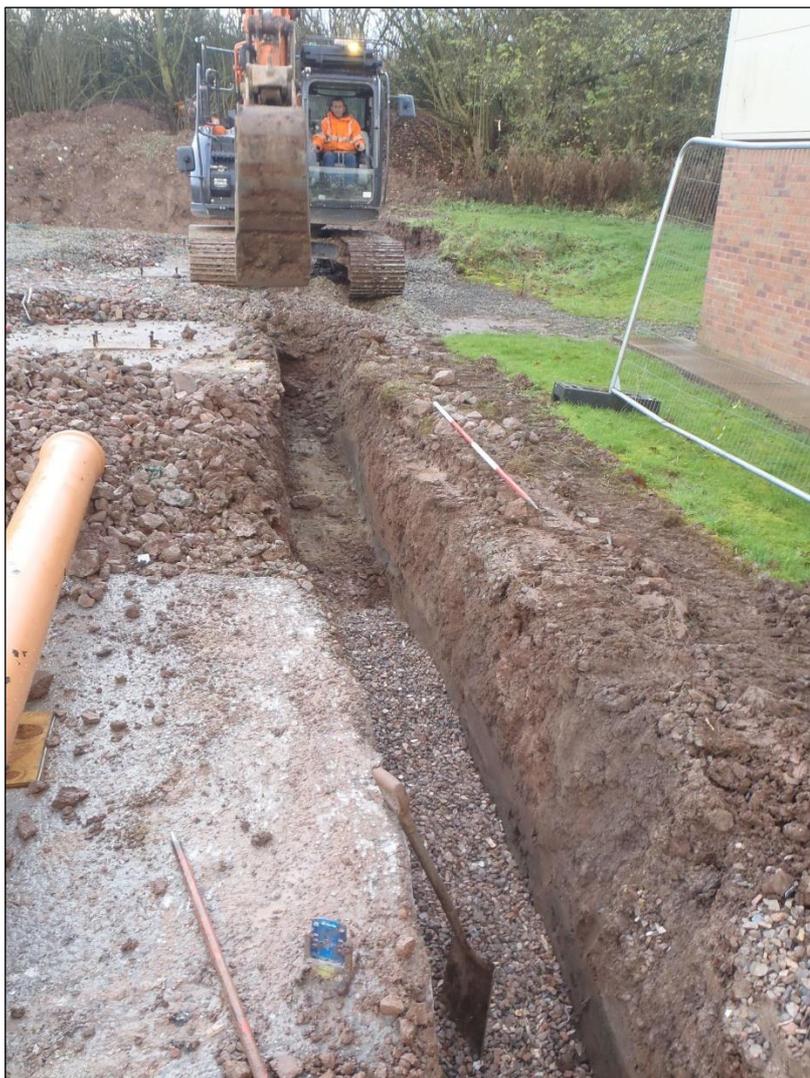
3.4.3 The results of the monitoring of the drainage routes and attenuation were similar to those for the foundation pads. The drainage routes primarily extended down the eastern and western sides of the development, whilst the attenuation was excavated in the north-eastern part, in the location of the car park. There was no evidence of archaeological remains in the northern and eastern drainage routes nor the attenuation, although as in the foundation pads, there was potential evidence for the upper deposits of moat **102** at the south-western end of the western drainage route (Plate 6). Again, the earliest deposit was **1005**, a mid-brown-grey and orange clayey sand, approximately 0.3m thick, similar to deposit **106**, identified in the evaluation trench (Section 3.3.3). This was in turn overlain by **1006**, a mid- to dark grey sandy silt, approximately 0.15m thick, similar to deposit **107** identified in the evaluation trench (Section 3.3.3). The cut of the feature was not visible in the trench.

Plate 6: Southern drainage route with potential moat deposits **1005** and **1006** identified in the base of the trench, looking south-west, scale 2m

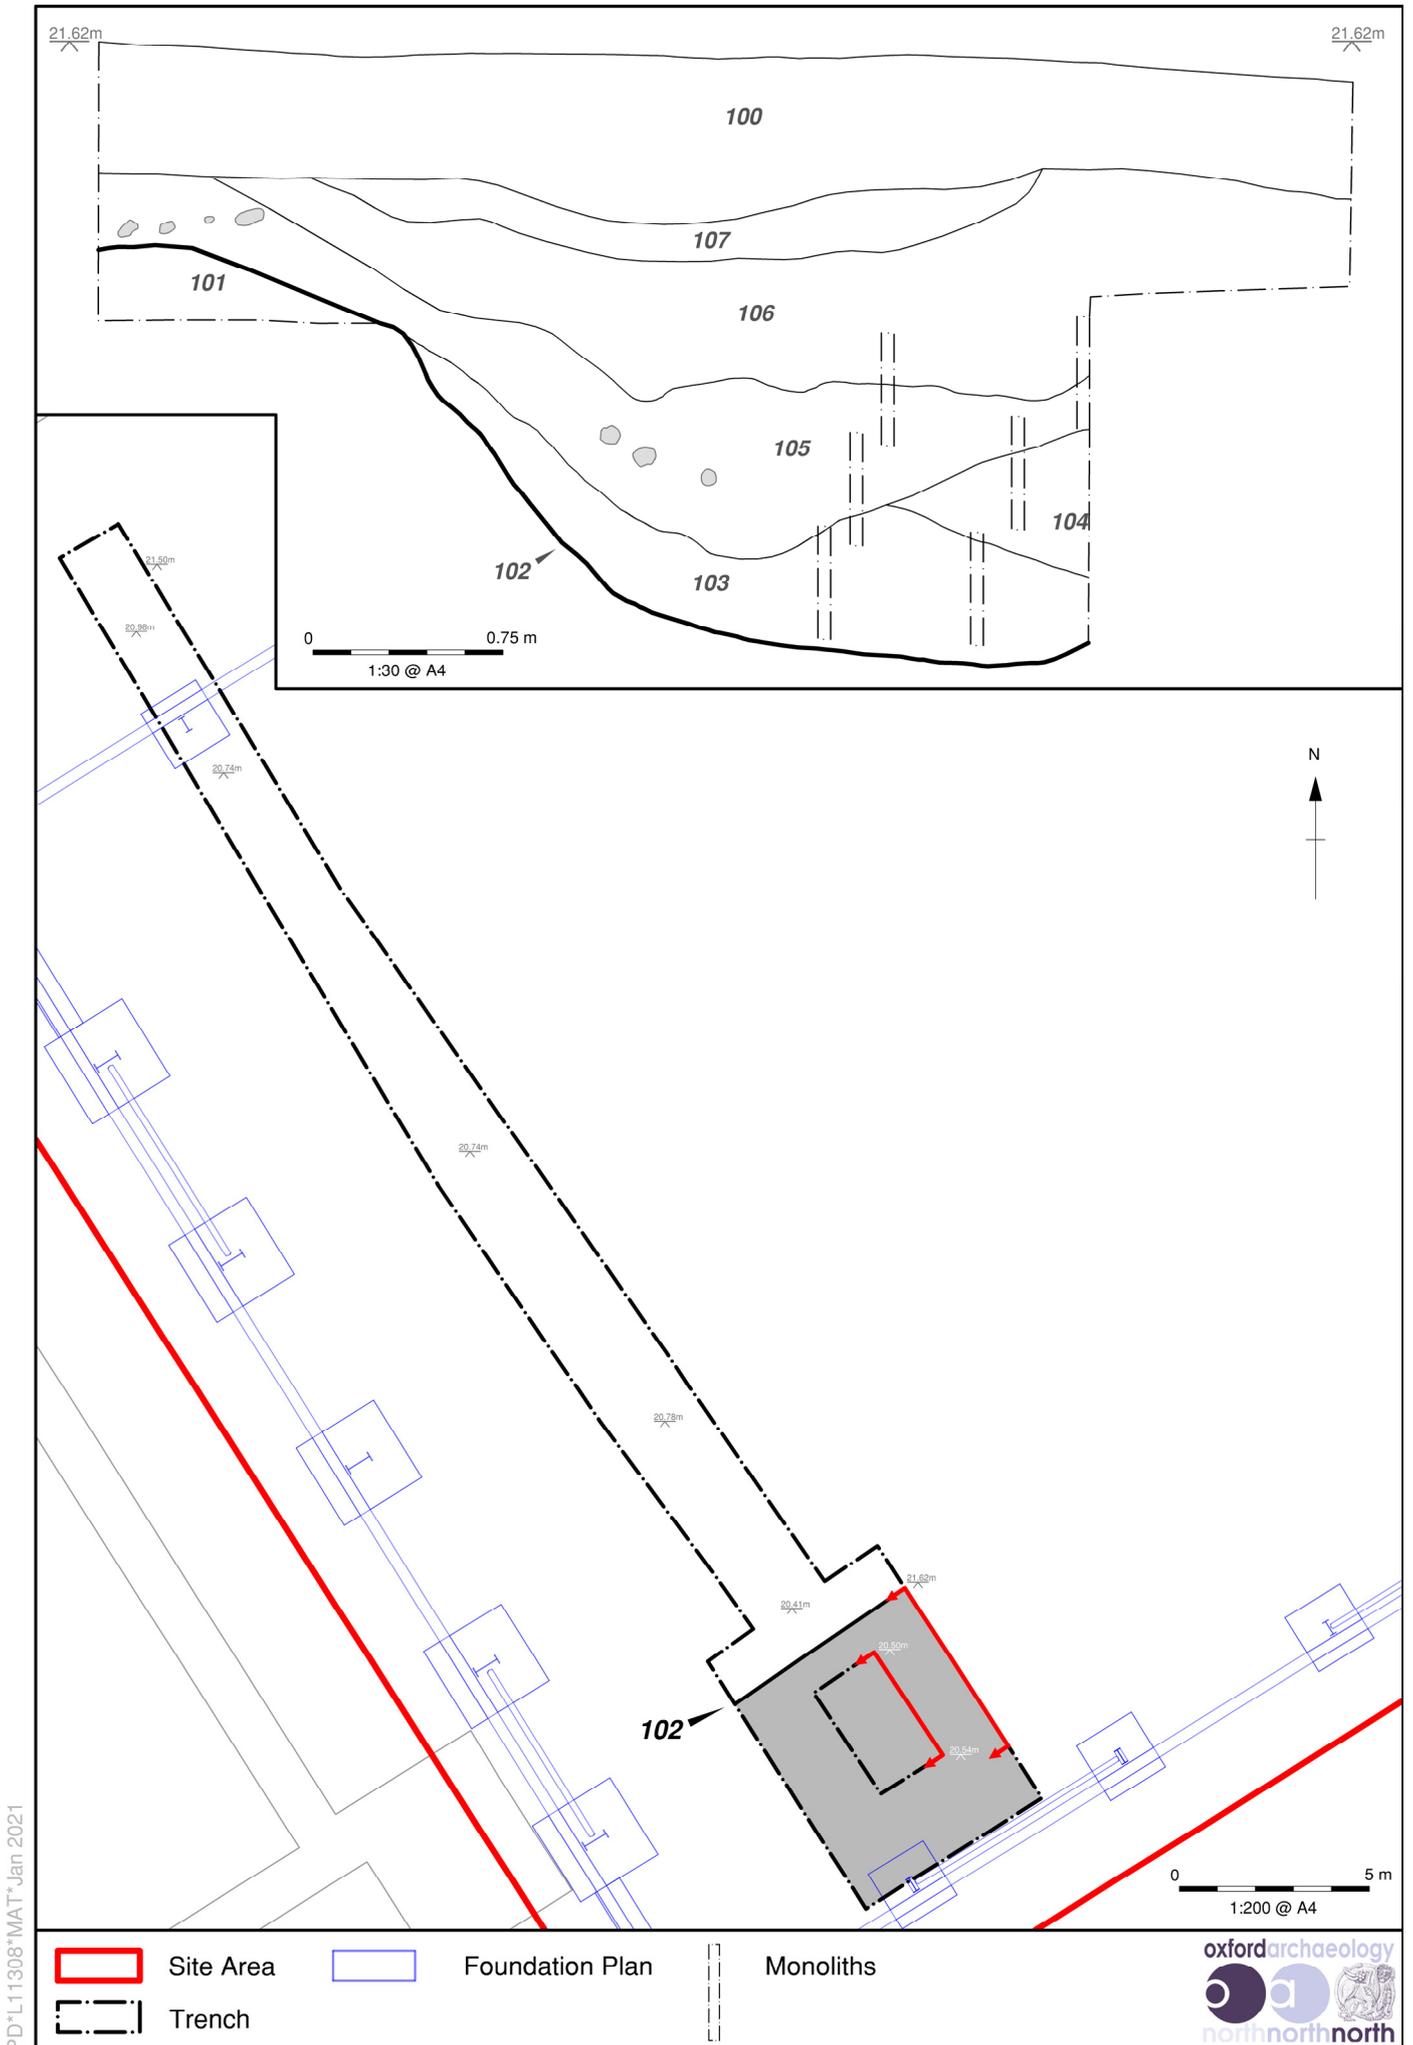
Figure 3: Plan of trench and section of moat 102

3.3.1 The evaluation trench was 40m long by 2m wide, excavated through the western part of the site on a north-west/south-east alignment (Fig 3). Natural geology **101** was identified throughout the trench, approximately 0.3m below the ground level, and was cut by moat **102**, a north-east/south-west-aligned feature in the approximate presumed location of the northern arm of Norton Priory's moat system.

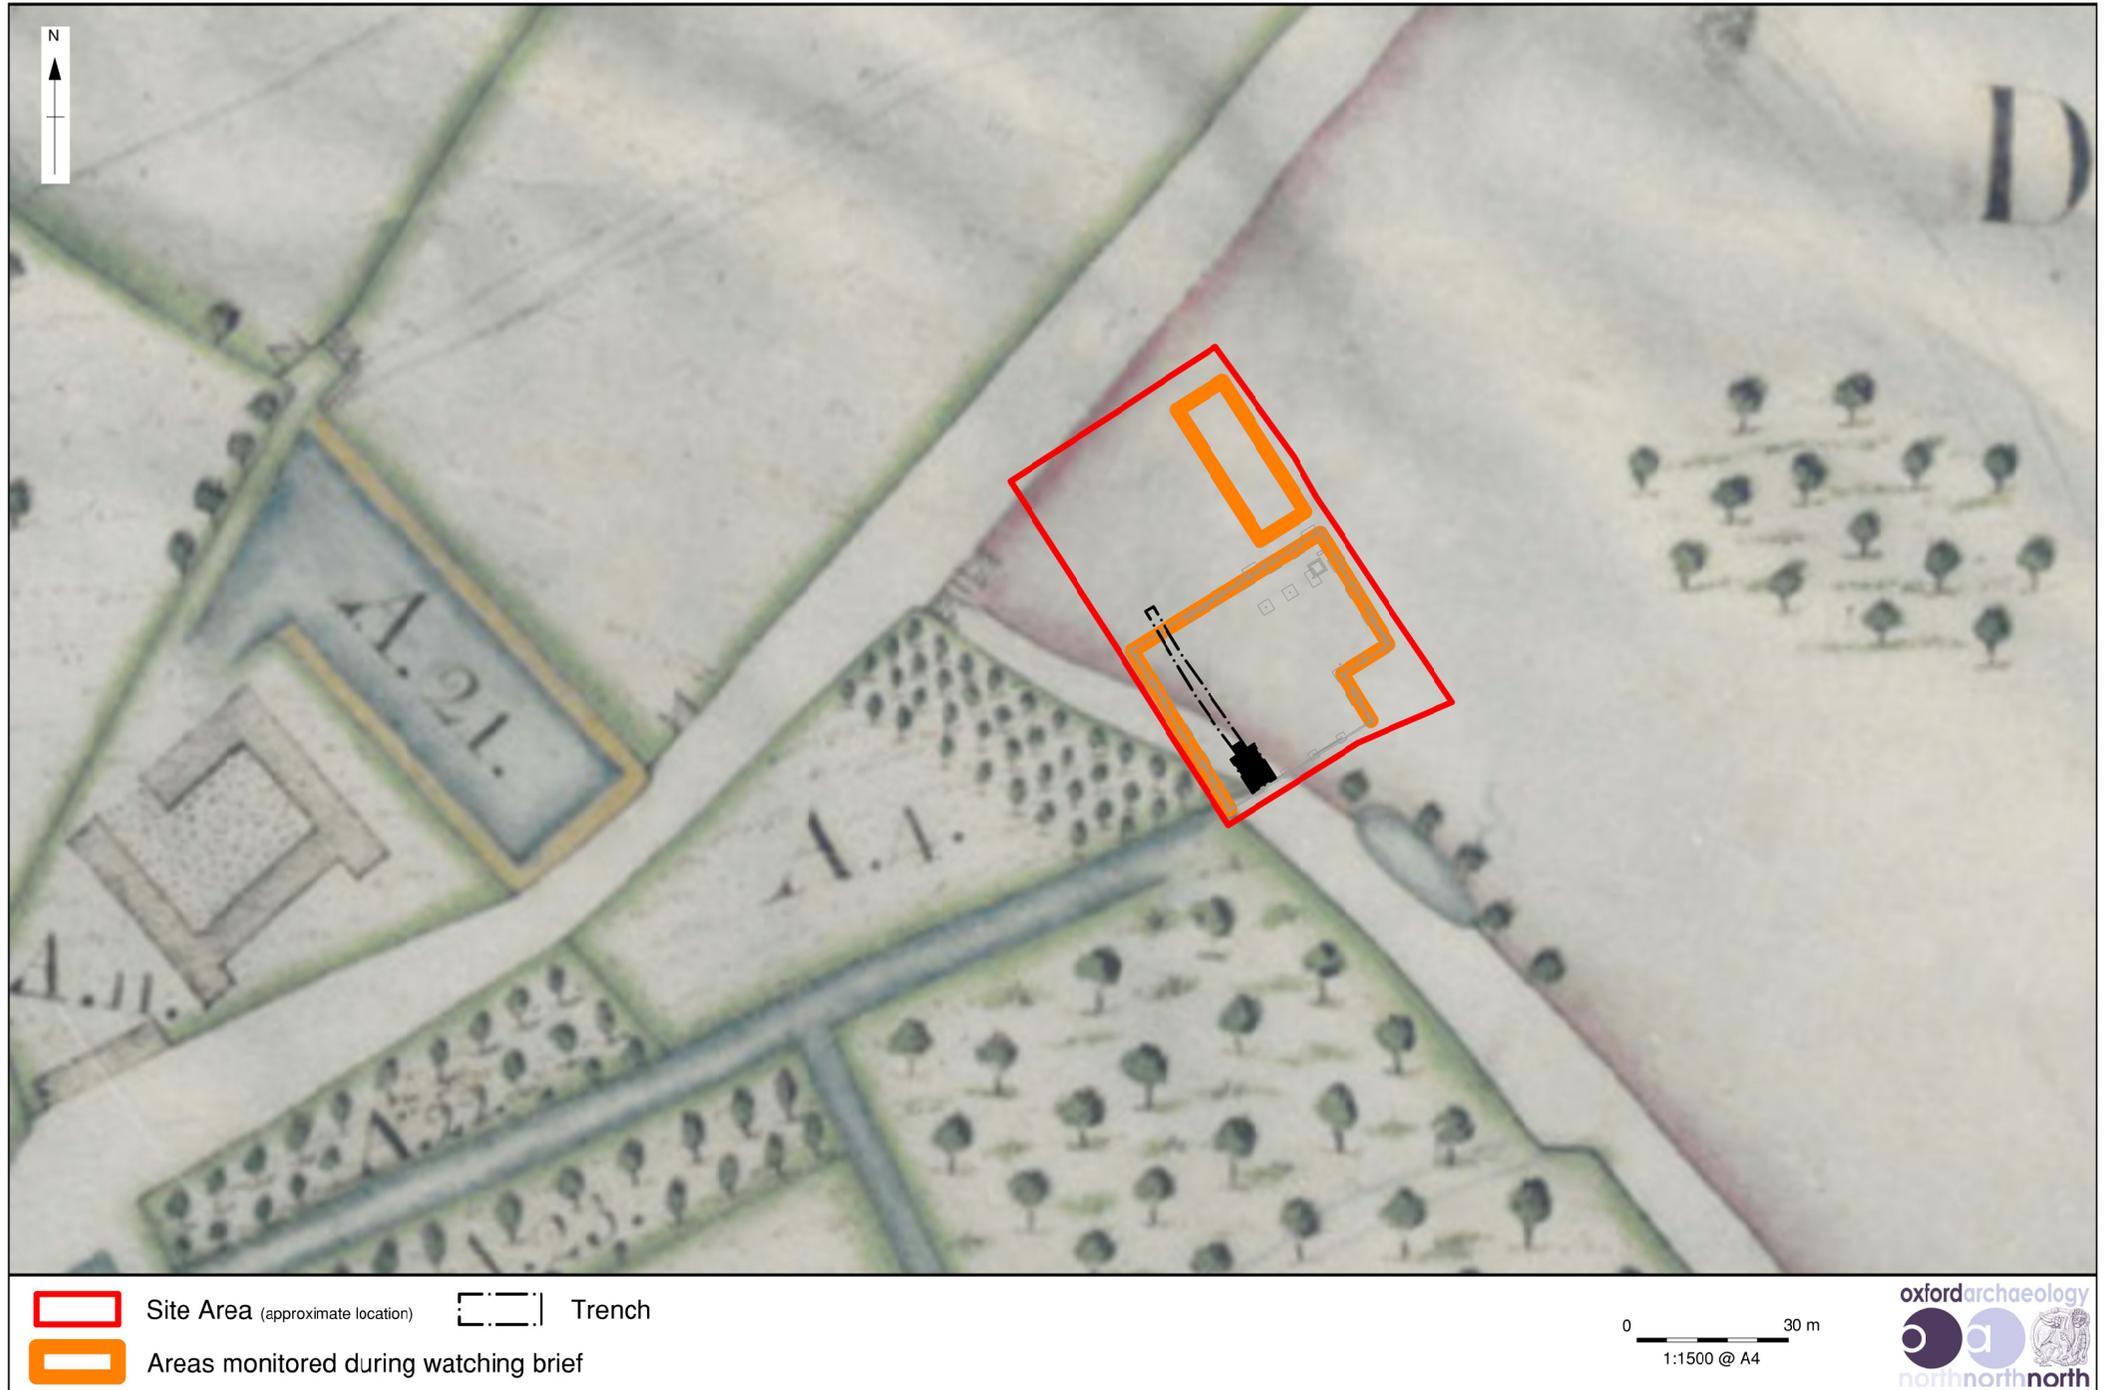
Figure 5: Evaluation trench and areas monitored during the watching brief, superimposed on an Estate map of Norton Manor (Eyes 1757)

4.3.1 The only archaeological feature identified within the evaluation trench was the targeted moat, relating to the water system associated with Norton Priory. The subsequent watching brief only identified the upper deposits of the moat recorded in the evaluation trench, with the majority of the foundation pads and drainage trenches being blank. The position of the moat does appear to correspond fairly well to its assumed location from historical mapping (Fig 5), and there was no evidence of moat deposits in the eastern drainage trench or foundation pads, suggesting that the moat does terminate in the middle of the development site, although due to the shallow nature of the excavations there was the possibility that the moat had either been partially backfilled by the time the historical mapping was produced or that the moat originally turned to the south, where a pond is depicted on the 1757 estate plan.
