Getrag Carpark, JLR Halewood, Merseyside

Archaeological Watching Brief Report

November 2018

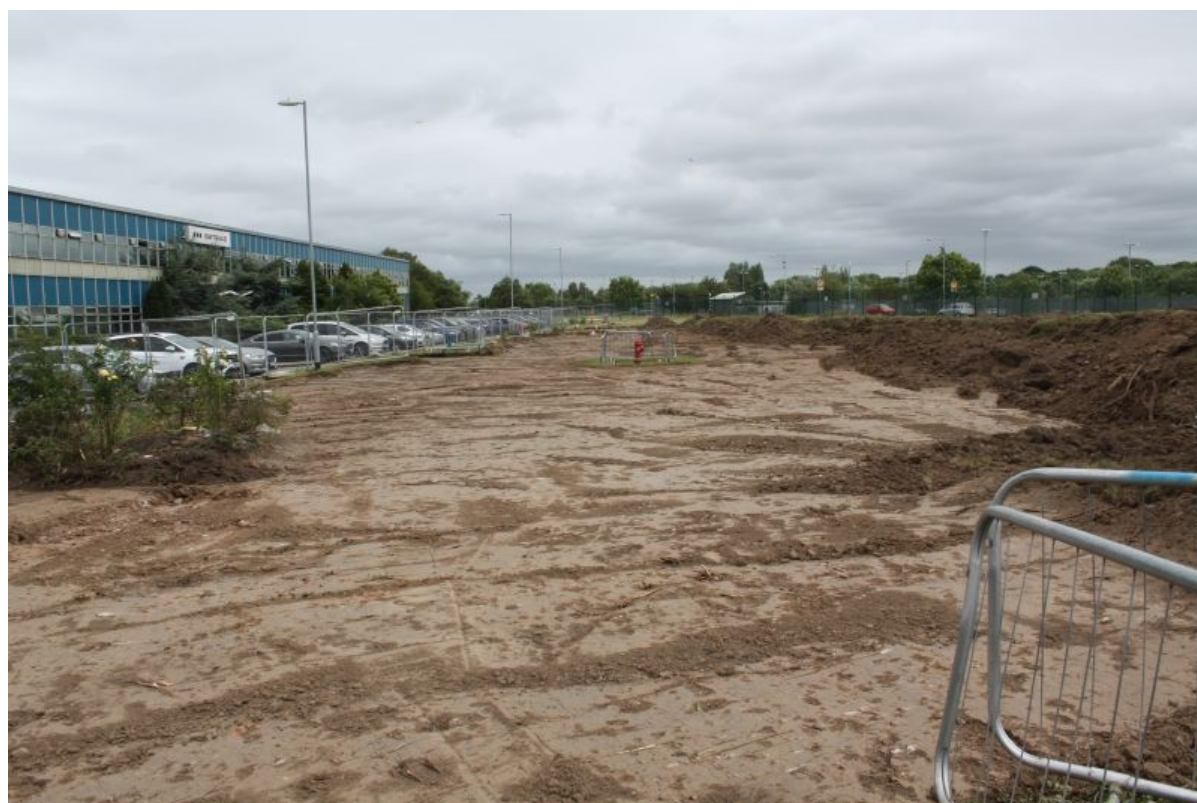
3.2.1 The soil sequence across the area was fairly uniform. Removal of a 0.1m-thick layer of imported topsoil, **101** (Plates 1 and 2; surface at 21.71–22.06m OD), revealed a deposit of redeposited clay (**102**), which was observed across the stripped area. This was the formation level for the site, and was cut into only during the excavation of the attenuation tank, where deposit **102** was found to exceed the 1.8m depth of those groundworks (Fig 3, Plate 3; base at c 20.2m OD). The mixed red and blue-grey clay contained lenses of soil, and modern detritus, including reinforcing bars, bricks and plastic. The natural geology was not reached during the course of works, and no archaeological features or finds were observed.

Plate 1: Topsoil strip of the former grassed area showing levelling layer **102**

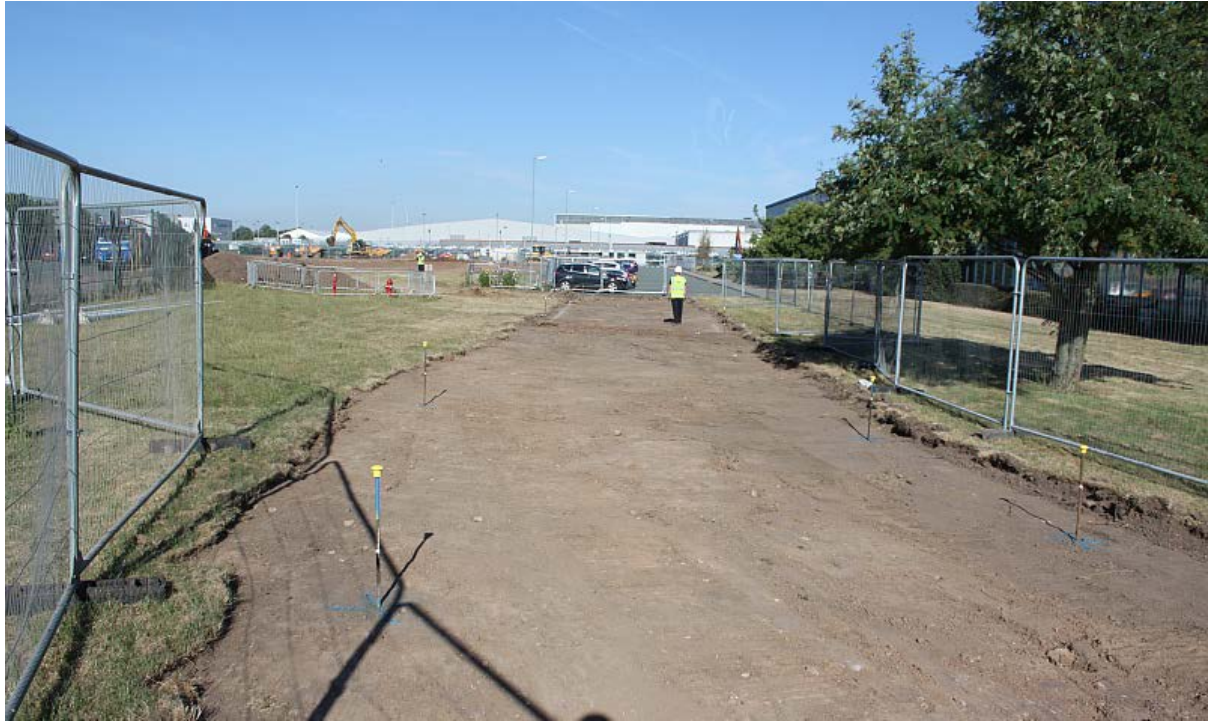
Plate 2: Topsoil strip of an access road for the proposed carpark

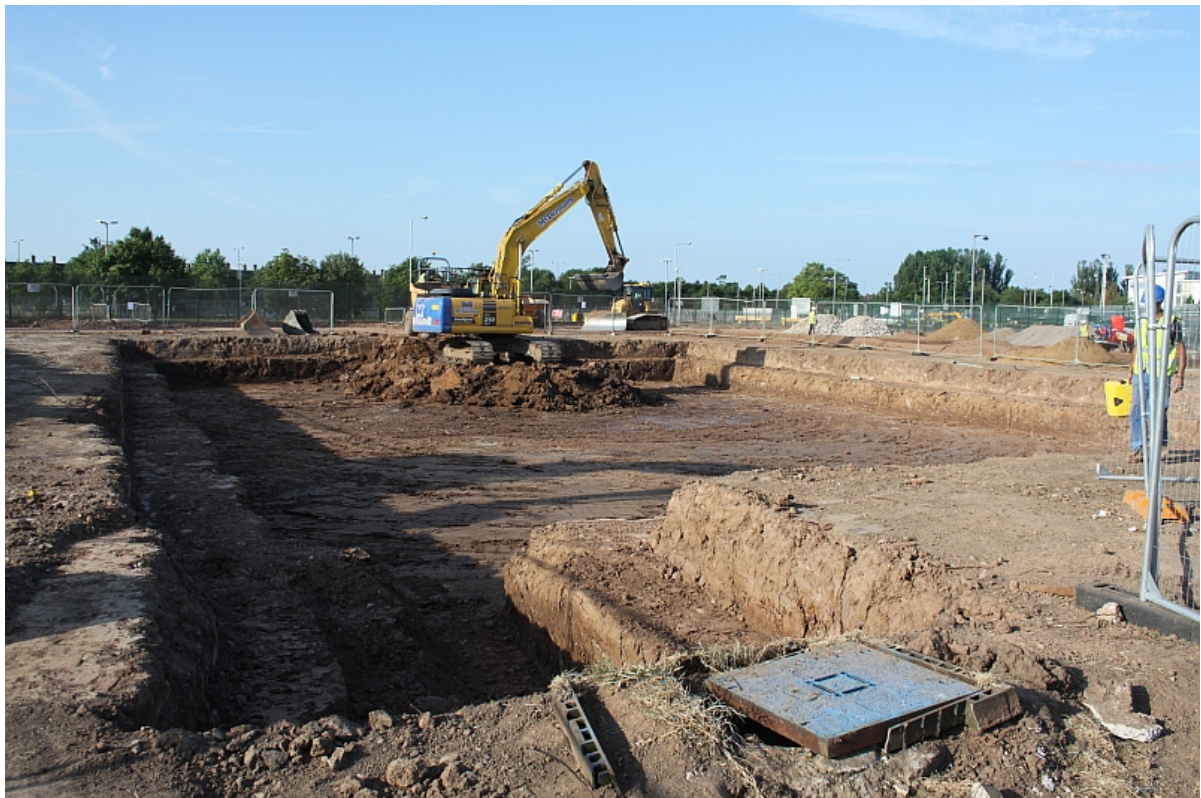
Plate 3: Attenuation tank excavation

- 4.1.1 Although no archaeological features or finds were identified during the watching brief, it is entirely possible that remains associated with the Old Hutt moated manor lie sealed beneath the deposit of made ground that was observed extending across the site. Certainly in the area of the attenuation tank, these deposits exceeded 1.8m in depth (ie, 20.2m OD). The site of the attenuation tank encompasses the north-east corner of the moat and, at first sight, it might be tempting to associate the depth of made ground with the backfilling of the moat, which, in 1960, still formed localised depressions some 2m below the level of the central platform occupied by the manor house (Wrathmell 1992). However, there is no apparent change in the thickness of the made ground at the southern and eastern edges of the attenuation tank, which seem to lie beyond the area occupied by the moat. This would suggest that the made ground is likely to be of considerable thickness, even beyond the area of the moat.

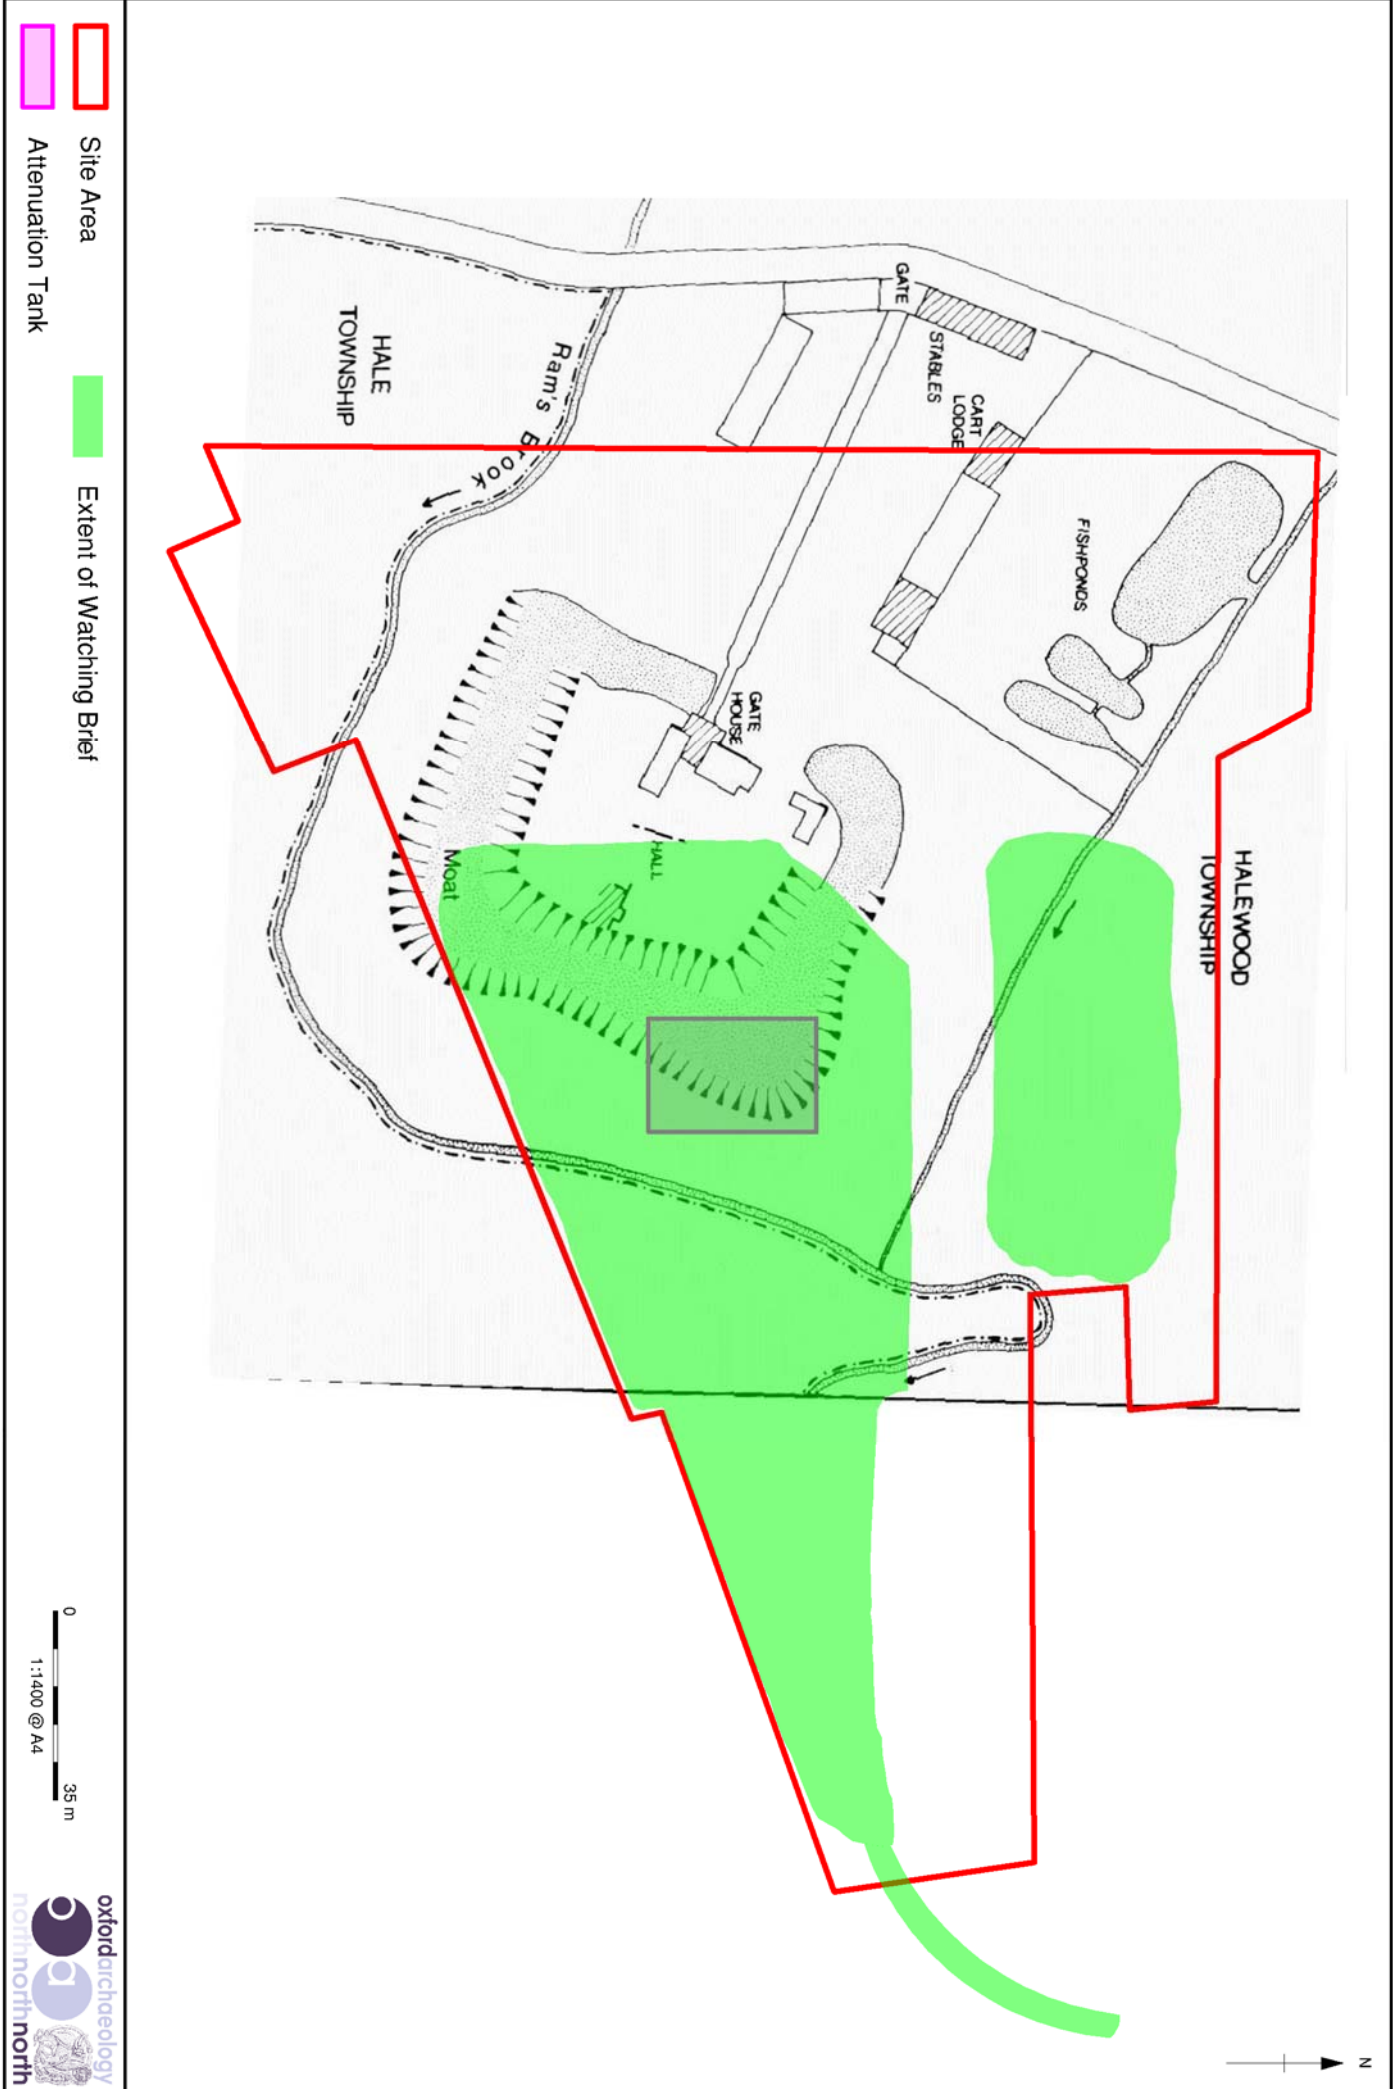
- 1.3.2 Old Hutt was excavated in 1960 (Fig 3; Wrathmell 1992) but the investigation was limited in its scope and was largely an exercise in following the walls of the former manor house. As a result, the conclusions of the excavation were limited. However, the excavators did identify the basic chronology of the manor house and the kitchen complex, in addition to expanding understanding of the size and layout of the manor house complex itself.

Figure 3: Location of attenuation tank excavation superimposed on 1960 plan of Old Hutt moated manor
