# Bayards Hill Primary School, Headington, Oxford

## Archaeological Watching Brief Report

**Client: Stepnell Ltd**

OA Job No: 5711

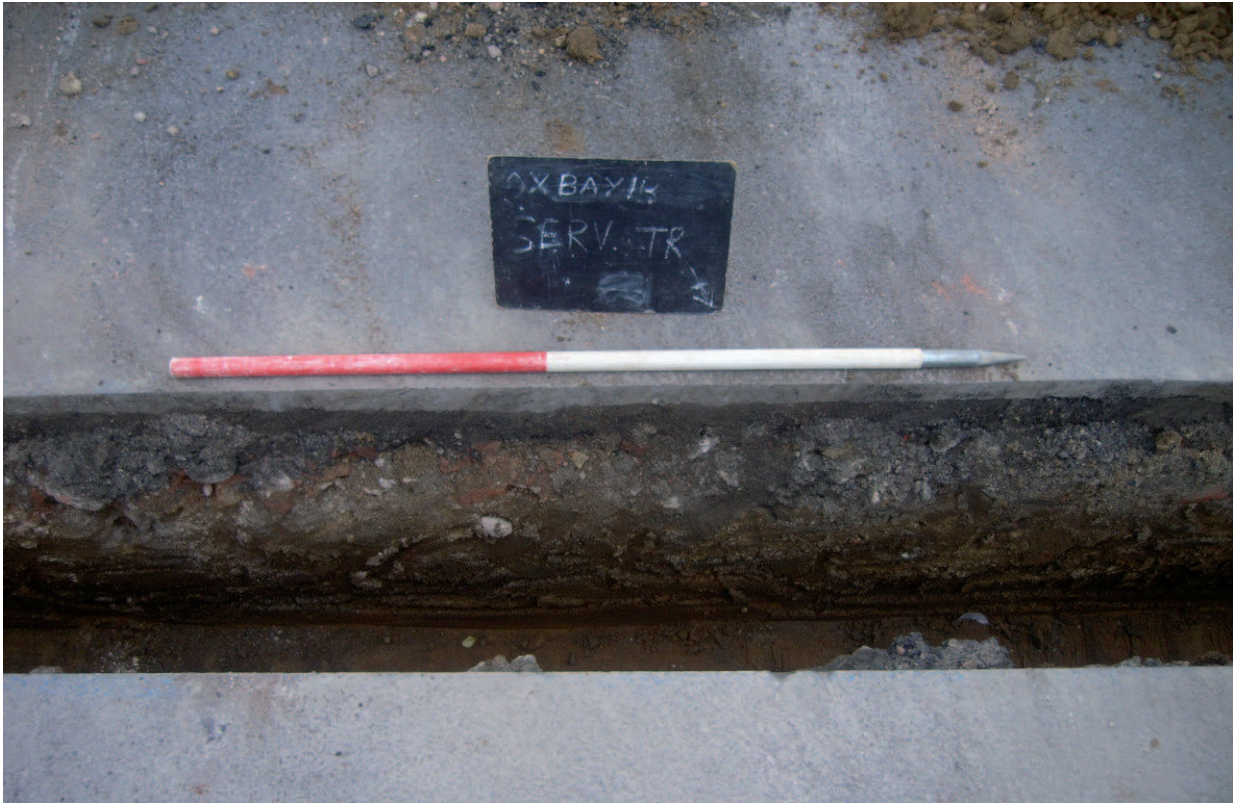
Plate 1: Section 100

- 3.1.3 At the northern end of the trench as it exited the school grounds a layer of mixed brown and very dark brown/black silty clays containing broken bricks and other construction debris was exposed within the base and sides of the trench (102) (Fig. 3, Sections 100 and 101; Plate 1).

- 3.1.4 A bedding layer of yellow sand (101) measuring between 0.1m and 0.2m had been laid directly over 102. This formed the base for the tarmac carpark surface (100).

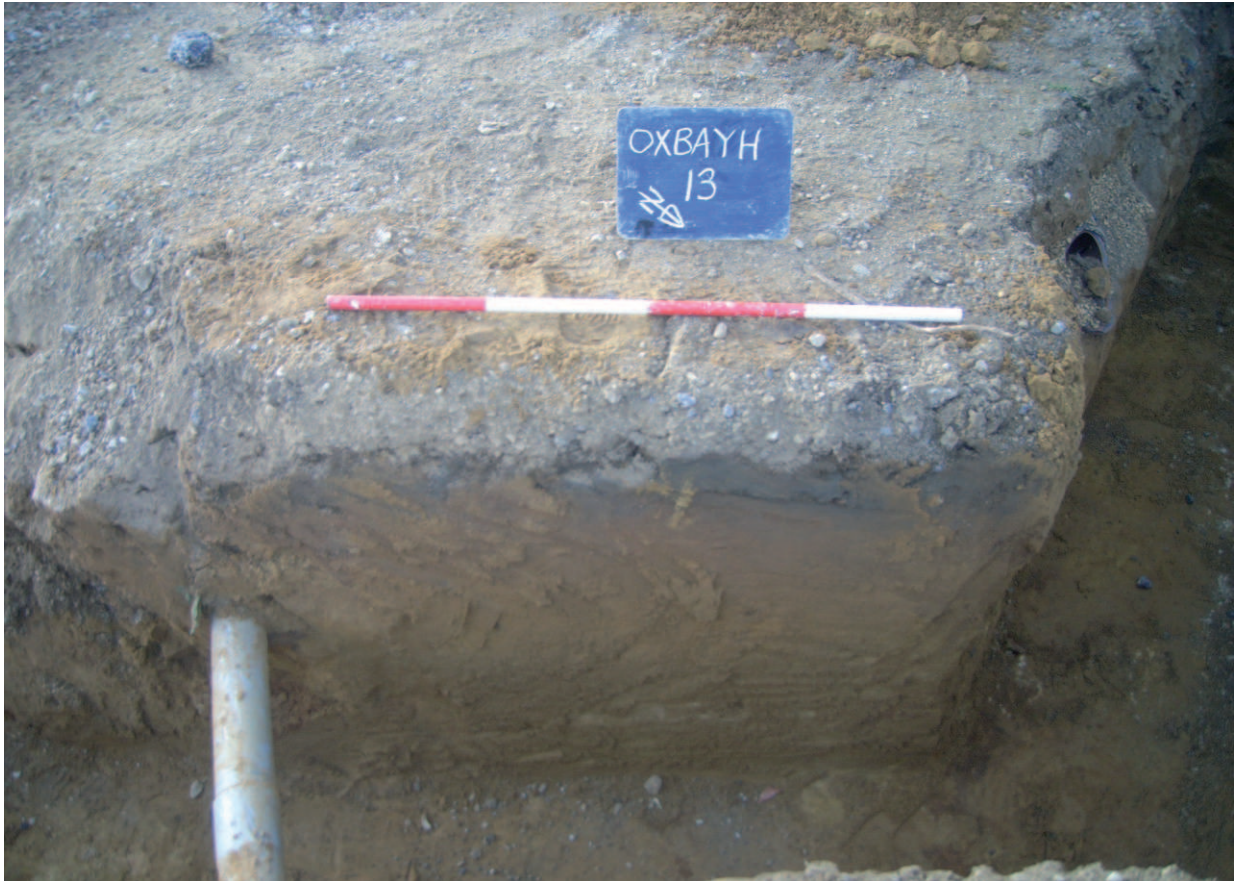
Plate 3: Section 105

- 3.1.10 Prior to trenching the tarmac surface was removed, the foundation trenching measured 0.7m in width and up to 1.5m deep.
- 3.1.11 The stratigraphy exposed was broadly similar throughout the area (Fig. 3, Section 105; Plate 3). A band of ragstone, the local limestone, was encountered at a depth of between 1.2m and 1.5m depth (117). Overlying the stone was a clean layer of light orange silty sand measuring between 1m and 1.2m in depth (116).

- 3.1.12 Above the sand was a 0.1m layer of dark brown silty loam containing charcoal flecking, abraded brick and sherds of post-medieval pottery (115). Cutting this deposit in the south of the buildings footprint was a rectangular area of hard standing approximately 3m in width and which extended outside the area of construction (114).

- 3.1.13 The limit of the hardstanding was bounded by a single line of frogged bricks, 0.228m x 0.115m x 0.072m in size stamped "Phorpes". The hard standing itself was formed using a clinker sub-base overlaid with compacted limestone and sealed by a cement skim.

- 3.1.14 Sealing layer (115) and the hard standing (114) was a 0.15m deep layer of crushed stone and tarmac (113), which formed the base for the tarmac playground surface (112).
