# Cherry Croft Cottage Kingwood Common

## Historic Building Report

May 2004

**Document Title:** Cherry Croft Cottage, Kingwood Common - Historic Building Investigation and Recording.

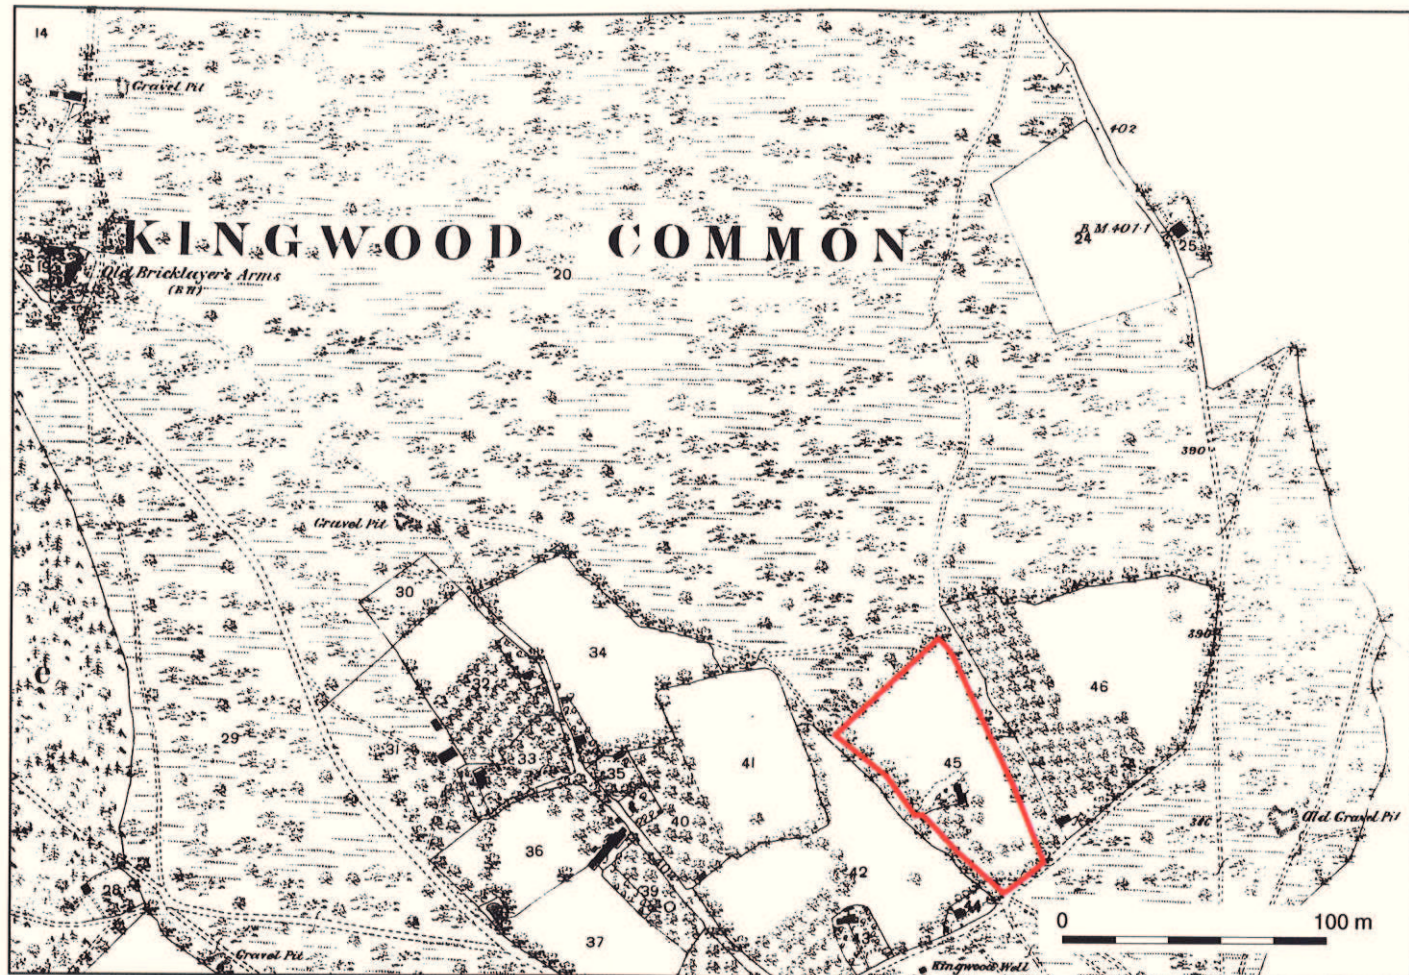
Figure 3: First Edition Ordnance Survey Map, 1882

north appears on the first edition 1:2500 ordnance survey map of 1872 (Fig. 3). The main cottage was probably constructed in the early twentieth century.

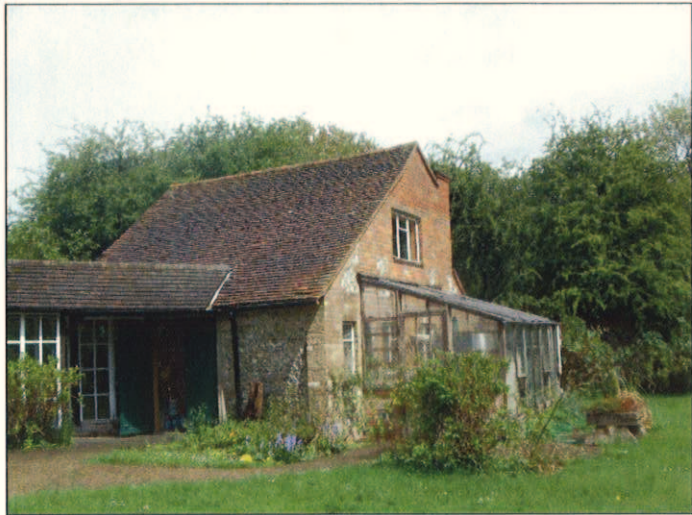
Plate 1: General Shot of the outbuildings

- 3.1.1 The outbuilding is aligned almost exactly north-south and consists of three main elements (Fig. 4); **Area A** is the two storey main block forming the southern part (Plate 1); **Area B** is a single storey extension added to the north on the west side (Plate 2) and an open sided single storey shed with a diagonal set of possible pigsties to the north on the eastern side forms **Area C** (Plate 3). There is also a glass greenhouse added to centre of the south side, **Area D**. The building is approximately 13m long, not including the green house and at its widest point is approximately 9.5m wide. The two storey element is approximately 5.5m high. All the elements are suffering from collapse and large cracks are visible in the walling and roof timbers of the extension and shed are rotted and failing.

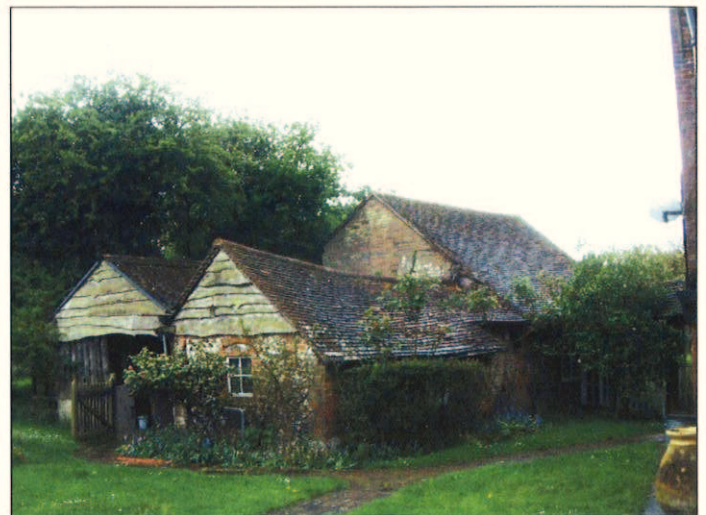
Plate 2: Extensions to the north

- 3.4.4 The second phase of this section is the extension to the west of the northern half of the room (see Plate 2). The extension is built into the southern end wall, leaving only the upper brick quoins, and abuts the western, original wall. The rafters, at least over this extension, have been replaced to extend to the new wall line and a new wall plate inserted, the old wall plate in this area now acts as a second purlin.

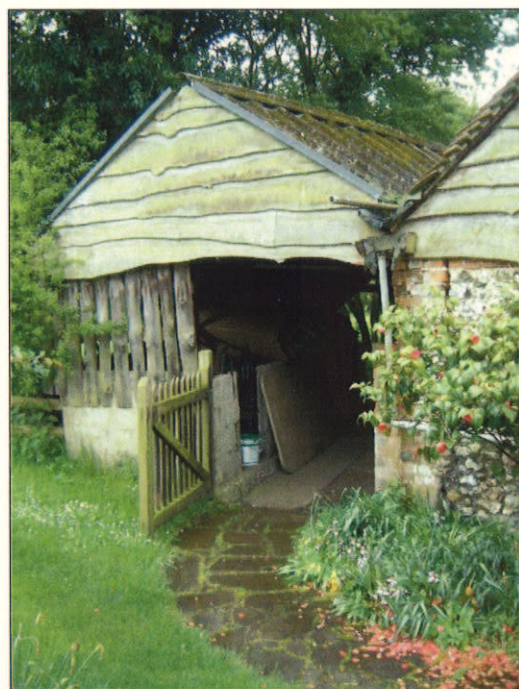
Plate 3: Shed to the north east

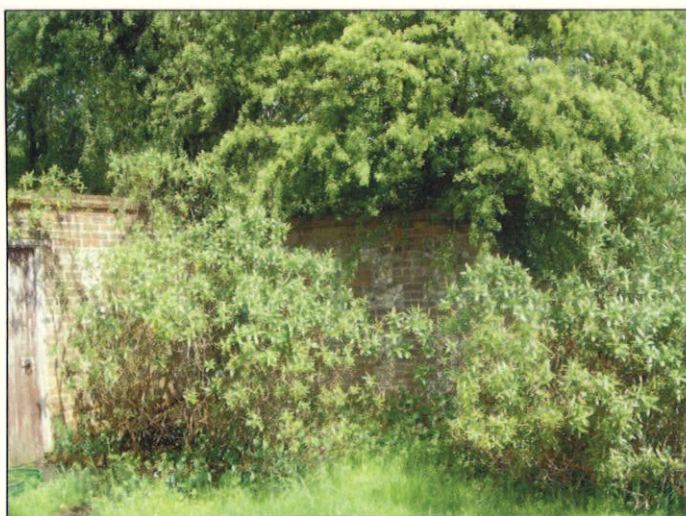
Plate 4: Garden wall to the south east of the building

- 3.1.2 At the building's south eastern corner a wall (Plate 4) extends to the east for approximately 4m with a door to the rear of the building, it then turns to the south for another 4m it also is of brick with irregular flint nodule panels and probably dates to the same period as the south front, which has the same style of brickwork and panels. The outbuilding is joined at its south western corner to the main house by a covered diagonal pathway with large windows between the posts on both sides. Cherry Croft Cottage itself sits to the west and slightly north of the outbuilding's south wall.

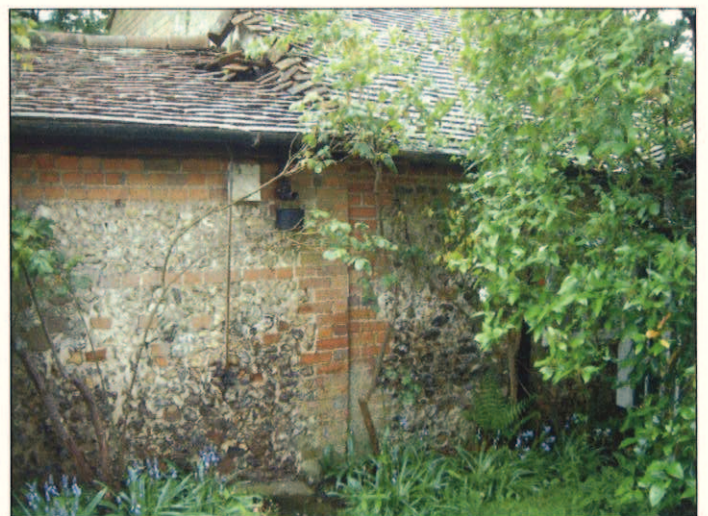
Plate 5: Brick banding in extension wall

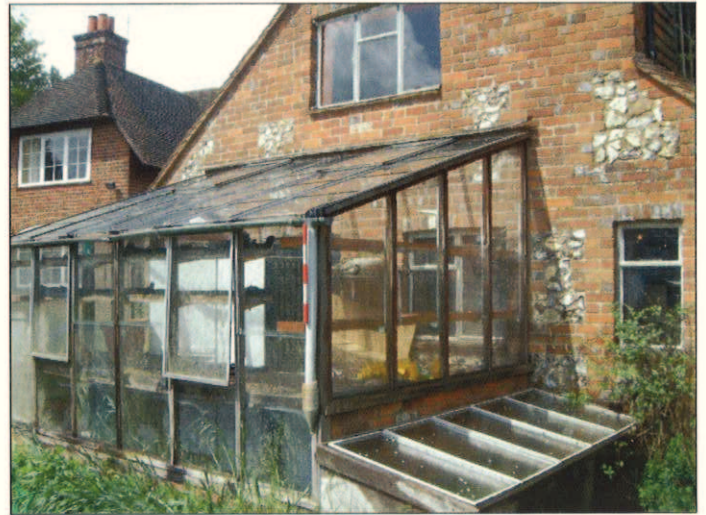
Plate 7: Greenhouse on south front

- 3.2.2 The modern green house, **Area D**, was not assigned a room number; it is of twentieth century date and has a timber frame holding large glass panes (Plate 7). The frame rests on a brick plinth. The greenhouse is entered through a door on the west side and it abuts the south face of the building.

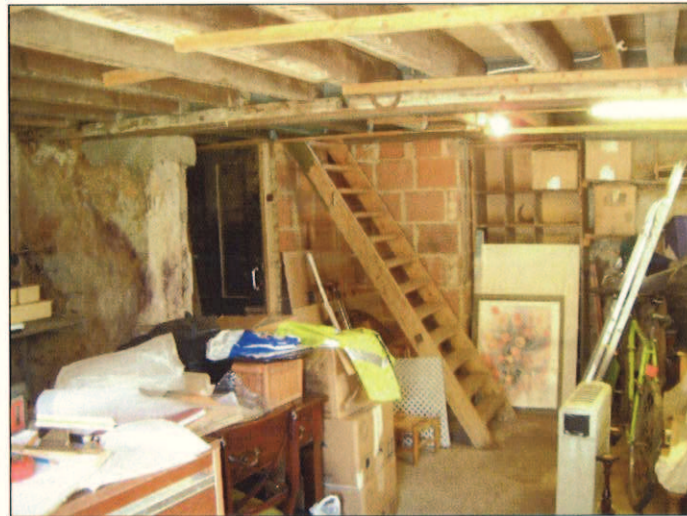
Plate 8: Room 1 general shot of east side

- 3.3.2 Room 1 is approximately square - 6.5 by 6.5m, it has a concrete floor and the ceiling joists are exposed, the ceiling is approximately at 2m high (Plate 8). On the south wall the concrete breeze blocks are visible; the east wall is painted flint rubble and brick. The north-west corner of the room which is the earliest part of the room is plastered with a crumbly lime based plaster. The room is now used for storage but is likely to have been the main functioning room of the building including, perhaps, cooking on the fireplace, the sink and stove on the south wall were added later.

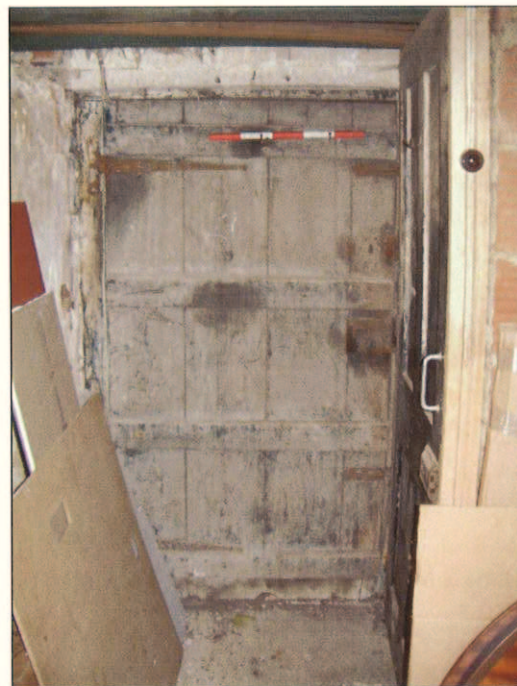
Plate 9: Room 1 door in north wall

- 3.3.3 The room has two doors. The first and earliest is in the north wall and is a plank and batten door with long tapering iron strap hinges and a box lock with two bolts (Plate 9). The second is a double door added later in the west wall, although it may have replaced an earlier door in the same place. It is within a concrete frame which has removed the southern brick edge of the earlier small window. This window is probably original to the oldest part of the building. It has a deep reveal lined with boards, a wooden frame with single wooden mullion supports small rectangular panes of glass held in lead. On the south wall are four twentieth century galvanised metal frames with horizontal opening top lights and large lower panes.

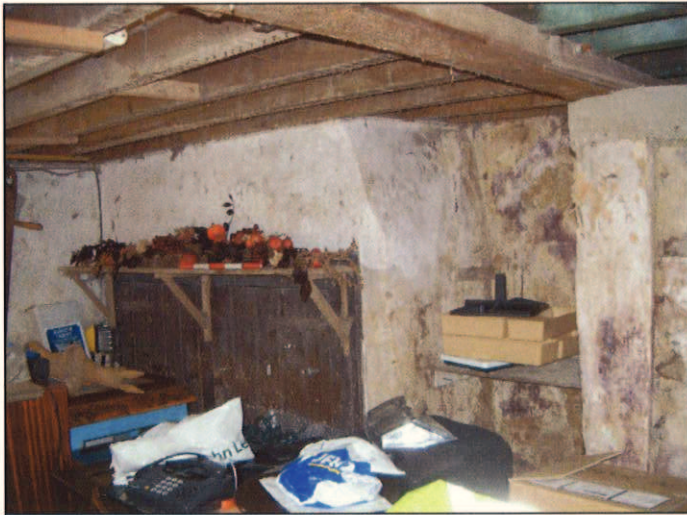
Plate 10: Room 1 fireplace

- 3.3.4 The fireplace is in the north-west corner and has at now been converted into a cupboard with double doors (Plate 10); it was not accessible for close examination. It was plastered including the lintel and tapered slightly towards the ceiling. The space to the right of the fireplace, between the chimney breast and a short pier, has battens fixed to support shelving.

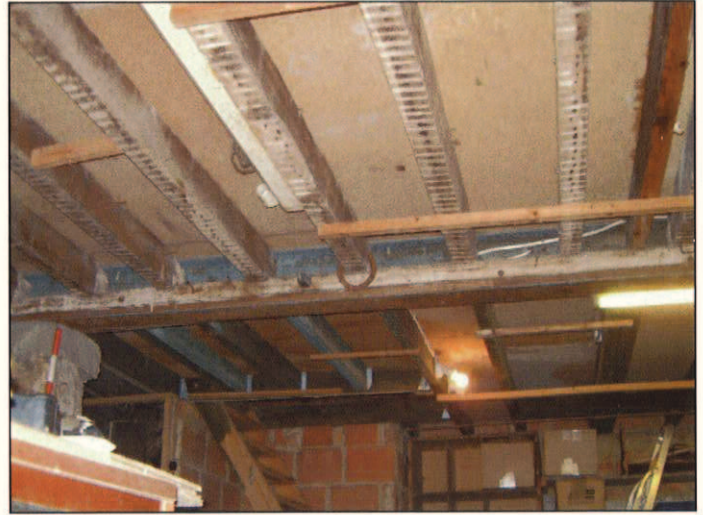
Plate 11: Room 1 ceiling joists

the north door to a shallow brick pier on the south wall. On the west side of this beam the joists show marks and nails from a lath and plaster ceiling which has been removed. On the east side the joists are clean. All the timbers are machine sawn and very evenly sized (50 by 100mm/2 by 4in) (Plate 11).

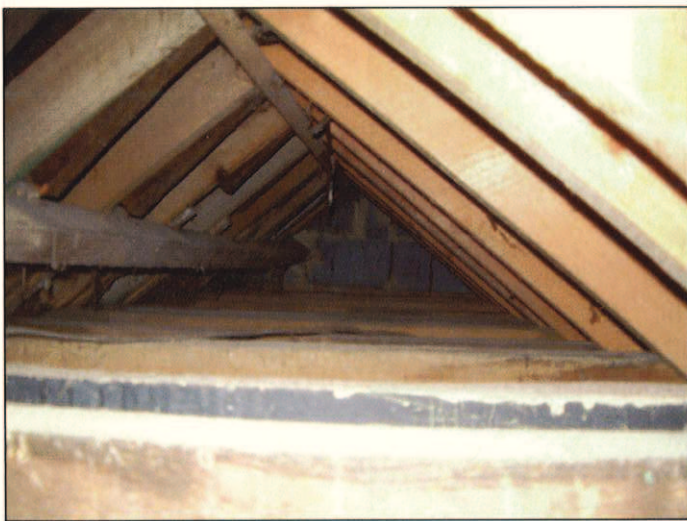
Plate 12: Room 2 breeze blocks in the north gable roof space

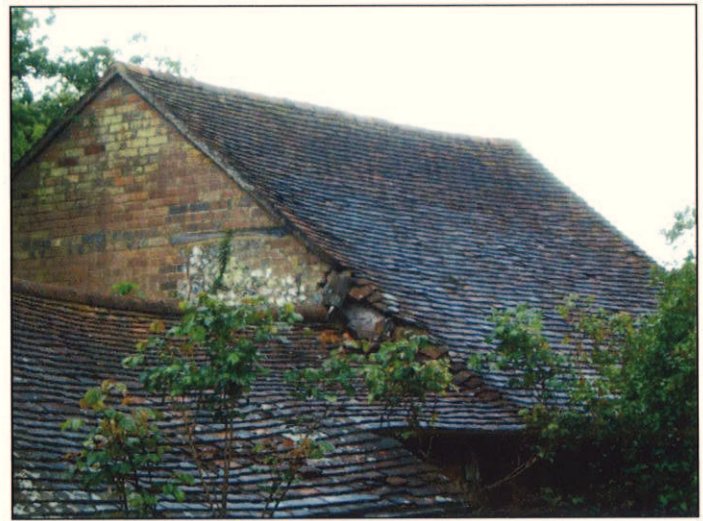
Plate 13: North wall gable showing original walling and rebuilt upper part

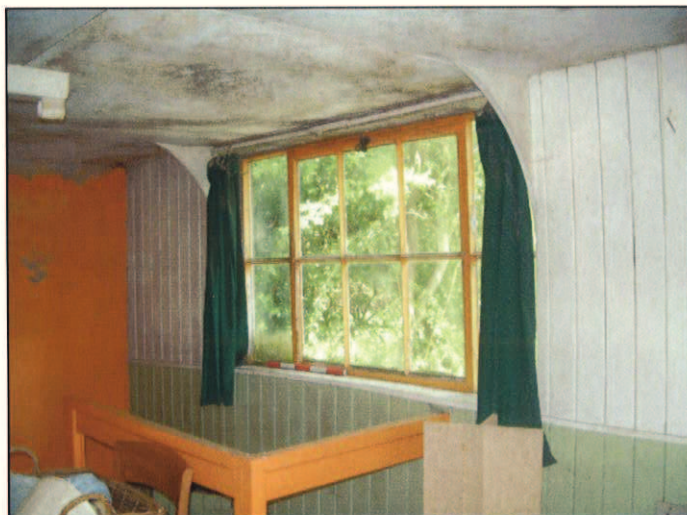
Plate 14: Room 2 window in east wall and panelling

3.3.9 The window on the south facing wall is of a similar type to those in room one, although larger with three sections the two side ones opening out and the middle section having a top hinged opening section. On the east wall are two large windows of ten panes in two rows. The frame is painted metal and the middle six panes are within a separate centrally hinged opening section which swings inwards from the top (Plate 14).

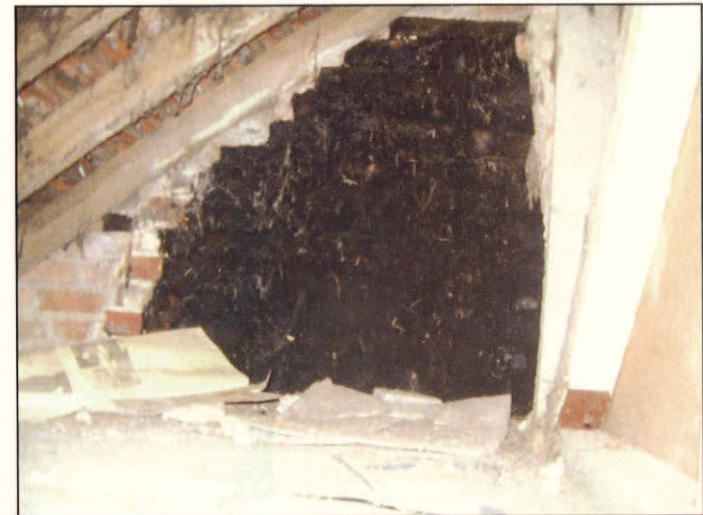
Plate 15: Room 2 sooting on the north wall visible in roof space

3.3.10 The space formed by the partition wall to the west of the room shows that the roof is a common rafter construction with rafters of 2 by 4in. The tiles are visible and are hung on battens with metal nails. At the north end of this small space the wall is heavily sooted indicating the course of the chimney, the sides of the chimney are indicated by stubs of brick projecting from the wall slightly (Plate 15).

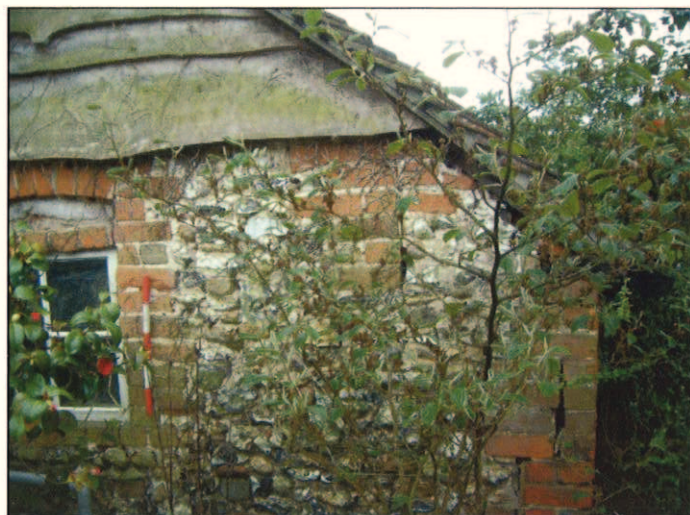
Plate 16: Extension gable showing original brick quoins and window

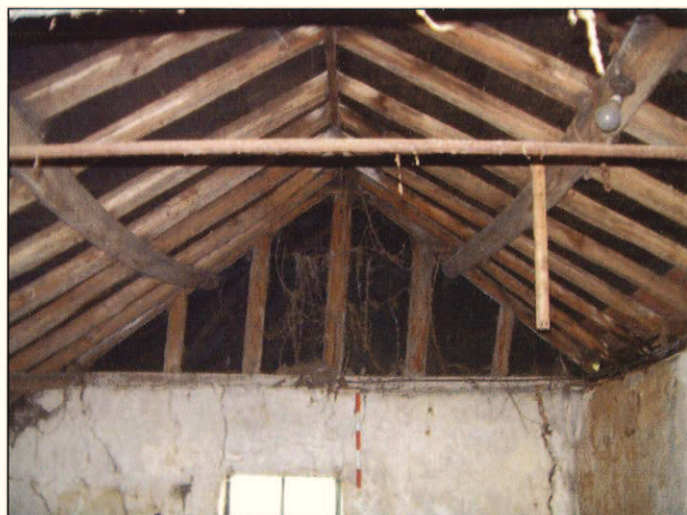
Plate 17: Room 3 north gable posts and roof

the tiles have been re-laid over a lining, perhaps with the extension of the room. The roof is of common rafter construction with rafters meeting at a ridge piece, a single tier of purlins under the rafters and wall plates. The timbers are mostly halved small trees or branches or roughly boxed timbers, several very waney. The north wall does not extend for the full height of the roof and the gable is weather boarded with the boards being fixed to five halved timber posts resting on a wall plate (Plate 17).

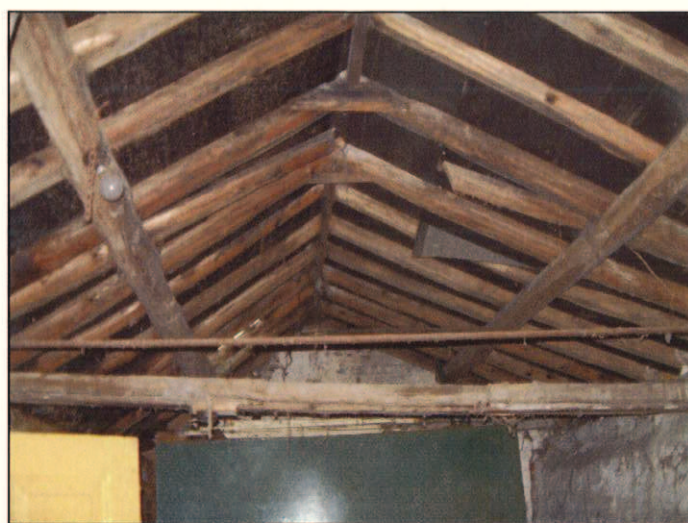
Plate 18: Room 3 break in ridge piece for possible stove pipe

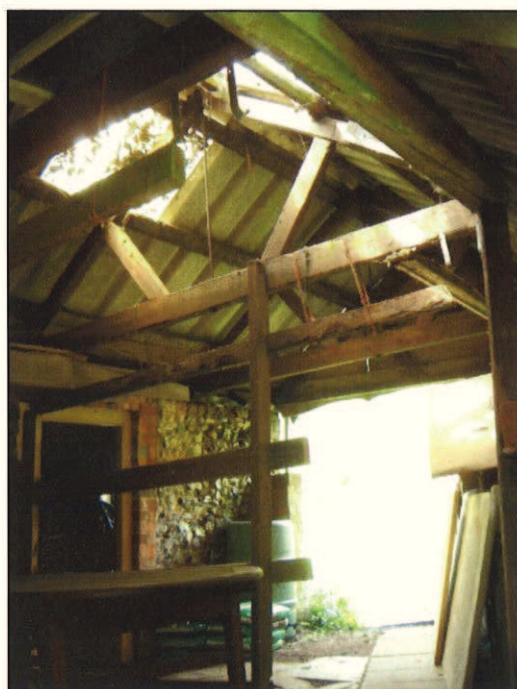
Plate 19: Room 4 shed roof construction

- 3.5.3 The roof consists of four bays divided by five trusses with queen struts and iron ties securing the apex of the rafters to the tie-beam, there are no common rafters but three plank purlins rest on each of the rafters (Plate 19). Two of the five trusses form the northern and southern ends of the structure; the northern has broad irregular weather boarding on it and the southern one is against the wall of the main block. Below the central southern two trusses are later inserted partitions of irregular pieces of timber, several are reused.
