Clapham Park Regeneration  
Lambeth  
London

**Archaeological Watching Brief  
Interim Statement – Area F**

March 2012

**Client: SKM Enviros**

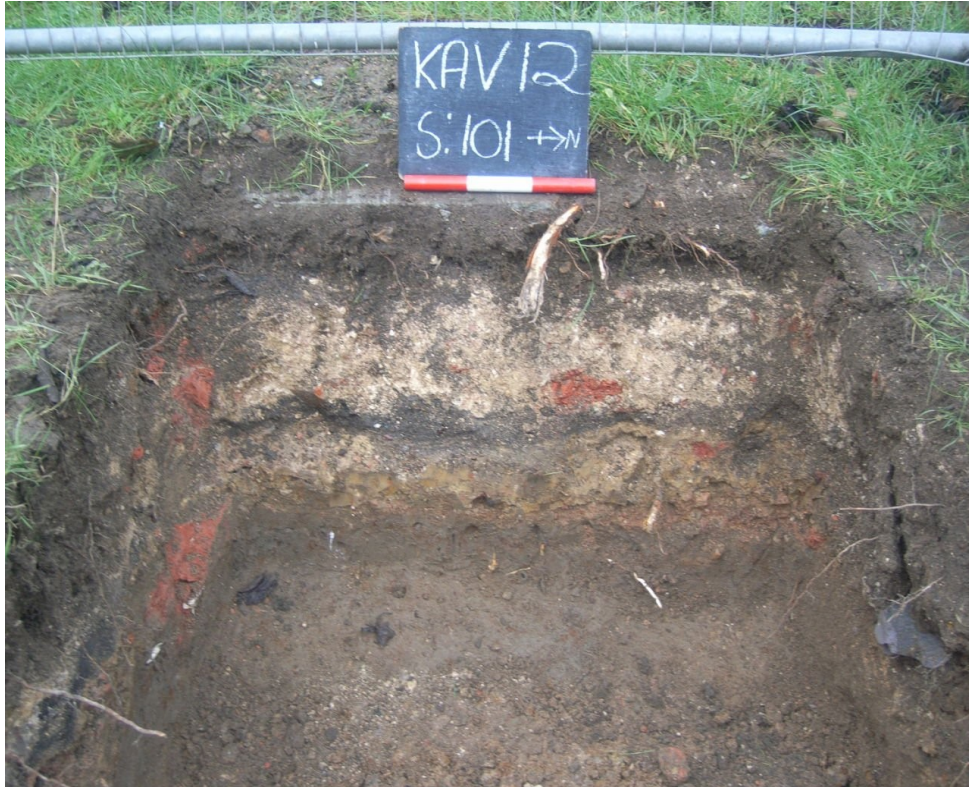
*Plate 1: Mortar layer*

- 4.1.2 On the western edge of the utilities trench a band of coarse white mortar (0.15m in thickness) constructed upon a thin band of black silt with ash inclusions 0.05m thick was recorded in section, this was not observed elsewhere during utilities identification (Plate 1). This may have been associated with Cubitt's houses although, having only been identified in section, this is uncertain.

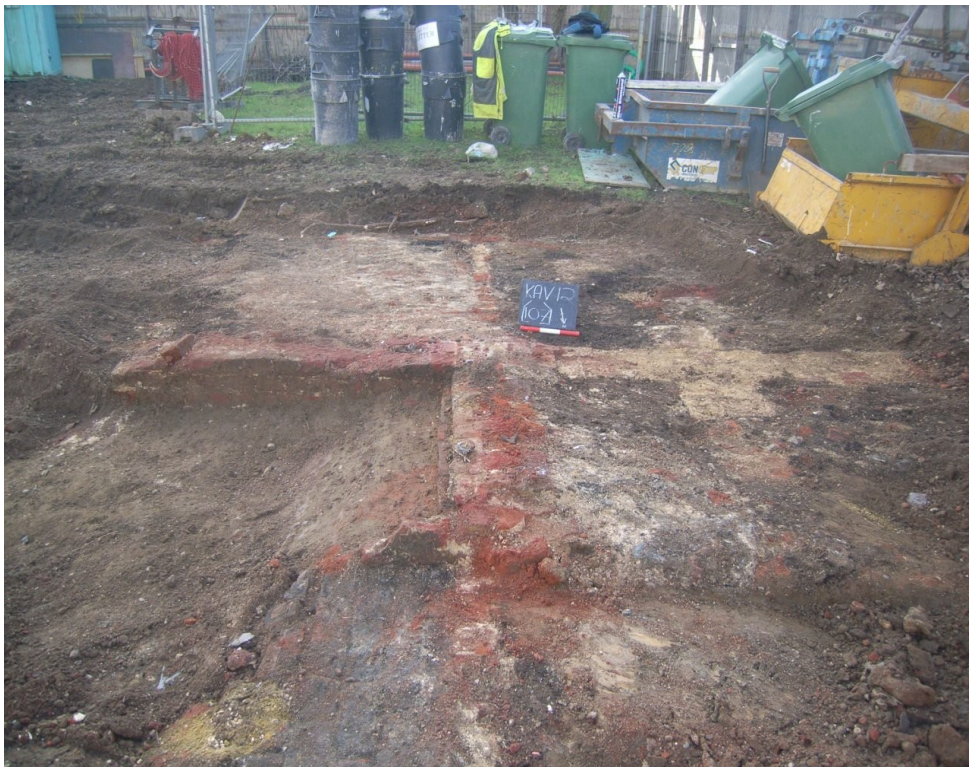
*Plate 2: Brick structure looking south*

- 4.1.3 During ground reduction to the west of the demolished structure, three walls were identified upon removal of the topsoil. A central wall running east-west for 4.5m, truncated at either end, was built in soft red bricks, handmade, with a very shallow frog. The wall was 3 courses wide and 3 courses high. A small wall 1 course thick, running parallel and 1.88m to the south, was two courses high, the lower course being two bricks wide. The third wall ran perpendicular to these linking them together (Plate 2).

- 5.1.1 The structure identified would appear to form part of one of Cubitt's terraced houses which originally fronted onto New Park Avenue. Due to heavy truncation a complete floor plan could not be established. The variation in the thickness between the walls suggests interior partition walls between rooms, or other spaces within the structure, but the limited extent of the excavation meant that the nature and plan of the building could not be established further.
- 5.1.2 Further excavations in the area have the potential to expose additional structural evidence which may provide a more complete picture of Cubitt's terraces. Further work is likely to be similarly hindered by heavy truncation resulting from 1950/60s redevelopment as observed during these works.

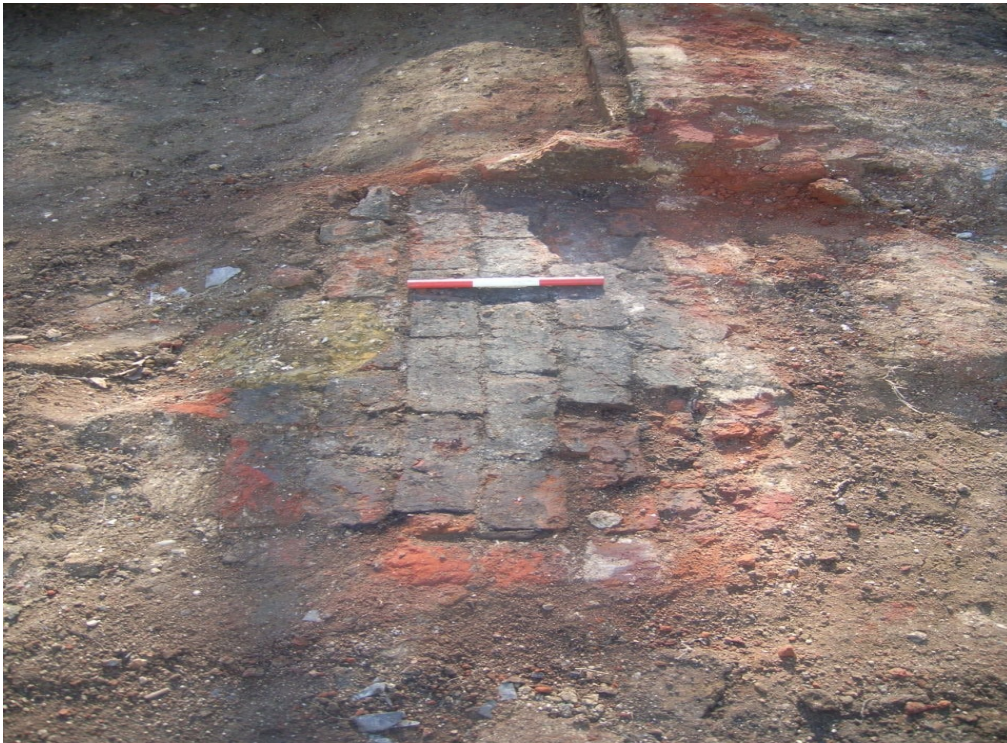
*Plate 3: Soakaway*

- 4.1.4 An additional structure at the northern end of the north-south aligned wall consisted of a rectangle brick structure 5 courses high, linked to a ceramic drain running to the north west, which appeared to be a soak-away or drain (Plate 3).
