Former Boswells Department Store

Broad Street

Historic Building Investigation and Recording

May 2022

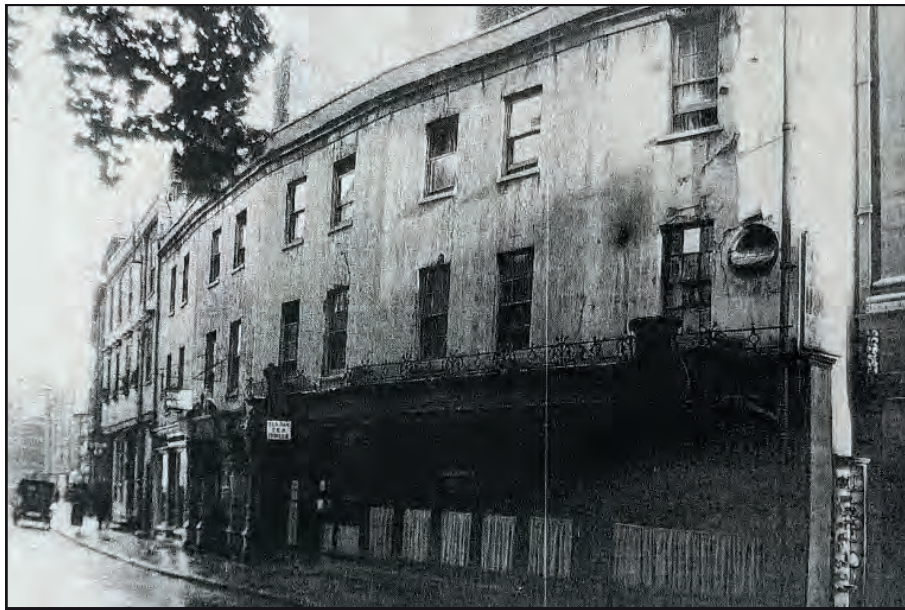
Figure 10: Undated photo c. 1925 showing previous building at 1-5 Broad Street prior to demolition (ref: Boswell Family Archive)

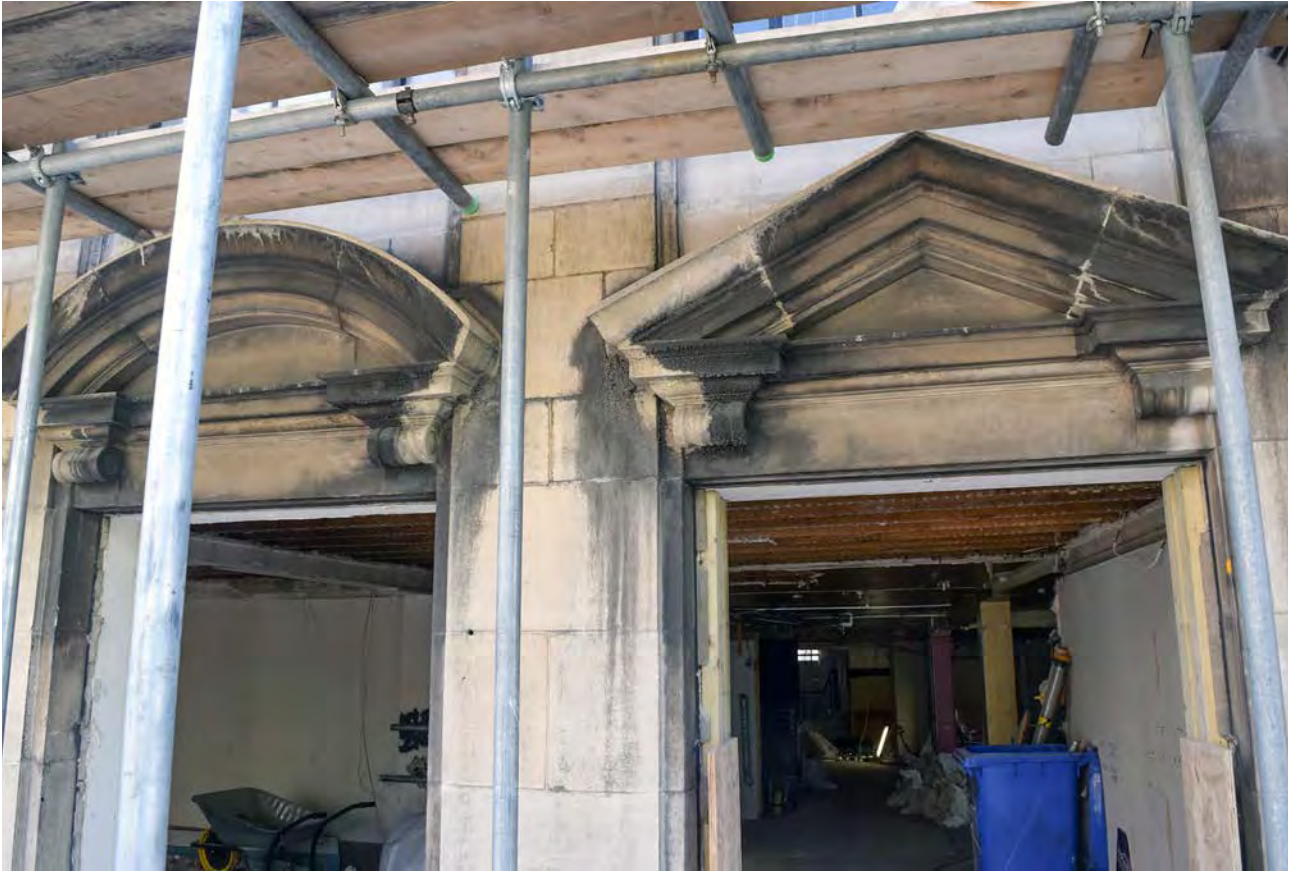
Plate 1: Window openings in the north facing elevation of Boswells

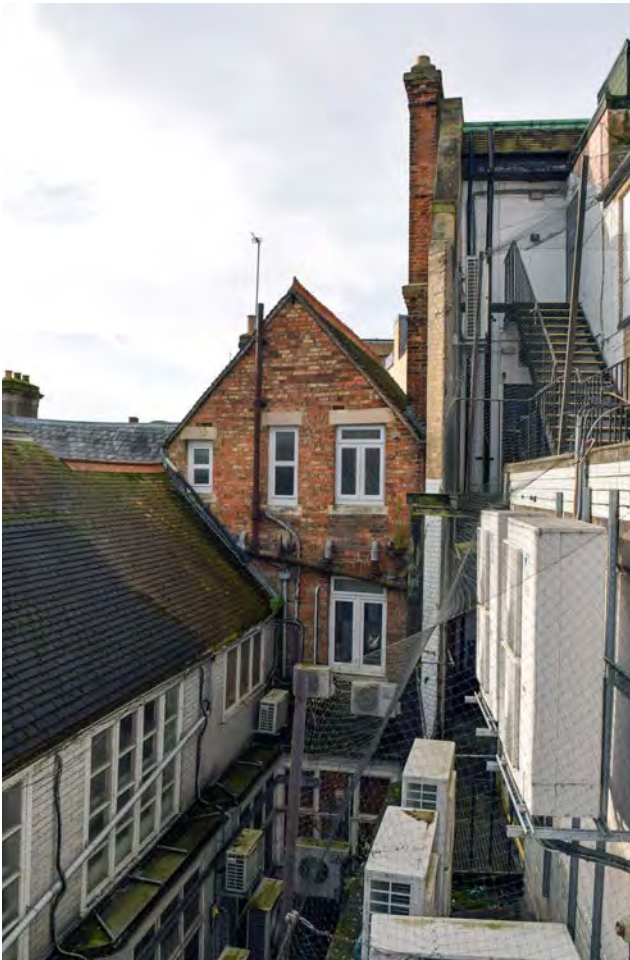
Plate 2: The lightwell between Boswells and the building occupied by Waterstones, looking west

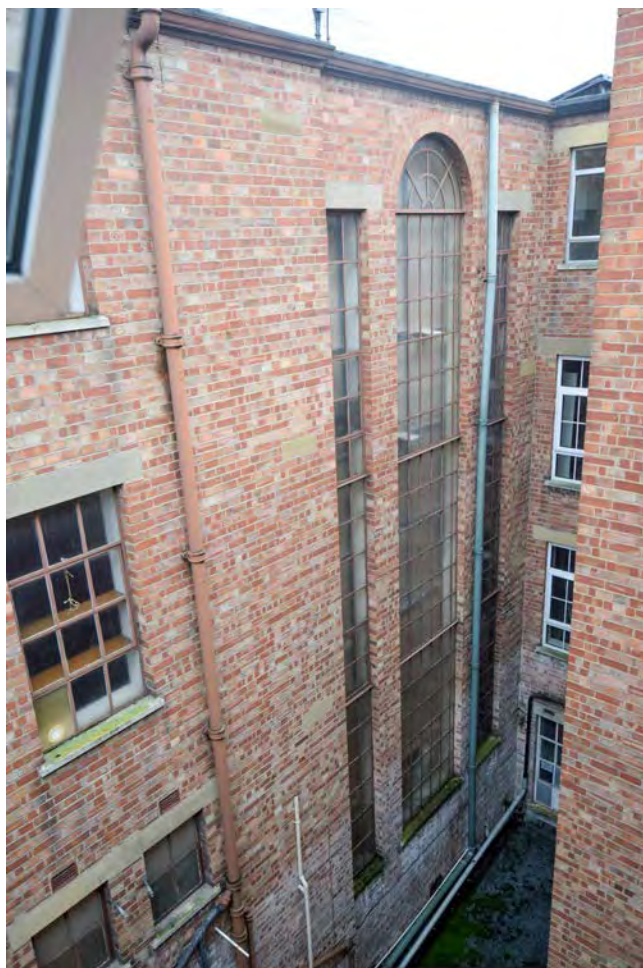
Plate 4: The central lightwell in 1 to 5 Broad Street, looking south-west

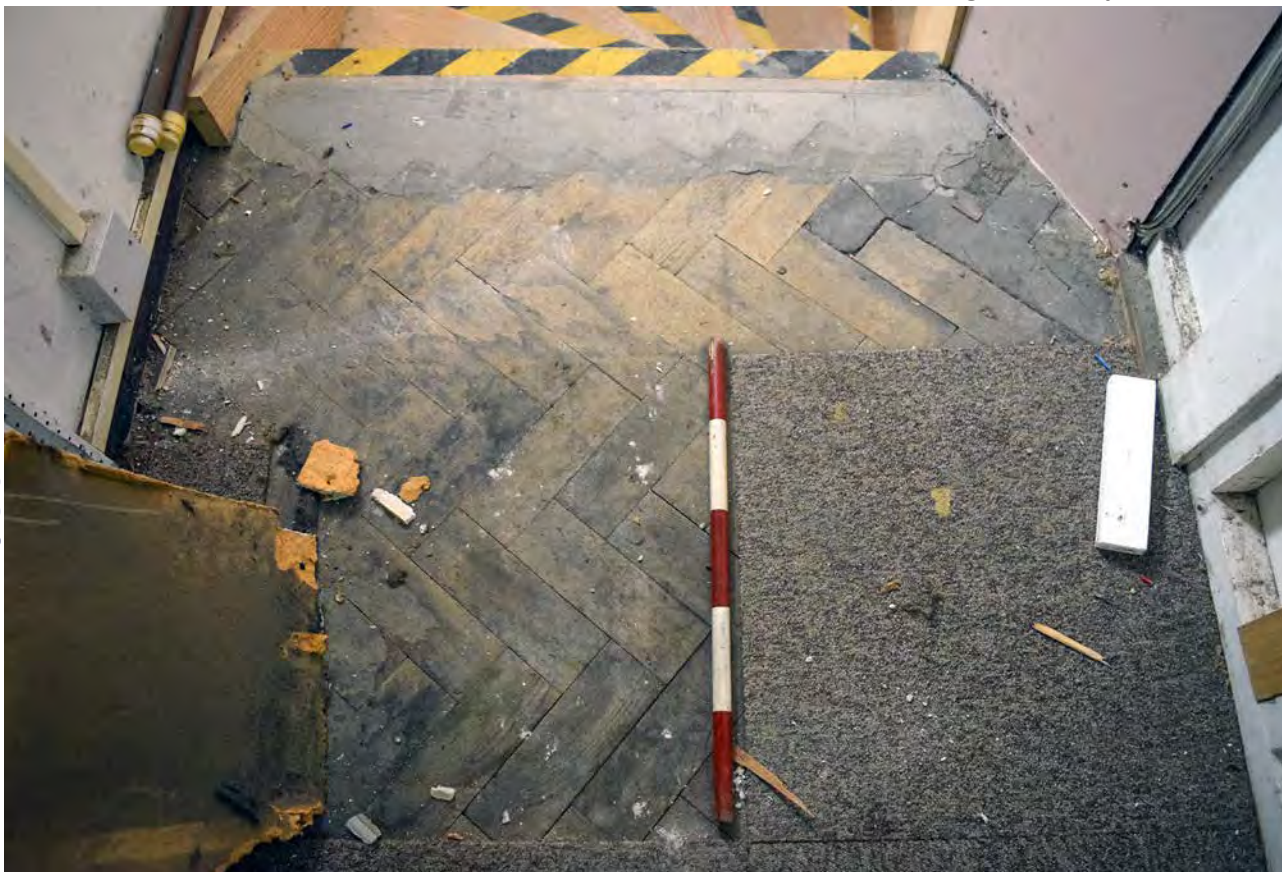
3.3.4 The ceiling is heavily plastered between north to south running rolled steel joists and there are large windows creating lights from the basement above. The windows comprise glass tiles in metal frames and are likely to date to the 1929 expansion of Boswells (Plate 7). The stairway in the corner is a modern timber and plywood structure that is likely to replace an earlier staircase. At the threshold of the stairs, at basement level, there is an area of parquet flooring that is likely to date to 1929 (Plate 8).

Plate 8: The floor of the south stairway in the basement of 31 Cornmarket Street, looking west

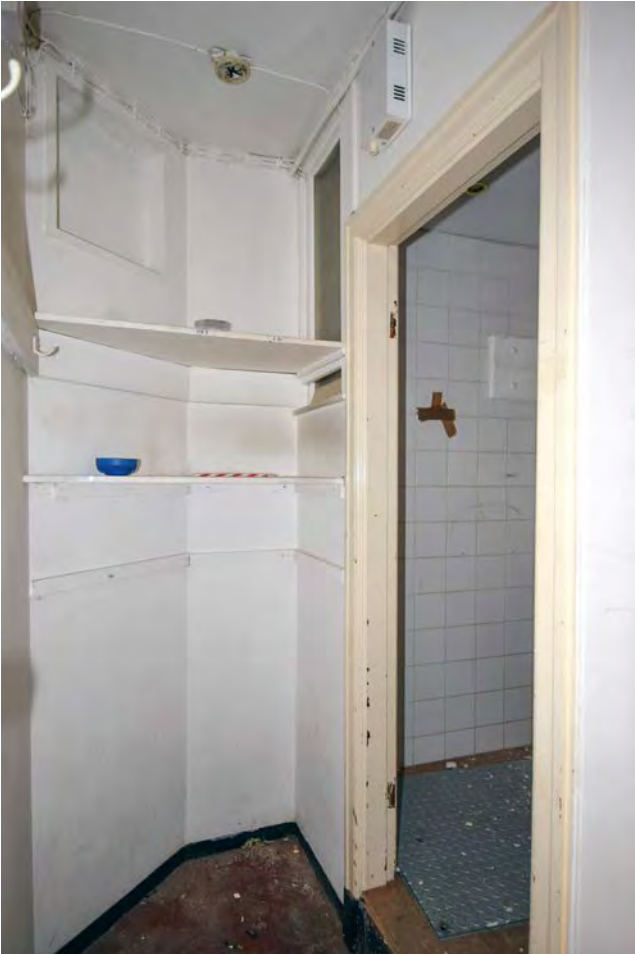
- 3.3.10 Features of historic interest were observed on the west side of the shop floor where two small staff WCs are subdivided from the rest of the floor. The joinery of the doorways suggest that the subdivisions date to the early 20th-century (Plate 13). In the south WC is a small, iron-framed, four-light casement window in the south- west facing wall (Plate 14). This is characteristic of early 20th-century fenestration. The patterned lino on the floor has the appearance of being 1960s or 1970s in date (Plate 15). Both areas have round light switches which are characteristic of the early to mid 20th century. This area is likely to be original to the 1929 expansion of the store, at least in plan.

Plate 13: WC in the basement of 1 to 5 Broad Street, looking south-east

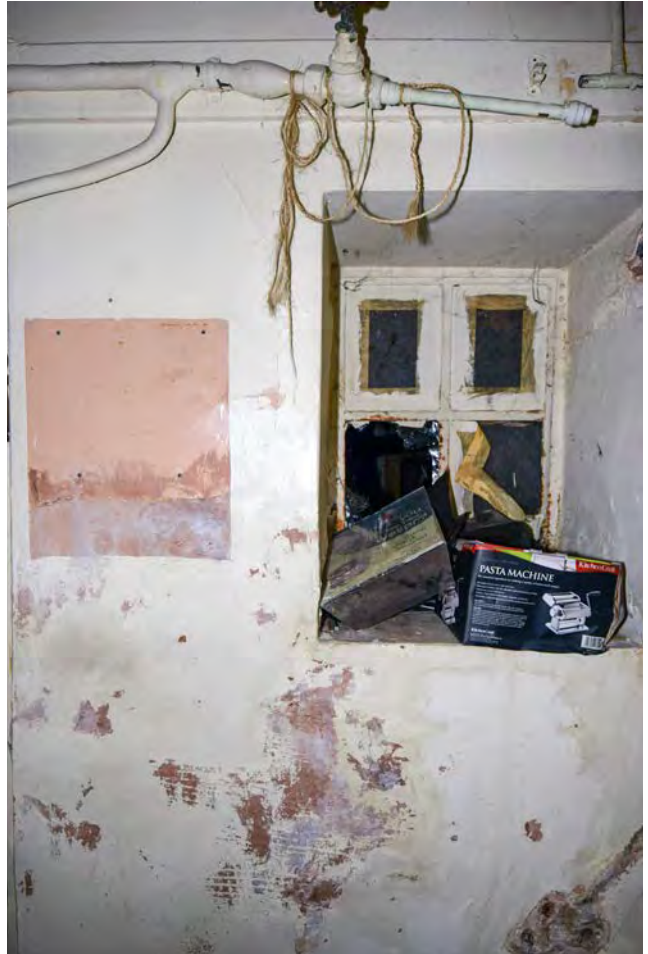
Plate 14: WC in the basement of 1 to 5 Broad Street, looking south

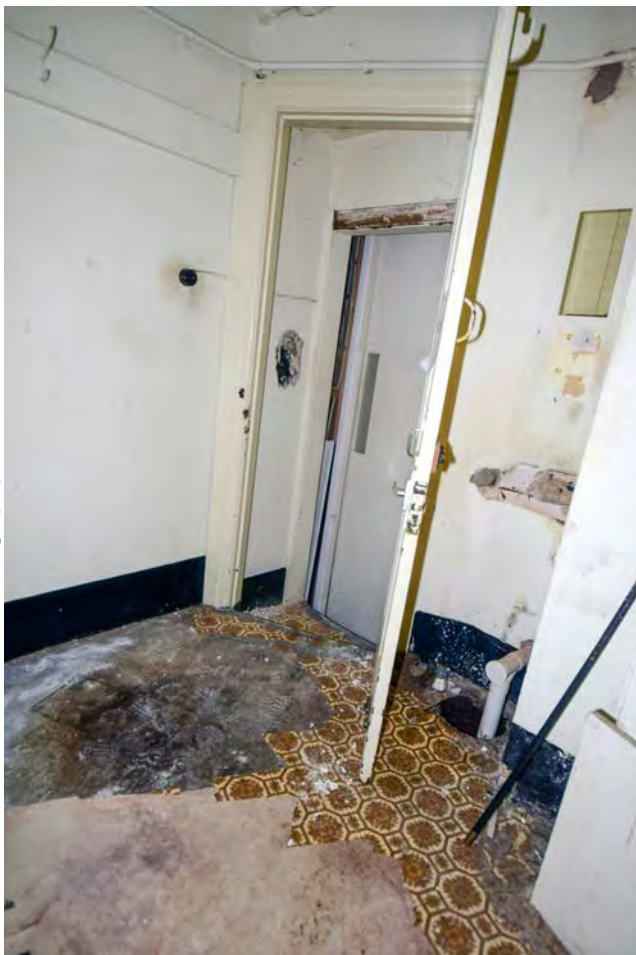
Plate 15: WC in the basement of 1 to 5 Broad Street, looking south-east

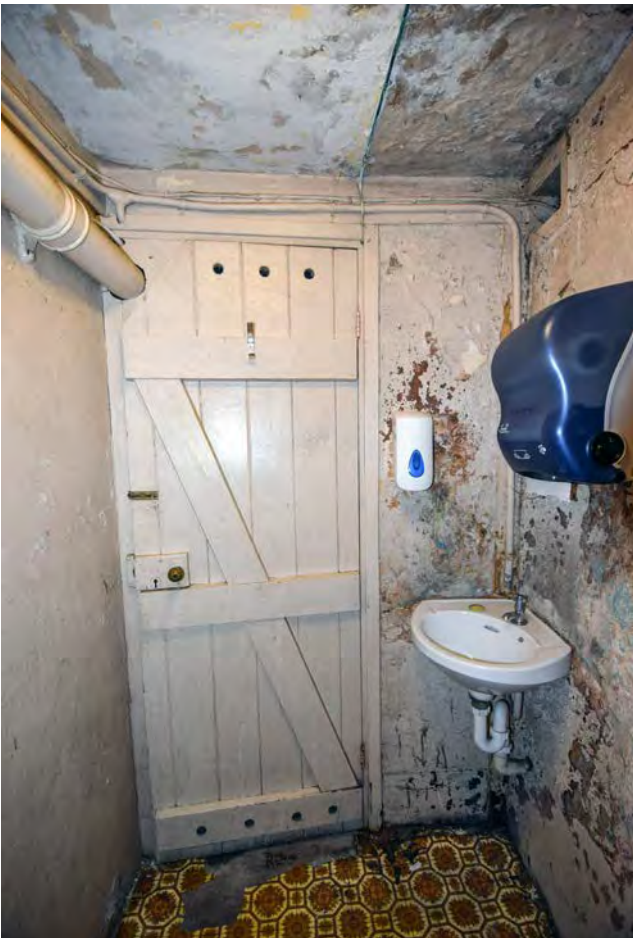
Plate 23: WC in the basement of 1 to 5 Broad Street, looking east

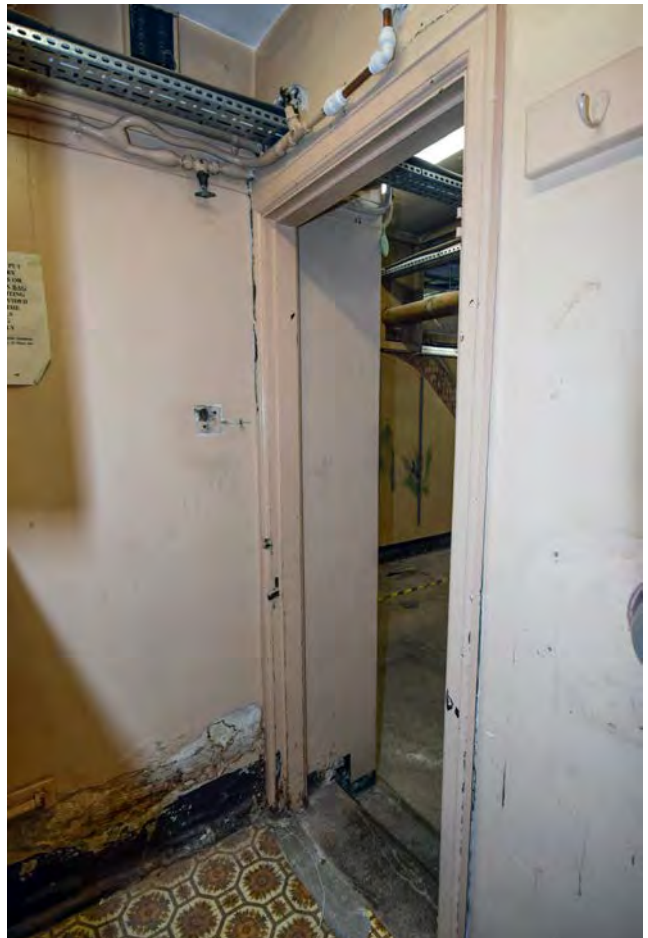
Plate 24: Kitchenette in the basement of 1 to 5 Broad Street, looking north-west

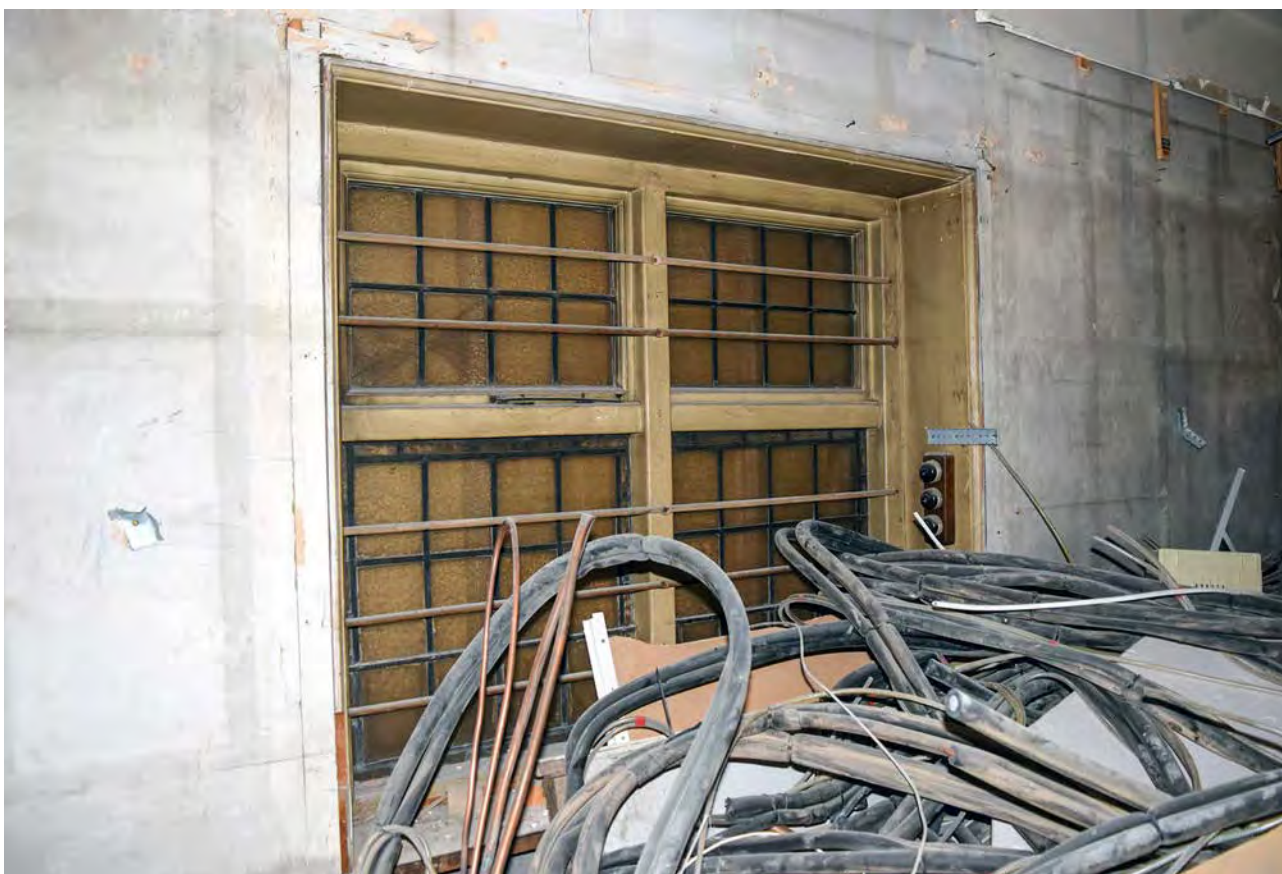
Plate 30: Window in the ground floor of 31 Cornmarket Street, looking south-west

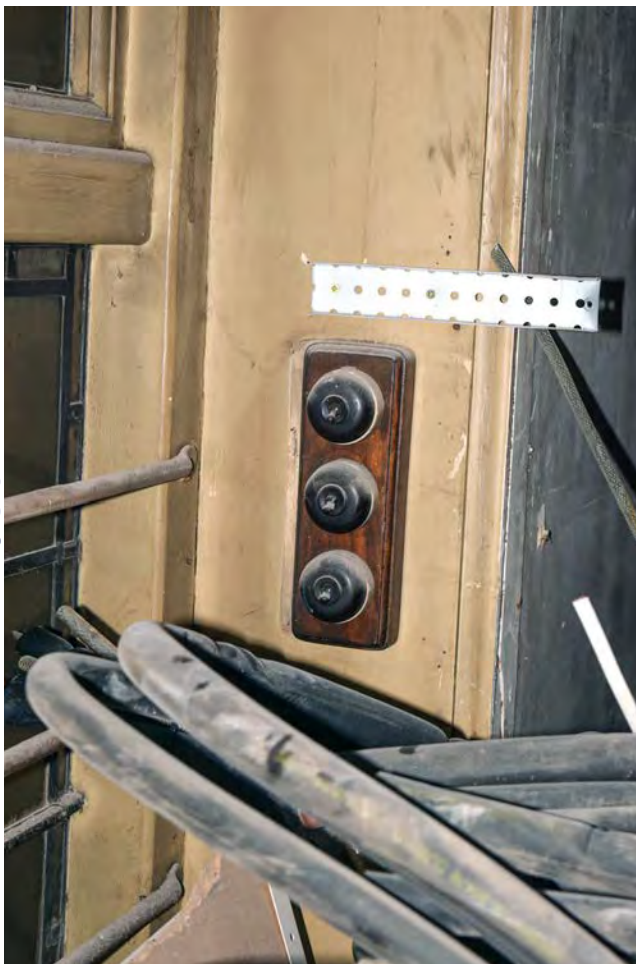
Plate 31: Light switches in the ground floor of 31 Cornmarket Street, looking west

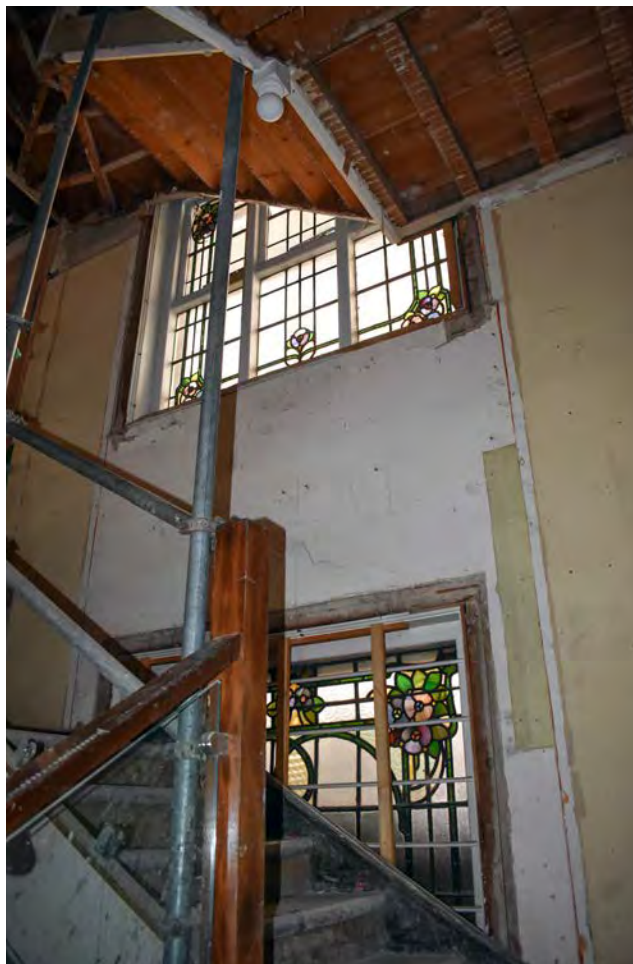
Plate 32: Windows in the stairway of 31 Cornmarket Street, looking south-east

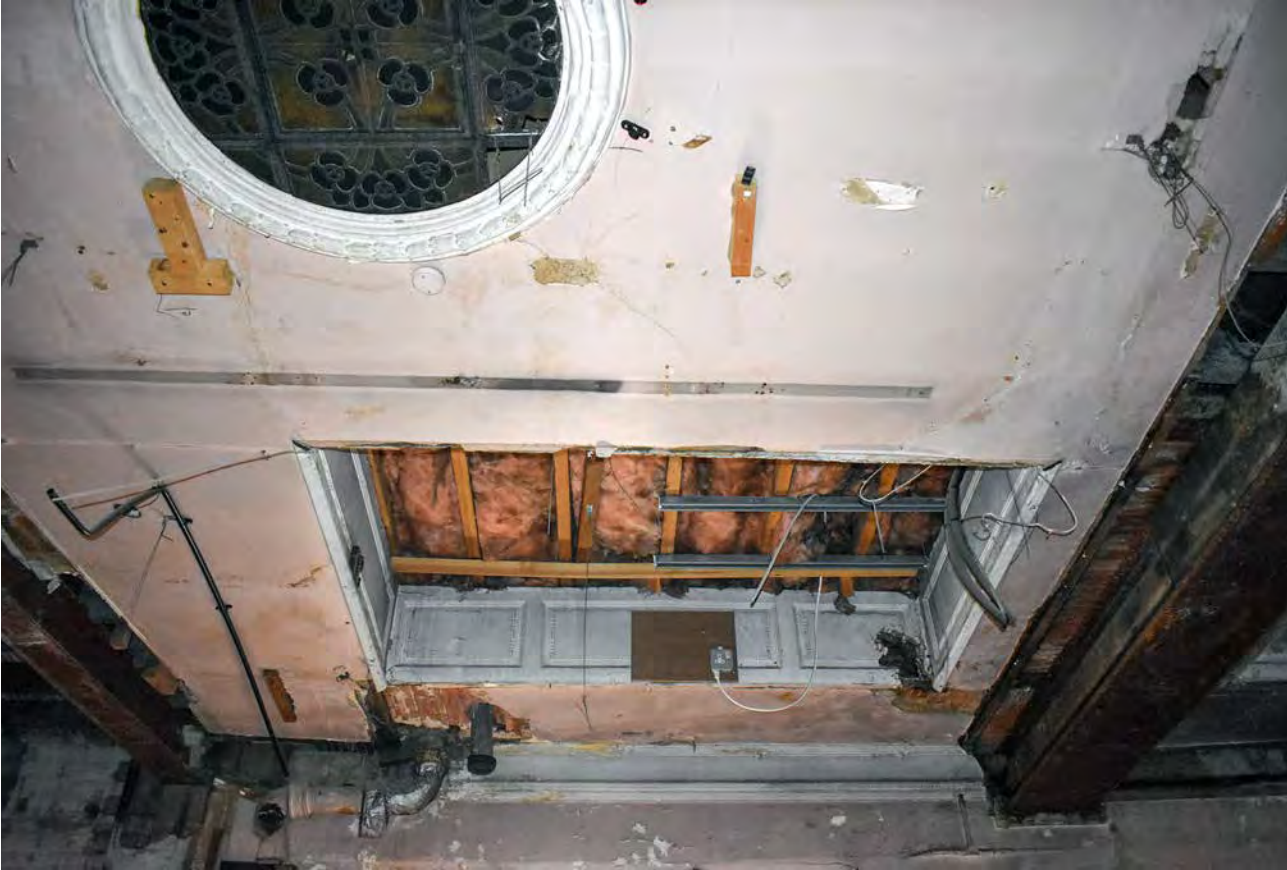
Plate 35: Ceiling in the ground floor of 31 Cornmarket Street, looking north

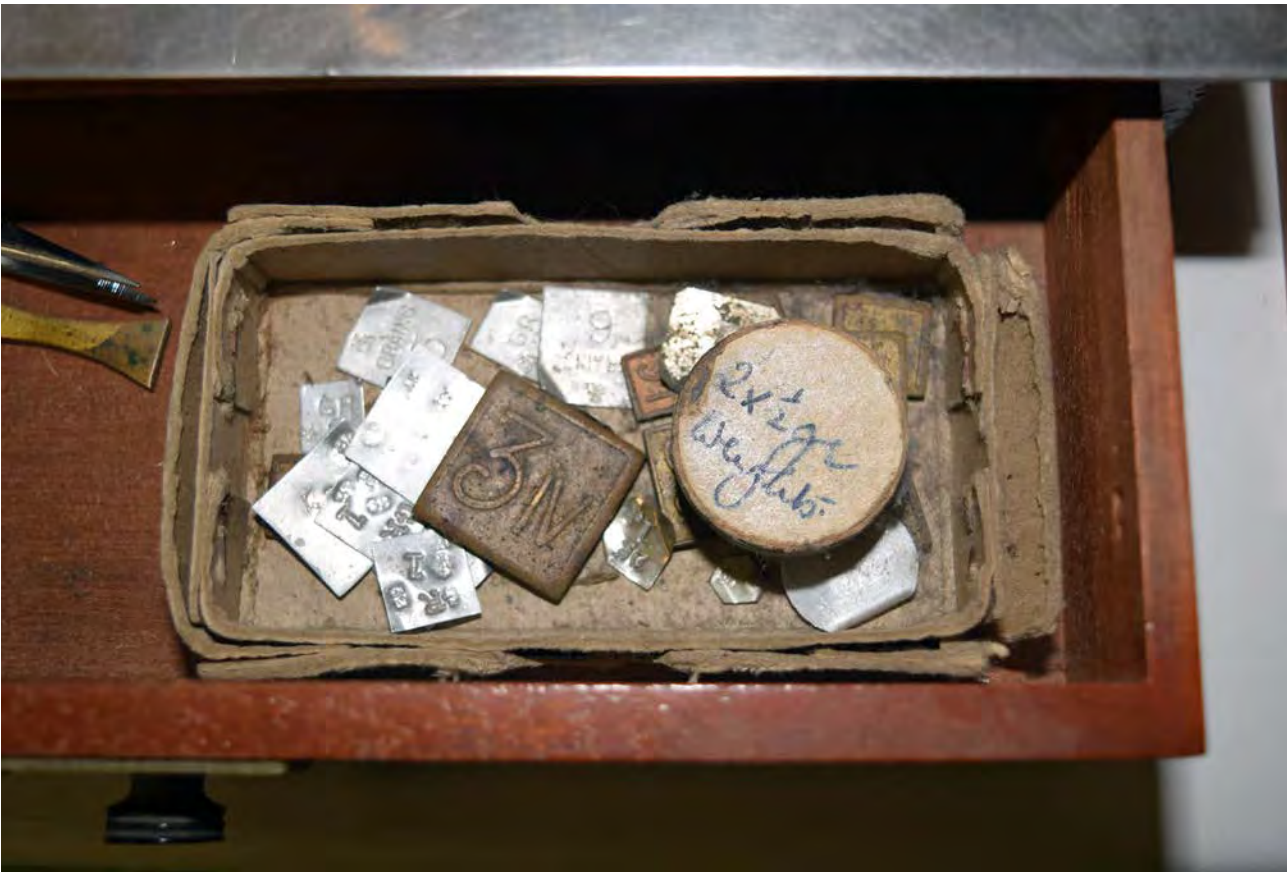
Plate 45: The weights and measures of the Apothecary System in the pharmacy of Boswells Store

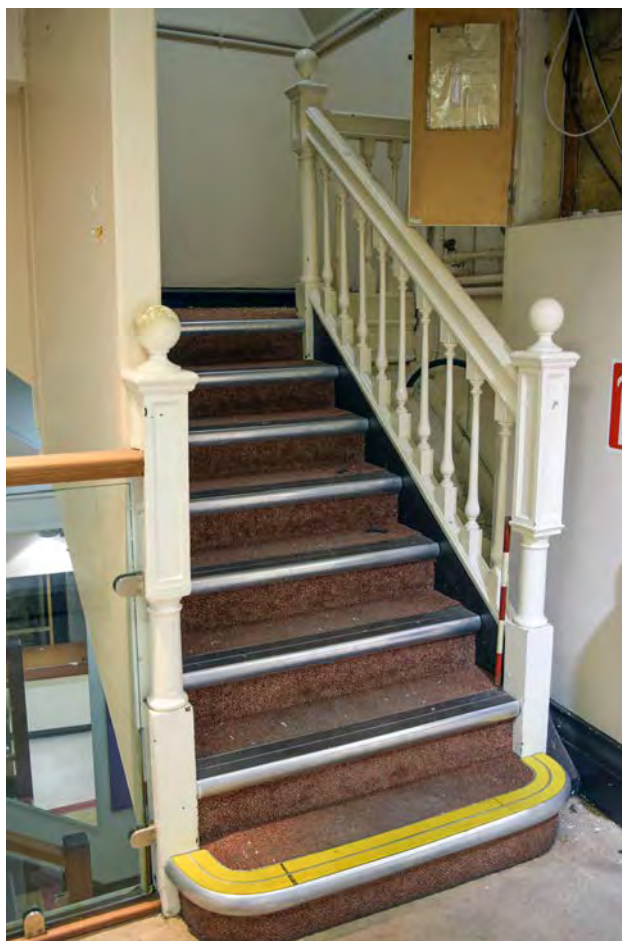
Plate 59: The stairway between the first and second floor in 31 Cornmarket Street, looking south-west

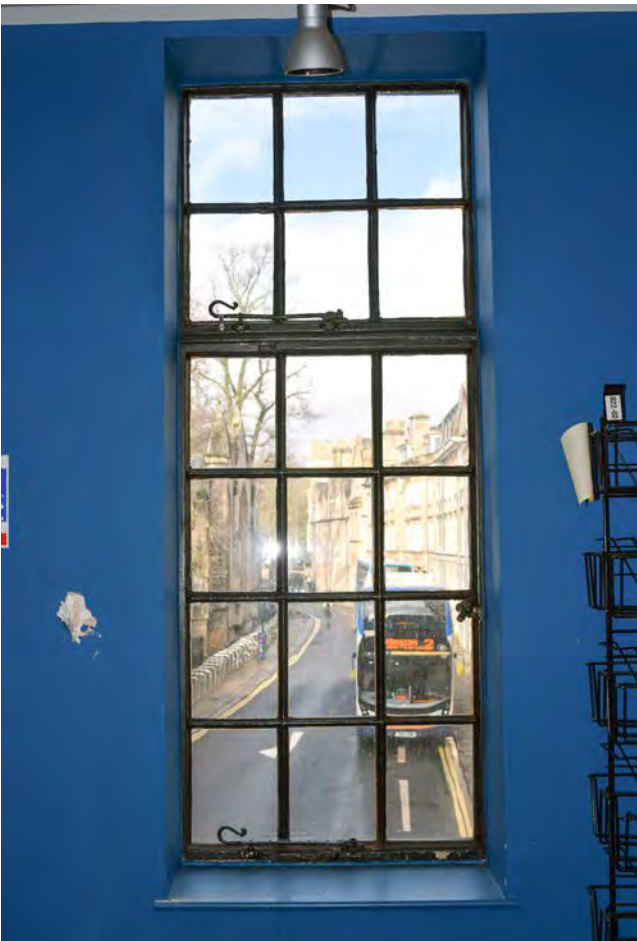
Plate 64: Window overlooking Broad Street in the first floor of 1 to 5 Broad Street, looking north

- 3.3.27 This area was surveyed before the shop fronts were stripped out so exposed historic features were limited. In the north wall, overlooking Broad Street, were the original, iron-frame, multi-pane windows of the 1929 store (Plates 64 & 65). It is also interesting to note that where panels of shop front have been removed from walls and from a pillar, the paint to the walls underneath is gold, representing a previous phase in the colour scheme of the store (Plates 66 & 67).

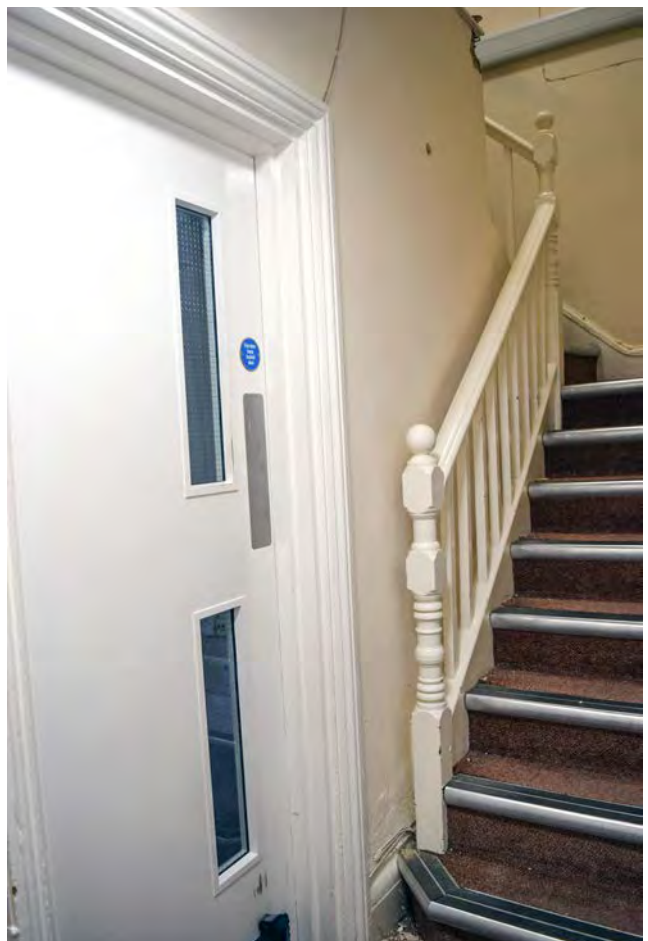
Plate 70: The second floor of 31 Cornmarket Street, north-west

- 3.3.28 **31 Cornmarket Street** The second floor of the Cornmarket Street element of Boswells is reached by means of the timber stairway from the first floor on the south side. It is made up of offices and staff areas and as such is more functional in character as well as being subdivided into many small rooms. The stairway opens onto a landing (Plate 68) at the west end of a corridor that runs along the wall of south side of the L-shaped lightwell on the exterior (Plate 69). A passage on the west side of the landing leads to two offices. This area has been altered in the 20th century with modern doors and utilities but the 1912 building is still very much apparent in the form of moulded architraves and cornicing (Plates 70 & 71), and fireplace in the north wall with its original, plain timber surround and iron interior (Plate 72). The staircase between the offices that leads to the third floor also retains its original timber balustrade with turned newel posts featuring ball caps (Plate 70).

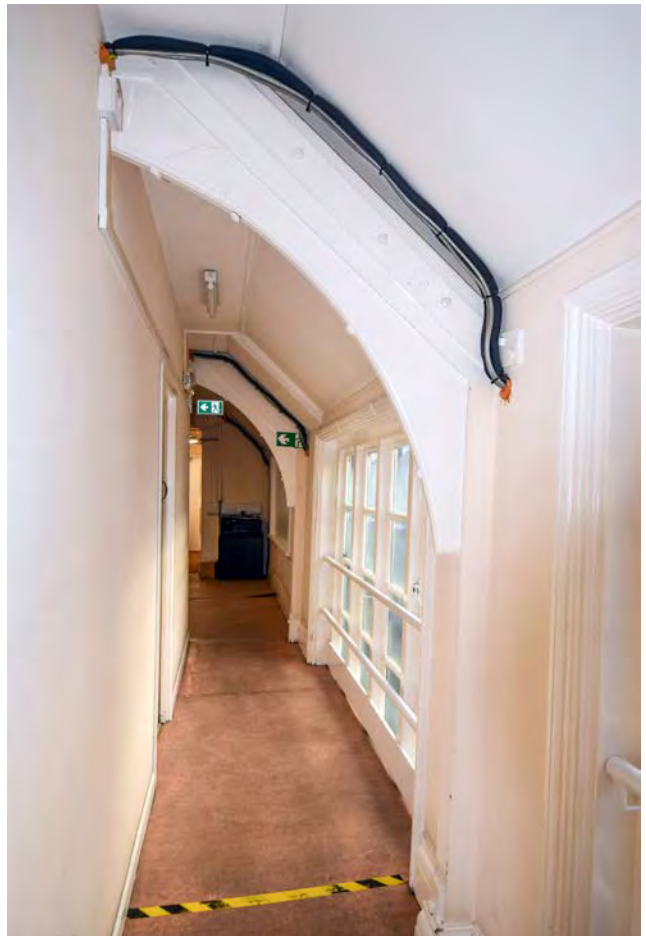
Plate 73: The second floor of 31 Cornmarket Street, looking west

- 3.3.29 The corridor running eastwards from the landing has two large, sixteen-light casement windows in its north wall, overlooking the L-shaped stairwell. Extending from the ceiling are exposed principal rafters with moulded arched timbers bolted to their undersides (Plate 73). On the south side of the corridor are modern doorways into two offices, the walls of which are likely to be modern insertions. The principal rafters as well as the tie-beams of the trusses are also visible in these offices and the four-light casement windows are the same in character as those found in the south wall of the shop floors below (Plates 74 & 75). The east end of the second floor of the Cornmarket Street side is divided into a locker room on the north side (Plate 76), and a staff rest area on the south side (Plate 77). The trusses can be seen in these rooms also, as well as the 1929 window in the staff room on the south side. These have the same heavy timber casement frames and leaded lights with Minster glass as the windows in the south walls on the floors below. In the north-east corner of the second floor is a small kitchen with a modern UPVC window that overlooks the L-shaped lightwell, and a door in the north wall that leads to the Broad Street element of Boswells (Plate 78). Between this kitchen and the staff room is a small stairwell

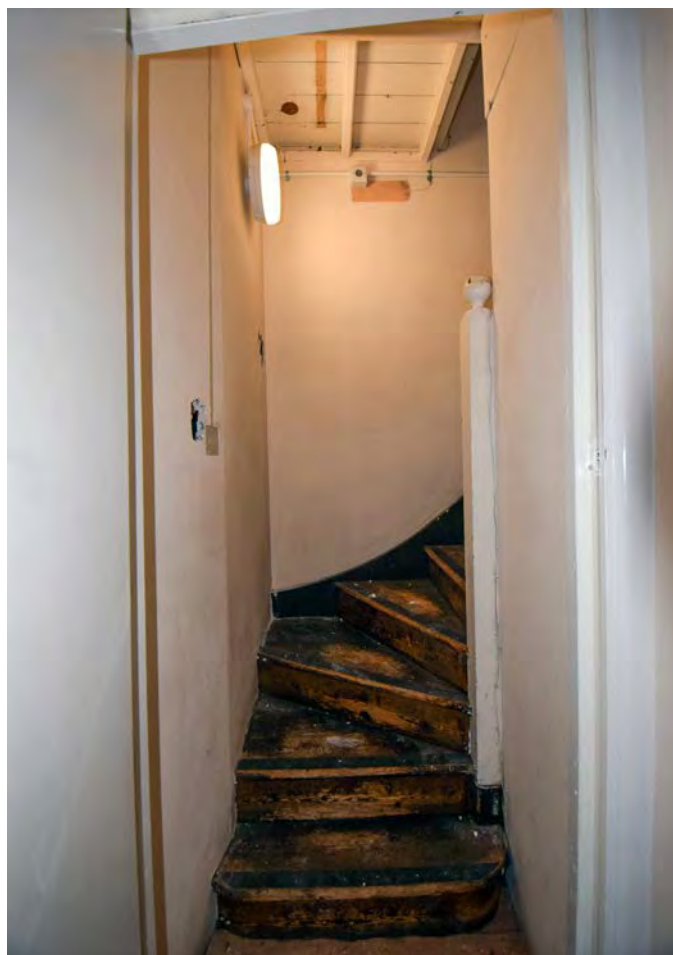
Plate 79: The second floor of 31 Cornmarket Street, looking east

with a staircase that appears to be original to the 1912 building that leads to the third floor (Plate 79).

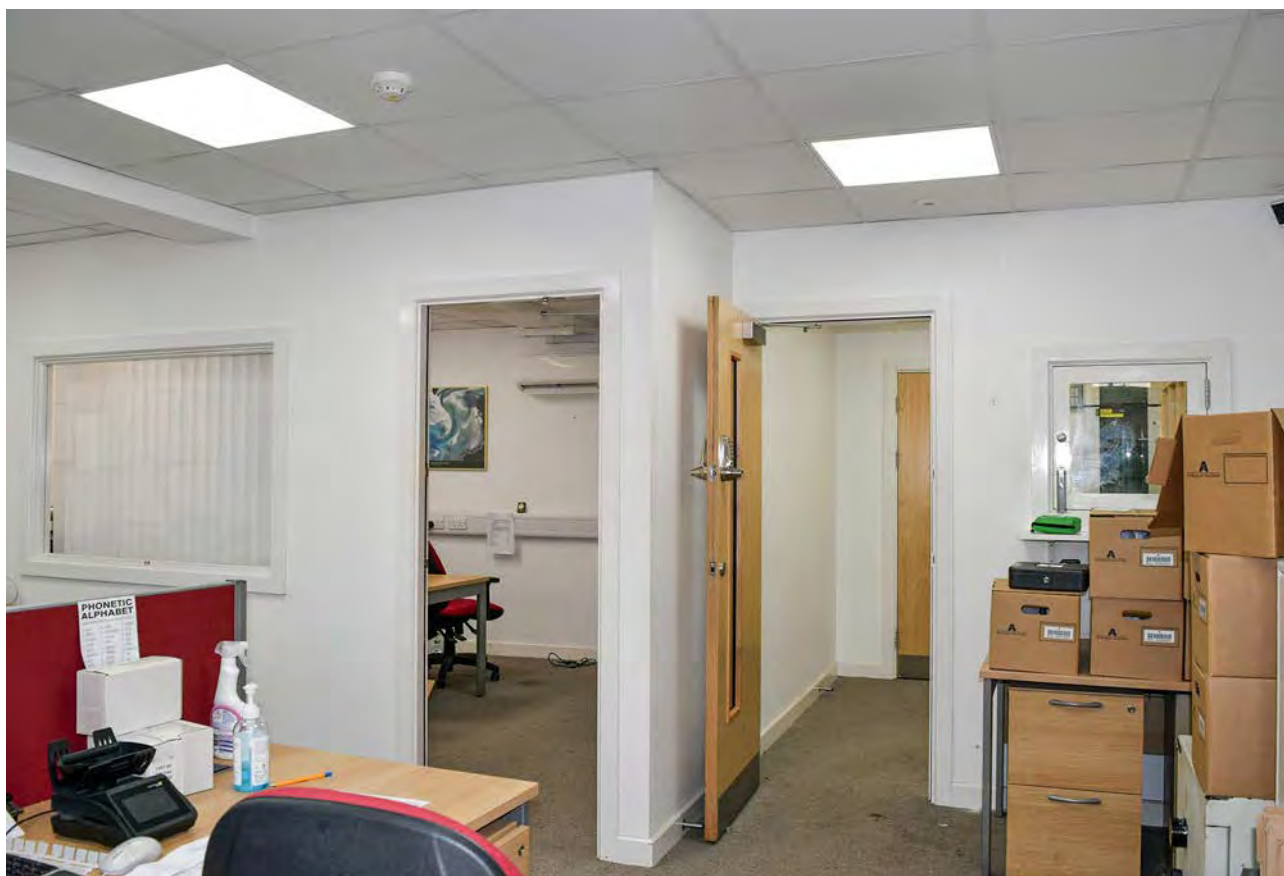
Plate 82: The second floor of 1 to 5 Broad Street, looking west

- 3.3.31 Two doorways on the south side of the shop floor lead to modern, subdivided offices and small storage spaces. Like the public areas of the second floor, this are fitted with laminate wood flooring and carpeting, suspended ceiling tiles with lighting panels and modern fire doors (Plate 82). The east wall of the office on the east side is largely glazed with modern aluminium windows which overlook the alleyway on the east side and the bastion of Oxford's medieval city walls (Plate 83).

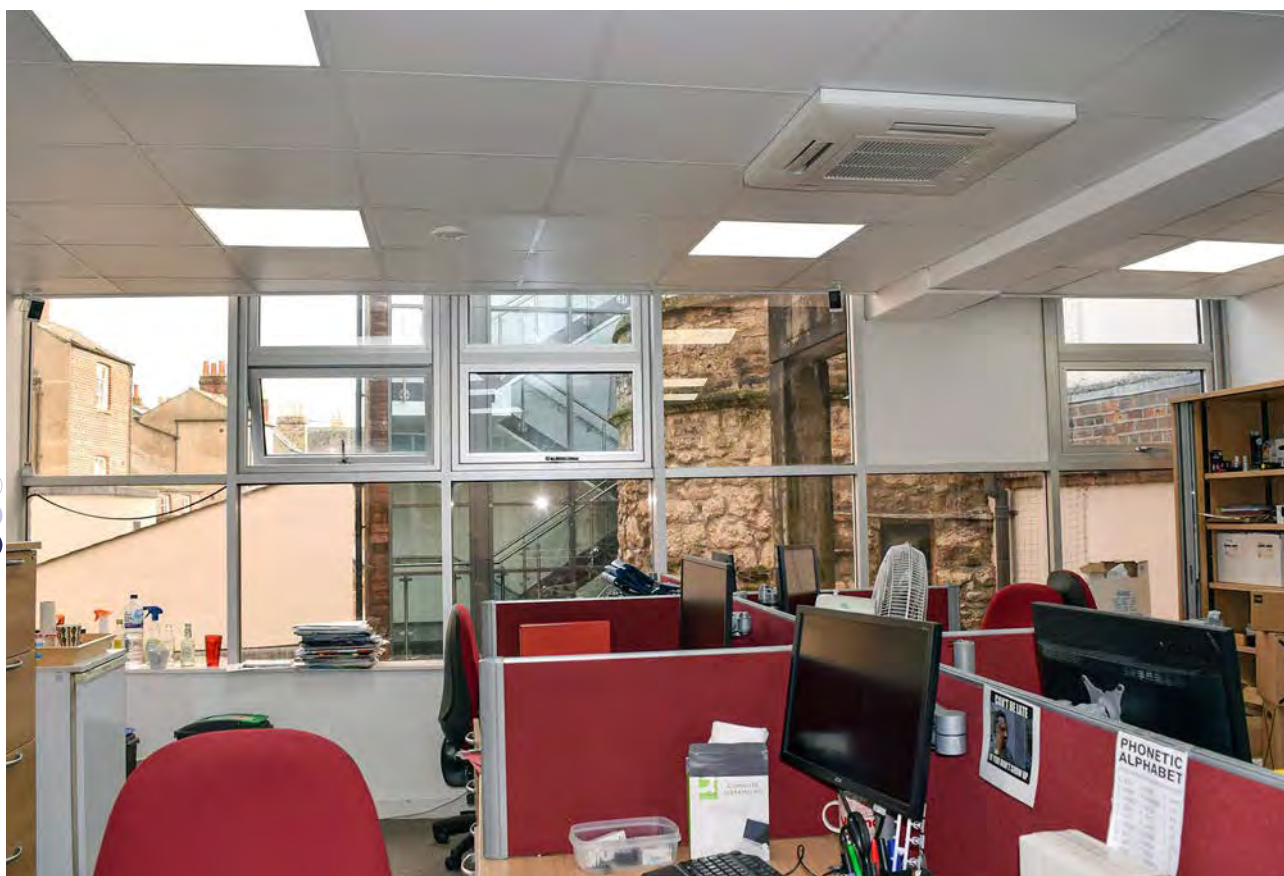
Plate 83: The second floor of 1 to 5 Broad Street, looking east

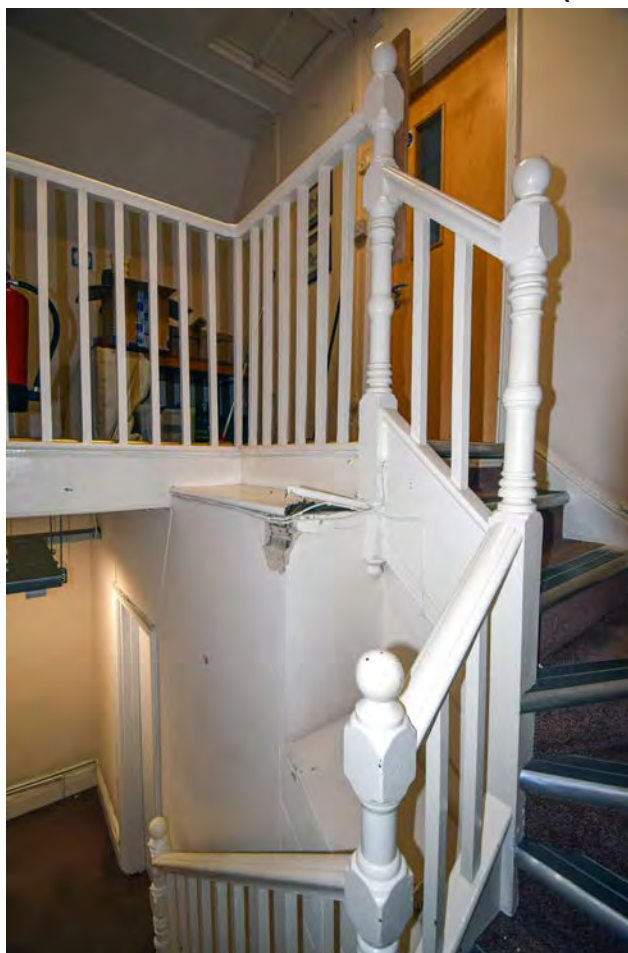
Plate 84: The stairway between the second and third floor of 31 Cornmarket Street, looking south-west

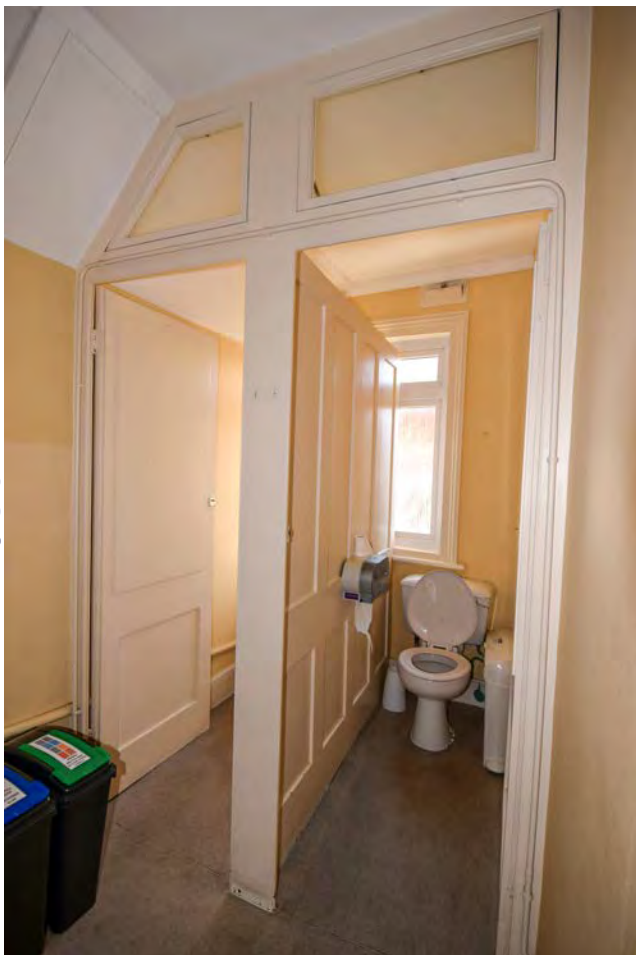
Plate 88: The third floor of 31 Cornmarket Street, looking north-east

- 3.3.33 The area on the east side of the landing has been subdivided into a small, modern WC block. The two casement windows in the east wall have modern windows but retain their original moulded, timber frames. The panelled divisions of the stalls appear to be mid-20th century in date (Plate 88).

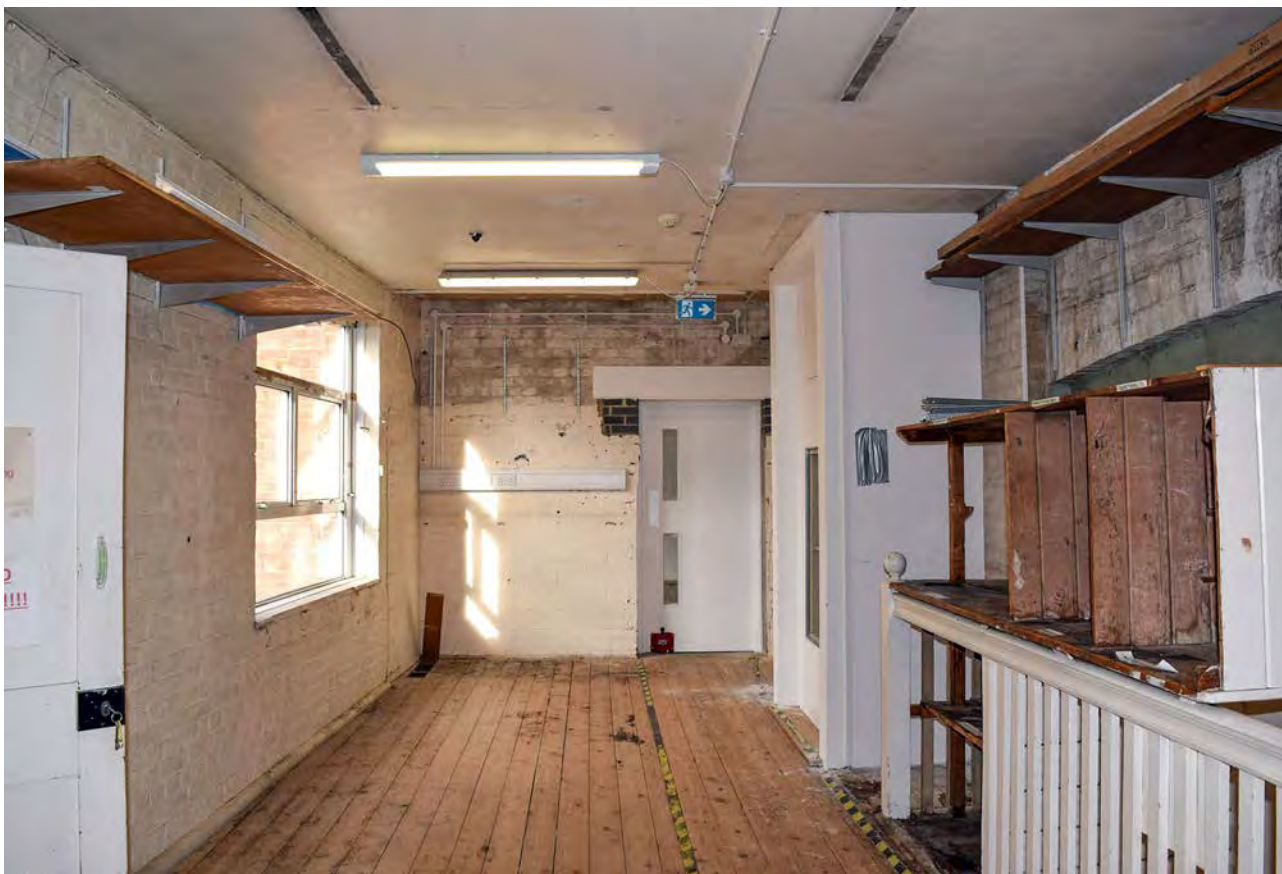
Plate 90: The third floor of 31 Cornmarket Street, looking north

balusters and plain newel posts with ball caps, suggesting a lower status, more utilitarian area (Plate 89). It opens onto a large landing, the east side of which features the highest dispatch point of the goods lift observed throughout all floors from the sub-basement (Plate 90). The area has plain floorboards and brick walls painted white, and over the stairway in the east wall is a large segmental supporting arch. Built against this are timber shelving units that are mid-20th century in character. A modern fire door on the north side leads to the third floor of the later Broad Street side of Boswells and a doorway in the west walls leads to an attic space. This doorway is flanked by two modern windows that overlook the roof between the east and west ends of the third floor. The doorway into the attic features what appears to be an original plain, four-panel door (Plate 91). The attic space has timber work surfaces built along its north side (Plate 92). The timber framing is early 20th century in character with machine cut timbers and bolted iron traps. The floor is boarded and the narrow joisted ceiling that runs under the ridge piece suggests it was built as a work space that people could walk into.

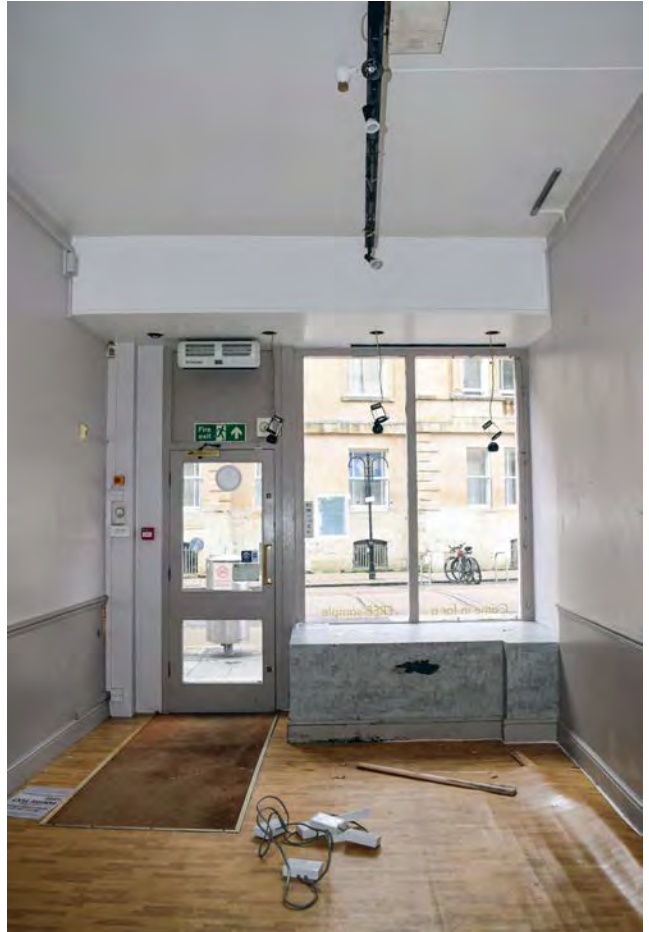
Plate 110: The ground floor of no. 5 Broad Street, looking north

3.4.3 No. 5 Broad Street, previously a fudge shop, is entered from Broad Street at ground floor level through its modern glazed shop front. It has a decorative dado rail, that is probably modern and a floor covering of lino (Plate 110). Behind a modern sink unit in the south-east corner is the decorative balustrade of the stairway to the

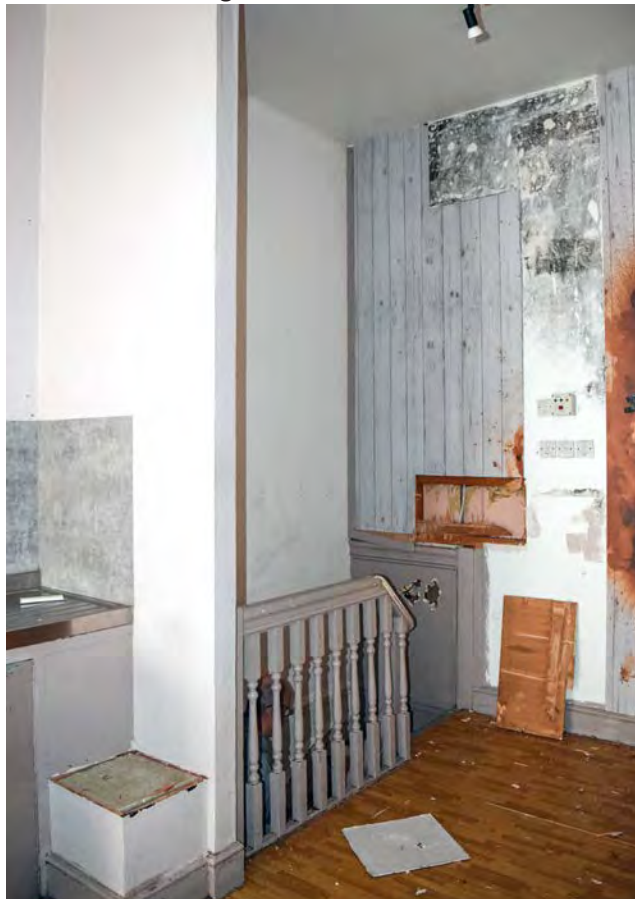
Plate 111: The ground floor of no. 5 Broad Street, looking south-east

basement. Both this, and the dado rail of the stairway on the south side, appear to be 19th century or early 20th century in date (Plate 111). The stairs descend south to north into the basement and along the treads is an original beaded skirting board.
