Former Boswells Department Store

Broad Street

Historic Building Investigation and Recording

May 2022

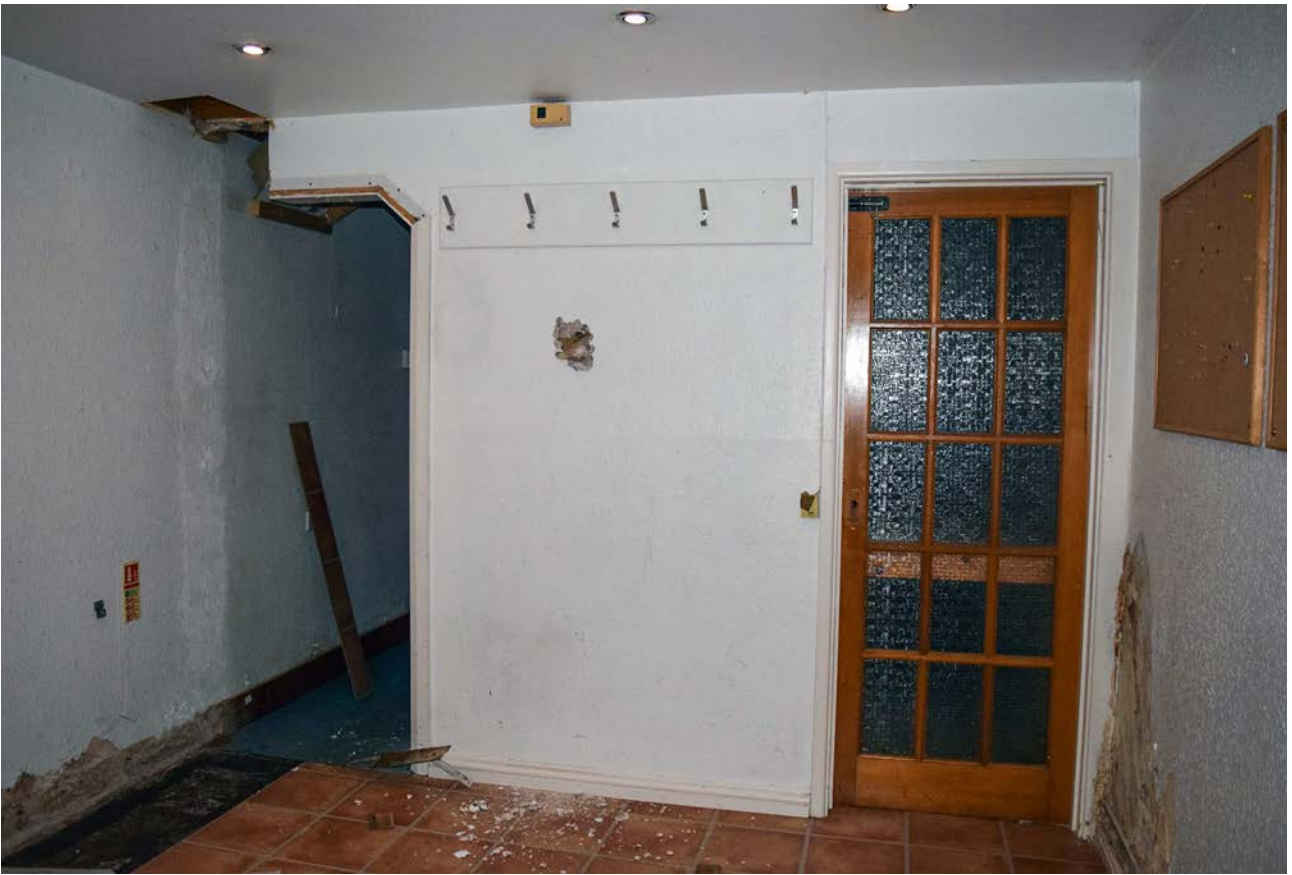
Plate 112: The basement of no. 5 Broad Street, looking north

- 3.4.4 The basement is subdivided with modern partitions into staff and storage areas as well as a WC (Plates 112 & 113).

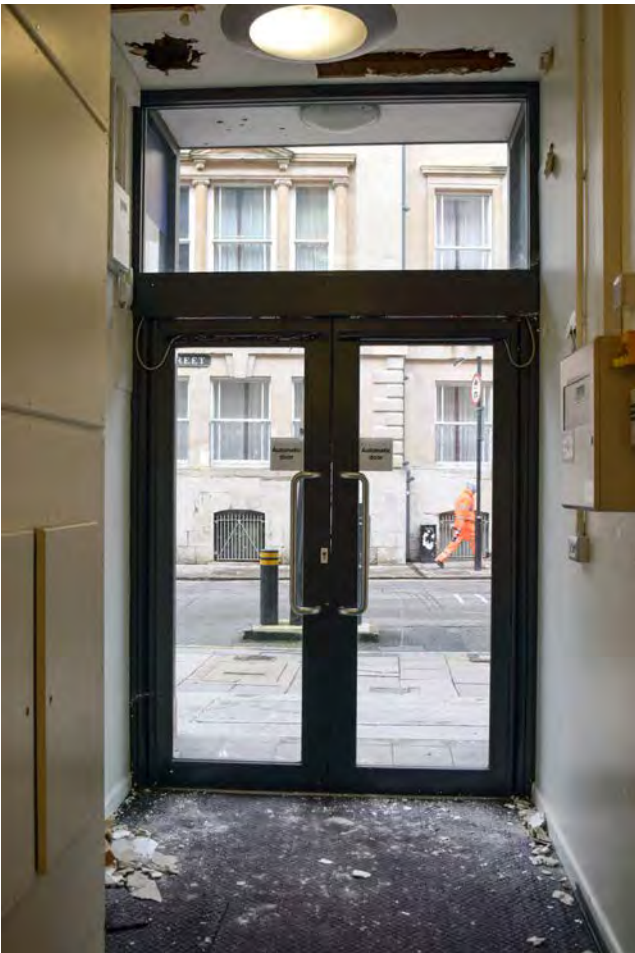
Plate 114: The ground floor entrance to Oxford Language School from Broad Street, looking north

- 3.5.1 Oxford Language School was situated in what is known as Boswell House, 1 – 5 Broad Street, that part of Boswells on the north side of the central lightwell. It is entered through a doorway on Broad Street to the immediate left of the entrance to the department store (Plate 114). This opens into a small lobby area with access to the stairway on the east side. The language school occupies the first to the fourth floors.

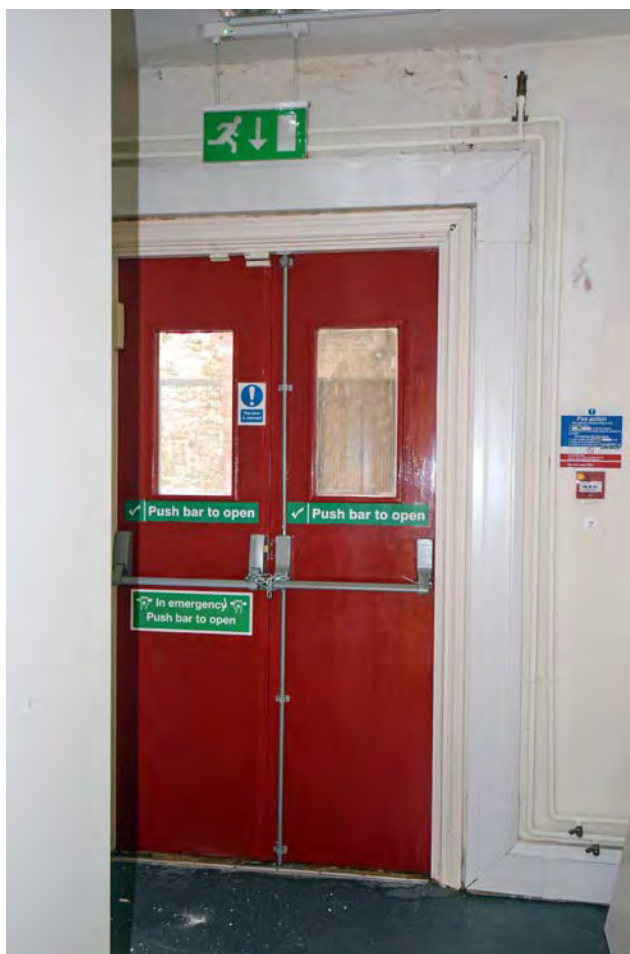
Plate 122: The first floor of Oxford Language School, looking south

- 3.5.3 The first floor of the language school is accessed through a doorway in the east wall of a landing on the north side of the stairway. It opens into a corridor with offices and meeting rooms along the north and south sides. These sub-divided spaces are largely a modern arrangement with laminate wood flooring, modern fire doors and lighting panels to the ceilings throughout (Plate 119). Some original features of the 1929 building were observed on the first floor, however. A small kitchen and storage space on the east side of the stairway retain small four-pane windows with timber frames and obscured glass like those in the rooms of the half landings (Plate 120). Two large, factory style Crittall windows in the south wall of this floor overlook the central lightwell (Plate 121). These are the same as those seen in the third and fourth floors of Boswells department store, with central, swivel lights. At the east end of the south wall is an opening for double doors into the central lightwell that retains a decorative, moulded architrave (Plate 122).

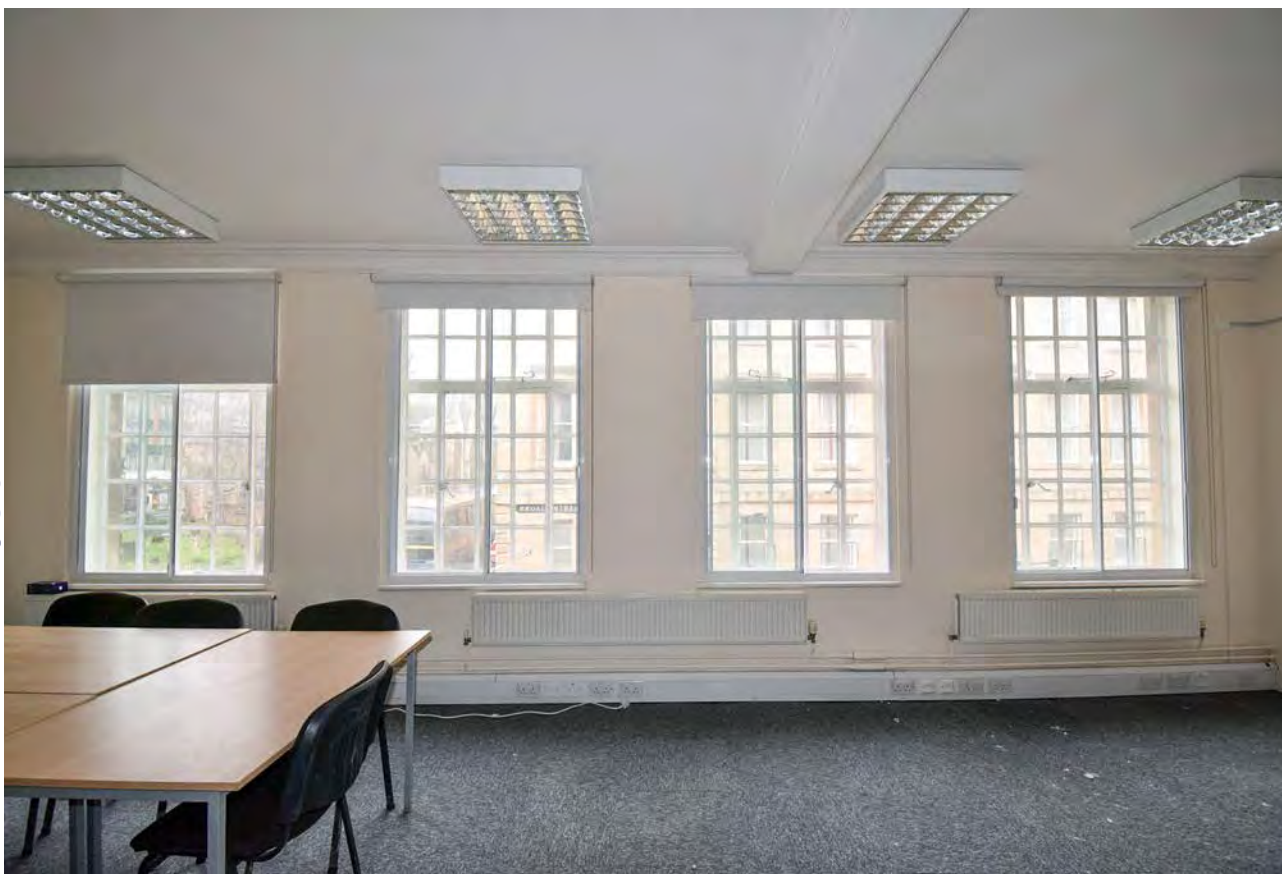
Plate 123: The first floor of Oxford Language School, looking north

abutted by modern partitions in places (Plate 123). The window openings along the south wall of this floor feature the original 1929, iron-frame windows with curled, iron window stays and catches (Plates 124).

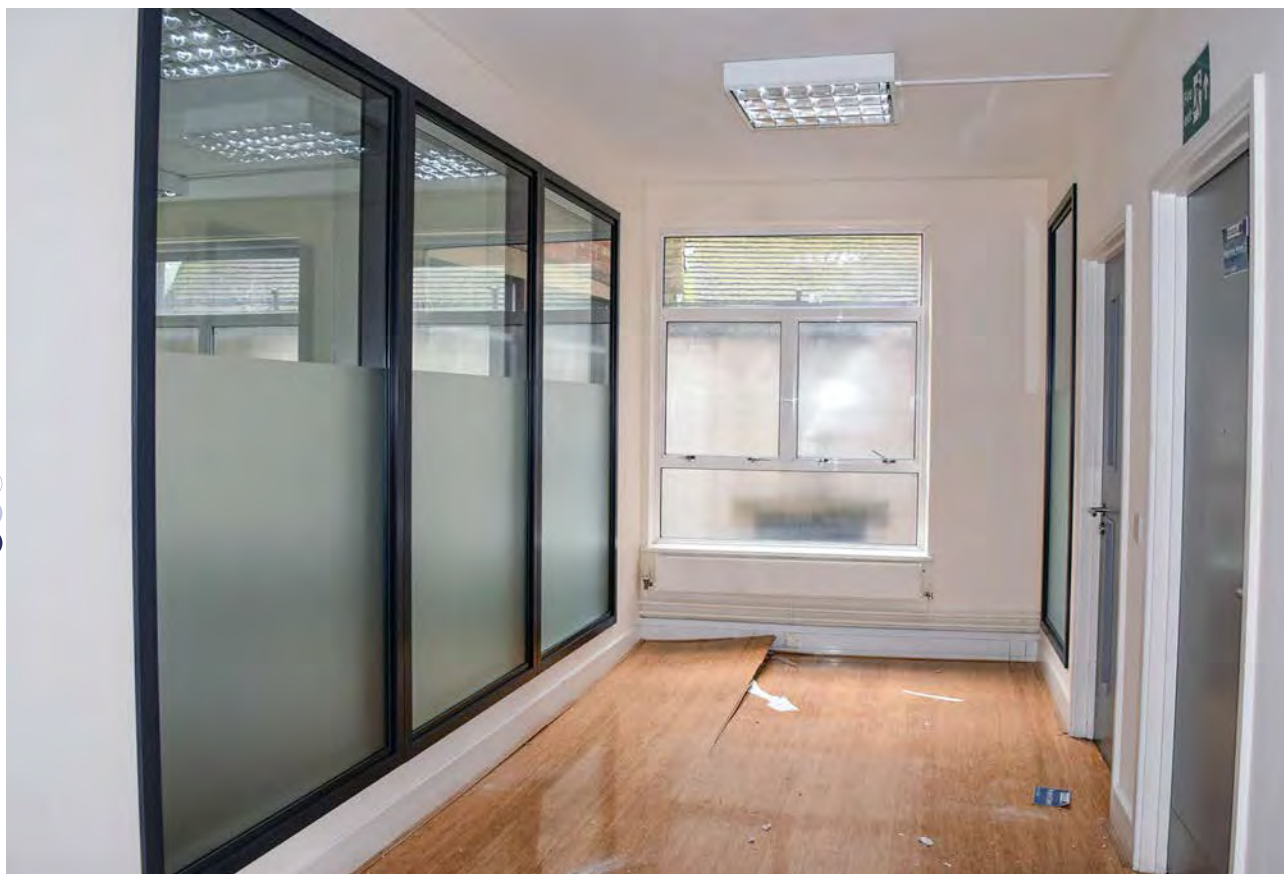
Plate 125: The second floor of Oxford Language School, looking west

3.5.5 The second floor is accessed through doorways in the east and west walls of a landing on the north side of the stairway. This floor is largely modern in character and has been subdivided into many spaces for office and teaching purposes, and for WCs (Plates 125). The floors feature laminate wood boards and carpet, the modern divisions have fire doors and on the ceiling are lighting panels.

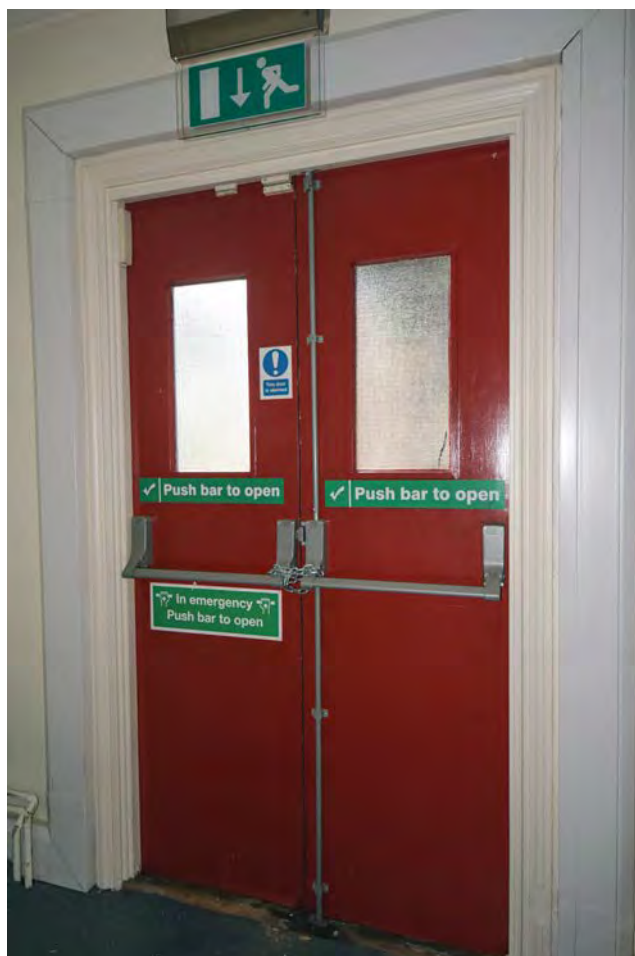
Plate 126: The second floor of Oxford Language School, looking south-east

3.5.6 At the time of survey, the only historic features observed were the moulded architrave around the double doors into the central lightwell on the south side (Plate 126), and the original iron-frame windows across the north facing façade of the building (Plate 127). As on the first floor, these original, multi-pane windows retained their curled iron catches and stays (Plate 128). The windows throughout the rest of the floor are UPVC, those in the north wall have a similar arrangement of panes to the original Crittall windows that overlook the central lightwell (Plate 129).

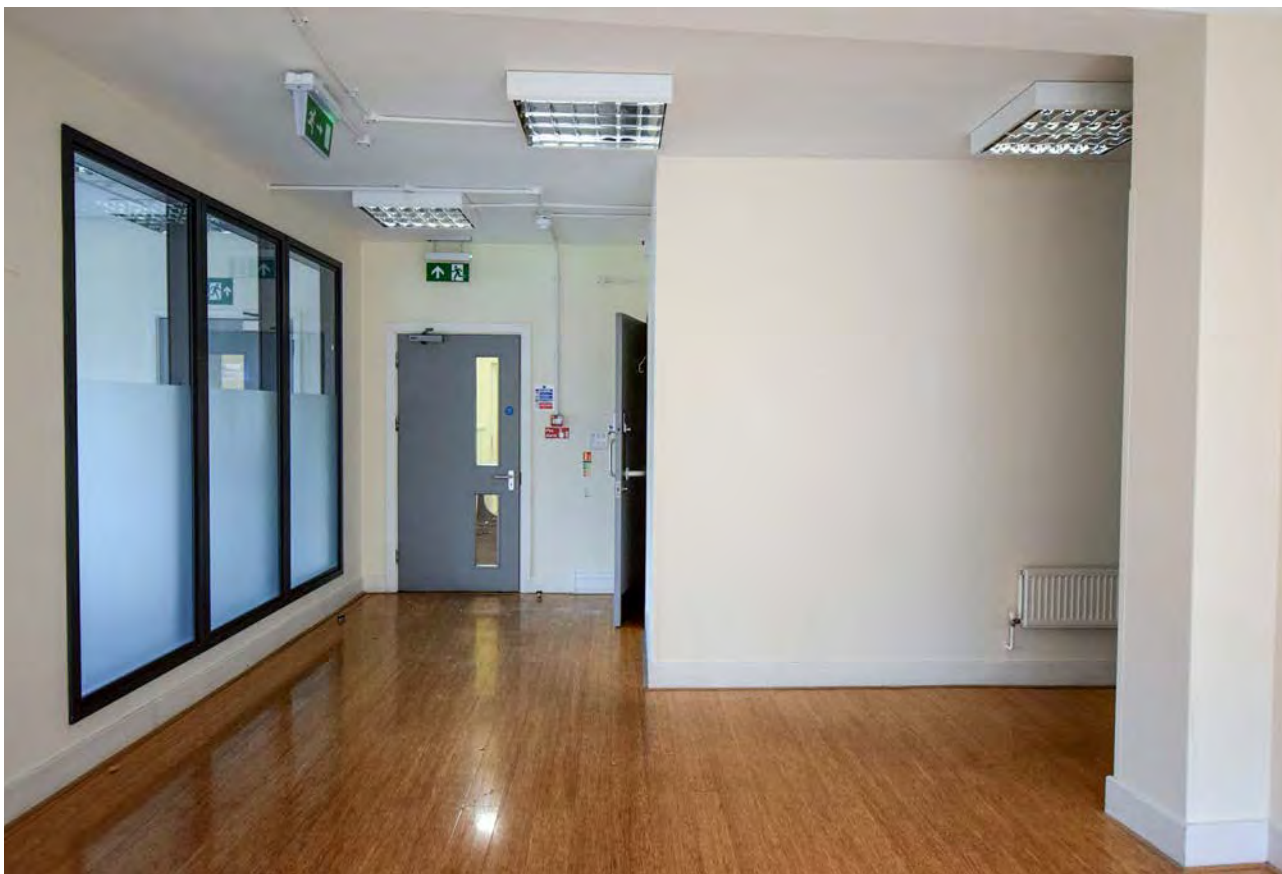
Plate 130: The third floor of Oxford Language School, looking east

3.5.7 The third floor is accessed through doorways in the east and west walls of a landing on the north side of the stairway. This floor, like those below, is largely modern in character and has been subdivided into many spaces for office and teaching purposes, as well as for WCs and a small kitchen. The floors feature laminate wood boards and carpet, the modern divisions have fire doors and on the ceiling are lighting panels (Plate 130).

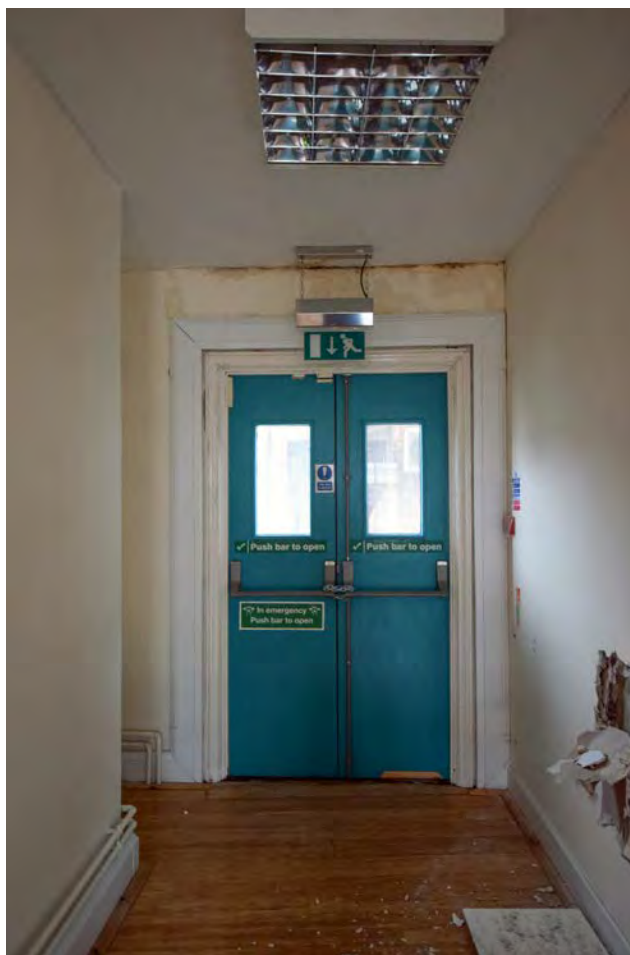
Plate 131: The third floor of Oxford Language School, looking south

3.5.8 At the time of survey, historic features observed were the moulded architrave around the double doors into the central lightwell on the south side (Plate 131), and the original iron-frame windows across the north facing façade of the building (Plate 132). As on the first floor, these original, multi-pane windows retained their curled iron catches and stays. This floor also retained a number of its original Crittall windows in the north wall, overlooking the central lightwell, and two in the west wall, overlooking the rear of Waterstones (Plates 133 & 134). The windows throughout the rest of the floor are UPVC, but some of these have a similar arrangement of panes to the original Crittall windows.

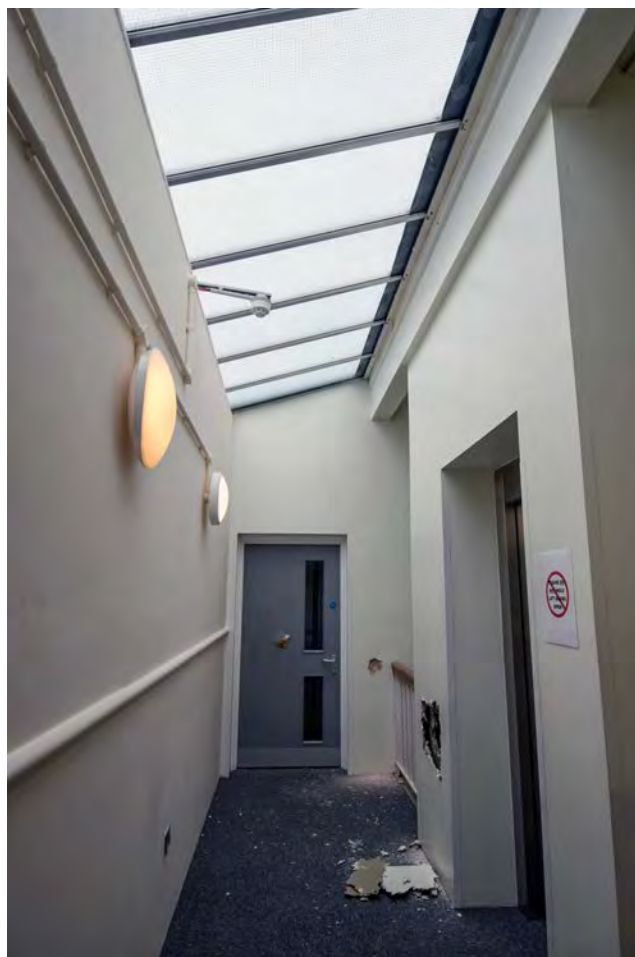
Plate 135: The fourth floor landing of Oxford Language School, looking east

3.5.9 The fourth floor is accessed through doorways in the east and west walls of an attic landing on the north side of the top of the stairway. This is illuminated by a modern skylight and a short balustrade on the south side appears to be original (Plates 135 & 136). This floor, like those below, is largely modern in character and has been subdivided into many spaces for office and teaching purposes, as well as for a WC and kitchen (Plates 137 & 138). The floors feature laminate wood boards and carpet, the modern divisions have fire doors and large glass panes. On the ceiling are modern lighting panels.

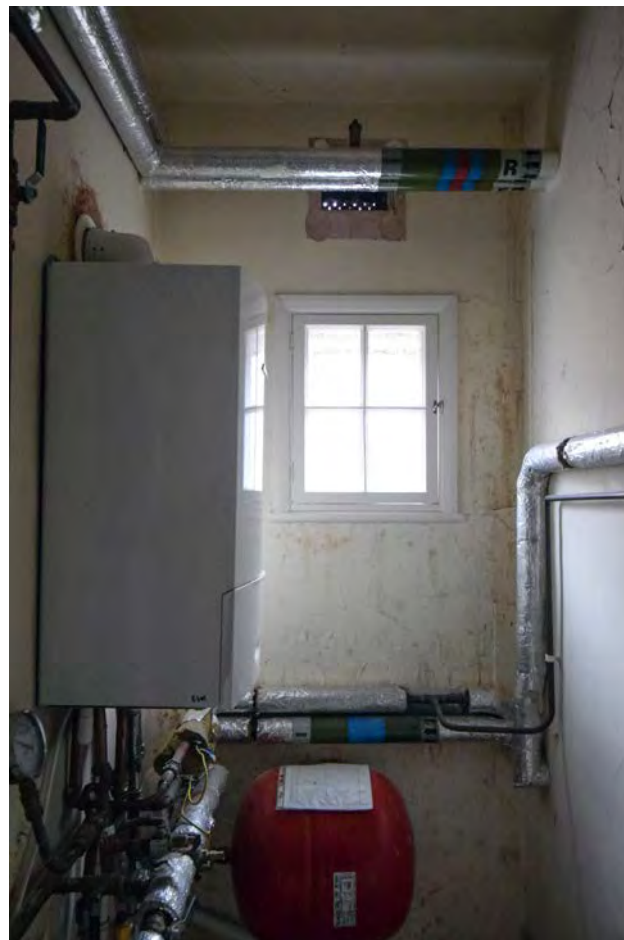
Plate 140: The fourth floor of the Oxford Language School, looking south

3.5.10 At the time of survey, the only historic features observed was the moulded architrave around the double doors into the central lightwell (Plate 139), and two small timber

frame windows on the south side (Plate 140). The dormer openings in the roof along the north side have modern UPVC windows (Plate 141).
