Ley Community, Sandy Lane, Yarnton, Oxfordshire

Archaeological Evaluation Report

April 2021

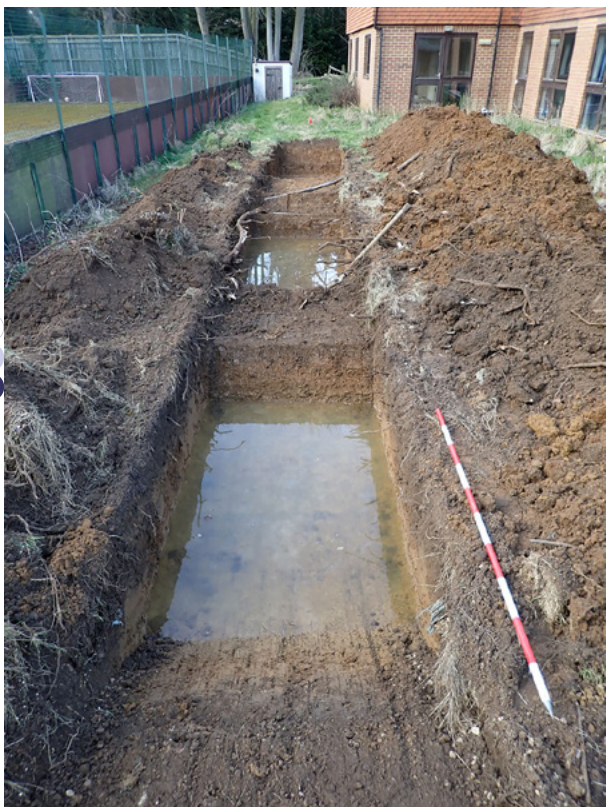
Plate 1: Trench 1, view to NW

- 3.2.2 Except for Trench 1, which flooded to a depth of c 0.2m following excavation, ground conditions were generally good, and remained dry. Despite the density of services, the geological horizon was clearly established in all the trenches.

- 3.2.3 Three electric cables were revealed in Trench 1 resulting in the trench being excavated in three steps (Plate 1). Four pipes associated with the swimming pool were revealed at the south-west end of Trench 3, and a metal pipe was revealed towards the north-east end. However, it was still possible to observe the geological horizon for 5m of the 10m long trench.

Trench 1						
General description					Orientation	NW-SE
Trench devoid of archaeology. Consists of topsoil and subsoil overlying natural geology of silty sand.					Length (m)	15
					Width (m)	1.5
					Avg. depth (m)	0.65
Context No.	Type	Width (m)	Depth (m)	Description	Finds	Date
100	Layer	-	0.44	Topsoil	-	-
101	Layer	-	0.21	Subsoil	-	-
102	Layer	-	-	Geology. Tenacious, light brown silty sand.	-	-

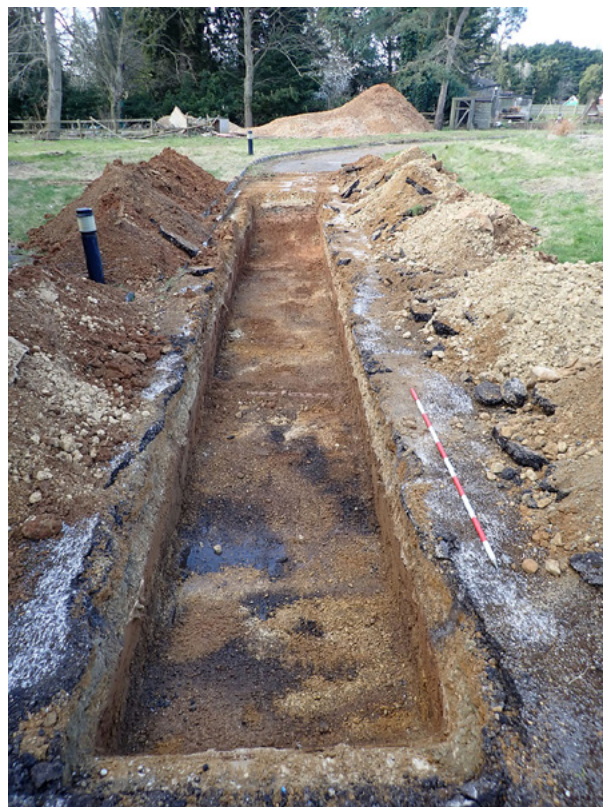
Plate 2: Trench 2, view to NW

Trench 2						
General description					Orientation	NW-SE
Trench devoid of archaeology. Consists of tarmac and subsoil overlying geology of sandy gravel.					Length (m)	14
					Width (m)	1.5
					Avg. depth (m)	0.65
Context No.	Type	Width (m)	Depth (m)	Description	Finds	Date
200	Layer	-	0.13	Tarmac	-	-
201	Layer	-	0.38	Crushed stone on geotextile. Make up for 200.	-	-
202	Layer	-	.22	Subsoil.	-	-
203	Layer	-	-	Geology. Sandy gravel.	-	-

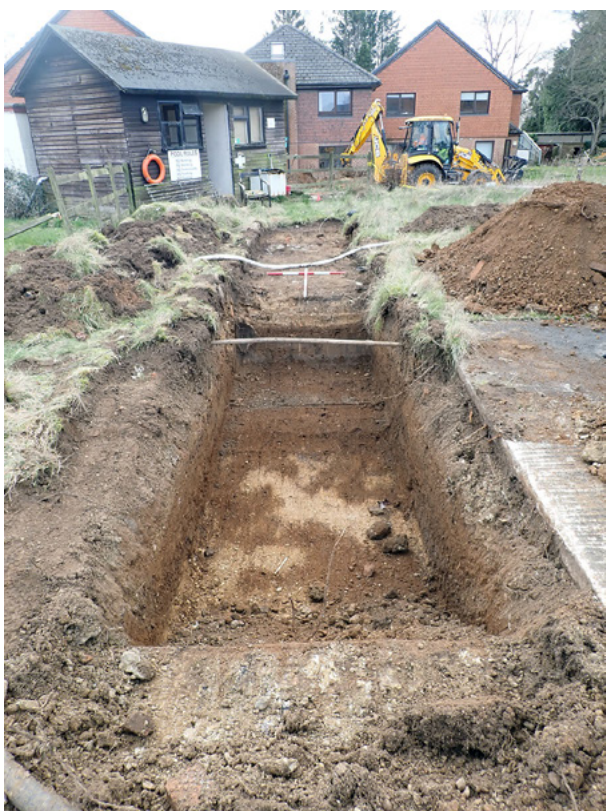
Plate 3: Trench 3, view to WSW

Trench 3						
General description					Orientation	NE-SW
Trench devoid of archaeology. Consists of topsoil overlaying a landscaping deposit and subsoil overlying geology of sandy gravel.					Length (m)	10.6
					Width (m)	1.5
					Avg. depth (m)	1.1
Context No.	Type	Width (m)	Depth (m)	Description	Finds	Date
300	Layer	-	0.25	Re-deposited topsoil. Landscaping.	-	-
301	Layer	-	0.15	Landscaping deposit. Loose brick and stone rubble.	-	-
302	Layer	-	0.5	Subsoil.	-	-
303	-	-	-	Geology. Sandy gravel.	-	-

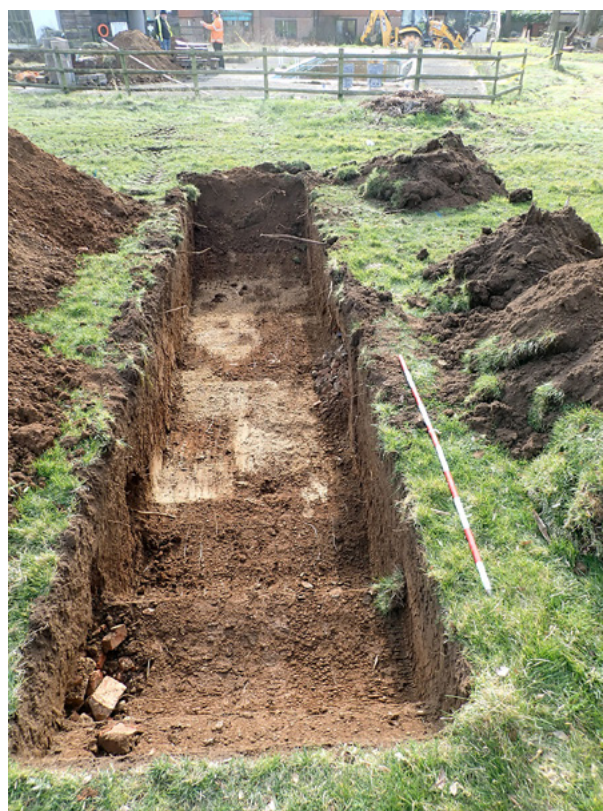
Plate 4: Trench 4, view to SW

Trench 4						
General description					Orientation	NE-SW
Trench devoid of archaeology. Consists of topsoil and subsoil overlying geology of sandy gravel.					Length (m)	7.8
					Width (m)	1.5
					Avg. depth (m)	0.8

Context No.	Type	Width (m)	Depth (m)	Description	Finds	Date
400	Layer	-	0.15	Topsoil	-	-
401	Layer	-	0.15	Subsoil	-	-
402	Layer	-	-	Geology. Sandy gravel.	-	-

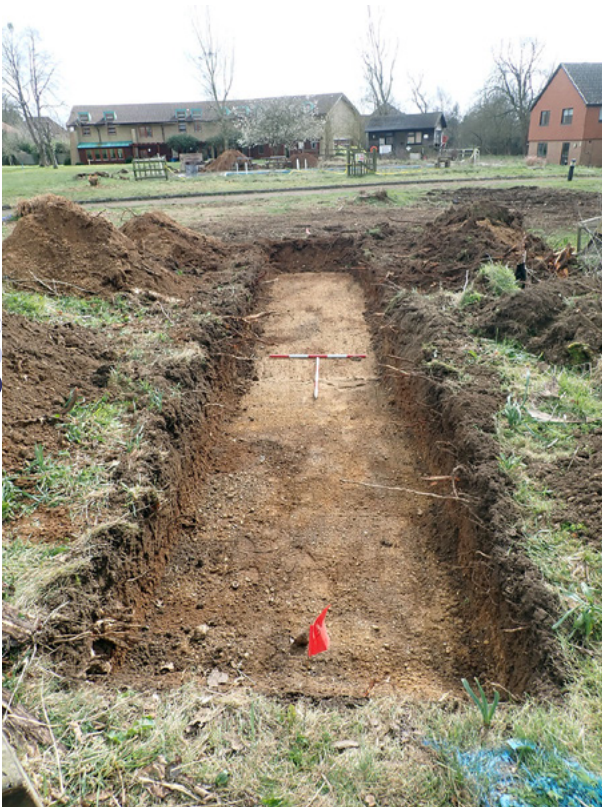
Plate 5: Trench 5, view to SSE

Trench devoid of archaeology. Consists of topsoil and subsoil overlying geology of sandy gravel.

Context No.	Type	Width (m)	Depth (m)	Description	Finds	Date
500	Layer	-	0.3	Topsoil	-	-
501	Layer	-	0.3	Subsoil	-	-
502	Layer	-	-	Geology. Sandy gravel.	-	-

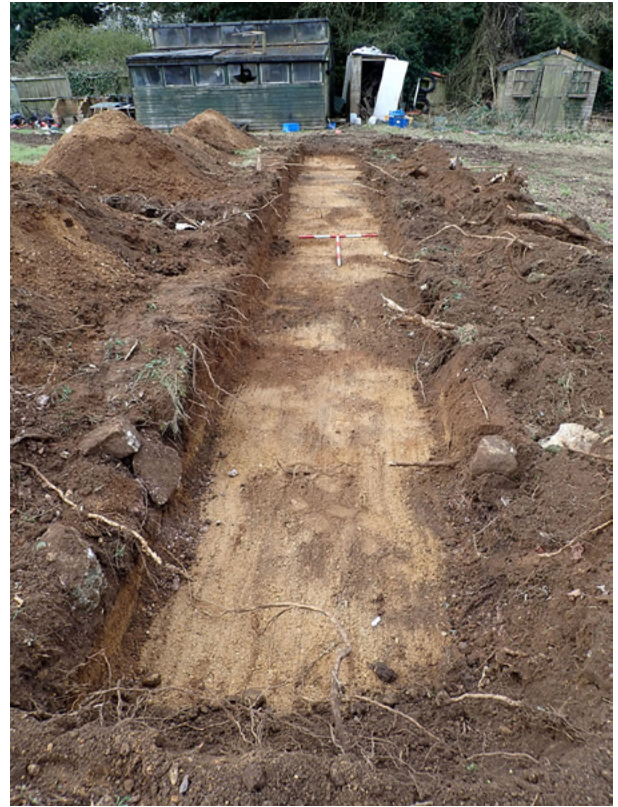
Plate 6: Trench 6, view to SW

Trench devoid of archaeology. Consists of topsoil and subsoil overlying geology of sandy gravel.

Context No.	Type	Width (m)	Depth (m)	Description	Finds	Date
600	Layer	-	0.15	Topsoil	-	-
601	Layer	-	0.15	Subsoil	-	-
602	Layer	-	-	Geology. Sandy gravel.	-	-

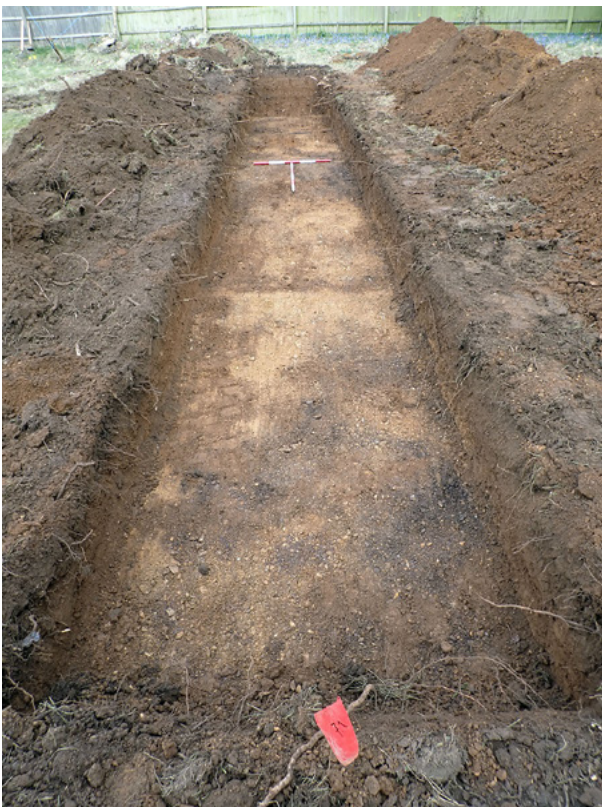
Plate 7: Trench 7, view to N

Trench devoid of archaeology. Consists of topsoil and subsoil overlying geology of sandy gravel.

Context No.	Type	Width (m)	Depth (m)	Description	Finds	Date
700	Layer	-	0.25	Topsoil	-	-
701	Fill	-	1.05	Fill of 702. Loose, mid brown sandy silt, 20% mixed gravels. Extensive roots and rootlets.	-	-
702	Cut	1.5 (as seen)	0.75 (as seen)	Tree bowl.	-	-
703	Layer	-	0.25	-	-	-
704	Layer	-	-	Geology. Sandy gravel.	-	-
