1-3 Golden Cross Oxford

Historic Building Investigation and Recording

March 2020

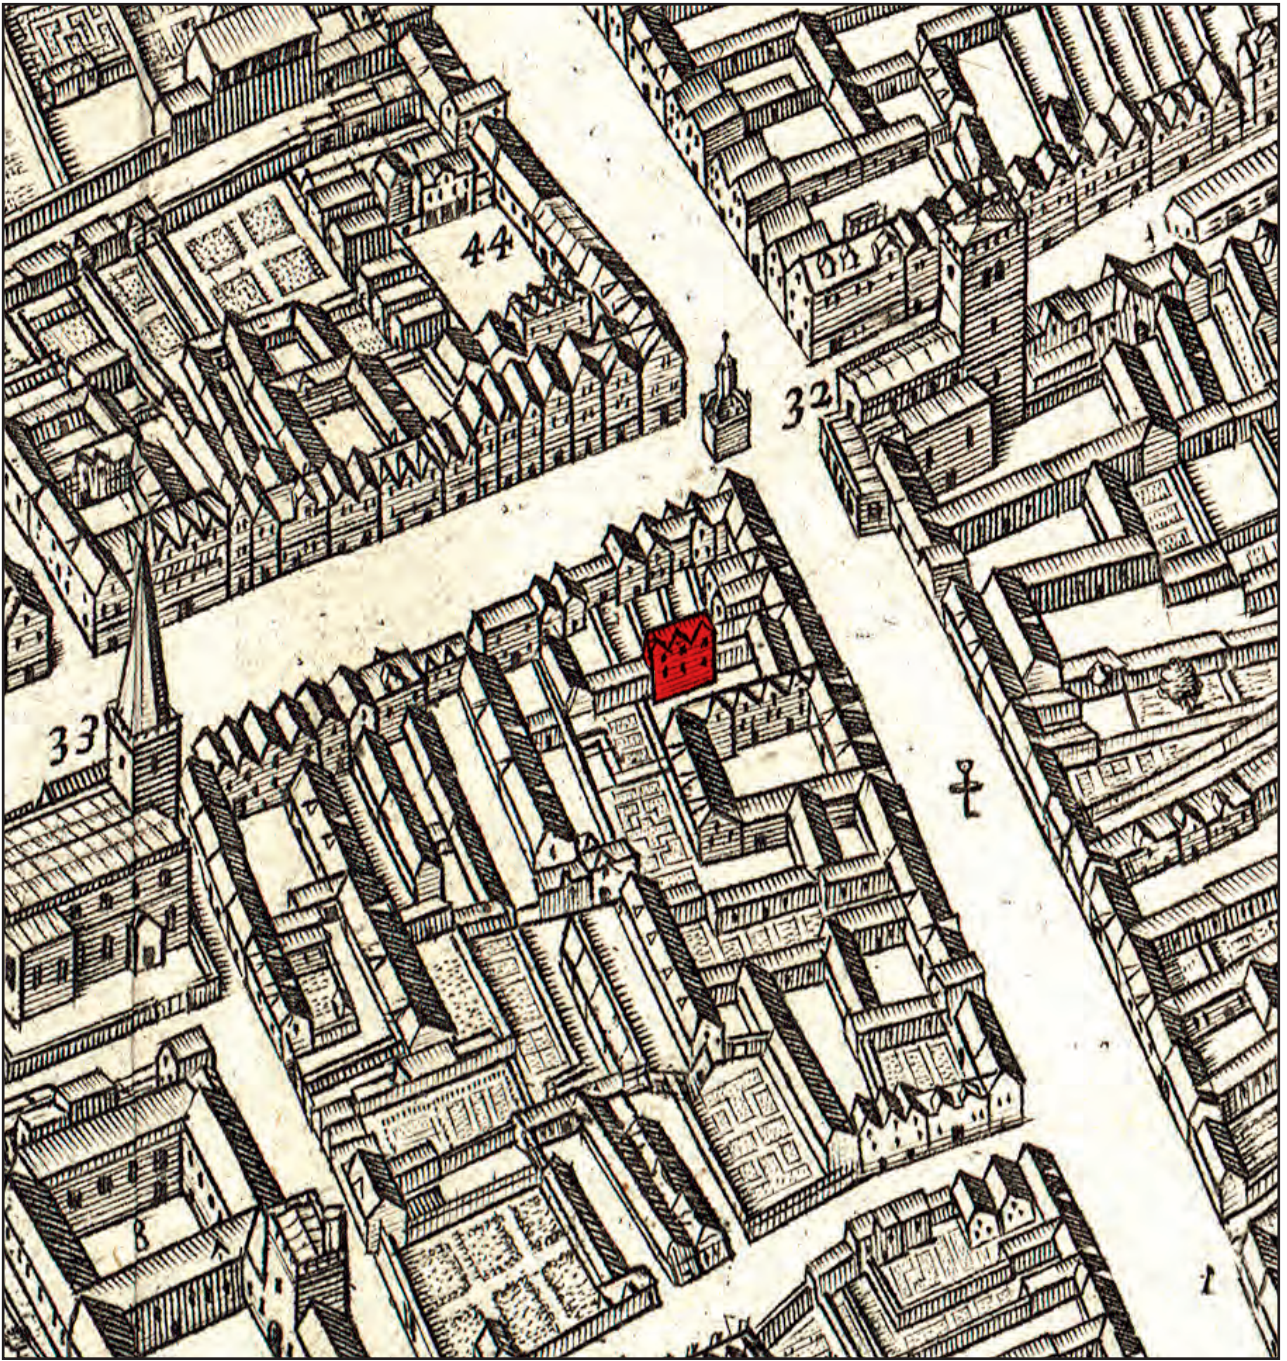
Figure 2: Extract from David Loggan's 1675 view of Oxford with south range of Golden Cross highlighted

- 2.2.1 The South Range of the Golden Cross, the subject of the current project, appears to have been constructed in the third quarter of the 17th century; as outlined in Pantin's 1955 article in *Oxoniensia* it does not appear to be listed in a 1656 survey of the complex but it does appear to be shown on Loggan's view of 1675 (Fig 2).

- 2.2.5 A referred to above the South Range appears to be shown on David Logan's 1675 view of Oxford; this is shown as a distinct structure, taller than its immediately adjacent structures and with three gables facing into the courtyard. The Golden Cross complex is shown on a number of early maps although it is only in the 19th century that the level of detail is sufficient to reliably be able to pick out specific details on the South Range. Robert Hoggar's map of 1850 shows a projecting bay just to the east of the centre of the range (similar to today) and with the elevation slightly further forward to the west of this bay than to the east of it. The Ordnance Survey Town Plan of 1878 (surveyed 1873-4) shows a similar arrangement (Fig 3). Another useful 19th-century source is JC Buckler's 1824 view of The Golden Cross which shows the exterior of the South Range very similar to today and the ground floor bays of the western half of the building set slightly in front of the upper floors.

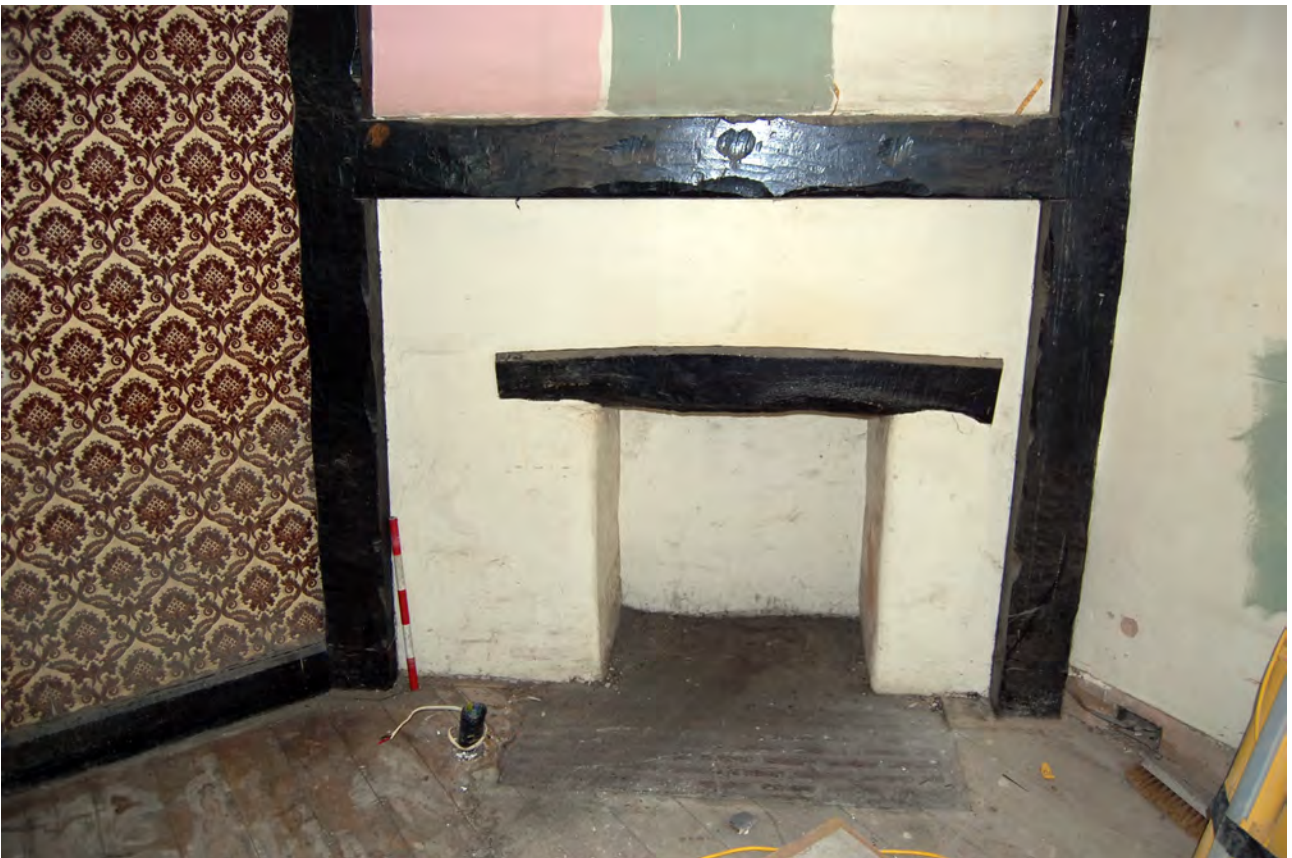
- 3.3.14 **Fireplace in 27B.** The removal of modern plaster from the angled wall at the south-west corner of the room exposed the void (74 cm wide by 82 cm tall and 36 cm deep) of a small former fireplace beneath a timber lintel (Pl. 6-7). The void was rendered and painted so the bricks were not visible and there is a hearth projecting from the wall formed from pavers (probably early 20th-century in date). The floor within the void is formed from concrete and the imprint was visible of what was probably three frogged bricks set together as a base for a small stove or fire surround.

- 3.3.15 The angled section of wall is framed by two timber posts, one at each end together with a mid-height horizontal beam resting on notches cut into the posts. These timbers are each set immediately in front of the wall rather than being within it and their high-gloss lacquered finish was more suggestive of a secondary (possibly early 20th century) addition rather than being part of the primary structure.

Plate 7: Angled fireplace at SW corner of 27B

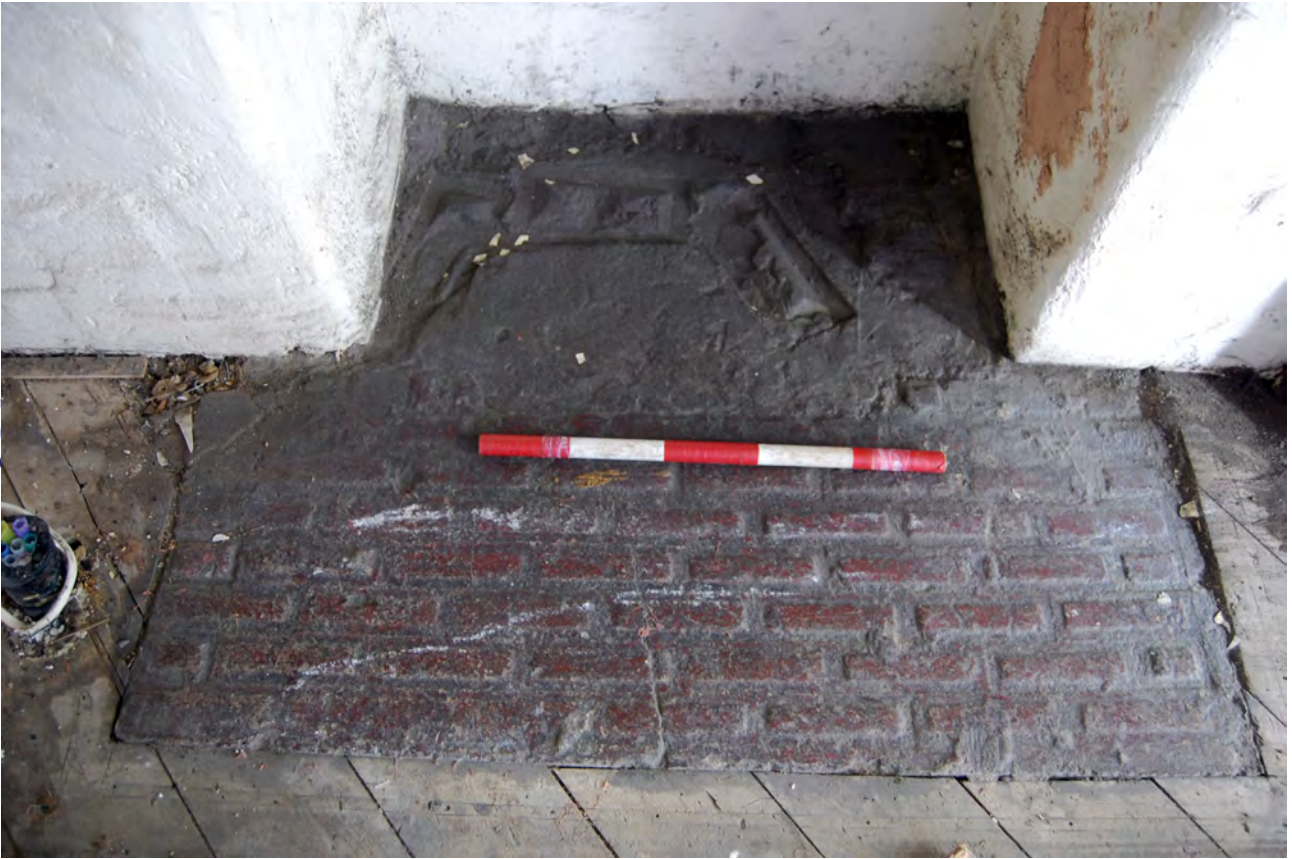
Plate 8: Brick paved hearth to fireplace at SW corner of 27B

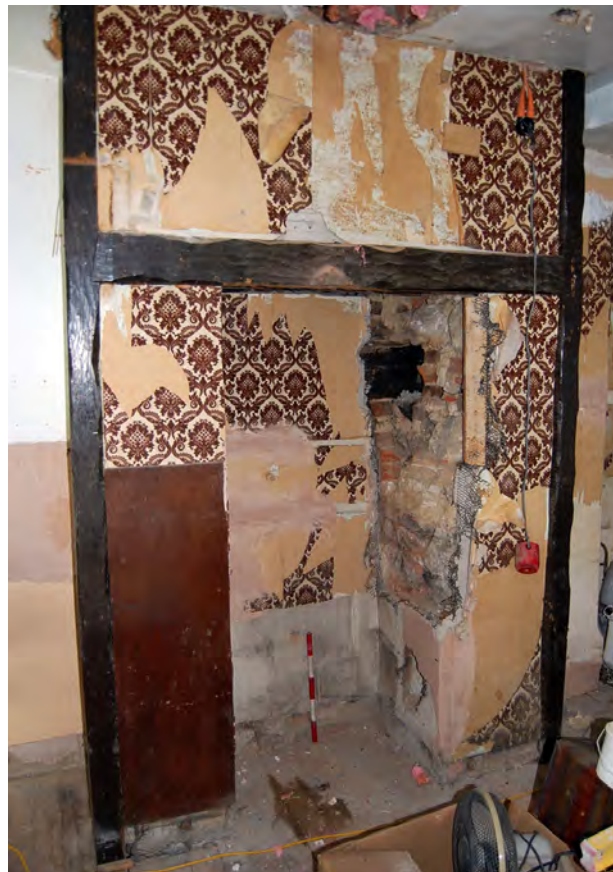
- 3.3.16 The smoke-covered flue remained open although it was not possible to closely investigate this.
- 3.3.17 **Fireplace in 27C:** The fireplace and chimney breast in the south wall of the eastern room (27C) was also partially exposed by the removal of modern boarding, plaster on chicken wire and kitchen equipment (oven, extractor fan etc). The chimney breast is framed by a timber post at each outer edge together with a horizontal member supported on notches formed within the sides of each post (Pl. 9). Similarly to the posts framing the angled chimney breast in 27B the position and character of these timbers is suggestive of them being a secondary addition rather than part of the primary structure. It can be seen in the west jamb of the recess that the timbers are set immediately in front of stonework which presumably lined the fireplace (Pl. 10-11). There are several patches of brickwork within the stone jamb including three courses at the front of the wall which could indicate the location of a former lintel over the opening although the bricks and stones are all bonded with a very similar soft beige mortar. At the same height at the rear of the jamb is an opening to the smoke lined flue.

Plate 9: Exposed fireplace and chimney breast in
27C

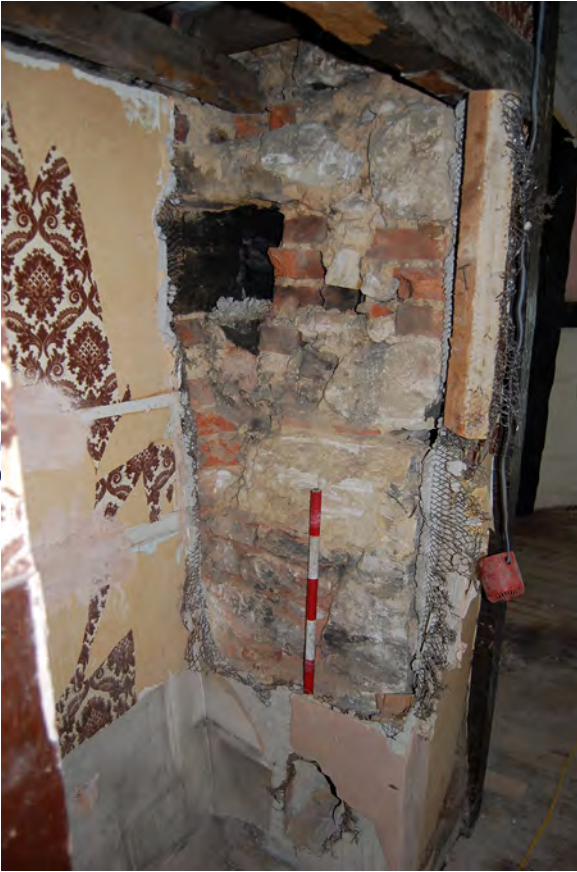
Plate 10: West jamb to fireplace in 27C

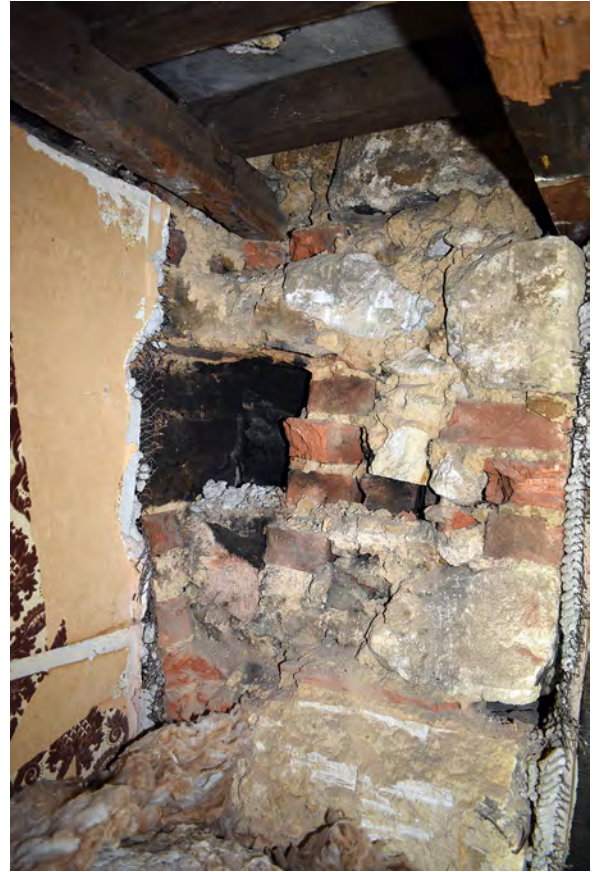
Plate 11: West jamb to fireplace in 27C

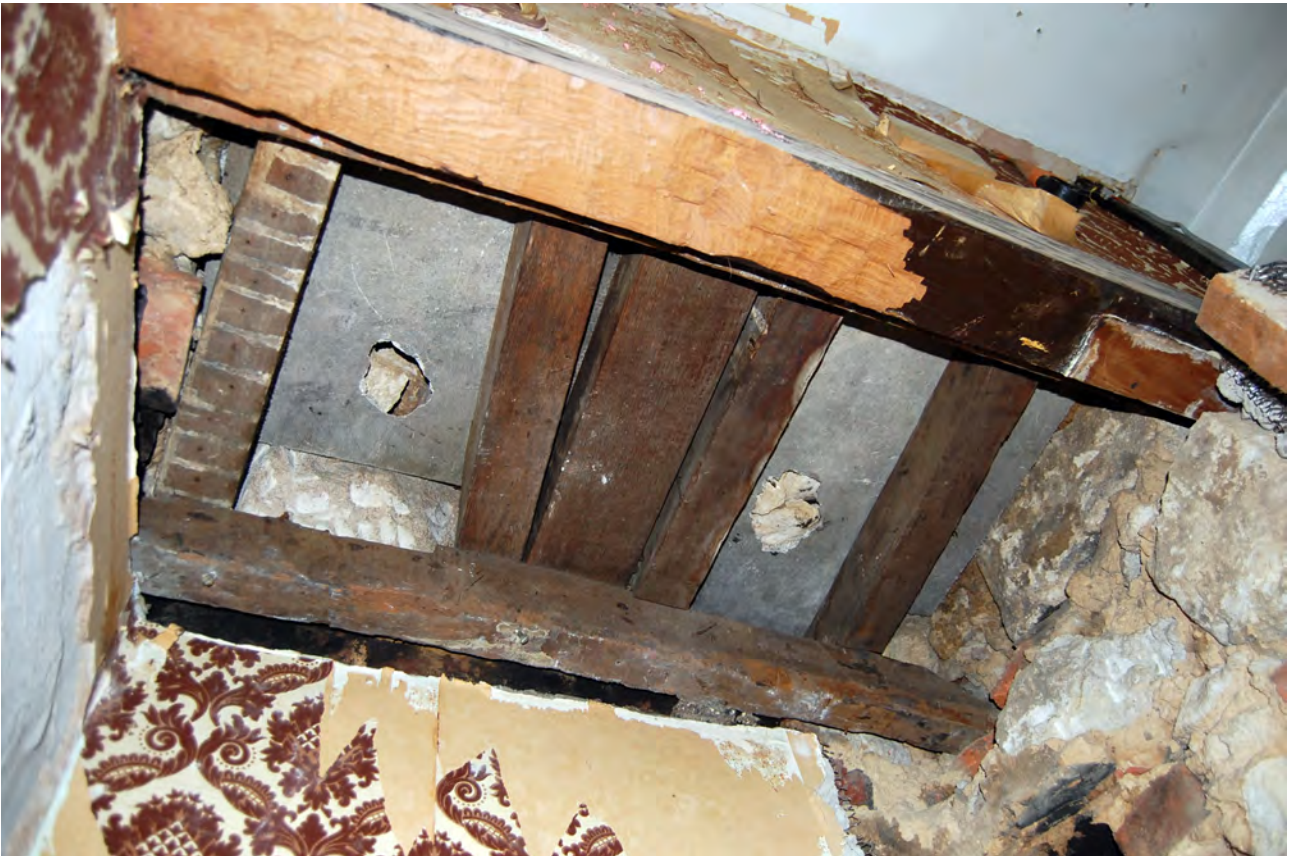
- 3.3.18 The plaster has not been removed from the east jamb so the construction of this wall has not been exposed.
- 3.3.19 Directly above the fireplace recess is a simple secondary frame formed from reused timbers with a fibre-type board (Pl. 12) which was probably added in the 20th century after the fireplace had been removed, although the flue may have continued to be used by a stove/oven.

Plate 12: Blocking above fireplace void in 27C

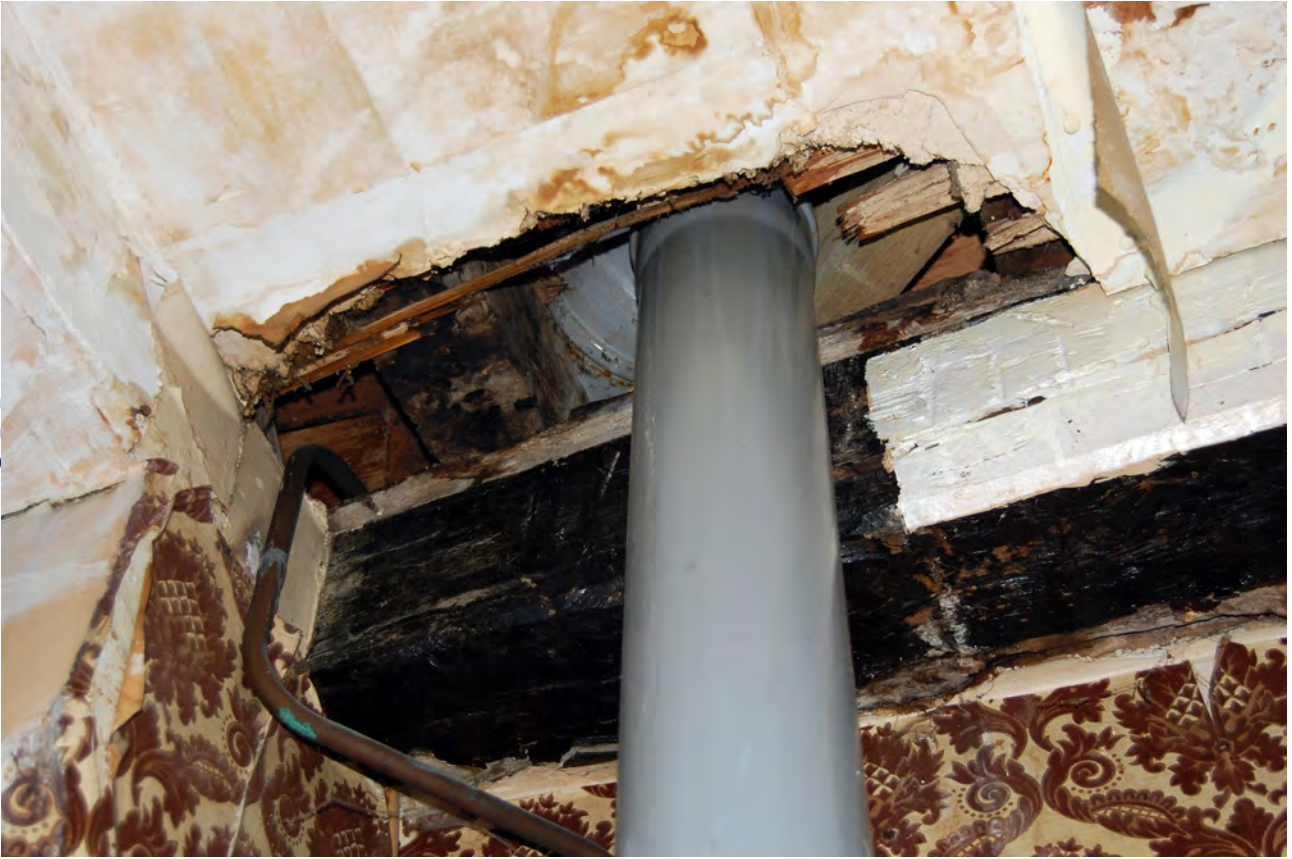
3.3.9 The room has most recently formed a kitchen, servery and small eating area with the surfaces largely clad in modern boarding. The underside of a large north-to-south beam with chamfered edges is visible in the ceiling, dividing 27B from 27C; this beam is covered by old lath and plaster which has not been removed in the current project. This beam, particularly with its chamfered lower edges is suggestive of the room being a single open space rather than subdivided into two (27B & C) so it may have been inserted when the space was unified, although the lath and plaster that covers at least some of it suggests that this probably happened at a relatively early date.

Plate 13: Detail of beam at SE corner of 27B

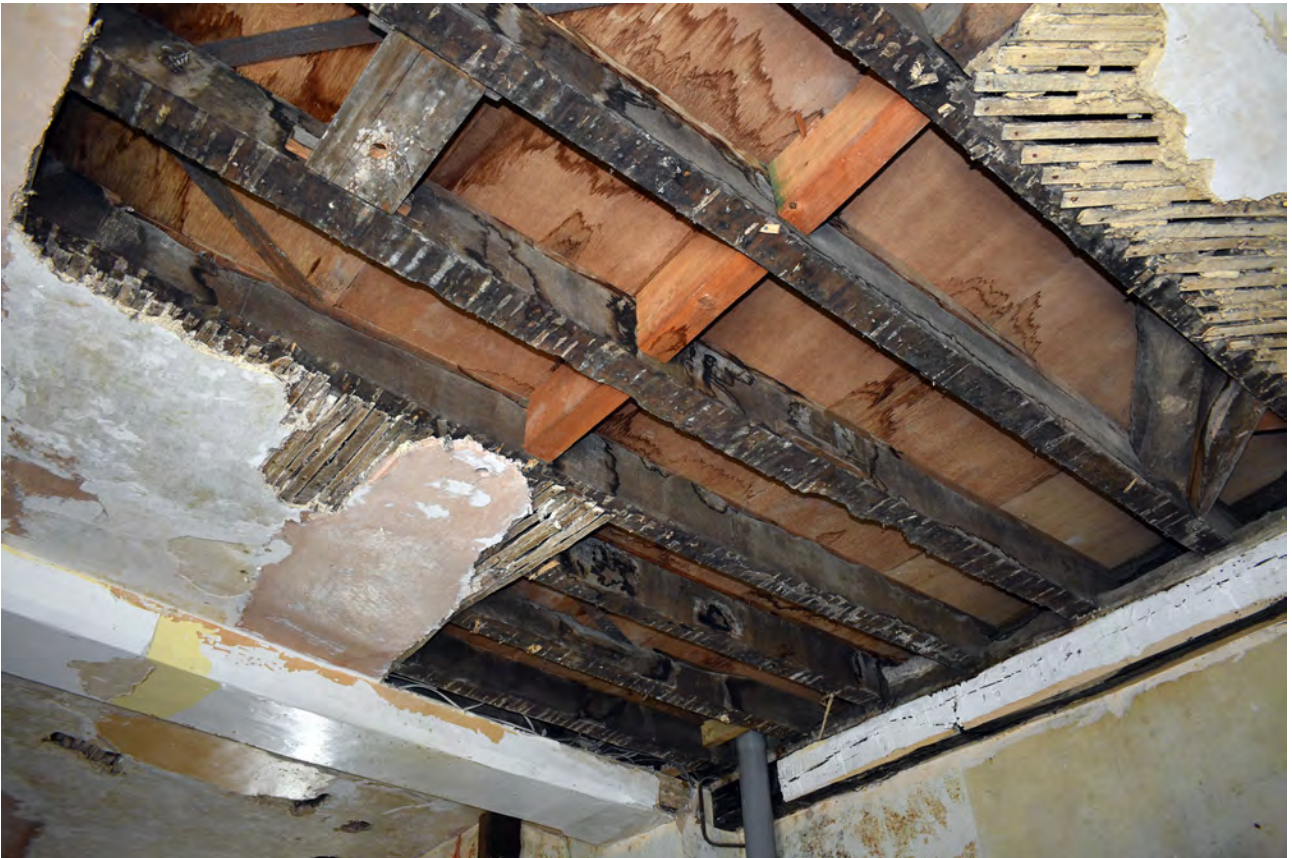
3.3.12 **Underside of first floor structure:** The ceiling in this room is a patchwork of phases with extensive areas of modern plaster but some surviving areas of historic lath and plaster. Much of the ceiling in the southern half of 27B was removed to allow it to be reformed and this exposed seven primary joists (c.15 cm tall x 10 cm wide) spanning north-to-south with large modern plywood boards above (Pl. 14-15). At the south end the joists sit on an east-to-west joist that is set immediately in front of the wall.

Plate 14: Underside of joists exposed in 27B, looking SE

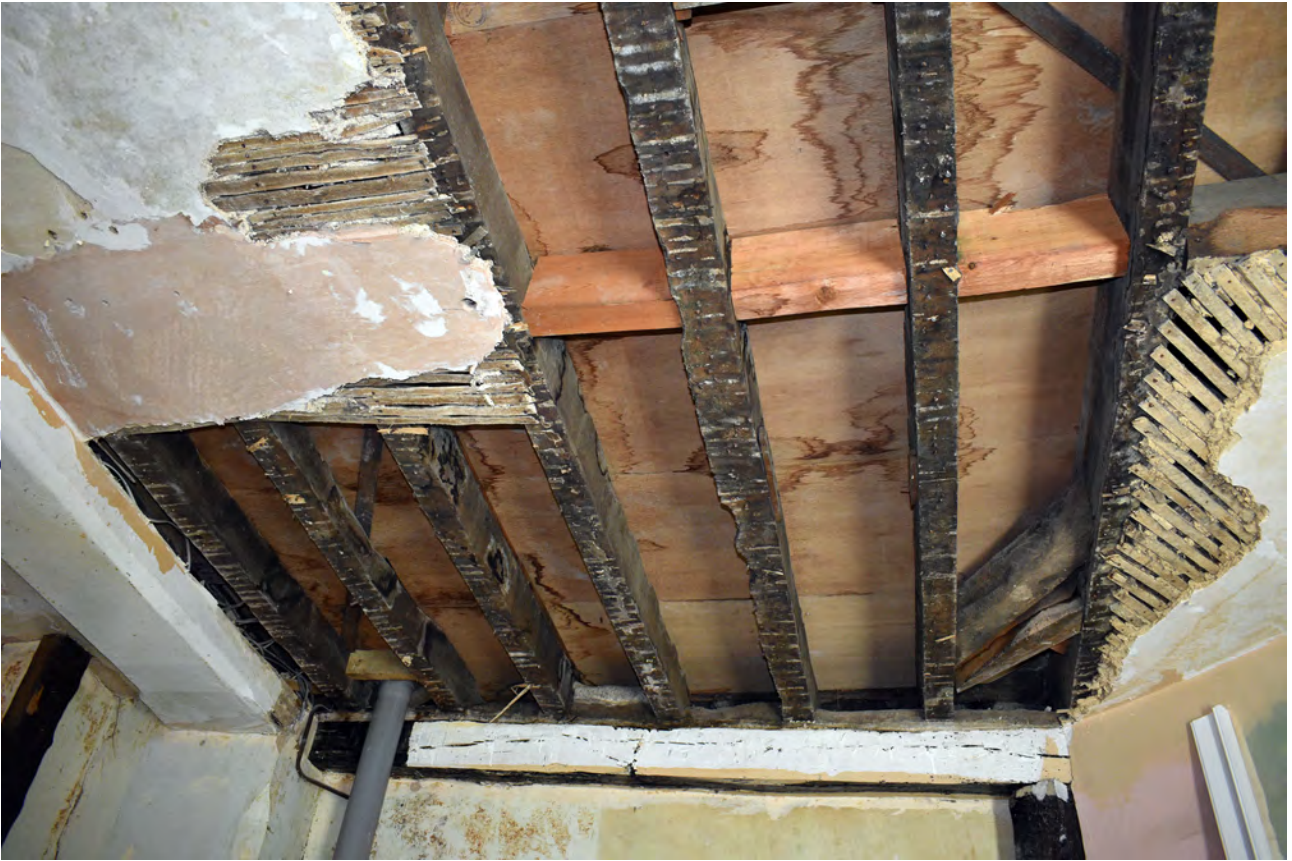
Plate 15: Underside of joists exposed in 27B, looking S

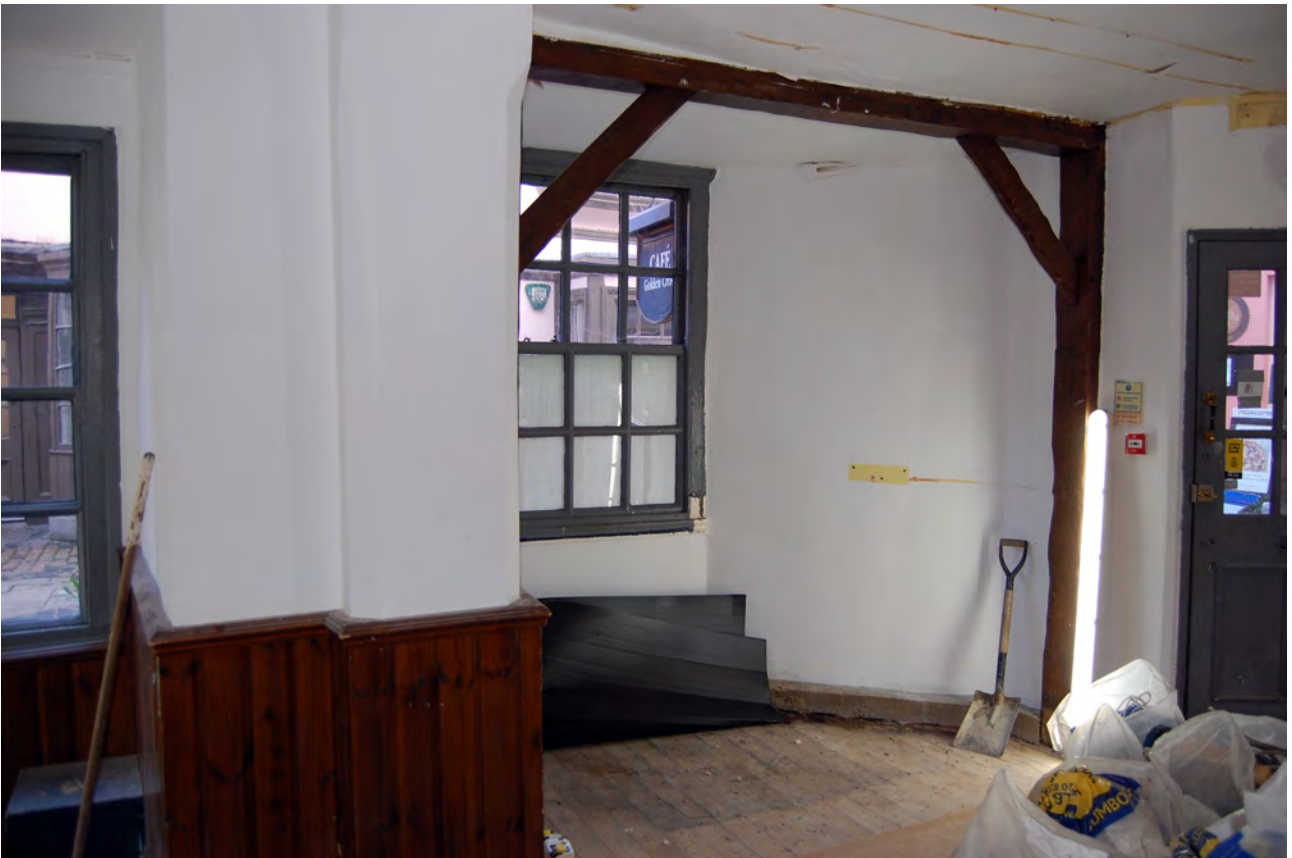
- 3.3.20 The bay window on the north side of 27C is framed by two posts as well as a horizontal and raking braces at the two upper corners (Pl. 16-17). Similarly to the timberwork around fireplaces the character and position of these timbers is suggestive of them being part of a secondary refurbishment intended to give the building an historical character rather than primary features.

Plate 16: View in 27B-27C looking NE

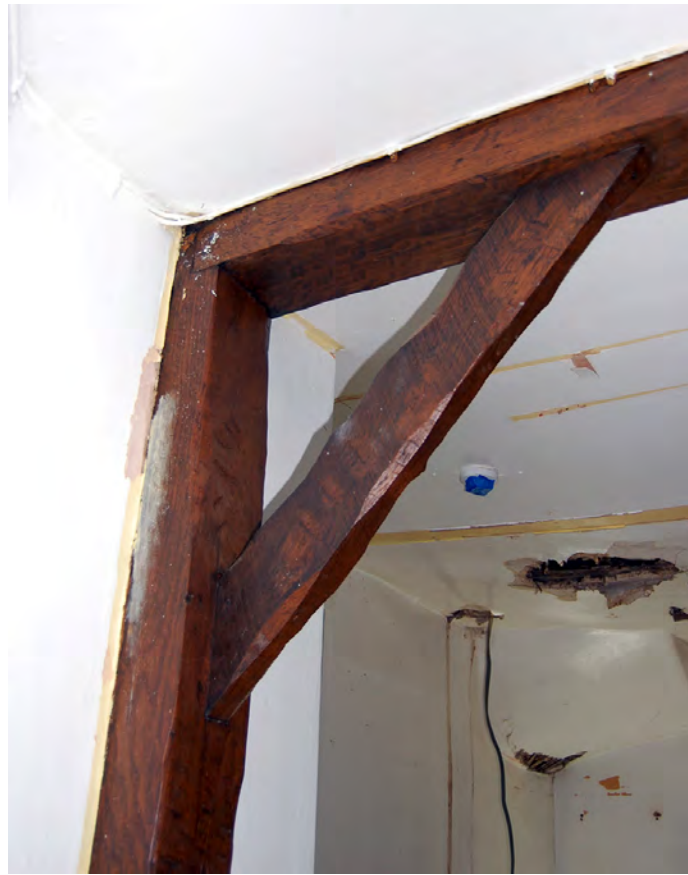
Plate 17: Detail of secondary bracing in 27C

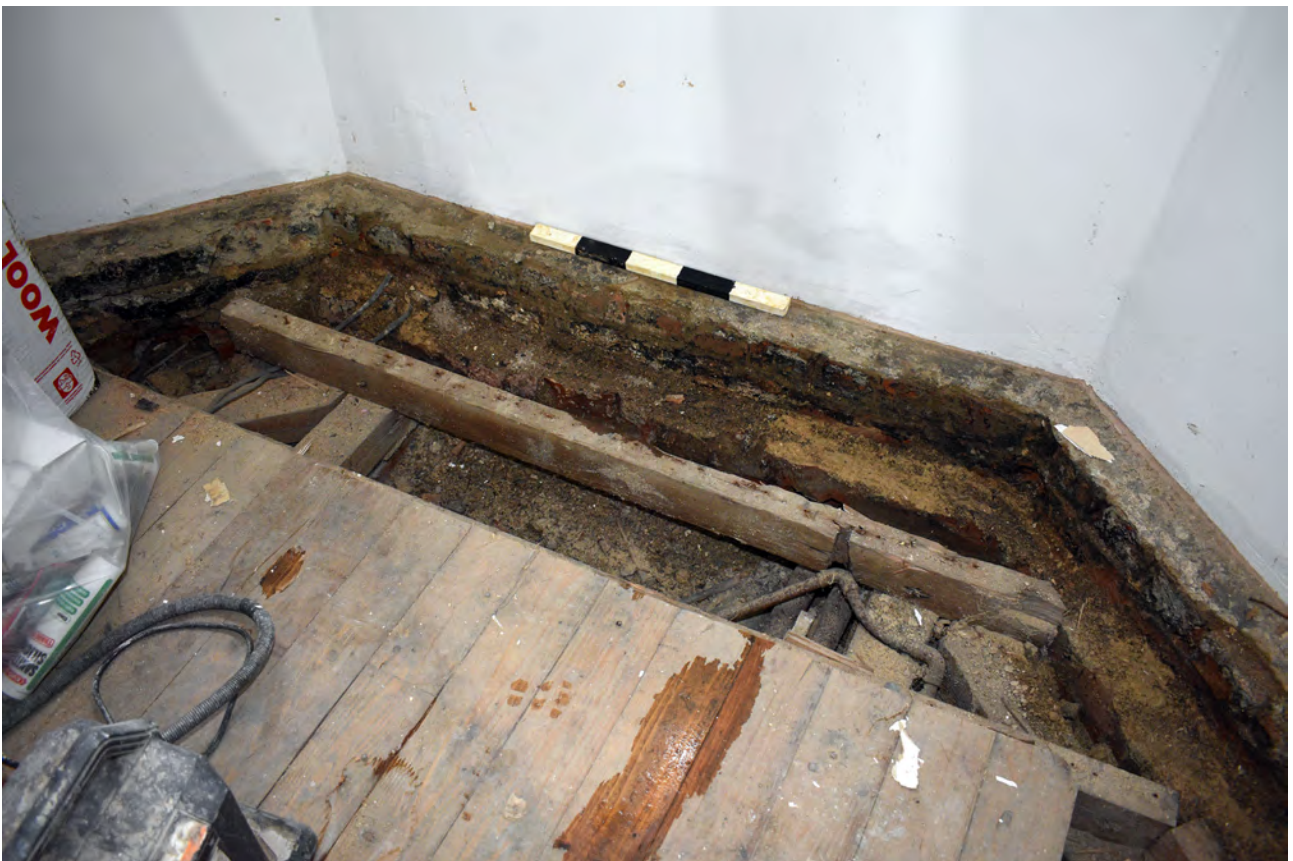
- 3.3.21 **Floorboards and plinth to bay window:** Where they were exposed the floorboards in this room were found to be of 20th century date and some were lifted around the base of the bay window (Pl. 18). This exposed a small brick plinth immediately above floor level set on what appeared to be crude concrete underpinning.

Plate 18: Exposed plinth to bay window in 27C.

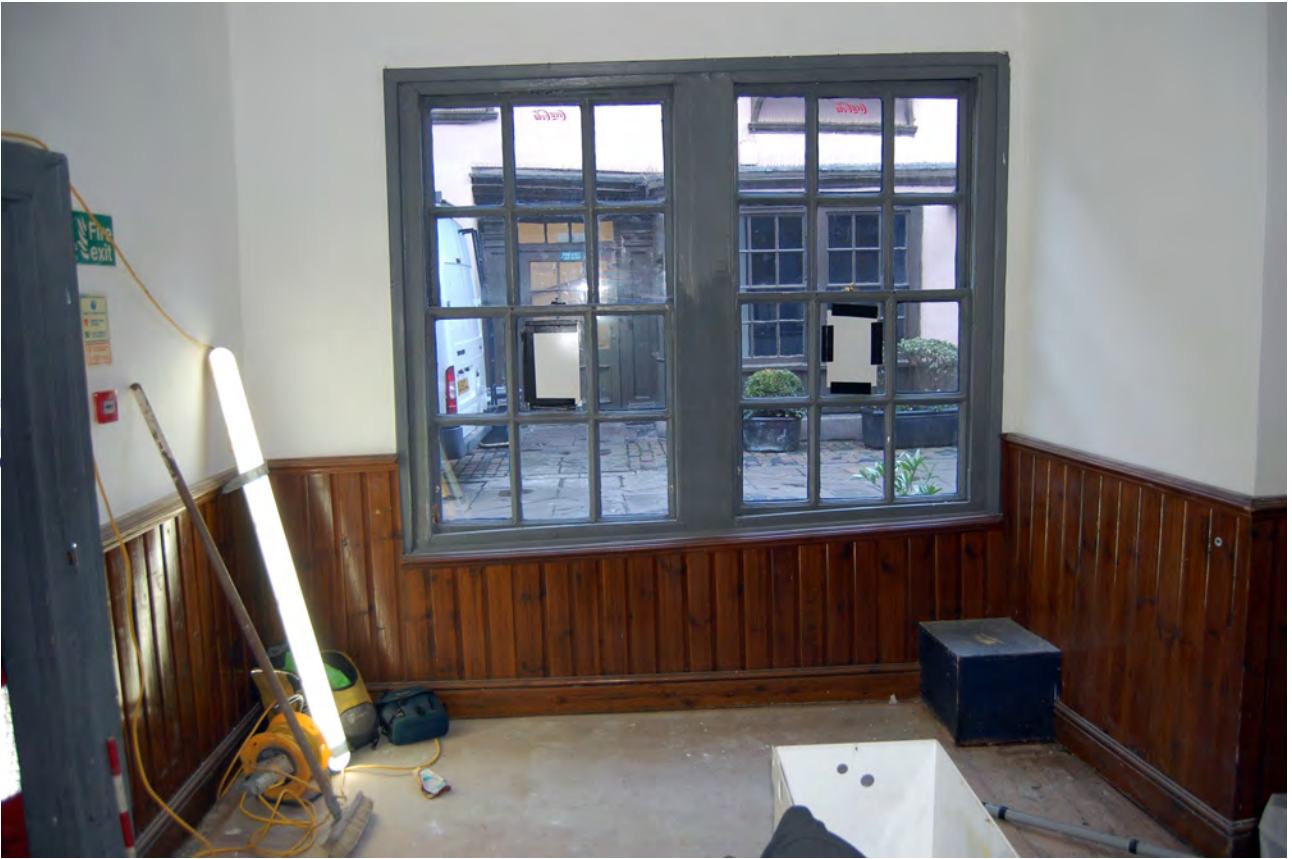
3.3.8 As stated above it is believed that the large eastern room at ground floor level would originally have been divided into two separate rooms, to east and west with each one accessed from separate staircases. In Pantin's 1955 *Oxoniensia* article the two halves are numbered 27B (to W) and 27C (to E) although at this date the rooms had already been combined into a single space. It is believed that the room was also enlarged slightly in the late 18th or early 19th century when the north wall was rebuilt and pushed forward beyond the line of the upper storeys. The windows are sashes which survive from these works (Pl. 19).

Plate 19: Window in 27B

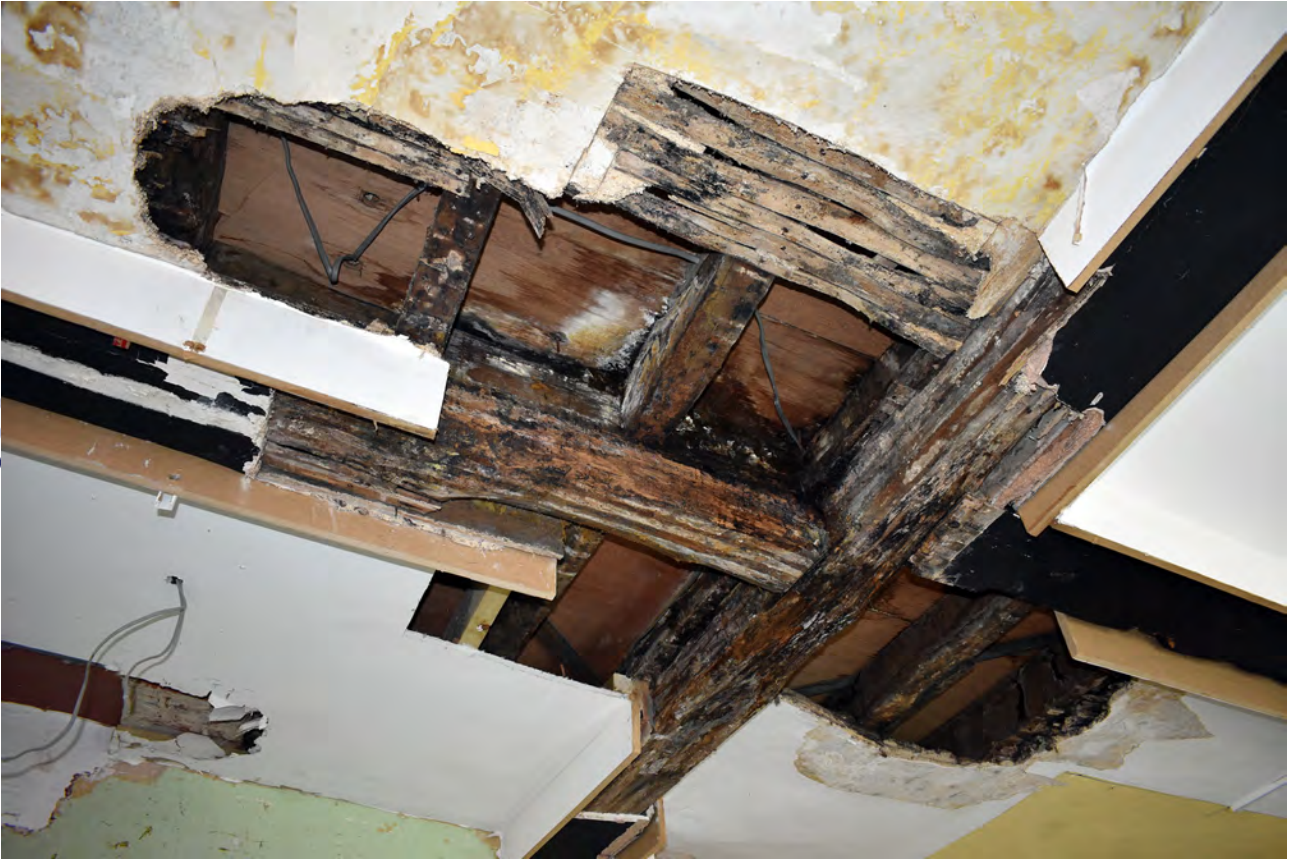
3.3.26 **Underside of second floor:** a large area of lath and plaster was removed from the central part of the ceiling, principally due to severe damp and a leak from above (Pl. 26-28). This exposed part of the principal joist (N-S) as well as stepped or staggered binders (E-W) and common joists (N-S). The various joists were all tenoned and strongly appeared to be from a single phase of construction. This would appear to discount the suggestion that has previously been tentatively made that the two halves of the South Range could have been constructed in two separate but closely dated phases.

Plate 26: Exposed floor joists in Room D looking south

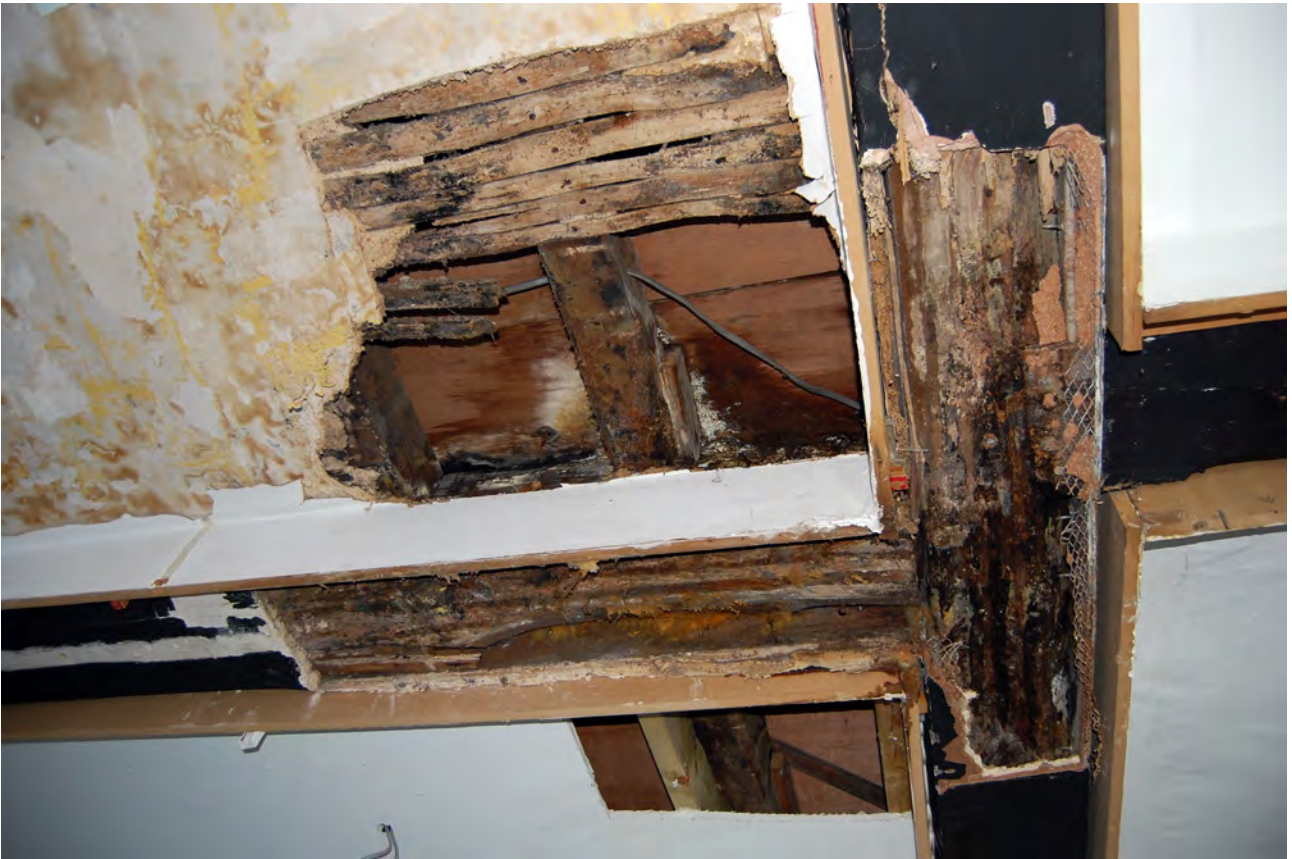
Plate 27: Exposed floor joists in Room D looking south

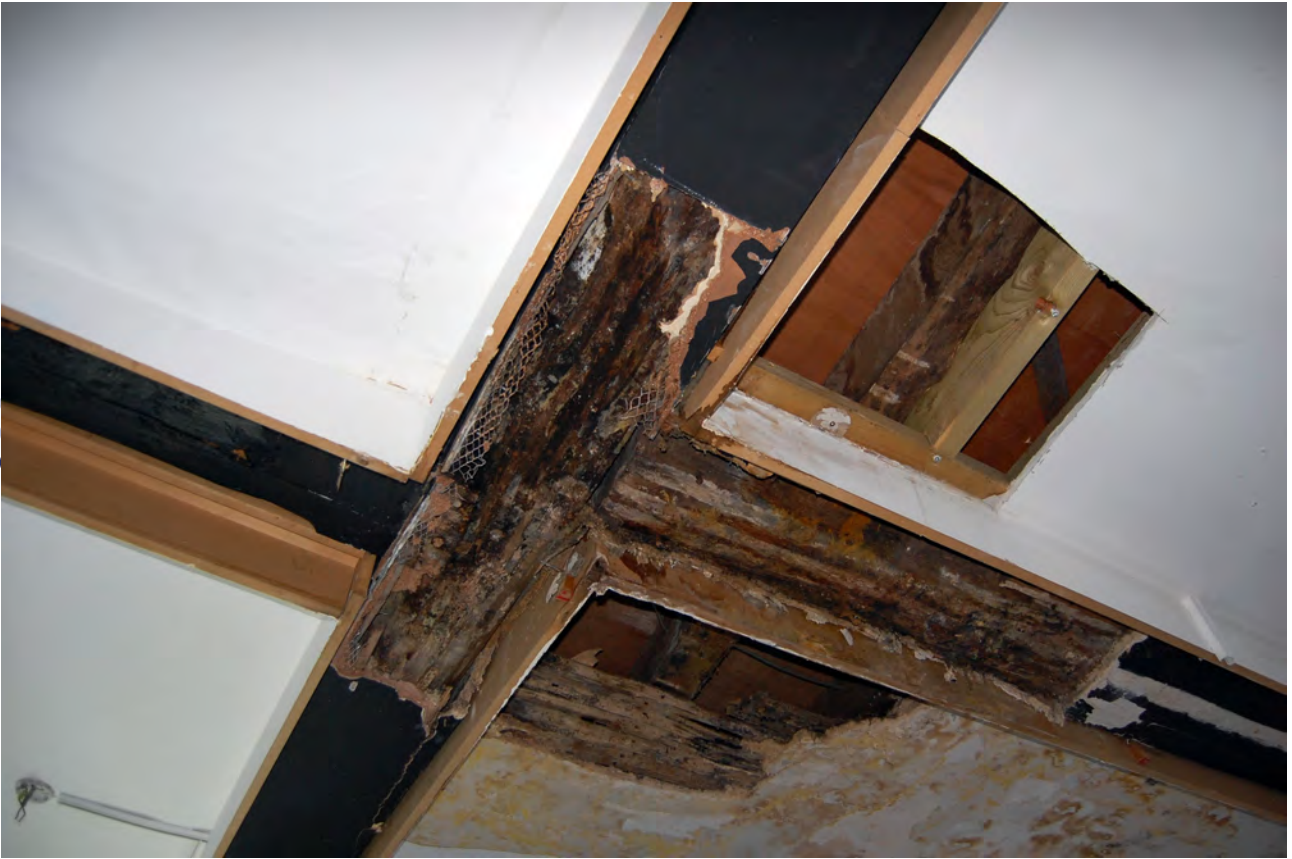
Plate 28: Exposed floor joists in Room D looking north

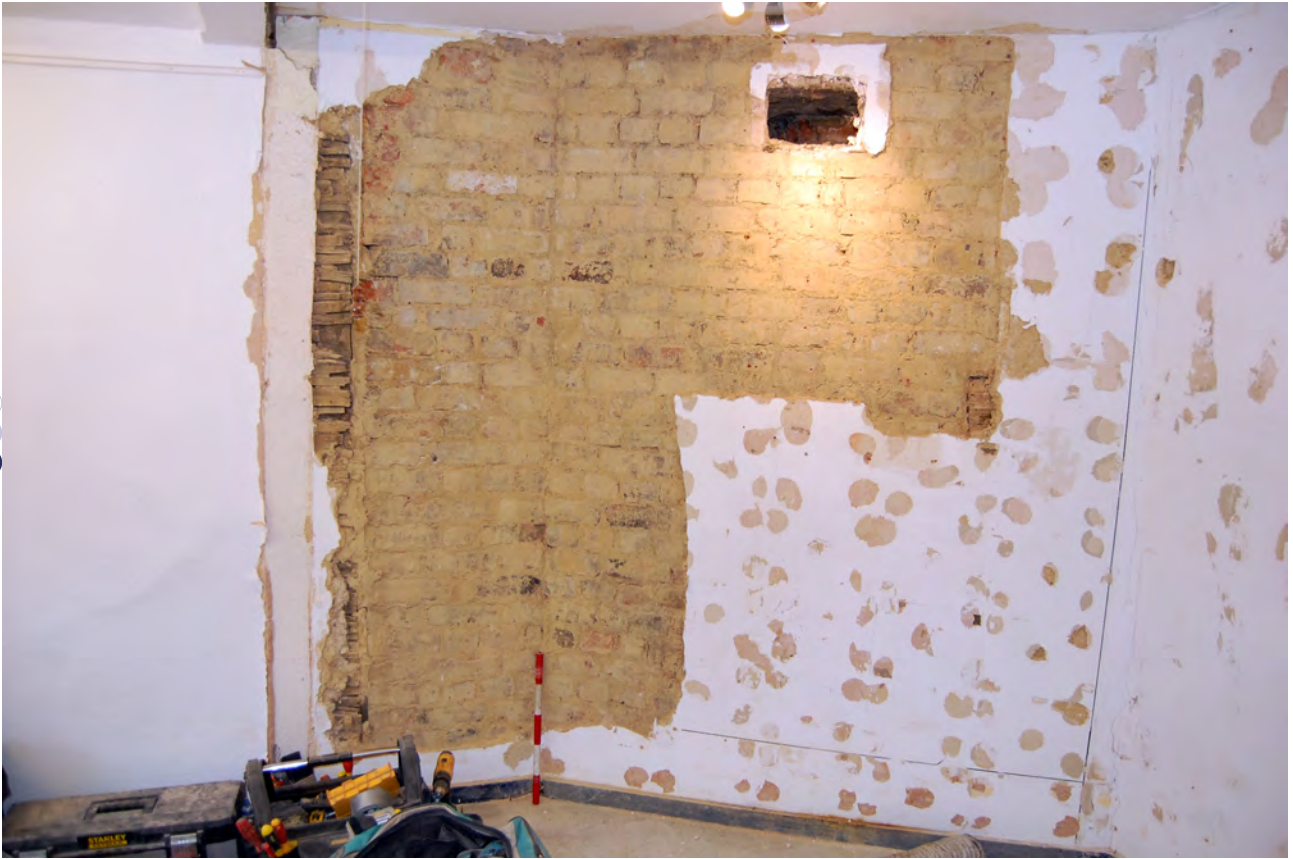
- 3.3.33 It has been assumed that the chimney breast is part of the original c.1650-70s building although it should be noted that the nature of the mortar and the character of the exposed bricks are more suggestive of an 18th or 19th-century date than one from the 17th century. This impression may be misleading, especially because the removed plaster has left a residue that covers the bricks, but the possibility cannot be discounted that the chimney breast is a secondary alteration.

Plate 30: Chimney breast at SE corner of Room C after plaster removal
