Knowsley Business Park, Draw Well Road, Knowsley, Merseyside Historic Building Survey Report

August 2020

Issue No: 2020-21/2081

Historic Building Survey Report

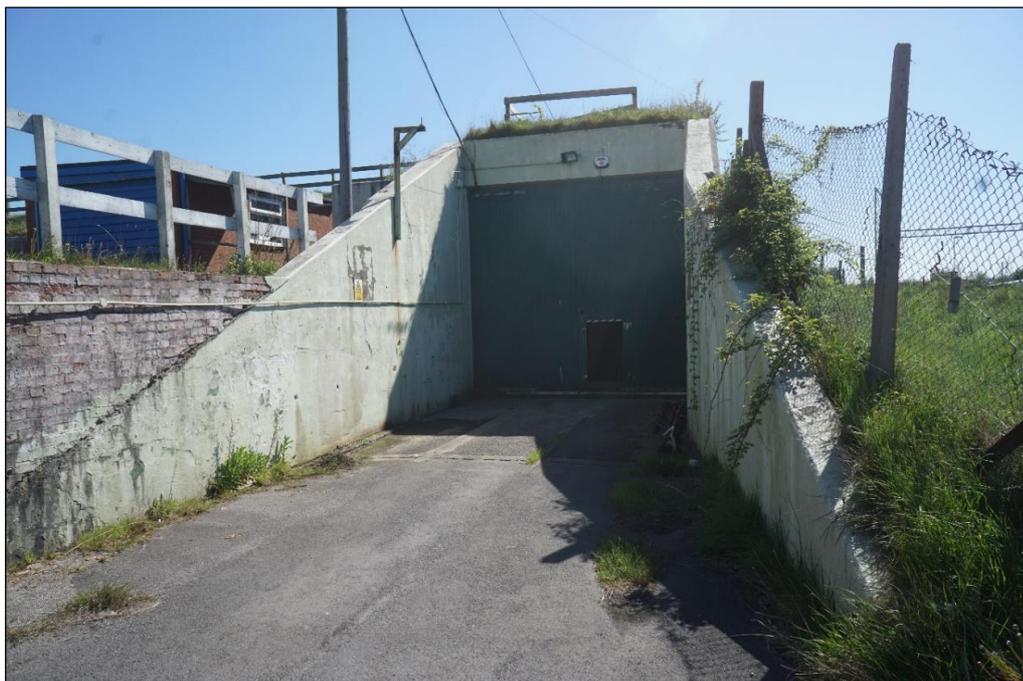
Plate 6: Main entrance to Bunker 9/3

- 4.3.1 At the western end of the northern elevation the main entrance was flanked by a pair of tapering blast walls, the western example splayed slightly to the west to accommodate access for the railway (Plate 6). The ground level to the east of the entrance was approximately 2m higher and was retained by the blast wall on this side, which had here been extended to the north in brick up to mid-height. The entrance was fitted with a pair of large timber loading doors, hinged to open externally and incorporating a low access hatch at the base of the western door.

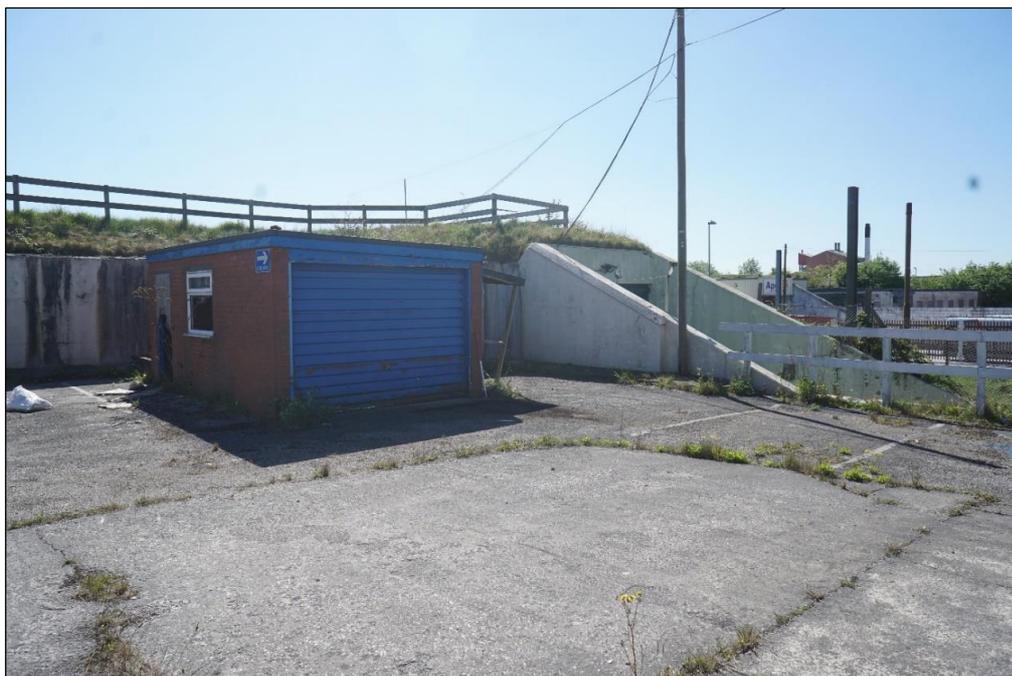
Plate 7: Single-storey structure to the north of Bunker 9/3

4.3.2 Despite the removal of the bank from the Bunker's northern side there were no openings in this wall, although a detached rectangular single-storey structure had been built at the western end (Plate 7). This building had been erected in red brick and had a large entrance on its northern side fitted with a roller shutter, a pedestrian entrance at the southern end of the eastern wall with a window to its north and another window on the opposing elevation. The garage-type structure housed a large diesel generator inside, powering what appeared to be an extractor fan, perhaps associated with the ventilation of the building (Plate 8).

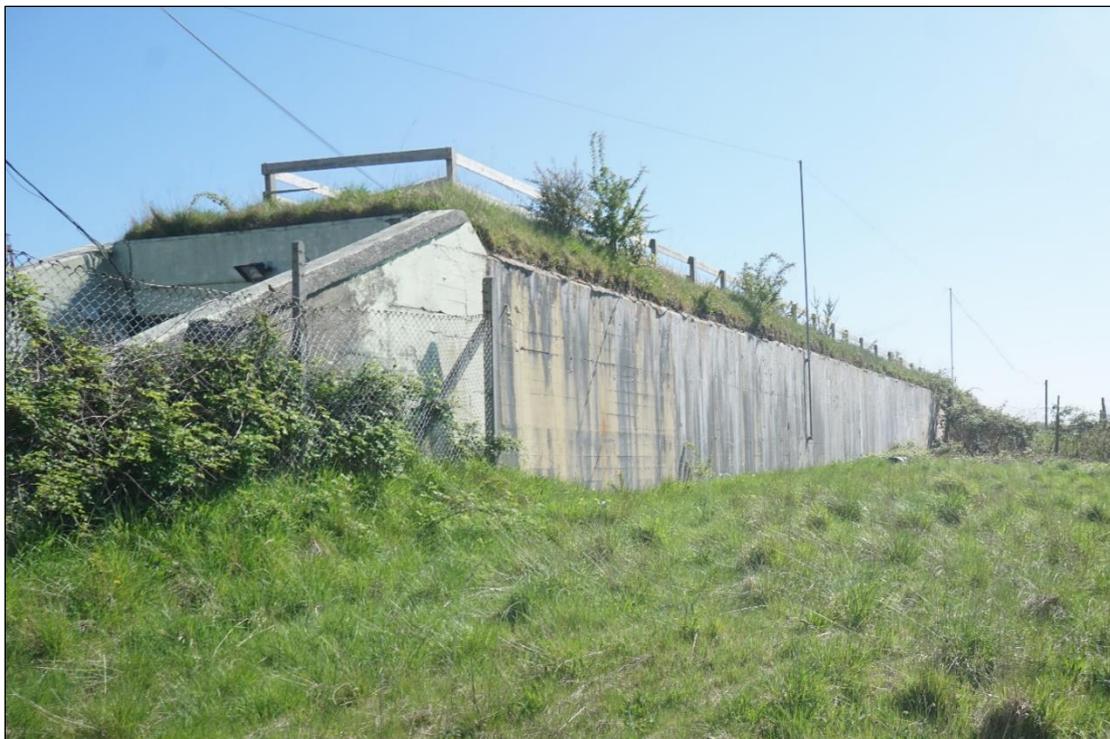
- 4.3.4 To the south, the soil bank remained as a gentle gradient leading up to the Bunker's grass-covered roof, which was surrounded on the remaining three sides by a timber post and rail fence. The bank had been removed from the western elevation, but no openings or further features were identified on this wall (Plate 10).

Plate 10: Western elevation, note the horizontal lines denoting the use of the cast in place technique

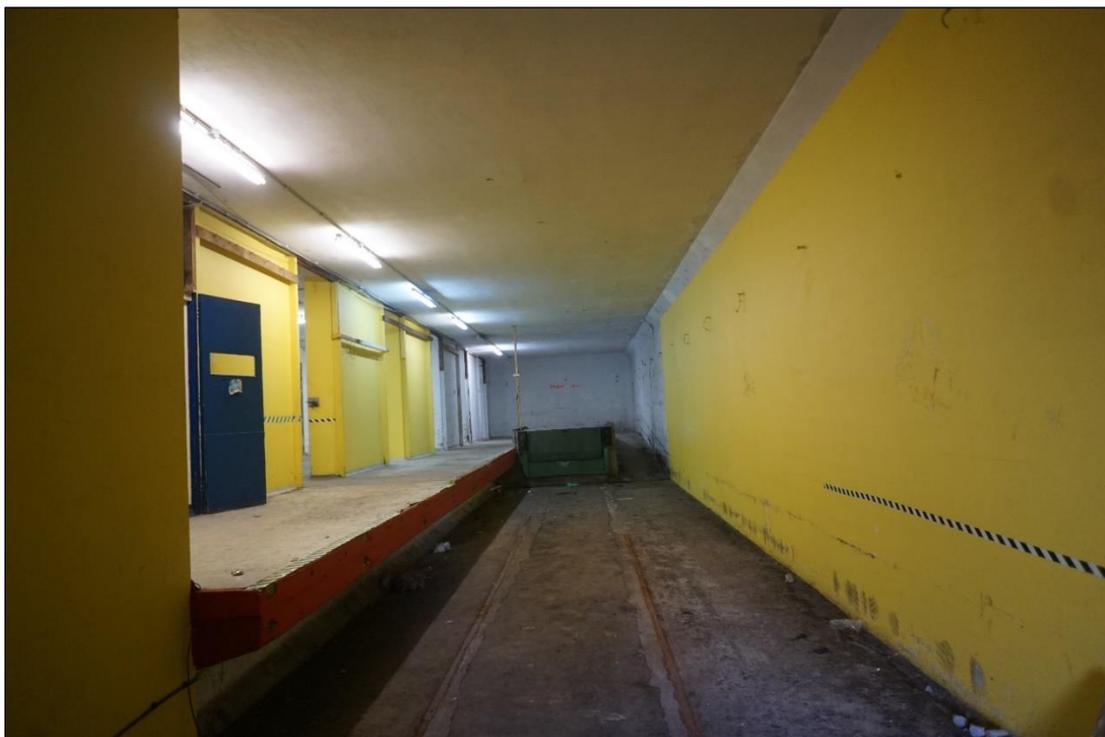
- 4.3.5 The loading bay was an elongated rectangular space with an overhanging concrete platform running along the eastern side (Plate 11), accessed via a set of five steps at its northern end enclosed within a small stairwell (Plate 12). The floor was laid in concrete with a switch-back ramp at the southern end (Plate 13), rising to a docking station for the unloading of goods from a reversing vehicle, but the tops of a pair of parallel steel rails, approximately 1.4m apart, had been preserved within the present floor surface, denoting the standard gauge of the original railway line (Plate 11). The walls were painted yellow and white, with the ceiling coated in white.

Plate 11: Loading bay, facing south. Note the original rails preserved in the concrete floor

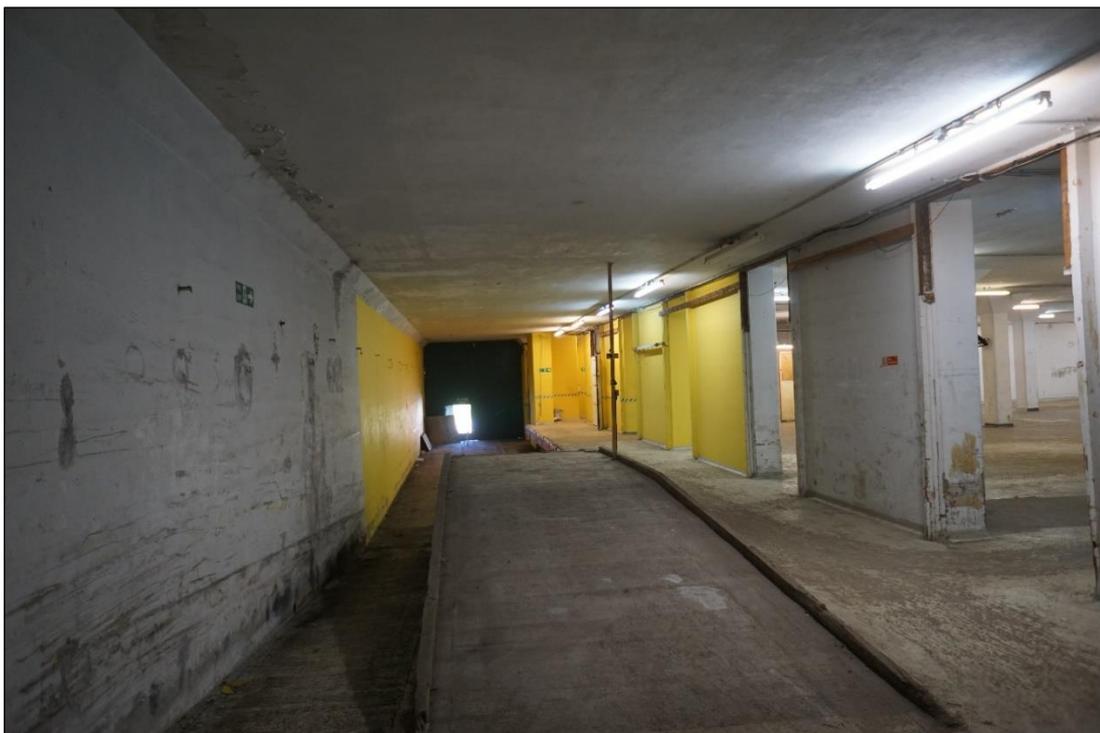
Plate 13: Loading bay facing north, with ramp to centre, full height openings to right of frame and truncated brackets on the opposing wall

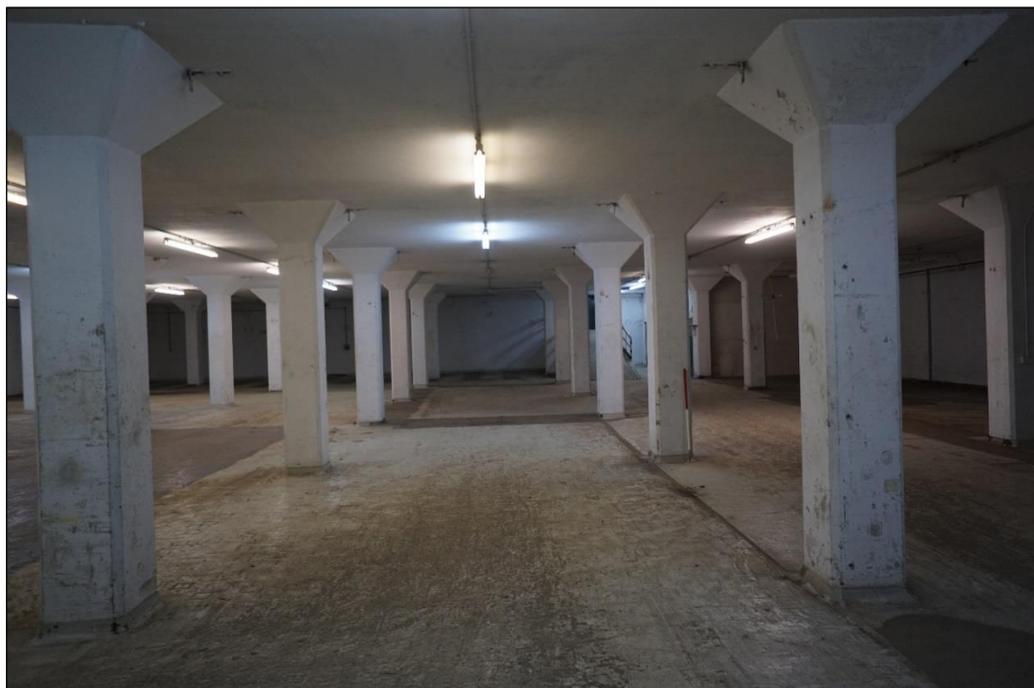
Plate 14: Typical bay in the storage room, facing east with 1m scale

- 4.3.7 Within the storage room historic detail was sparse, reflecting the room's basic function to provide secure storage while eliminating any potential source of ignition. The walls and ceiling were coated in white paint and modern fluorescent strip lighting had been installed down the centre of each bay (Plate 14). To the north and south of each column an L-shaped metal bracket had been attached to the ceiling, possibly the remains of attachment points for racking or some other form of shelving.

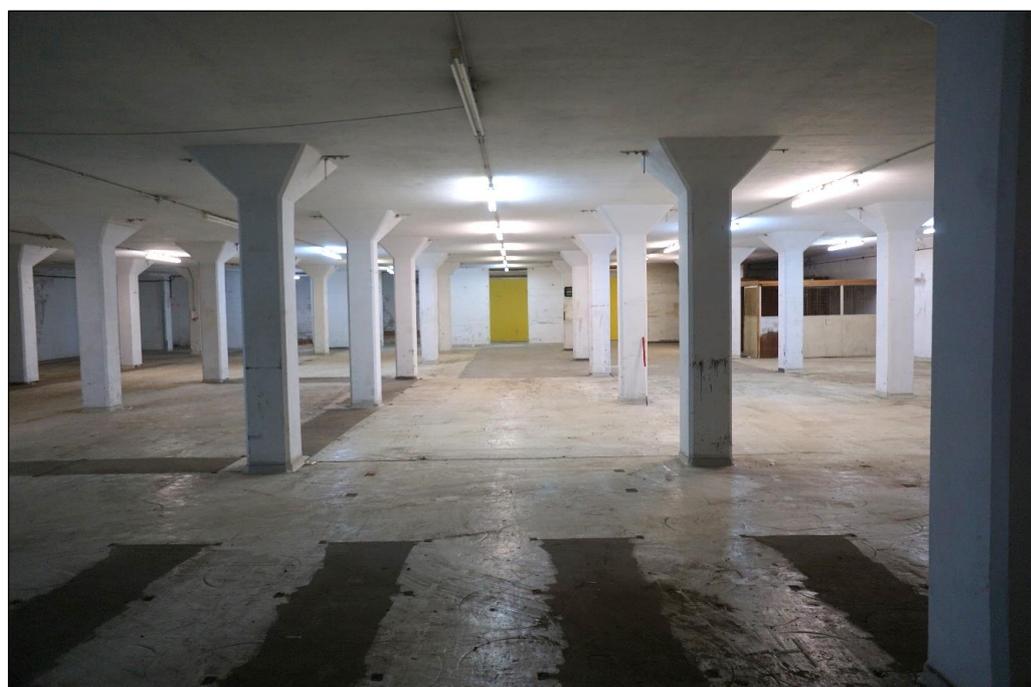
- 4.3.8 Much of the concrete floor had been painted, but this had evidently been undertaken without emptying the building and against the eastern wall a series of small repeating square markings and elongated patches which had not been painted, presumably indicated the position of racking (Plate 15). In addition, and more widely observed across the entire floor, were the circular imprints of what may have been barrels or drums. The relationship of these circular markings to the location of the shelving indicated the former to be the earlier of the two.

Plate 15: Looking west along the storage bay towards the platform opening, with markings on the floor visible in the foreground

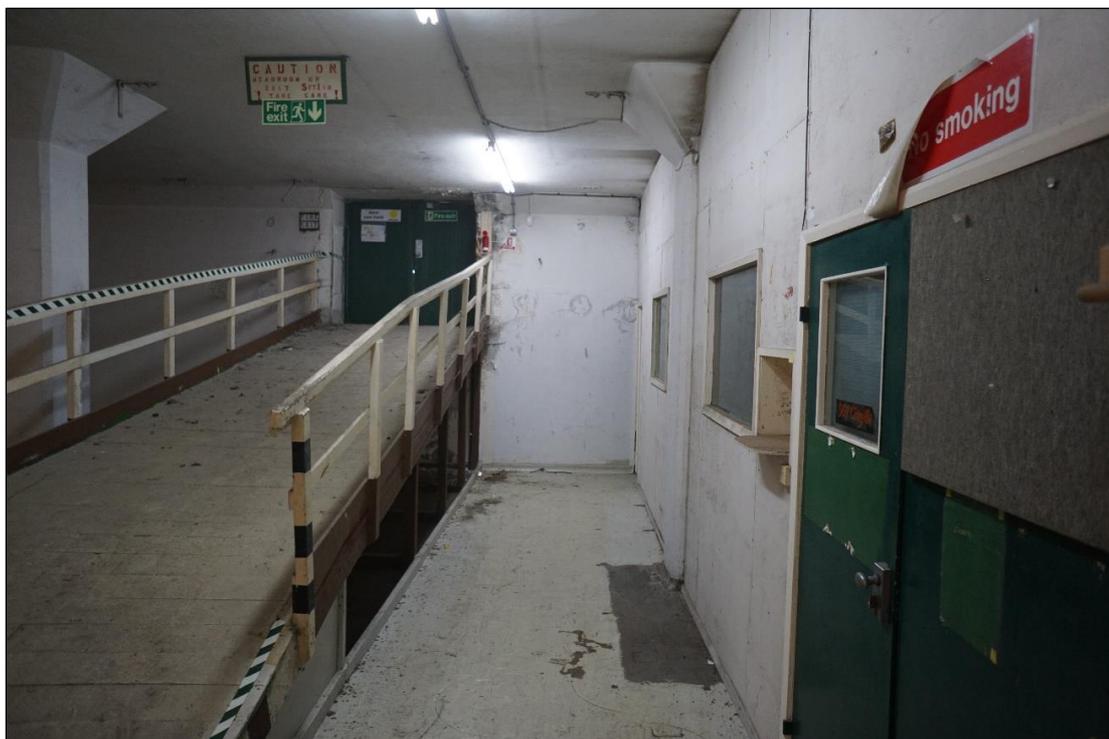
- 4.3.9 Modern timber partitions installed within the north-western corner of the room had created two small rectangular cells, one of which was heated, probably an administration space, and the other as a storage room. Similar timber partitions had been erected across two bays in the south-eastern corner, providing another large room in this location and, to its north, a timber ramp led up to the fire escape described on the eastern external elevation (Plate 16).

Plate 16: Ramp leading up to the fire escape on the eastern wall with partitioned room to the right

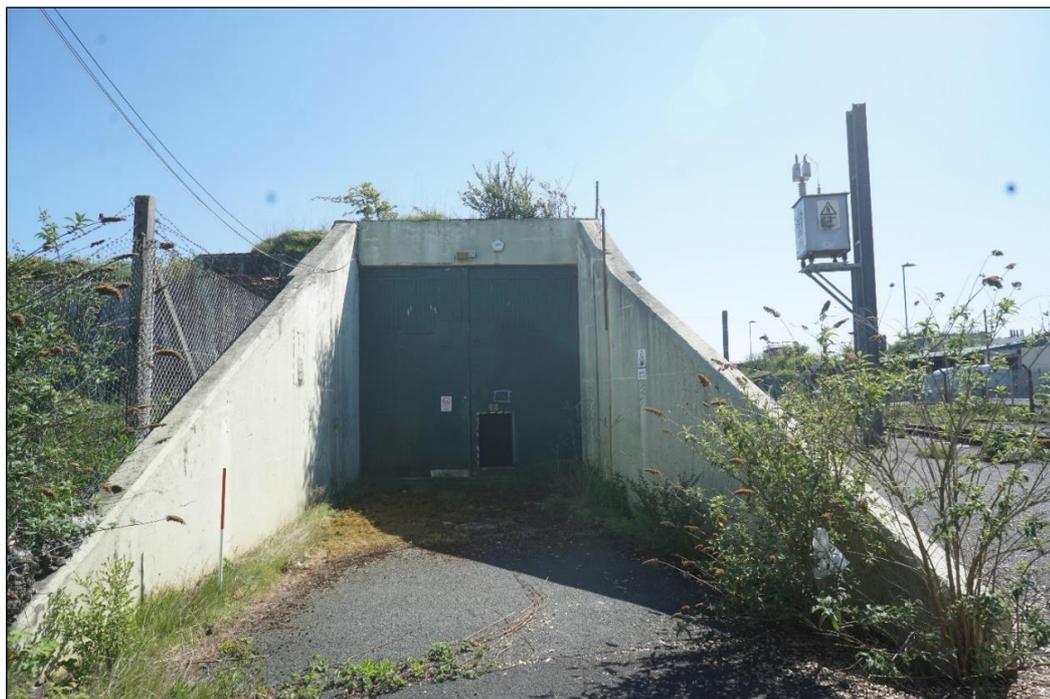
Plate 17: Main entrance on northern elevation, facing south, with 1m scale

- 4.4.1 As with the previous Bunker, the north-western entrance was flanked by tapering blast walls and had been fitted with two large externally-opening timber doors, each set upon a pair of pintel hinges (Plate 17). Pedestrian access was provided by a low hatch cut through the lower portion of the western door.

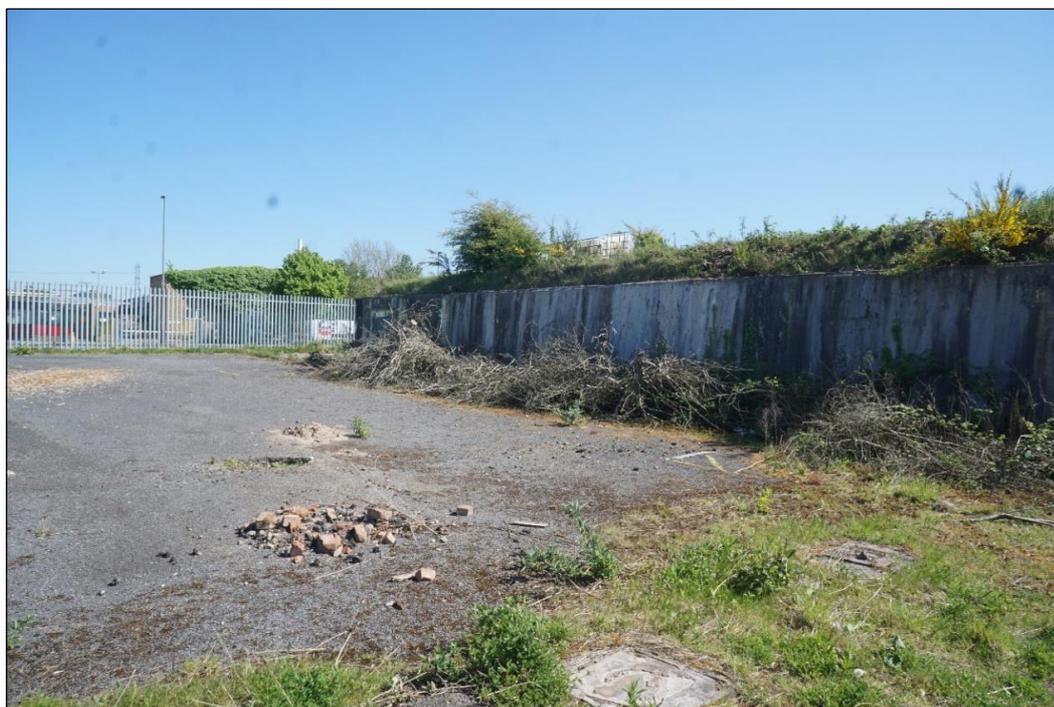
Plate 18: Northern elevation, facing south-east

4.4.2 The ground surface to the east of the entrance was also slightly raised, with the change in soil level being retained by the lower portions of the eastern blast wall. The bank that had once abutted the remainder of the northern elevation had been removed and a fire escape door had been inserted at the eastern end (Plates 18 and 19). At the western end of this elevation there were a series of small concrete plinths, arranged in three rows of four across the ground, which presumably represented the foundation pads of a now demolished small square structure (Plate 20).

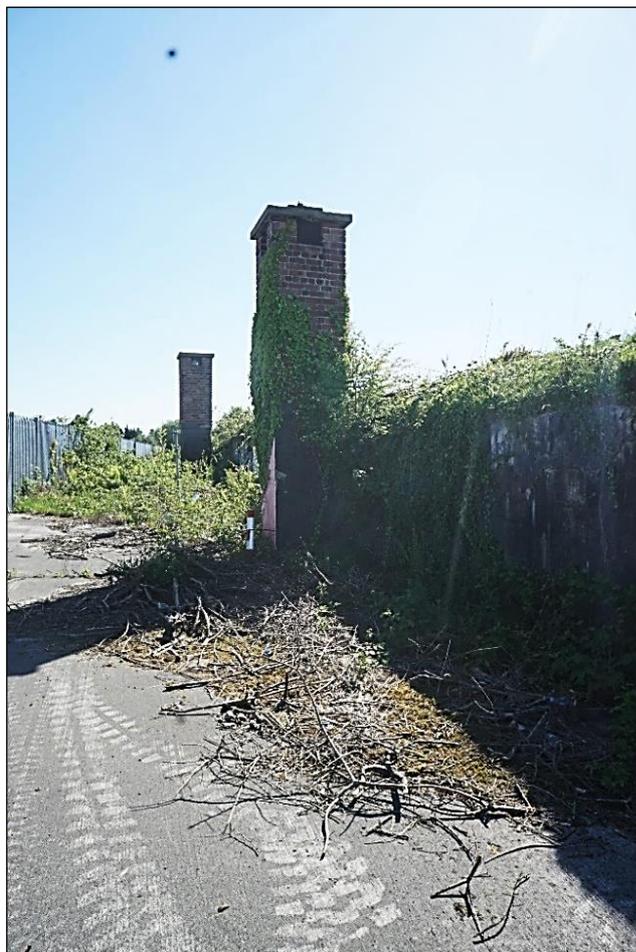
Plate 21: Brick ventilation towers on the eastern elevation, facing south

- 4.4.3 The bank had also been removed from the eastern side of the building, exposing the base of a pair of brick-built ventilation towers located at thirds across its length (Plate 21). Each tower extended to a height of approximately 3.75m, and at the top of each elevation there was a small square aperture fitted with a honey-combed mesh. The towers were topped by an oversailing concrete cap and the base was coated in a waterproof sealant. On the northern example, a metal bracket had been fitted to the centre of the concrete cap, the remnants of a fixture since lost.

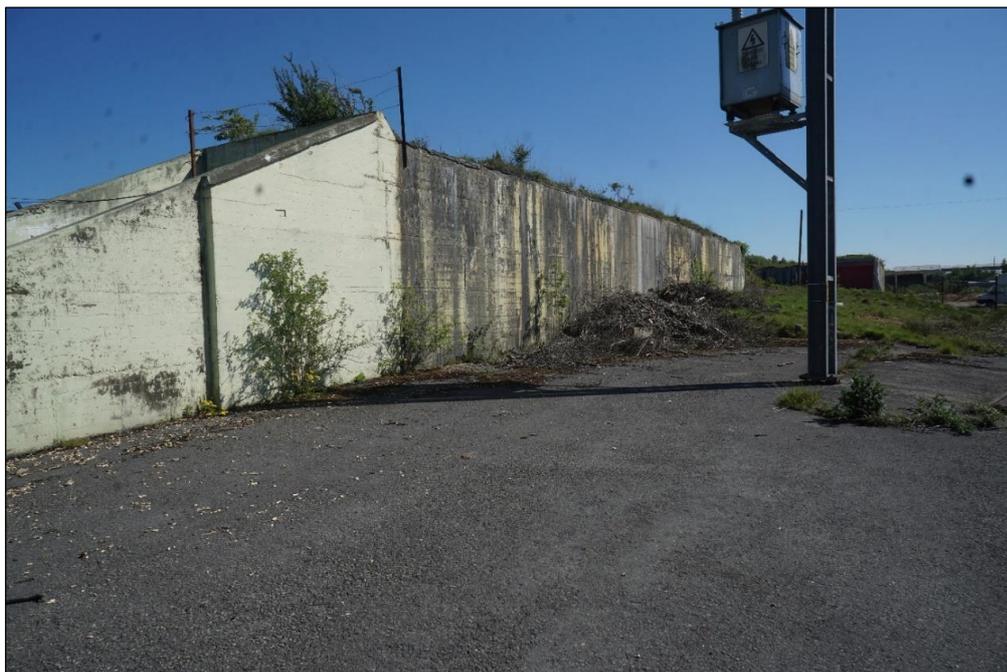
Plate 22: Eastern elevation, facing south-east

- 4.4.4 The bank had also been lost from the western side of the structure, but no alterations had been made to this elevation (Plate 22), while the slope of the southern bank remained *in situ*, providing access to the grass- and scrub-covered roof.

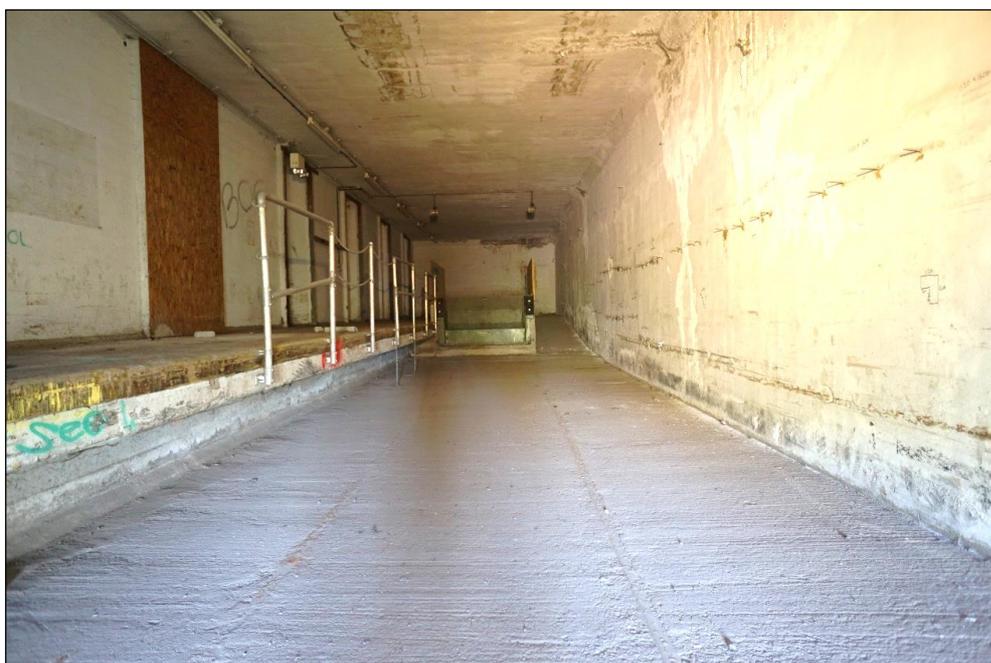
Plate 23: Loading bay, facing south

- 4.4.5 The interior was similarly arranged to Bunker 9/3, with a stairwell at the northern end accessing a concrete platform running along the eastern side of the elongated loading bay and a switch back ramp at the southern end fitted with a modern docking station (Plates 23 and 24). Here, however, a modern steel safety rail and chain link had been installed along the side of the platform and a series of modern bolts projected at regular intervals from half height along the western wall. Again, the concrete floor had been raised slightly but the rails had been left *in situ* and were just visible in plan.

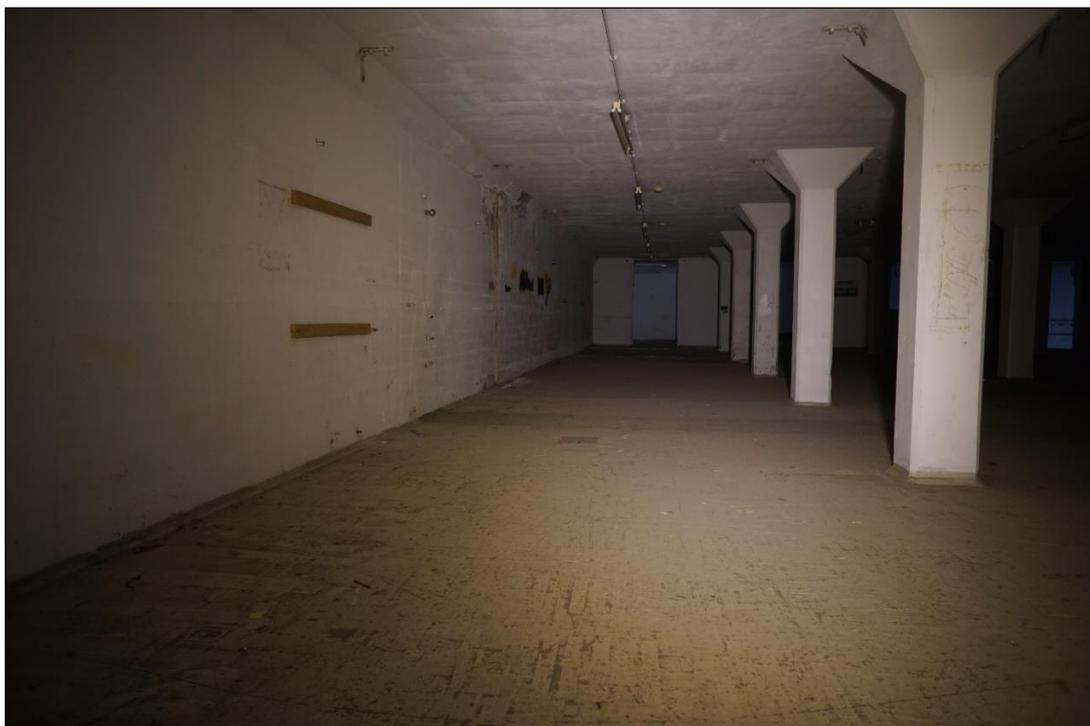
Plate 25: Southern bay of the storage room, facing west

4.4.6 The walls and ceiling of the storage room were coated in white paint and the same arrangement of lighting was used as in the previous bunker (Plate 25). The L-shaped ceiling brackets were also common to both buildings but here despite the pattern of small square impressions on the floor surface there was no evidence of the circular marks seen in Bunker 9/3.

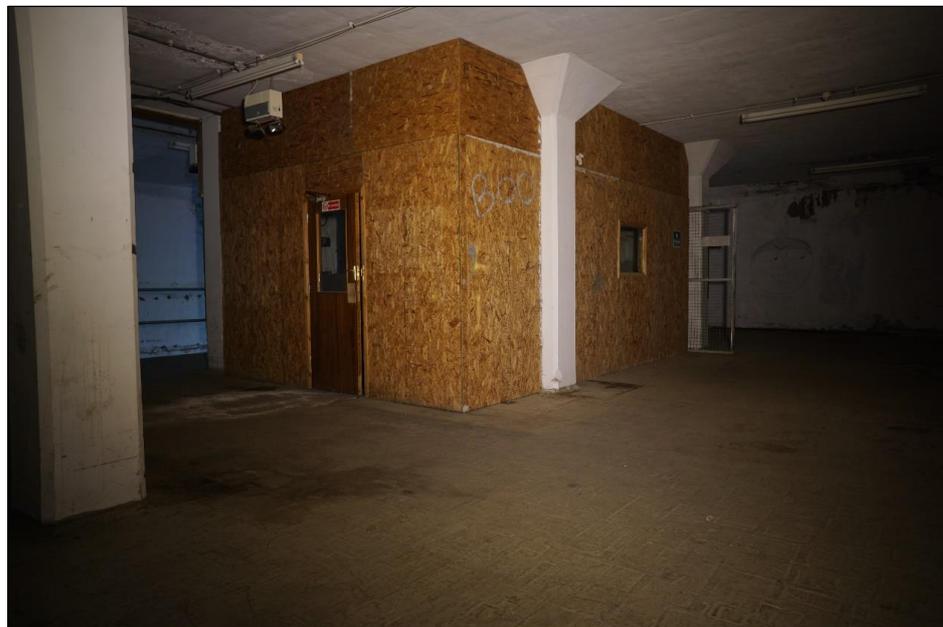
Plate 26: Modern partitioned room in the north-western corner

4.4.7 A single room had been partitioned off in modern timber at the western end of the penultimate northern bay, which had occasioned the blocking of the opening of the dividing cross-wall in this location (Plate 26). This room was accessible via a doorway from the south but was of no historic interest.

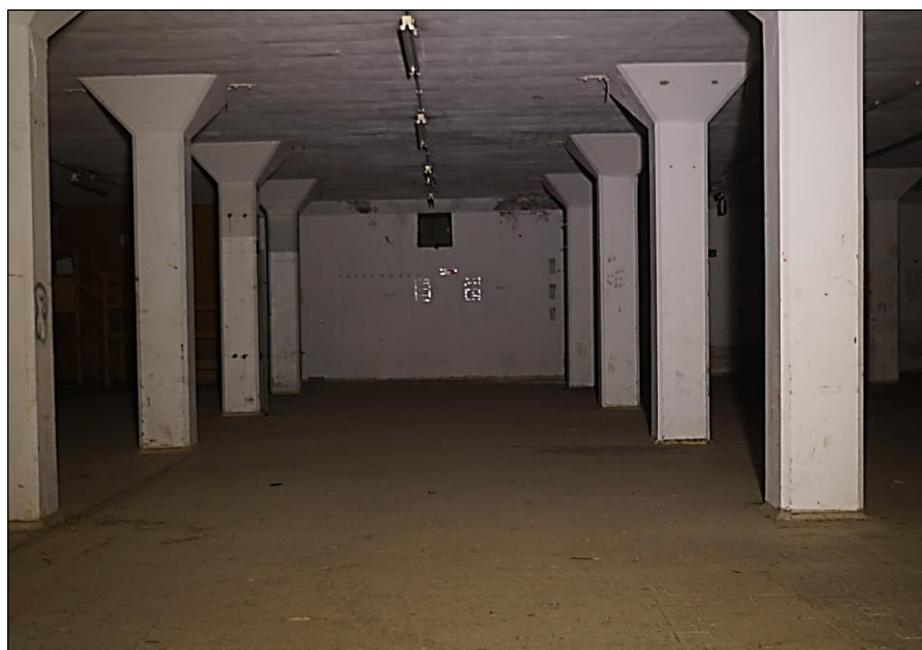
4.4.8 The only other features of note were a timber staircase located in the north-eastern corner of the storage area, which led in three stages up to the fire escape located at the eastern end of the northern external elevation, and a pair of square apertures located at either end of the eastern wall just below ceiling height (Plate 27). The latter coincided with the ventilation towers noted externally.

Plate 27: Penultimate northern bay, facing east. Note the square aperture in the eastern wall, one of two on this wall which coincides with the external ventilation towers

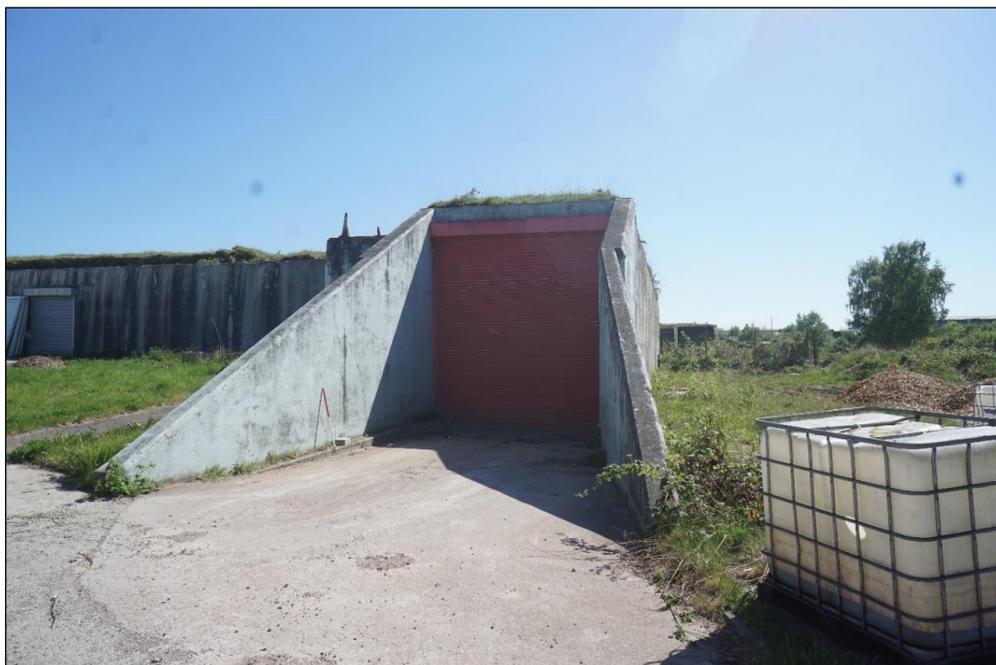
Plate 28: Main entrance on the northern elevation, facing south with 1m scale

- 4.5.1 The main entrance at the western end of the northern elevation had been fitted with a steel roller shutter but was otherwise identical to those previously described (Plate 28). In this instance, the ground to the east of the main entrance was broadly level with that to the west and may perhaps have been reduced to make it so. The bank had again been removed to expose the remainder of the northern elevation and a pedestrian doorway fitted with a steel roller shutter having been inserted into the western end (Plate 29). A concrete path had been lain as an approach to this doorway.

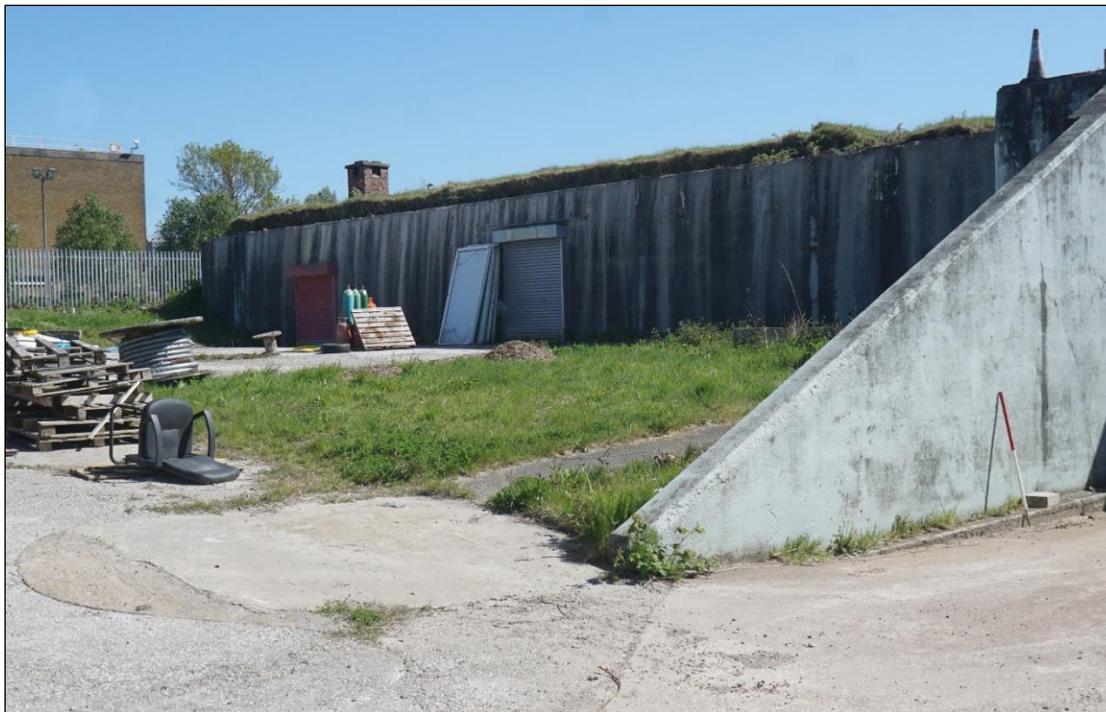
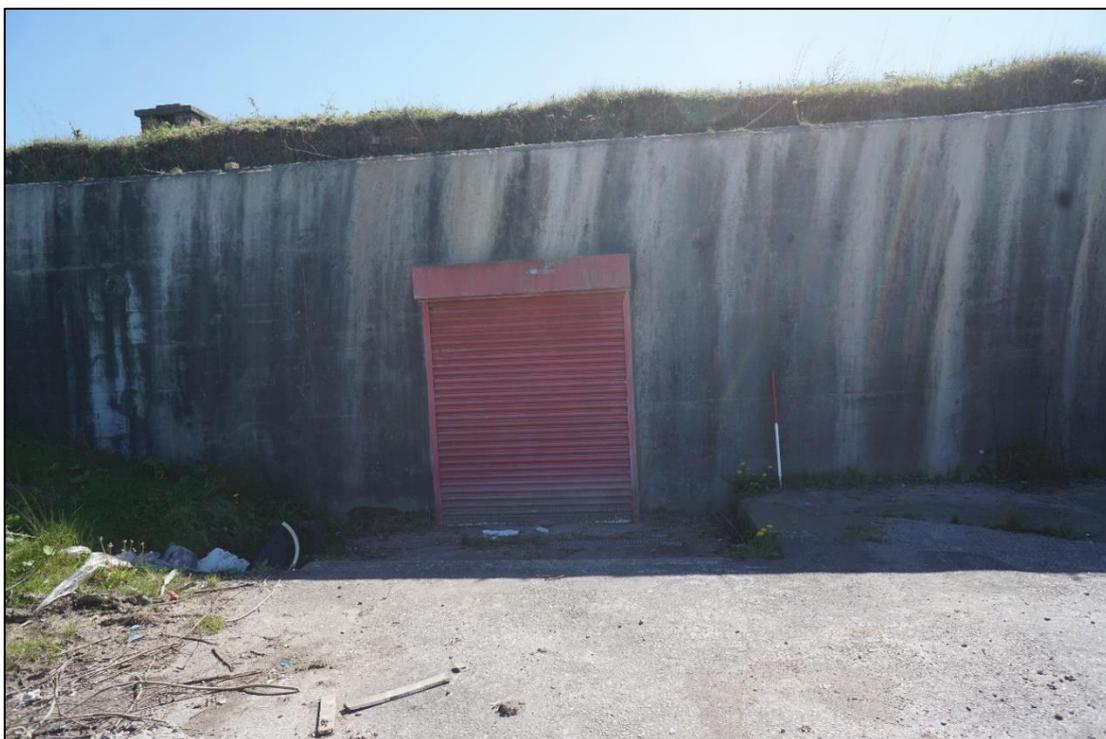
- 4.5.2 At the centre and eastern end two more entrances had been cut through the wall, slightly wider in dimension than the last for the purposes of loading but both again fitted with steel roller shutters (Plates 30 and 31).

Plate 30: Northern elevation facing south-east

Plate 31: Inserted entrance at the eastern end of the northern elevation, 1m scale

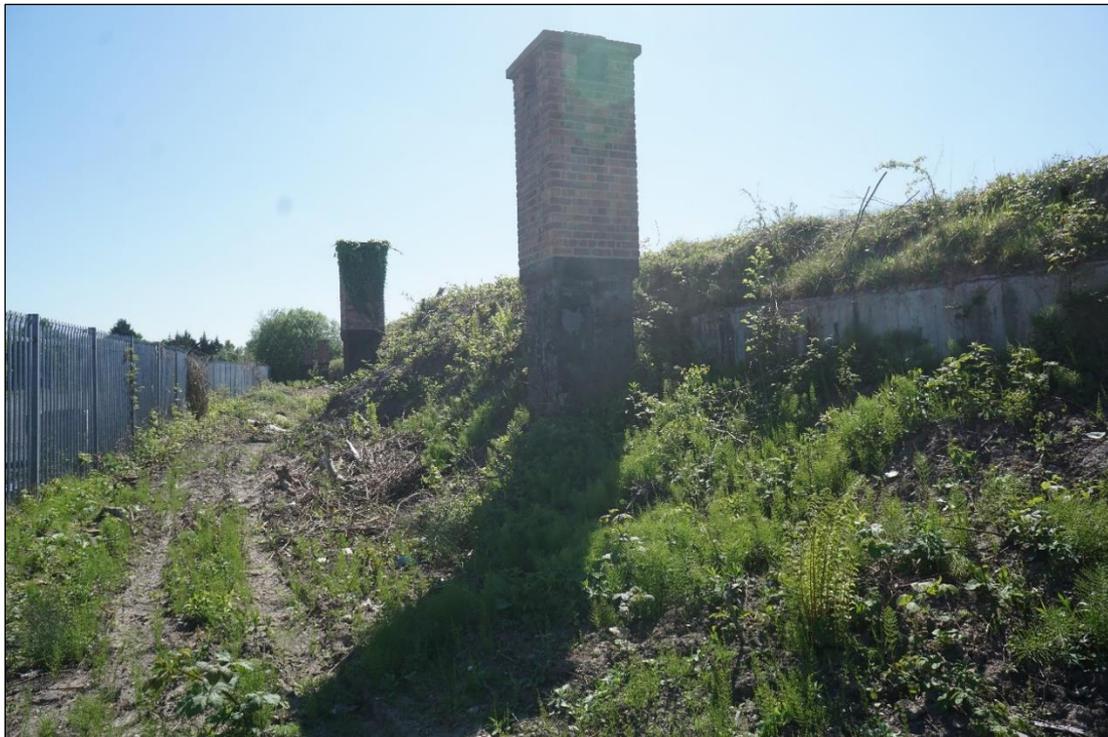
Plate 32: Brick ventilation towers on eastern elevation, facing south-west

ventilation chimneys, identical to those described in the same position as on Bunker 9/5 (Plate 32).

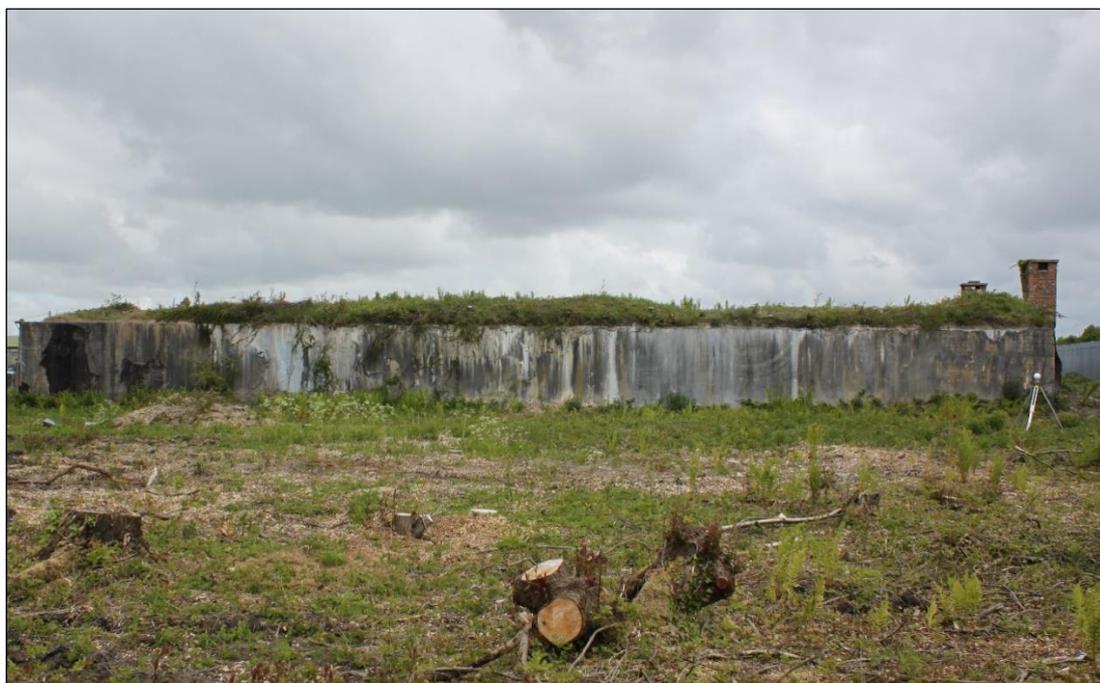
Plate 33: Southern elevation, facing north

4.5.4 The bank had been completely removed from both the southern and western elevations, but neither revealed any features of historic interest (Plates 33 and 34).

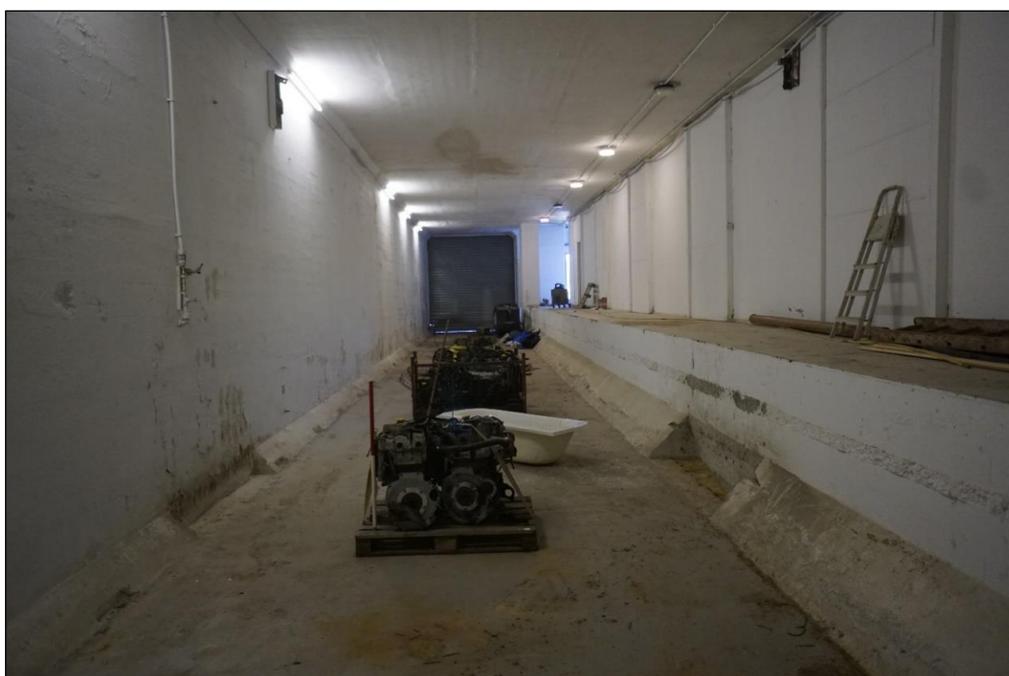
- 4.5.5 Although dimensionally identical to those previously described, the loading bay in Bunker 9/7 had been modified, with the removal of the overhanging portion of the platform to leave a vertical step accessible only from the stairwell at the northern end (Plate 35). In addition, there was no evidence to suggest it had ever had a switchback ramp at the southern end and a deep channel had been cut through the centre of the floor at the northern end, perhaps to form a vehicle inspection pit (Plate 36).

Plate 35: Loading bay facing north, showing the removal of the platform and blocked doorways on the cross-wall

- 4.5.6 Several of the openings on the cross-wall had been boarded over (Plate 35), leaving just the southern entrance and the northern entrance intact, although the latter had been reduced in width and height to facilitate pedestrian use (Plate 37). Few details remained on the opposing western wall, but towards the southern end a vertical metal channel had been attached to the wall just below ceiling height (Plate 38). The features purpose was unclear, but an identical channel had also been bolted to the opposing wall in the corresponding position.

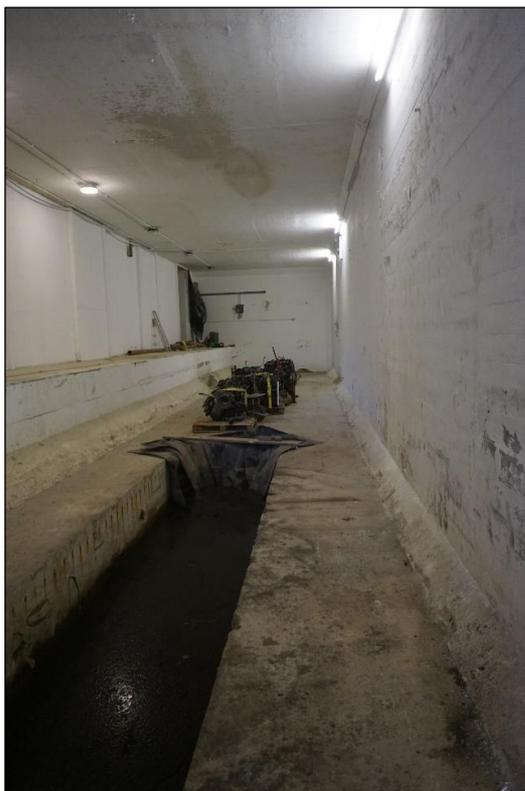
Plate 36: Loading bay facing south, showing channel cut into the floor

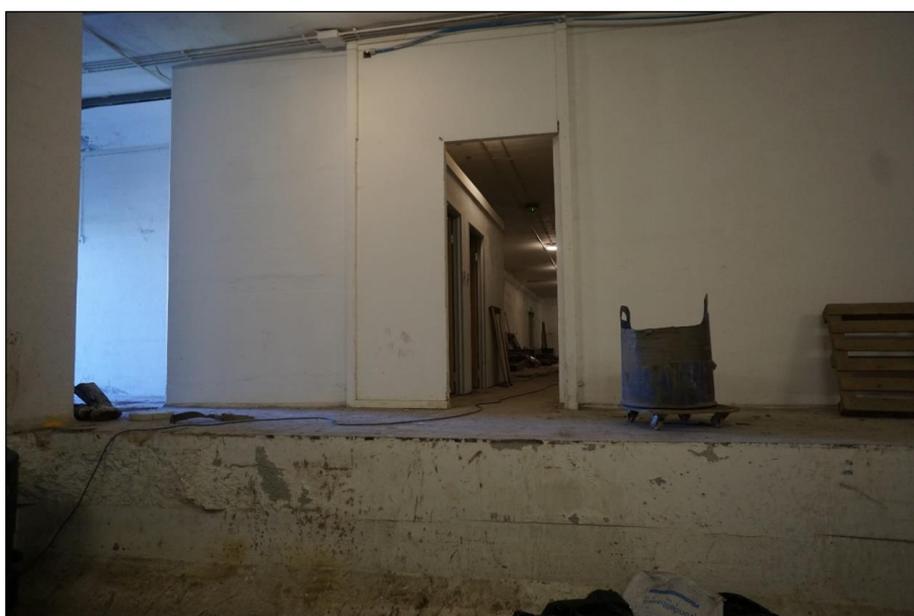
Plate 37: Modified northern opening in the cross-wall, facing east

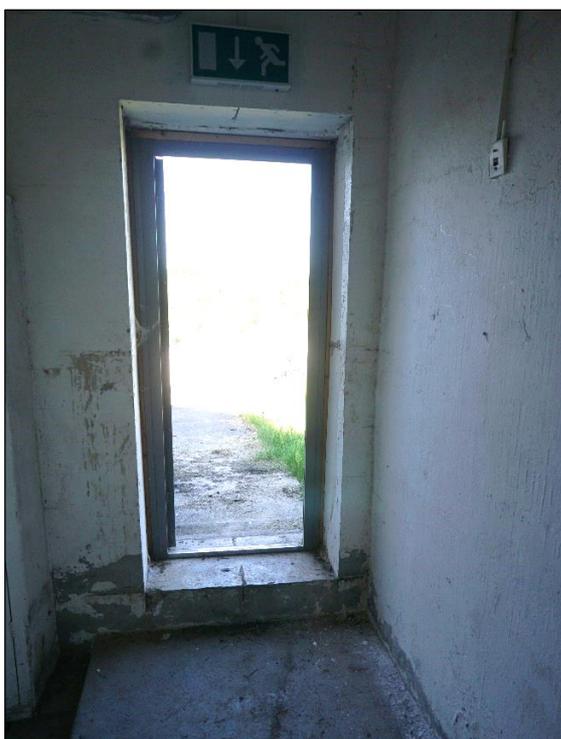
Plate 39: Entrance into stairwell, facing north

4.5.7 The first of the three inserted doorways identified on the northern elevation provided a direct entry to the stairwell via a single step down (Plate 39). It was topped by a modern fire-escape sign and was otherwise unremarkable in its form. The second opening lay within the fourth bay from the west in the storage room and was served by a short flight of steps formed out of timber pallets (Plate 40), while the third opening in the penultimate eastern bay, had a lower threshold and required no step.

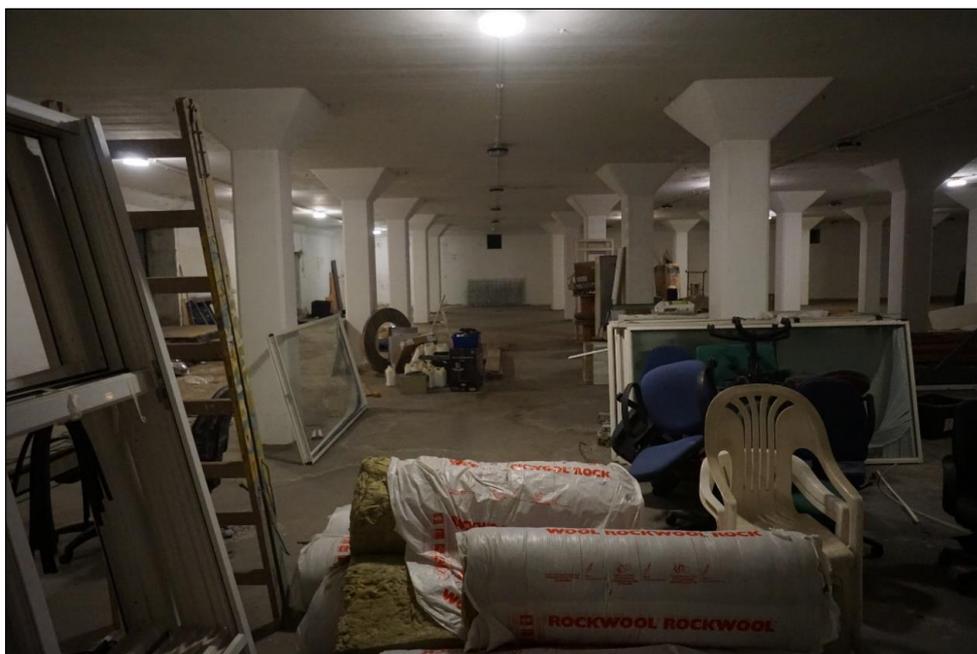
- 4.5.8 The storage room itself was decorated in the same manner as the previous two bunkers, although the L-shaped ceiling mounted brackets had all been removed, in each case leaving just the two projecting bolts upon which they had been set. The floor again showed evidence for heavy goods storage in the preservation of indentations of both circular and square form. On the eastern wall a pair of square apertures, set just below ceiling height, were presumably associated with the ventilation towers observed externally (Plate 41).

Plate 41: Storage room facing east, with 1m scale. Note the square ventilation aperture on the eastern wall

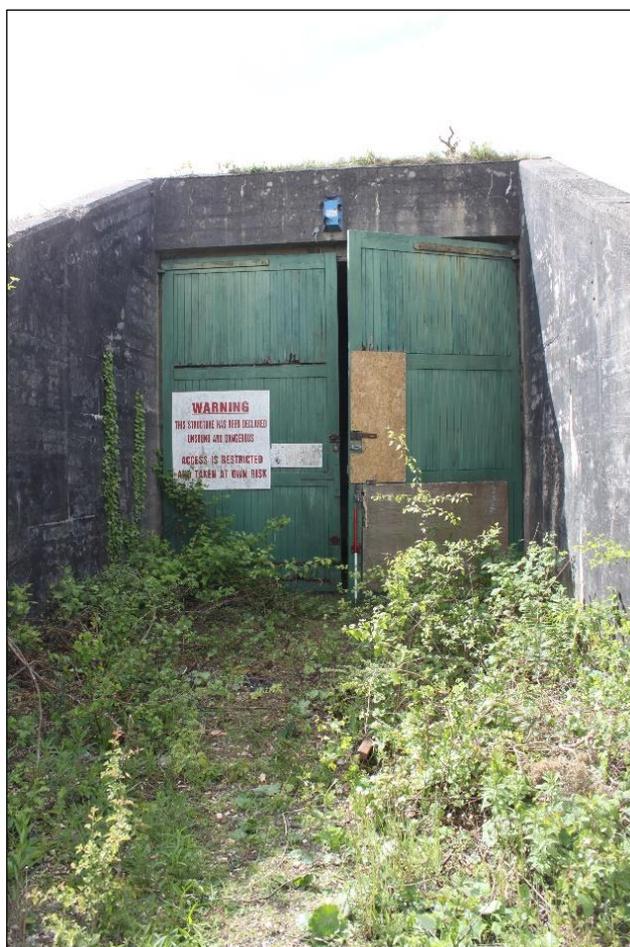
Plate 42: Northern entrance facing south, with 1m scale

4.6.1 The entrance at the western end of the northern elevation was fitted with the same timber doors as those on Bunker 9/5, although the building's disuse meant the approach was more vegetated than any of the previous examples (Plate 42). The bank had been removed from the remainder of the northern elevation and this too was partially obscured by vegetation, but there did not appear to be any additional openings (Plate 43). The bank had been removed from the eastern (Plate 44) and southern (Plate 45) elevations too, once again exposing the two ventilation chimneys on the eastern side, but no further openings were observed on either wall.
