Knowsley Business Park, Draw Well Road, Knowsley, Merseyside Historic Building Survey Report

August 2020

Issue No: 2020-21/2081

Historic Building Survey Report

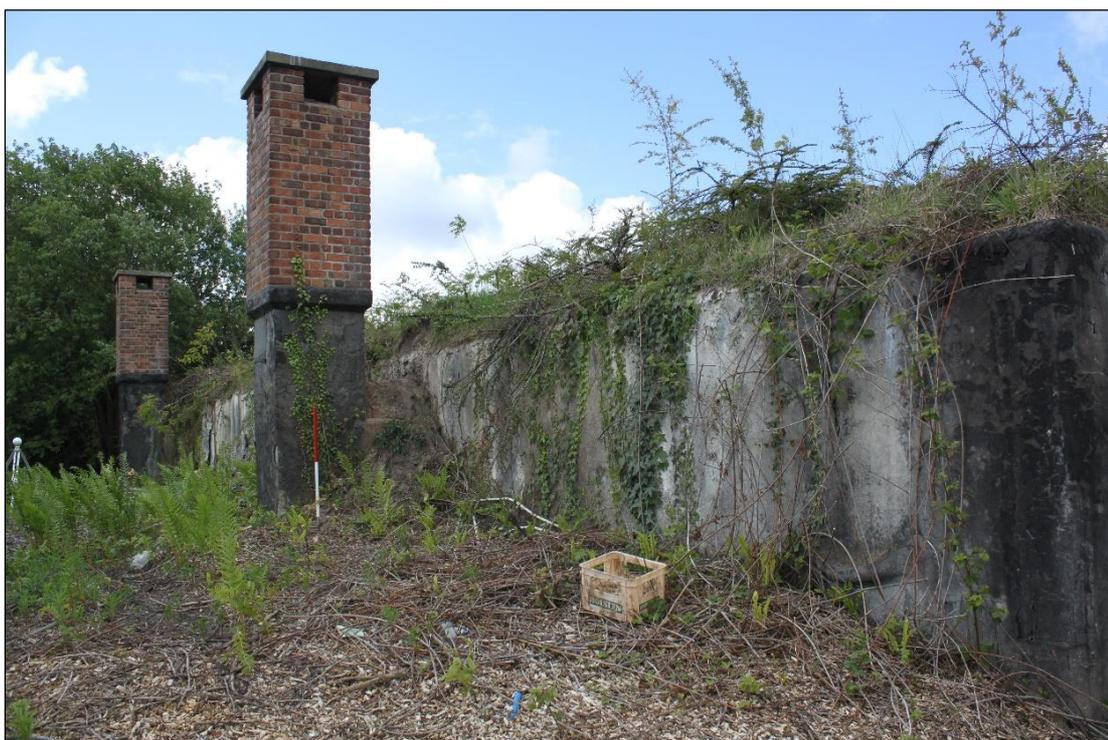
4.6.1 The entrance at the western end of the northern elevation was fitted with the same timber doors as those on Bunker 9/5, although the building's disuse meant the approach was more vegetated than any of the previous examples (Plate 42). The bank had been removed from the remainder of the northern elevation and this too was partially obscured by vegetation, but there did not appear to be any additional openings (Plate 43). The bank had been removed from the eastern (Plate 44) and southern (Plate 45) elevations too, once again exposing the two ventilation chimneys on the eastern side, but no further openings were observed on either wall.

Plate 44: Eastern elevation, facing south-west and showing ventilation towers with 1m scale

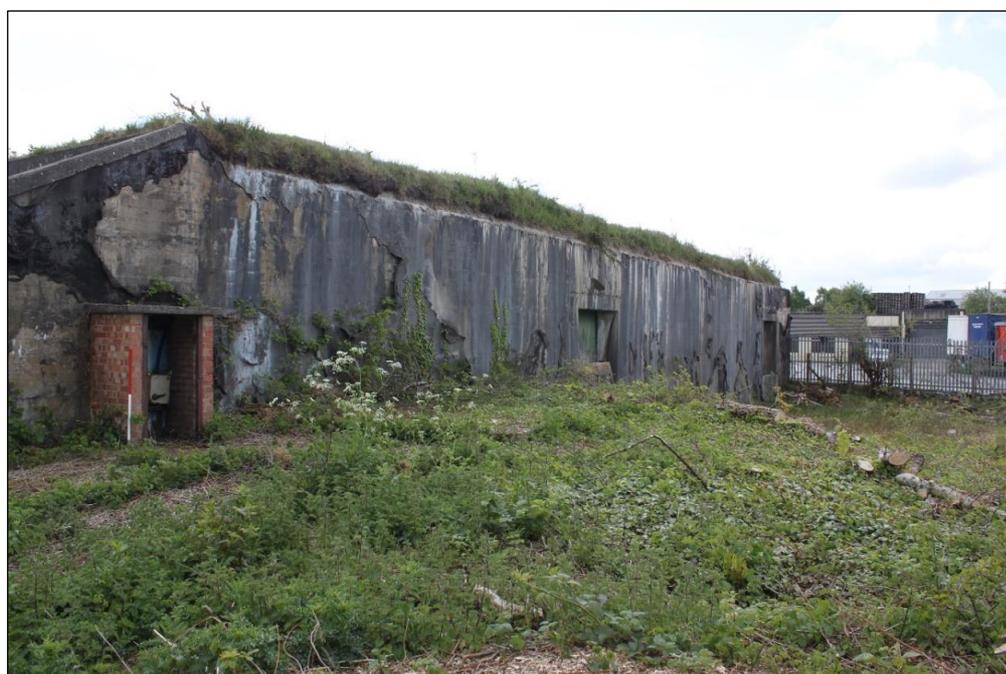
Plate 46: Western elevation facing south-east, with 1m scale

4.6.2 On the western elevation, the removal of the bank had been followed by the introduction of loading doors through the southern end and centre of the wall (Plate 46). In both instances, the sills were raised above ground level, reflecting the difference in the external and internal floor heights (Plates 47 and 48). Both openings were fitted with internally-opening double timber doors, had single piece reinforced concrete lintels and their surrounds had been patched with concrete render. At the northern end of the elevation an abutting small brick structure with a flat concrete roof and an entrance to the west enclosed what appeared to be the building's electrical isolation switch (Plate 46).

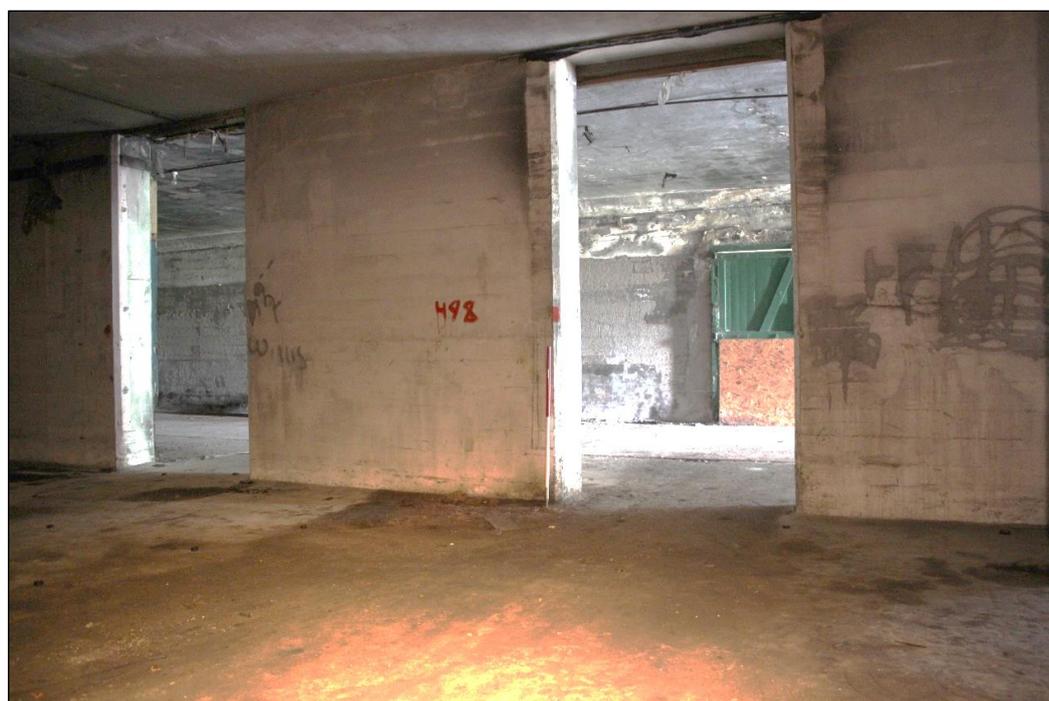
Plate 52: Cross-wall entrance from platform, facing west, with 1m scale

4.6.4 The remainder of the building was in largely original condition, with no additional openings added to any of the walls. It preserved its original and undivided six by seven bay storage room and each bay's associated entrance from the platform was intact (Plate 52). Unlike the previously described bunkers, however, it also retained what appeared to be its original lighting system, which consisted of a series of ceiling-mounted bulbs, arranged to illuminate the centre of each east/west-aligned bay (Plate 53).

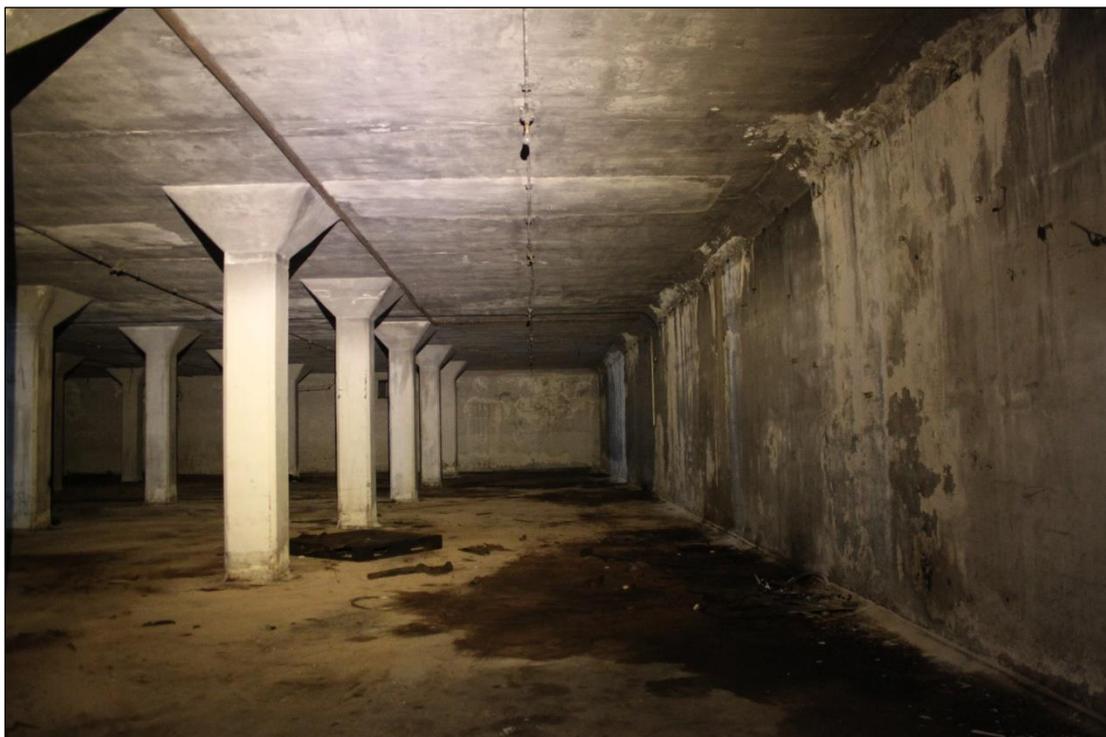
Plate 53: Southern bay, facing east. Note the original light fittings running along the centre of the ceiling

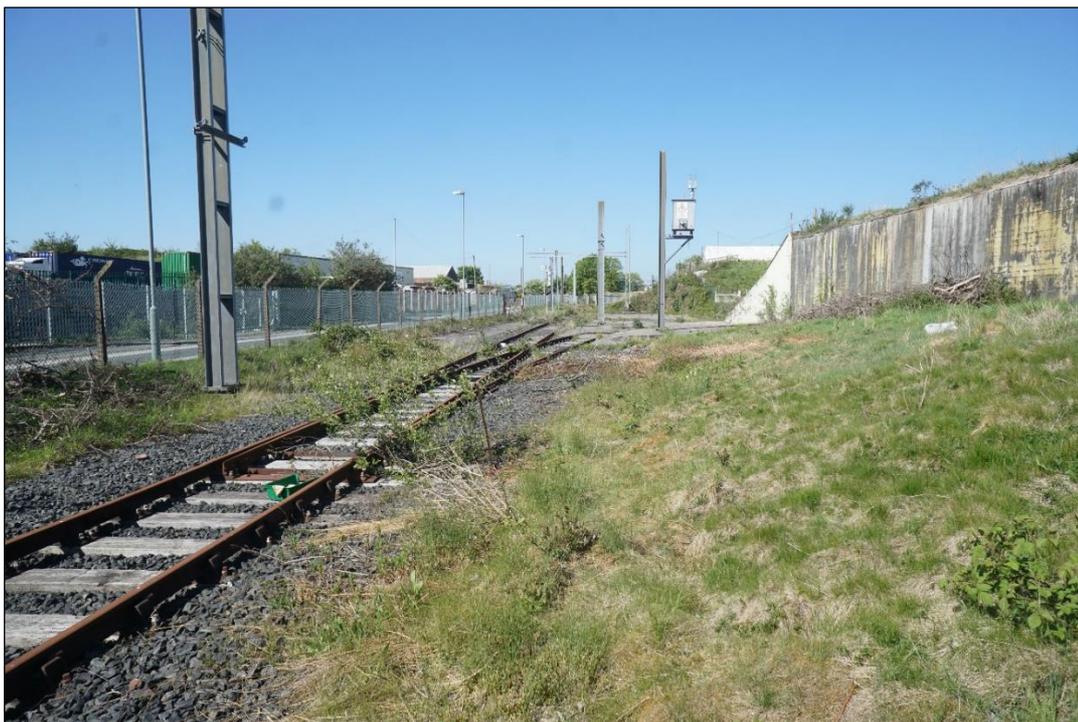
- 4.7.1 In addition to the portions identified within the loading bays, substantial elements of the railway tracks were observed to the west of Bunker's 9/3 and 9/5, with the latter preserving a siding, that branched away from the main track in a north-easterly direction (Plate 54). The rails were of standard gauge and attached to timber sleepers via chairs using square-headed bolts bearing the letter S on their tops. The rails were affixed to each other using fish plates and the stone chippings forming the track ballast remained. A tall steel lever survived to operate the points where the siding divided from the main line to the west of Bunker 9/5 (Plate 55).

Plate 54: Railway line to the west of Bunker 9/5, showing the main transit line and siding to the north-east

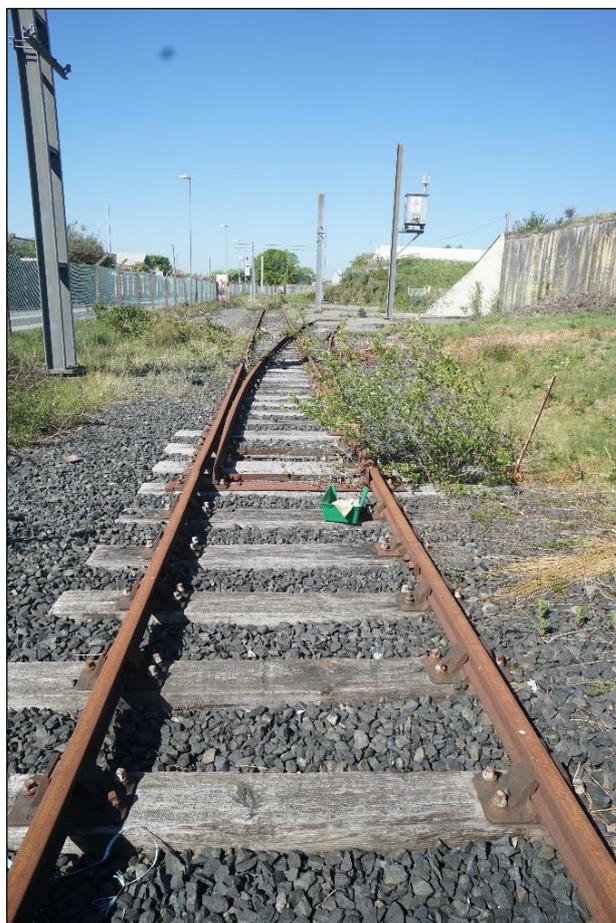
Plate 55: Looking north along the track, with the lever operating the points to the right of the frame
