Magdalen College Winter Common Room Archaeological Watching Brief Report

December 2020

Client: Magdalen College, Oxford

OA Reference No: JN7306

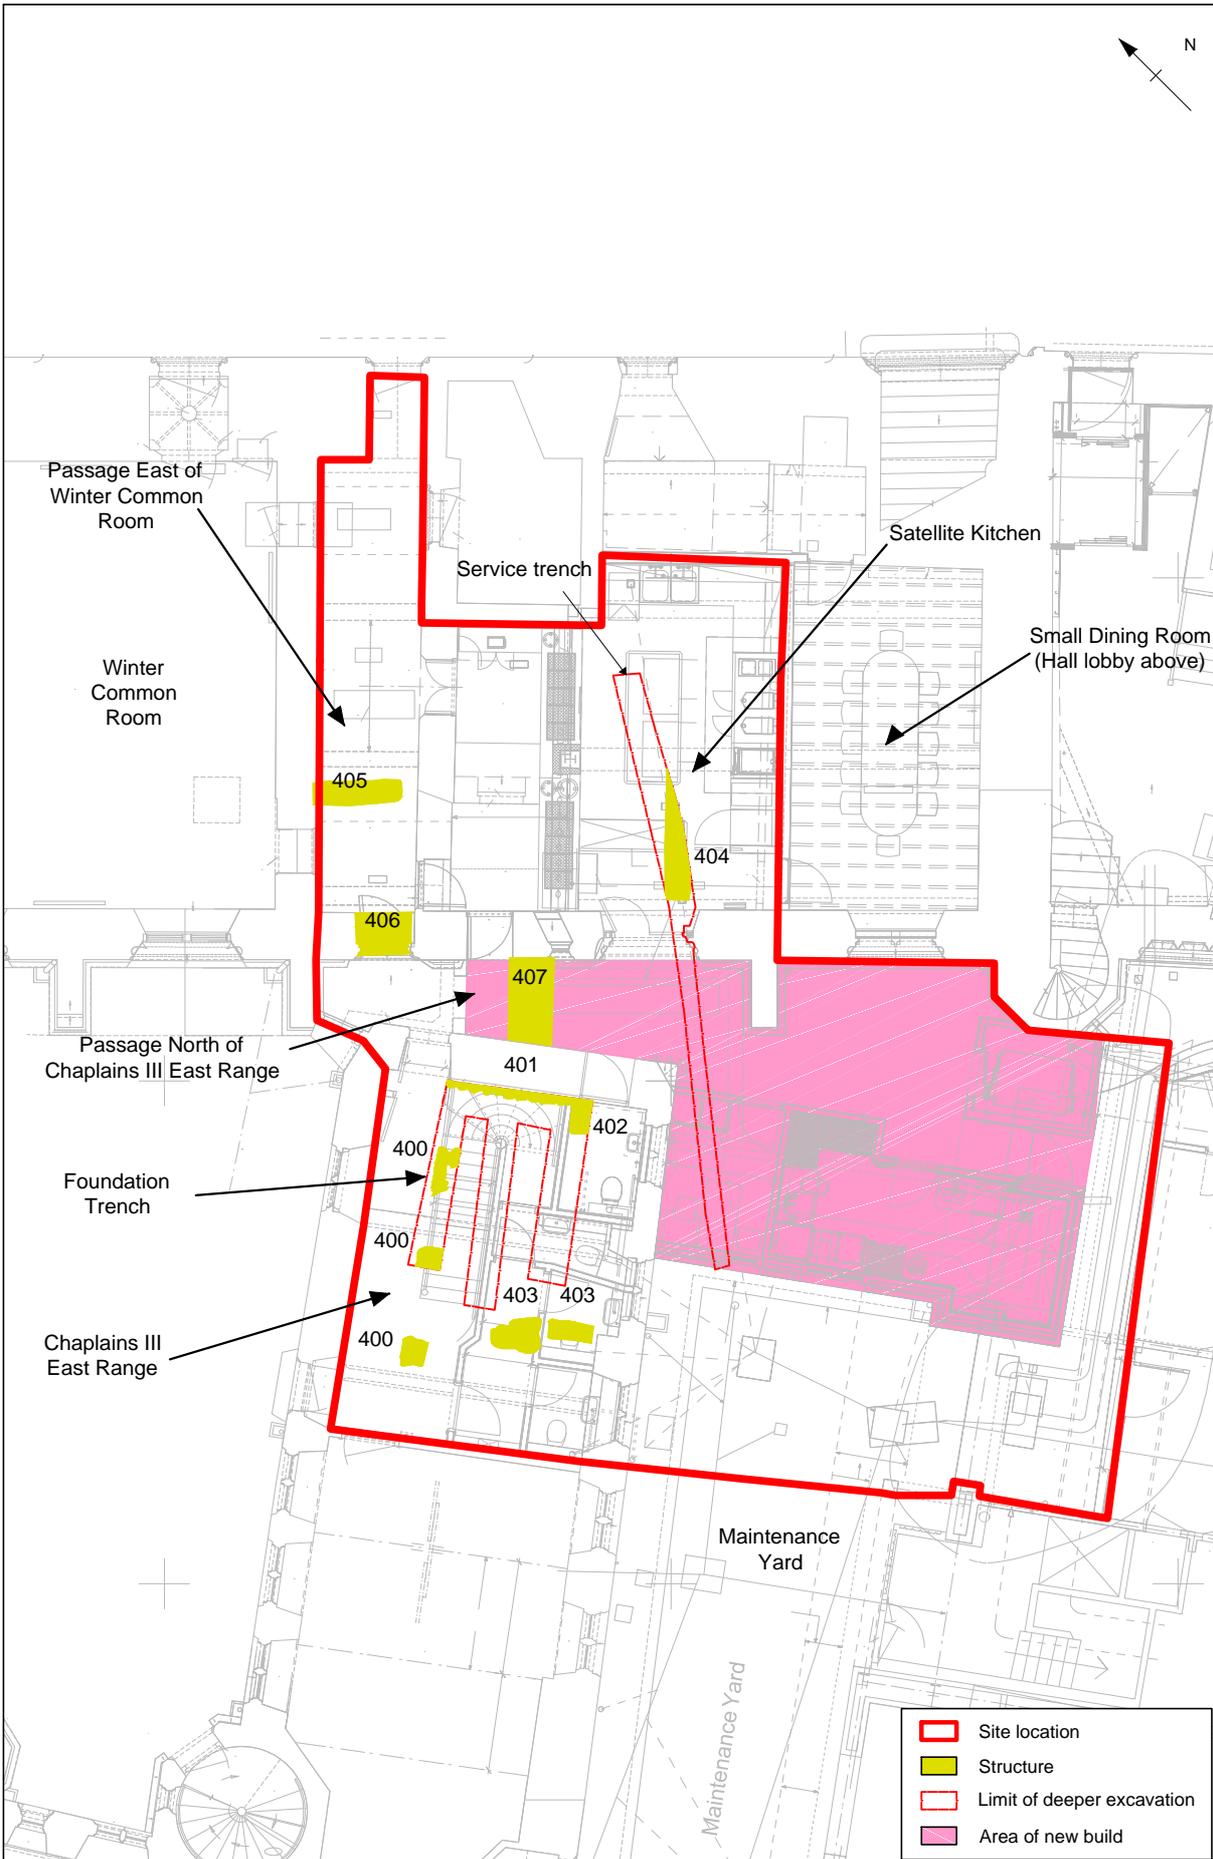
Figure 2: Plan showing archaeology found

3.3.1 Archaeological remains of former stone, and stone and brick, structures were identified in the Chaplains III East Range, the Satellite Kitchen, the passage east of the Winter Common Room and the passage between the Chaplain's III East Range and the Satellite Kitchen. Homogenous humic soils were observed in the Maintenance Yard.

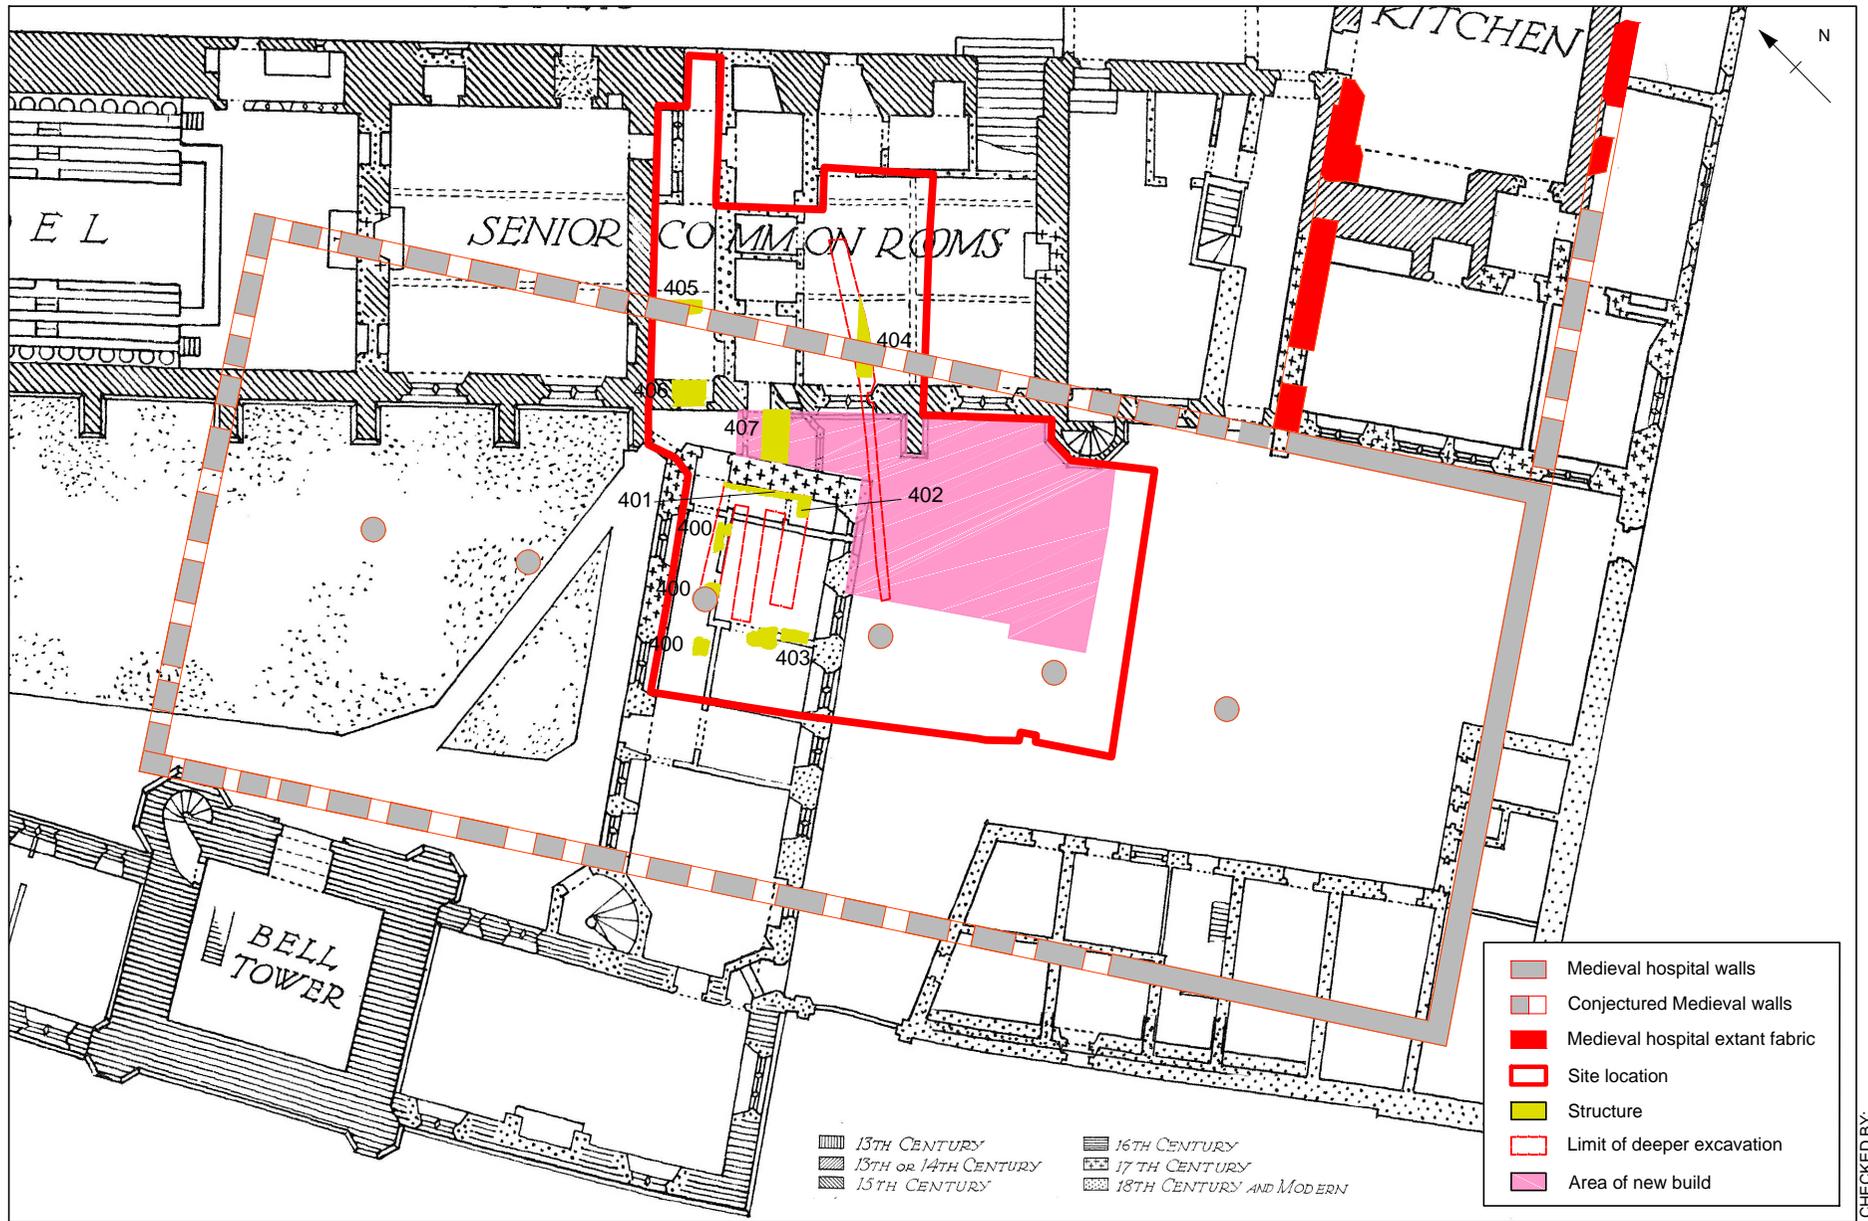
Figure 3: RCHME dated plan of Magdalen College (1939) with projected 13th Century hospital footprint

- 1.3.3 During 1987 when Magdalen College rebuilt and reconfigured its kitchens significant archaeological remains that had been part of the Hospital of St John the Baptist were encountered (Durham, 1991). Evidence included substantial remains of the eastern end of the Infirmary and an adjacent hall located in the south-east corner (these remains and their conjectured extent are shown on Fig.3).

- 1.3.5 Works started on the construction of The Great Tower in 1492 and were completed in 1509 (RCHME 1939), with the bells and clocks installed in 1505. It is also during this period that the completion of a set of buildings to the east of the tower, now known as the Chaplain's III East Range, was completed to connect the tower with existing buildings. During the 17th and 18th century these buildings were redeveloped with the northern most limits of this range being a 17th century addition to the earlier 16th century building (RCHME 1939). The redevelopment of this range and dates of the college buildings are shown on Figure 3.

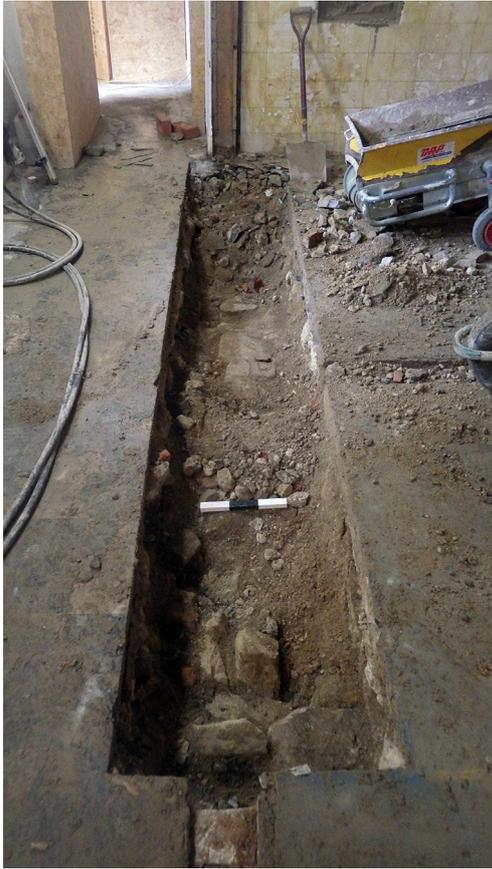
Plate 1: Wall 400, looking north

3.5.2 Wall 400 (Fig. 2, Plate 1) was a foundation three courses high, two courses of west facing dressed limestone blocks with a single course of unfrogged red brick on top. The wall measured a total of 2.70m by 0.35m by 0.40m and was bonded with a yellowish white mortar. It was encountered 0.37m below ground level (bgl) at a height of 57.30m aOD.

4.3.2 Within the Chaplain's III East Range, foundations 400 and 403 appeared to be on the same alignment as the suggested footprint of the medieval Infirmary, although without any further evidence it is difficult to ascribe them to that phase of construction. However, it should be noted that during the archaeological investigations in 1987 the medieval floors relating to the hospital were recorded at depths between 56m to 56.60m aOD (Durham 1991) and foundations 400 and 403 were recorded at depths between 57.30m and 57.32m aOD. Thus, the level of which these walls were encountered suggests they are much later in date and perhaps relate to the original phase of constructions of the Chaplains III East Range during the late 15th and early 16th centuries.

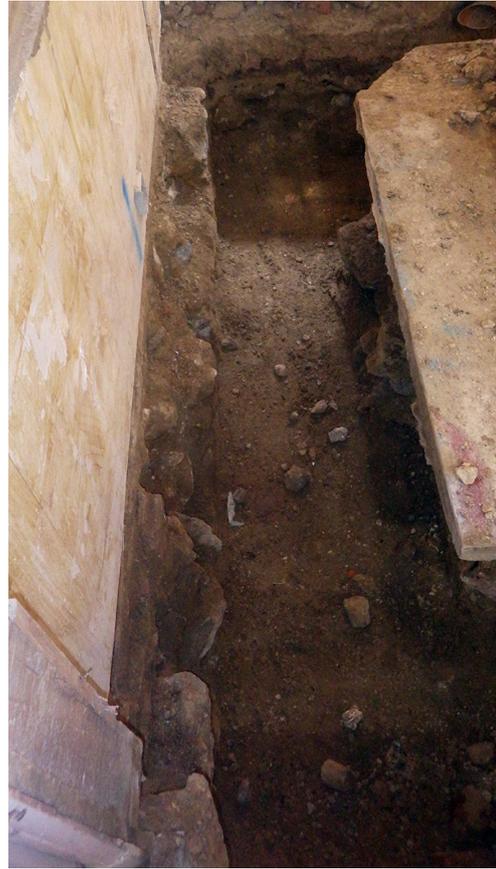
Plate 2: Wall foundations 401 and 402, looking east

3.5.3 Structure 401 (Fig. 2, Plate 2) is the offset foundation for the existing north wall of the Chaplain's III East Range. Only the south side was exposed and so it is not possible to give exact dimensions, but the exposed five courses of masonry measured 3m east – west and was offset by 0.15m from the south face of the upstanding wall. It was constructed from roughly faced limestone blocks, bonded with yellowish white mortar. It was encountered at a height of 57.30m aOD.

- 3.5.4 Foundation 402 was exposed at the eastern end of foundation 401 (Fig. 2, Plate 2) but was only visible in plan at the base of the trench at a height of 56.92m aOD. It measured a total of 0.50m x 0.40m and was aligned roughly north – south. It was constructed using roughly squared limestone blocks bonded with mortar and is suspected to be part of the foundations for the standing building.

4.3.3 Structure 401 and probably 402, are the offset foundation to an extant north wall which is part of a 17th century addition to the Chaplain's III Range (Fig.3, RCHME 1939). The remaining structures identified within the Chaplain's III East Range were

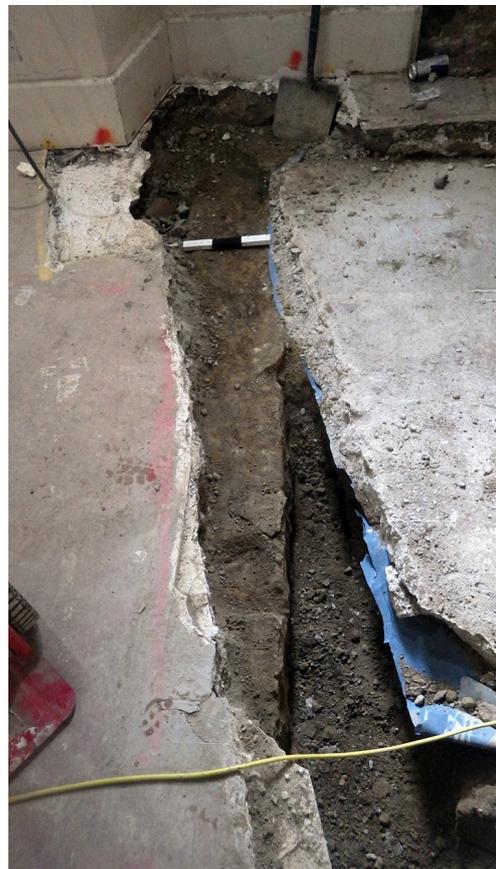
Plate 4: Wall 404, looking north

- 3.6.1 The drainage run within the Satellite Kitchen exposed wall foundation 404 (Figs. 2 and 3, Plate 4). The north-south aligned structure was built using roughly squared limestone blocks with a yellow lime mortar and measured 2.10m in length, 0.35m in width and survived to a height of 0.28m (two courses). It was also faced on its western side.
- 3.6.2 Foundation 404 was exposed below the concrete slab, 0.20m bgl at a height of 57.19m aOD. This foundation crosses the line of the projected infirmary footprint (Fig. 3) and so is unlikely to be related to that structure if the projection is accurate; therefore, it is more likely to be a previous internal division.

4.3.4 Wall foundations 404 and 405 were also internal divisions within the proposed Satellite Kitchen and the passage east of the Winter Common Room, respectively. Whilst these structures are projected along and over the line of the medieval infirmary's north wall, they are on different alignment to Durham's projection. It is also evident that within this area of the college the internal nature of the building was subjected to redevelopment during the 18th century and it is most likely that walls 404 and 405 relate to the 18th century redevelopment (Fig.3).

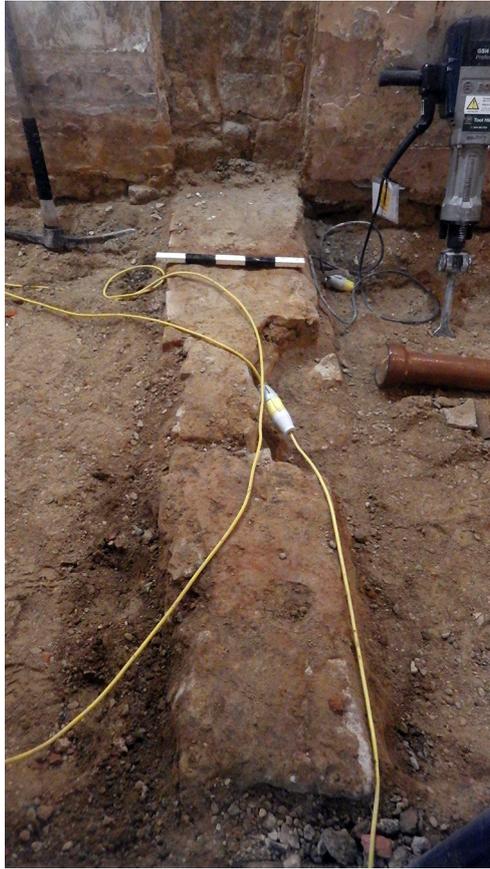
Plate 5: Wall 405, looking west

- 3.7.1 There were two foundations (walls 405 and 406) exposed within the passage east of the Winter Common Room (Figs. 2 and 3, Plates 5 and 6).
- 3.7.2 Foundation 405 was aligned E-W and constructed using squared limestone blocks, bricks, and a yellow mortar. It had two faces, north and south, and measured 2.07m in length by 0.46m in width and 0.24m in height, surviving immediately below the floor slab, at a height of 57.49m aOD; however, a scar in the plaster work suggests that part of it had survived to a greater height and was only reduced quite recently. The foundation also butts against the upstanding north – south walls. Figure 3 also shows that it is close to the projected line of the infirmary footprint, although observations regarding its relationship and association with extant features strongly suggests that this cannot be a remnant of that structure and is probably an old internal division of the passage.

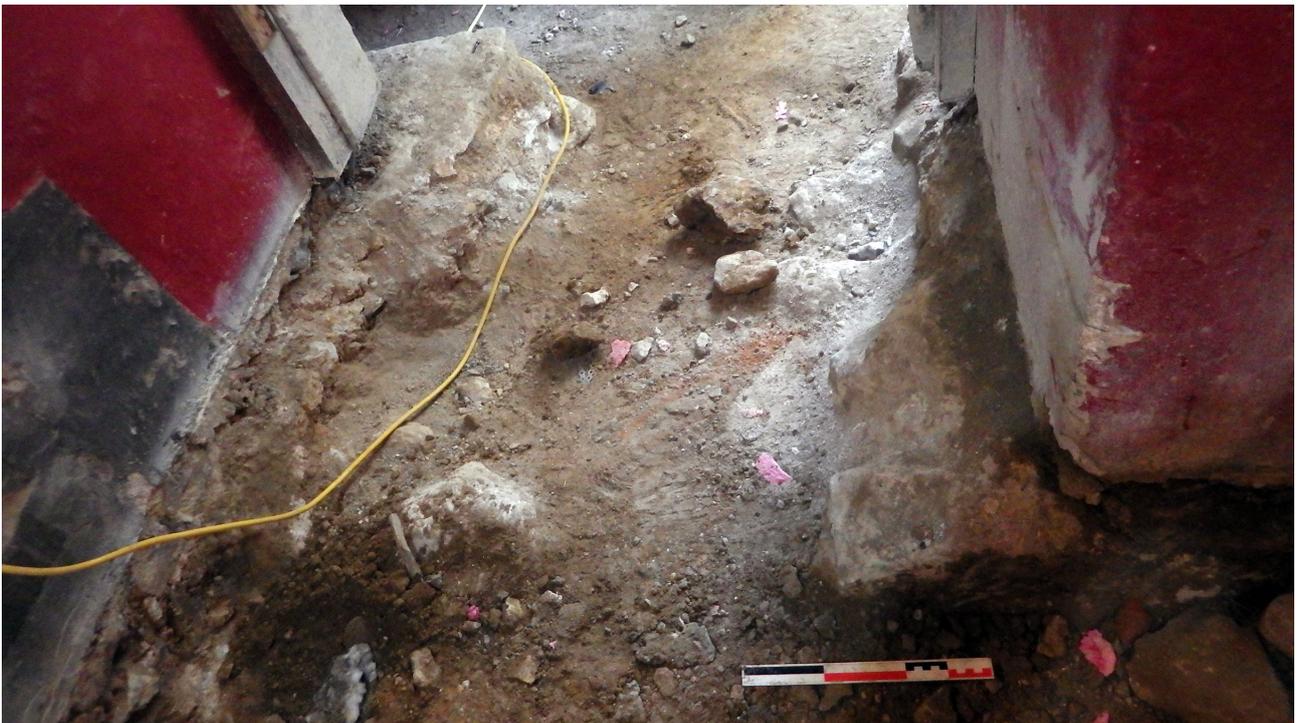
Plate 6: Wall foundation 406, looking south

- 3.7.3 The second foundation exposed in this passage was wall 406 (Figs. 2 and 3, Plate 6). This was aligned east – west and made from squared limestone blocks faced on the north and south sides, with a yellow mortar. It measured 1.05m in length, 1.23m in width and 0.15m in height. It was located directly below the concrete floor at a height

of 57.51m aOD It is quite clear that this is the remnant foundation of the south wall of the passage which had a doorway inserted through it.

4.3.5 Foundation 406 and buttress foundation 407 were both part of the external south wall of the southern cloister range of the Great Quad, which was constructed between 1474 and 1484. Both walls were modified at some point during either the 17th or 18th centuries as part of the redevelopment of the college for new access routes (Fig.3).

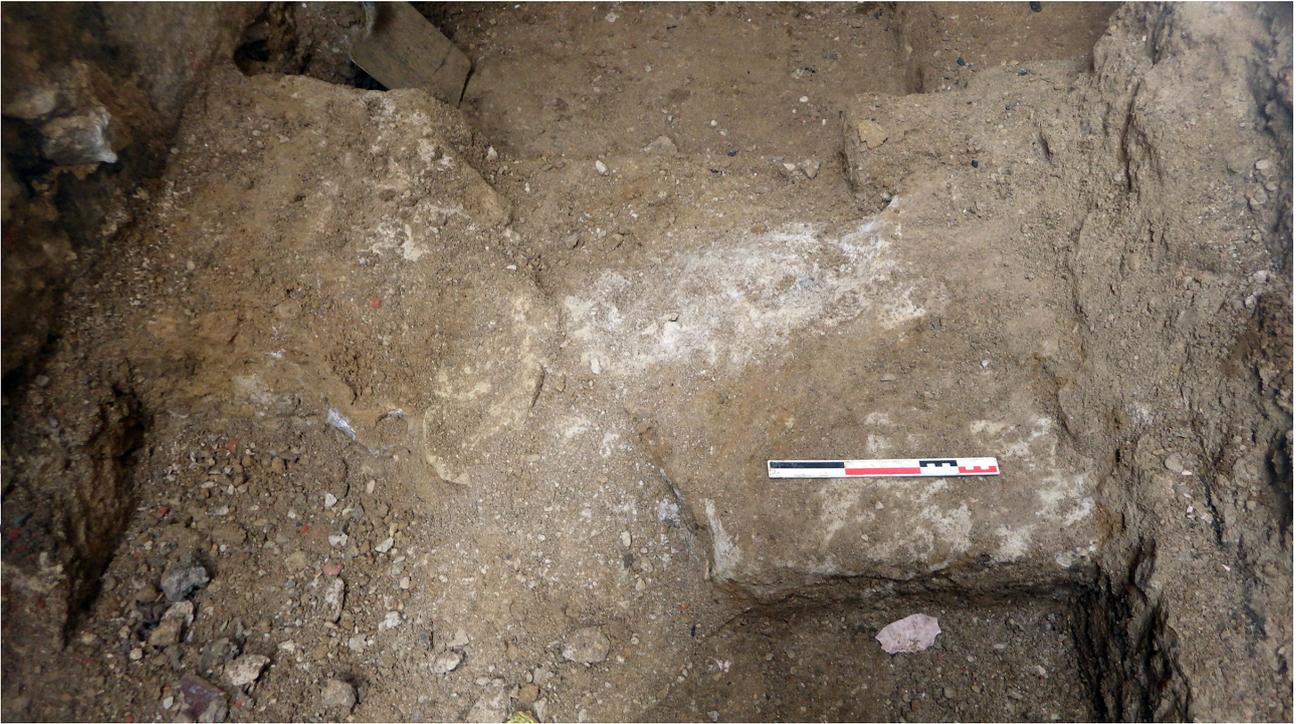
Plate 7: Butters foundation 407, looking west

3.8.1 Within the passage north of the Chaplain's III east range, a single foundation (wall 407) was uncovered (Figs 2 and 3, Plates 7 and 8) immediately below the concrete slab, at a height of 57.55m aOD. This north-south aligned foundation was made from roughly squared and faced limestone blocks with a white mortar. It measured 1.50m in length, 0.90m in width and 0.24m in height. The foundation is the remnants of a buttress that still survives from the first-floor level (Plate 8), which had a doorway put through it to create a passageway along the south side of the Satellite Kitchen's south wall.
