Pembroke College New Library Project Oxford

Historic Building Investigation and Recording

March 2019

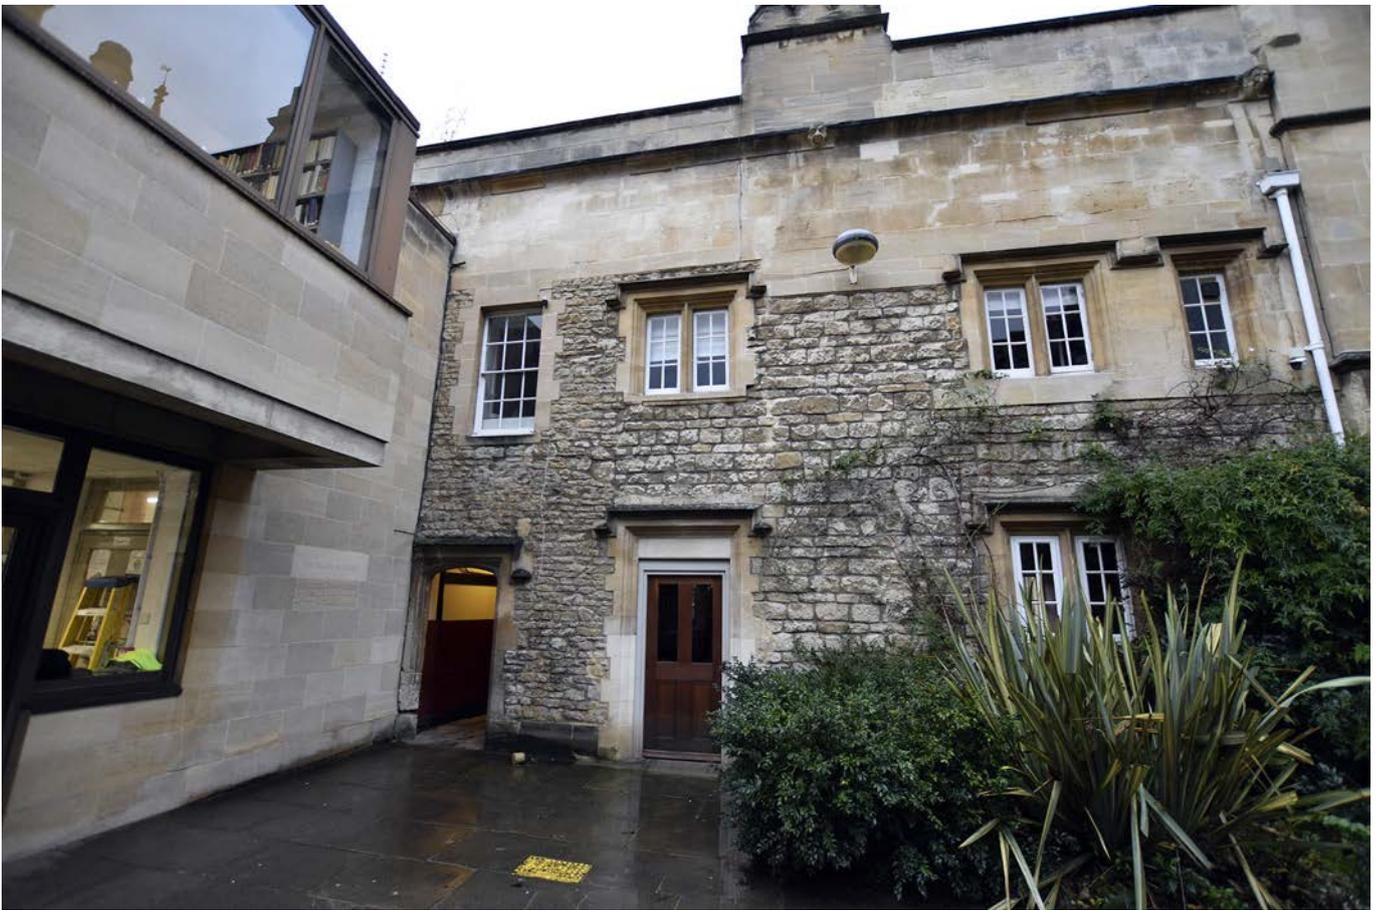
Plate 1: East elevation of East Range, McGowin Library to left

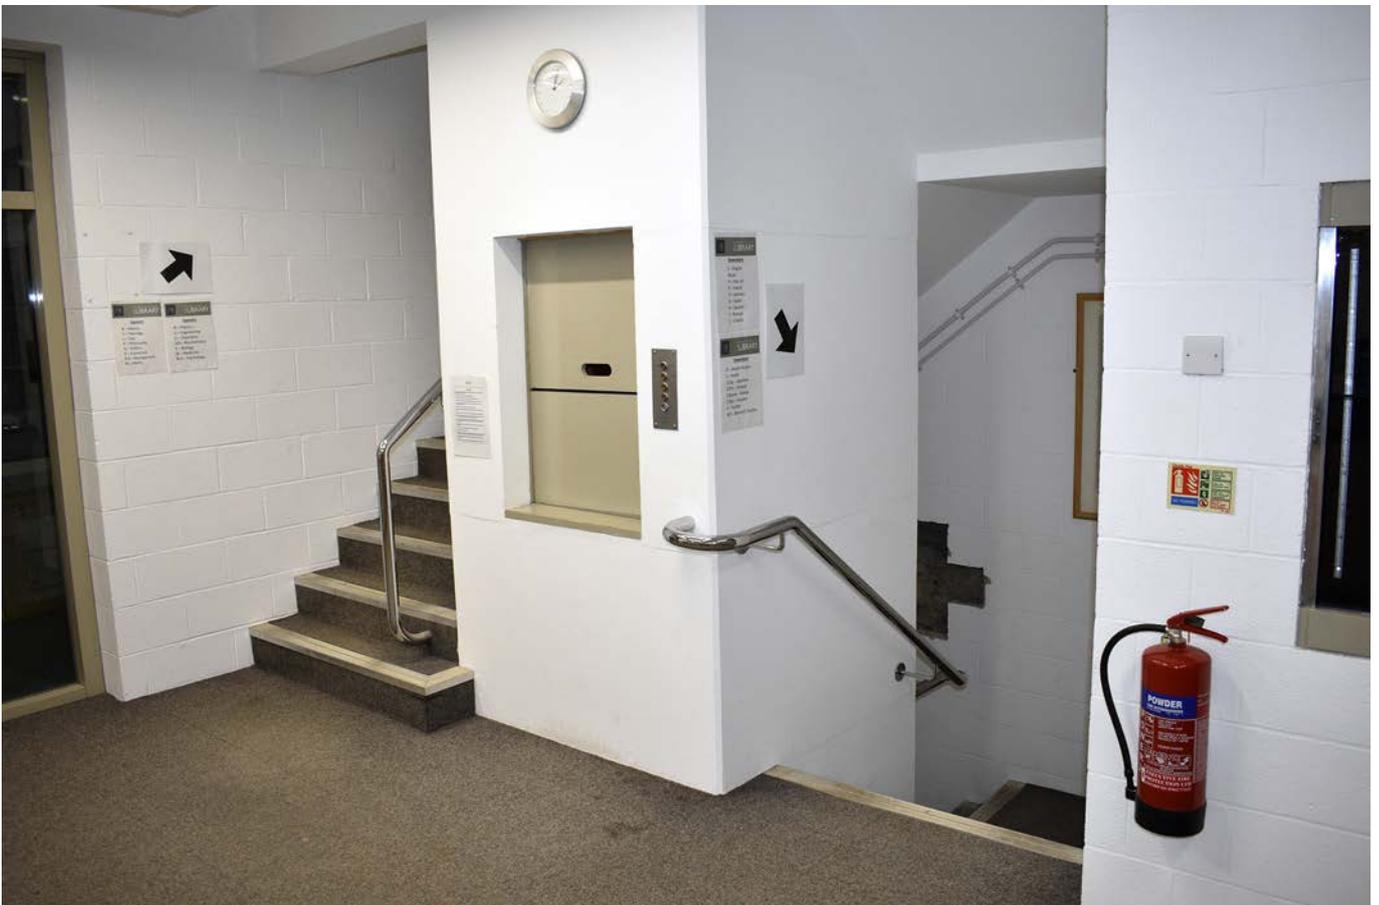
Plate 2: Stairs in library at Ground Floor, lower hole [A] in wall visible to lower landing

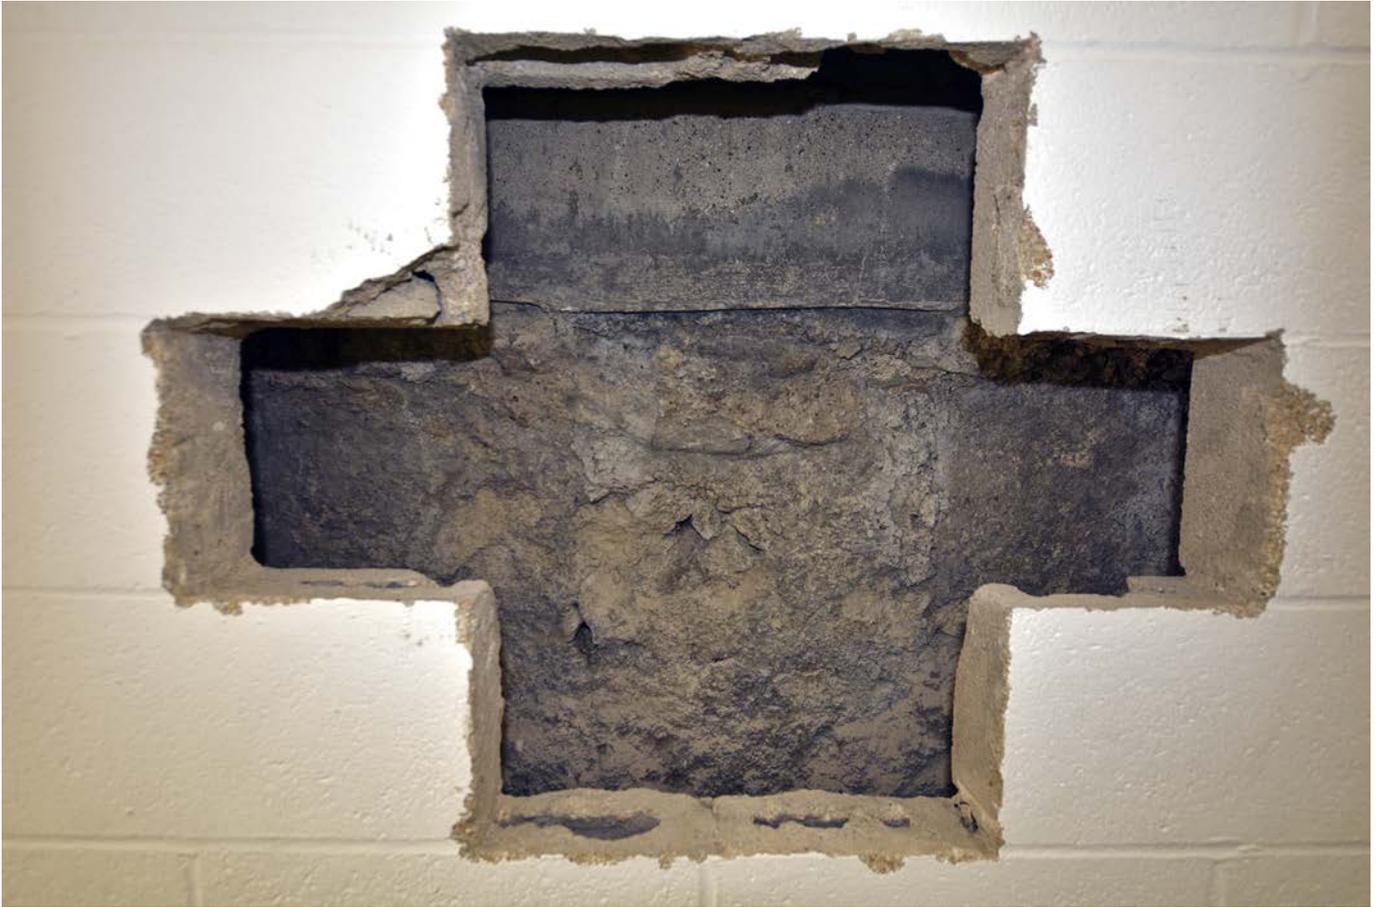
2.1.5 The lower opening [Hole A] exposed the concrete slab of the range behind at ground floor level and uncoursed stonework (generally rubble) below this although parts of the face were obscured by a lime mortar skim. Above the concrete slab the stonework was more regular, generally coursed non-dressed stone (various sized stones c.8-10 cm tall x c.30 cm tall) which could be seen to extend up to the sills of a pair of windows [Windows 1 & 2].

Plate 3: View in lower hole [A] in stairs, immediately below ground floor level

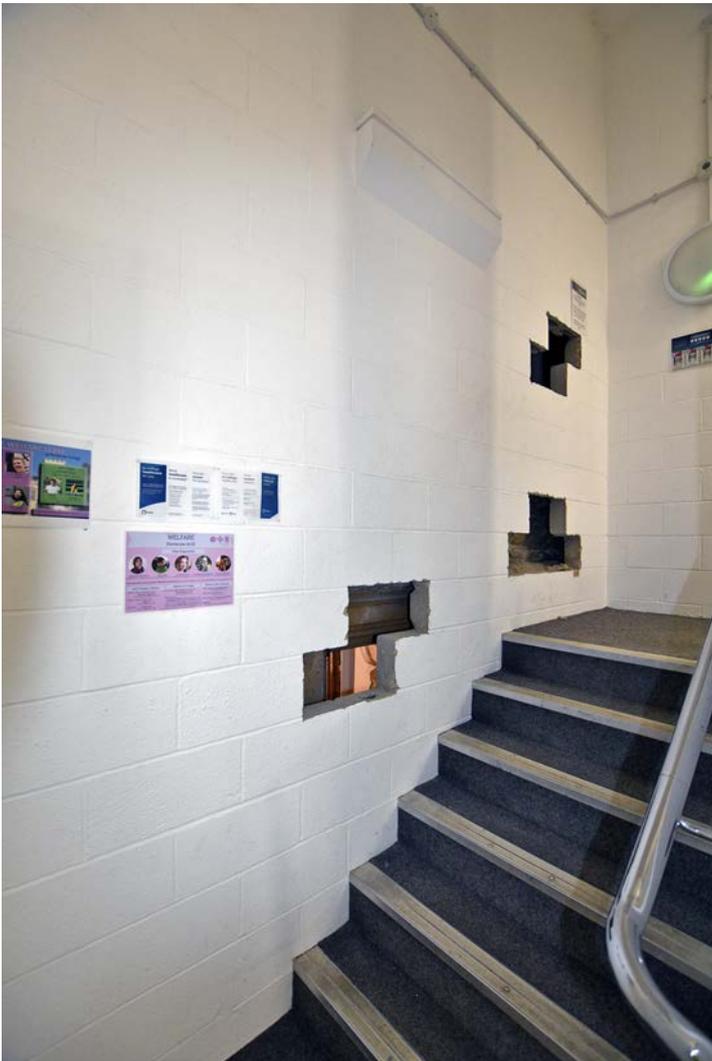
Plate 4: Stairs at landing above ground floor with 3 trial holes in wall [B, C, D]

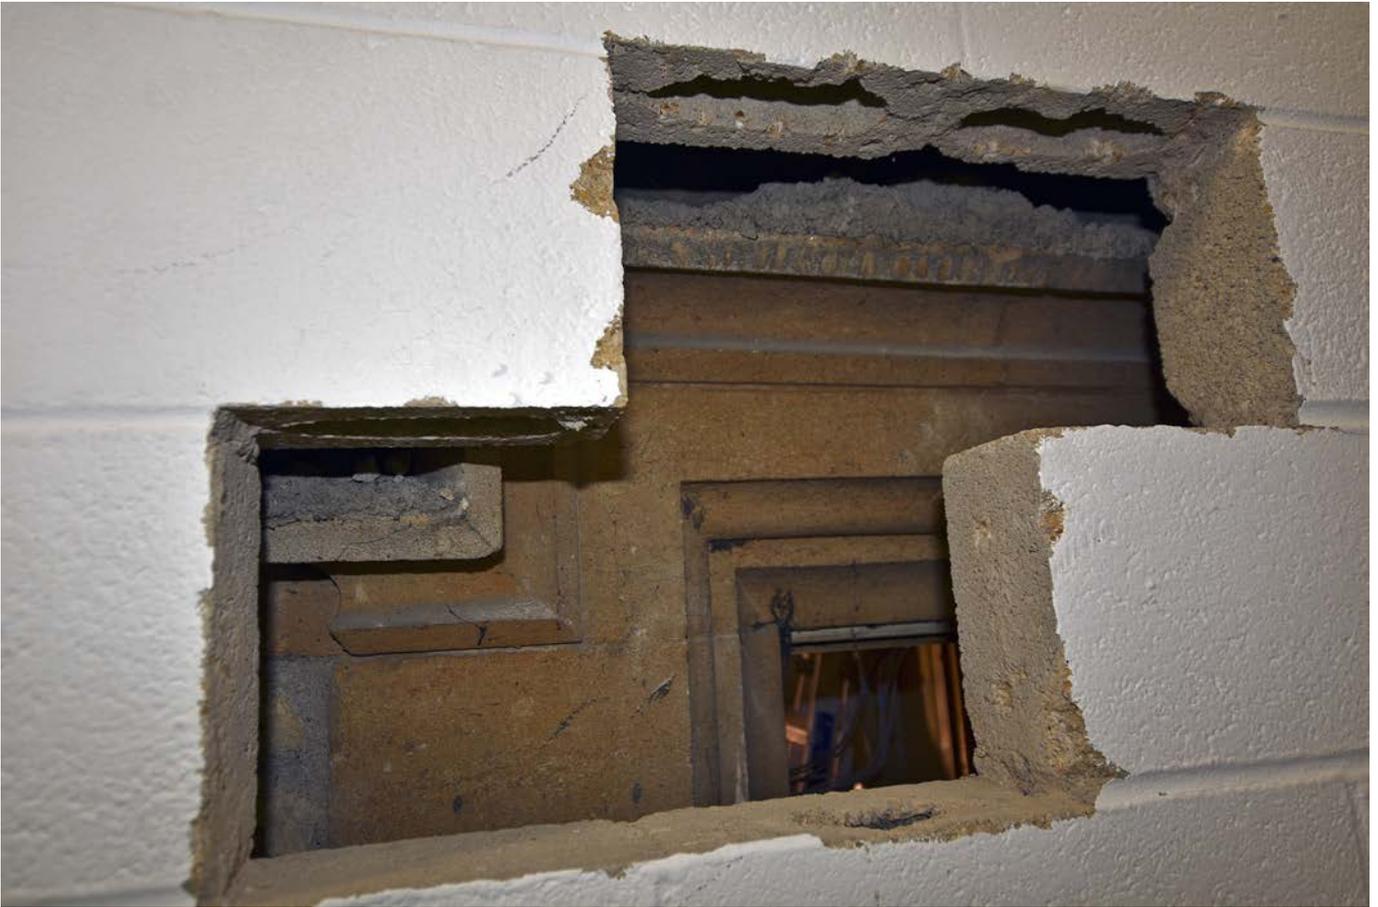
2.1.6 These ground floor windows were more clearly visible from the three holes [Holes B-D] opened adjacent to the landing above ground floor level and from here it could be seen that they comprised a pair of windows sharing a single hood mould and ashlar surround. The northern casement [Window 1] was largely covered over while the southern one [Window 2] had been removed. The mouldings and stonework was crisp and it seemed unlikely that they survived from the original 17th century construction of the range. As outlined above substantial works were undertaken in 1838 including refacing various ranges and it may well be that the window dates from this phase (or possibly even later repairs).

Plate 5: Window 2, exposed in trial hole [B] between ground and first floor

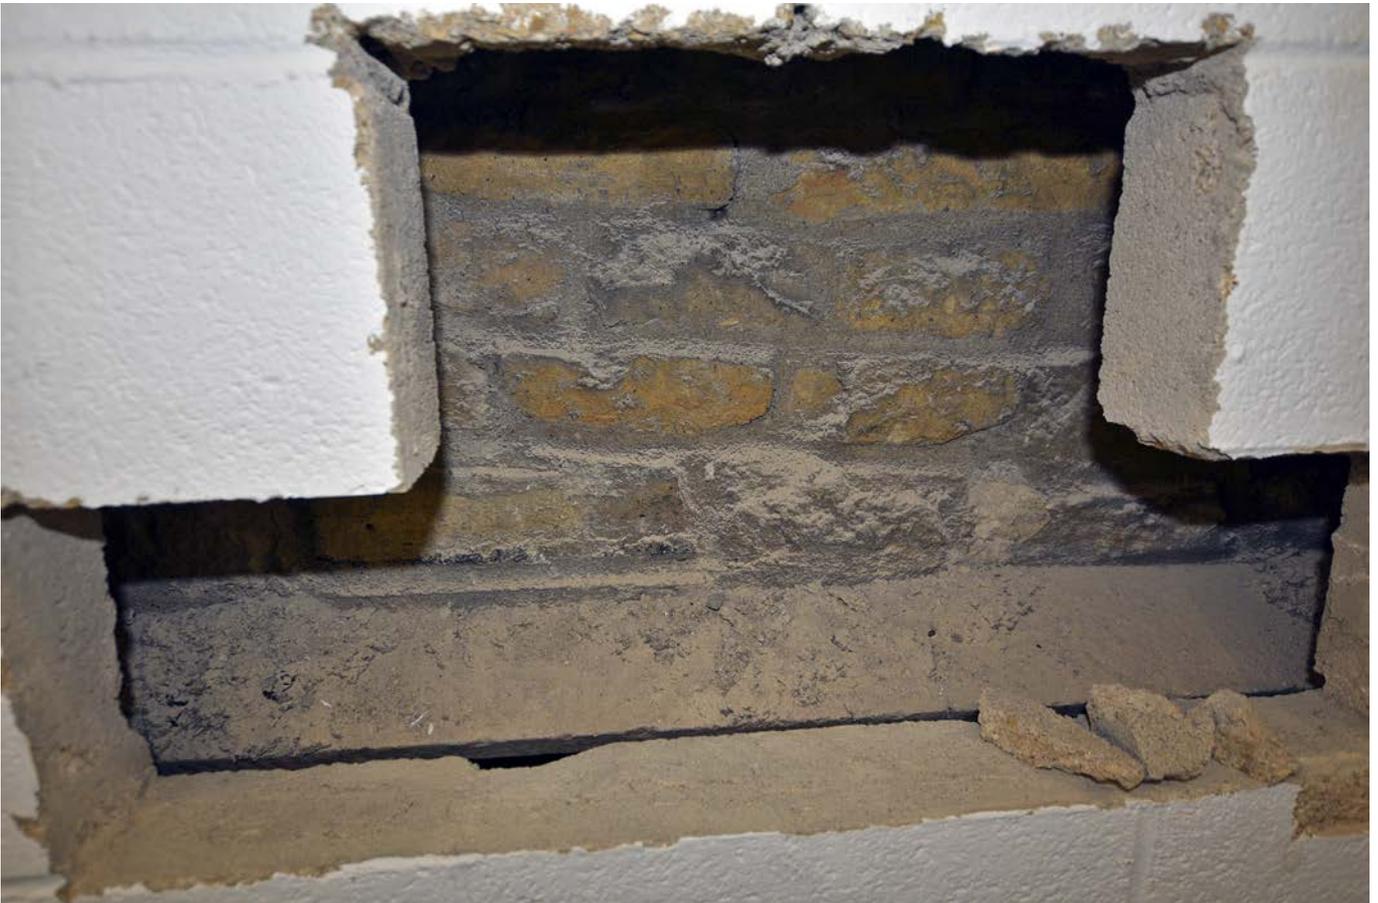
Plate 6: Lintel and wall above Window 1 exposed in hole C between ground and 1st floor

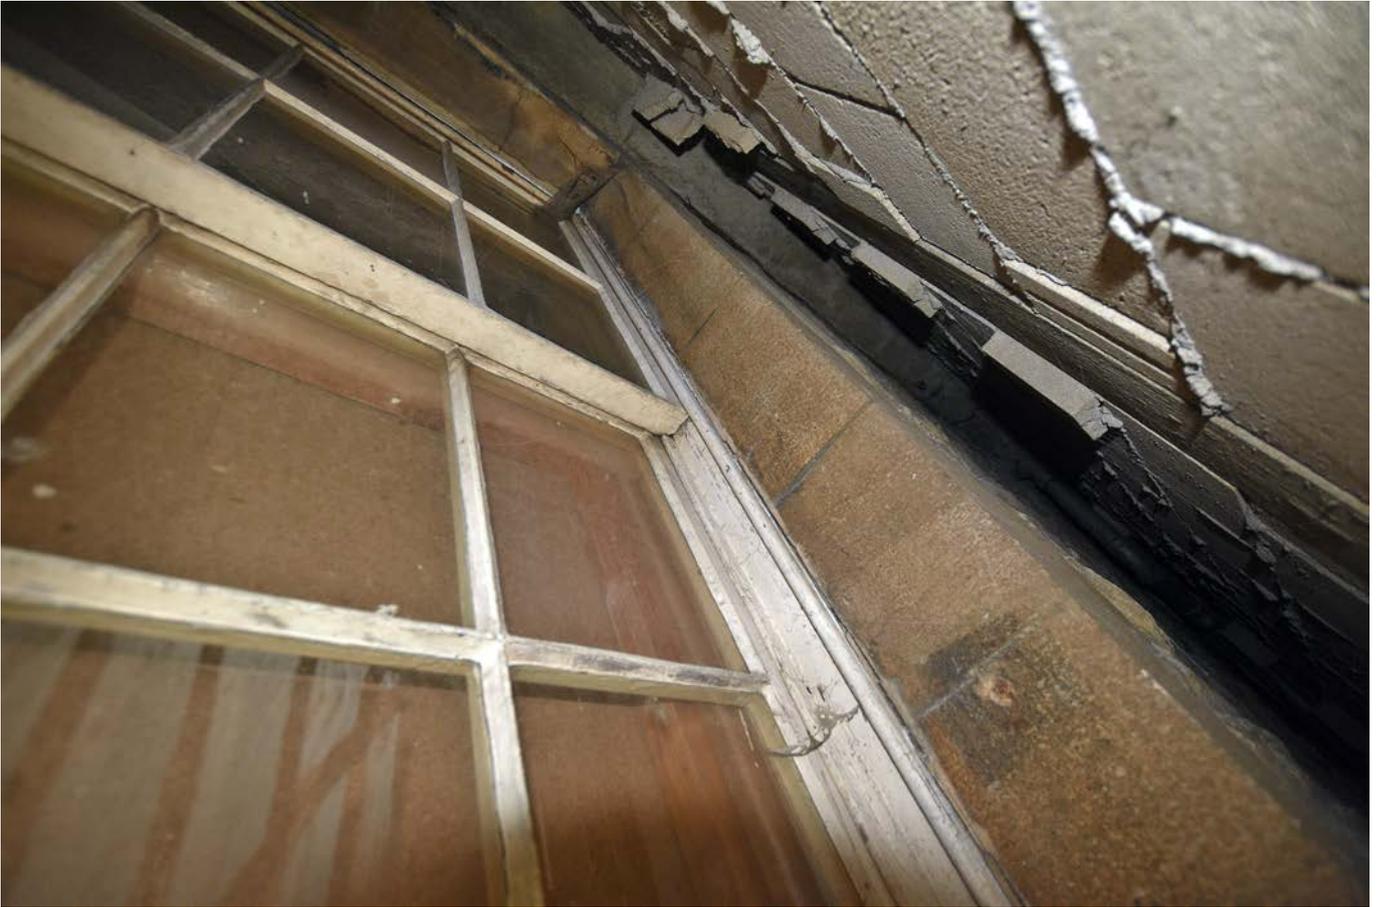
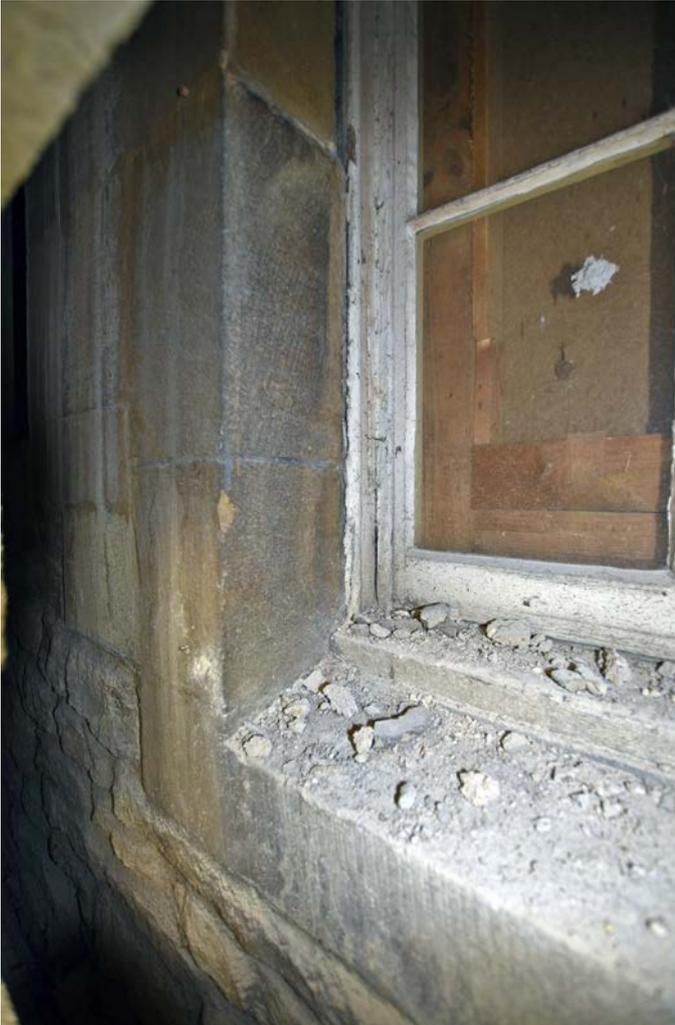
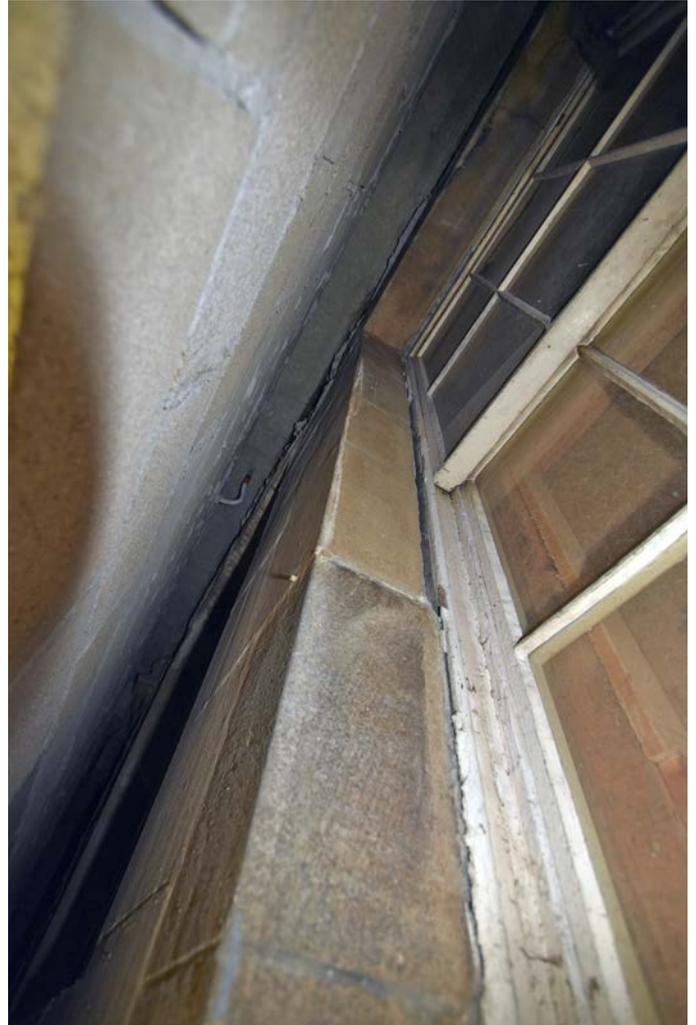
2.1.8 The highest of the three openings at the landing between ground and first floor exposed a first floor, 6-over-6 sash window [Window 4] with stone surround but no

hood mould. This is likely to be of 19th century date and a further two first floor windows could also be seen in the void towards the left (south). One of these was a 2-light mullion window [Window 5] without a hood (but with mouldings to jambs) while the more distant one had a [Window 6] hood mould but it was not possible to examine it closely.

Plate 7: Detail of Window 4 exposed in Hole D between ground and first floor

Plate 8: Detail of Window 4 exposed in Hole D between ground and first floor

Plate 9: Detail of Window 4 exposed in Hole D between ground and first floor

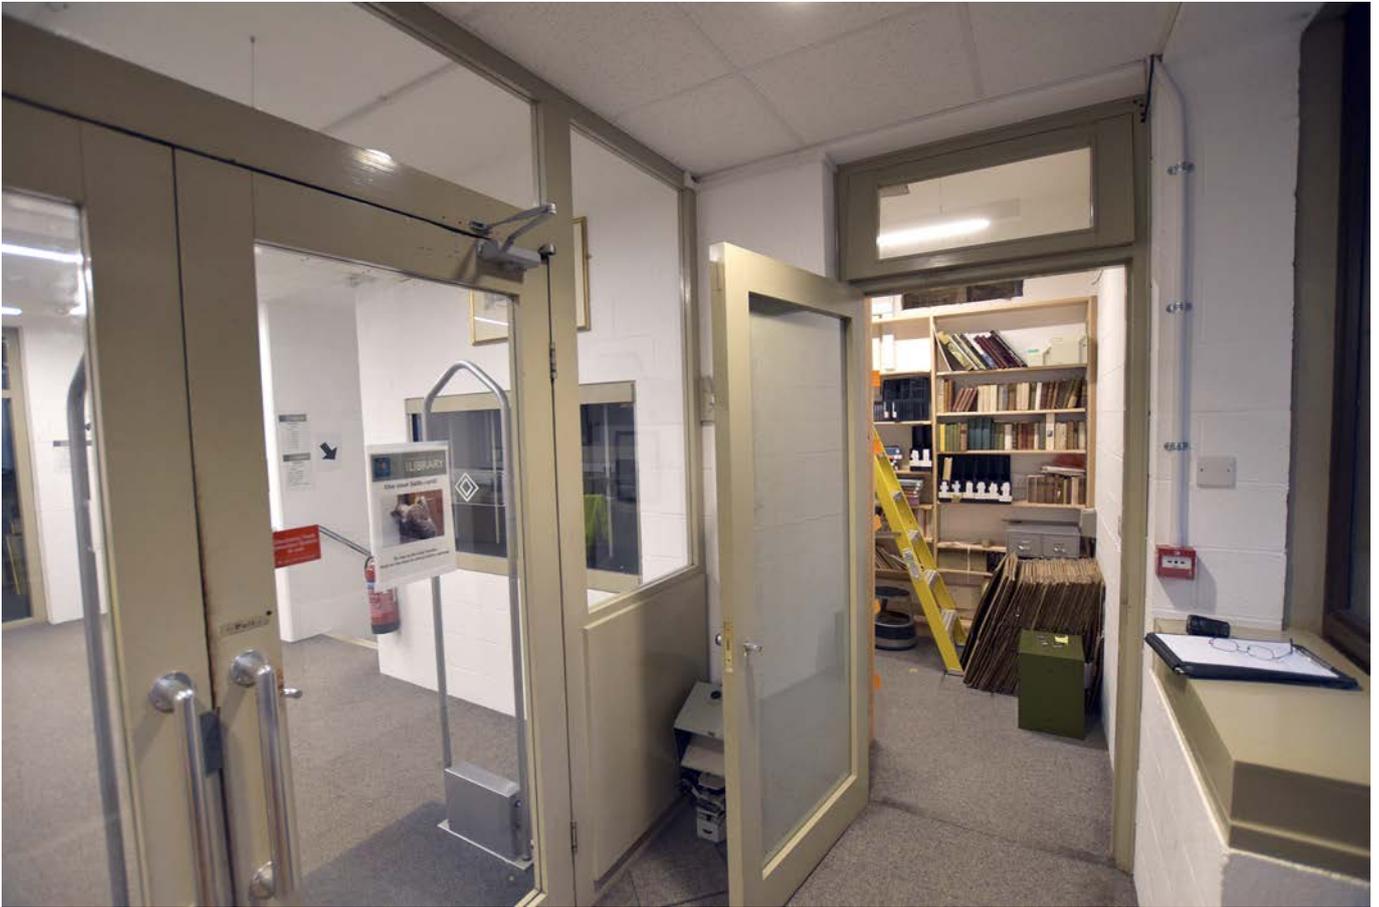
Plate 10: View into store room by library lobby with Hole E just visible above shelves

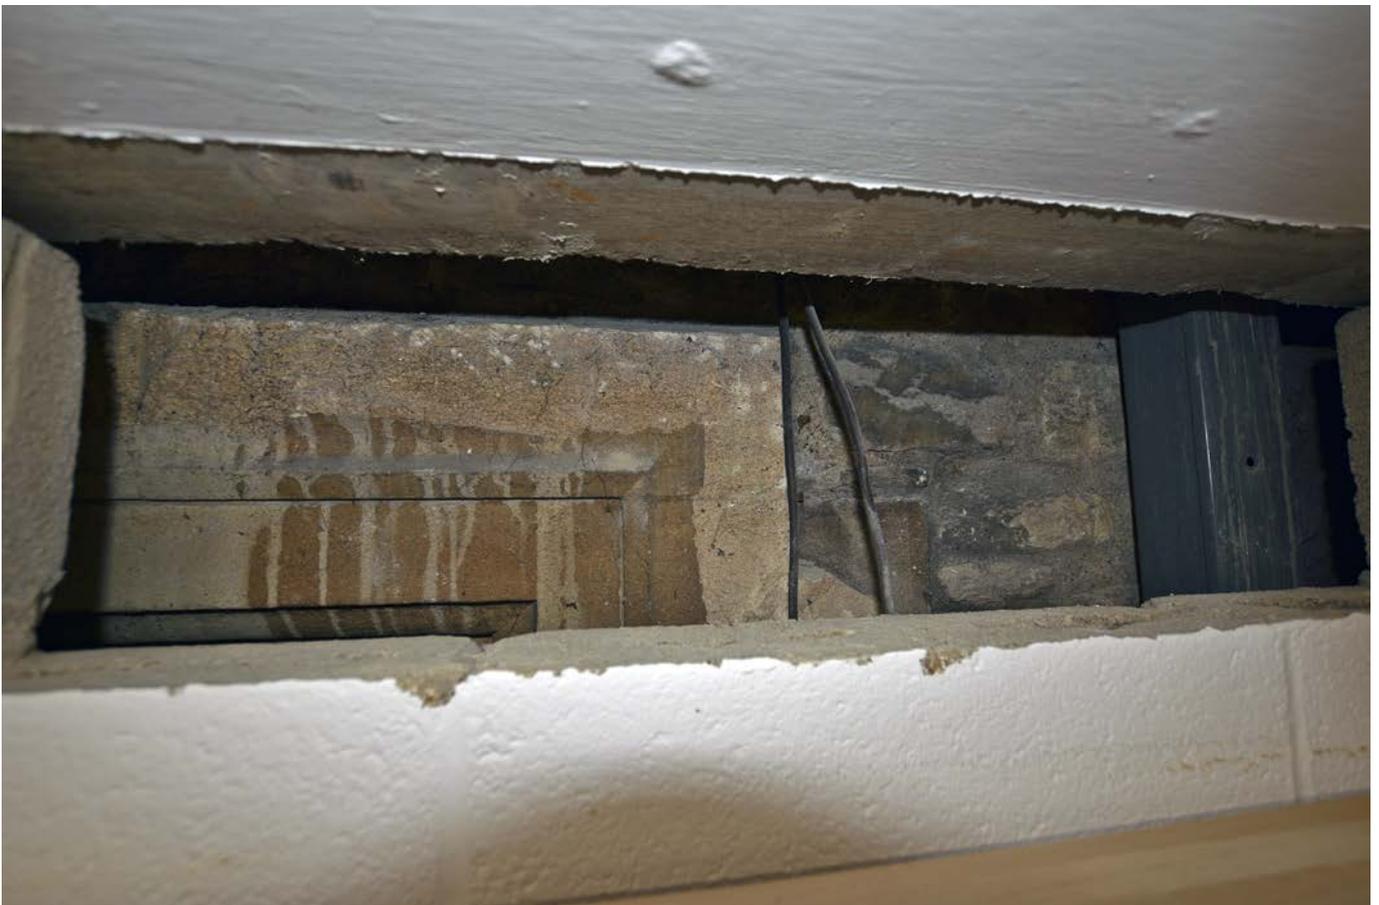
2.1.10 Immediately to the west of the main entrance lobby into the library, and to the north of the staircase, is a small storeroom and a further small opening was made in the west wall of this room. This opening was high in the wall, above a set of fixed shelves and it exposed a single-light (6 pane) window [Window 7] in the formerly external east wall of the east range. This would have been a short distance to the north of the other windows exposed in the stairwell and again it strongly appears to have been from a secondary phase (either 1838 re-facing or possibly later). The hood mould has been truncated and the glazing broken where a duct has been directed through.

Plate 11: Window 7 visible in Hole E with hood mouldings cut off

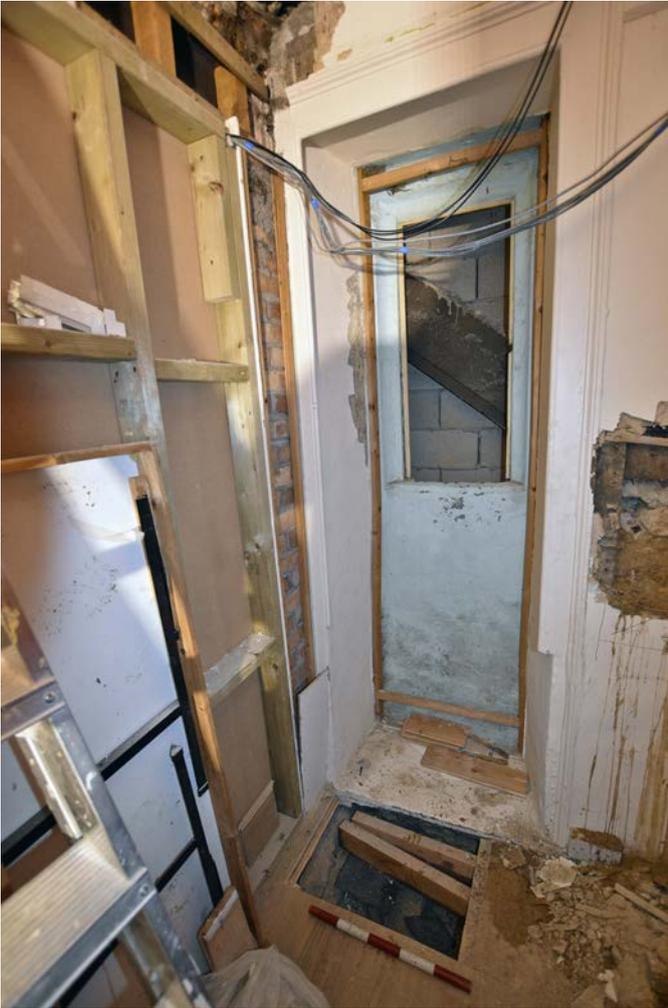
Plate 12: Narrow room to west of wall with various openings

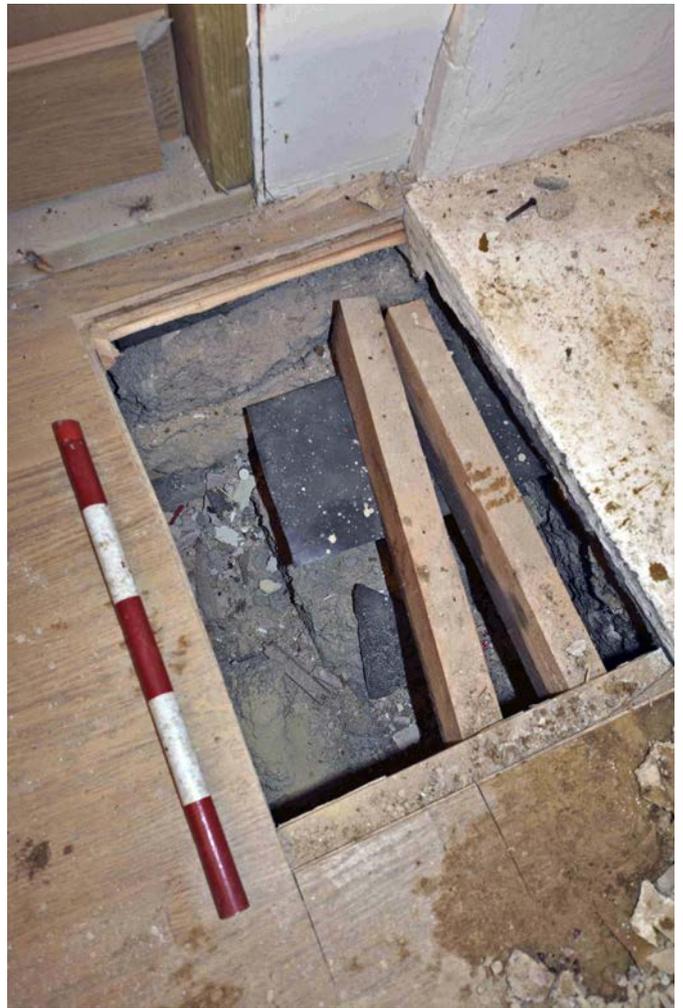
2.1.17 A 50 cm² hole was also made in the floor, adjacent to the window, by removing a section of the modern floorboards. No features of significance were exposed and the boarding was supported by modern joists.

Plate 13: Hole in floor to west side of wall

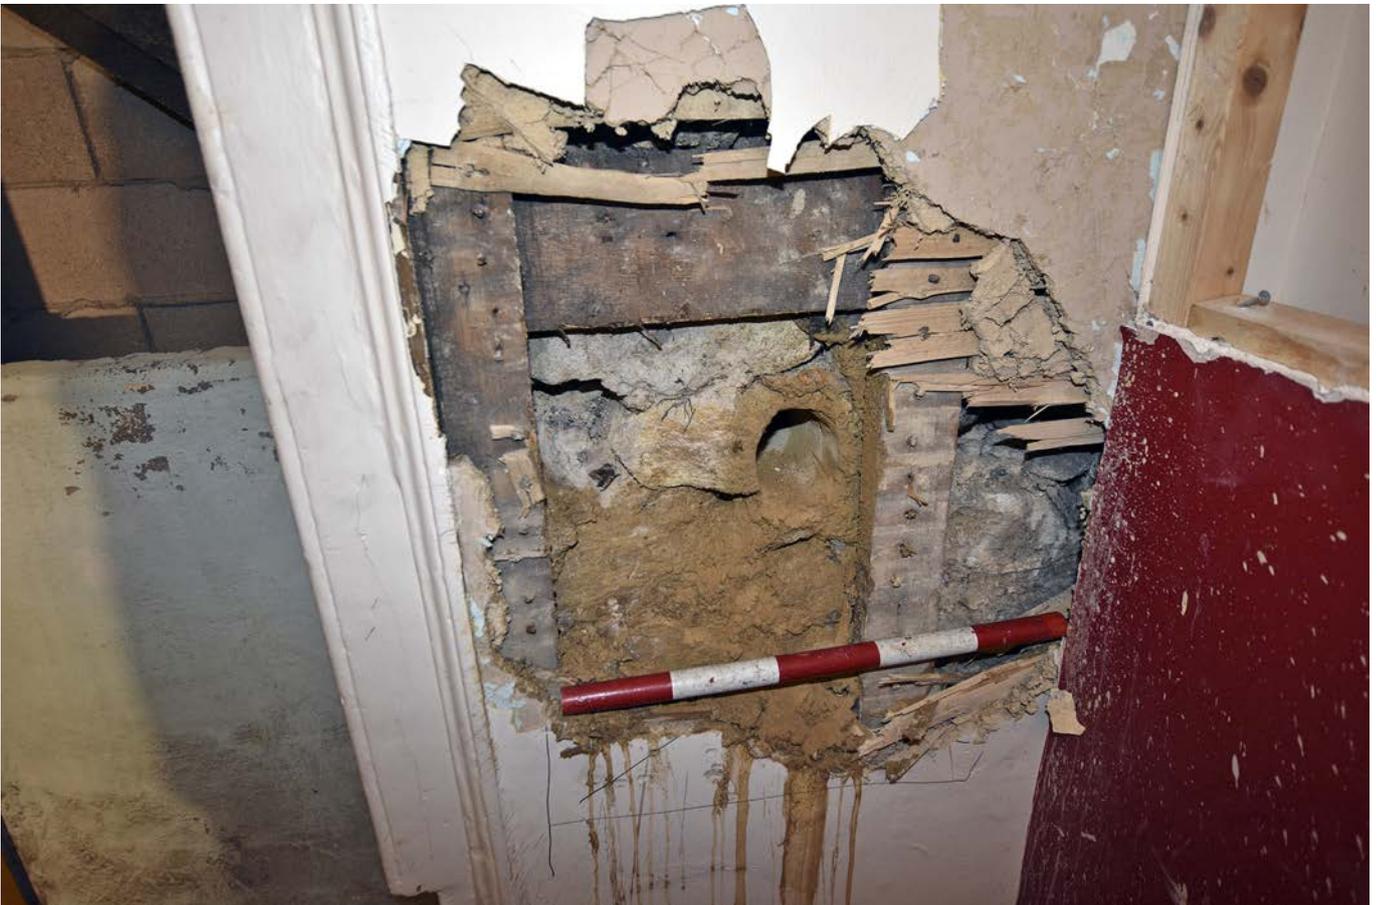
2.1.14 Immediately to the south of the window a c.50 x 50 cm hole was opened in the lath and plaster which covers the main wall and this exposed uncoursed stonework with the studs and plaster forming a type of dry lining on the stone. A core was also taken through the full wall within this area which confirmed that the wall was formed with very thick solid stone.

Plate 14: Hole in lath and plaster on west side of wall

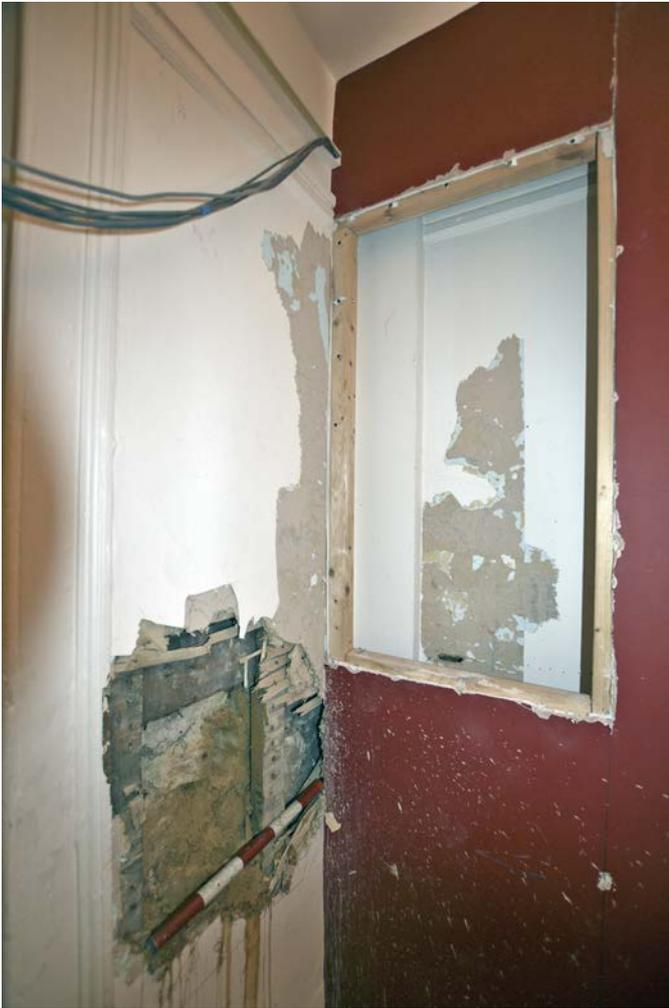
2.1.15 The east-to-west wall which formed the south side of the store room was clad in modern plasterboard and a section of this at the east end was removed in December 2018 to expose more plasterboard behind as well as a recess that may have been a former doorway towards the centre of this wall. This area has subsequently been investigated more fully (discussed further below).

Plate 15: Section of plasterboard removed from E-W wall on south side of narrow store

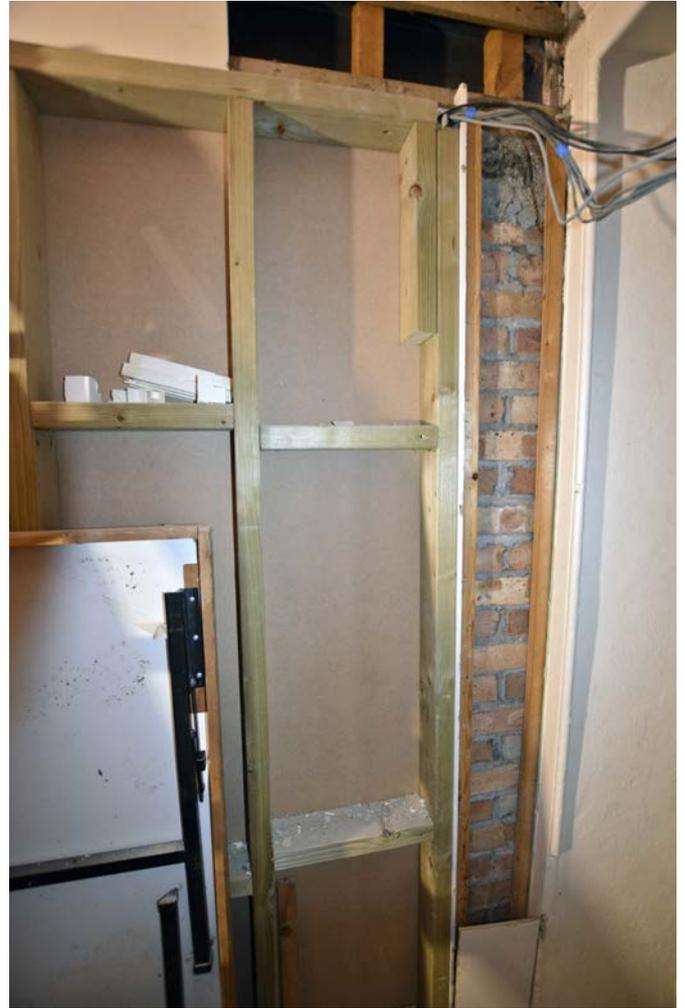
Plate 16: Exposed section of E-W wall on north side of narrow store room

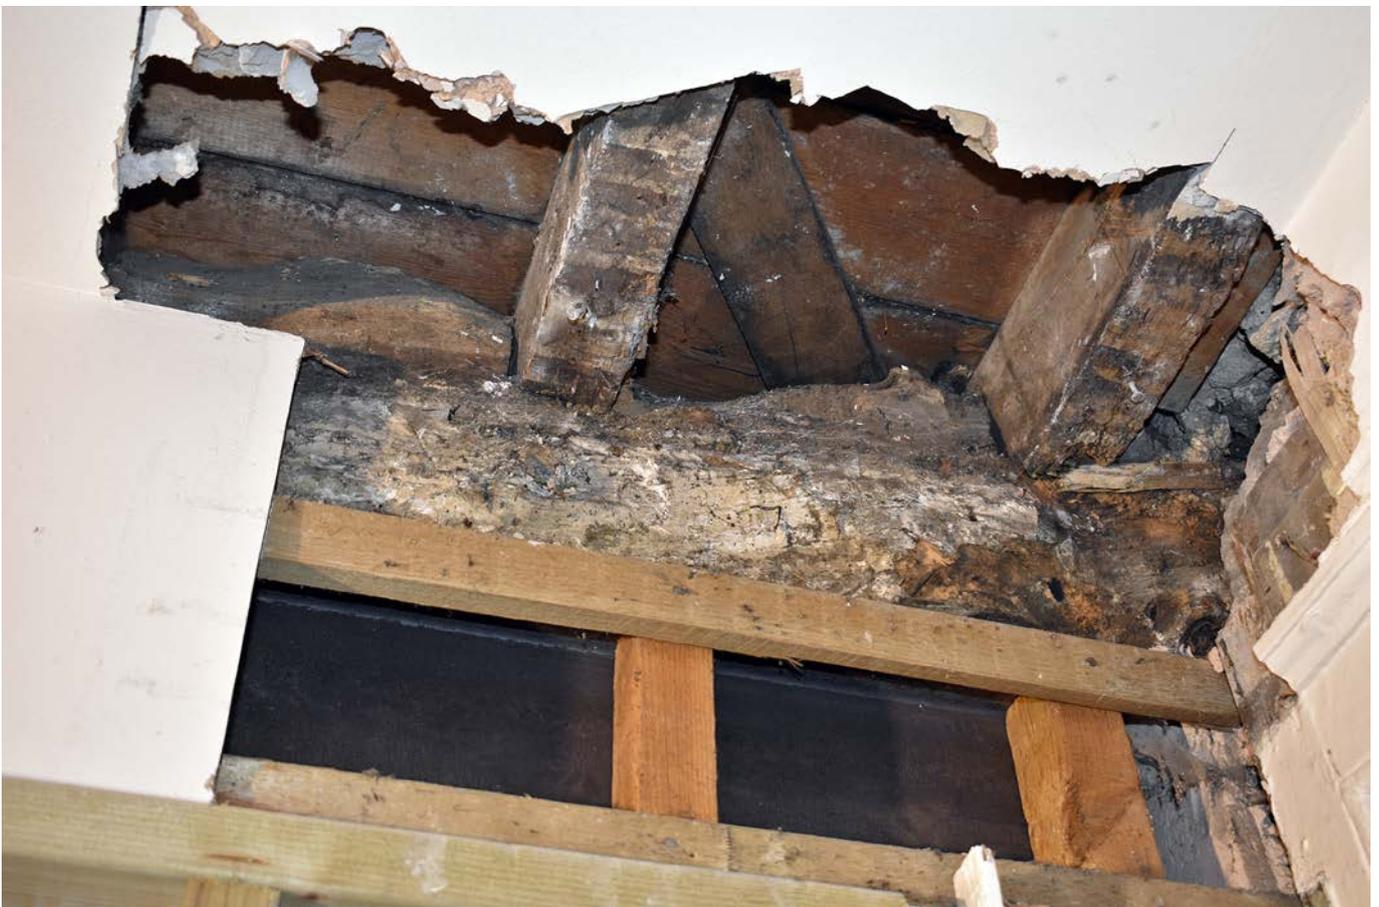
2.1.16 A small opening was made at the top of the north wall of this room, at the east end, and also from an adjacent section of the ceiling. These openings exposed an historic east-west principal joist (c.30 cm tall) at the top of this wall, with a modern steel joist below this and then modern studwork forming the main partition. There were also a series of common joists (c. 14 cm x 8 cm) tenoned into the principal. The principal joist had traces of old paint below the current ceiling.

Plate 17: Exposed junction at top of E-W wall on north side of store with old principal joist and modern RSJ beneath

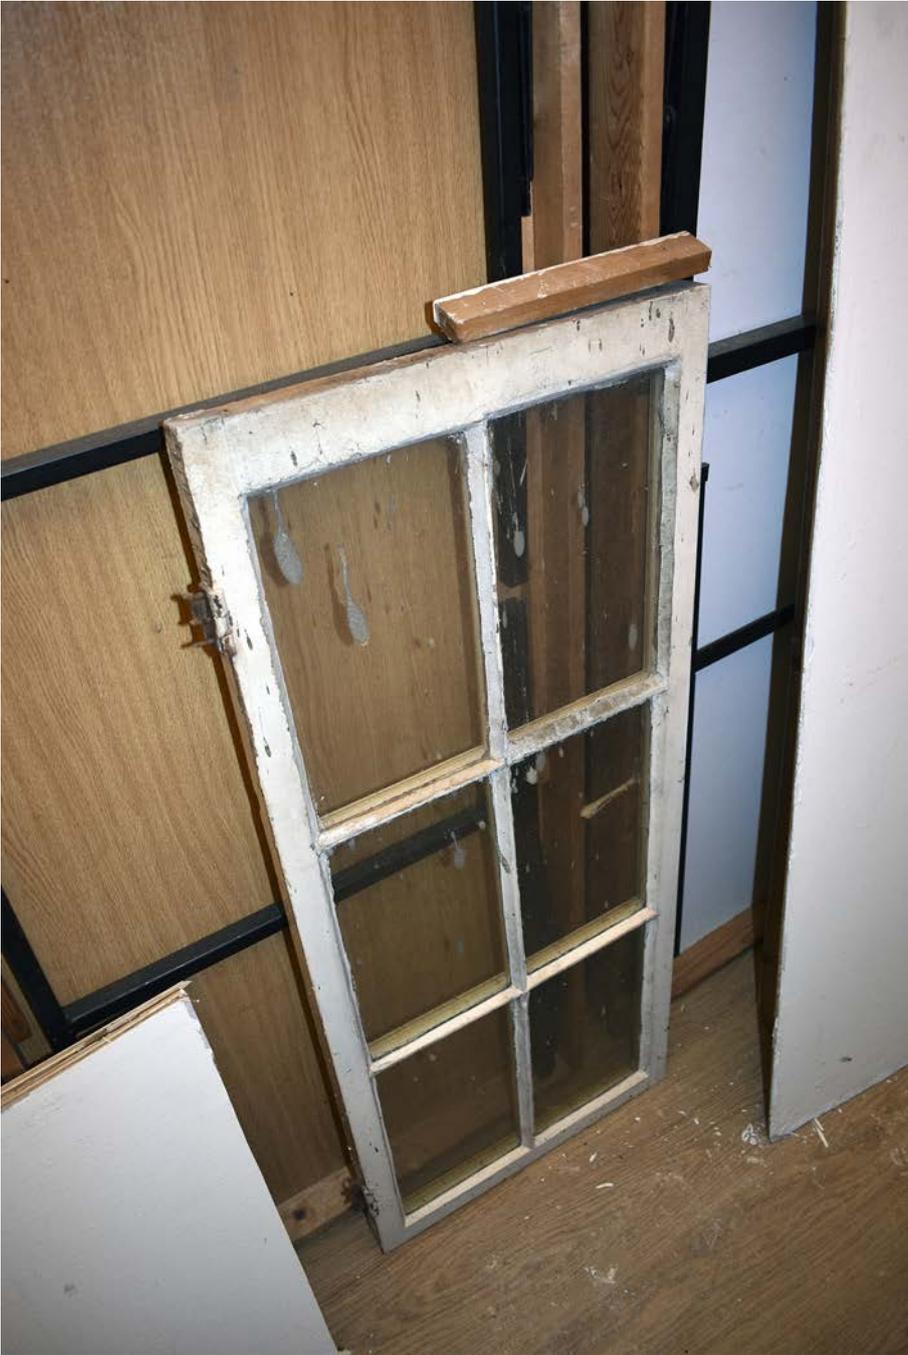
2.1.13 At the eastern end of this narrow room a simple boarded panel was removed from the wall to uncover Window 2 which had been partially exposed on the opposite side of the wall. As referred to above the casement from this opening had been removed recently but was still in the store room. Cavetto mouldings were visible surrounding the opening, plastered and painted light blue but no other features of significance were exposed. The opening was 1.1 m x 0.45 m.

Plate 18: Ex-situ casement from Window 2
