A Nissen Hut at Church Lane, Ellington

Historic Building Investigation and Recording

October 2020

OAE Report No: 2459

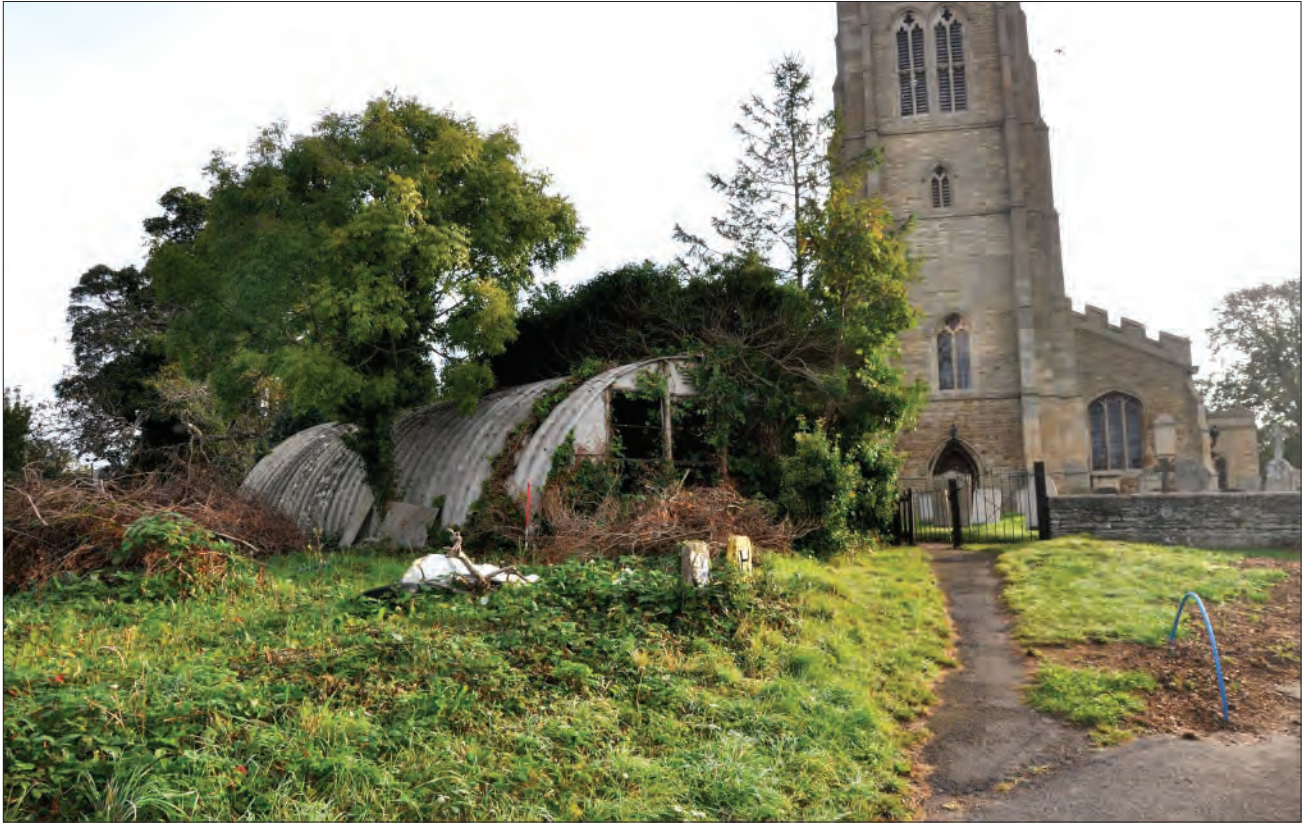
Plate 1: General view of Nissen hut, looking north-east

- 1.3.1 The site lies in the core of the historic village of Ellington, on undeveloped ground off Church Lane. It is situated between No. 2, Church Lane (to the west) and the church yard of All Saints Church (to the east) (Fig. 1).
- 1.3.2 The Grade II listed Mermaid public house (National Heritage List for England ref 1165237, CHER ref DCB2837) lies just to the north-east and although the plot now lies within the curtilage of the Mermaid it is shown as a separate plot on maps prior to 1978.
- 1.3.3 The Nissen hut is located at the south end of the plot, up against the boundary with the church yard to the east (Plate 1).

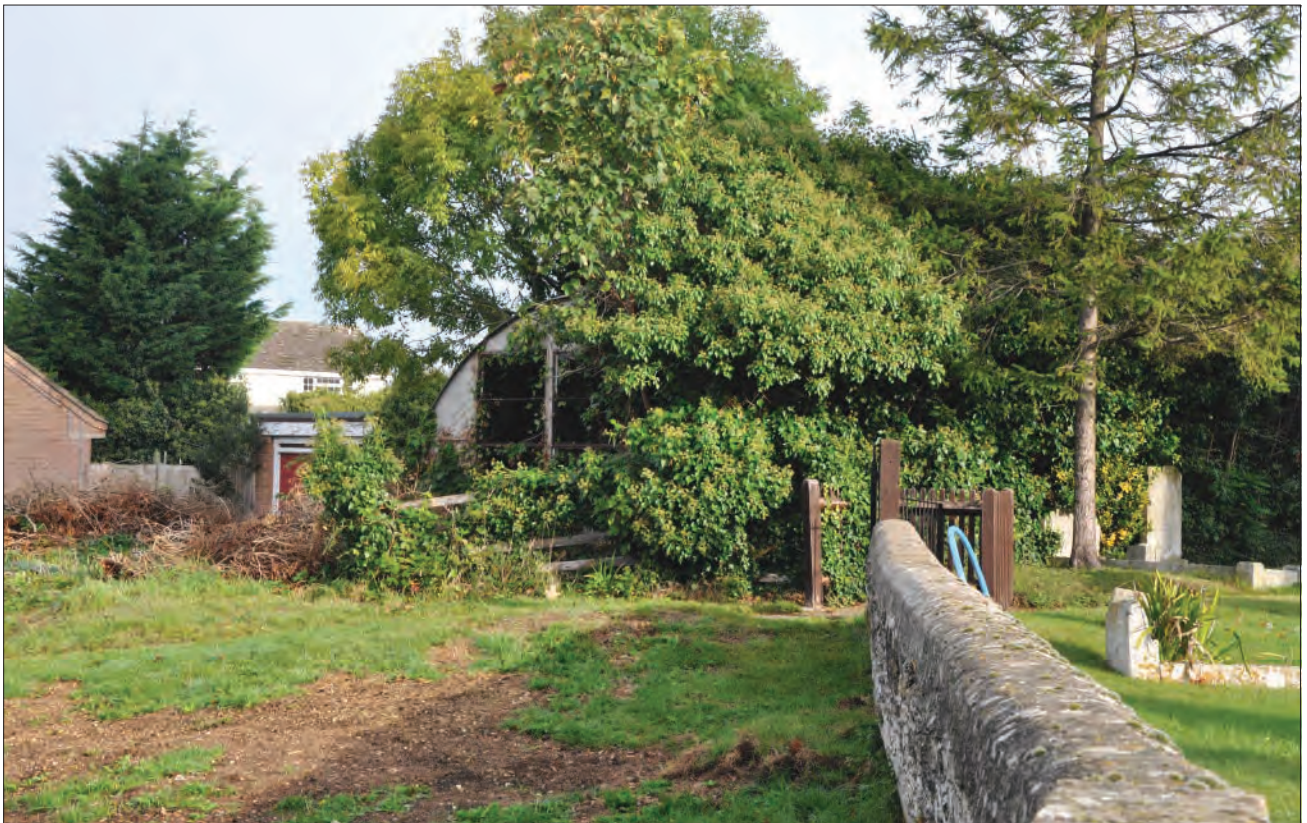
Plate 2: South-west facing elevation, looking north, showing vegetation cover on the building's south-eastern side

3.1.1 The building is located to the south of the plot and is mostly covered in foliage and vegetation. The south-east side of the building was inaccessible due to its proximity to the boundary of the graveyard and being completely obscured by vegetation (Plates 2 and 3). Internally the building is in disrepair with large cracks and damage to the door and windows.

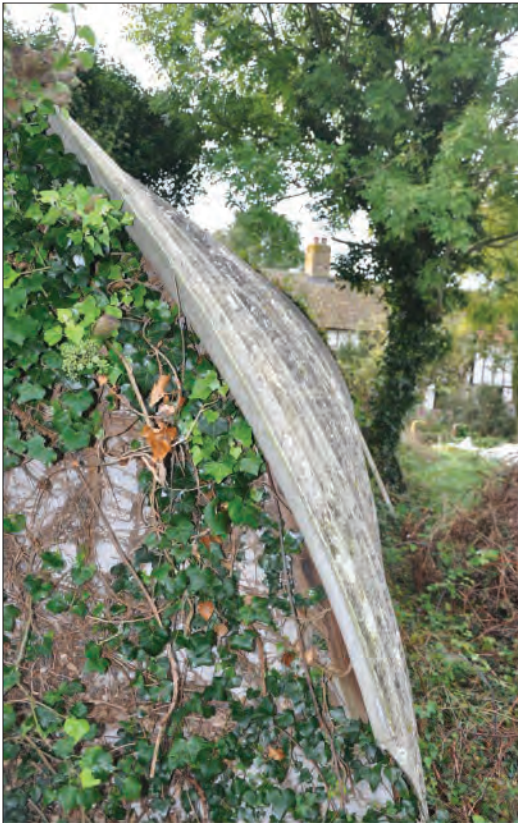
Plate 4: Detail of curved asbestos sheeting, looking south-west

3.1.3 It is constructed from corrugated asbestos sheeting over a steel frame. Nine sheets per side are covered with convex roof sheets to form the distinctive semi-circular shape (Plate 4). The sheets have been fixed in place by steel bolts (Plate 5).

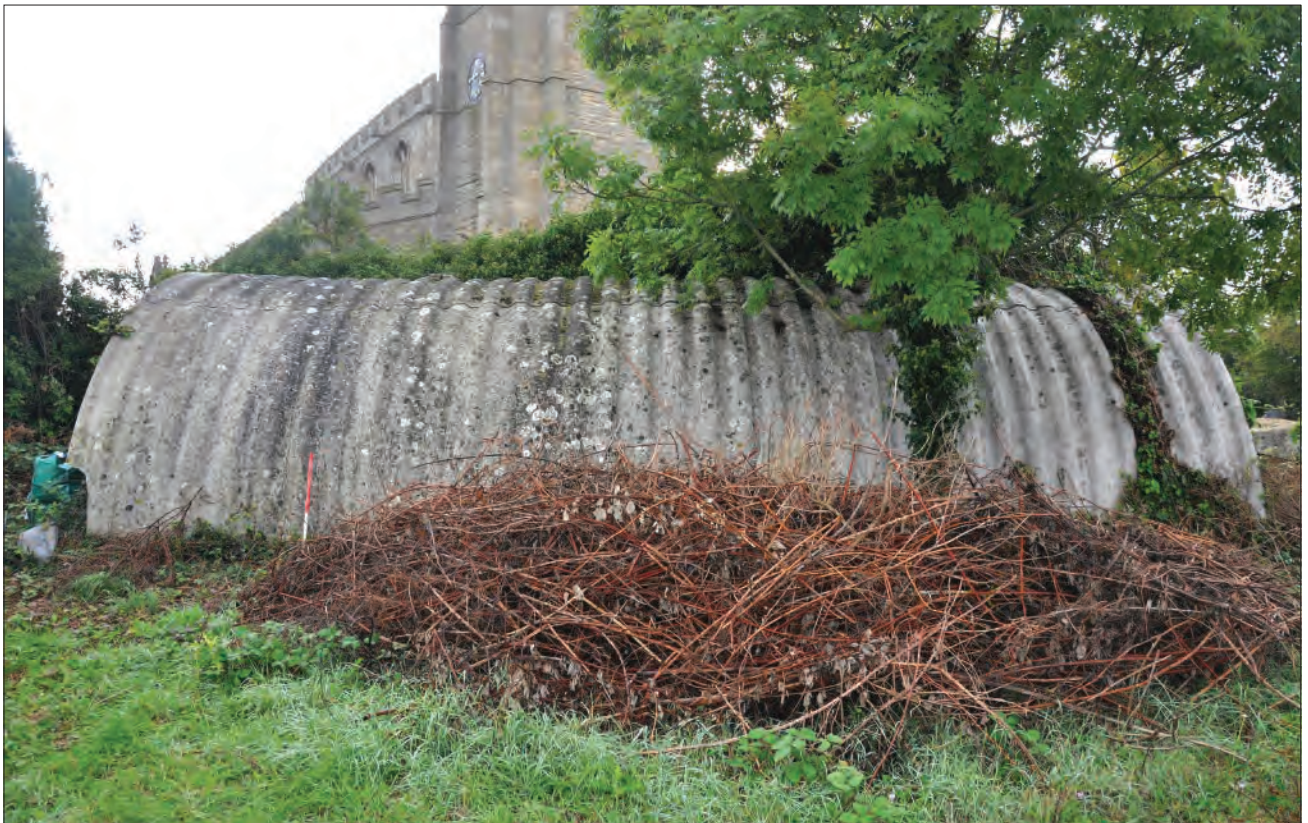
Plate 6: North-west facing elevation, looking south-east, showing sheets of corrugated asbestos

3.2.1 The south-west elevation is 9.8m in length and consists of nine asbestos sheets secured by metal bolts (Plate 6).

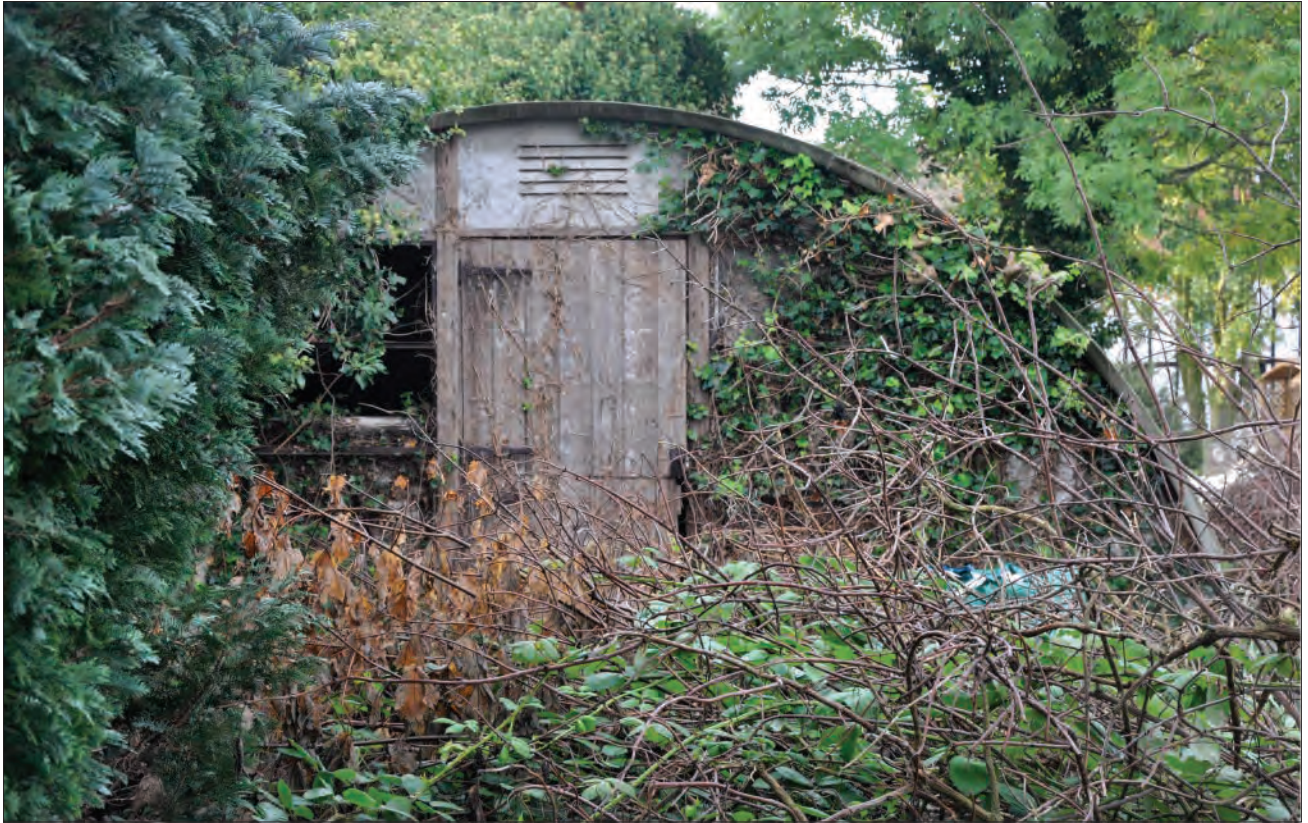
Plate 9: Detail of north-east facing elevation

3.2.5 There is a wooden stable door in the centre, measuring 2m x 1m, set between two wooden uprights (Plate 9). The door has simple metal strap hinges to the left-hand side (Plates 10 and 11).

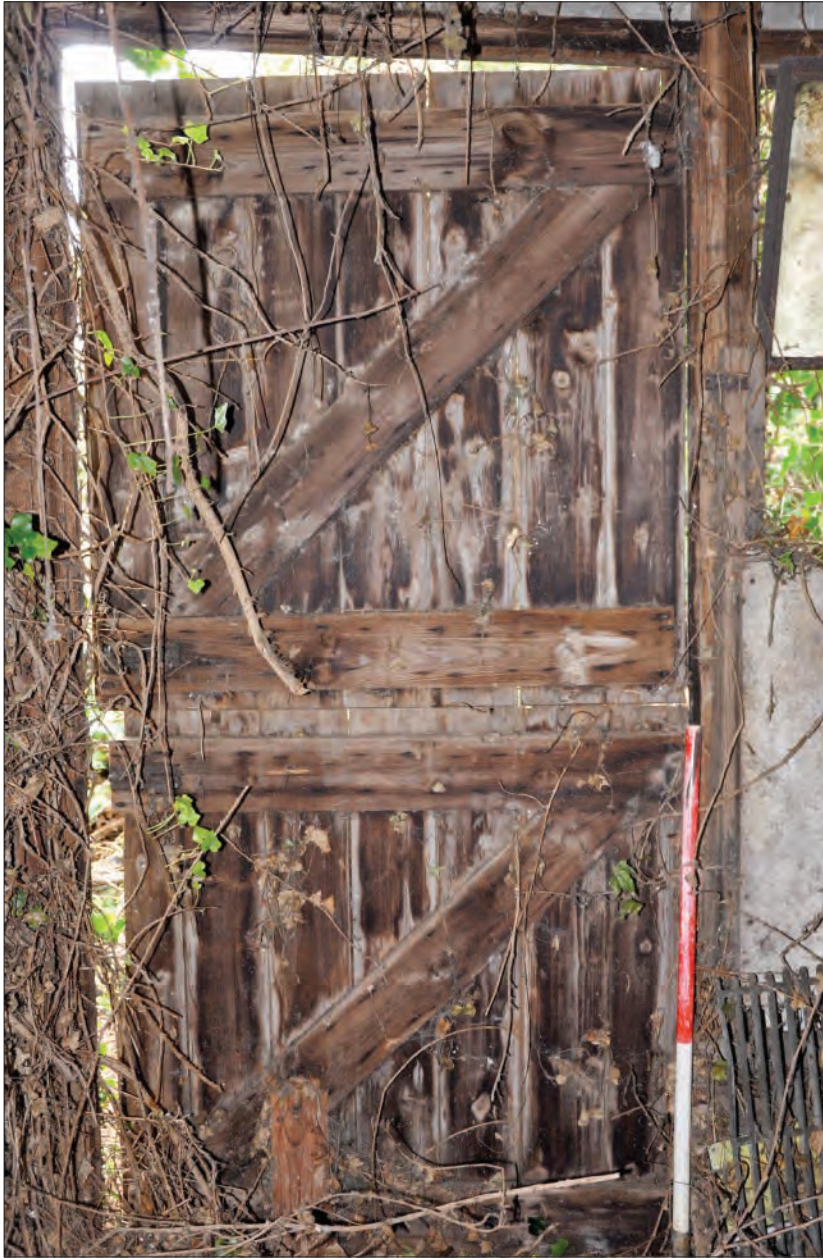
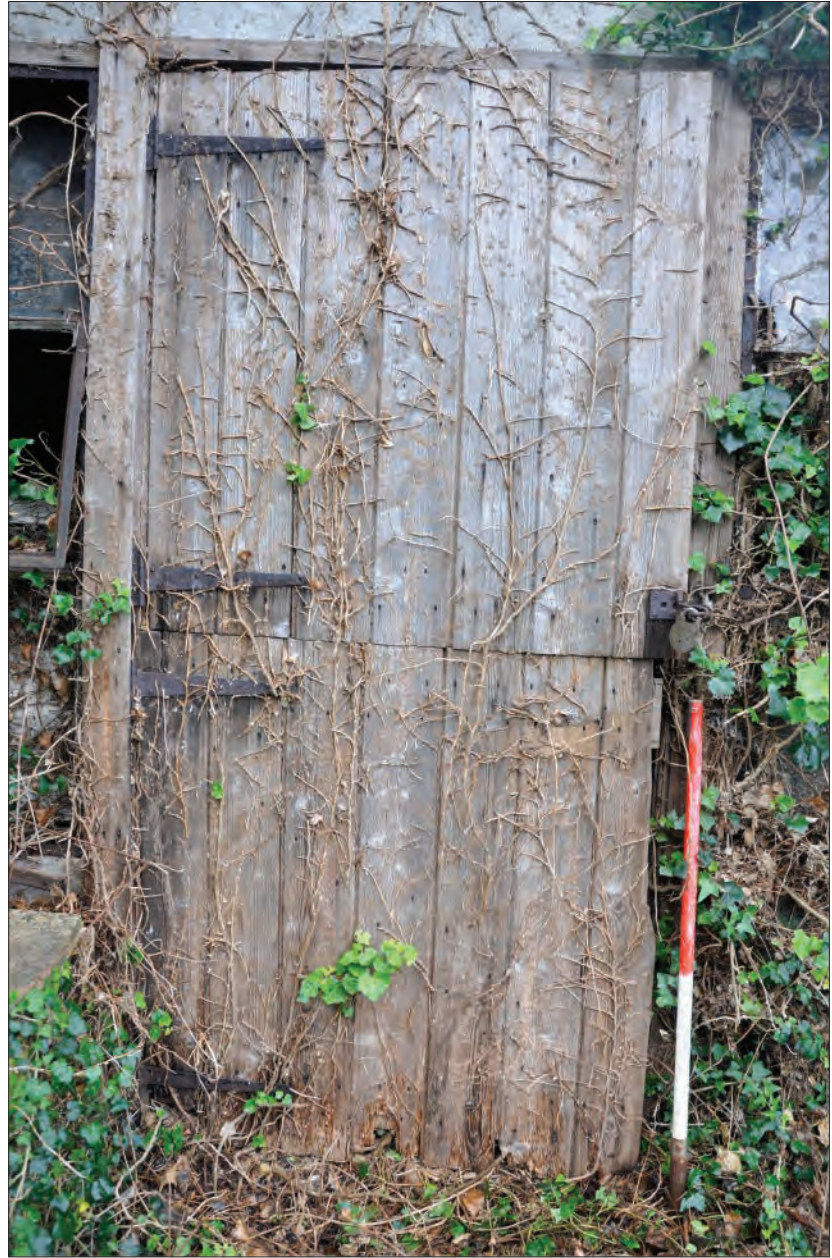
Plate 11: Detail of door, internal view

Plate 10: Detail of door, external view

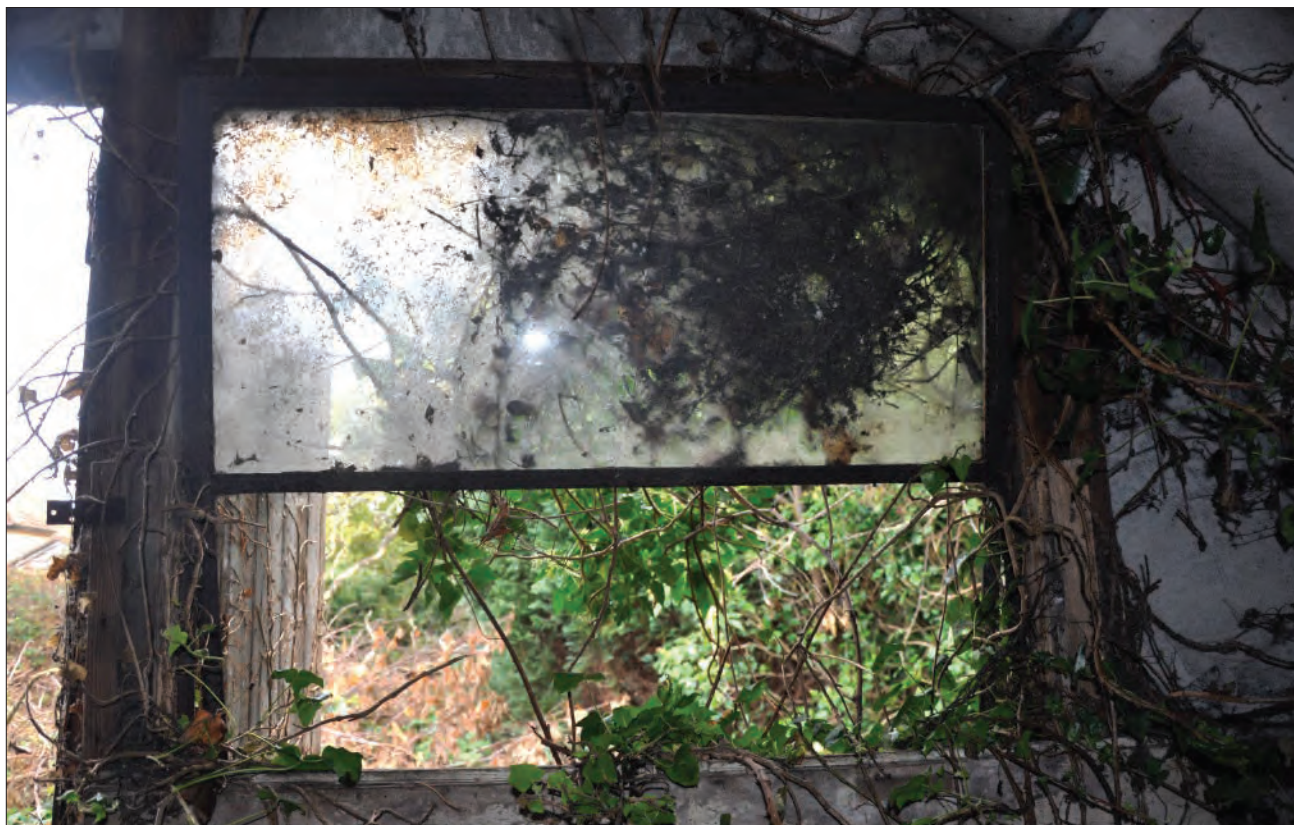
3.2.6 Two rectangular windows are located either side of the door, each measures 0.92m wide and 0.75m high. They are constructed of steel with one horizontal glazing bar and are set in a wooden frame. Each has a central pivot mechanism and the window on the right retains some glazing (Plate 12).

Plate 12: Lefthand window on northeast facing elevation, viewed from the interior, showing surviving glazing

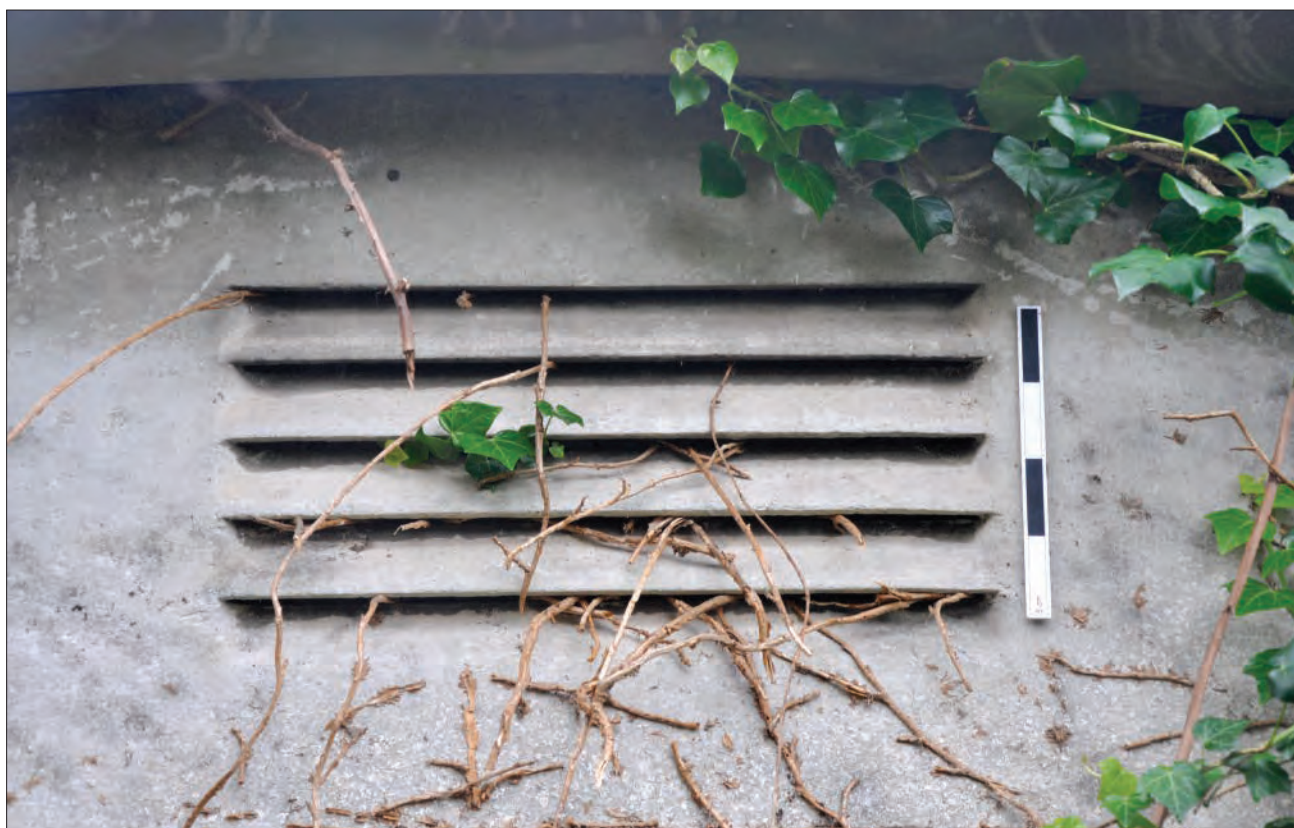
Plate 13: Detail of vent above door on the northeast facing elevation

3.2.7 A central Louvre vent is located above the doorway (Plate 13).

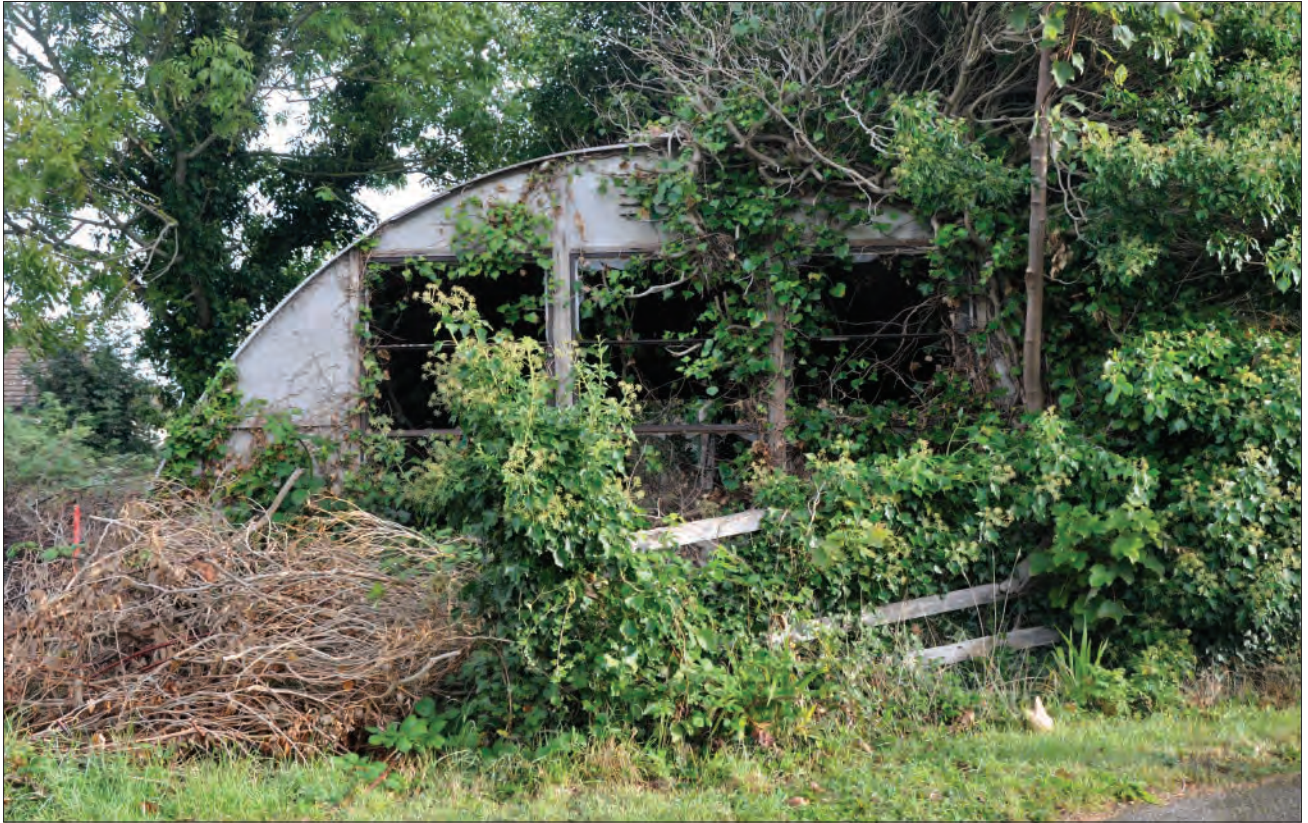
Plate 14: Southwest facing elevation, looking northeast

3.2.8 The south-west facing elevation has a width of 5.5m and a height of 2.75m. It is constructed from asbestos sheeting with three windows centrally placed and separated by wooden uprights (Plate 14). Each window measures 1.5m x 1m and would have contained three panes of glass (Plate 15). They are made of steel and set into a wooden frame.

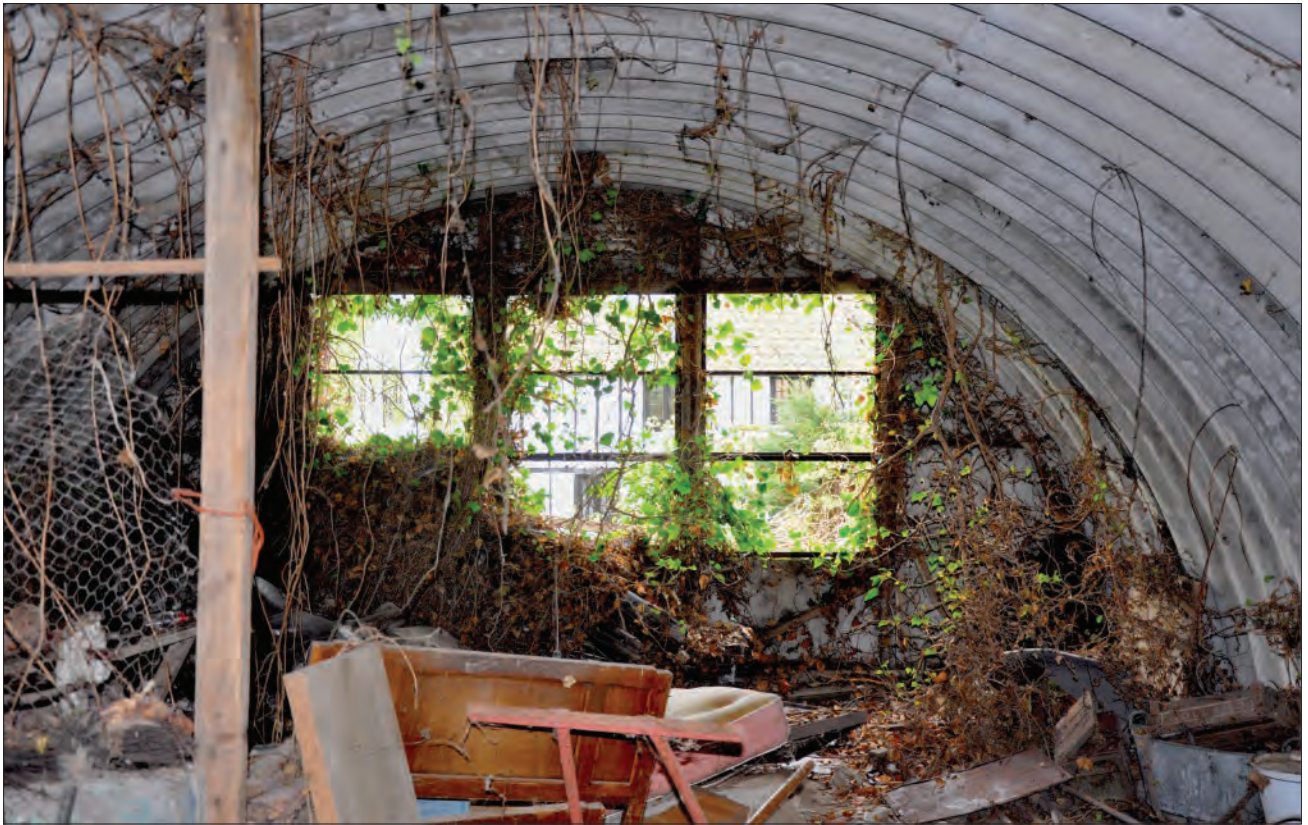
Plate 16: Internal view, looking southwest

- 3.3.1 Internally the building measures 9.6m x 5.3m and has a height of 2.73m. Vegetation had encroached on the interior, and this made a detailed study difficult (Plate 16). However, it could be seen that the internal space was open plan, with no evidence of former divisions visible. Its recent use has been one of storage, and there are no indications of former use except a small amount of chicken wire covering the lower part of the central window on the south-west facing elevation (Plate 17). This could support the anecdotal evidence that the building was formerly used to house animals.

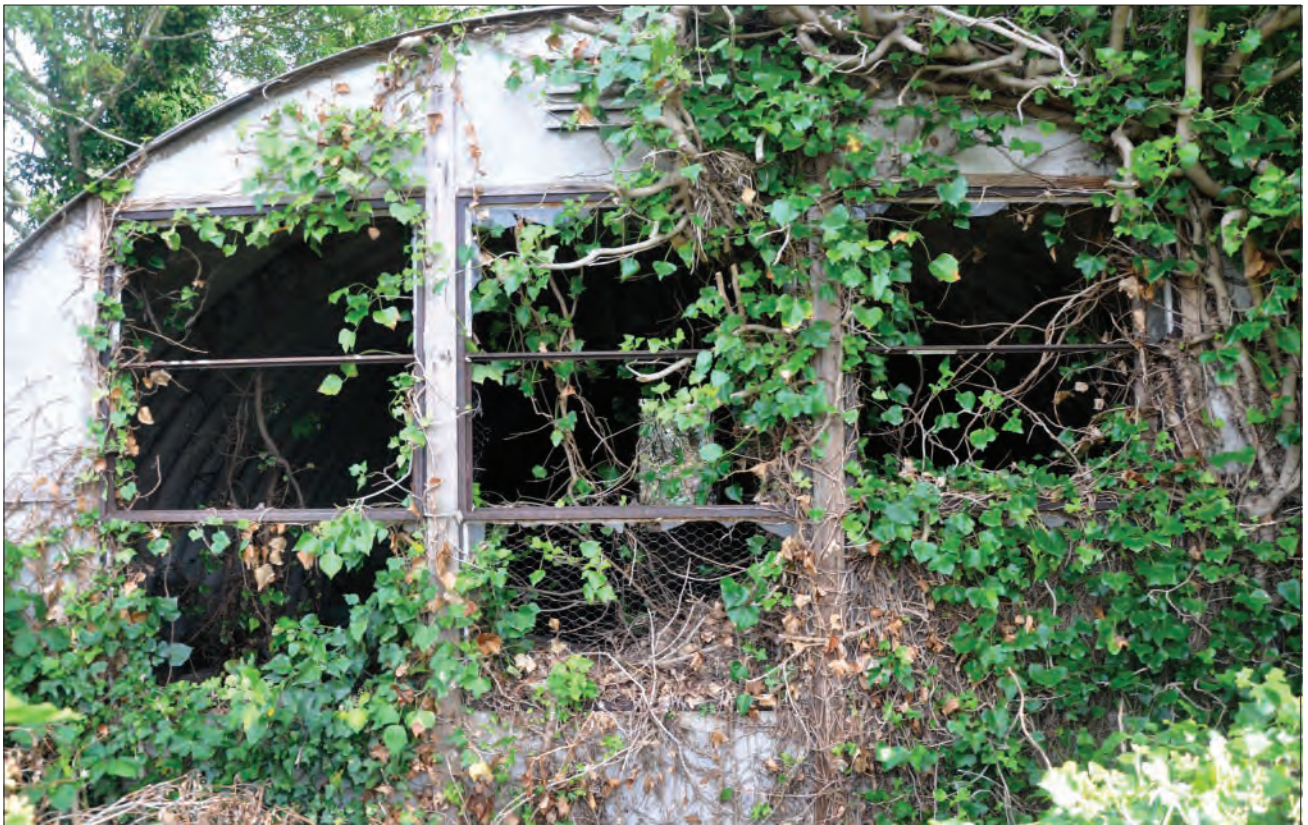
Plate 17: Detail of southwest facing elevation showing chicken wire

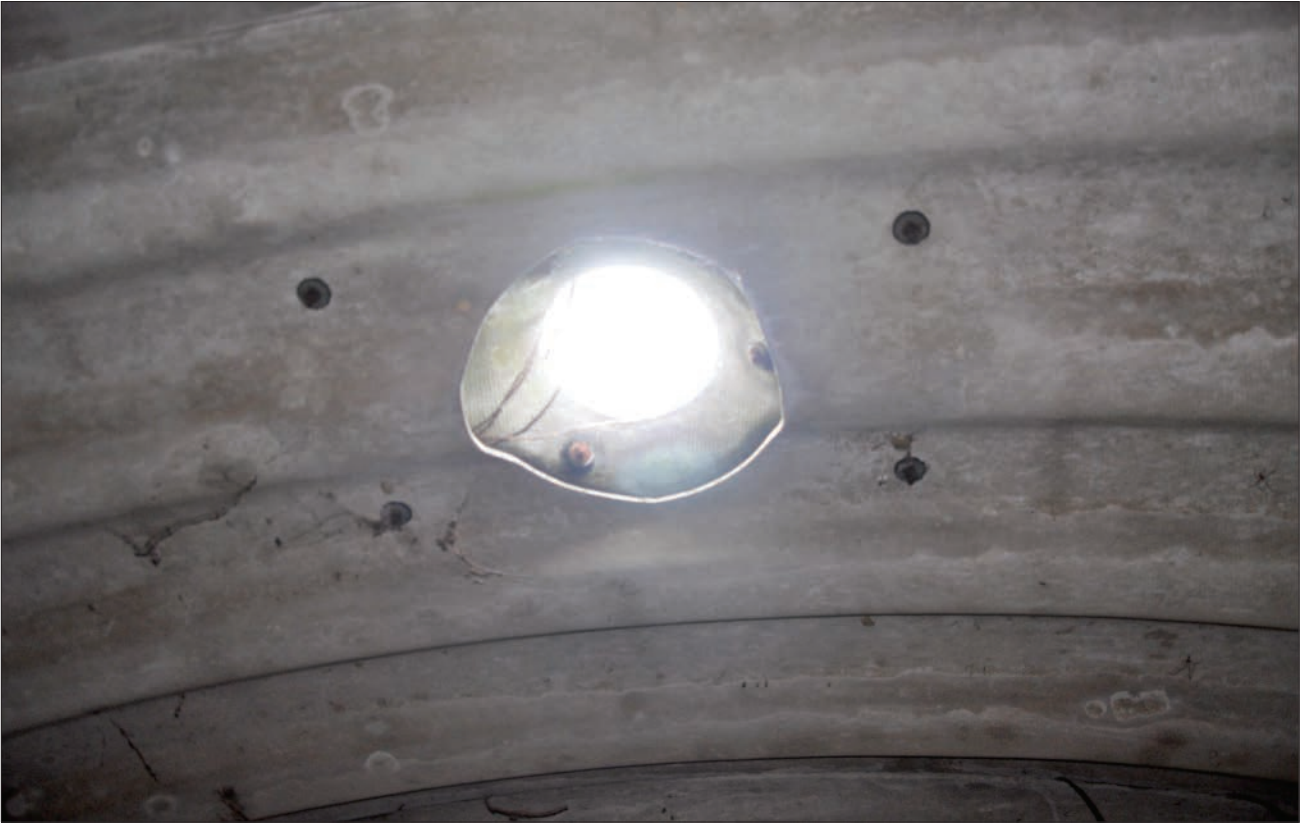
- 3.3.2 Two openings were present in the roof sheets (Plate 18), which appeared to have been added post construction. These may have been openings for small chimneys, as seen at other huts (Taylor 2009), which have now been removed.

Plate 18: Detail of opening in the roof

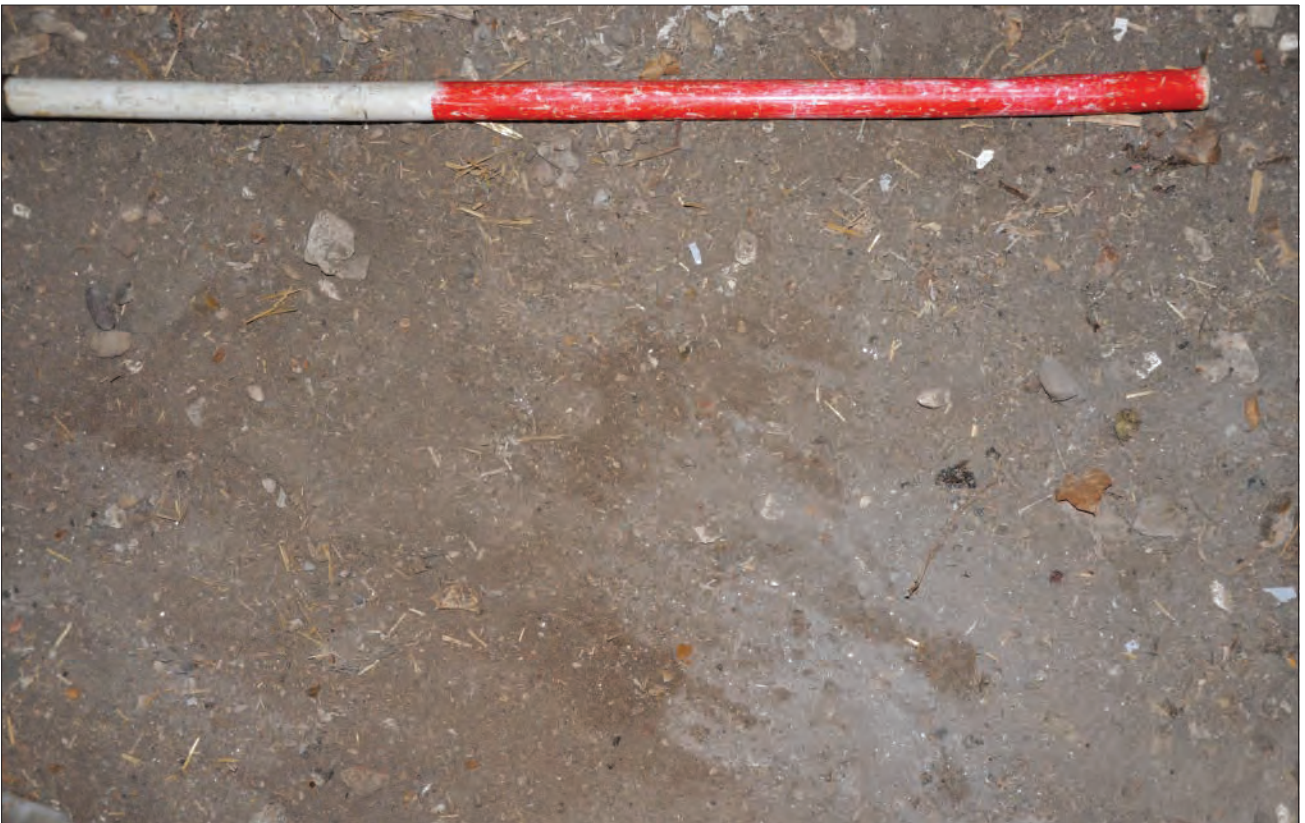
- 3.3.3 The floor consisted of a simple beaten earth (Plate 19). No other signs of floor or floor covering were noted.

Plate 19: Internal earthen floor
