# Lot 1, Avenue Farm, Padgetts Lane, Fenton, Cambridgeshire Archaeological Evaluation Report

November 2020

Report No: 2474

### *Archaeological Evaluation Report*

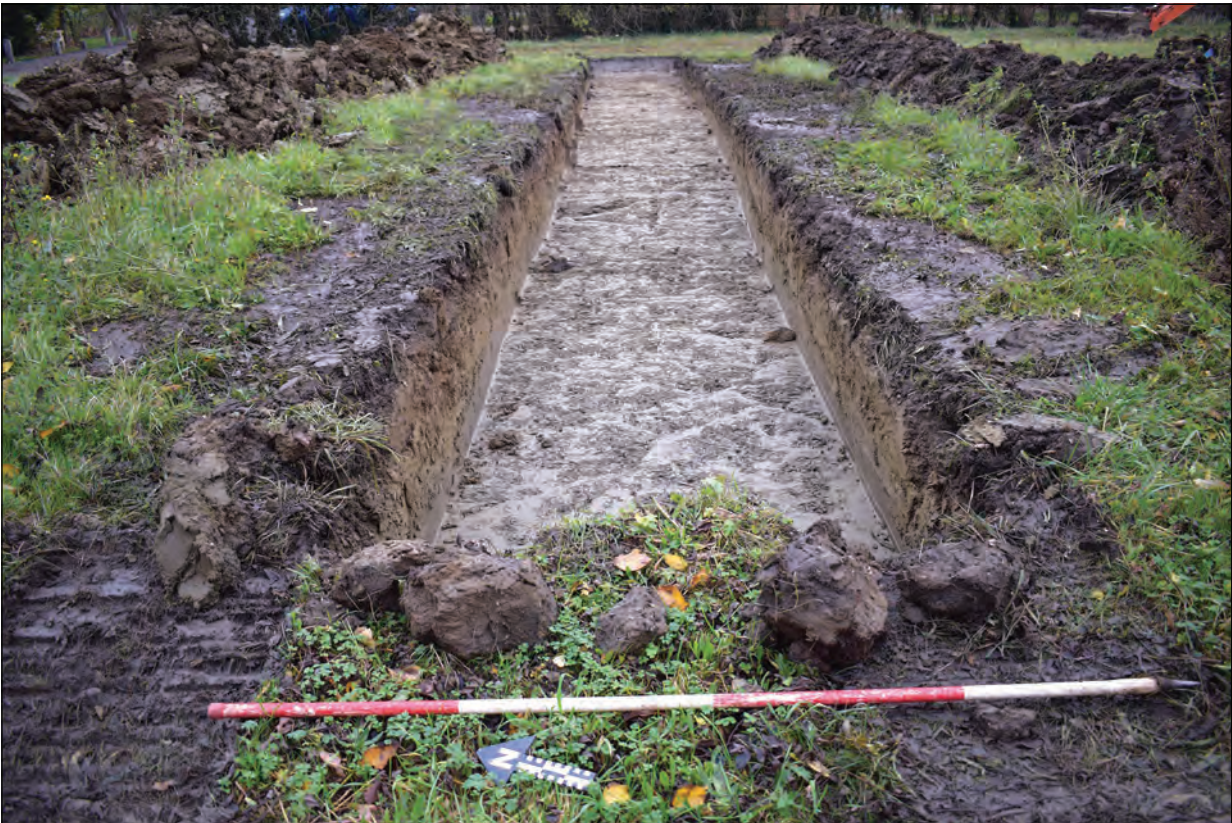
3.4.1 Trench 1 (Plate 1) was orientated east-north-east to west-south-west and lay in the north-western part of the site. It measured 20m by 1.8m and was devoid of archaeology. A modern demolition deposit (3) overlay the subsoil in the central part of the trench. This demolition material was more intermittent towards each end of the trench.

Plate 1: Trench 1, looking north-north-east

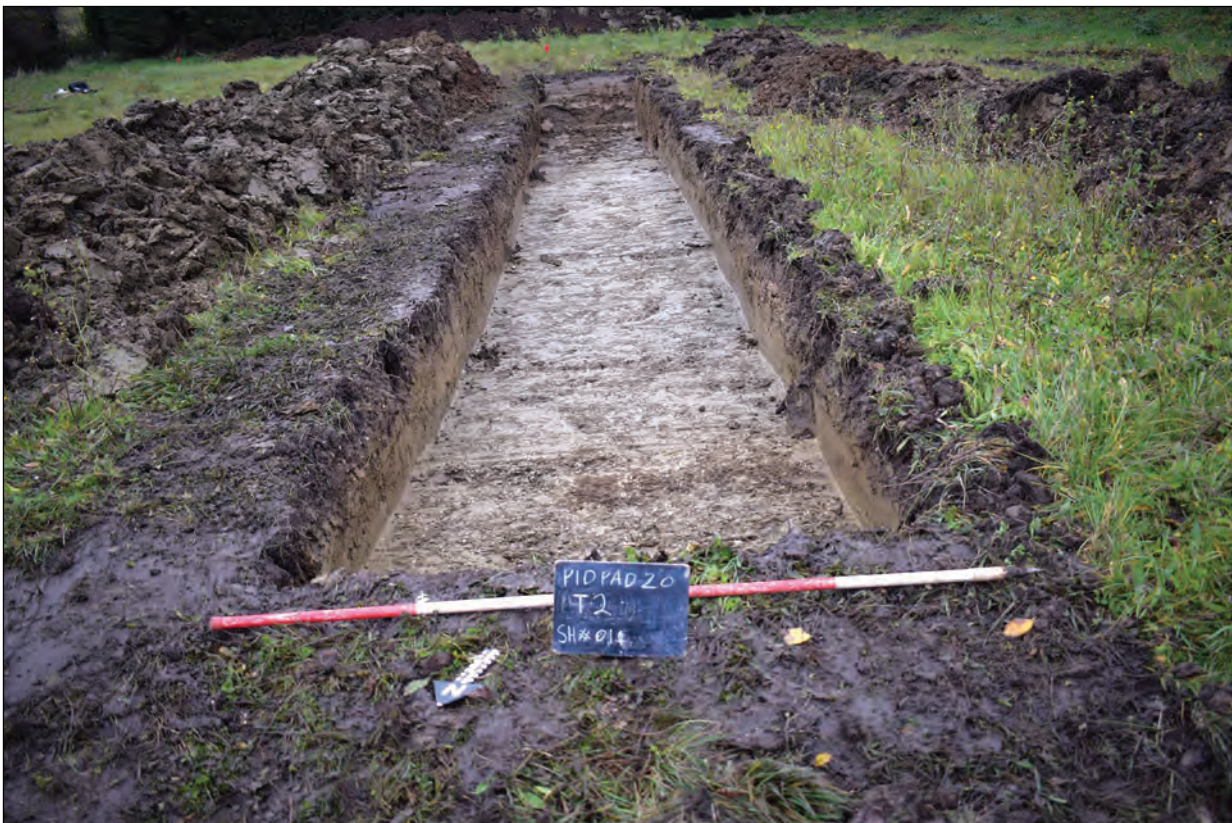
3.5.1 Trench 2 (Plate 2) was orientated north-north-west to south-south-east and occupied the central area of the site. It measured 20m by 1.8m and was devoid of archaeology. A demolition deposit (3) was present along almost the entirety of its length, although not at a consistent depth (Plate 3).

Plate 2: Trench 2, looking south-east

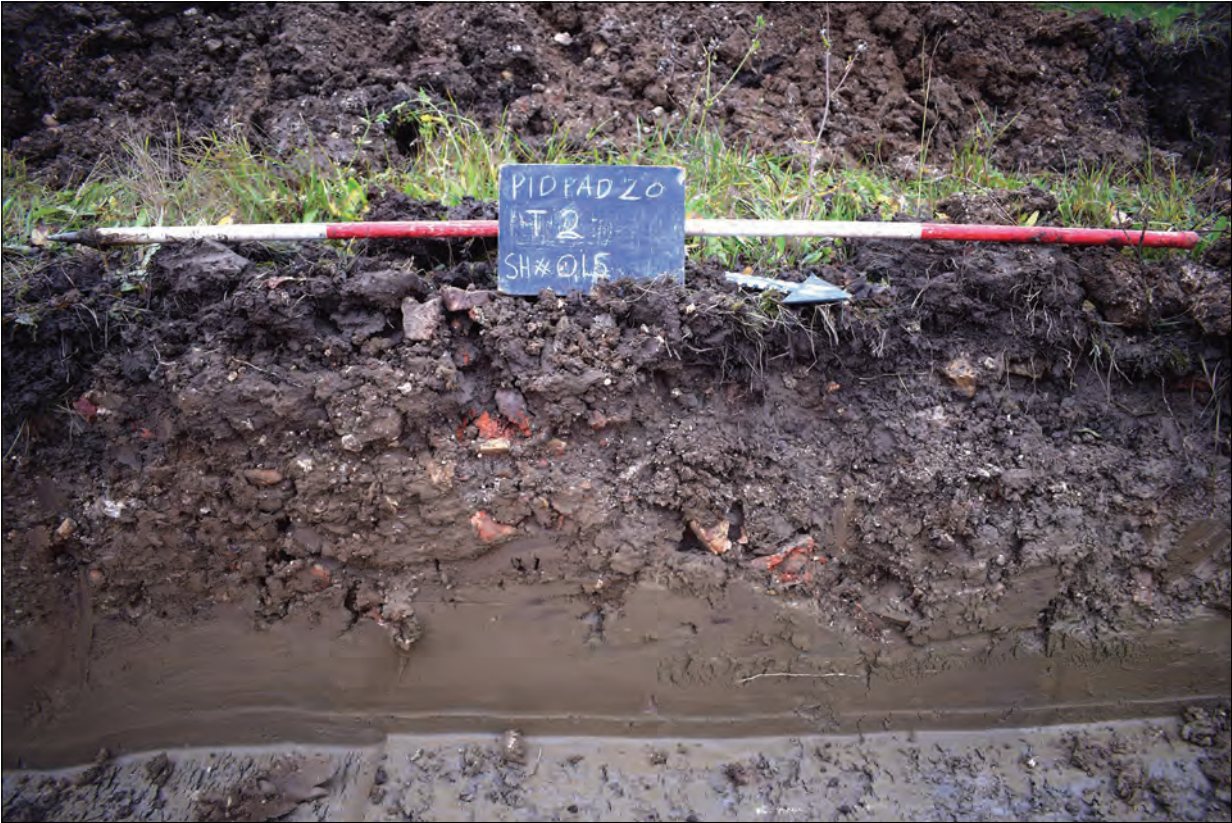
3.2.1 The soil sequence in the trenches was fairly uniform. The natural geology of Ampthill clay was overlain by a silty clay subsoil (2), up to 0.66m thick. A demolition deposit (3), which contained brick, tile and associated rubble was present at the interface between the topsoil (1) and the subsoil (2) in some areas of the trenches. This was in turn overlain by a shallow layer of clayey silt topsoil (1), up to 0.36m thick. In places, some of the rubble had made its way down into dips and hollows in the subsoil.

Plate 3: Baulk section in Trench 2, looking west-south-west

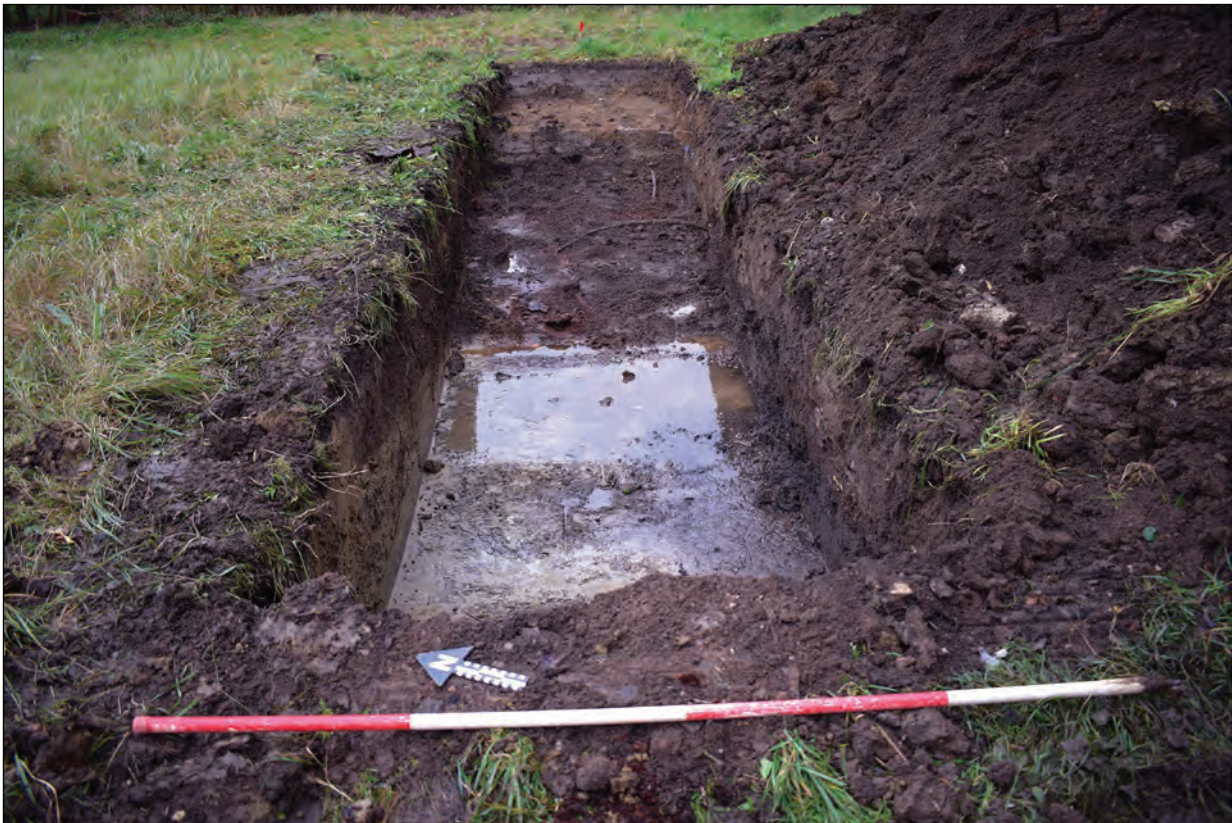
3.6.1 Trench 3 (Plate 4) was orientated south-west to north-east and lay towards the south-eastern end of the site. It measured 10m by 1.8m and contained modern rubbish pit (6) which produced brick and tile, rusted iron, and glass from its dark grey silty clay fill (5). None of this material was retained. At the eastern end of the trench, the top of a disused septic tank and an associated waste pipe was revealed during the mechanical stripping of the trench. A post 1960s plastic pipe was revealed at the same level as the disused septic tank.

3.6.2 The demolition deposit (3) observed in Trenches 1 and 2 was also revealed by Trench 3 very close to the surface. It overlay the area occupied by the disused septic tank at the eastern end of the trench and was observed to have been cut by the modern rubbish pit (6) at its western end. This layer was also cut by a modern drain that extended across the trench on a north-east to south-west alignment.

4.3.1 The demolition layer (3) is likely to have originated from the pulling down of a building that once stood in the south-eastern part of the site. The disused septic tank was possibly associated with this building.

Plate 4: Trench 3, looking north-east after exposing the septic tank at the eastern-most end of the trench
