Goodhart Building University College Oxford

Excavation and watching brief report

November 2016

Archaeological Excavation and Watching Brief Report

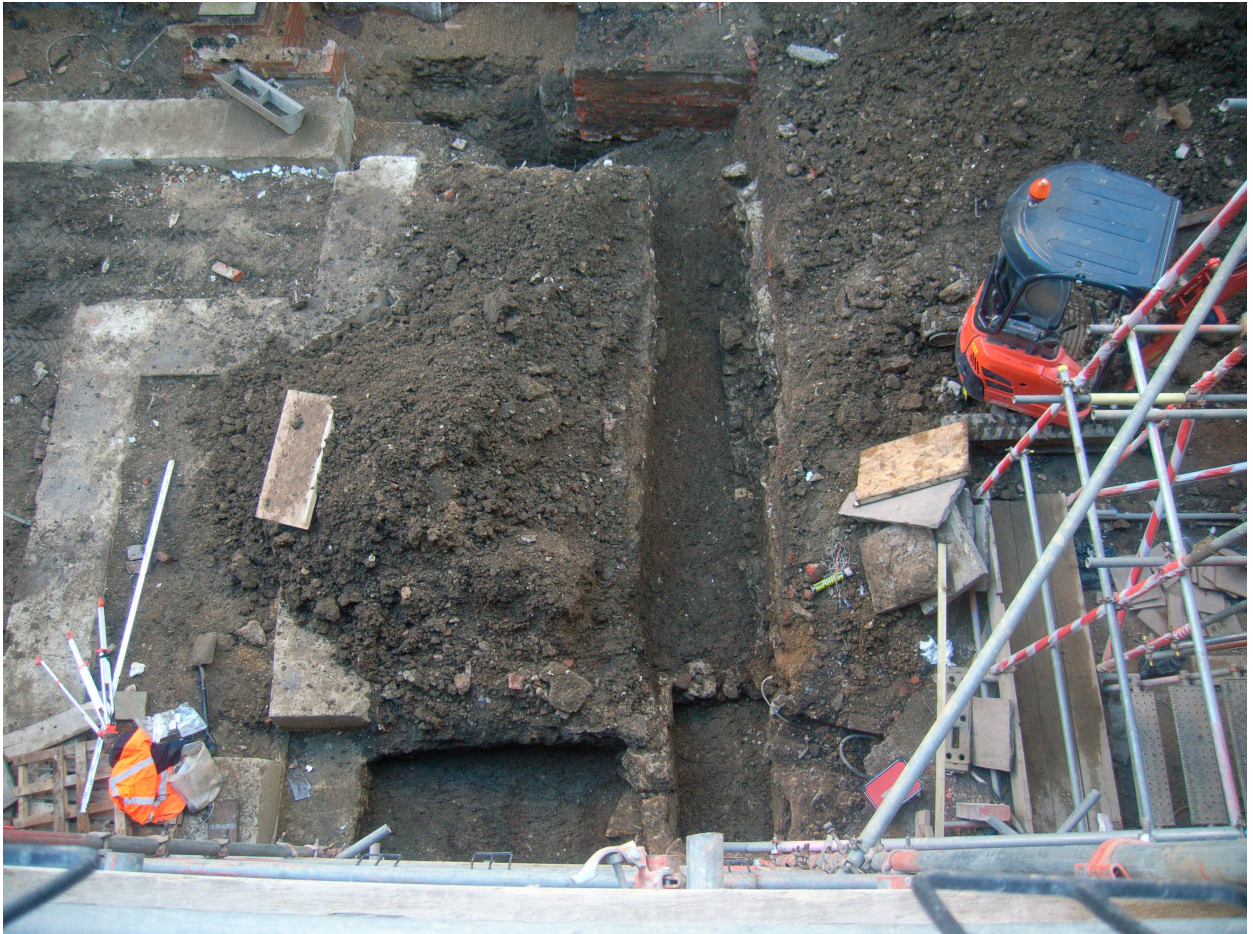
Plate 1 Walls 70/71 and Structure 57/61

- 4.2.8 The fill (56) of the construction cut (58) for the northern wall (57) of the stone-lined pit described above (4.2.5) had been truncated by the cut of a large pit (36/55) which also truncated the garden soils (35). The composition of the lower excavated fills of pit 36/55 (37, 53 and 54) was indicative of degraded organic content, perhaps suggesting that the primary function of the feature was as a cess pit. The upper fills (39 and 48-52) are interpreted as the backfilling of the feature once it had become redundant.
- 4.2.9 The garden soil (here numbered 35) and possible cess pit (36/55) had been truncated by the cut of a sub-circular feature (41), which had some evidence for a brick and stone lining (33) around its south-eastern extent (Plate 2). The fills of the pit (42-45) contained 18th to early 19th century artefactual material.

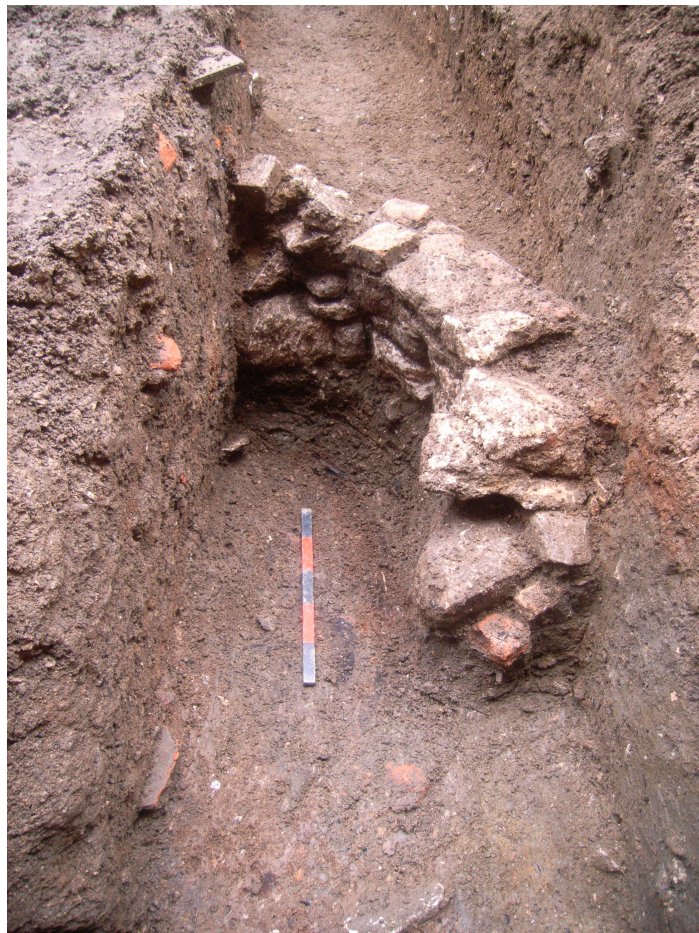
Plate 2 Structure 33

- 5.2.10 In contrast to the structures overlain by these garden soils, a number of structures were also encountered which appeared to post-date the deposit(s). The stone-lined semi-circular structure (33), with some evidence for brick repair of the upper courses, was located centrally within the new build. This may have represented the top of a well to the rear of the Angel Inn, which fronted High Street from at least the 16th century. The fact that the stone lining was not consistently present around the top of the feature may suggest an alternative interpretation, although it is possible that the top of the structure had been robbed prior to backfilling.
