Box Vicarage Box Wiltshire

Archaeological Evaluation Report

September 2006

On 11th September 2006, Oxford Archaeology (OA) carried out a field evaluation at Box Vicarage, Box, Wiltshire (NGR: ST 823 685) on behalf of the Hookway Partnership LLP, in advance of new drainage work and the installation of a replacement septic tank. The evaluation revealed the existence of probable Romano-British wall within the area of the replacement septic tank and natural colluvium sealed by a buried soil horizon on the line of the new drainage works. .

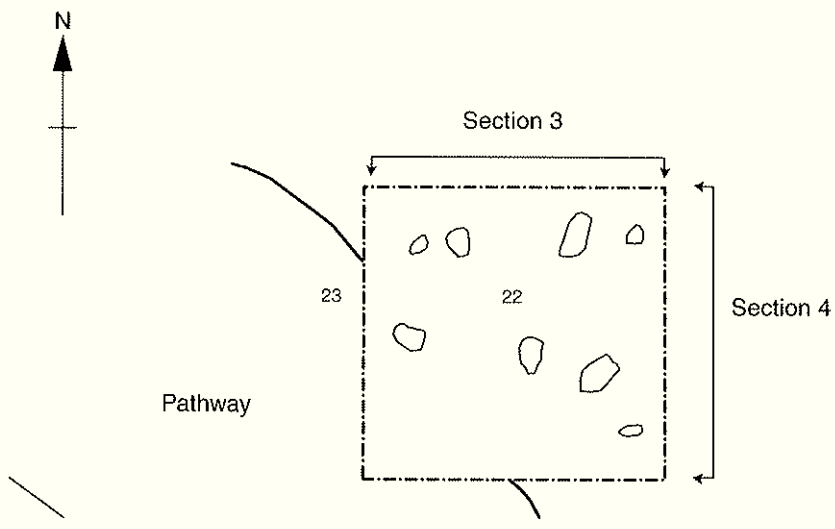
Figure 4: Test pit 2 plans and sections

Test Pit 2 (Fig. 4, Plan and sections 3 and 4)

- 5.1.3 This was located in the north-east corner of the garden on the site of the proposed new manhole.
- 5.1.4 A layer of pale yellow clay silt (22) was encountered at a depth of 0.55 m below the current ground level. This was a clean, compact layer with several small rounded limestone blocks embedded in its surface. This probably represents a layer of colluvium, possibly pre-historic in origin. Overlying this was a 0.25 m deep layer of grey-brown clay silt (21). This contained numerous small limestone fragments and some charcoal flecking and is a probable buried soil horizon, possibly a continuation of Layer 4.
- 5.1.5 This was sealed by a 0.3 m deep layer of dark grey-brown silt loam (20), the present day garden soil. Within the south-west corner of the test pit this was overlaid by a 0.1 m deep layer of crushed sandstone (23), the edge of the garden path.

- 7.1.1 The test pits have shown that the density of Romano-British activity within this area is small. It is probable that if any new drainage works are kept wherever possible within the footprint of existing disturbed areas then the impact will be small.
- 7.1.2 The results from Test Pit 2 suggest that the excavation of a new drainage trench within the north-east corner of the garden is within a low density area and that again its impact should be small.
