# The Kings Arms Desborough Northamptonshire

## Historic Building Recording

**Oxford Archaeology**

December 2003

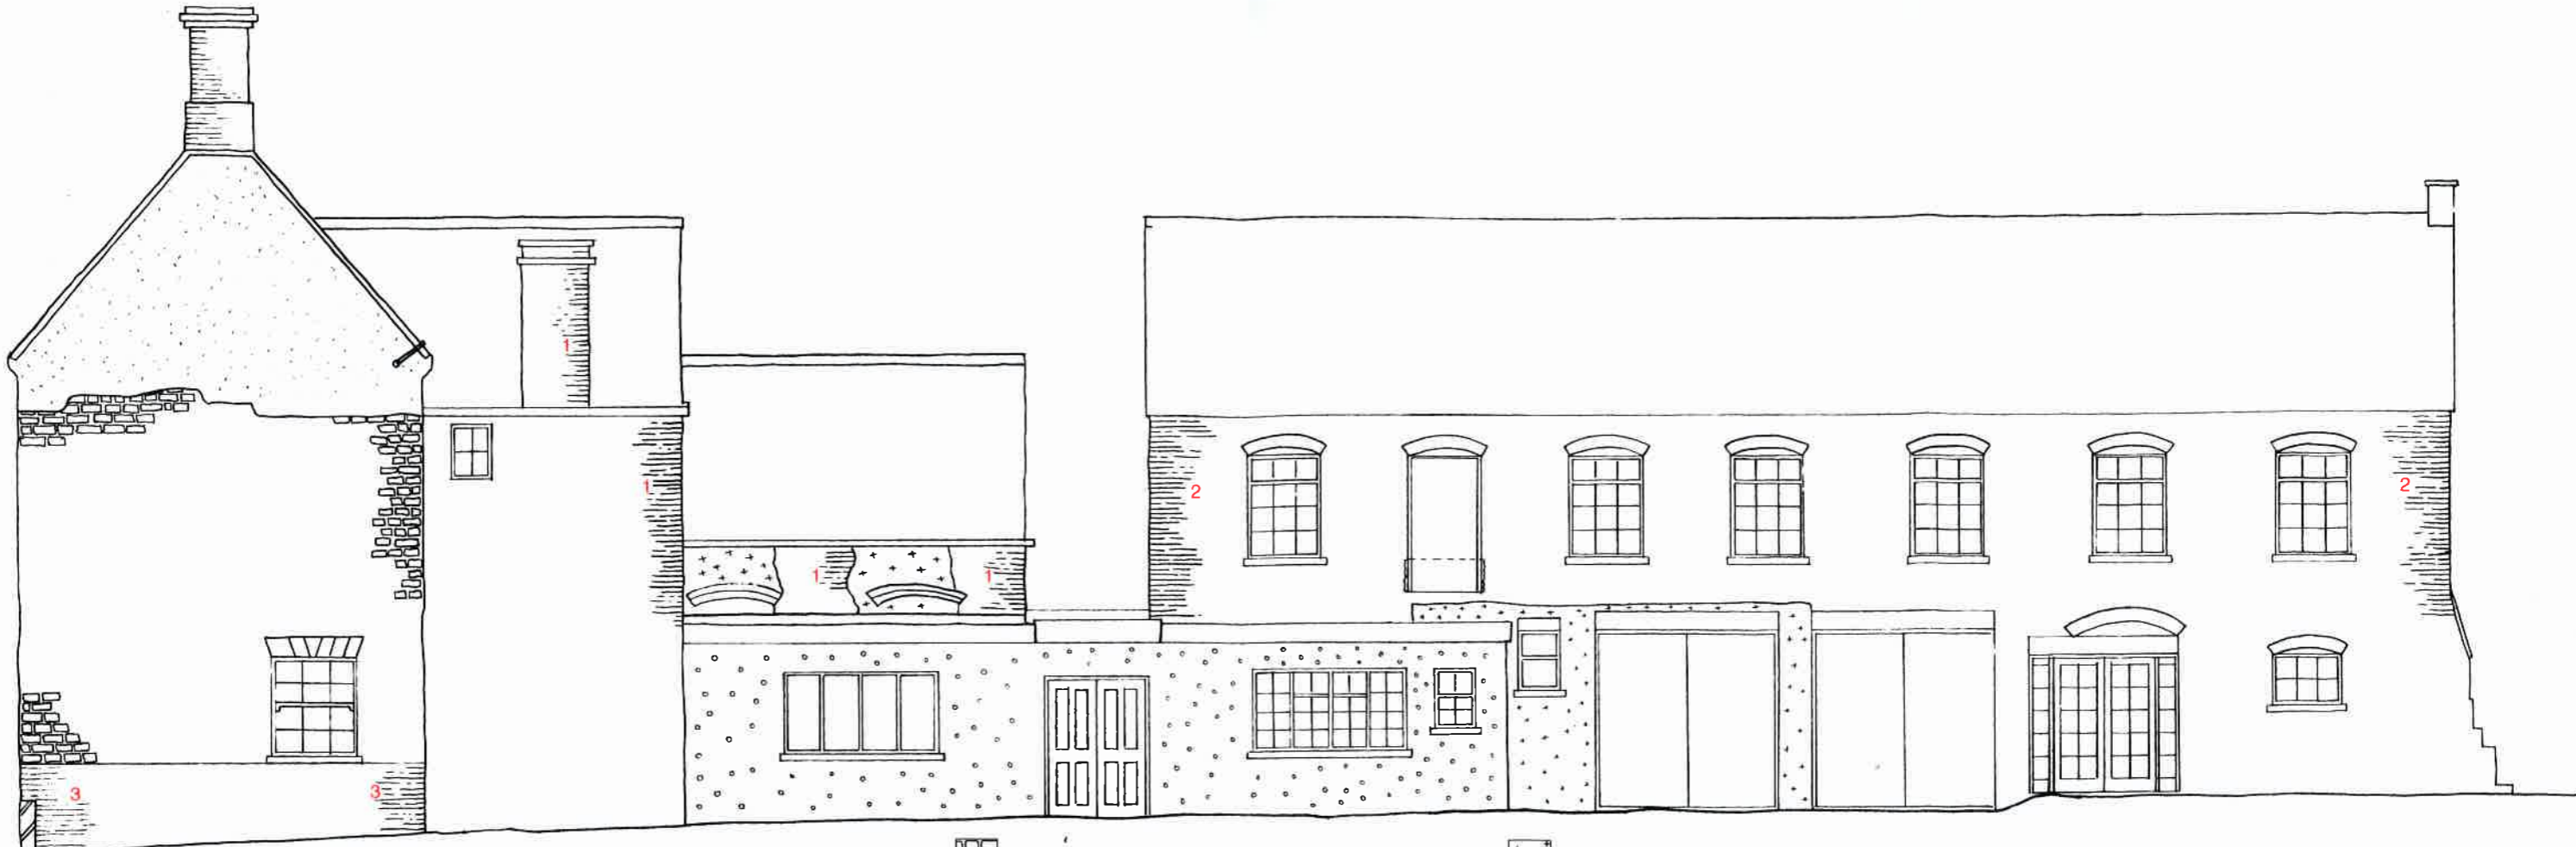
Figure 9: Elevations I

- 3.2.2 The *east elevation* consists of elements of all five phases of the Kings Arms. The gable of the original building is again of coursed ironstone set on a secondary blue brick plinth although the construction of the upper third of the elevation is obscured beneath a modern cement render. Presumably the whole elevation was previously covered with the render but most of it has come away or been removed. The only window is a single sash (6-over-6) at ground floor. There are raised stone roof ridges and a brick (18<sup>th</sup> century, probably primary) chimney stack at the apex. The side of the Phase III building is flush with the primary wall and is formed of 19<sup>th</sup> century red brick (Flemish bond 8 cm x 22 cm). There is a single small casement window below the eaves and a brick chimney stack primary to this part of the building. Behind the Phase III building, but projecting beyond it, is the similar Phase II projection again of 19<sup>th</sup>-century Flemish bond red brick. This has two brick segmental arches, reflecting the openings into the bar area within the building, but the wall is largely obscured by the single storey 20<sup>th</sup>-century link (Phase V) in front of it. The link is constructed of light brown brick (6.5 cm x 21 cm) and has a flat roof. It incorporates central double doors and 4-light mullion windows to either side. Beyond the link (and partially behind it) is the Phase IV range which would have originally been detached from the main pub. Although the rear of this range is of earlier brick this elevation is of 19<sup>th</sup>-century red brick (English bond 8 cm x 22 cm). There are seven first-floor openings each beneath brick segmental arches. Six of these are windows with upper casements and the seventh (2<sup>nd</sup> from the west) would originally have been a window but has been converted in the mid 20<sup>th</sup> century to a fire escape door onto the flat roof of the Phase V link.

- 3.2.3 The *west elevation* includes elements of Phases I, III and IV. The Phase I gable end is of coursed ironstone. Similarly to the east elevation the west elevation has raised roof ridges and a brick chimney stack at the apex. To the north of this is the side of the Phase II projection but this wall is entirely rendered thus obscuring its construction. To the north of this is the rear wall of the originally detached Phase IV range. The quoin of this wall (and the gabled south elevation of it) is of 19<sup>th</sup>-century red brick but the rest of the elevation is of earlier coursed, squared ironstone similar in character to the original part of the pub. The brick quoin is neatly keyed into the stonework and it is likely that the original stone building extended further to the south but that its end was capped at this point when the structure was rebuilt in the 19<sup>th</sup> century.

- 3.2.5 The most significant feature of the elevation is a 3 m wide former opening, to the south of the centre, which has now been infilled with pink 20<sup>th</sup>-century brickwork. The opening is created by a shallow 4-centred brick arch (probably 18<sup>th</sup>-century bricks) and the jambs are also of brick keyed into the stone. The opening allows access into what is now a narrow, overgrown passage adjacent to the higher ground level of the built-up car park but presumably there would originally have been a larger low area into which this opening would have exited. The most obvious suggestion that the wide doorway provides is that this building was originally a long stable block to the rear of the inn and that the Kings Arms served as a coaching inn where travellers could stay while passing through Desborough and their horses could be rested. It is likely that there would have been a similar wide opening in the east elevation prior to its conversion and it may be that the doorway was originally central which would mean that the original building's south end would be overlain by the north end of the current Phase II building.

former arched doorway in primary stables  
arch formed of 18th -century bricks

inserted window

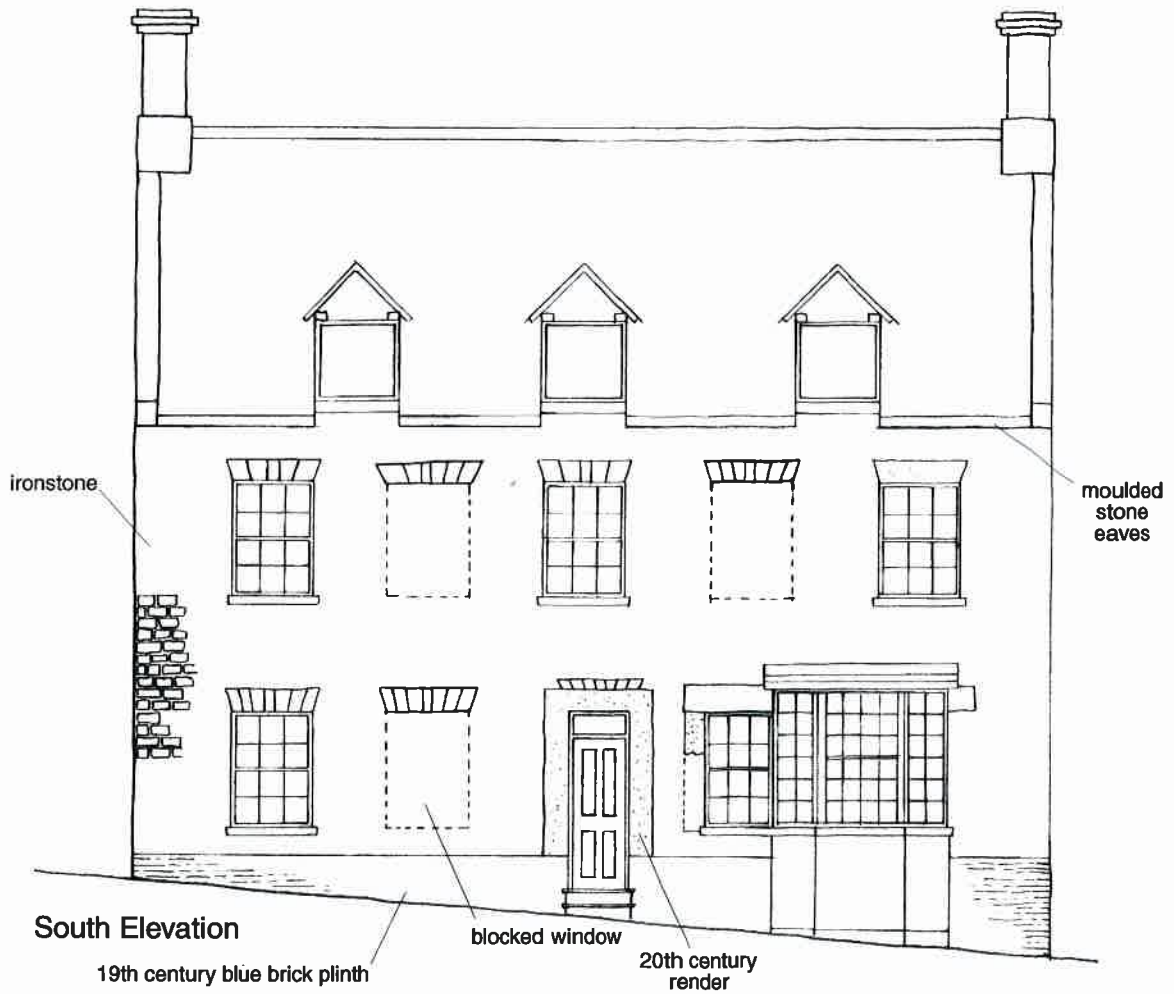
Figure 10: Elevations II

- 3.2.1 The *south elevation* (front) is entirely formed by the Phase I building. It is of squared coursed ironstone (average size 20 cm x 14 cm) set on a plinth which has been refaced with 19<sup>th</sup>-century blue bricks (English bond, 7.5 cm x 22). There are three first floor windows (6-over-6 sashes) each one beneath a lintel of stone voussoirs and a keystone. There are two further mid-spaced stone lintels showing that there must originally have been five first floor windows. The former windows have been blocked with ironstone keyed into the primary coursing. There is a central ground floor doorway surrounded by cement-rendered jambs and lintel but behind the cement render the top of a further similar stone lintel is visible. To the west of the door is a blocked window and a sash window, each beneath stone lintels, matching the arrangement on the first floor. The original arrangement has been lost to the east of the door and replaced by a secondary projecting bay window beneath a long timber lintel. There are three dormers within the roof which appear to be primary although the windows themselves are largely secondary. Each dormer sits immediately above a break in the primary moulded stone eaves although the sill of each is formed of secondary chamfered blue bricks. To each side of the roof there are plain stone raised ridges thus enclosing the roof slates.

19th century blue brick plinth

blocked window

20th century render

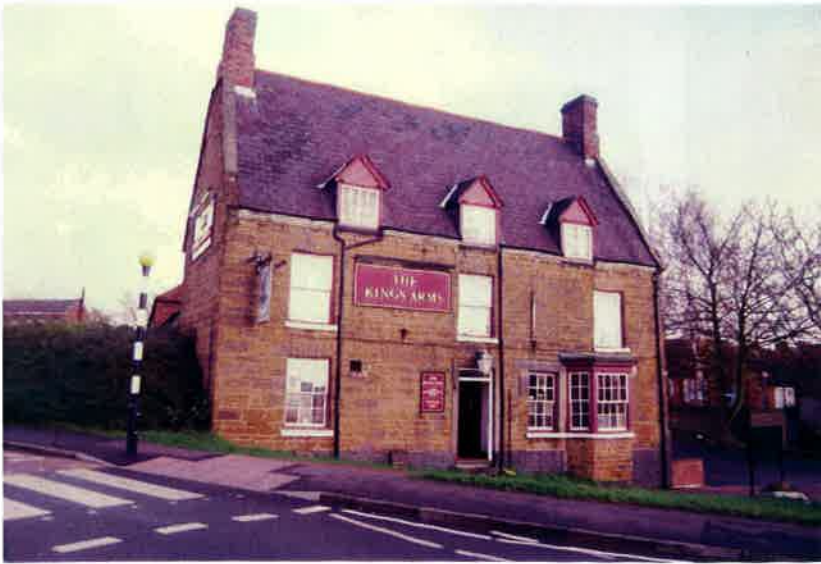
Plate 1: View of south front of Phase I pub

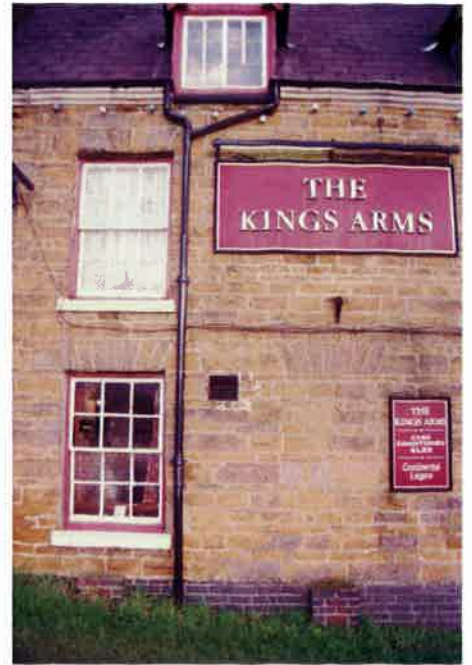
Plate 2: Detail of front of pub showing blocked window

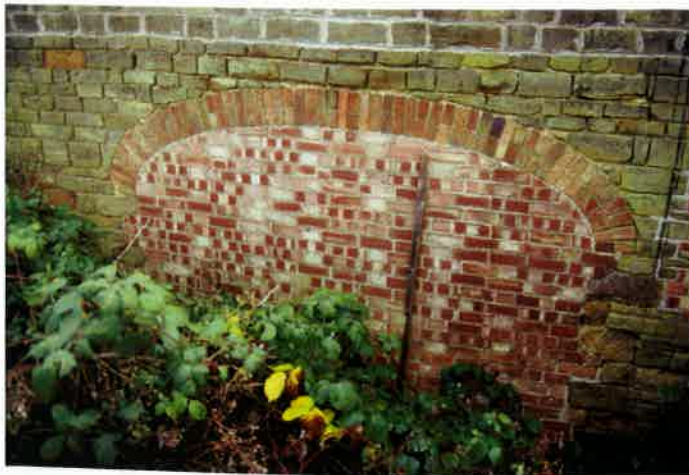
Plate 5: Blocked arched opening in rear of former stable block

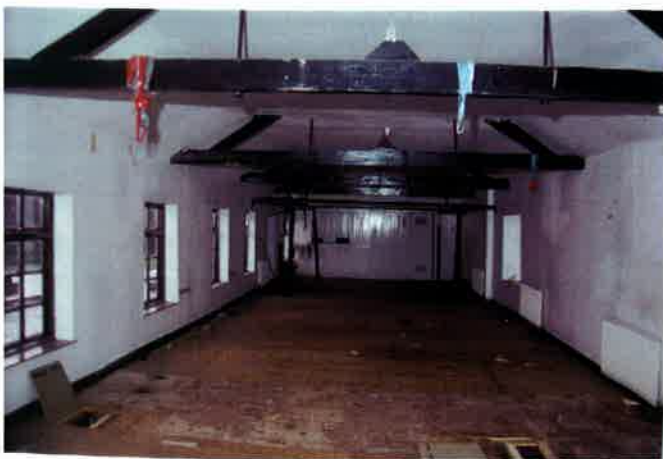
- 3.3.11 There is a modern ceiling the full length of the room, other than within the small boiler room at the south end where it is open to the roof, but the lower halves of four trusses are visible beneath the modern ceiling. The trusses clearly date to the 19<sup>th</sup>-century rebuilding of the Phase IV structure. Each truss consists of a tie beam (machine-cut softwood, 17 cm x 7.5 cm) and two principal rafters (14 cm x 7.5 cm). The principal rafters are secured to the tie beam by two evenly spaced, circular, iron tie-rods with square bolts to the undersides of the tie. Each principal rafter has a wedge-shaped block fixed to its upper face which supports a single purlin which runs over the principal. The common rafters run over the purlin (rather than being notched or tenoned) and thus there is a gap between the roof slope and the principal rafters. On the upper face of each tie beam, at its central point, is a triangular shaped softwood block with a semi-circular shape cut in its apex. Presumably the blocks acted as bearers for a circular horizontal bar (or shaft) along the length of the building. The bearers look relatively historic (probably 19<sup>th</sup> century) but they are clad in black paint thus largely obscuring their age and nature.

Plate 11: Interior of first floor of Phase IV building

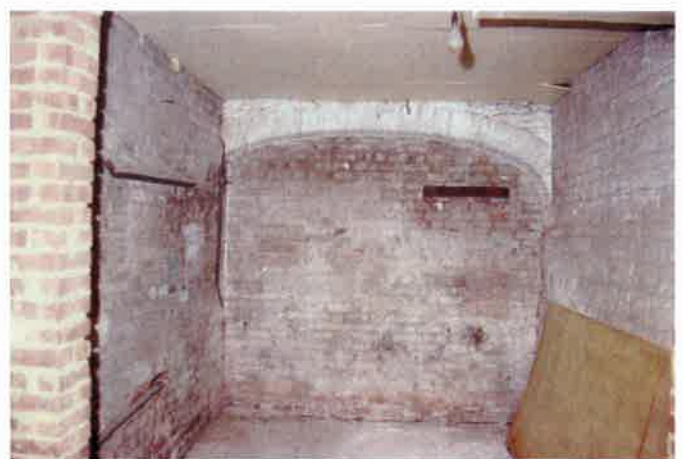
Plate 12: Internal view of blocked arch in former stables

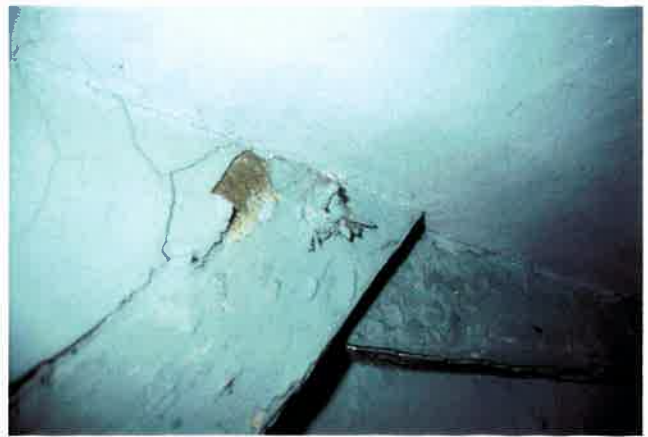
- 3.3.17 An unusual feature of each of the two trusses is that although the collar is tenoned to the principal rafter the joint in each case is secured with an iron forelock bolt rather than a conventional timber peg. Each iron bolt is circular in section and has a round head to its west side. On its east side the bolt's face has been flattened and a slit created in it like a needle. An iron wedge passes through the eye to secure the bolt and there is a circular washer between the wedge and the collar. Due to each truss being partially plastered over the northernmost joint on each of the two trusses is obscured but similar forelock bolts are visible in the southern joint of each truss.

Plate 14: Detail of forelock bolt in truss between S1 and S2
