Electrical Infrastructure at Hertford College, Oxford

Archaeological Watching Brief Report

December 2020

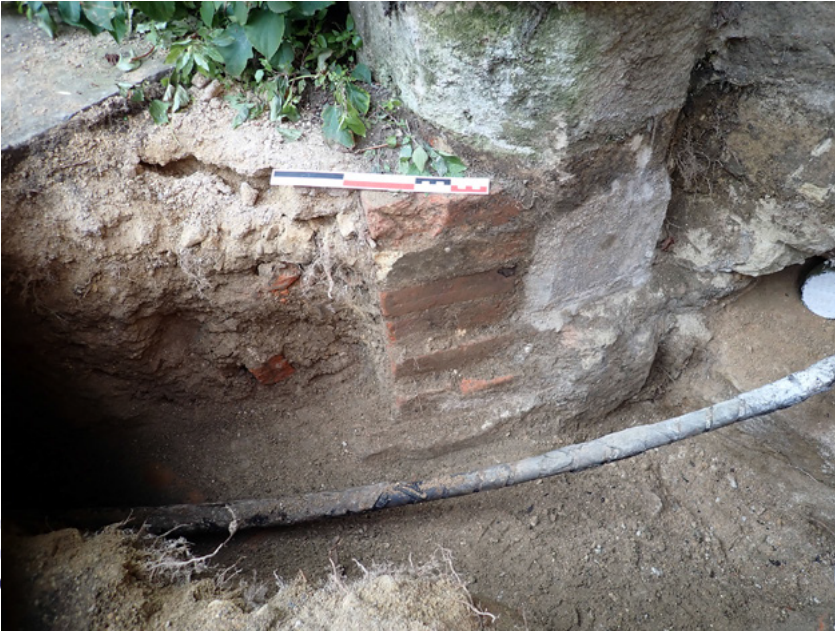
3.5.2 The earliest archaeological feature encountered within Trench 2 was the limestone foundation wall, 205, for the existing building (204). This was encountered at 0.18m bgl (63.33m OD) and was exposed to a depth of 0.60m bgl (62.91m OD). Part of either a later brick repair, 203, or perhaps a later garden structure, was seen abutting 205. This was encountered at 0.08m bgl (63.43m OD), at the western extent of the trench. No construction cut for either structure was observed.

Plate 1: Trench 2, showing foundation wall 205, looking south

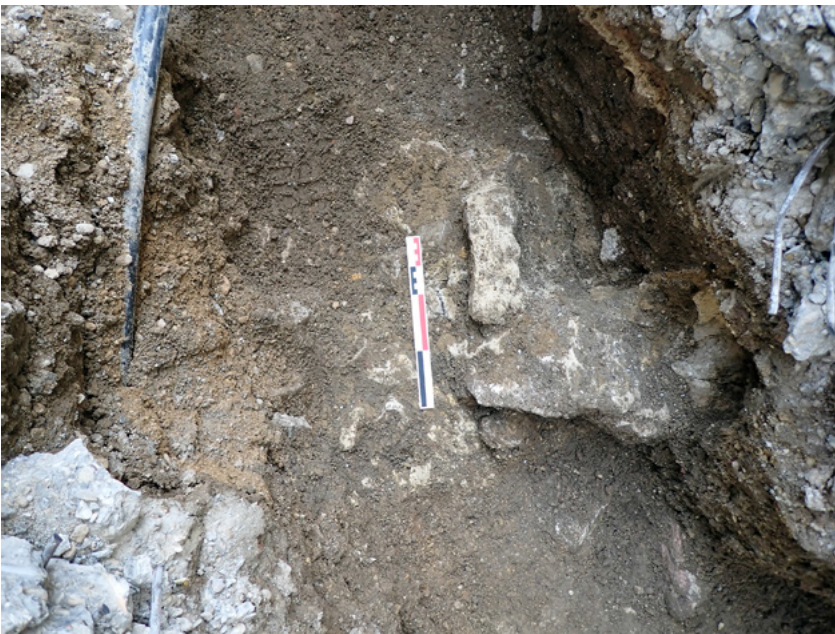
3.6.3 Foundation wall 309 was encountered at 0.50m bgl (61.84m OD). It measured 0.40m wide and was exposed to a depth of 0.26m. It continued beyond the limits of excavation, and was abutted on the N-W face by garden soil 316 which was encountered at 0.60m bgl (61.74m OD). This appeared as a firm mid greyish-brown clayey silt containing occasional inclusions of charcoal flecking, degraded ceramic building material, subrounded flint gravel, and burnt limestone fragments.

Plate 2: Trench 3, showing wall 309, looking south-west

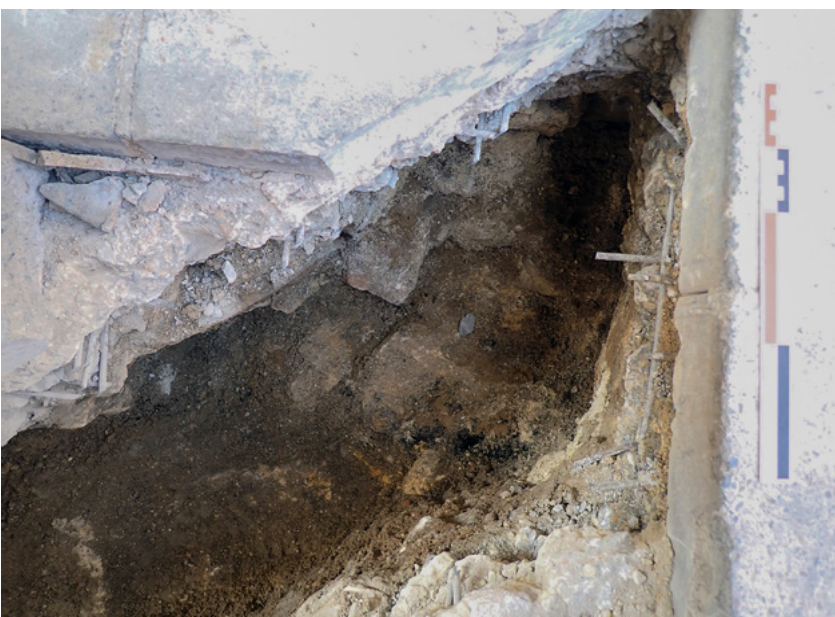
3.6.7 Foundation wall 322, located just north of foundation wall 309, was encountered at 0.28m bgl (62.06m OD). It measured 0.65m long by 0.55m wide and was exposed to a depth of 0.26m. It continued beyond the limits of excavation and was overlain by modern made ground 324.

Plate 3: Trench 3, showing wall 322, looking east
