Newhaven Flood Alleviation Scheme East Sussex

Archaeological Evaluation Report

December 2016

Client: JacksonHyder

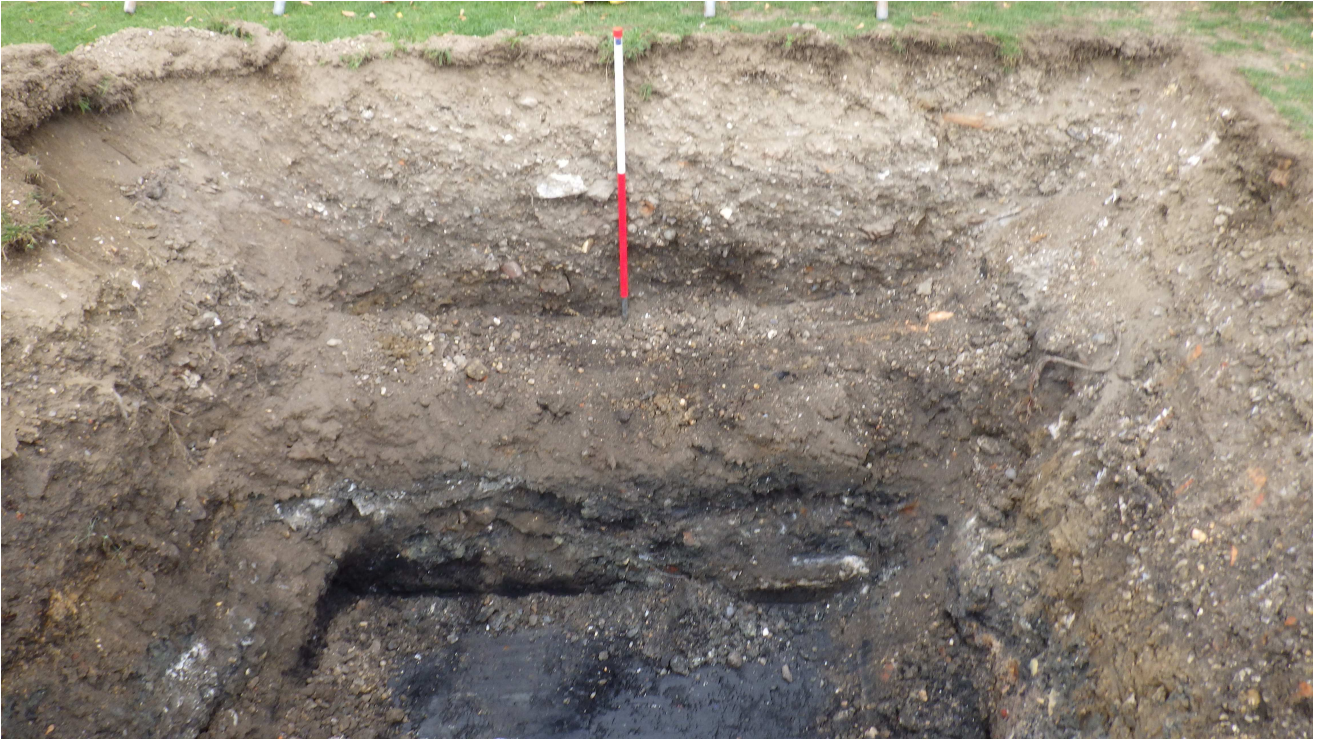
Plate 1: Trench 3; section 300, facing south-west

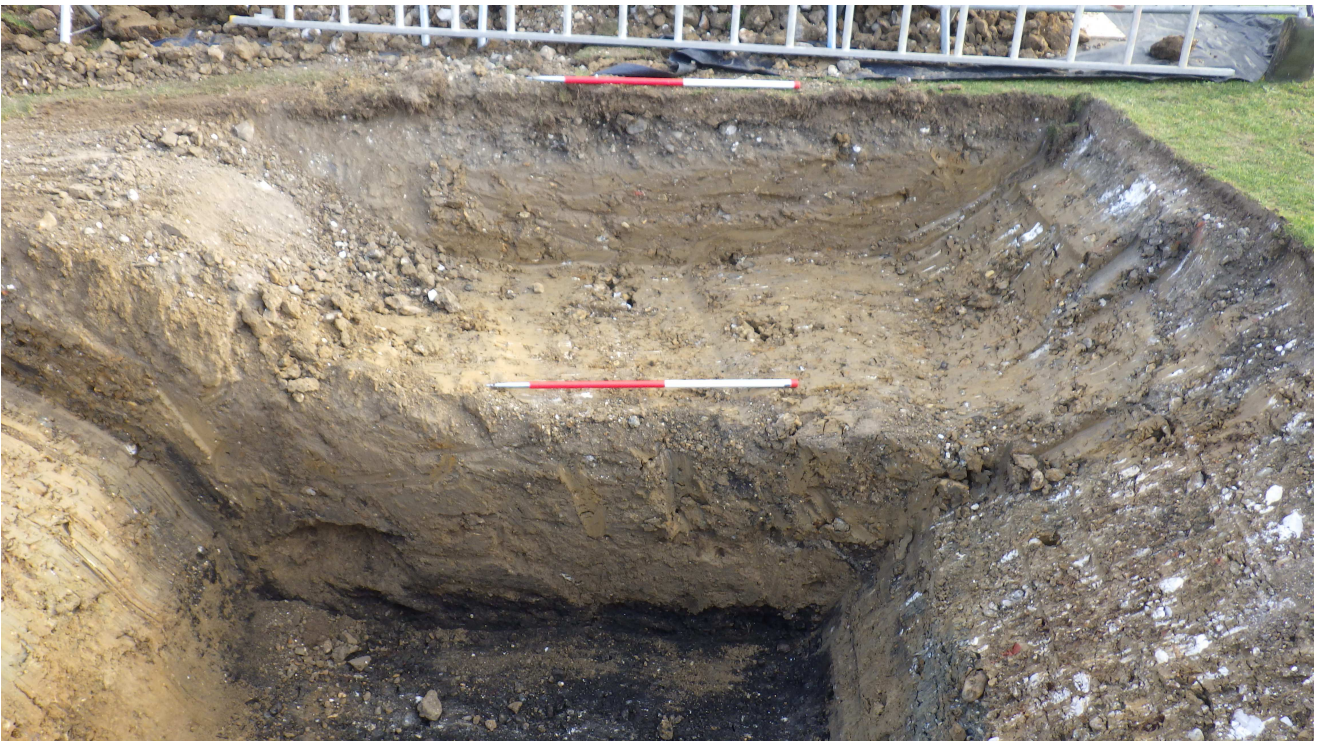
Plate 2: Trench 4; section 400, facing east

- 3.5.3 Overlying layer 406 was a black demolition/levelling deposit, 405, comprised of sand, pebbles, charcoal, ash, decomposed wood, rusted metal and coal dust. A brick and a brick fragment of 18th–19th century date and a brick fragment of 17th – 18th century date were recovered from deposit 405. A copper alloy strip was also recovered from this deposit.

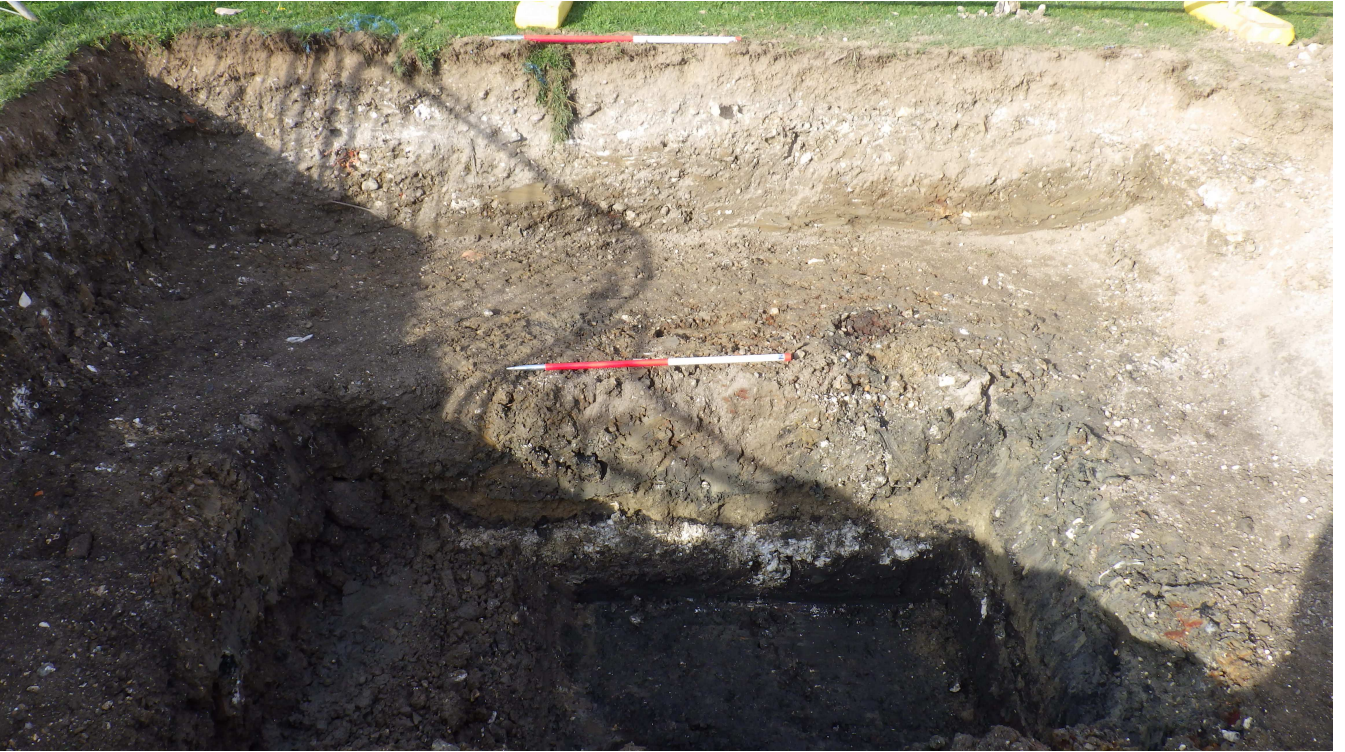
Plate 3: Trench 6, section 600, facing north-west

- 3.7.1 Trench 6 was located along the western side of the riverside park area, to the south of Trench 5.
- 3.7.2 A hand-dug sondage slot was excavated at the base of the trench to expose layer 609, which was composed of chalk blocks and dust compacted into a levelling deposit.
- 3.7.3 Overlying layer 609 was a black demolition/levelling deposit, 607, comprised of silt, grit, charcoal, ash, rusted metal and coal dust. A fragment of post medieval handmade moulded brick, dating from the 17th–early 19th century, was recovered from deposit 607.

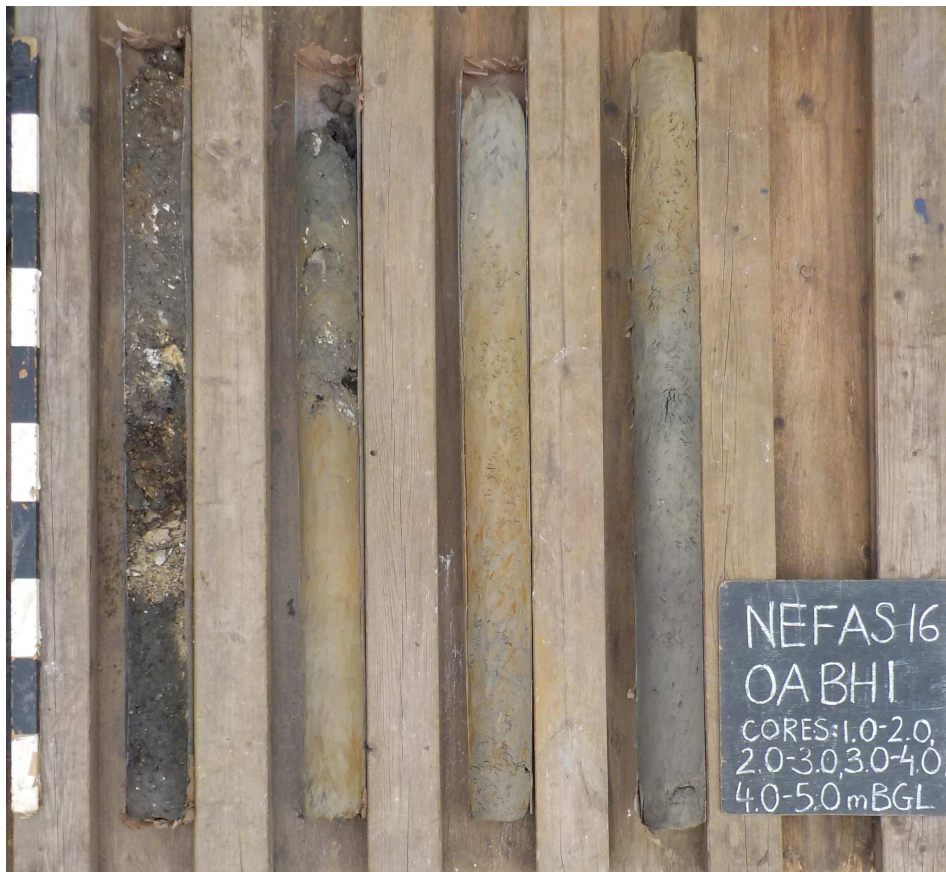
Borehole sequence OABH1 (1m scale)

The borehole survey identified a sequence of alternating silts and sandy deposits, representing estuarine sedimentation below various ground made-up layers. No evidence of peat deposits or the presence of Head gravels were noted within the samples.

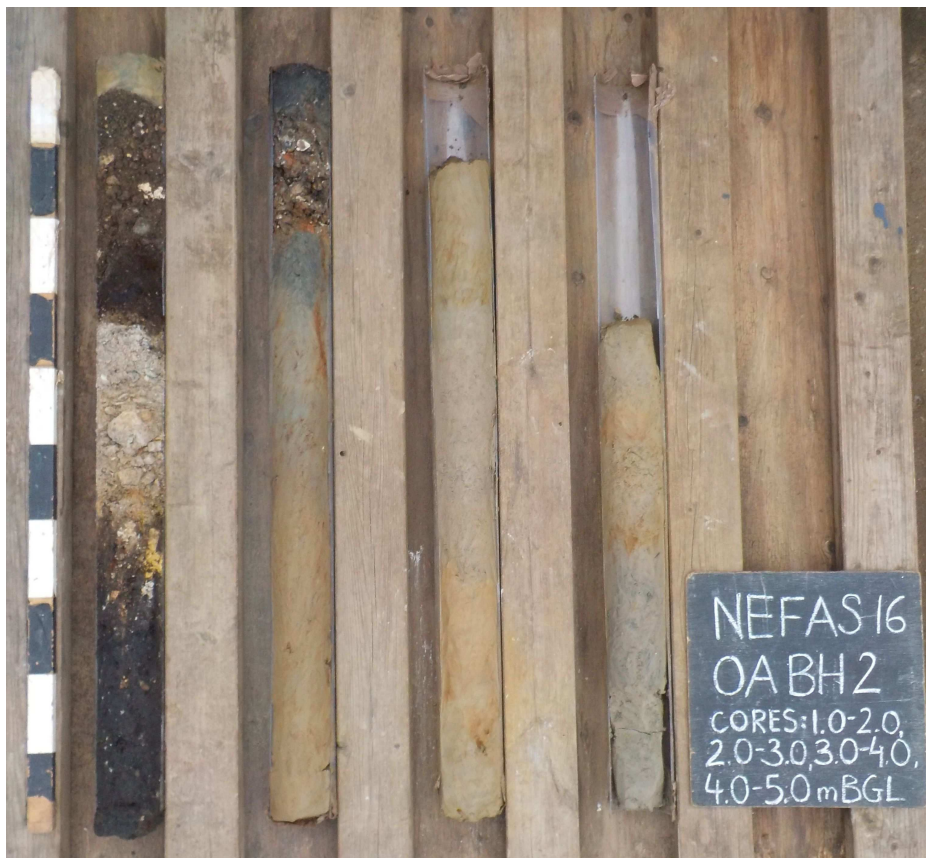
Borehole sequence OABH2 (1m scale)

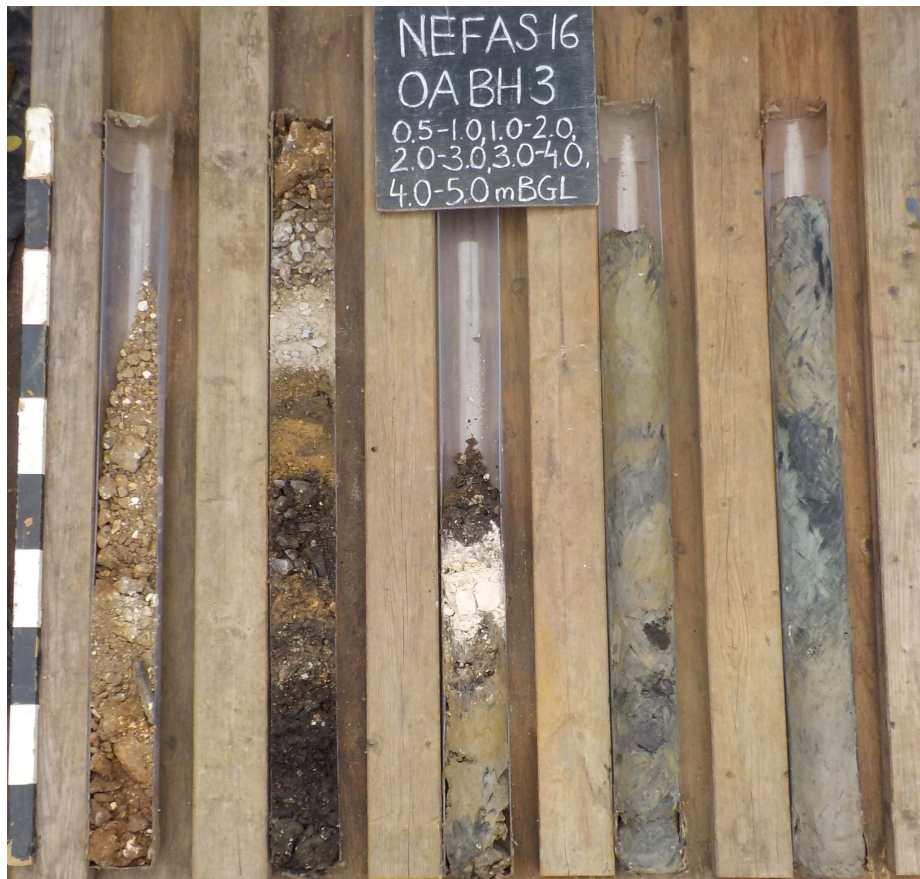
Borehole sequence OABH3 (1m scale)

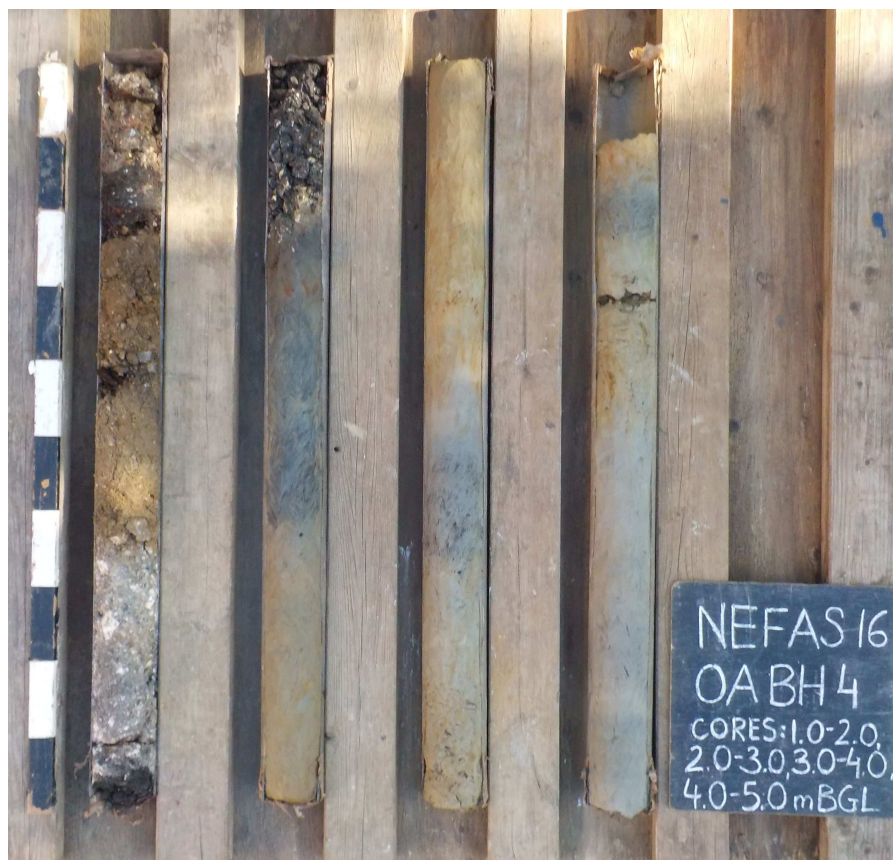
Borehole sequence OABH4 (1m scale)
