Dorchester Abbey Tower Dorchester on Thames Oxfordshire

**Building Recording and
Watching Brief**

**Dorchester Abbey Tower,
Dorchester on Thames
Oxfordshire**

Historic Building Investigation and Recording

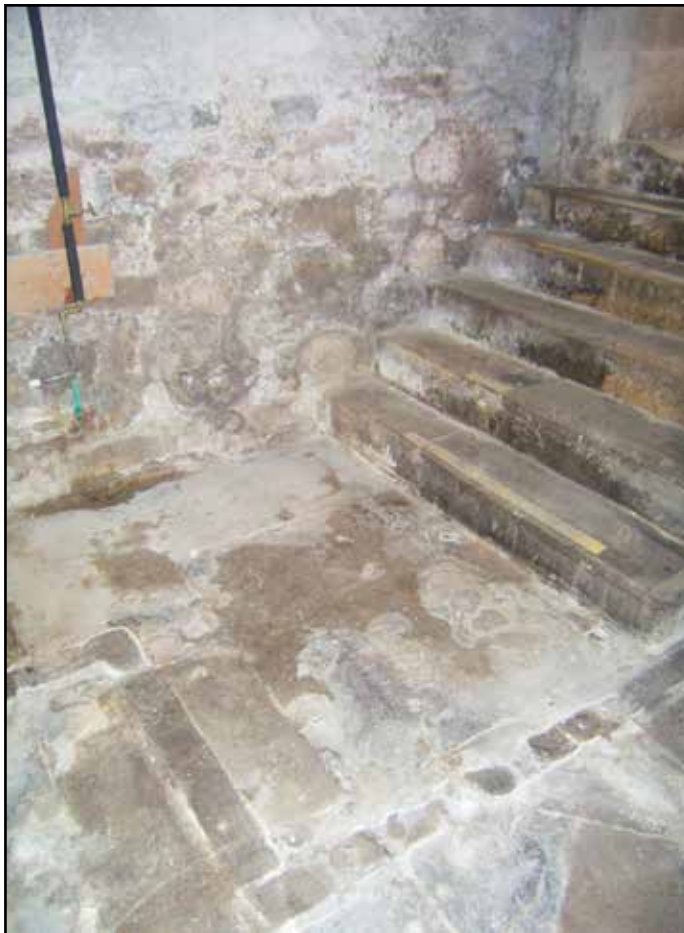
4.4.1 This is in the north- west corner of the tower, to the west of the entrance steps. It is orientated north-south and measures approximately 0.8m by 0.8m. Stone flags to the depth of 0.05m were removed (400). A stone, mortar and flint rubble layer was beneath this to 0.85m, this was probable building debris (401). Beneath this, a dark grey to black organic silt was uncovered to the eastern edge of the pad (402). Animal bone was recovered from (402). It is possible (402) represents the further edge of a pit, as was seen in Foundation Pad 2, but not enough was uncovered, to be certain.

Plate 14. Area of Foundation Pad 4

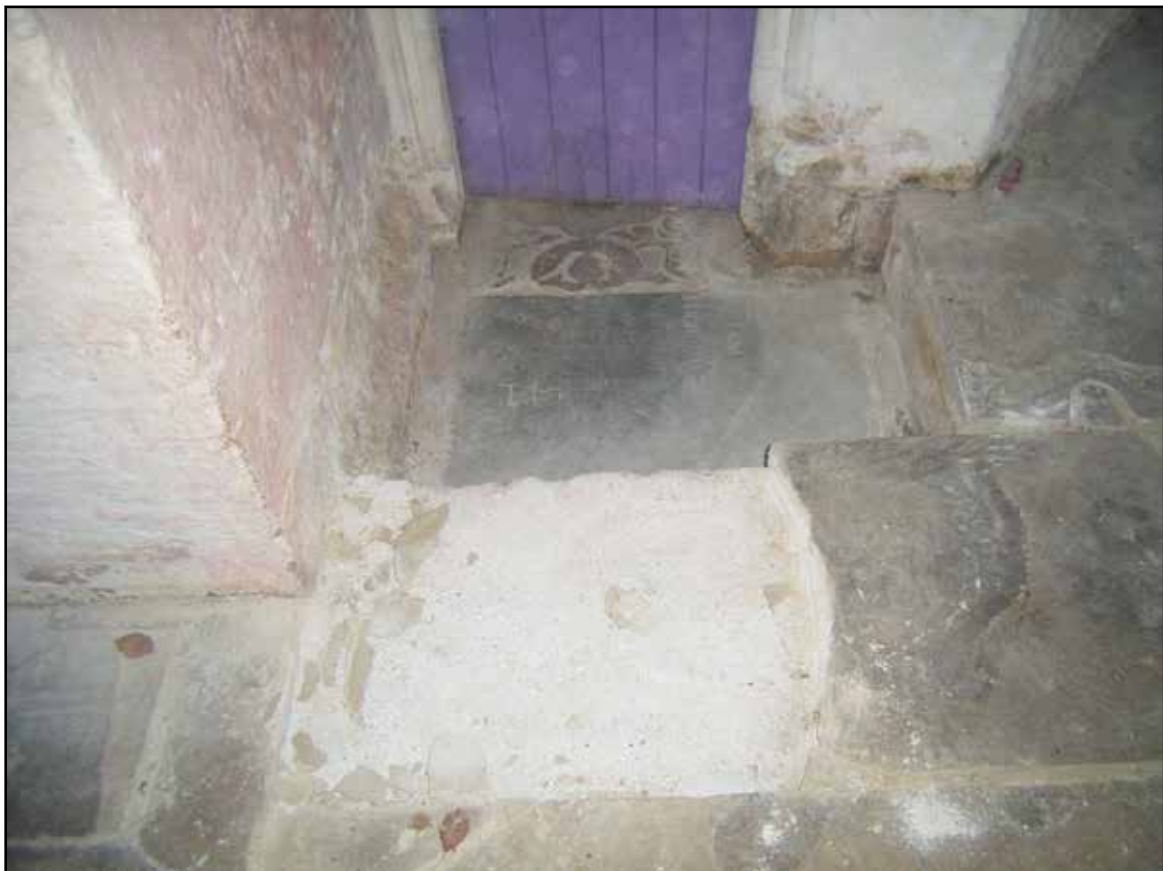
4.6.1 This is in the north-west corner, to the north of the entrance steps of the tower. The trench is aligned east- west and measured 0.6m by 0.4m. A stone flag (600) of 0.05m was removed and beneath this a stone, mortar, flint rubble, which was probably building debris, was located (601). This was to a depth of 0.35m. Once this was removed, the original stone foundations (602) of the tower were recovered, which prevented any further excavation. A grave stone, on an east-west alignment was also recovered. This restricted the extension of the Foundation Pad and extension to the north was disallowed.

Plate 20. Foundation Pad 6 during excavation

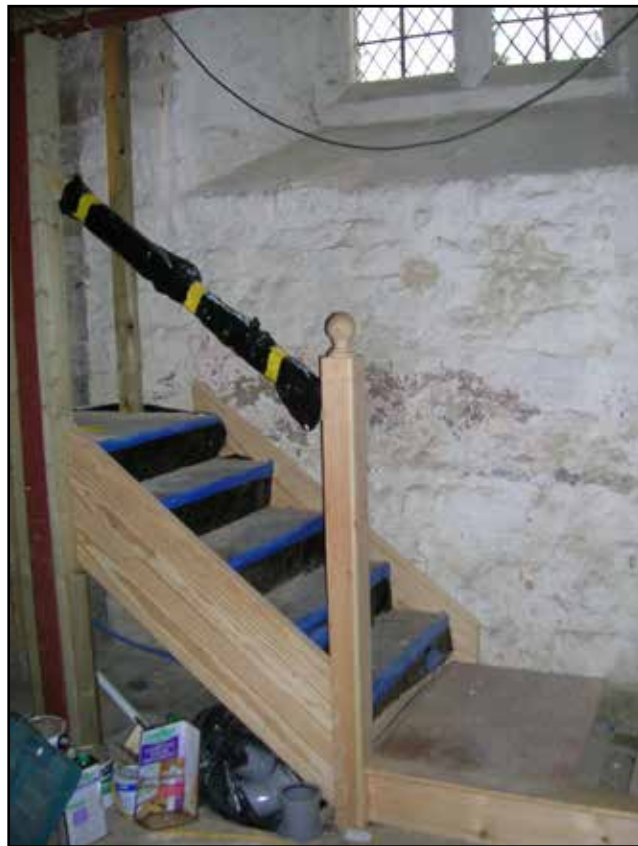
4.7.3 The erection of a new staircase to lead to the doorway on the north elevation and to provide access to the two new floors was, also, constructed and, subsequently, recorded using photography. The new staircase appears to go over the top of the already existing entrance steps. It is possible these are still intact beneath the new renovation work.

Plate 24. Erection of staircase
