St. Giles' Church, Oxford

ARCHAEOLOGICAL WATCHING BRIEF REPORT

Oxford Archaeological Unit
March 2001

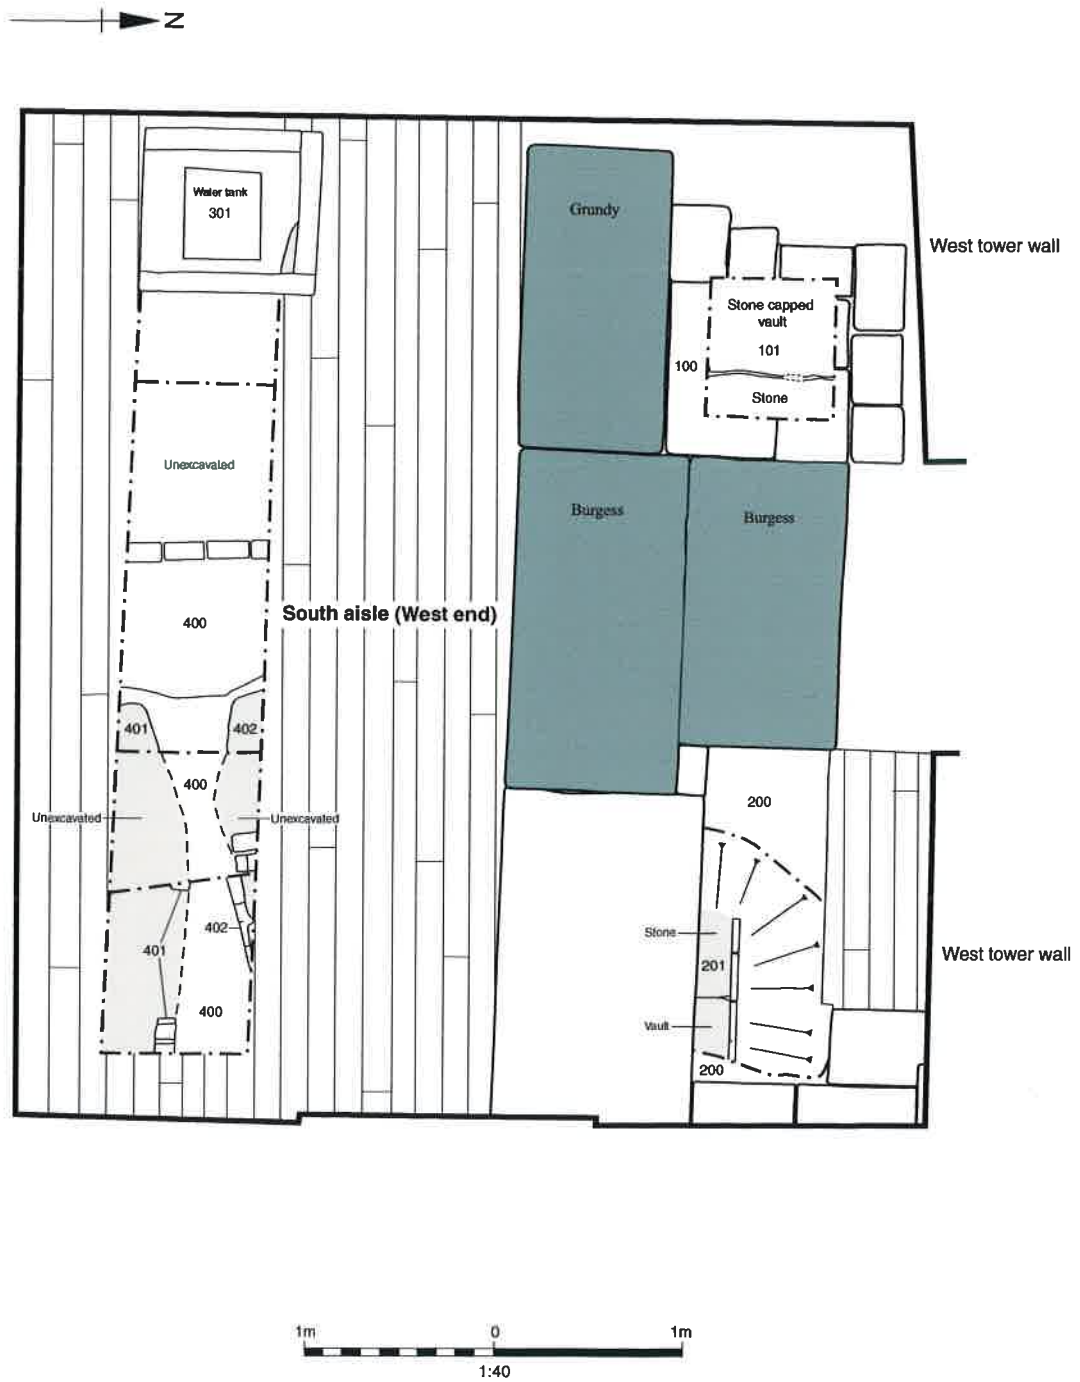
Figure 2 : Plan of watching brief observations.

The excavation work took place at the west end of the South Aisle in the area partly covered by existing marked grave stones (Burgess et al, Fig. 2) . A general layer of make-up material for the present church wooden floor was observed during all intrusive work. The layer (100=200=300=400) comprised loose grey-brown sandy gravel containing fragments of previously disturbed human bone and occasional pieces of coffin furniture. The layer was generally 0.65 m thick and overlay a number of brick vault structures that were partly exposed in the course of the works. In total four were observed, together with a brick structure interpreted as a water tank of recent build.

At the west end of the South Aisle adjacent to the tower was a stone capped brick vault (101) measuring 0.7 m by 0.75 m as exposed. The bricks measured 120 mm x 240 x 80 mm and were bonded with a grey-white cement, constructed in layers of staggered stretchers. The capping stones were roughly cut slabs and un-

mortared. The vault contained at least one lead or lead-lined coffin that was not further investigated.

East of 101 lay a stone capped brick vault (201), with the same brick type and bond. The vault measured 0.7 m by 0.3 m, but was only partly uncovered. Two wooden coffins were seen within the vault; the upper coffin had collapsed although the lower one was well preserved.

In the south-west corner of the South Aisle was a brick structure (301) measuring 0.65 m x 0.88 m and 0.6 m deep. The bricks were coated in lead paint. The structure may have served as a water tank - some rendered stone at the north-east side of the structure hinted at the presence of a further stone-capped brick vault.

Along the south wall of the South Aisle were two further vaults: a partly demolished brick vault (401) had previously been opened. The construction type and build was the same as structures 101 and 201- the structure survived in parts for a length of 1.9 m. The brickwork was infilled with the general floor make-up material (400). A second vault (402) was brick-built with part of the stone capping *in situ*. The construction method and brick types were the same as for 101, 201 etc., but there was no evidence for a coffin.
