AN INVESTIGATION OF A VICTORIAN PAPER HOUSE

ARCHAEOLOGICAL AND PHOTOGRAPHIC RECORD IN ADVANCE OF DEMOLITION

OXFORD ARCHAEOLOGICAL UNIT
JUNE 1998

NMR DATA	
SITE NAME	PAISLEY HOUSE
ADDRESS	436 ABINGDON ROAD, REDBRIDGE, NR. COLD HARBOUR
TOWN	OXFORD
PARISH	SOUTH HINKSEY
COUNTY	OXON
NGR	SP 5172 0380
LISTED STATUS	GRADE II
VISIT/SURVEY DATE	APRIL-MAY 1996
OAU SITE CODE	OXABPH 96

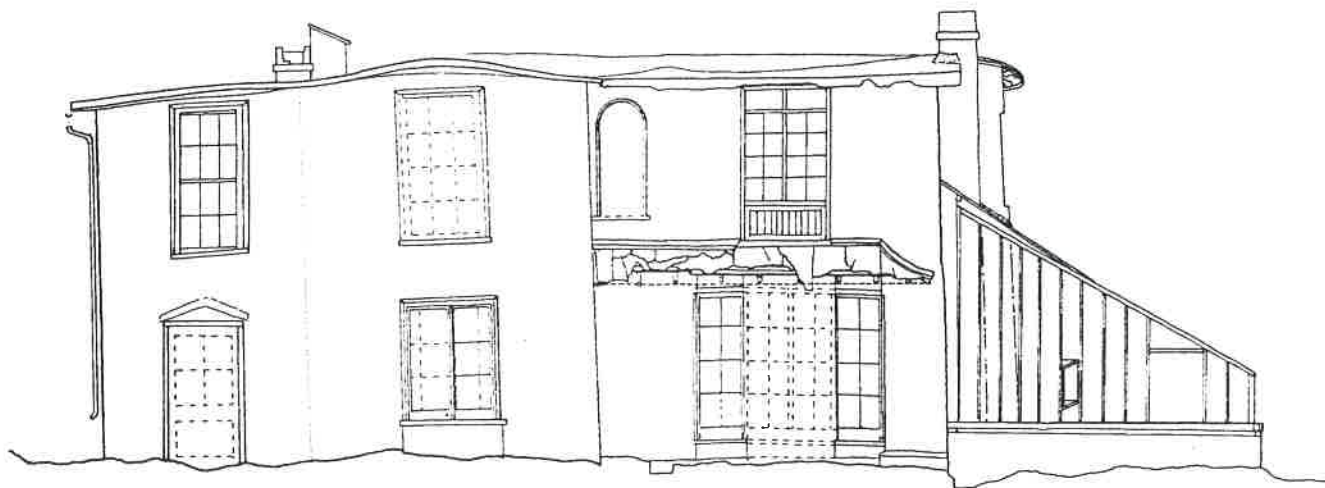
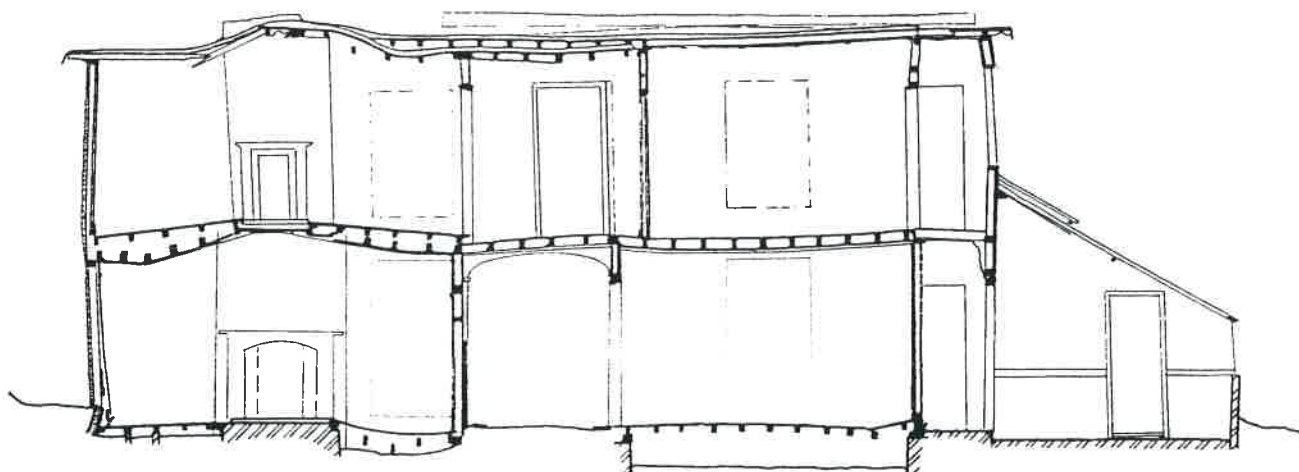
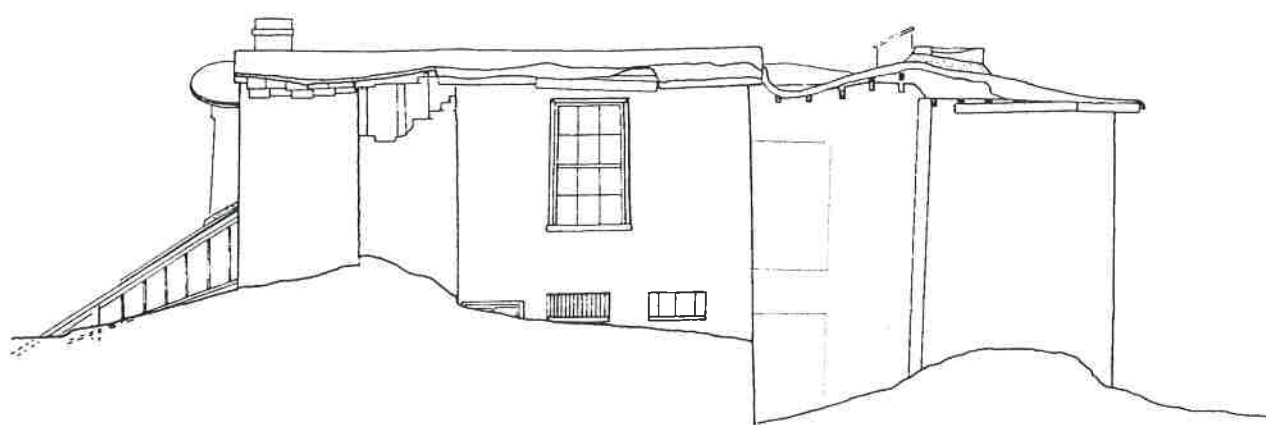
Fig 5 Paisley House: longitudinal section and north and south elevations

North Elevation

Section at A-A'

South Elevation

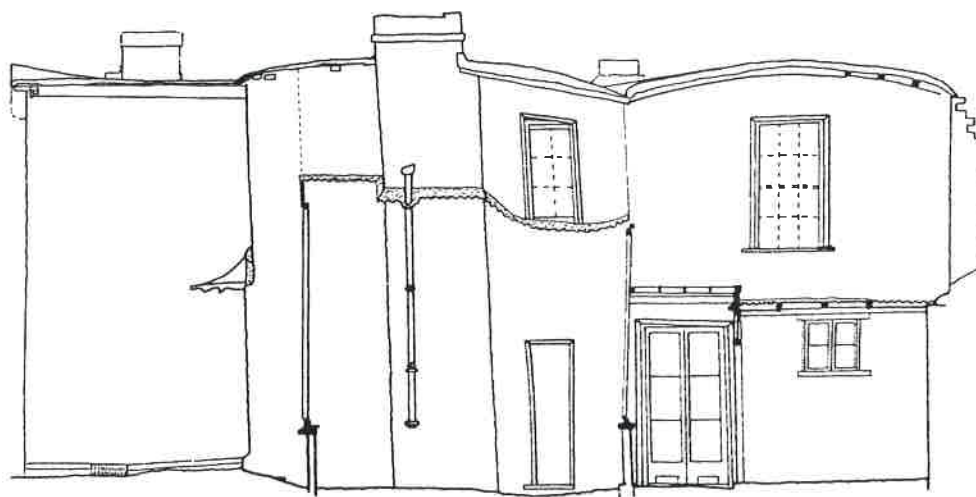
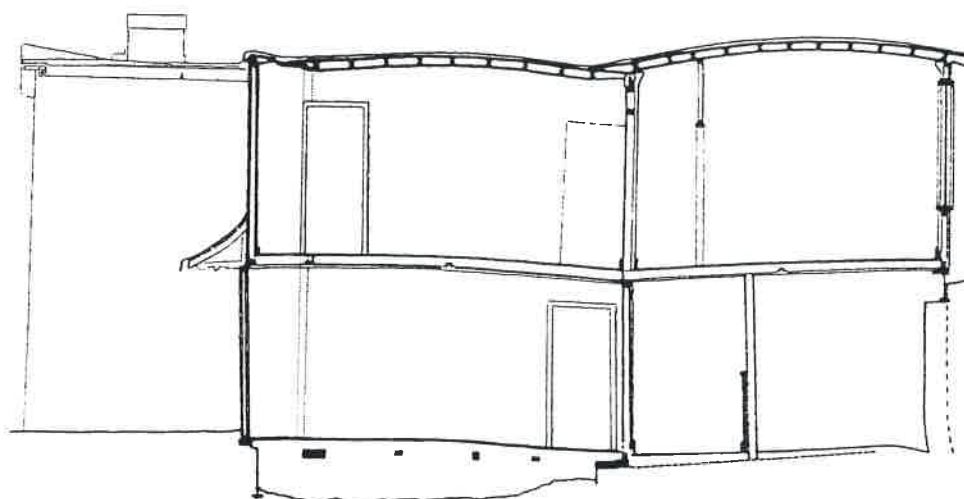
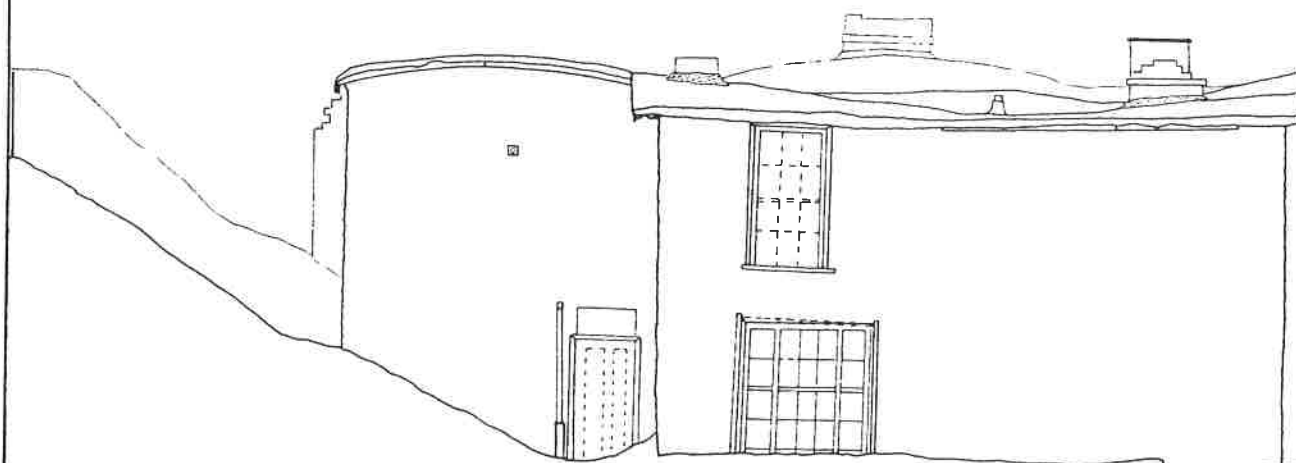
Fig 6 Paisley House: transverse section and east and west elevations

West Elevation

Section at B-B'

East Elevation

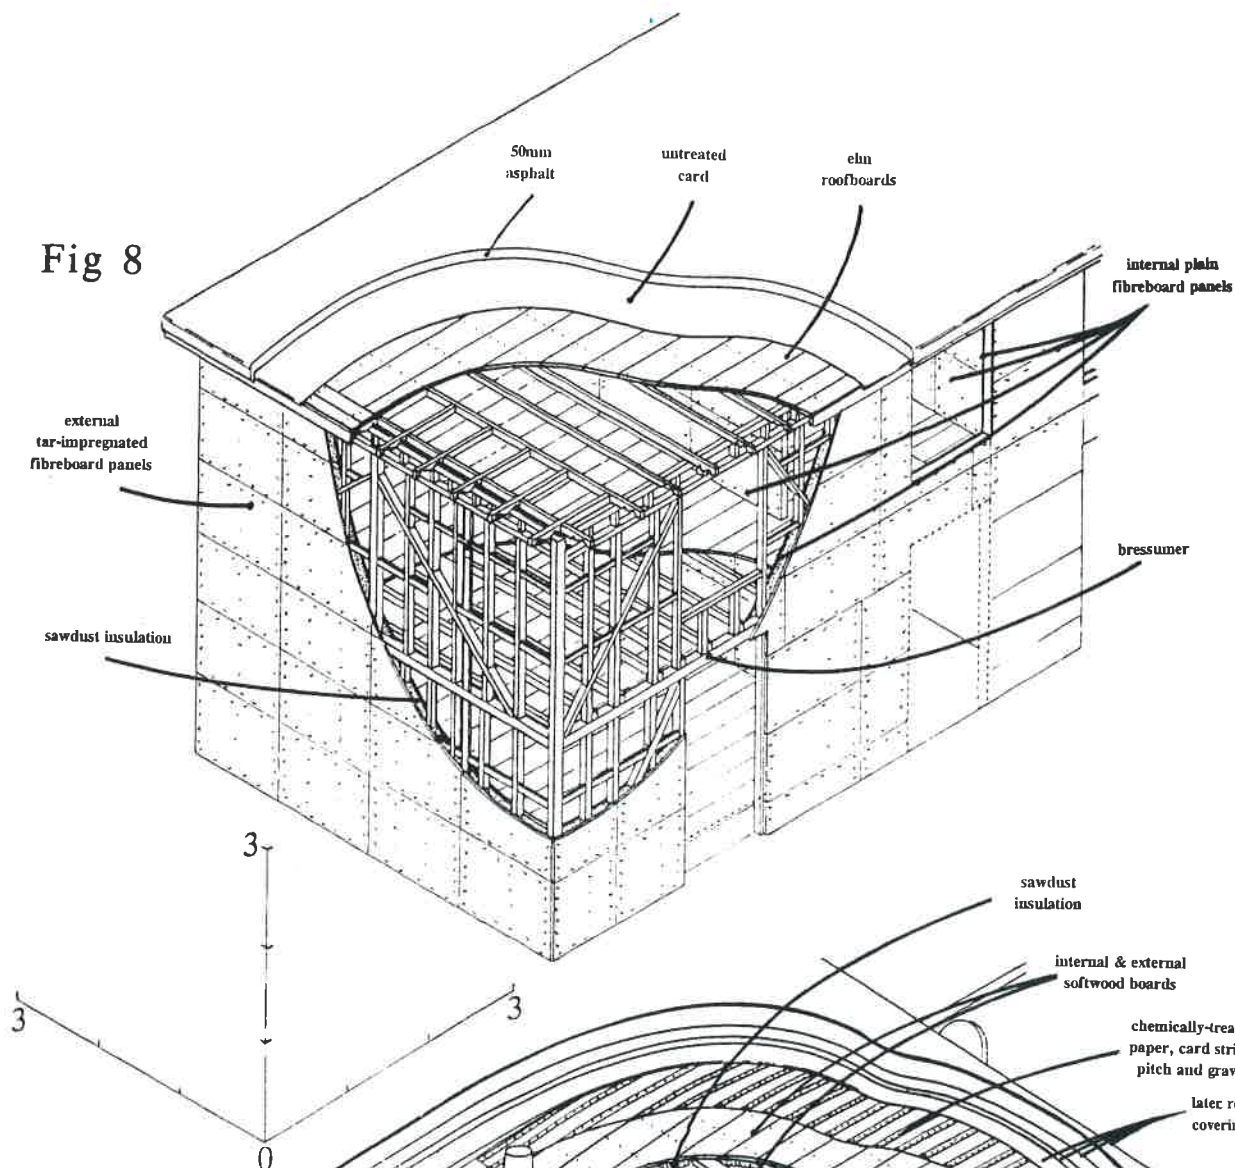
Fig 8 Paisley House: axonometric projection showing construction of phase I building from the south-west (restored)

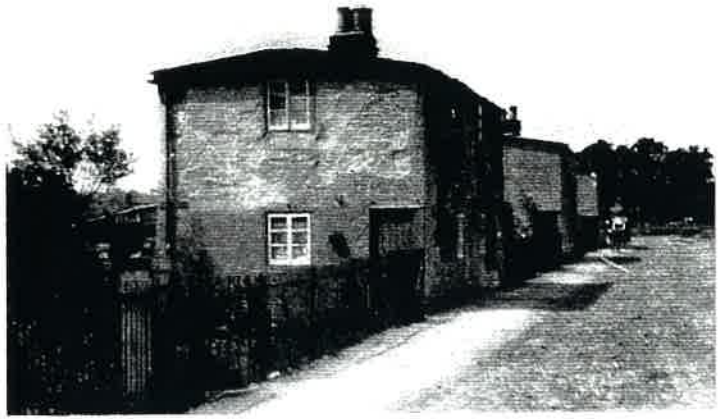
Plate 2 (Above) Towle's cottages in Wiers Lane, shortly
before demolition, June 1923
(Bodleian Library M.S. Top. Oxon. d.493, fol.59r bottom)

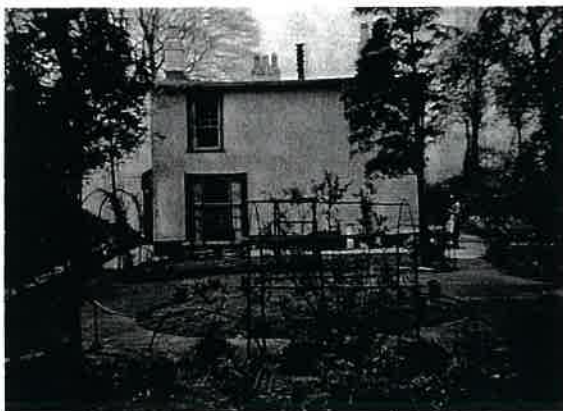
Plate 3 Paisley House, east elevation c.1950
(Courtesy Rosemary Johnson)

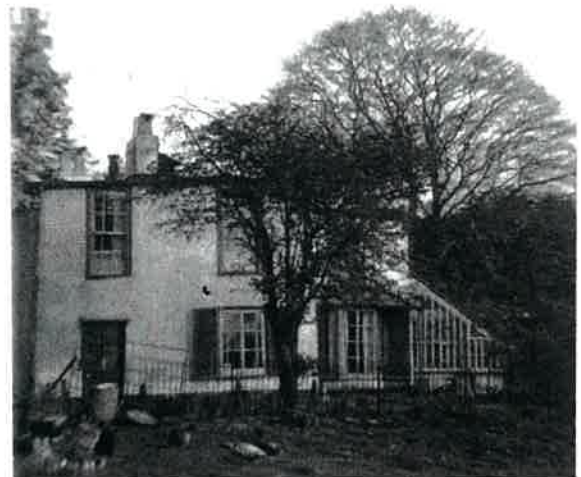
Plate 4 Paisley House, north elevation, April 1953
(Courtesy Rosemary Johnson)

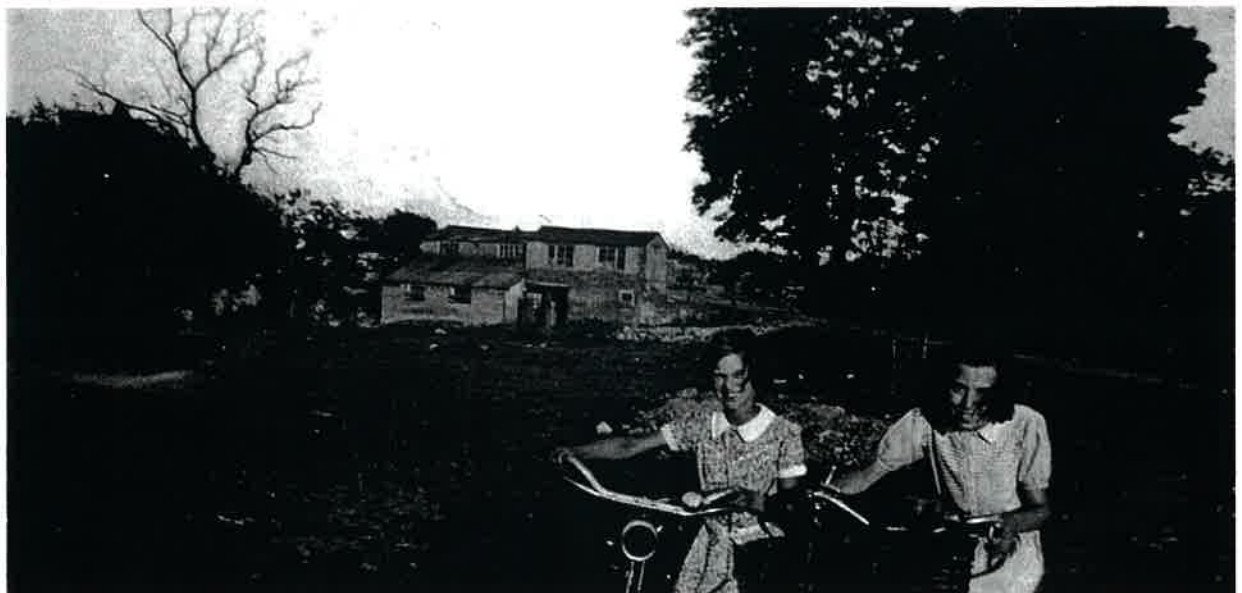
Plate 5 View from the north showing the sheds built to the east of Paisley House, probably as part of the Turner's dairy/smallholding
(Courtesy Rosemary Johnson)

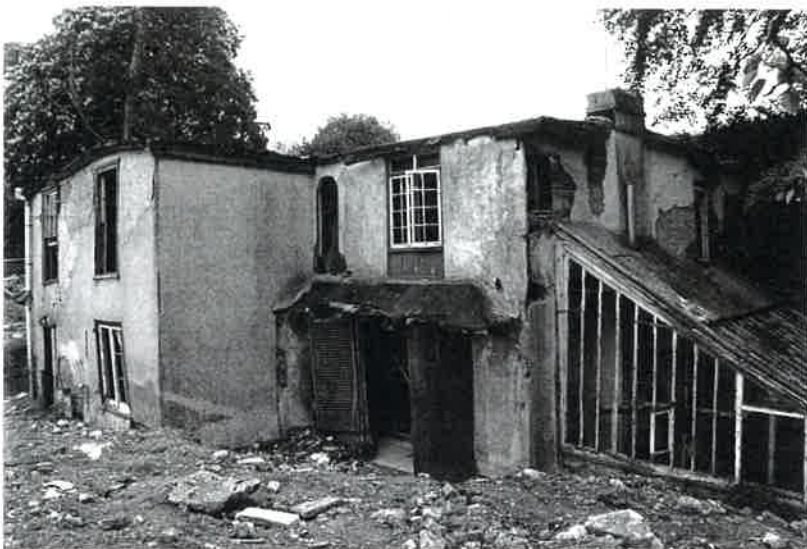
Plate 6 Paisley House from the north-west, shortly before demolition

4.9 *Phase IX (Plates 6 & 9) D/P (2nd extension)*
(Lath & scribed render walls)

4.10 *Miscellaneous additions (Plates 6 & 9) Conservatory (U) and other structures*
(Brick & timber)

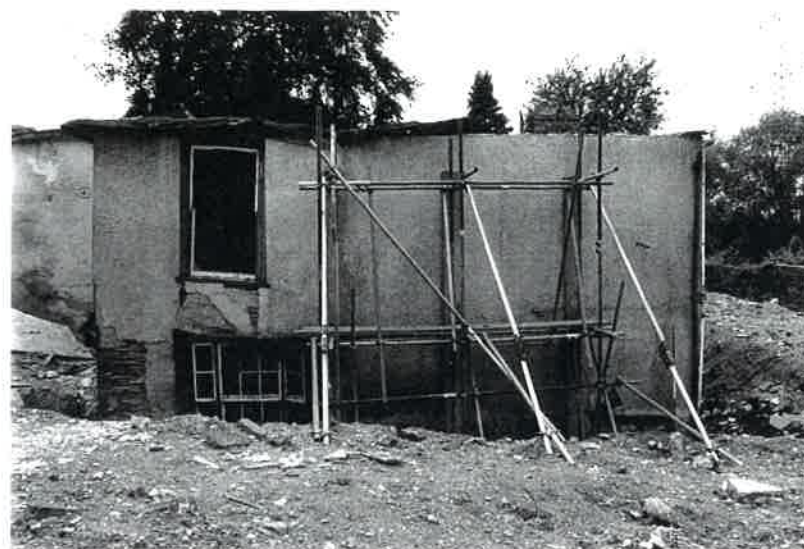
Plate 7 Paisley House, east elevation

- 4.4.3 *Roof* The roof of the extension was flat and composed of 70x55mm rafters. Dummy stub-rafters were built into the south wall. These were shaped to match the ogee profile of the phase I soffit detail (plate 7). The rafters were clad on the exterior with 275-300x10mm softwood boards covered with thin treated paper, card strips, pitch and a gravel. The new section of roof abutted and incorporated the rafter ends and soffit of the phase I roof (plate 35).

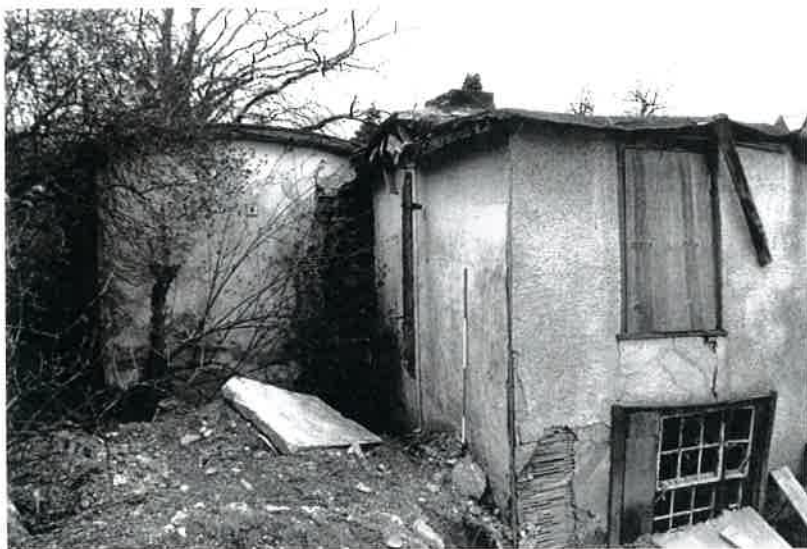
Plate 8 Paisley House from the south-east showing the quantity of rubble latterly dumped against the building

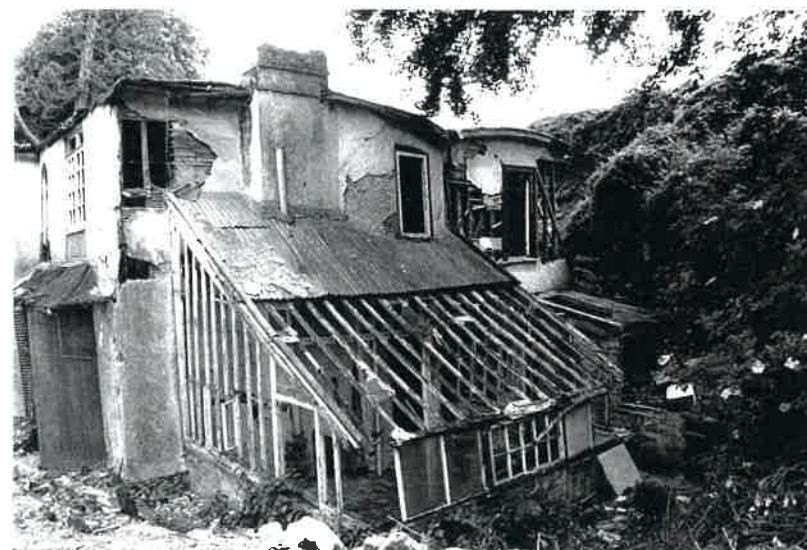
Plate 9 Paisley House from the north-east showing the G/H/I-N/Q extension built into the embankment behind and the conservatory and lean-tos

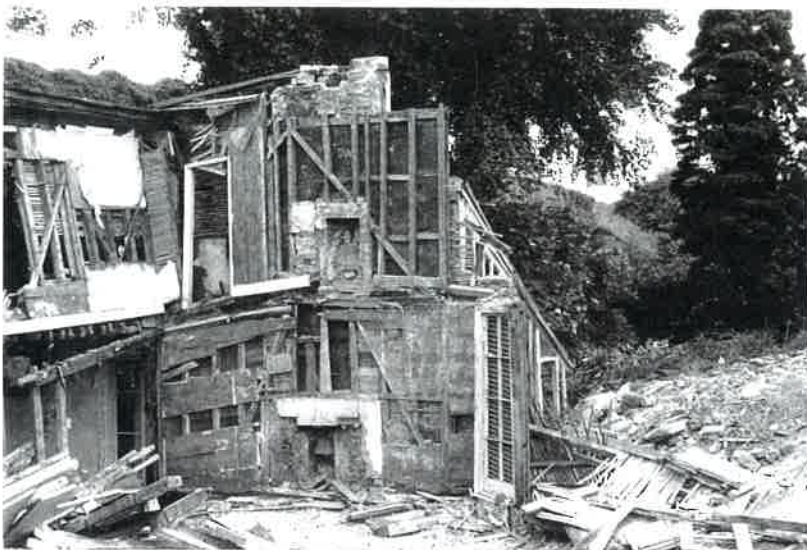
Plate 10 The phase I south and west walls of rooms D/P during demolition showing studding, tarred fibreboard exterior cladding and inserted fireplaces

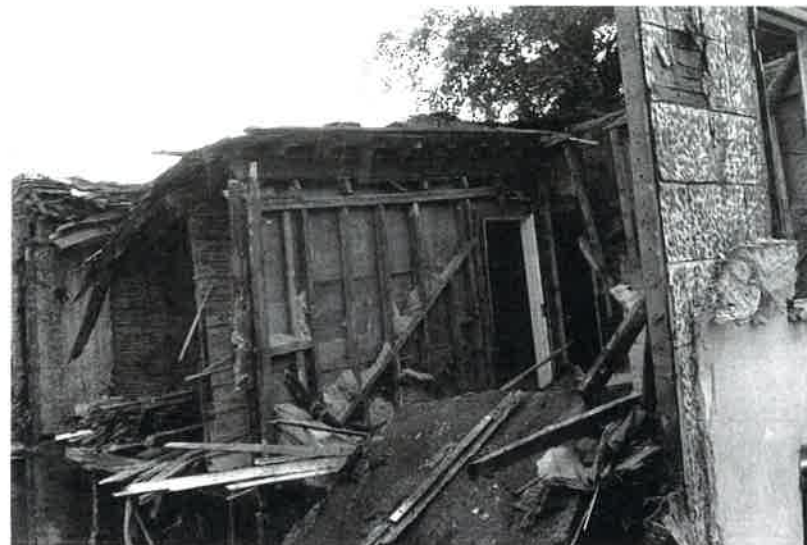
Plate 11 The former north wall of the phase I house showing single diagonal, upper brussumer plate and the eaves of the phase I roof. Prior to dismantling this wall was clad with tarred feather-edge boarding overlain by traces of tarred card

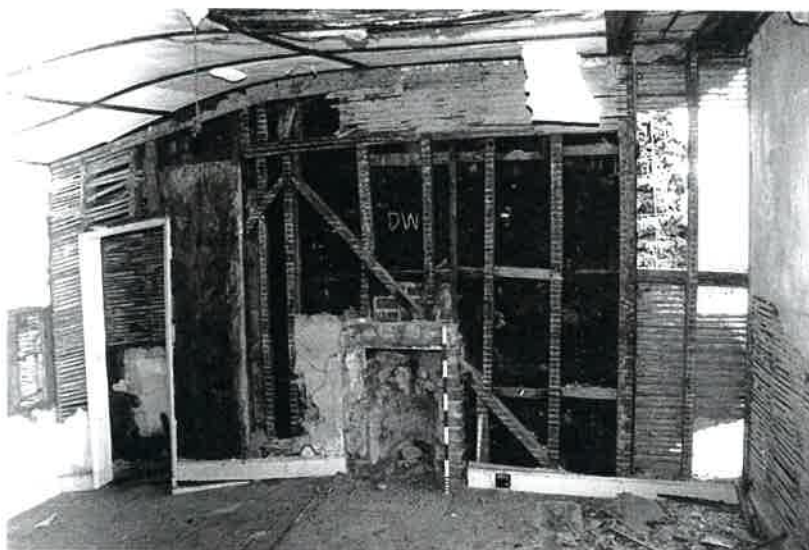
- 4.1.3 *Roof* The flat roof structure of the original building had remained largely intact apart from that part over room D which had been replaced with a phase II type 'vaulted' roof (plate 12).

Plate 12 The interior of the phase I west wall of room D showing the inserted fireplace, the tarred fibreboard exterior cladding and later phase II roof. Note the phase IX extension on right with original rafter end incorporated

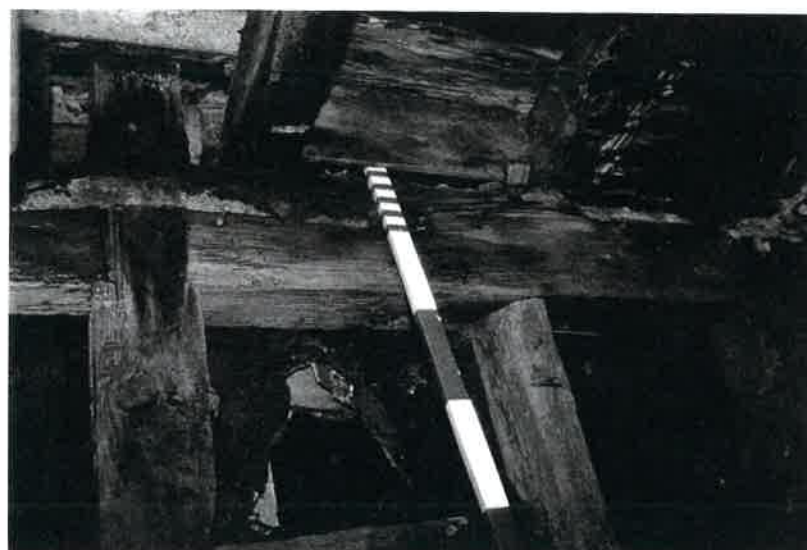
Plate 13 Studding detail within south wall of room P showing first floor brussumer supporting joists and phase I exterior tarred fibreboard behind

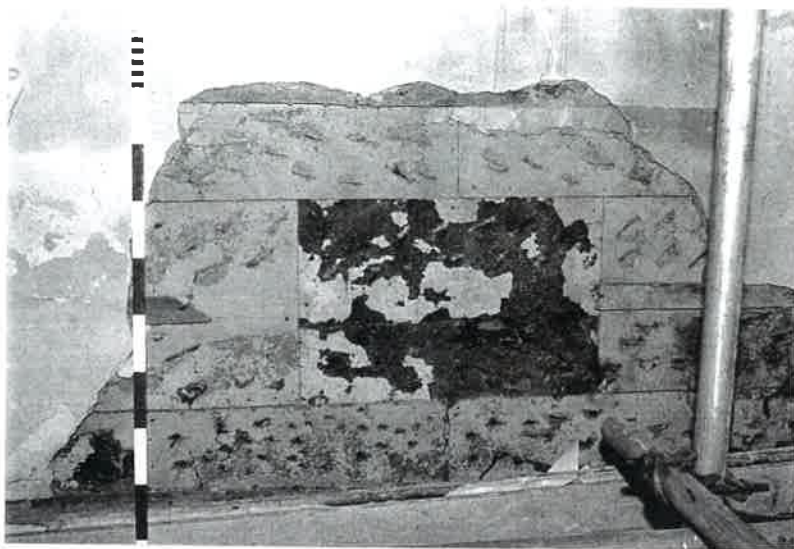
Plate 14 The former external (south) face of the south wall of room P showing phase I painted tarred fibreboard wall cladding revealed by the removal of butting *faux*-ashlar card tiles and phase VII scribed ashlar-effect plasterwork

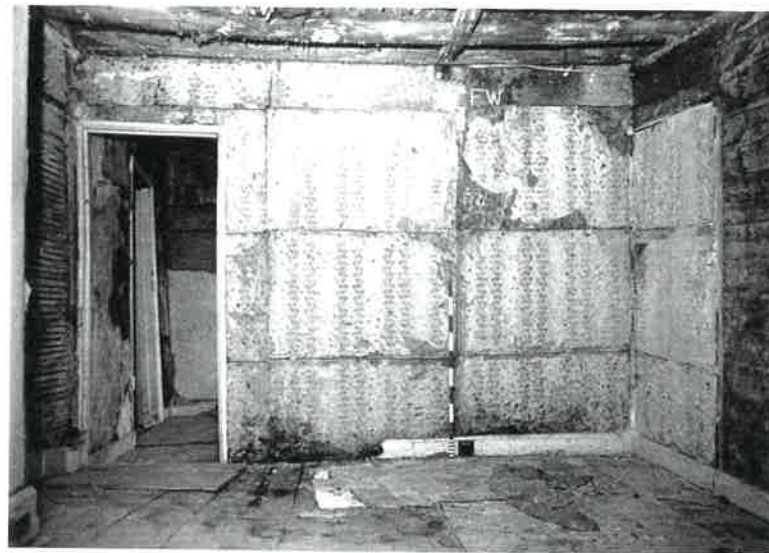
Plate 15 The west wall of room F showing plain fibreboard panels (phase I reused) retaining primary wallpaper. Note phase I roof and blocked door to right

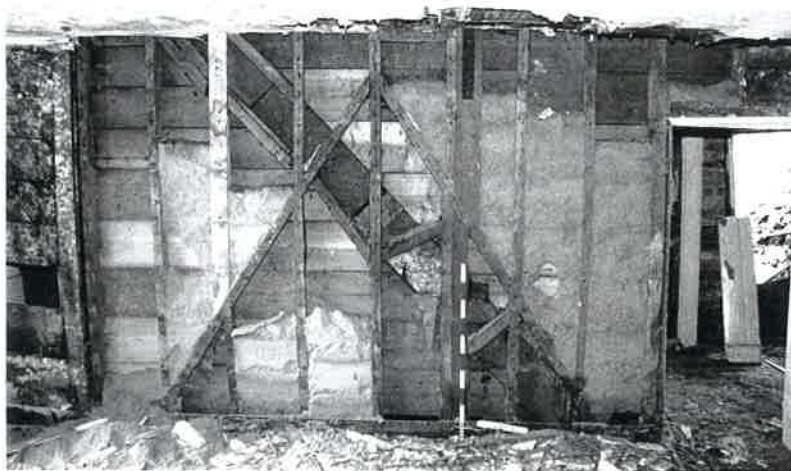
Plate 16 The east (internal) wall of room P showing Phase I studding and line of former primary staircase in room L behind rising from south to north. Note also sawdust insulation, secondary boarding and blocked phase IV doorway on left. The inserted stud in line with the scale supports the inserted bridge rail joist

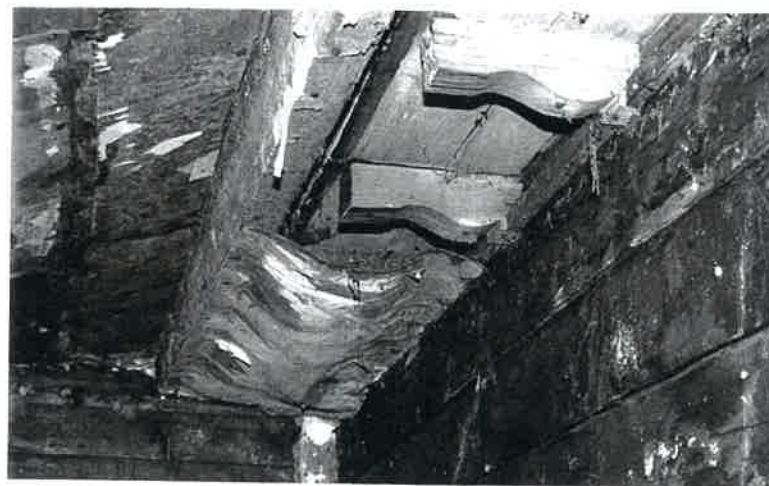
Plate 17 The original eaves of the phase I roof still extant within room B of the phase II extension (B/K). Note the tarred feather-edge boarding of the phase I north wall below

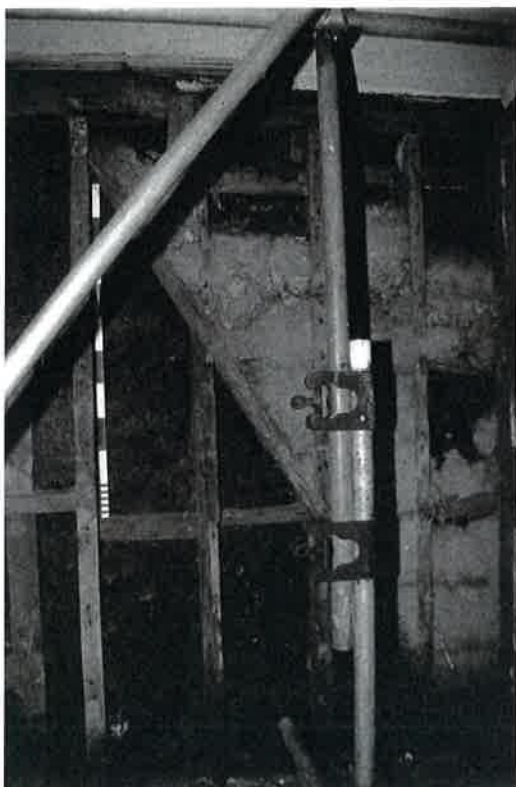
Plate 18 Detail of the north (internal) face of the phase I south wall of room P after removal of secondary boarding. Note the sawdust insulation, the internal face of the phase I exterior wall panels and primary window, blocked with reused phase I panels, on left

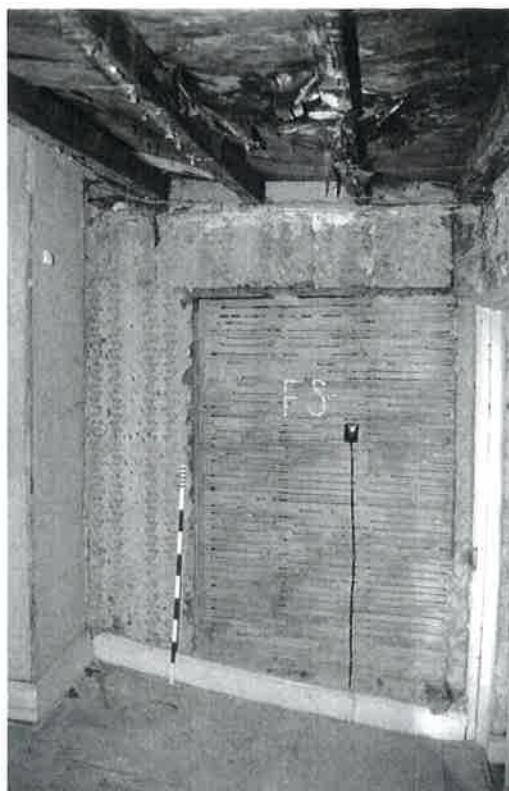
Plate 19 Former phase I south window in room F, blocked with lath and plaster. Note primary plain fibreboard wall panels and wallpaper overlain by phase VI chimney-breast

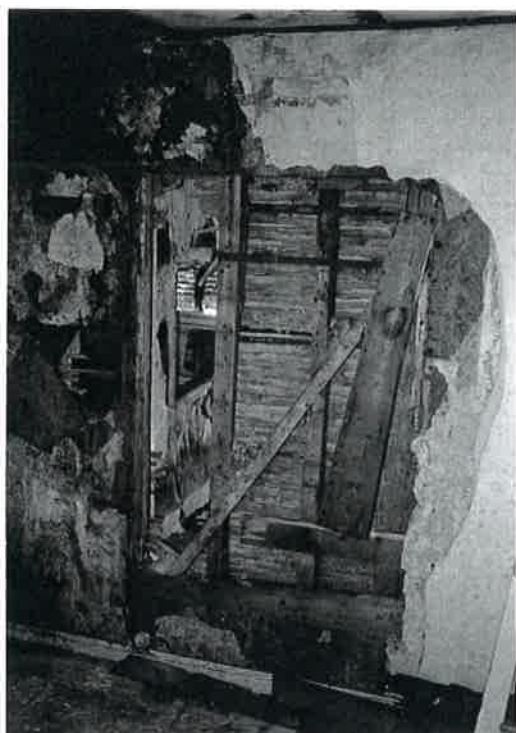
Plate 20 Former phase I south window of room D, blocked with boarding and lathwork of room H. Note fragments of primary wallpaper and phase I plain fibreboard internal wall panels

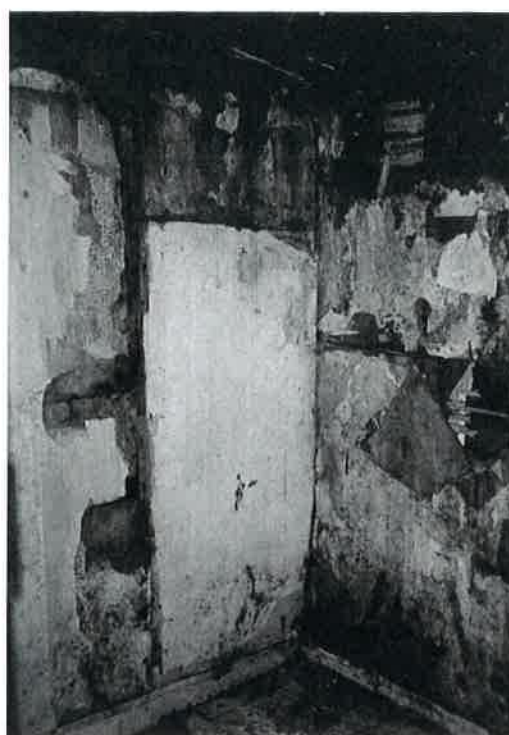
Plate 21 Blocked phase I door between rooms D and E. Note primary wall panels and fragments of original wall paper

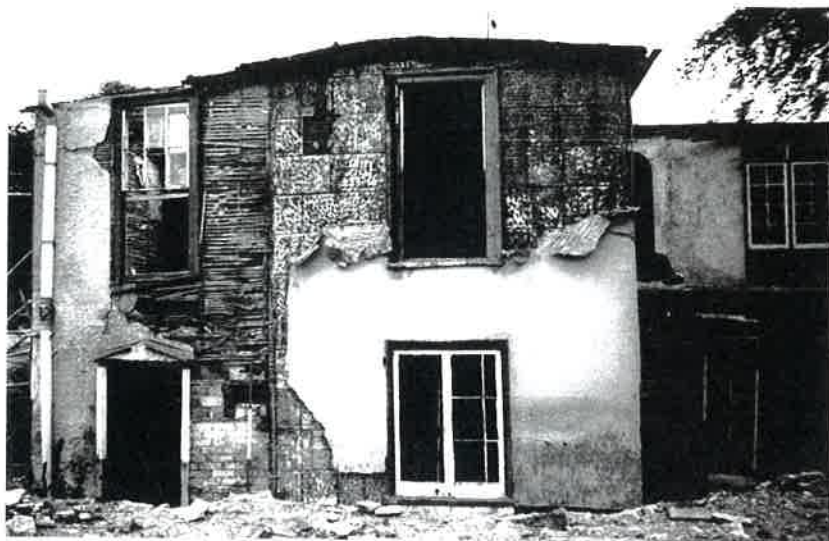
Plate 22 North elevation of phase II extension (B/K), abutted to left by phase V/VII extensions J/A. Note painted tarred card wall tiles and curved roof profile.

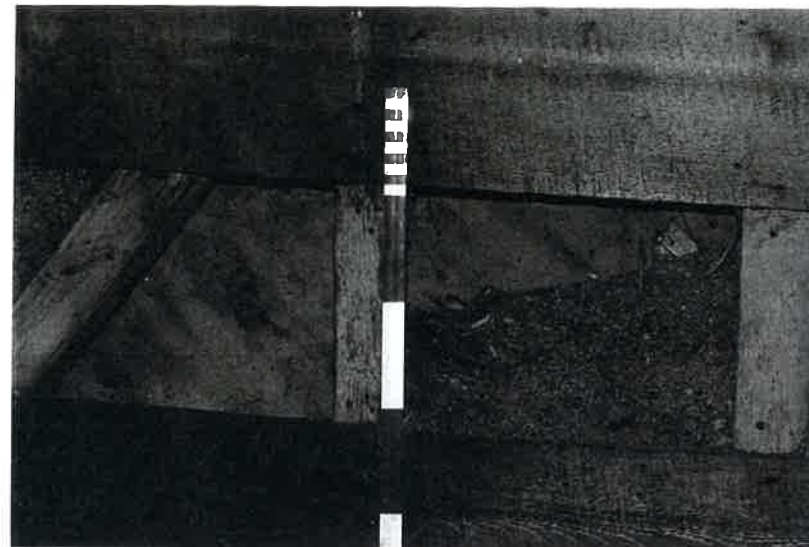
- 4.2.2 *Wall Cladding* The walls were clad internally and externally with loosely butted 230x9mm softwood boards laid horizontally. A coarse brown/grey paper was interposed between the studs and the outer boarding and the cavities between the studs were filled with sawdust (plate 23). The boarded walls were weather-proofed with c4mm thick pitched card tiles which measured 600x420mm (23.6x16.5in) and overlapped each other by c25mm (1in) (plates 22 & 24). The card tiles appeared to have been treated by dipping in hot tar or pitch before use and all had a few lengths of dry grass adhering to the reverse as if the production process was quite rustic and executed out of doors. These tiles were nailed in place with equal proportions of 30-35mm cut nails and 20mm clouts, the latter having 12mm round heads. An area of these tiles was discovered behind the phase III chimney-breast in room A (see plate 28). These had received no further treatment apart from a coat of light stone coloured paint matching that on the pitched fibreboard panels of phase I. As none of this paint was evident on the phase I tarred card tiles where the west wall of B/K butted the north wall of phase I, it appeared that the stone coloured paint on the rest of the phase I exterior post-dated the construction of phase II. This layer of paint probably represented an attempt to unify the exterior appearance of the house when phase II was added. The only exception to the use of softwood cladding on the phase II walls was on the interior on the ground floor where, in the vicinity of the later fireplace, the eastern half of the northern wall and the southern half of the eastern wall were clad with 595x415mm (23.4x16.3in) plain card tiles which overlapped one another by c25mm (1in). The earliest wallpaper on these tiles indicated that they were contemporary with the rest of the inner boarding of this phase and the likely explanation for their presence is that they were a temporary wallcovering anticipating the later fireplace and kitchen-range (phase III). It is likely that the horizontal internal softwood wall cladding in phase I rooms M and P dates to this construction phase.

Plate 23 Detail showing phase II wall construction from the interior. Note the sawdust infill and the coarse brown paper sandwiched between the studs and the external boarding

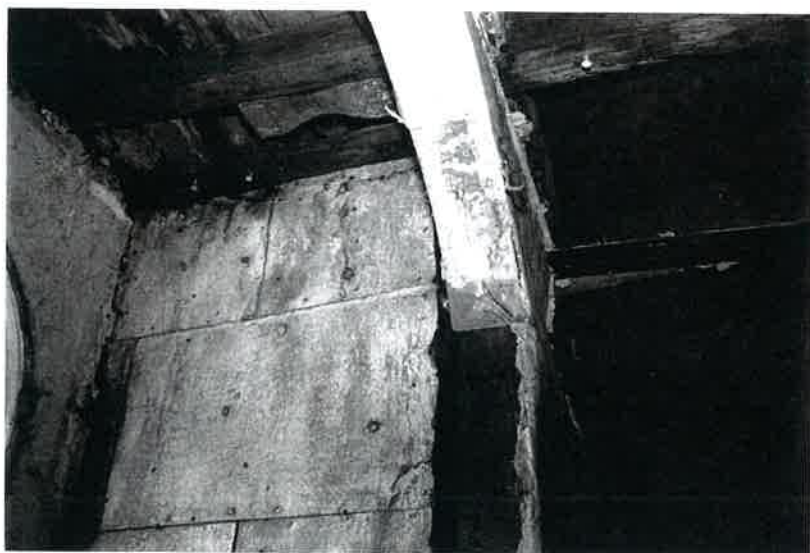
Plate 24 Detail showing the phase II exterior tarred card wall tiles incorporated into the body of the house by the phase IV northward extension of rooms D/P/E

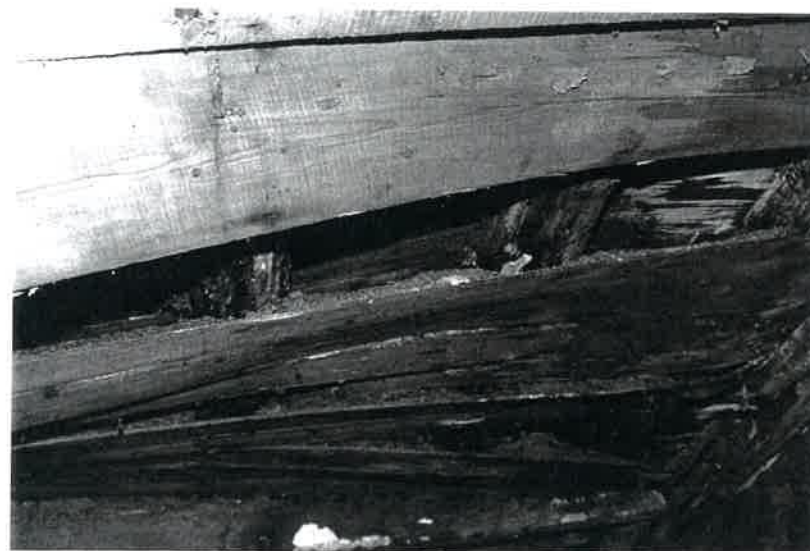
Plate 25 Phase II roof from the underside (room B). Note the halved log common purlins, sawdust fill. The sawdust was originally retained within the roof by a layer of coarse brown paper between the inner boards and the common purlins

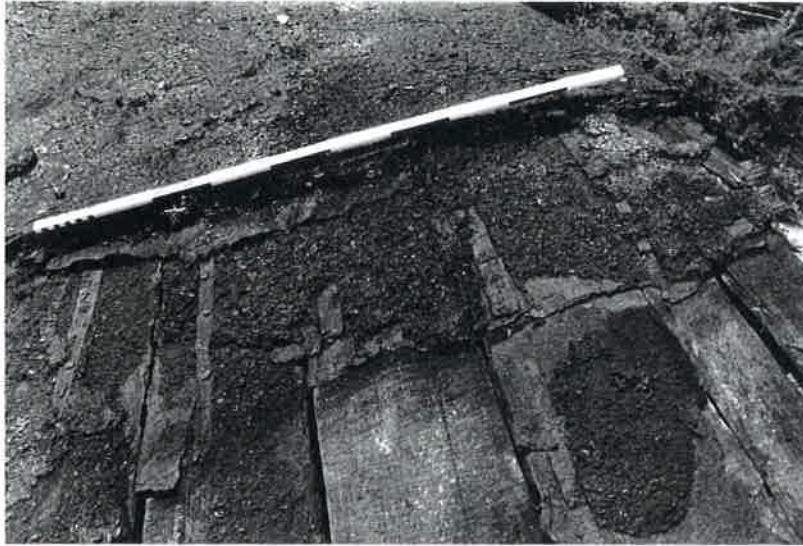
- 4.2.3 *Roof* The wall-plate of the north wall carried a 75mm thick shaped segmental plate which increased in height from 0mm at either end to 100mm at the centre. This, and a corresponding plate set on the eaves of the phase I roof, carried the 90x75-155x90mm quarter and half scantling poles set at c465mm centres which made up the common purlins of the 'vaulted' roof structure. This roof structure was clad internally and externally with 230x9mm softwood boards. The same coarse brown/grey paper as was used in the wall structures was found interposed between the common purlins and the inner boarding and the roof cavities were again filled with sawdust (plate 25). The roof was weather-proofed by covering it with large sheets of 2.35mm thick treated coarse paper whose black colour but matt appearance suggests a chemical rather than hot pitch treatment (possibly some form of creosote). This substantially overlapped on joints (200+mm) and was held in place with similar treated 20-30mm card strips running east-west at c400mm intervals, fixed in place with 20mm clouts with 12mm heads at c100mm centres. This paper covering had then been covered with a coarse c5mm thick layer of pitch and small (5-10mm) gravel (plate 26). At a later date the

Plate 26 Phase II roof covering over room B, as exposed by removal of later layers of paper and pitch

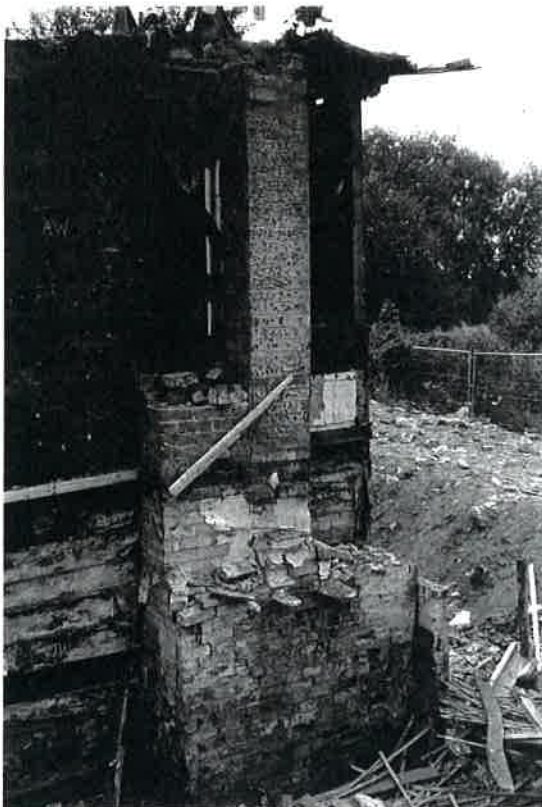
Plate 27 Phase 3a and 3b chimneys during demolition

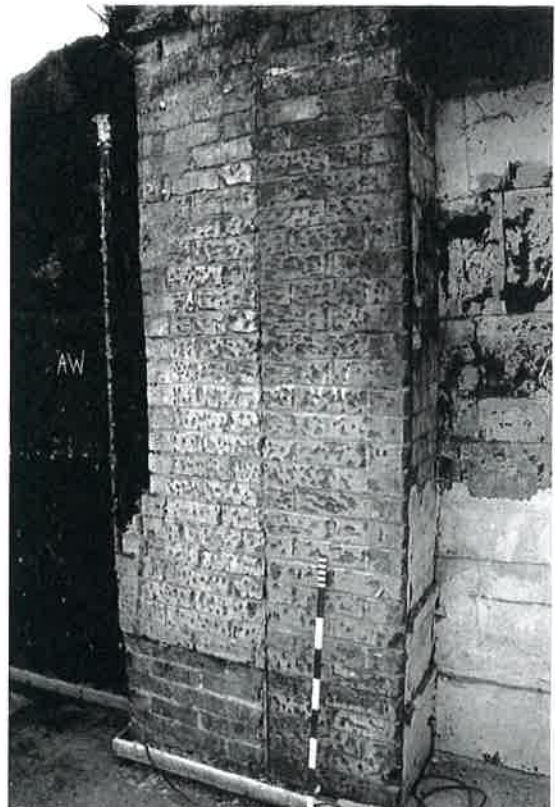
Plate 28 Upper portions of phase 3a and 3b chimneys within room A. Both chimneys overlay the tarred card wall tiles of the former east external wall of the phase II extension (on right). Note the remains of exterior paint on both chimneys and wall tiles

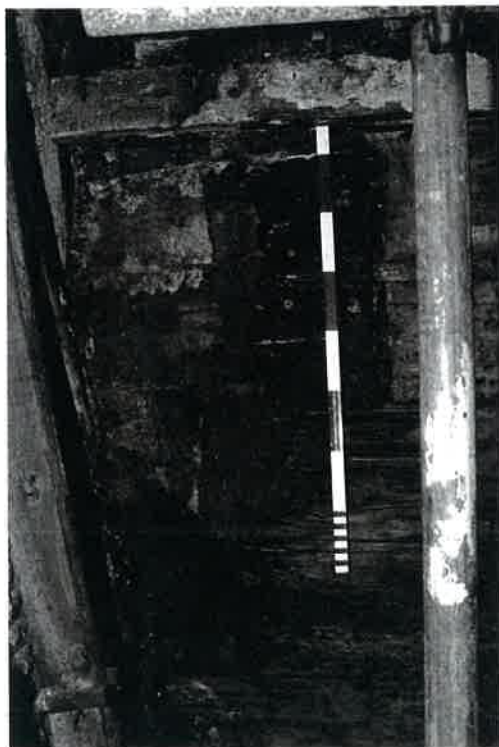
Plate 29 Vestiges of oiled card and tarpaulin on the former exterior boarding of the north wall of room M, visible after removal of later interior boarding in room J

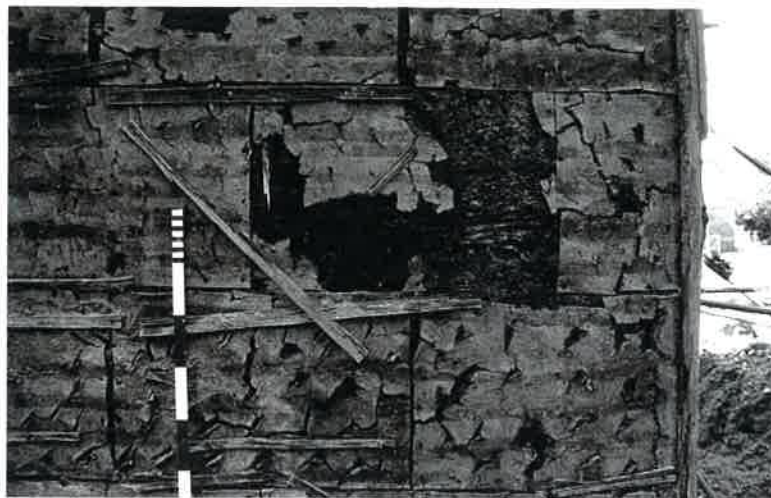
Plate 30 Phase IV tarred paper and untreated *faux*-ashlar card tiles revealed after the removal of later scribed render and pebbledash on the south wall of F/M extension

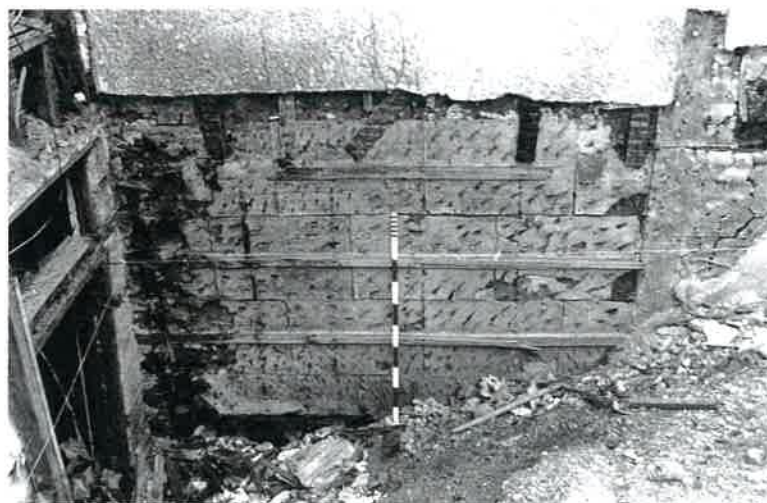
Plate 32 View of the south wall of rooms F/M, showing how the *faux*-ashlar tiles on phase I section of the wall about those of the Phase IV extension. They also overlay the phase I south windows of both rooms (on left)

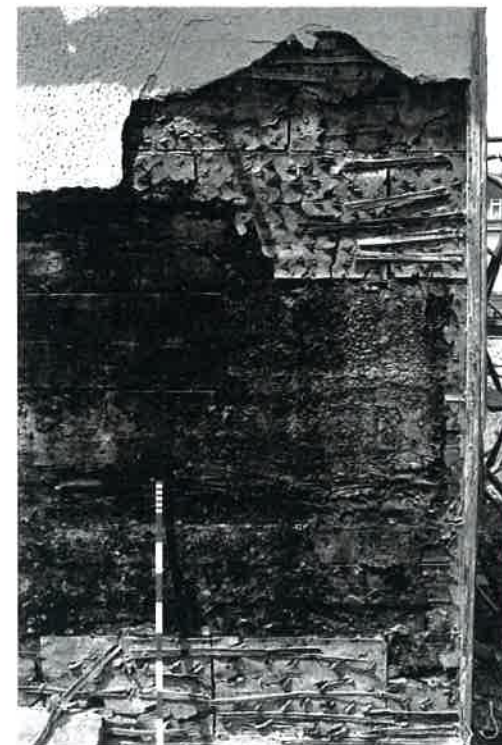
Plate 31 Detail showing phase IV exterior boarding and tarred paper after removal of *faux*-ashlar tiles

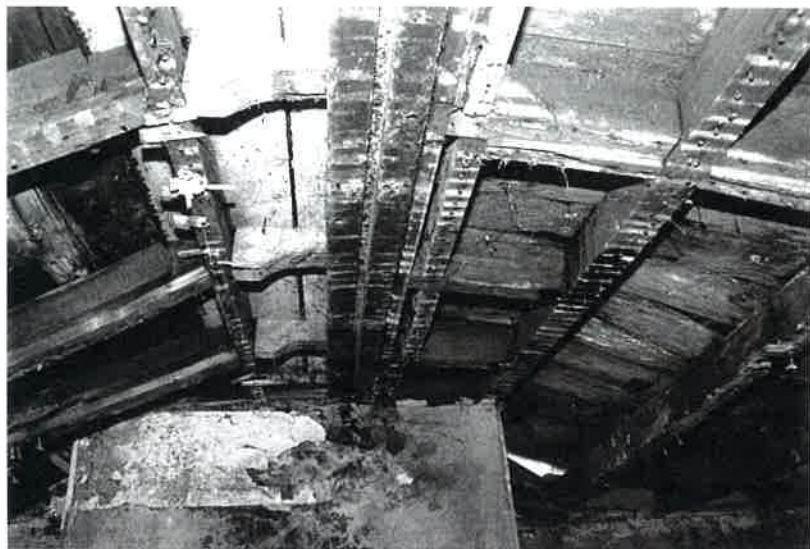
Plate 33 Ceiling/roof of room F showing phase I roof (including former rafter ends) to right and phase IV roof to left. Note length of bridge rail taking the place of the phase I east wall and slightly staggered noggins indicating the possible position of a window or chimney breast

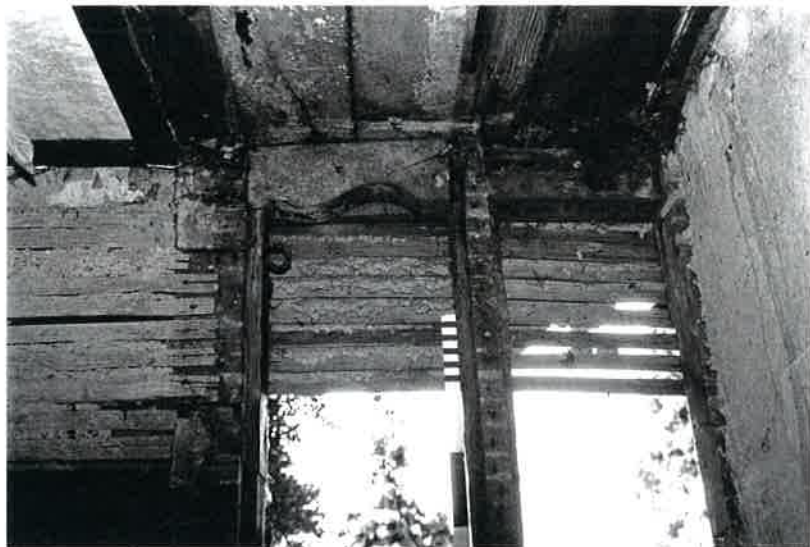
- 4.4.7 The other feature of which is attributed to phase IV is the first northward extension of rooms **D/E/P** (plates 12 & 34). Remains of this were found on the first floor and encased behind the upper part of the bay of room **P**. These earlier sections consisted of c70x50mm studwork clad with lath and plaster internally and lath and scribed render externally. The former north wall had been replaced with a joist formed of a length of 'bridge rail'. This was very worn and from the way it was de-laminating, clearly of wrought iron. The arched window in the north wall of room **E** appeared to belong to this phase and originally contained decorative stained-glass. The detailing of the casement window in the north wall of room **D** implied that it was a later insertion, though clearly replacing an earlier window. It is presumed that this wall was initially clad with the butting 'ashlar' type card tiles however any clear evidence of this had been destroyed by later lathwork. The attribution of this part of Paisley House to this phase was fairly clearly demonstrated by the way in which the secondary 'ashlar' card tiles on the west wall of **B/K** clearly predated this extension.

Plate 34 Detail showing west wall of room D showing the former rafter end and eaves and the phase IV northward extension

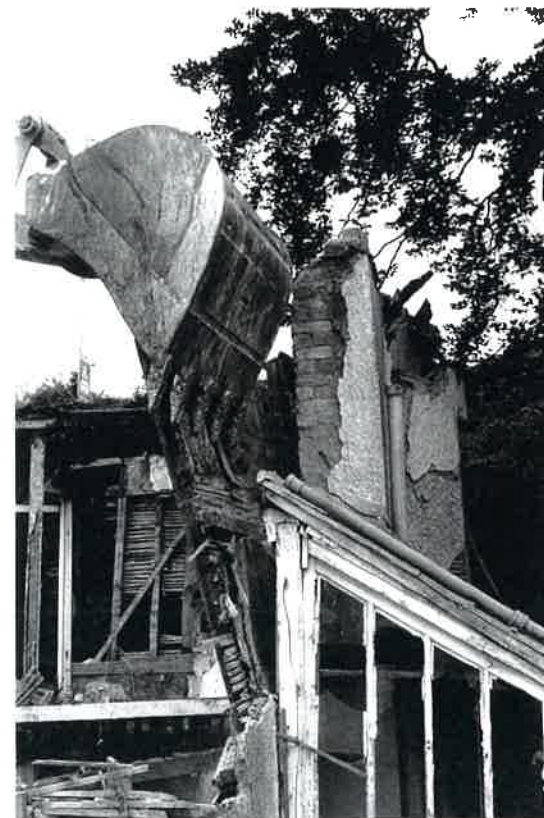
Plate 35 View of the west wall of rooms D/P during demolition showing the primary tarred fibreboard panels and secondary un-tarred *faux*-ashlar tiles continuing behind the phase VI chimney
