AN INVESTIGATION OF A VICTORIAN PAPER HOUSE

ARCHAEOLOGICAL AND PHOTOGRAPHIC RECORD IN ADVANCE OF DEMOLITION

OXFORD ARCHAEOLOGICAL UNIT
JUNE 1998

NMR DATA	
SITE NAME	PAISLEY HOUSE
ADDRESS	436 ABINGDON ROAD, REDBRIDGE, NR. COLD HARBOUR
TOWN	OXFORD
PARISH	SOUTH HINKSEY
COUNTY	OXON
NGR	SP 5172 0380
LISTED STATUS	GRADE II
VISIT/SURVEY DATE	APRIL-MAY 1996
OAU SITE CODE	OXABPH 96

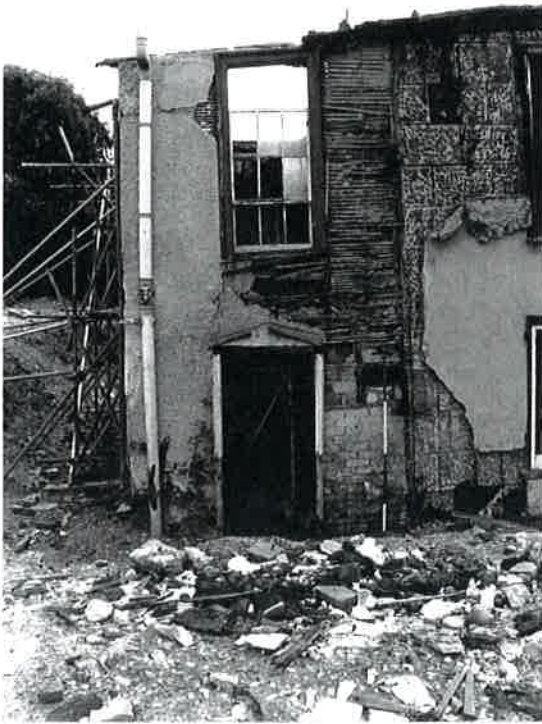
- 4.7.3 *Wall Cladding* The walls were clad externally with lath and render (plate 36). The render had very largely been replaced with pebbledash but fragments remained of earlier smooth render, scribed to resemble ashlar. This lath and render appeared to have been primary. Similar render was discovered on the west and south walls of phase I (plate 14) (**E/L/O-D/P-F/M**), the north and west walls of phase II (**B/K**), the south wall of phase IV (**F/M** ext) and phase VI (**D/P** chimney) as well as the remainder of the north wall of **D/P** ext I (see below). This would indicate another attempt to unify the exterior appearance of the house as well the final abandonment of the paper wall experiment. Internally, the walls of the upper room (**A**) were lathed and plastered and this also had the appearance of being primary. The walls of room **J** were clad with tongued and grooved softwood boards however these did not appear to have been primary and nail holes in the studs implied that these walls also were initially lathed and plastered.

Plate 36 North elevation of phase VII extension (A/J) abutting the phase II extension (B/K). The floor between the ground and first floors was found to contain the paper-covered roof from the phase V single-storey building on the site however, the exterior walls, which were always of lath and render construction, appeared single-phase

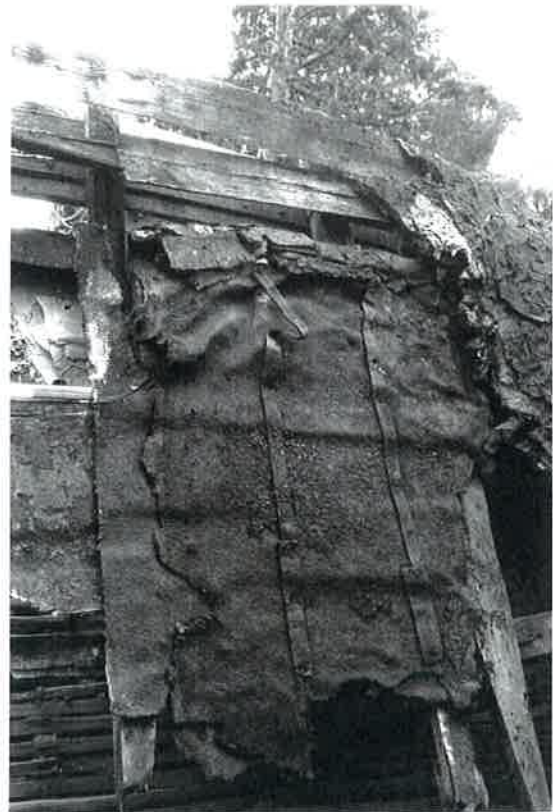
Plate 37 Collapsed phase VII paper-covered roof over room A after removal of several secondary layers of tarred paper, pitch, hessian and asphalt

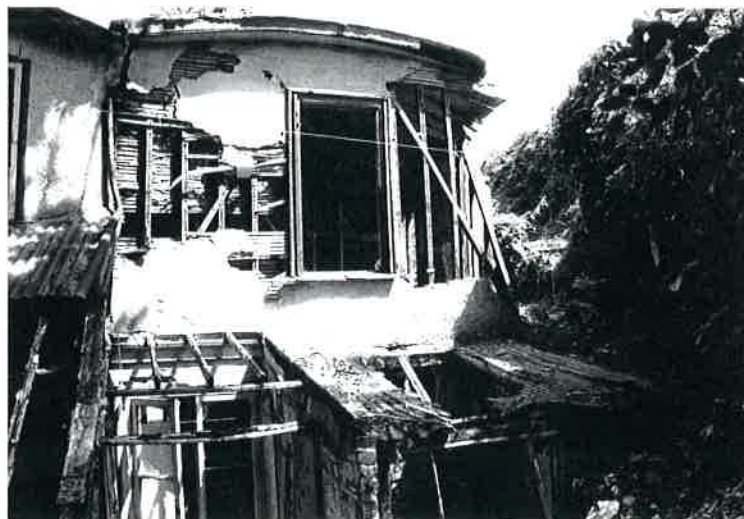
Plate 38 West elevation of phase VIII extension (rooms G/H/I-N/Q) showing the curved profile of the paper-covered roof and stud, lath and render wall construction

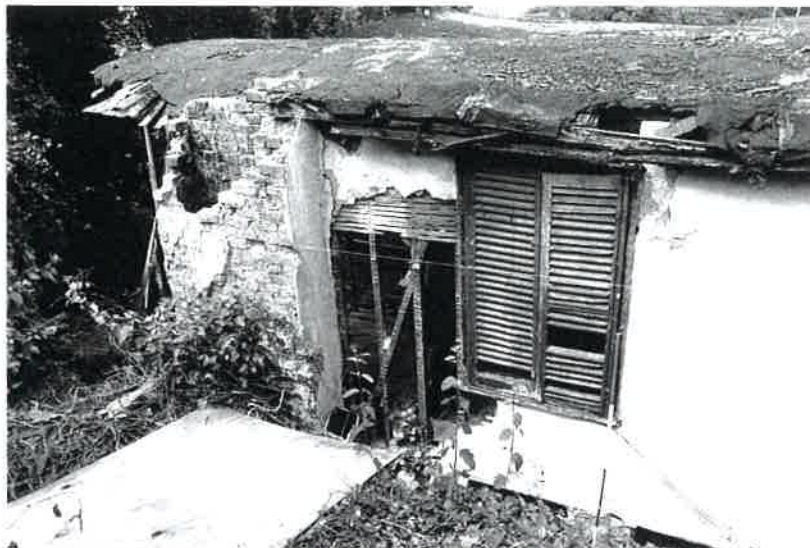
Plate 39 Upper storey of phase VIII extension (rooms G/H/I) from the south

4.8 Phase VIII (Fig 7 & plates 38-44) Rooms G/H/I-N/Q & Tower (T)
(Lath & scribed render walls - timber & paper roof)

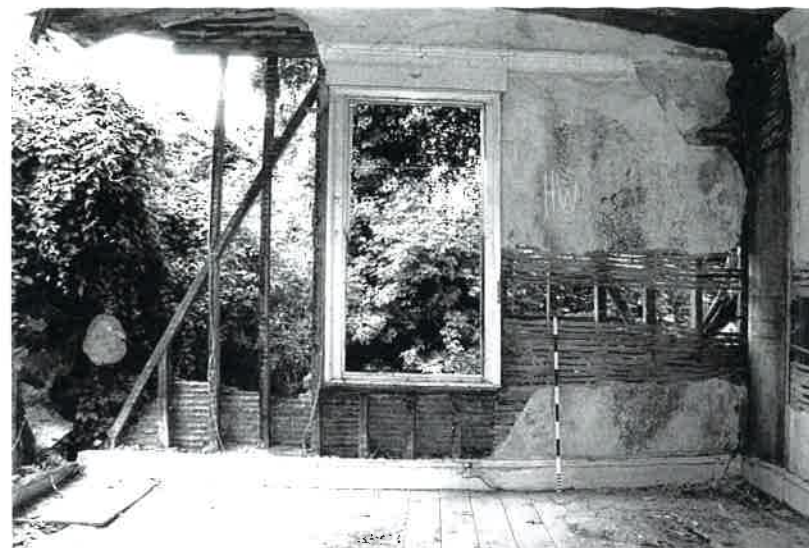
Plate 40 West wall of room H, showing construction of external walls and profiled wall plate

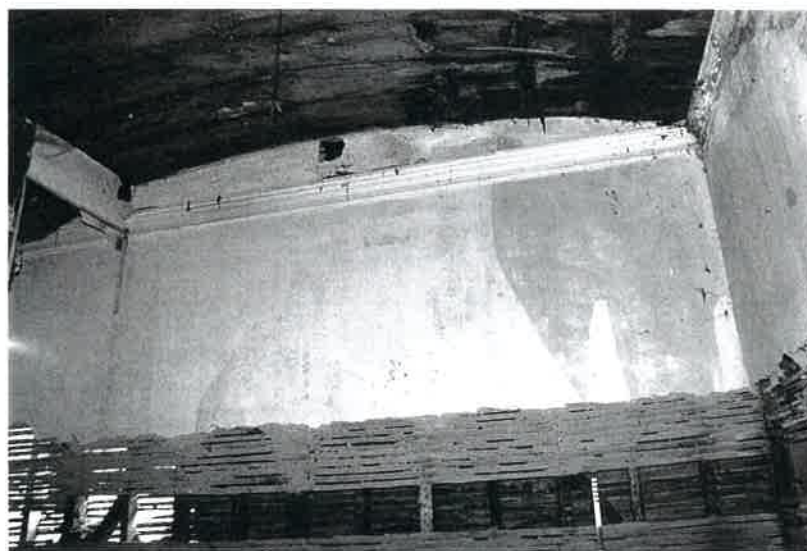
Plate 41 East wall of room I showing straight cornice and vaulted ceiling

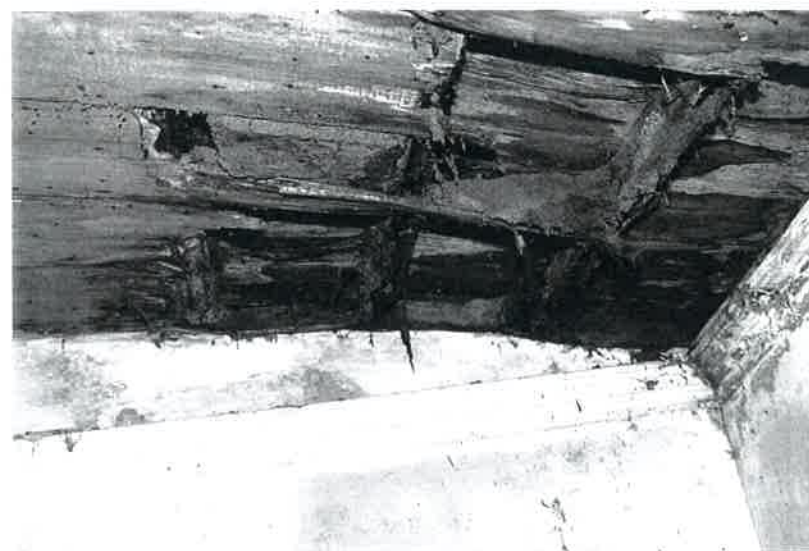
Plate 42 Detail of phase VIII roof, showing common purlins and sawdust-filled cavity

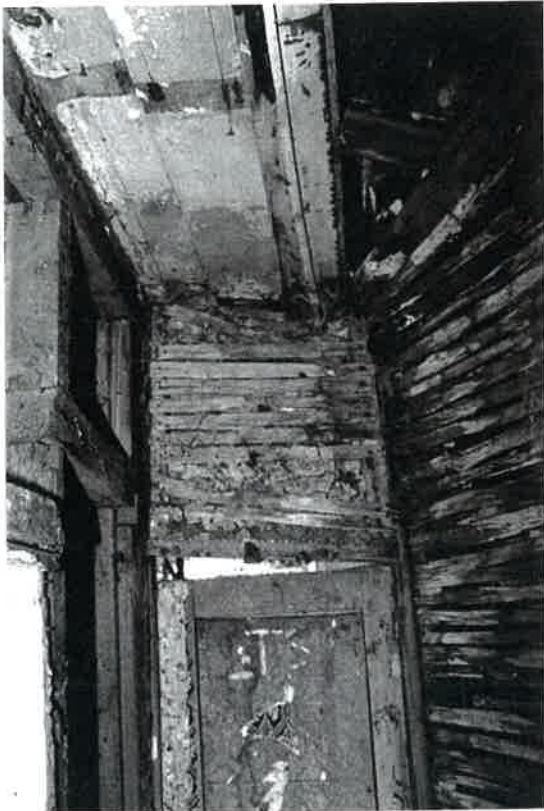
Plate 43 Upper tower room (T), showing lathwork, door to room H and phase I eaves

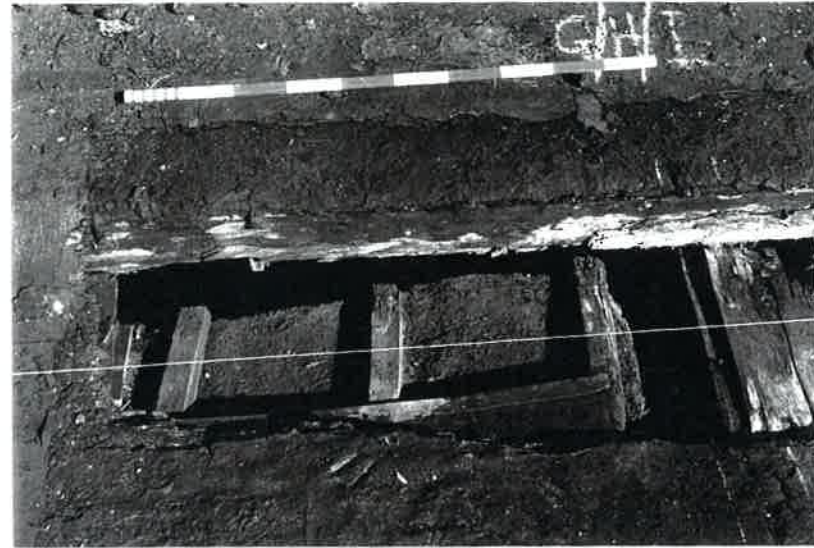
Plate 44 Section through the valley between the roofs over rooms G/H/I-N/Q, rooms D/P (to right) and E/L/O (centre). Note how the replacement vaulted phase II roof over D/P and the lower phase I roof over E/L/O are both overlain by furring, boarding and tarred paper associated with the phase VIII roof over G/H/I-N/Q

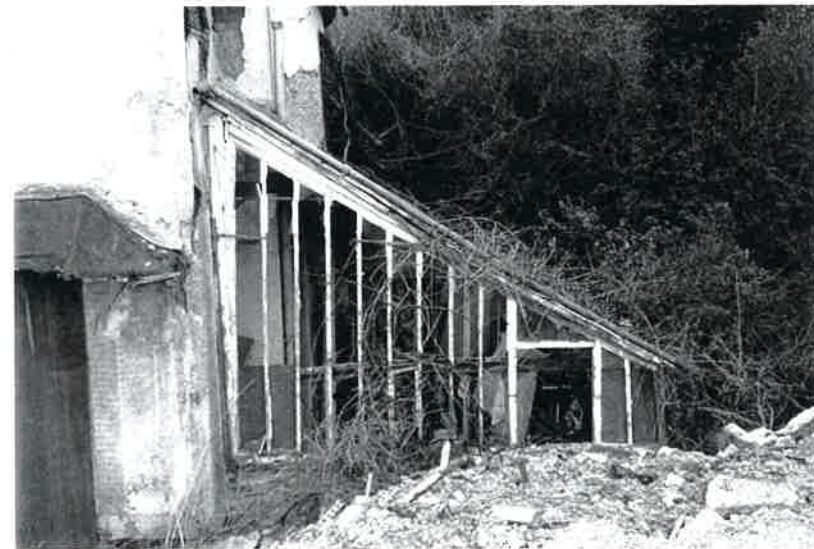
Plate 45 North elevation of the conservatory (room U)

4.10 *Miscellaneous additions (Plates 6 & 9) Conservatory (U) and other structures*
(Brick & timber)
