# Osney Mill

## Mill Lane

## Oxford

### Archaeological Watching Brief and Excavation Report

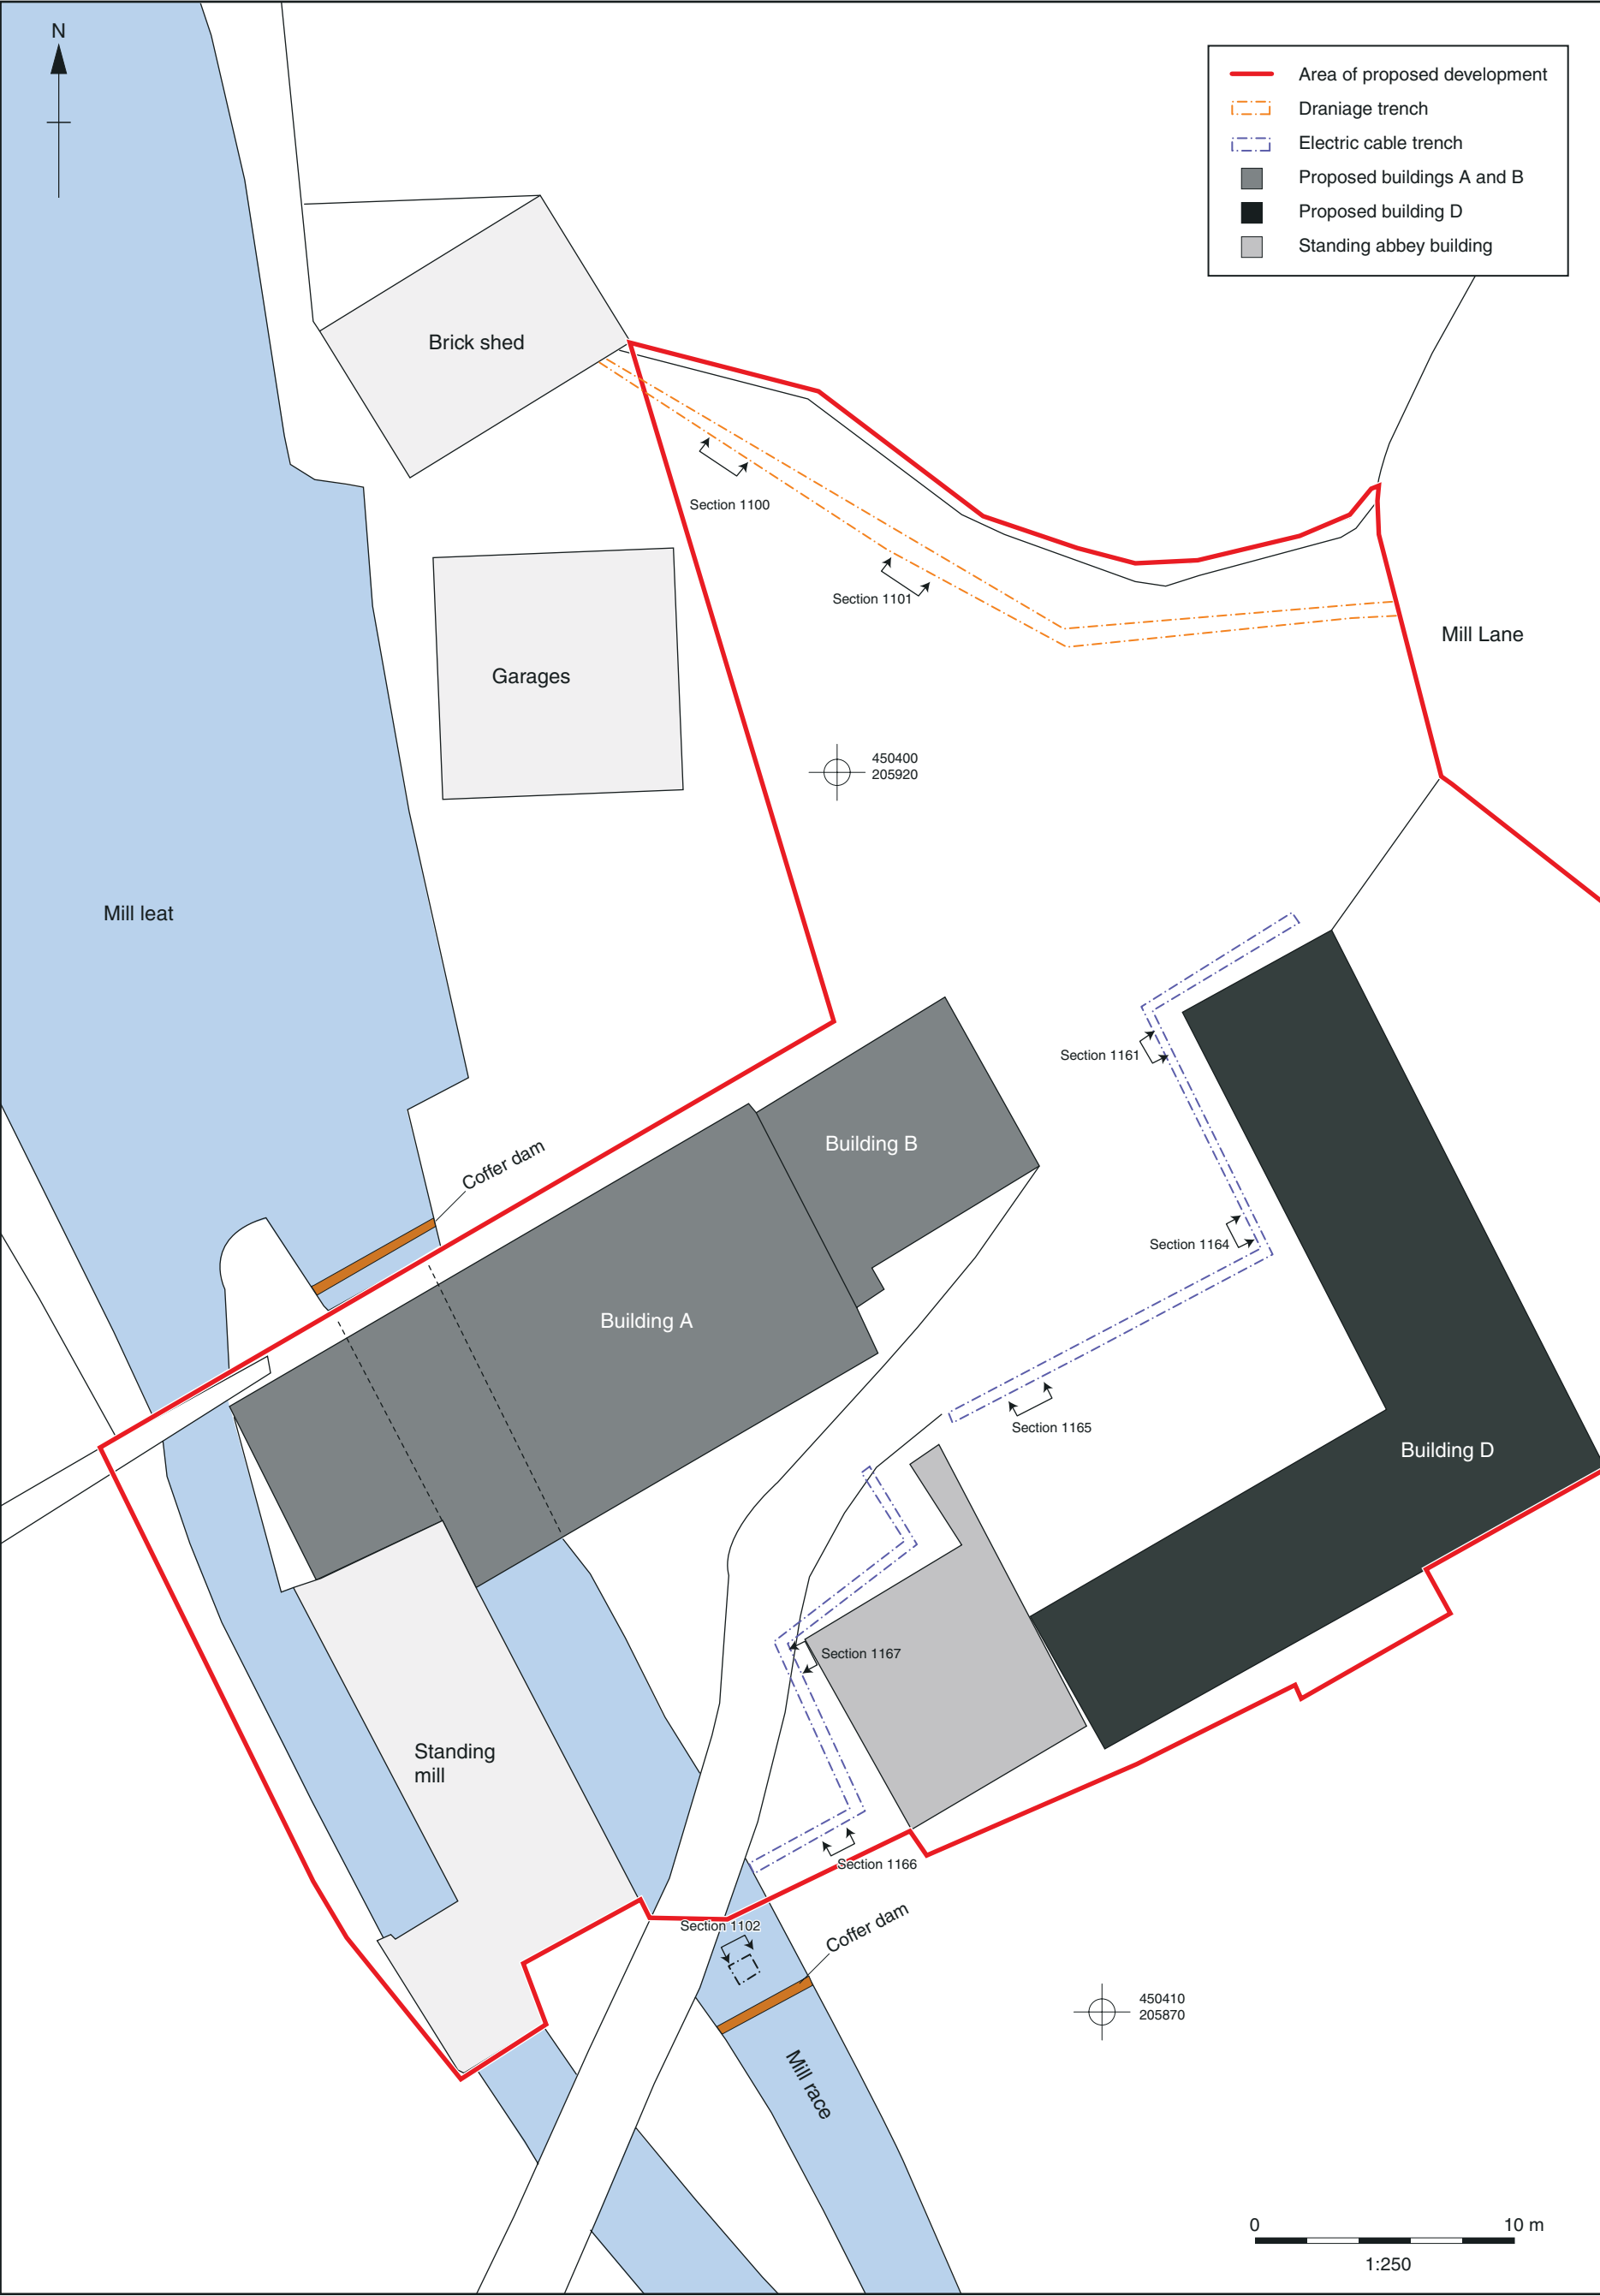
Figure 2: Overall site plan

- 4.1.11 Other evidence for the abbey was exposed within the drainage trench dug across the northern side of the yard (Fig. 2). In the base of this trench was the top of a 0.6m wide wall (1209) showing evidence of having originally been constructed using dressed blocks of stone on its outside faces and with a rubble core. Many of the dressed blocks had been robbed out leaving the rubble core and scattered blocks. The upper surface of the rubble core and some of the scattered blocks displayed evidence of burning which must have taken place subsequent to the robbing.

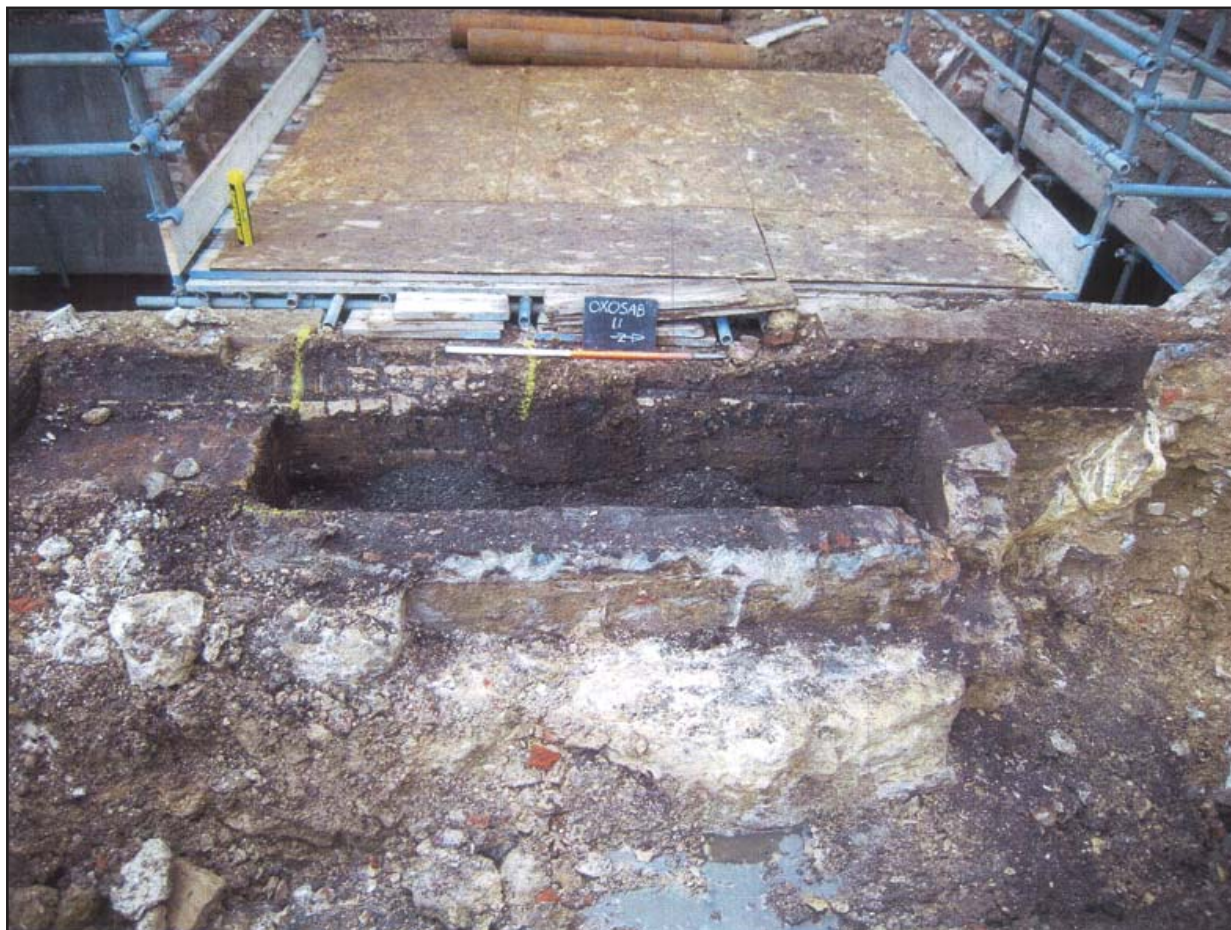
Plate 7: Gear pit **1110**

- 3.1.25 A later brick built gearwheel pit (1110) (Fig. 7, Plate 7) appears to have been inserted between 1111 and 1102, truncating the junction of those two structures. This new gearwheel pit measured 0.9m wide, 1.3m deep and 3.1m in length and was built using a plain pinkish yellow brick bonded with a cement mortar. A brick infill using the same bricks was laid over 1102. The pit had been backfilled with a loose grey-brown clayey silt mixed with demolition rubble.
