Wardington Manor Wardington Oxfordshire

Historic Building Investigation: Chimney C4

WARDINGTON MANOR, WARDINGTON: DEMOLITION OF CHIMNEY C4

HISTORIC BUILDING INVESTIGATION AND RECORDING

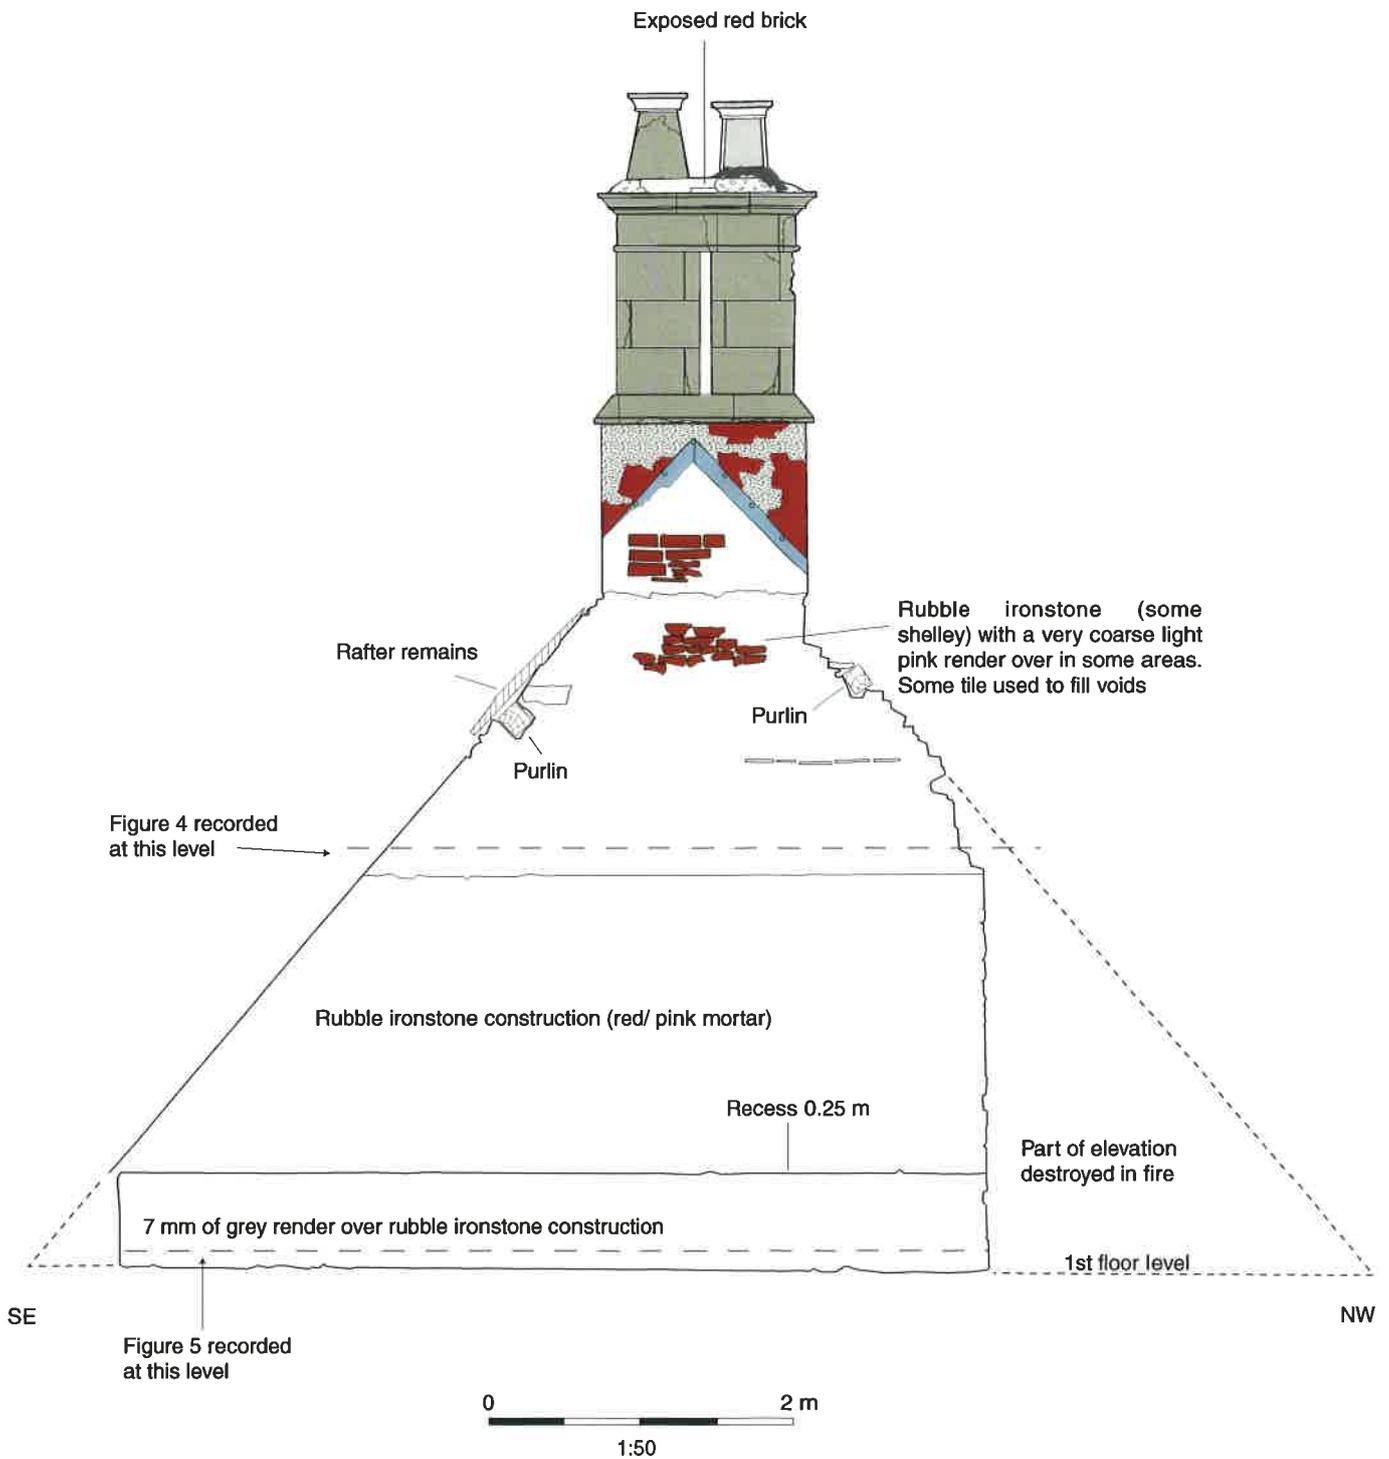
Figure 3 : Wardington Manor - central chimney C4, south-west wing, north-east elevation.

down the chimney. Initially the chimney was reduced down to the level of the top of the gable end, (0.75m above the purlins as represented in figure 3). The four stacks were constructed of a dark grey limestone stone, (probably not a local stone), with a concrete cap and a cement render on the sides. These appeared to be cemented to a red brick structure below and covered in a light / pale brown mortar.

- 4.1.1 Chimney C4 and the associated gable end below are located in the south west side of the manor house (Figures 3, 6 - 8). The gable end forms the north eastern wall of the panelled smoking room at ground level and rises up to form the north west elevation of the Butlers accommodation on the second floor. The chimney forms an integral part of the gable end and appears to serve the fire places in the smoking room at ground level, the dining room to the north east and several rooms at first floor level. The examination of the flues from chimney C4 will hopefully form part of a more comprehensive future programme of historic building analysis at Wardington Manor.

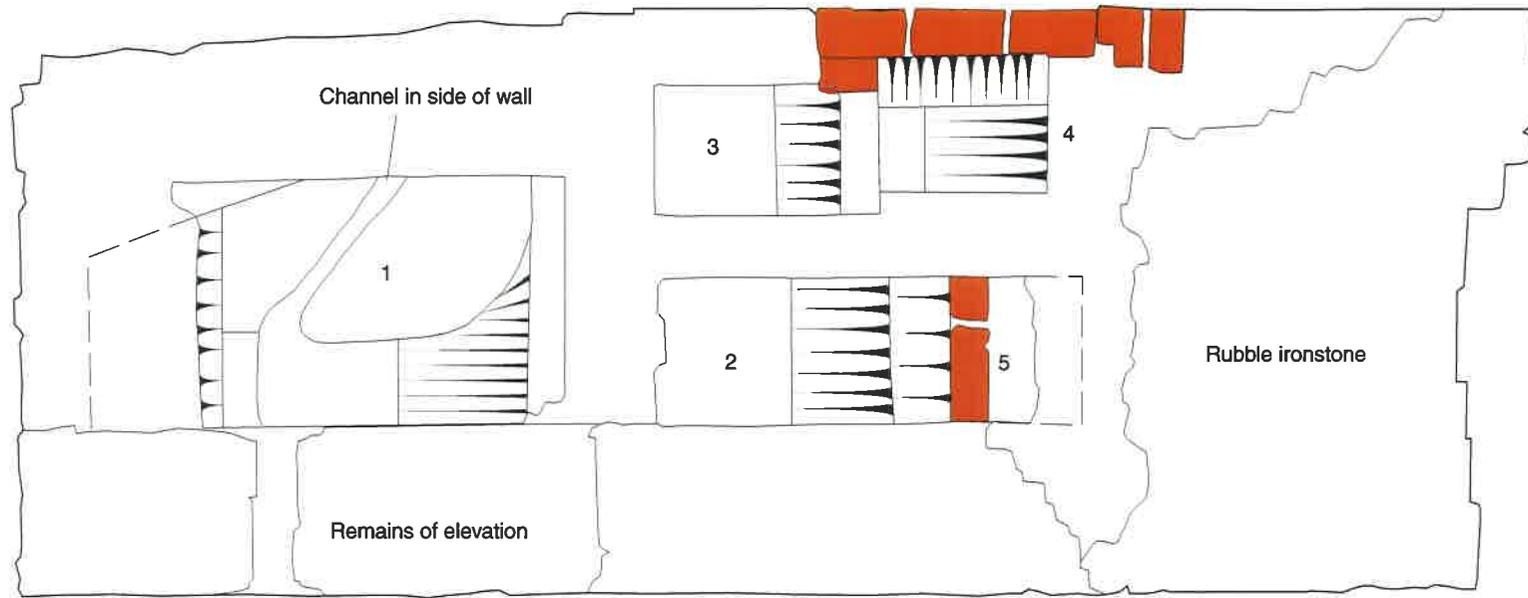
Figure 4 : Plan through elevation below chimney stacks (after stack removal)

Flue 1: Largest flue 1.28 x 0.65 m maximum (partially recessed on south side). Interesting 'channel' on West side at this level, approximately. 4 m to bottom of flue

Flue 2: 0.80 x 0.38 m max. - 2 slopes into vertical drop from North

Flue 3: 0.34 x 0.50 m, slope from North

Flue 4: 0.34 x 0.44 m, slope from North and West

Flue 5: 0.38 x 0.28 m maximum, partially hidden. 2 and 5 possibly one flue that has been divided

- 4.1.12 Figure 4 was drawn at a point 2.95m above the first floor level and revealed the presence of 5 flues (Figure 4.) They can be summarised thus;
- 4.1.13 Flue 1: Located on the south west side of the gable and exhibiting the largest opening at this point with a maximum measurement of 1.28m x 0.65m . The flue was partially recessed to a depth of 0.20m on its southern side. The flue slopes inwards from both the north and the south with two observable ledges on the north side and one on the south east. On the western side of the flue a vertical 'channel' approximately 0.10m wide had been cut, presumably to ease

- 4.1.14 Flue 2: Located on the eastern side of the gable in plan view. Approximately 0.80m x 0.38m with two internal breaks of slope on its north eastern side.

- 4.1.15 Flue 3: Positioned 0.16m west of flue 2, on the western side of the elevation in plan. One ledge present to the north.
- 4.1.16 Flue 4: Positioned immediately to the north of flue 3 with a 0.10m brick between them. Two ledges sloping in from the north and the west.

- 4.1.17 Flue 5: Positioned north of flue 2 with a maximum observable size of 0.38m x 0.28m. At this point it was not possible to discern whether not the flue extended further to the north or whether this was a separate flue. Again one brick width (0.10m) divides flues 2 and 5 and through observation of the north east elevation of both flues it appears that the bricks are part of a later attempt to divide a previously larger flue.

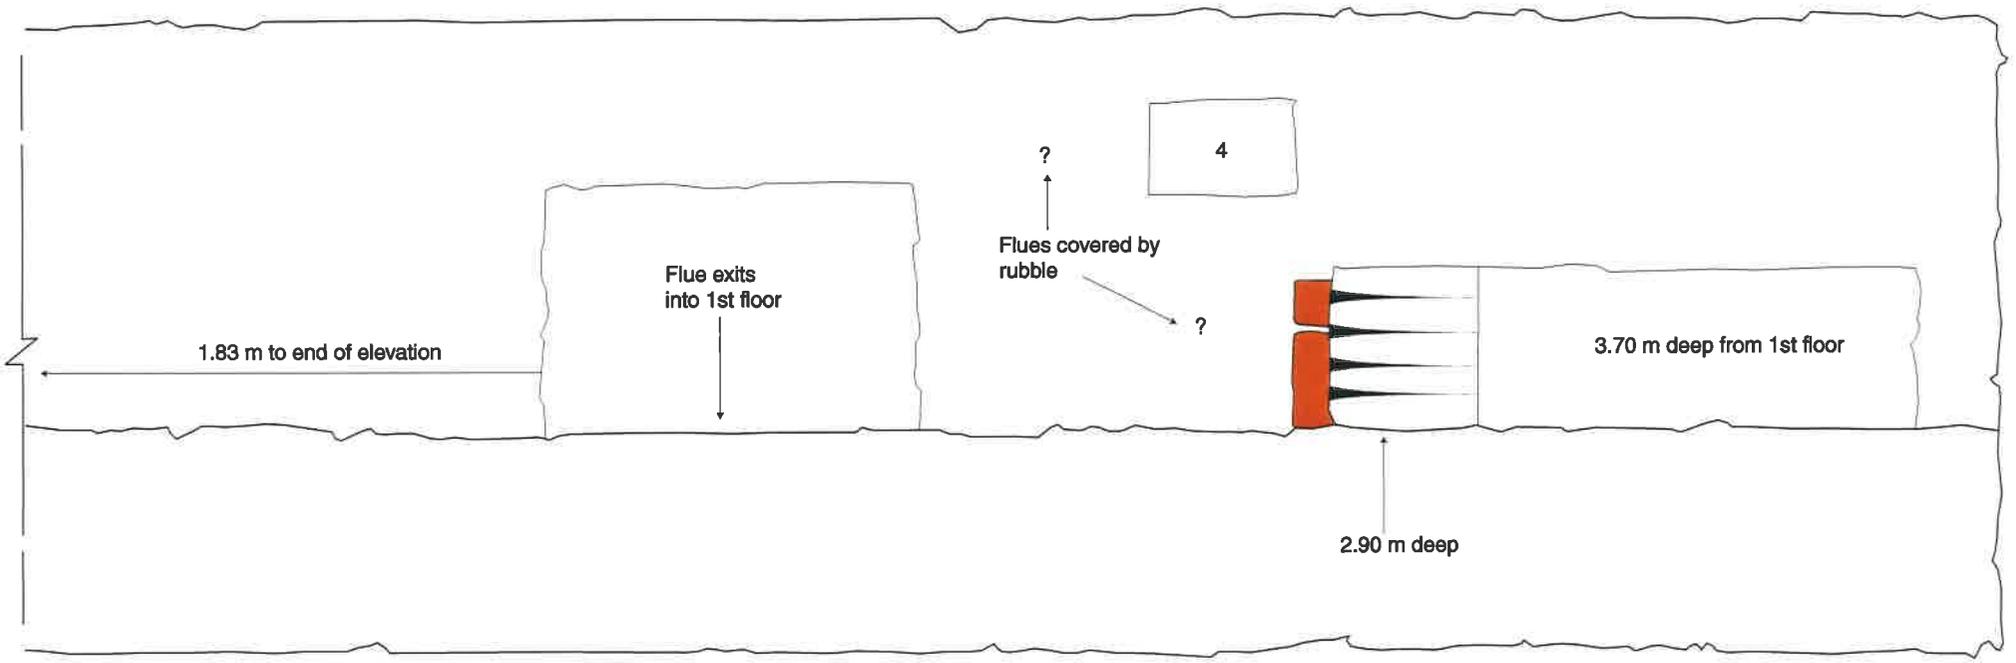
Figure 5 : Plan through elevation below chimney at 1st floor level

- 4.1.18 At first floor level a further plan was made of the positions of the flues observed 2.95m above (Figure 5). Although much of the gable was covered by rubble at the time of recording it was possible to identify reduced parts of Flue 1, 0.64m x 1.00m and Flue 4, 0.24m x 0.40m. What was apparent was that Flue 5 extended much further northwards than was observable higher up the elevation and appeared to have maximum dimensions of 0.42m x 1.54m with a considerable slope inwards from the south west. It is therefore likely that flues 2 and 5 were at one point part of the same large flue which has been subsequently divided into two. The brick used in creating the division into two appeared to be of late 19th / early 20th C in origin. The maximum depth measurable at this point was 3.70m reaching down to the ground floor levels (Plates 23 - 26).

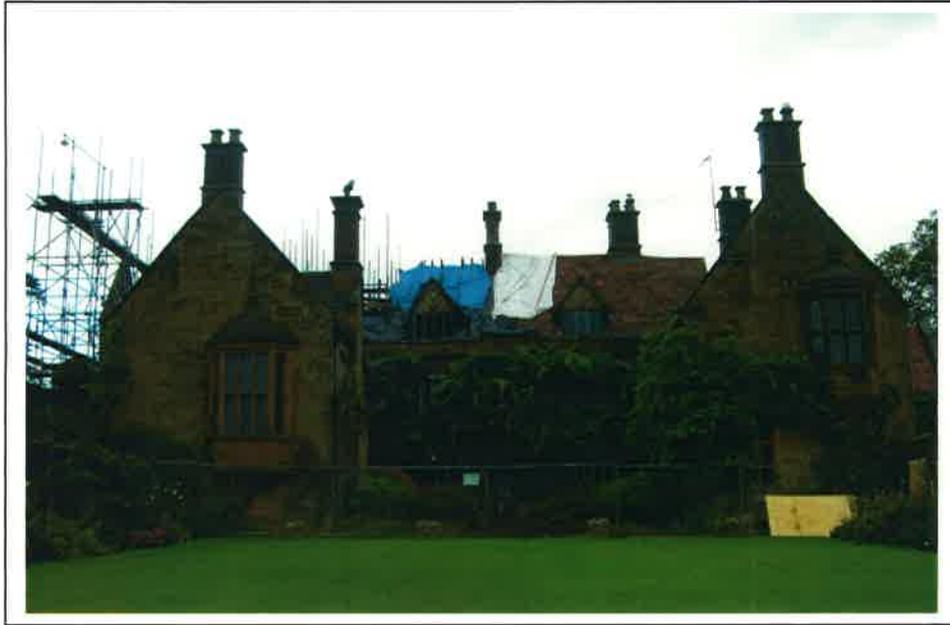
Plate 1: South east elevation - general damage to roof structure

- 1.3.3 As a result of the fire in April of this year (Plates 1 - 4), an extensive programme of restoration and conservation work has been proposed by Rodney Melville and Partners, Architects, details of which are currently being finalised and are likely to run until the latter part of 2005.

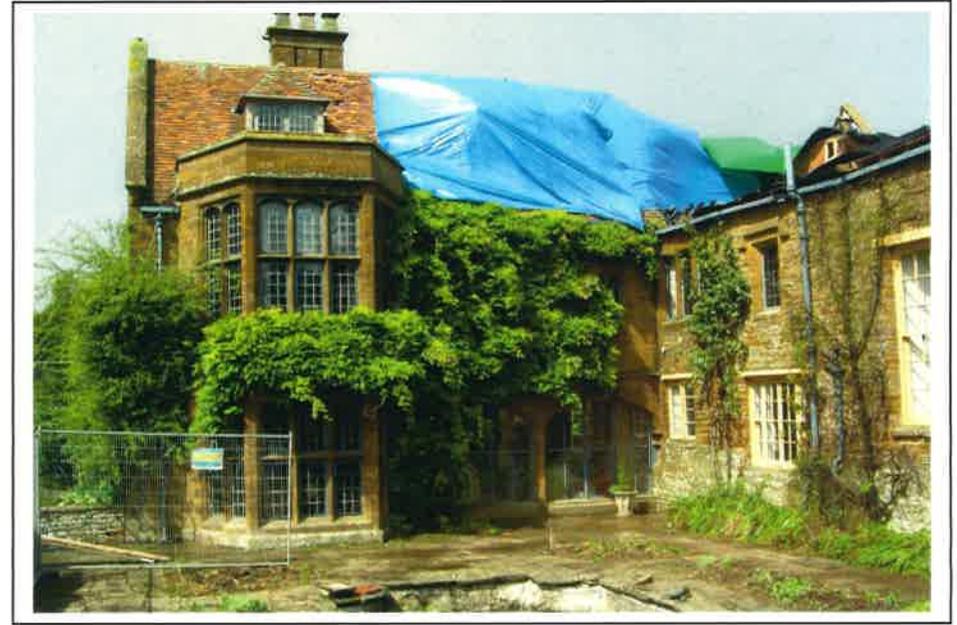
Plate 2: View north - general damage to roof structure

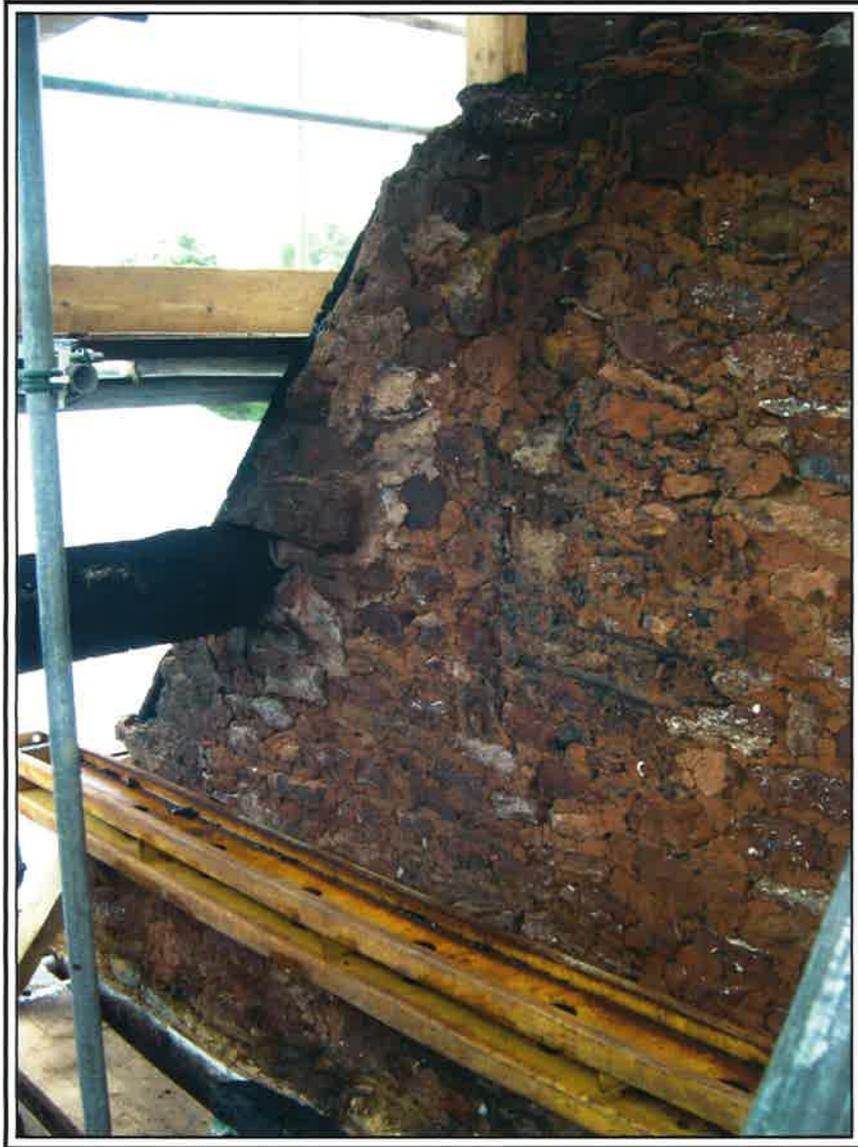
- 4.1.8 At 3.75m and 3.50m respectively above the first floor level the remains of 2 heavily charred purlins (Plates 13 & 14), were still set in the gable end, running north east - south west. The remains of charred rafters were also observable on the east side of the gable end.

Plate 13 : Charred purling embedded in south east side of elevation

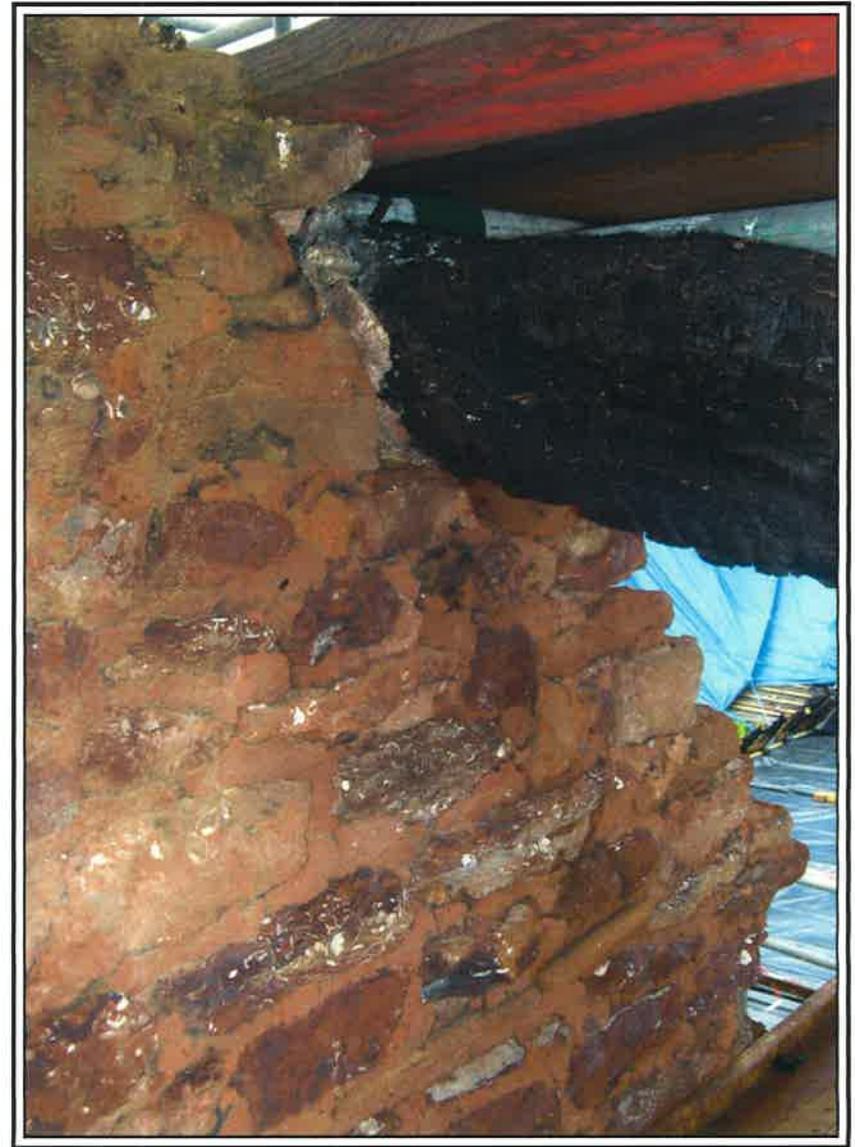
Plate 14 : Charred purlin embedded in north west side of elevation

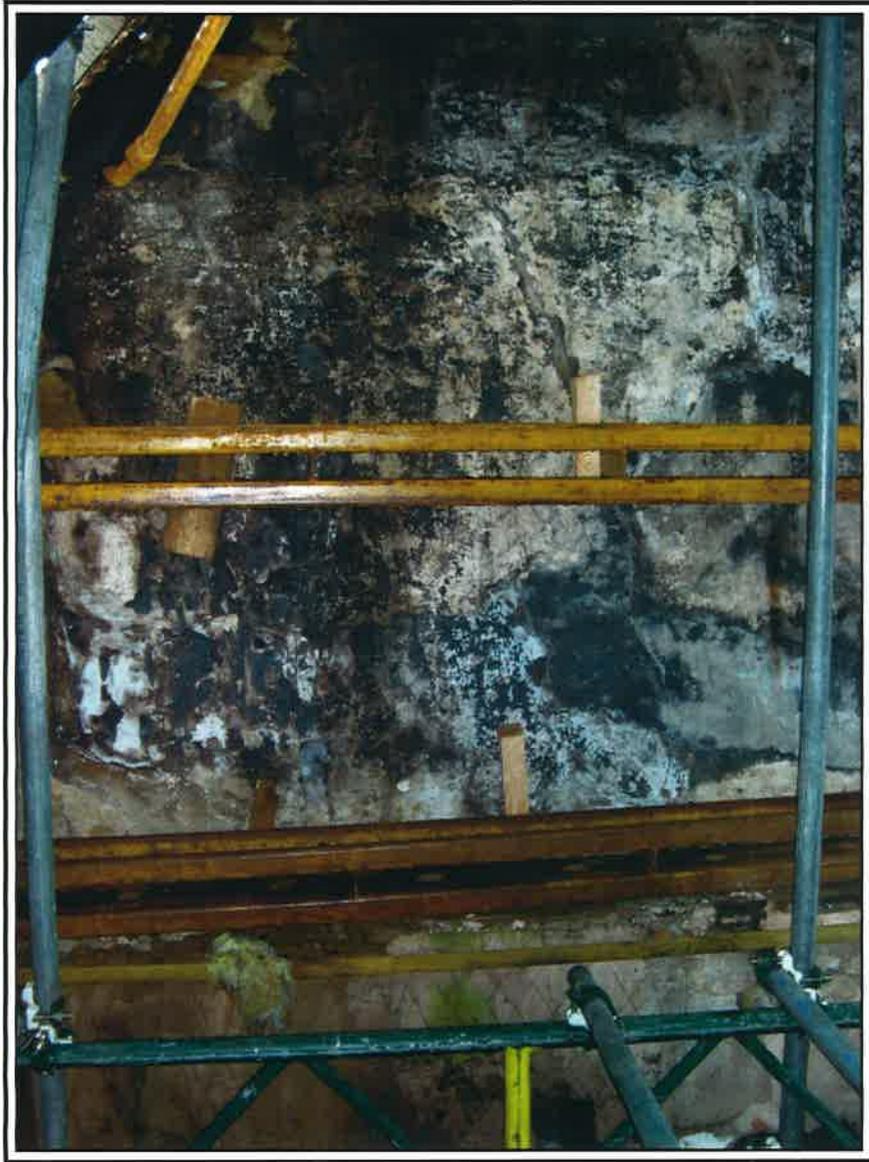
- 4.1.7 At 0.65m above first floor level the gable a ledge had been constructed that sprung to the north east for 0.25m. This again was of rubble ironstone construction but covered in 7mm of grey render (Plates 15 & 16).

Plate 15 : South east side of elevation - 2nd floor level

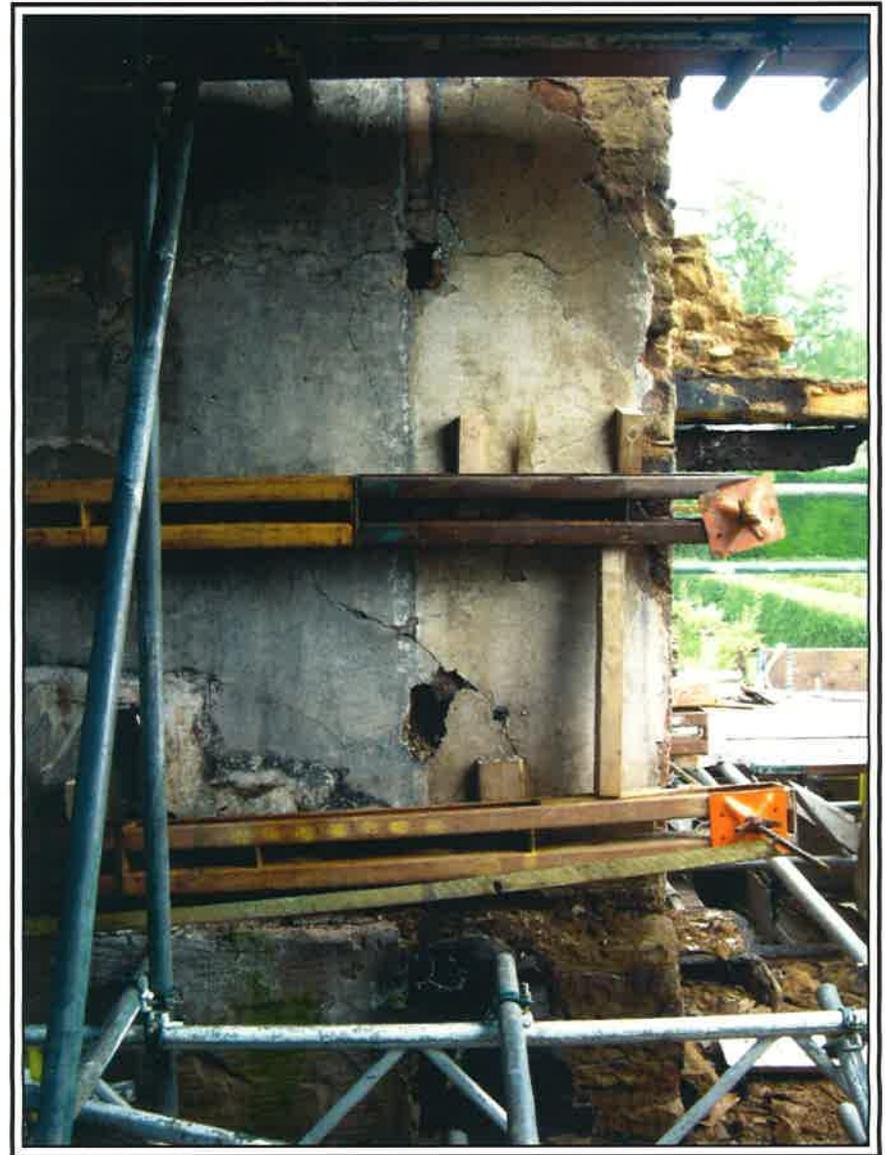
Plate 16: North west side of elevation - 2nd floor level

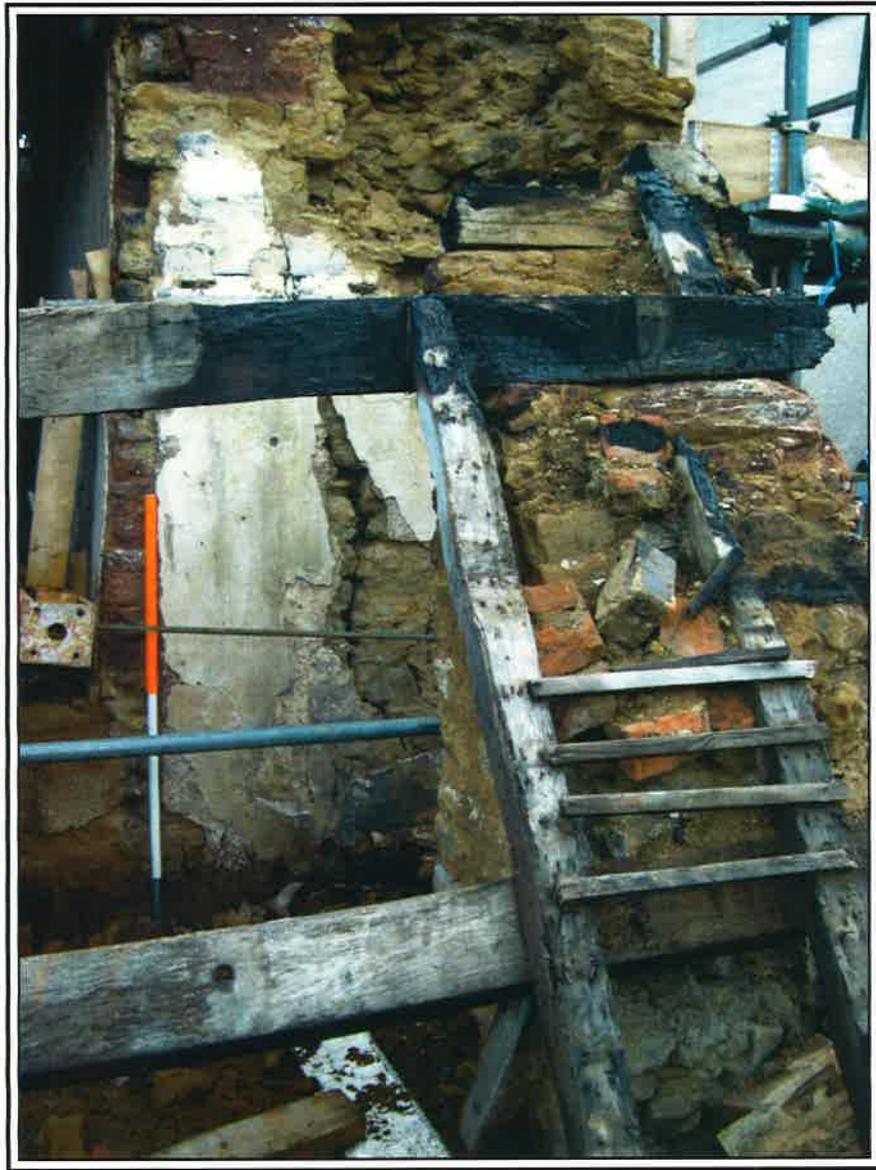
- 4.1.9 It should also be noted that a substantial part of the north west side of the gable end was destroyed and collapsed in the aftermath of the fire. Although part of this survived at the extreme north west it was inaccessible during the process of drawn recording, although was recorded photographically (Plates 21 & 22).

Plate 21: Detail of purlins on north west side of elevation

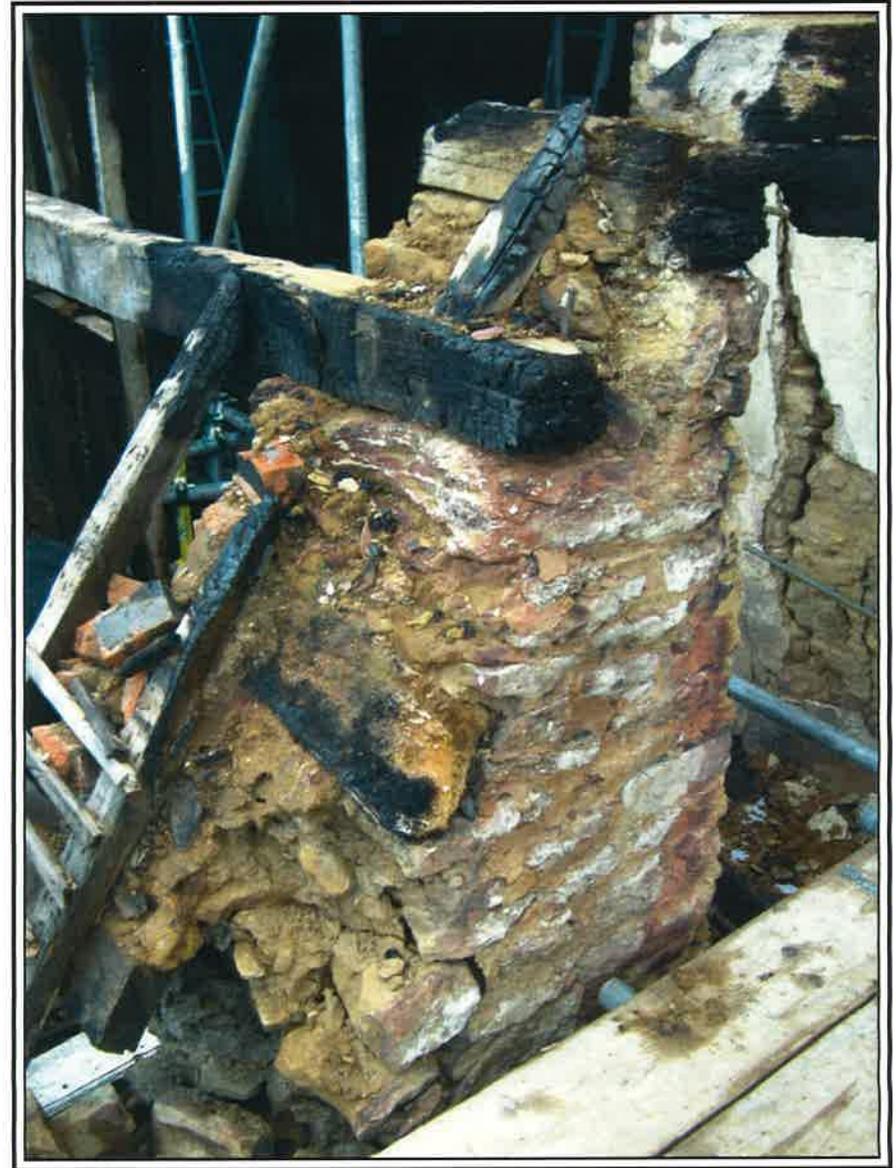
Plate 22: Detail of remaining north west side of elevation - view east

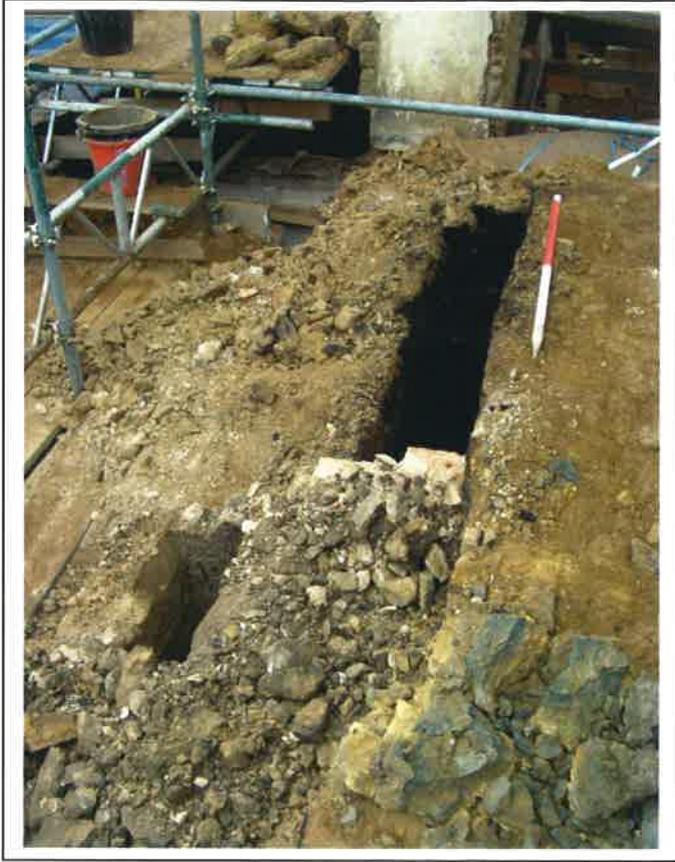
Plate 23 : Flue 5 at first floor level - view north west
