Greys Court Rotherfield Greys Oxfordshire

Archaeological Watching Brief Report

Greys Court, Archaeological Watching Brief on Drainage Trenches

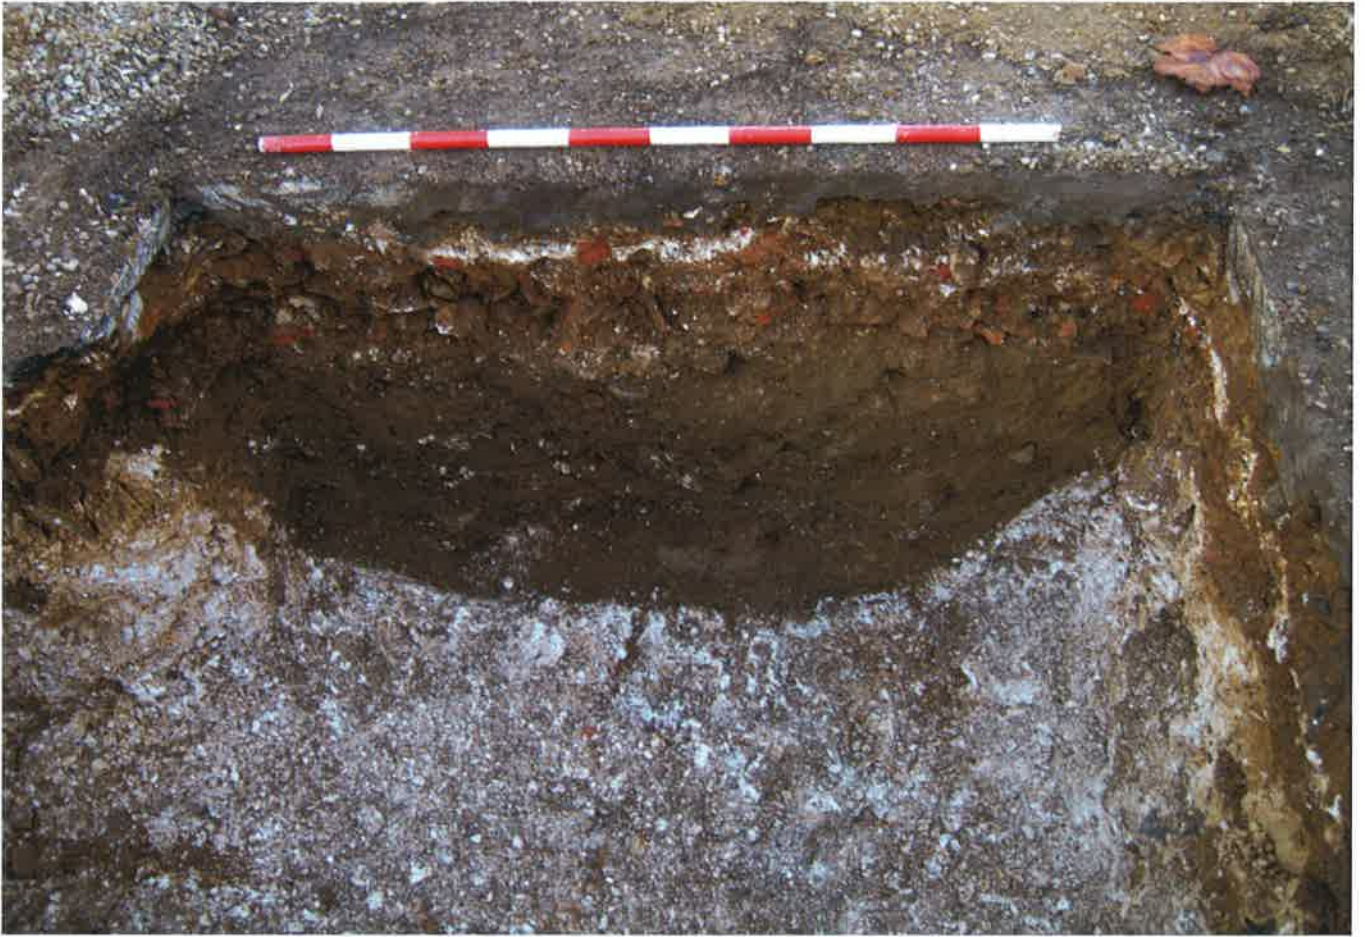
- 4.1.4 One feature (113) was seen dug into the natural chalk deposits, 1.0m from the east end of the trench (Plates 1-2). This appeared to be part of a north-south linear feature with very steeply sloping sides extending from 30cm below the surface and continuing below the base of the trench at 90cm thus being more than 60cm in depth. The feature was 66cm

wide at the top and 46cm wide at the base of the trench. The maximum excavated length of the feature was 1.3m and it extended into the sections at north and south.

Plate 1: Trench 1; cut 113 looking west (prior to westward extension of trench)

- 5.1.2 A single feature (113) was seen in trench 1, which appeared to be part of a north-south linear more than 1.3m long with very steeply sloping sides, this was not bottomed at 90cm thus being more than 60cm in depth.

- 5.1.3 The feature was filled with a uniform light brown silty sand (114) and one piece of medieval pottery, a local ware of possible 13th-14th century date was recovered from the fill. It is uncertain and difficult to say what this feature represents but it is probably medieval in date and if part of a long linear feature it may either be some sort of drainage gully or ditch, it is probably not a robber trench unless for a relatively narrow brick wall.

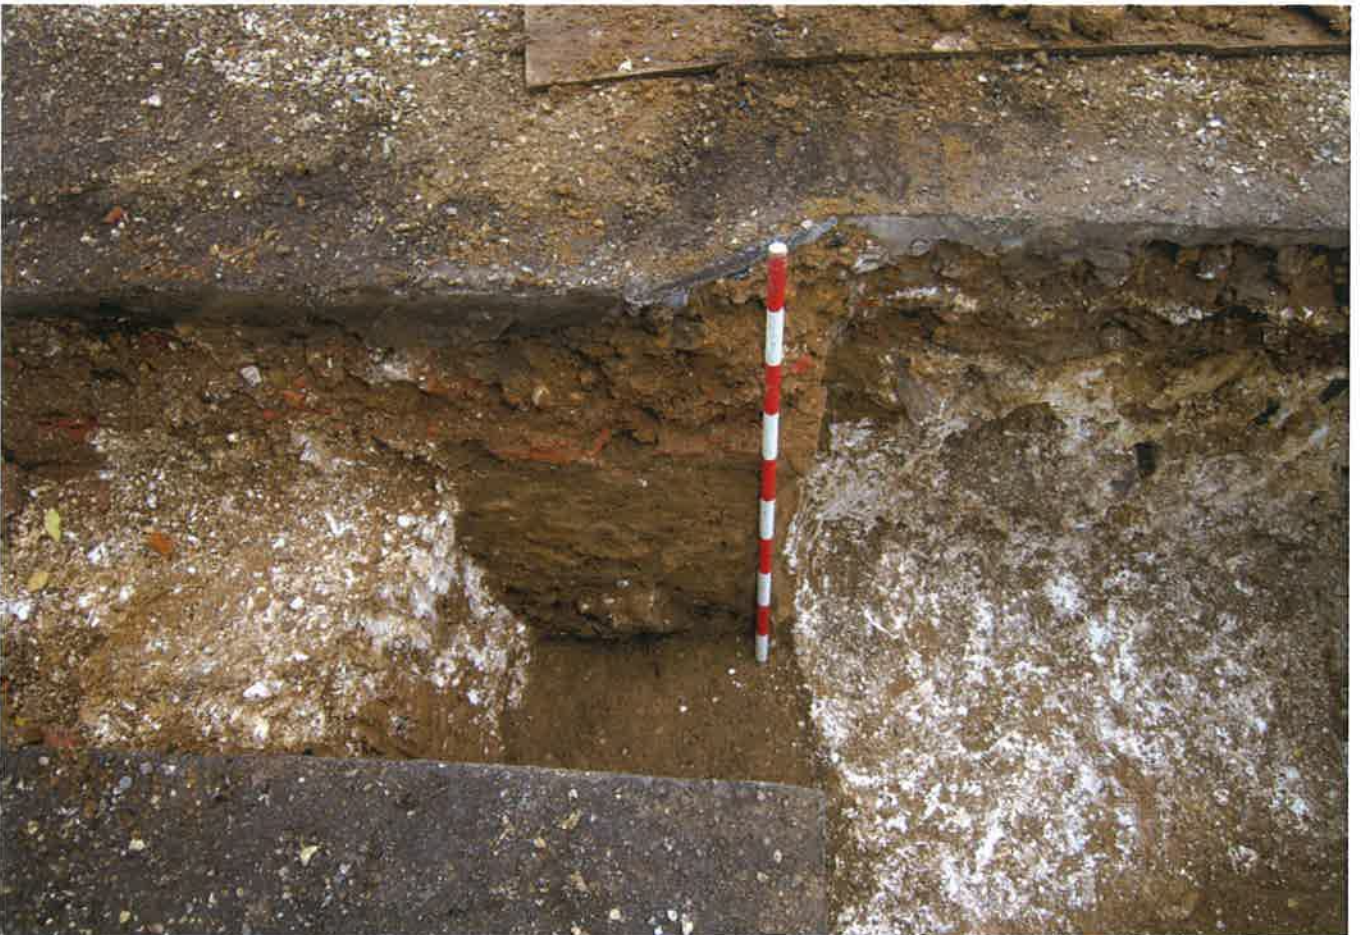
Plate 2: Trench 1; cut 113 looking north

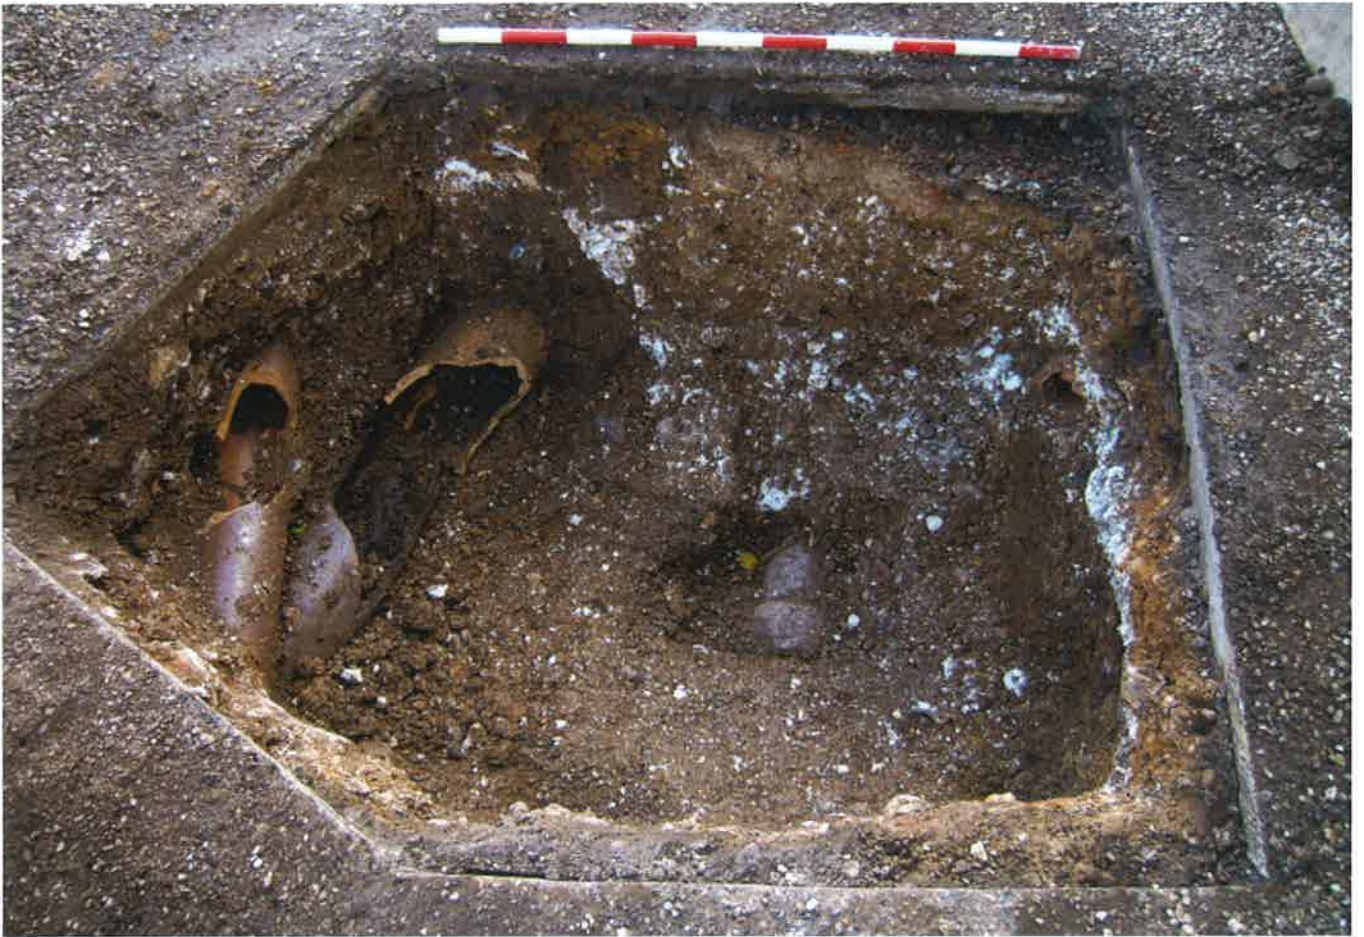
- 4.1.8 This was a small exploration just over 1m square just to the south east of the south east corner of the East wing of the house. This was excavated to investigate and give access to the old storm and surface water drains (Plate 3).

- 4.1.9 This trench revealed only 19th/20th century drainage trenches; the 4" foul water pipe passed through the centre of the trench running north to south at a depth of 0.7m with backfills 106, a light grey brown clay with frequent small chalk flecks and fragments, and 105, a mid orange brown clayey sand with frequent small flints and chalk flecks, above it.

Plate 3: Trench 2; looking south

- 5.1.4 This small trench just to the south east of the south east corner of the East wing of the house revealed only 19th/20th century drainage/sewage trench backfill and pipes (contexts 101-111) and nothing of archaeological interest was seen.

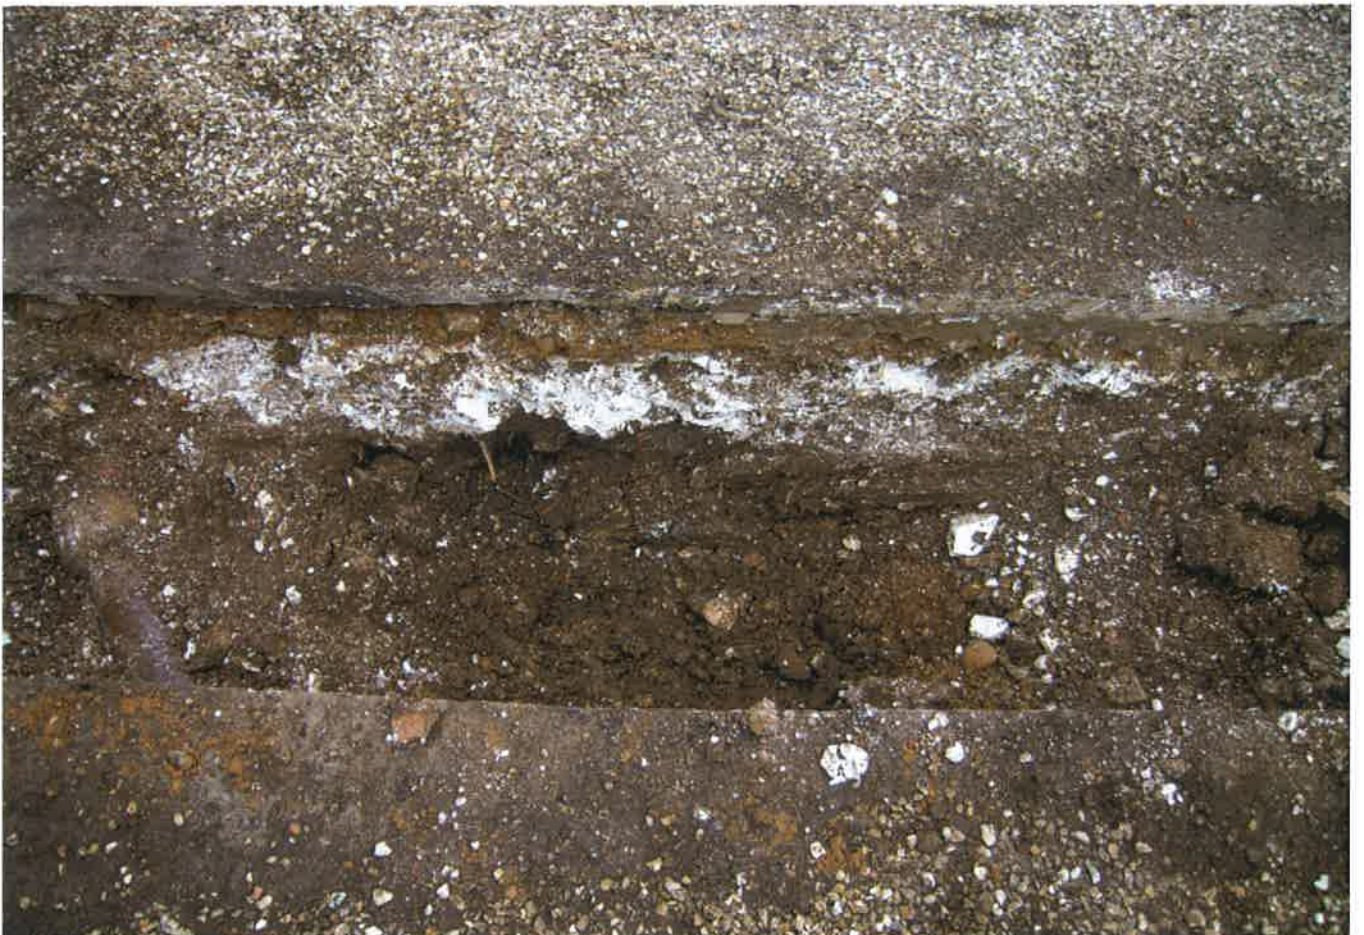
- 4.1.13 The eastern part of the trench contained at base a dark brown silty clay (117) with moderate small to medium flints. This extended from 30cm below the surface to the base of the trench at 60cm and was over 2m in width. This deposit contained some animal bone and one piece of post-medieval stoneware and one clay pipe fragment, the pottery was from a German Frechen stoneware vessel of c1550-1700 probably from a 'Bellarmine' jar and the clay pipe was a piece of worn stem of 17th-century date.

- 4.1.14 The deposit was probably either a post-medieval buried soil or possibly fill of a larger feature or make-up. Above 117 was a 15cm thick layer of chalk (116). At the west end

the deposits were cut by a trench (118) for a 4" drain, backfilled with a mixed light brown sandy silt with frequent small chalk inclusions and fragments of CBM (119). Above this was a levelling layer of hoggin (115) and the tarmac surface (100) (Plate 4).

Plate 4: Trench 3; looking north-east

- 5.1.5 This trench just south of the house revealed on the east a dark brown deposit (117) that contained some animal bone and a piece of post-medieval stoneware, and was probably either a post-medieval buried soil or possibly fill of a larger feature or make-up, this extended from 0.3m and was continuing at the base of the trench at 0.6m.

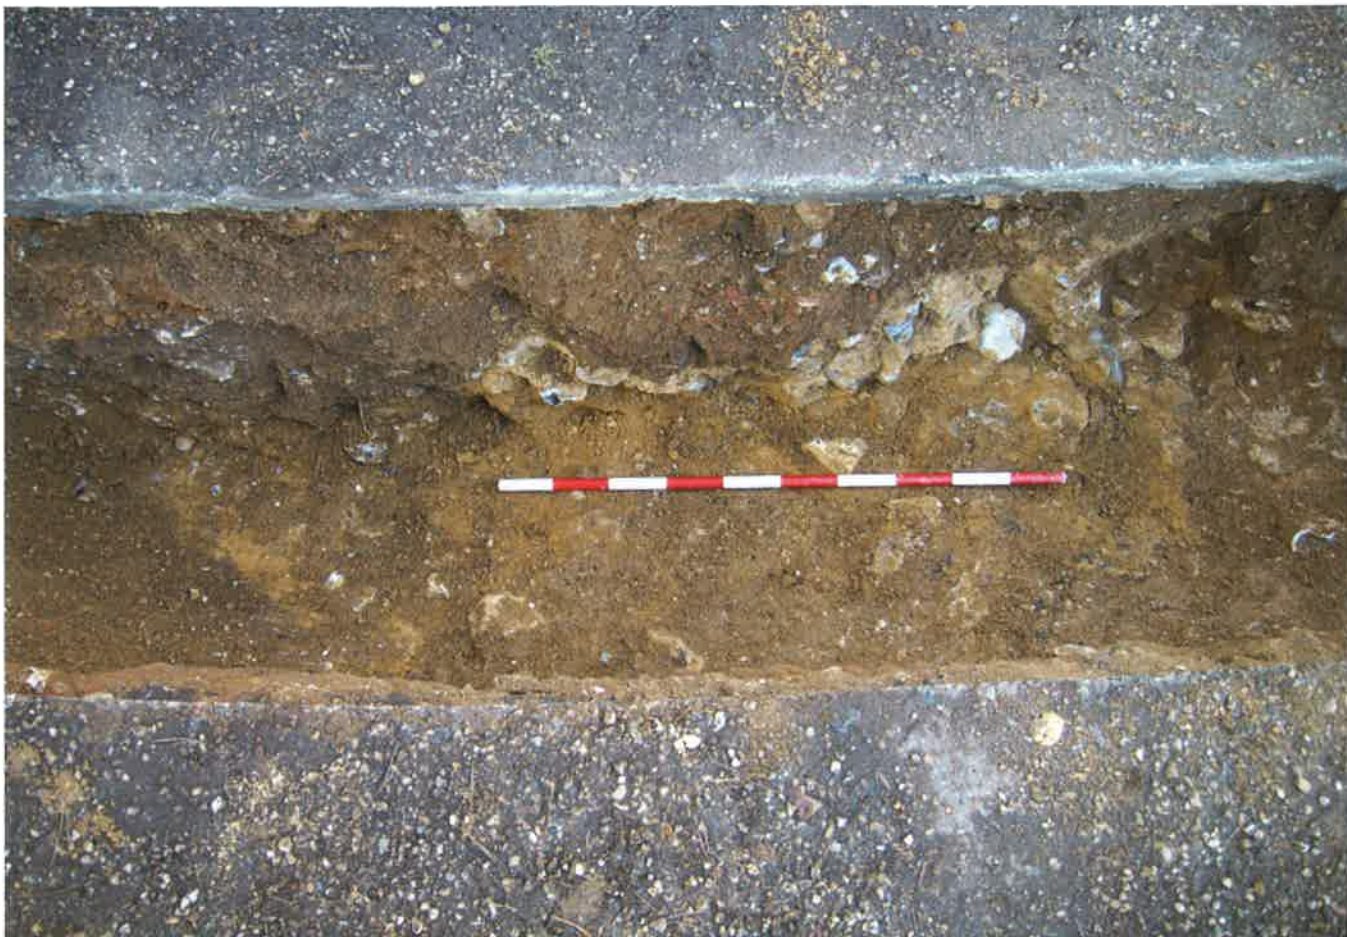
- 4.1.17 The first archaeological feature encountered was the remnant of a south-west to north-east aligned flint and mortar wall (123) at 42.5m-44m from the north (Plate 5). The base of the wall coincided with the base of the trench at about 70cm and the wall survived for a height of only about 20cm in the trench as it was truncated by the existing surface drain trench. This wall which seems to align with wall 035 as recorded in 1997 is of very rough rubble flintwork bonded with relatively hard light yellow brown lime mortar with frequent white chalk flecks. This wall was built against the south face of an earlier structure also a flint and mortar wall (124) little of this survived and the full width could not be ascertained as it had been truncated by later features. The south face (abutted by 123) was clearly either rendered or the lime mortar was smoothed deliberately when built. The mortar in 124 seemed almost identical in appearance and hardness to that in 123 (Plates 6-7).

Plate 5: Trench 4; wall 123 with 124 to right, looking west

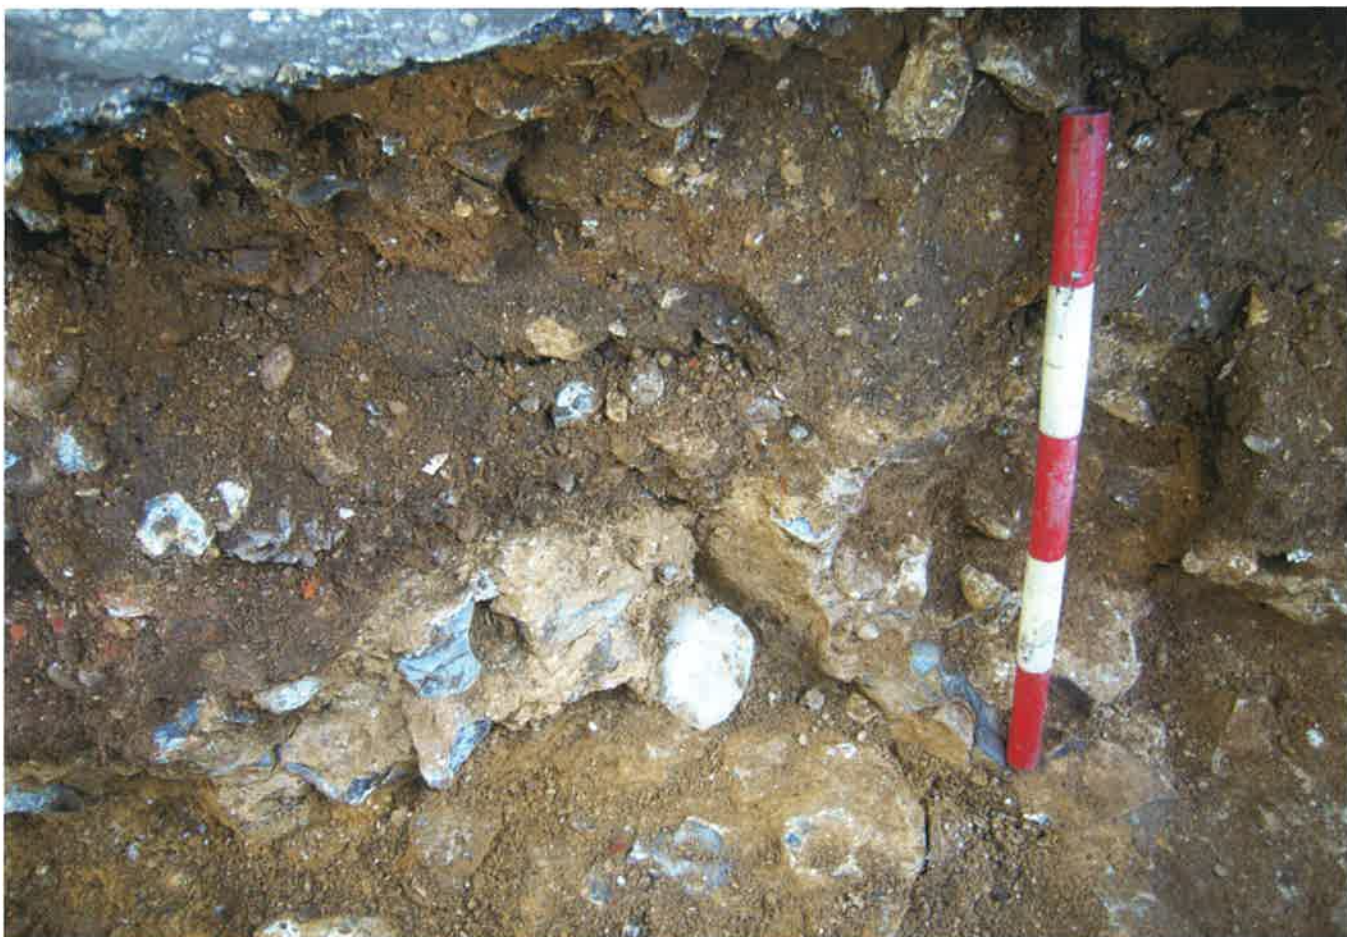
Plate 6: Trench 4; wall 123 on left abutting 124 on right, looking west

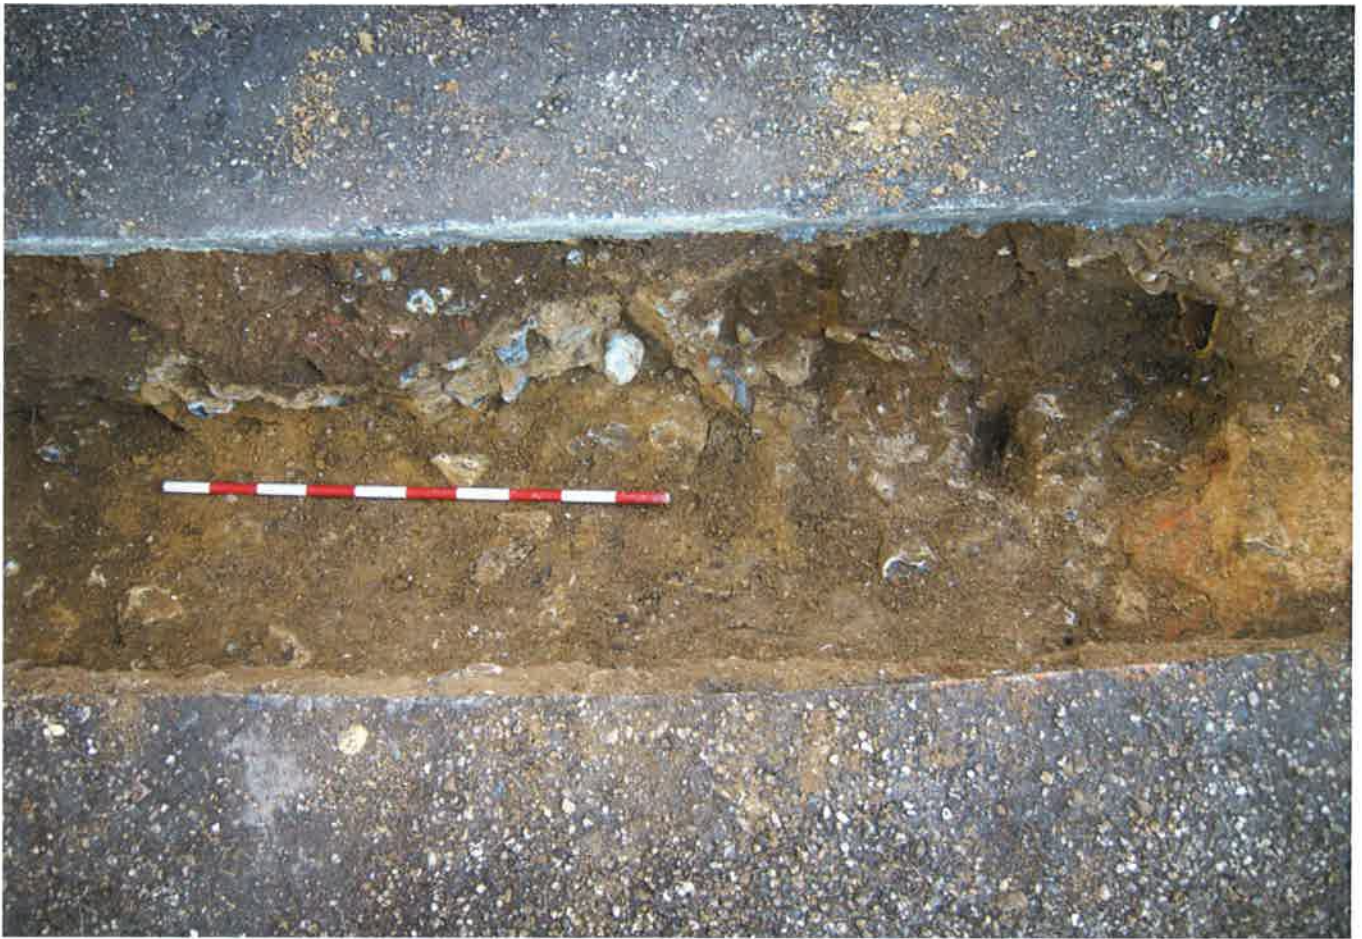
Plate 7: Trench 4; walls 123 & 124 with culvert 125 to right, looking west

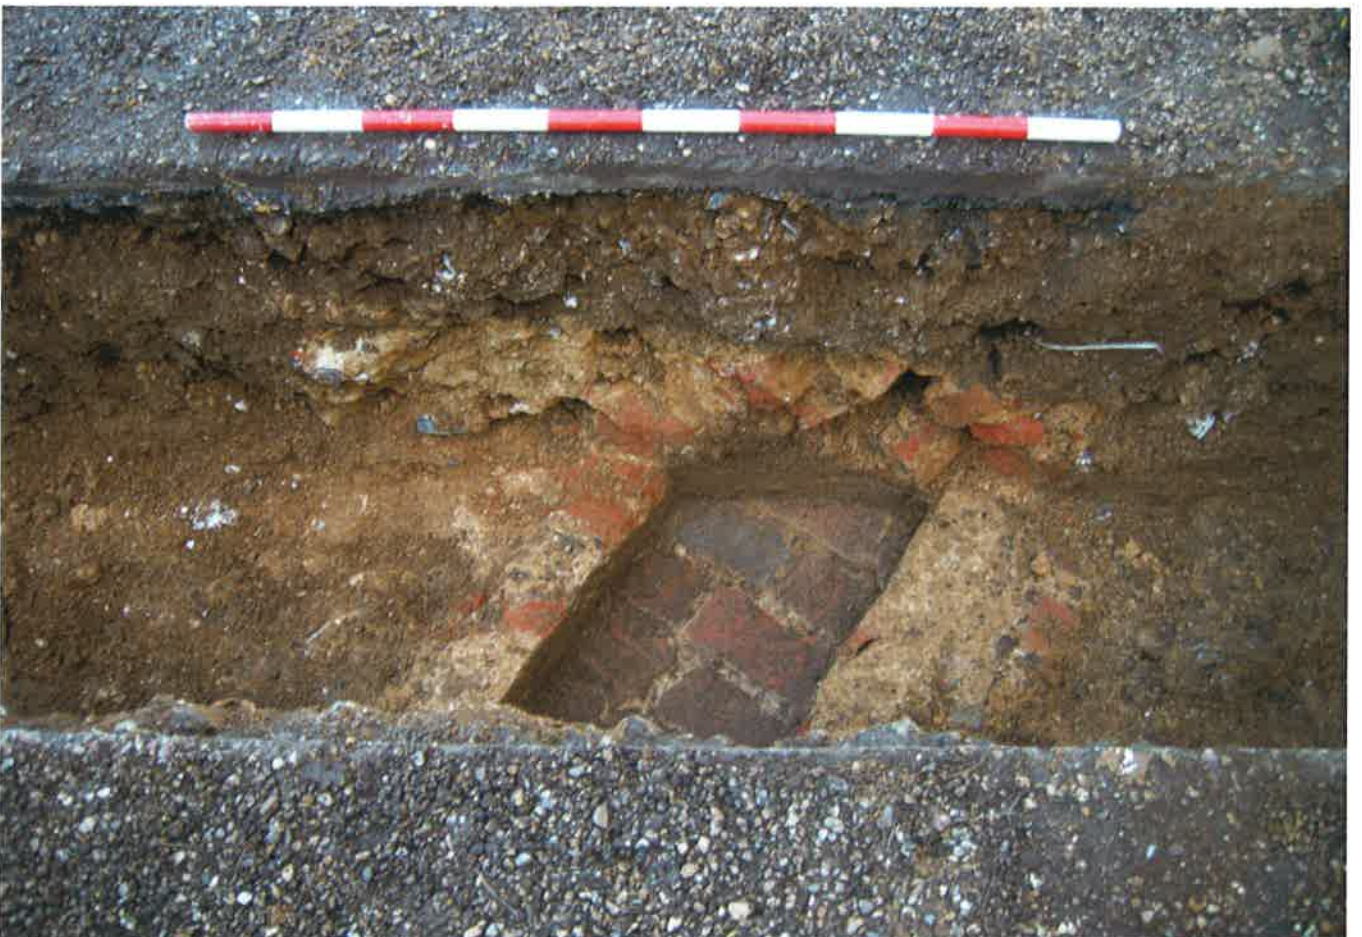
- 4.1.18 Wall 124 was truncated to the north by a small brick conduit (125) (Plate 8), aligned south-east to north-west, and the modern surface drainage pipe trench (120). The conduit consists of a brick and lime mortar segmental arched vault sitting on a flat brick base. The bricks are of a red fabric and some of those in the base had dark ashglaze on the exposed face, they measured 7cm high by 12cm wide. The conduit measured 75cm wide externally and 36cm wide internally, the internal height was 30cm (Plate 8). The arched top had been truncated by the existing surface drain trench on the west and the new trenching removed a further part of this. The conduit was filled by a very uniform light grey brown silty sand with no inclusions ranging from 20-25cm thick (126).

Plate 8: Trench 4; culvert 125 looking east

- 5.1.8 Just north of the medieval walls a small brick conduit of probable 16th-century date (125) was exposed this was smaller and on a different alignment to a brick conduit seen in 1997 (032) but the courses of the two conduits if projected would converge and as only one conduit appears in each trench it seems likely that they joined somewhere between the trenches and were part of a connected drainage system.

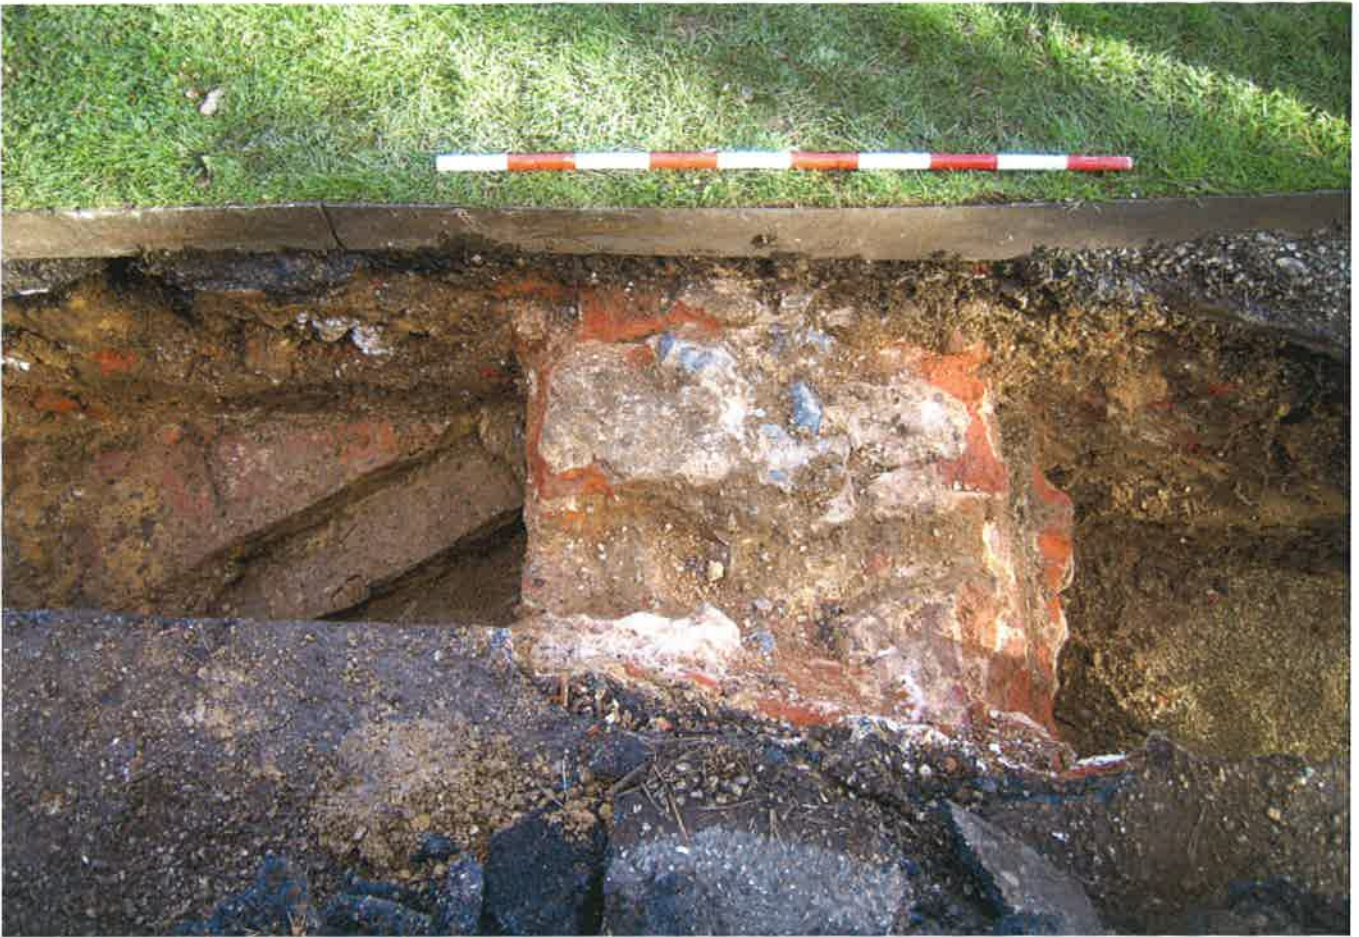
- 4.1.19 Approximately 3.5m north of the conduit the trenching encountered a south-west to north-east brick, flint and lime mortar wall (127) this was 90cm wide and 55cm thick the top was immediately below the present tarmac drive surface (Plates 9-10). The wall consisted of mostly red brick with some flint filler in the centre. The wall was bonded with a hard cream coloured lime mortar with frequent white chalk flecks and small fragments. The bricks were hand made of a dark red fabric with small dark inclusions bricks measuring 60 x 113 x 245mm and probably date from the 16th century.

Plate 9: Trench 4; wall 127 with wall 129 to left, looking east

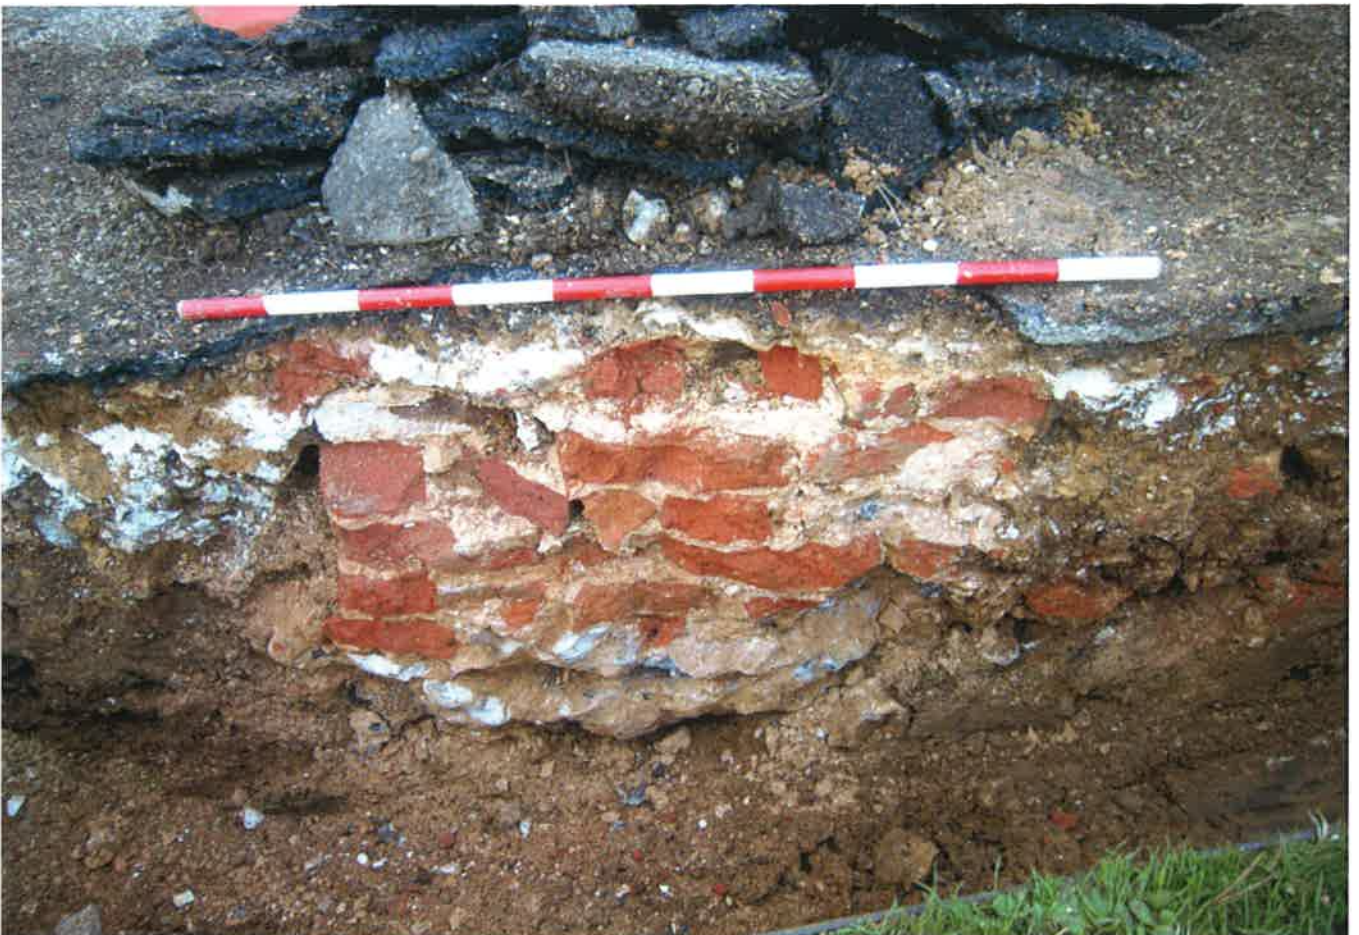
- 4.1.20 This was the base of a wall with much mortar adhering to the exterior of the bricks and no particular brick bond could be discerned, this wall is on the alignment of wall 029

Plate 10: Trench 4; wall 127 in section after breaking through, looking west

- 5.1.9 About two metres north of the conduit a substantial brick wall (127) was seen immediately below the surface and this was directly in line with a wall of the same type recorded in 1997 (029). This is the 16th century lower courtyard wall seen on early drawings and which is clearly visible as a parch mark in the lawn in the summer. This wall cut a narrow earlier brick wall (129), showing to the north, on a north-west to south-east alignment which had a tile capped flint footing. This was not encountered in the 1997 trench, it is probably not substantial enough to have belonged to a large building. It is difficult to say much more about the purpose of this wall and although it is

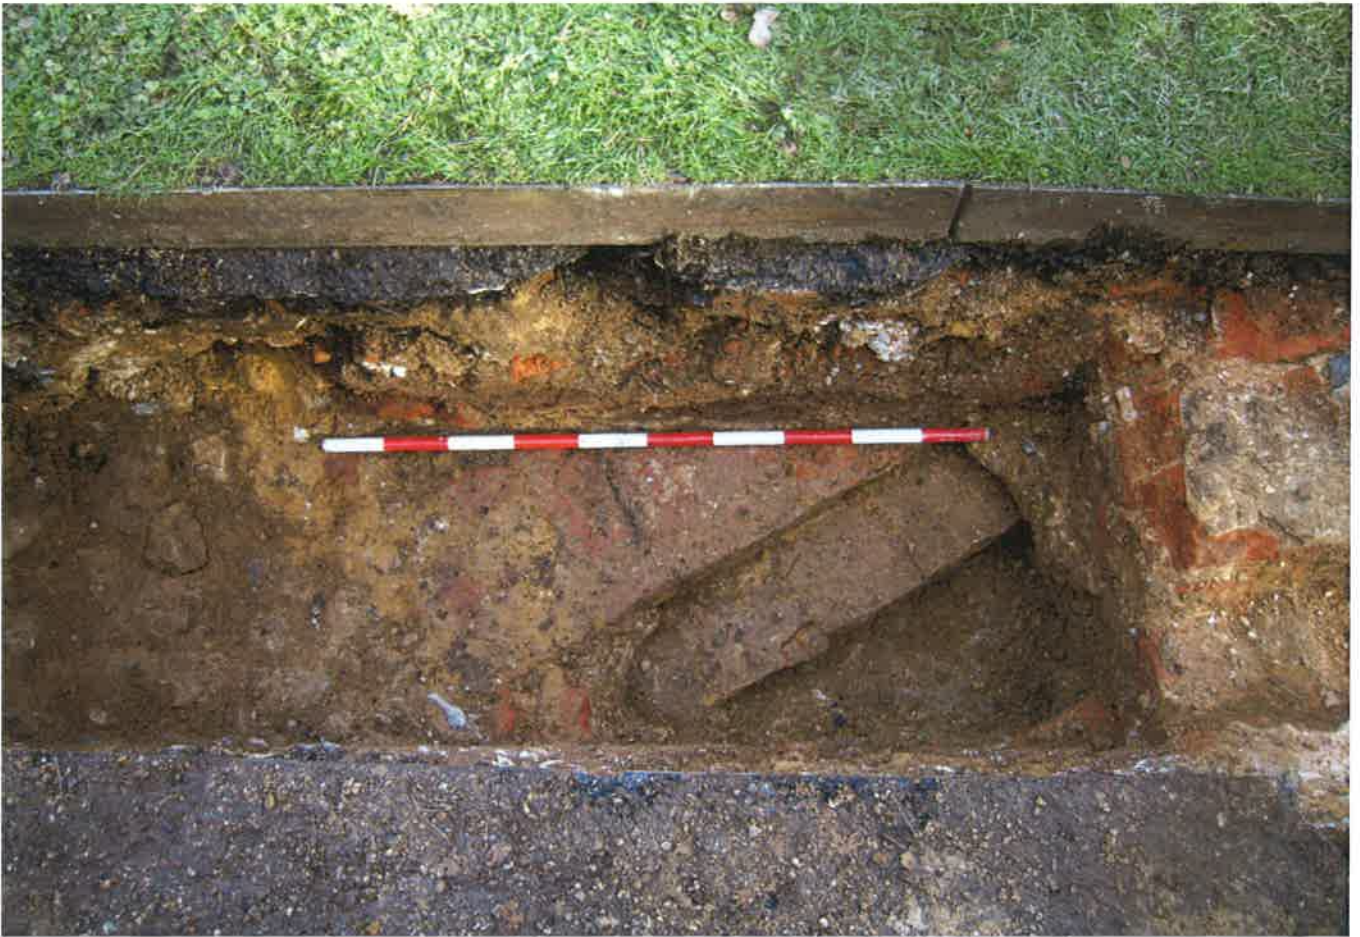
- 4.1.21 Immediately north of this wall, at an angle to it, were two further brick structures, 128 and 129, both aligned north-west to south-east (Plate 11). Feature 128 only showed for a short distance adjacent to wall 127 in the west side of the trench. It consisted of a single course of red bricks 39cm below the ground surface. The bricks were 5cm thick with about 5cm of lime mortar bedding below them and possibly represent part of a brick floor. It is on a similar alignment and in a similar relation to the boundary wall as brick floor 030 recorded in 1997 but that feature was about 0.2m deeper than 128. The south end of 128 physically projected into or partially below wall 127, it was difficult to tell whether it had been built into it or whether 127 had truncated and partially built over 128, the latter seems more likely especially considering that wall 127 clearly cut wall 129 which is parallel to 128.

- 4.1.22 Structure 129 is north-west to south-east aligned and appears to be a wall base consisting of a flint and sand footing capped with pieces of broken red clay tile forming an offset with one surviving course of bricks and mortar laid on the tiles. The tiles were approximately 1.5cm thick with about 9.5cm of sand and flint below on the west but this may have extended deeper. The bricks were laid in a header course which was 0.30m wide and consisted of some whole bricks and some part bricks, the tile and flint footing protruded 0.17m to the west and probably a similar distance to the east, although was not fully seen, which would make it 0.64m wide in total.

- 4.1.23 At the north end of 129 in the base of the trench was a deposit of medium to large flints in a matrix of light grey-brown sand with frequent chalk flecks (130) (Plate 11). The flints were not cobbles and probably too rough to have been a surface, 130 appeared to be later than 129 as it partially overlay 129. Deposit 130 extended for about a metre or so north and north of this was deposit 131. 130 may have been in a cut that truncated 129 and 131 or may have been related to the terminus of wall 129 but this was not certain.

Plate 11: Trench 4; wall 129 (with scale on) with wall 127 to right, deposit 130 to left and 128 at bottom left of 127, looking east

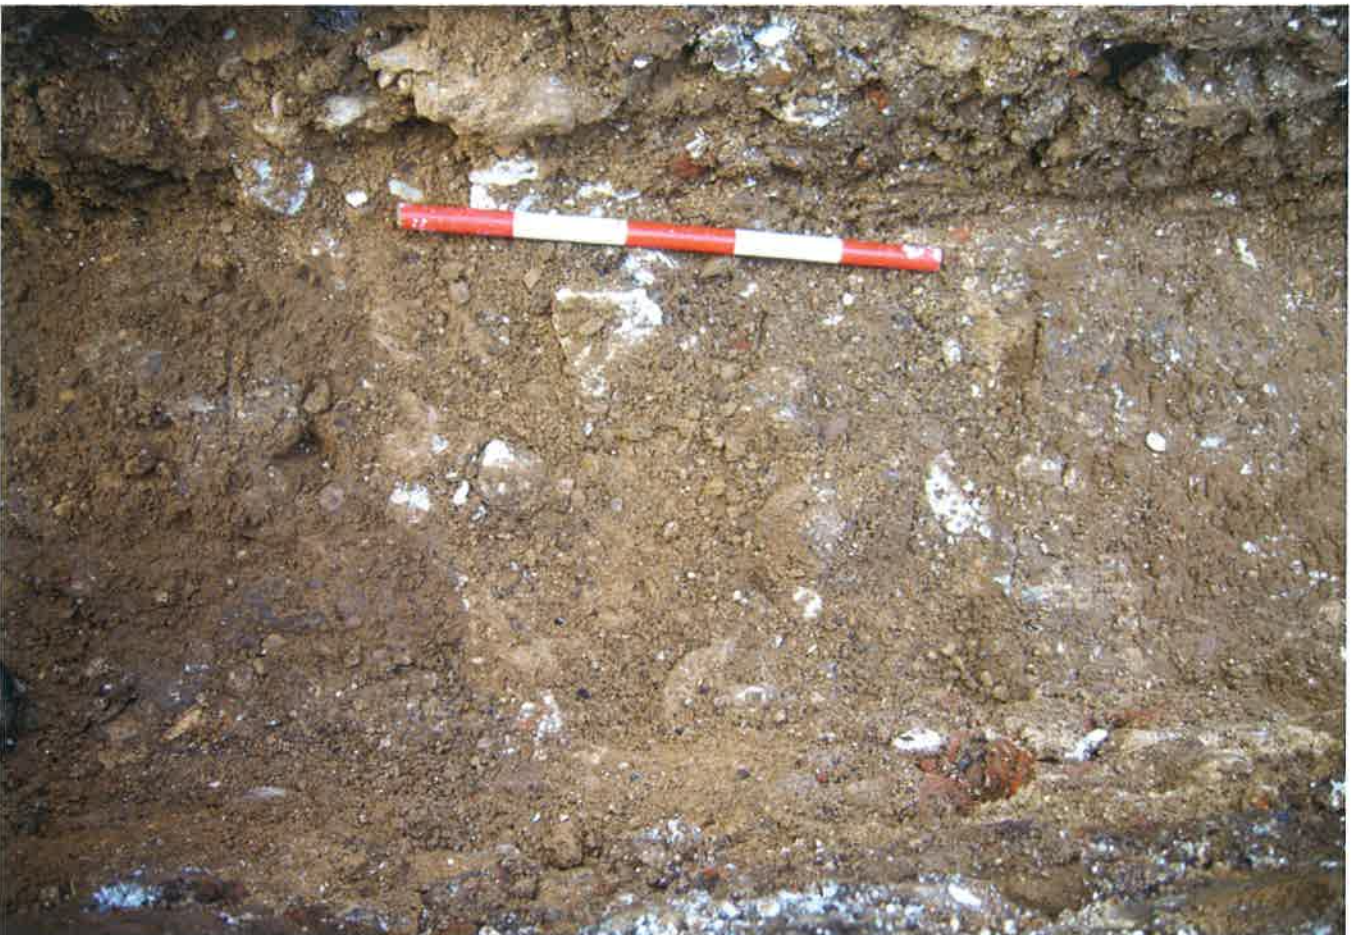
- 4.1.25 At about 3.5m north of wall 127, 131 was truncated by a cut (132) aligned south-west to north-east. The depth of the cut is not known, it was filled by 133 and 134. Context 133 was a coarse pale yellow brown sand with frequent medium to large flints and chalk fragments and frequent small to medium fragments of CBM, this deposit was about 0.5m in width. Context 134 which consisted of a compact plastic mid-brown clay with frequent chalk and charcoal flecks and occasional small flints and pebbles and was about 1m wide (Plate 12).

Plate 12: Trench 4; old soil 131 on left with cut 132 and fills 133 and 134 to right, looking west

- 5.1.13 North of these structures a north-east to south-west aligned cut (132) truncated the buried soil (131) and as this is on the same alignment as a medieval wall (025) seen just three metres to the west in 1997 it is likely to be robber cut for that wall. Marshall (1998) considered that the corresponding wall (025) in the west trench being similar and parallel to a wall seen 8m to the south (035) might together represent a former medieval building across the line of the lower courtyard wall and therefore possibly demolished by the 16th-century. As the northern of these walls was robbed out in the 2010 trench it is not possible to compare the fabrics and therefore the later trench does not really help to either confirm or deny the earlier theory but shows that both walls probably extended eastwards and the south wall had an earlier phase or was built against an earlier structure.
