48 and 49 High Street West Wycombe

Historic Building Recording and Investigation

Document Title: No 48 and 49 High Street, West Wycombe Village

Document Type: Building Investigation and Recording

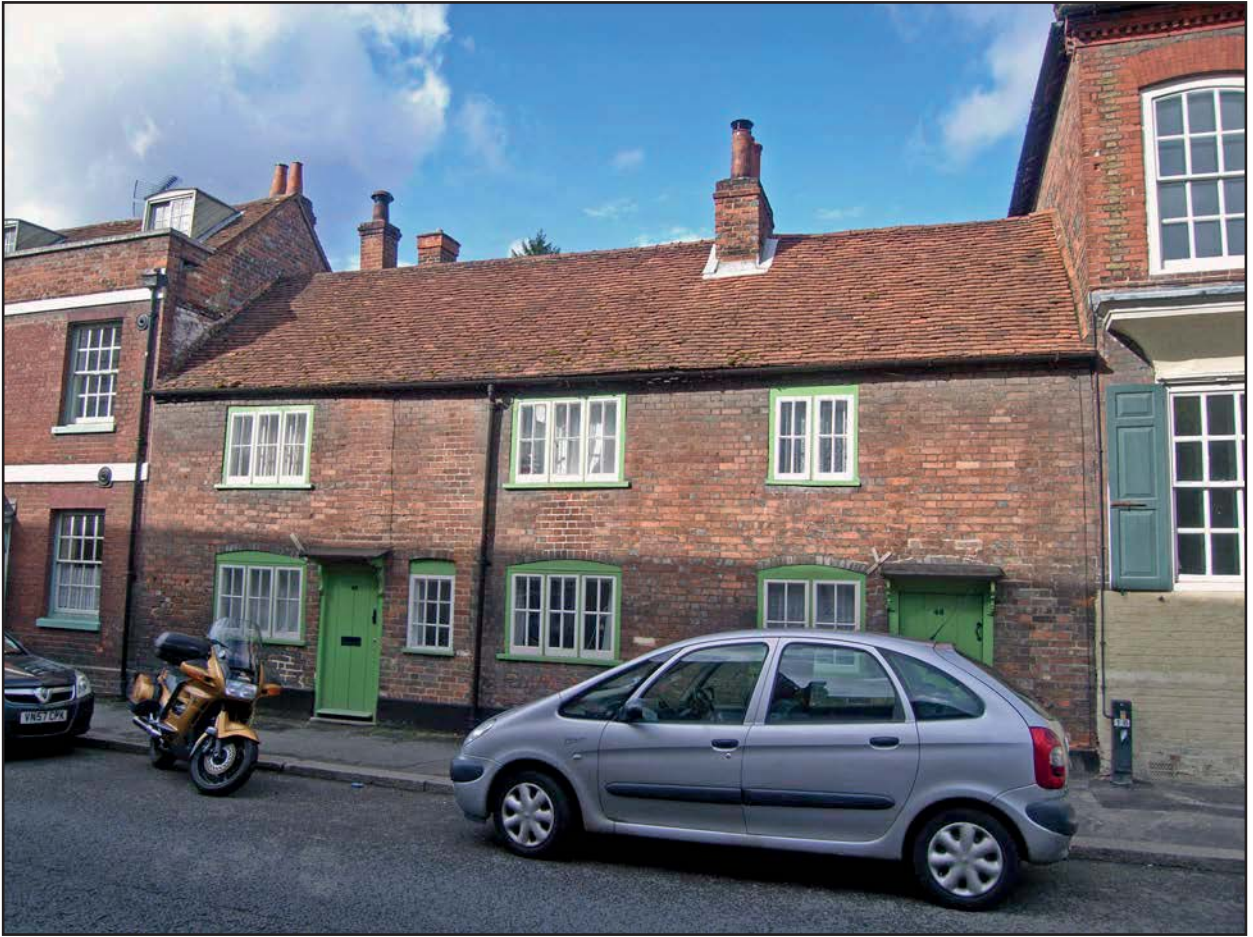
Plate 1: Front Elevation

- 2.3.1 The two houses form part of a continuous range of buildings running parallel to the street. The properties were refronted in brick during the 18th century using red/orange coloured bricks measuring 101 x 215 x 67mm laid in a Flemish bond. The joints are roughly pointed and finished with scored lines. The lime mortar is pale-coloured and friable. The brickwork under the eaves is dentilled. The bricks have sharp arrises and on the ground floor the headers are used in the decorative arch details for the windows and doors. As expected from a brick property facing onto a busy street, the bricks are blackened. The windows are mostly multi-light wood casements that are not original to the 18th century works which would have had sash windows. The sills are wood. The windows and doors sit within pegged wood frames. Small straight hoods have been inserted over both doors with cut or moulded brackets. This insertion cuts through the arch lintel for no.48. The plinth is rendered cement painted black.

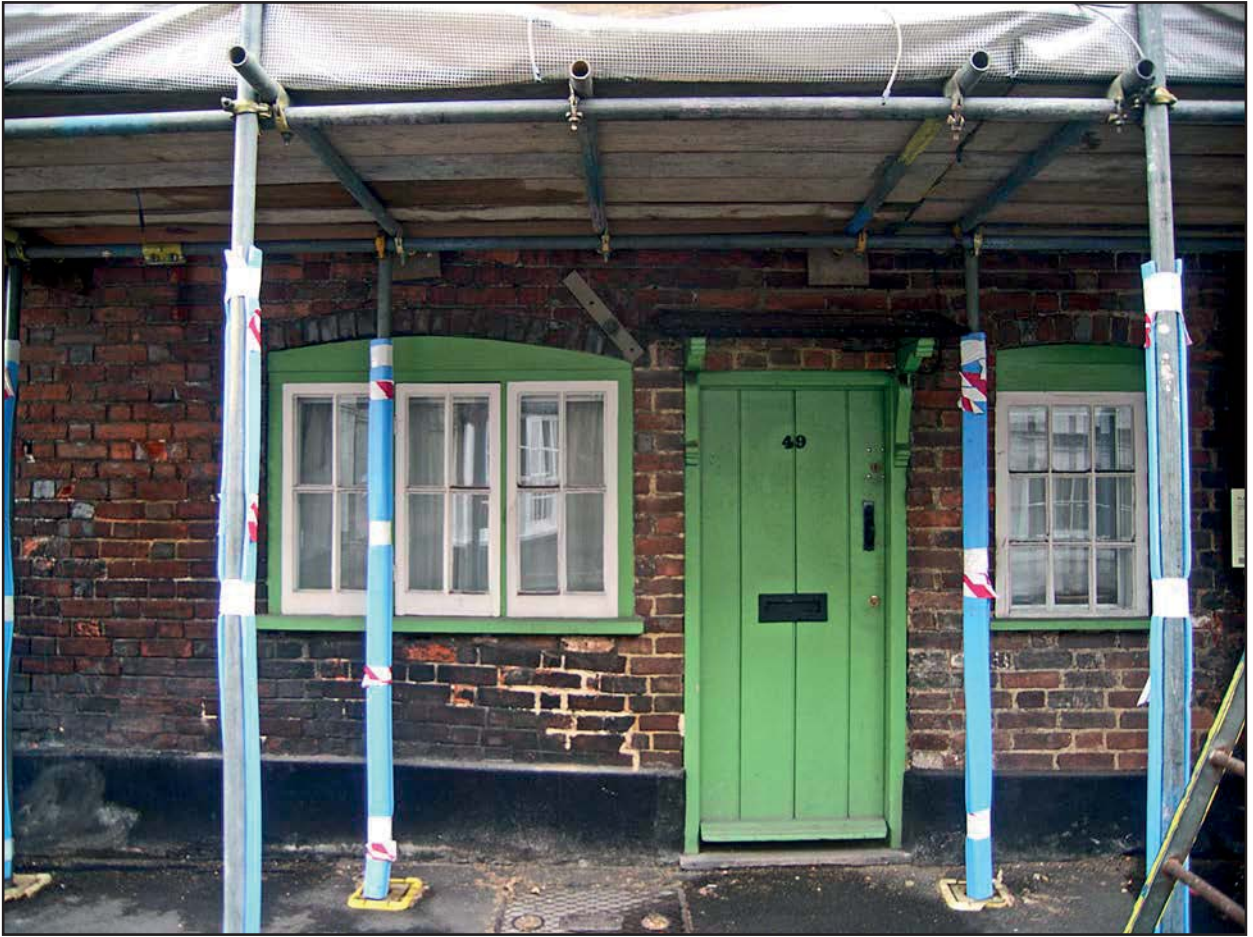
Plate 3: Entrance to no 49 and adjoining blocked doorway

- 2.3.2 There are several areas of alteration/repair work the most noticeable being the infilling of a doorway beside the entrance to no 49. Originally 3 cottages, the former entrance to the middle cottage can be seen on the front elevation where the door has been infilled and now contains a small window. The work to this area also includes the adjoining doorway to no 49 which has been rebuilt in brick and has a square-headed brick lintel as opposed to an arch lintel. The bricks used for this work are similar sized to the 18th century bricks but with sharper arrises and the mortar used is darker in colour. The VBS report suggests this was part of the 1930s works however the 1898 and 1921 OS maps shows only two properties instead of 3 suggesting the work is late 19th century.

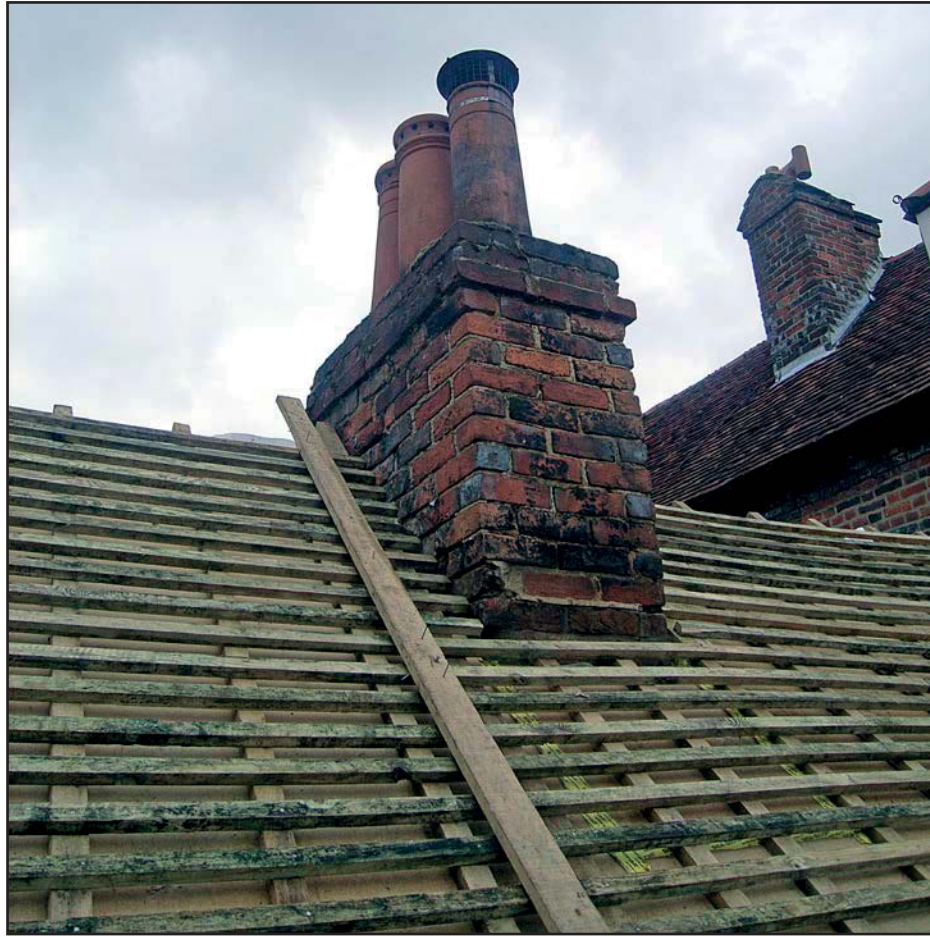
Plate 7: Chimney for 48 and 49

- 2.2.7 There is a brick chimney between no 48 and 49 and it is topped by three chimney pots. The bricks are similar to the brick facing on the front elevation but with sharper arrises and a brown coloured sandy mortar. This is most likely a later rebuild possibly dating to the late 19th early 20th century.

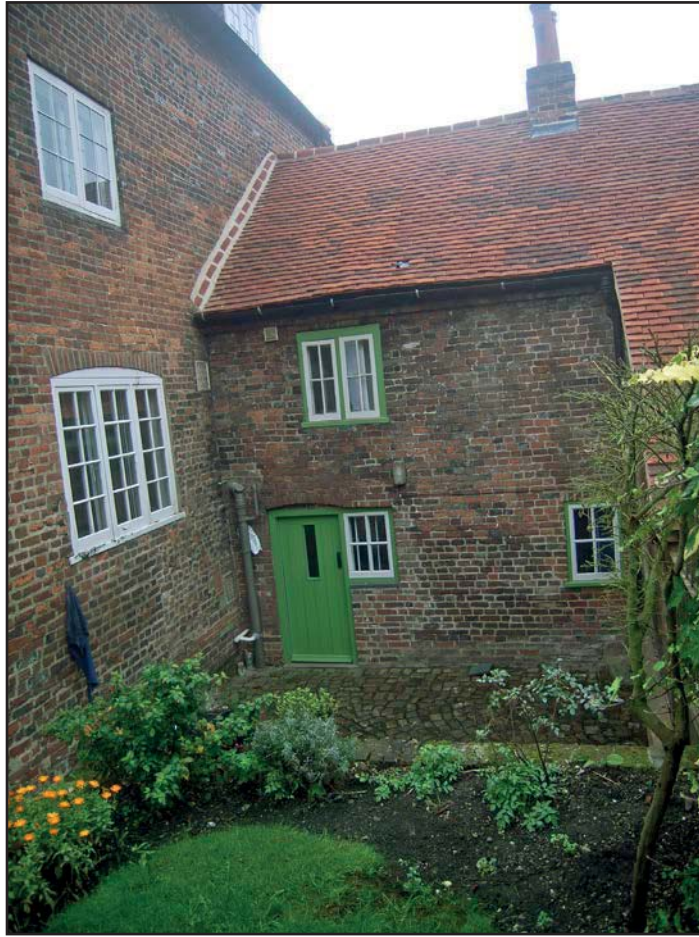
Plate 9: no 48 rear elevation

- 2.3.3 The brickwork to the rear of no 48 is the same as the frontage brickwork with the exception that the bond is extremely variable. This could be that the external face of the frontage was more important than the rear and so more care was taken. The rear doorway has an arched lintel and beside this is an inserted small window. The remaining windows have flat lintels.

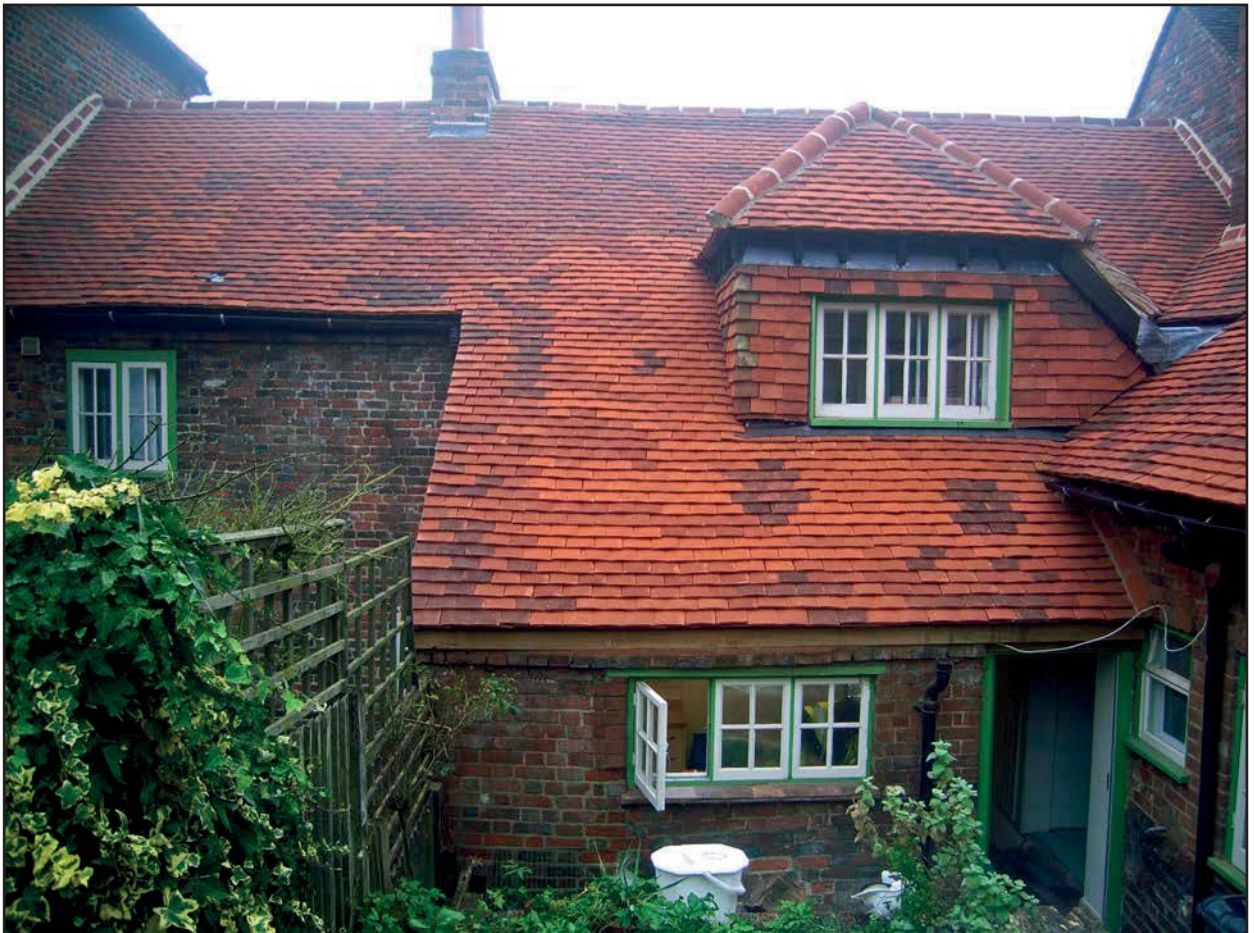
Plate 10: no 49 rear elevation

- 2.3.4 The rear elevation of no 49 is hidden by a single storey extension directly behind the front range. A dormer window sits above this and the roof of the extension and has hanging tiles to the side and front elevation. The extension has a wide window with a clay tile sill and timber lintel.

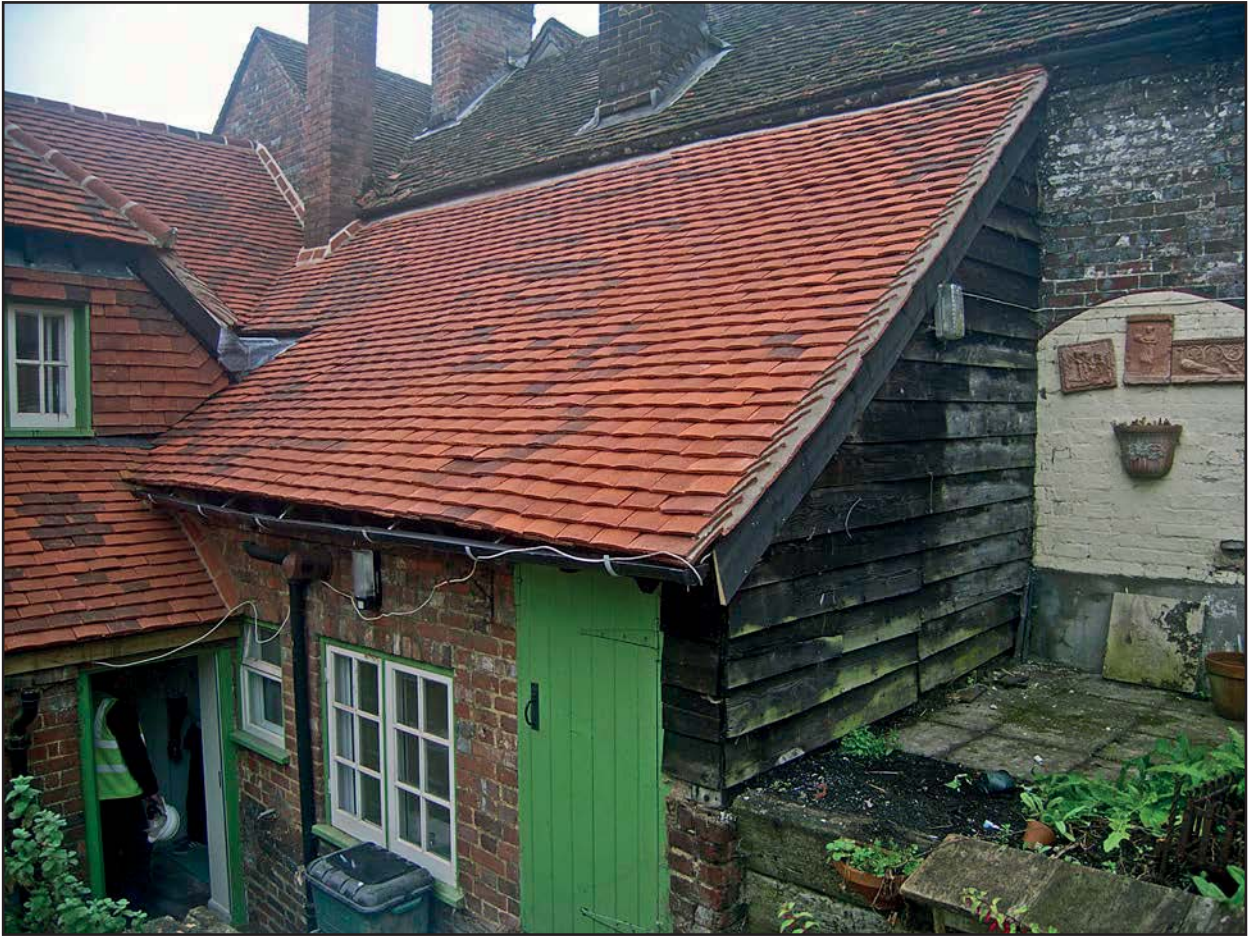
Plate 11: no 49 rear extensions

- 2.3.5 A further extension is situated to the rear of no 49 and adjacent to the wall of no 50. Again this is a single storey building with pitched roof. The extension is connected to the smaller extension and contains the staircase for the property and a small chimney stack. There is a small window, larger window and a doorway within this extension, the doorway being the entrance to an external store. The appearance suggests an early 20th century date and the building appears little changed.

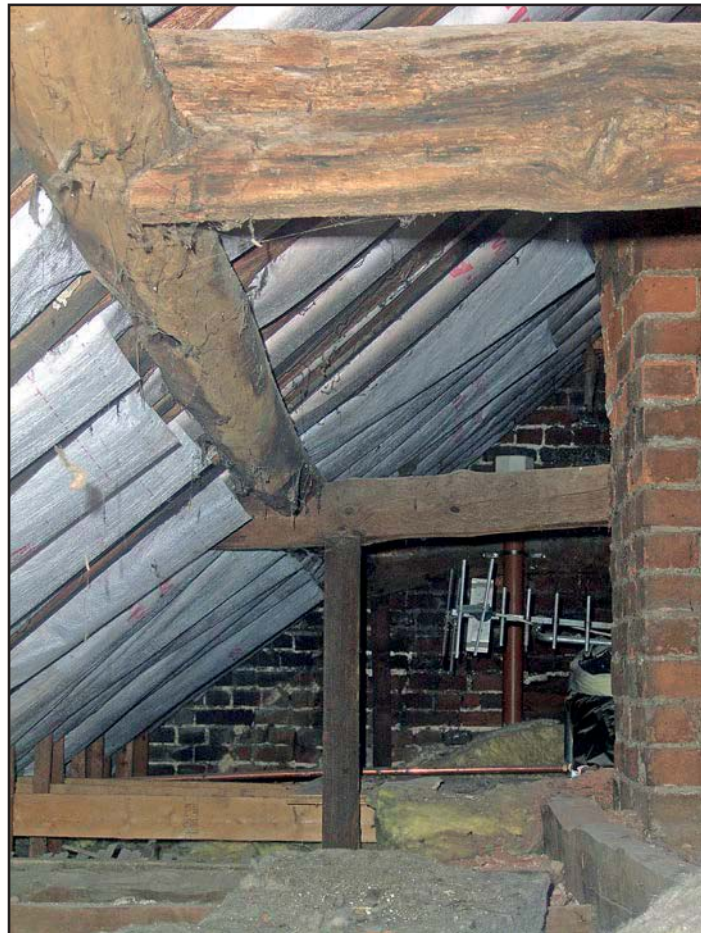
Plate 16: Detail of truss and purlin in eastern part of roof (Clasped purlin in 48 looking E)

- 2.2.9 *No. 48* – This section of roof is clearly more modern in date than that seen in no 49, most clearly shown by the rafters which are more evenly spaced and regularly sawn than in No.49. The rafters, which measure 80 x 100mm and are set at 320mm intervals, are attached to a vertically-set, plank ridge-piece although the exact method of attachment could not be clearly seen. The rafters are rebated to sit on a single purlin to each slope and these are supported by two queen-post trusses: one to the east of the central chimney and one adjacent to the wall of Steps House. The basic form of the queen-post trusses are typical for the village with principal rafters, collar, tie-beam and struts but the members are more regular and slightly more slender (particularly the struts) than found in earlier buildings. This is indicative of a later date. The purlins are set diagonally and are clasped between the collar and principal rafter.

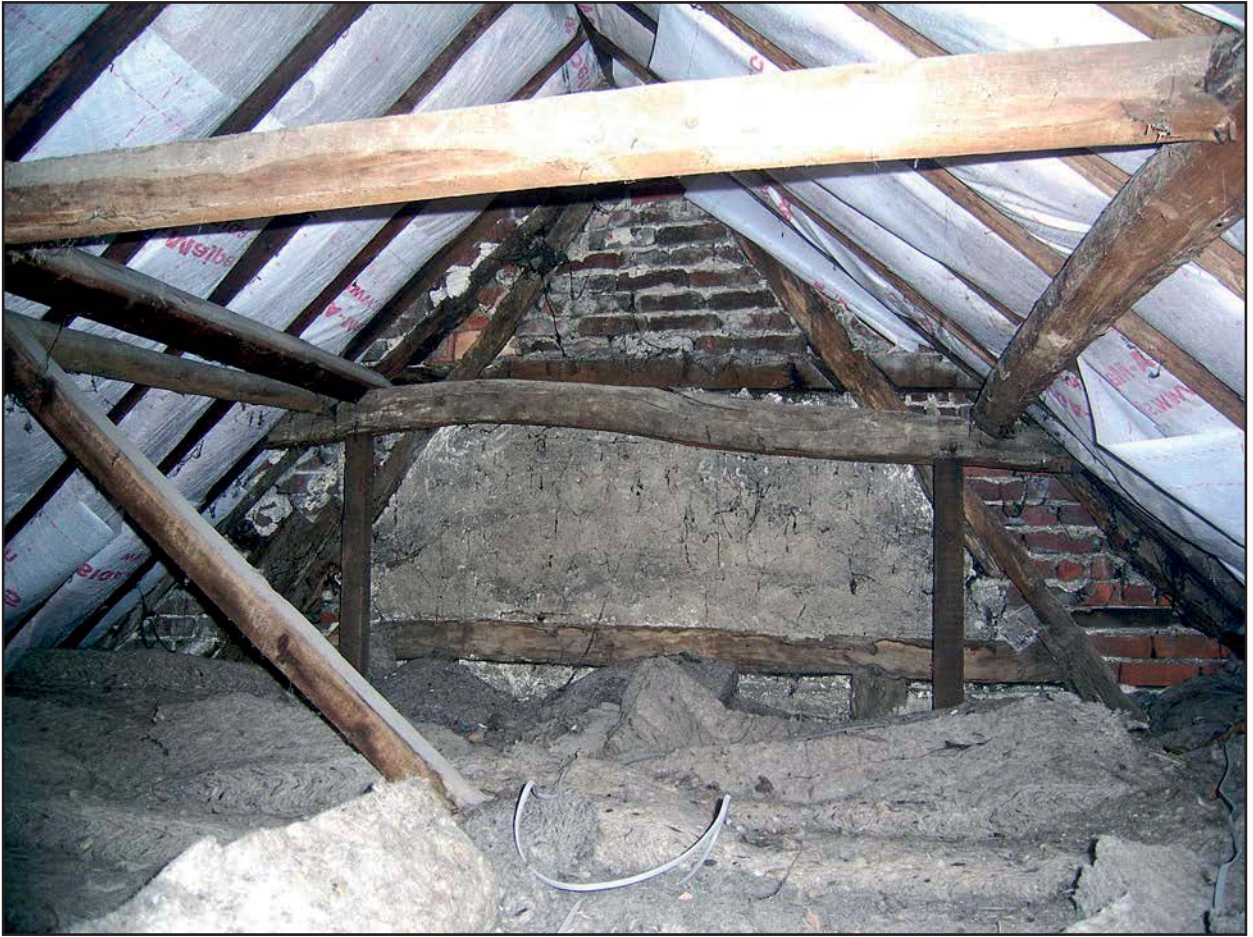
Plate 17: View of gable wall to west of roof (Looking west in No.49 towards wall of No.50)

- 2.2.4 The western end of the roofspace, where the eastern end wall of no. 50 abuts no 49 is of interest and shows several phases of construction (Pl.17-18). The earliest fabric here appears to be the remains of a steeply-pitched truss which is essentially sandwiched between the 18th-century brick eastern end wall of No.50 and the truss at the western end

of No.49. This presumably survives from a previous building, possibly on the footprint of No.50. This steeply-pitched truss comprises principal rafters and a collar, beneath which are three struts or studs. The principal rafters have rebates where they would have clasped purlins together with the collar but the purlins are no longer in-situ. The panels between the main members of this truss are plastered and limewashed although it was not possible to closely examine whether it was wattle and daub.

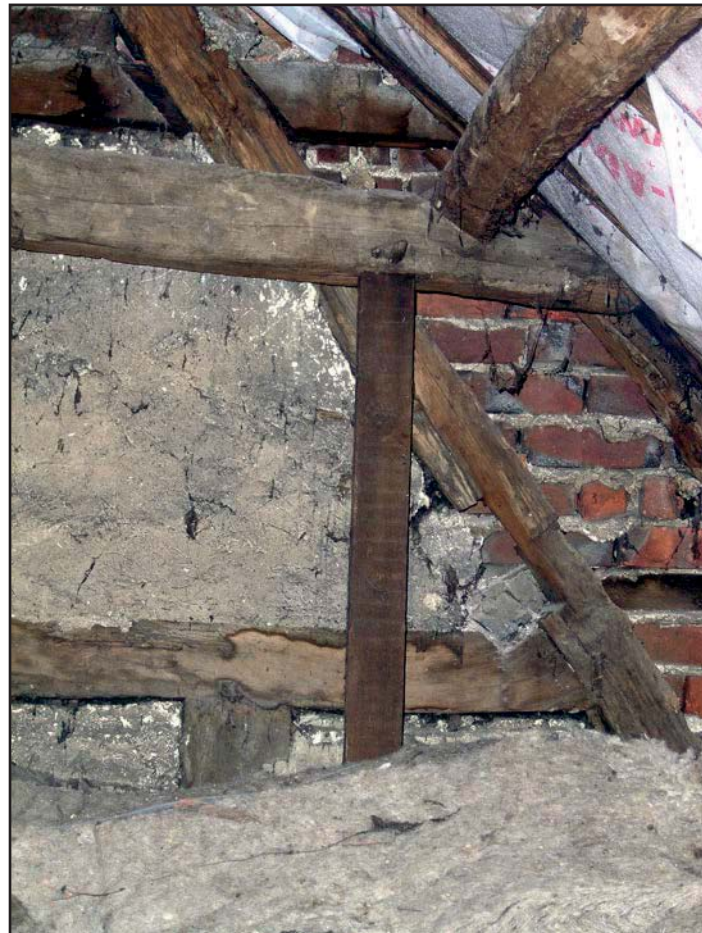
Plate 18: Detail of gable wall to west of roof (Looking west in No.49 towards wall of No.50)

- 2.2.5 The brick wall of No.50 is constructed immediately to the west of the steeply-pitched truss and the nature of the mortar to the brickwork clearly shows that it was constructed from the west side. This brickwork incorporates a long horizontal lacing plate approximately at the mid point between the collar and the apex of the earlier truss. This lacing member has rebates cut in its side so that it partially fits around the earlier principal rafters and it supports the brickwork constructed above it. The lacing plate continues horizontally to north and south beyond the roofspace.

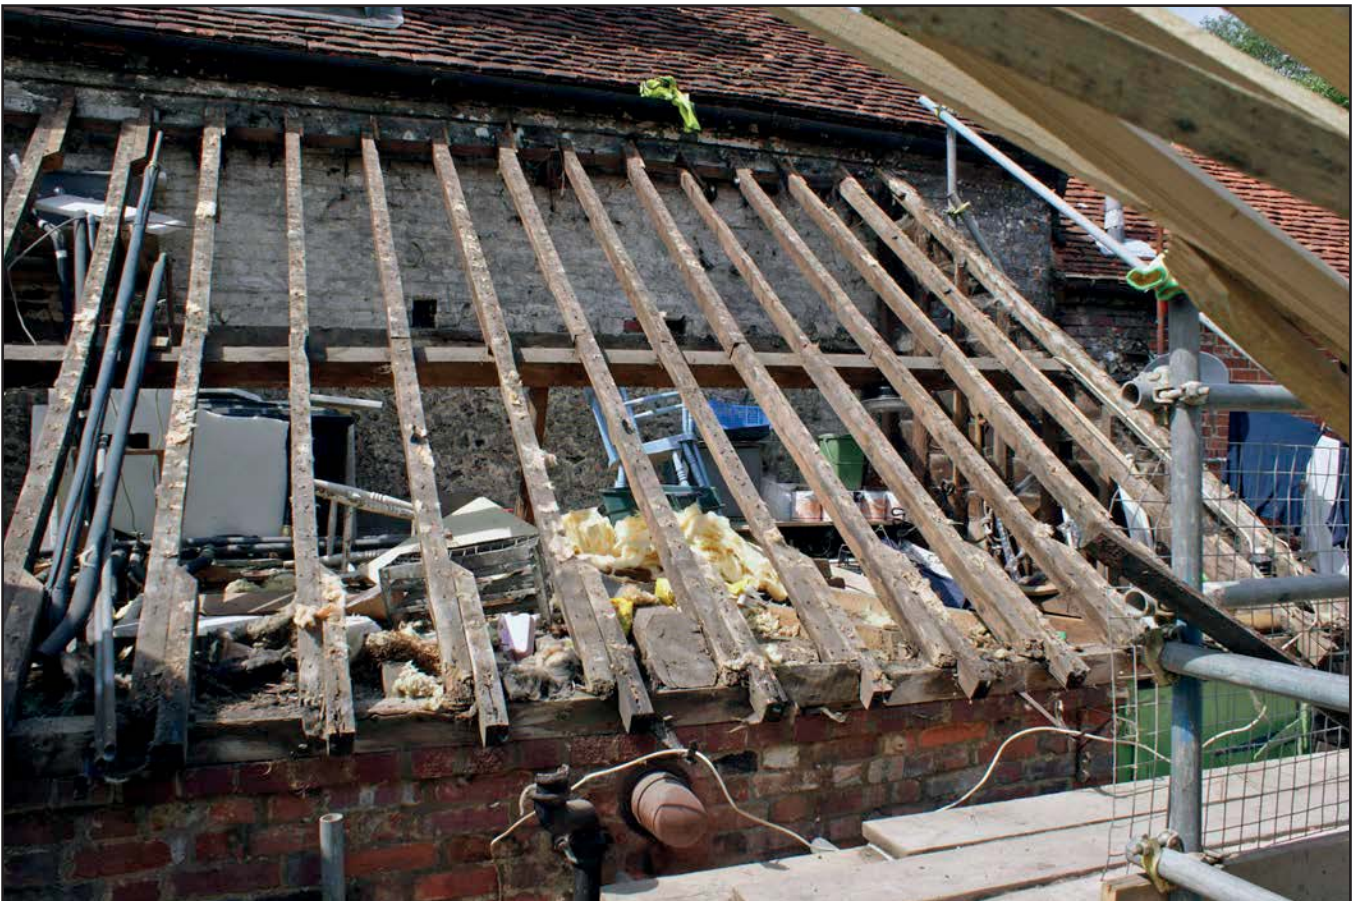
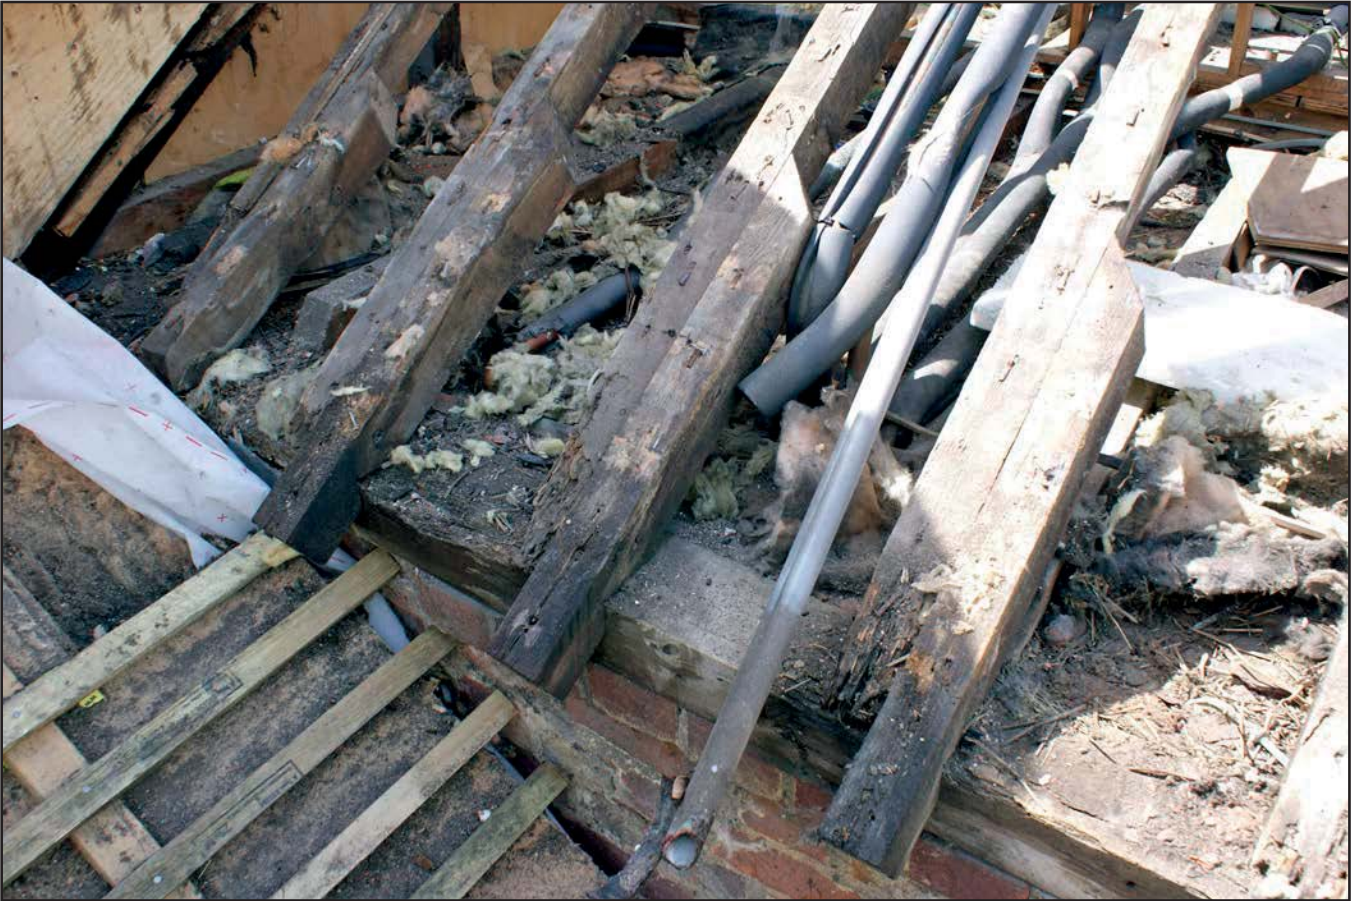
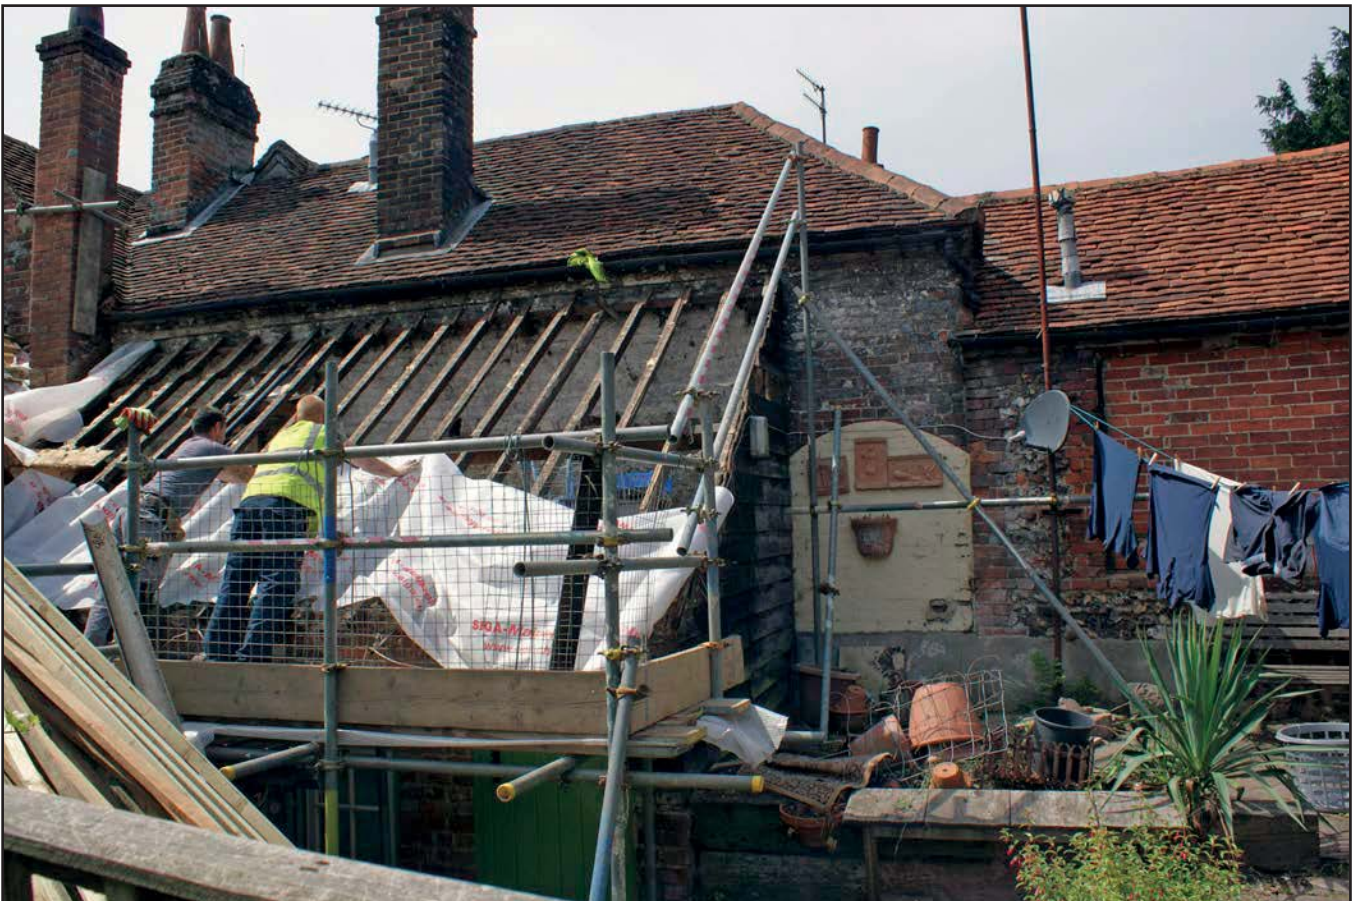
Plate 22: View of rear extension roof no. 49

- 2.2.11 *No 49 central rear extension* – This section of roof was only partially seen at the time of survey. At their upper ends the rafters of the extension sit on a horizontal trimmer plate that is set immediately adjacent to the wall plate for the main roof of no 49 and above the eaves brickwork. The rafters are largely of 20th-century date although there are two small sections where the rafters have potentially been reused from elsewhere. Towards the south-eastern corner of this extension are a number of short lengths of timber which have been inserted in a way that suggests that a feature such as a small chimney or vent has been removed and blocked. A dormer window sits above this extension and truncates the ends of the rafters on the main no 49 roof it is adjacent to.

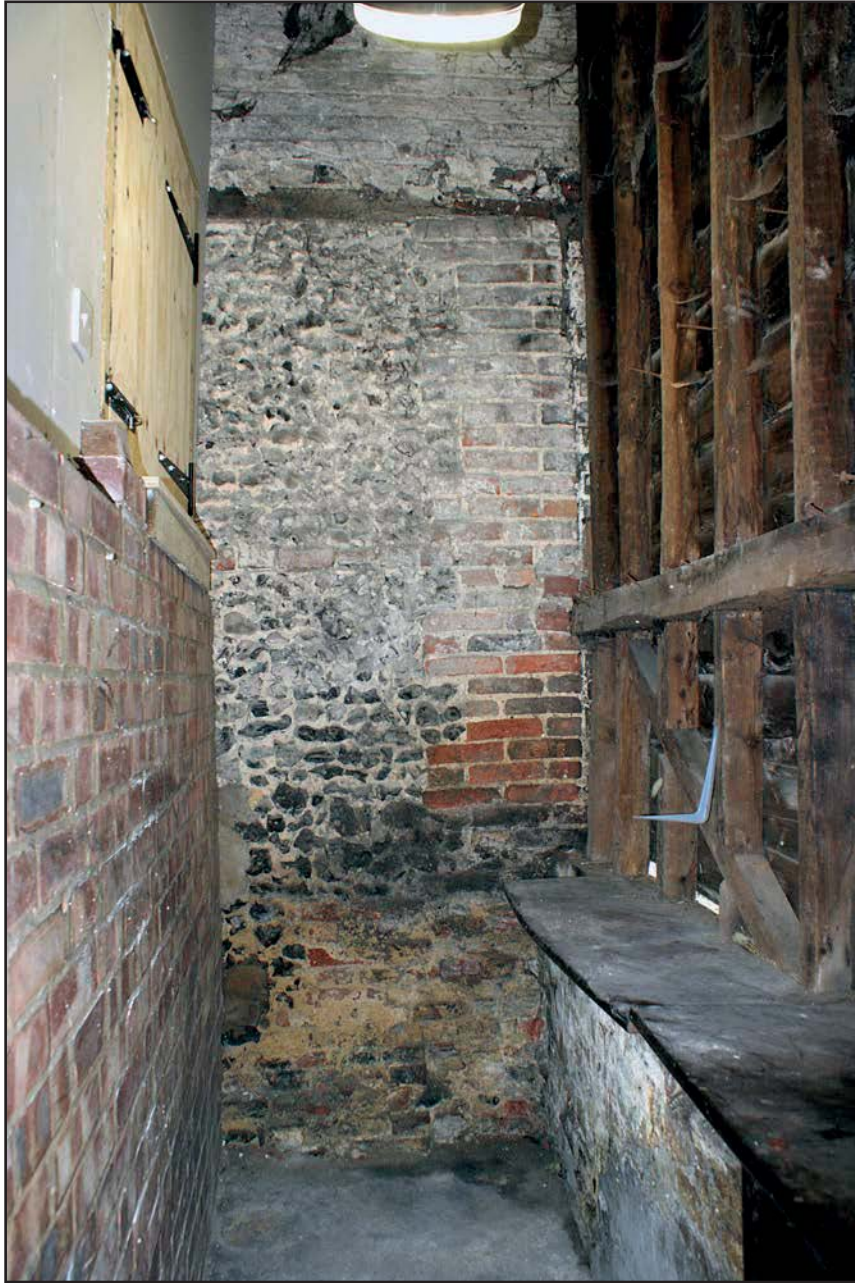
Plate 25: View of flint party wall between no 50 and the extension of no 49

- 2.3.6 During the works to replace the roof some on-site observations were recorded by the National Trust's archaeologist Gary Marshall. These included the presence of flint walling in the eastern party wall between the extension and the rear of no 50. This lower part is of flint construction with indented brick quoins to each corner. Running across the top of the flint wall is a horizontal wallplate which extends over but not beyond the quoins. Above this are 12 courses of brickwork, the brick coursing extending across and beyond the aforementioned brick quoins and thus forming an extension to the original flint walling. The quoin at the northern end appears to have been keyed and there is a return indicating the wall turned and ran eastwest at this point. The flint walling represents the remains of an earlier single storey flint walled building which has been extended both vertically and in a northerly direction.
