Black Boy Cottage West Wycombe Village

Building Investigation and Recording

Client: National Trust

Black Boy Cottage, West Wycombe Village, Buckinghamshire
Report on Historic Building Investigation

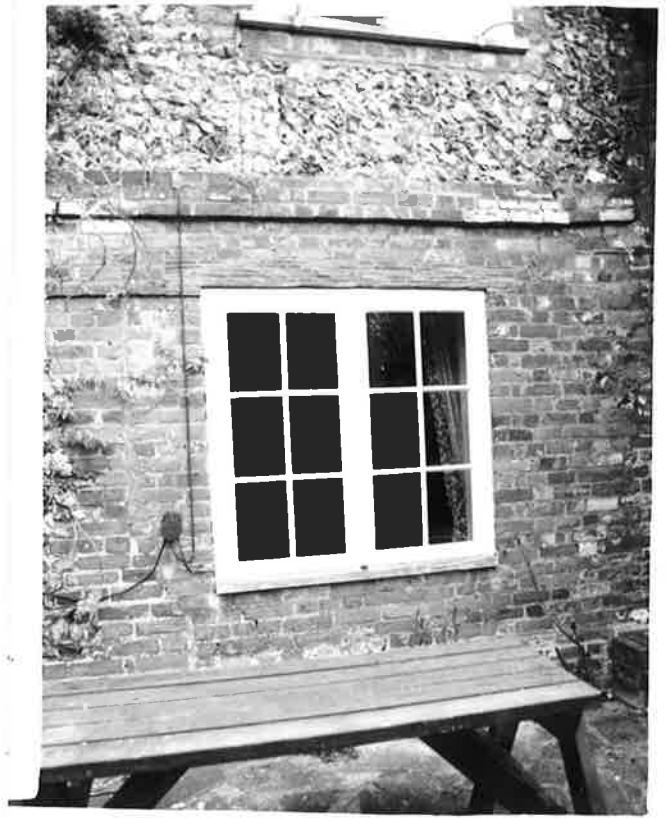
DETAIL OF BRICK INFILLING AROUND
WINDOW F. R 216 N 33.

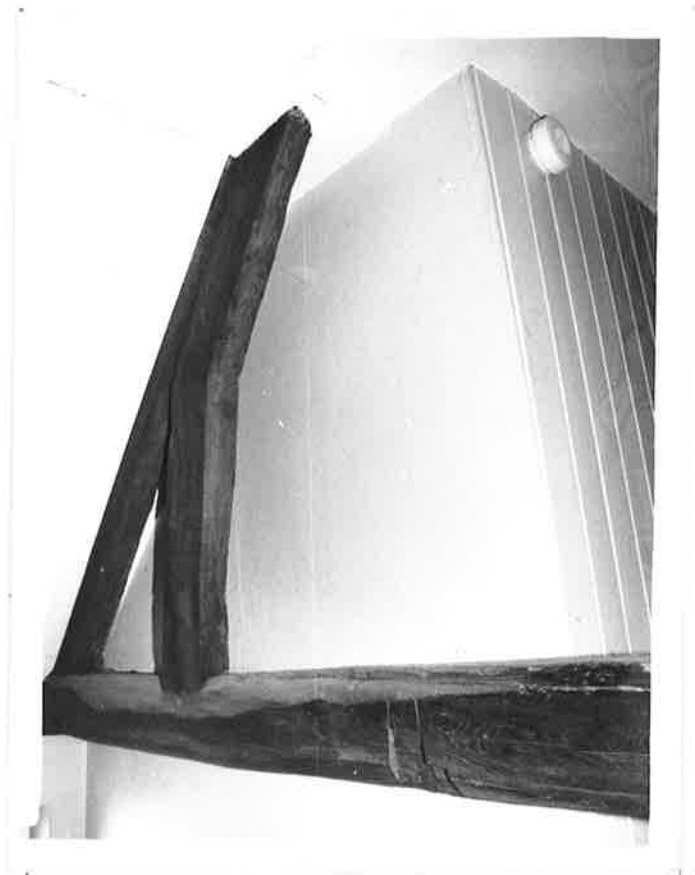
DETAIL OF ROOF TRUSS,
ROOM J, LOOKING
NORTH-EAST. RZIS N9.

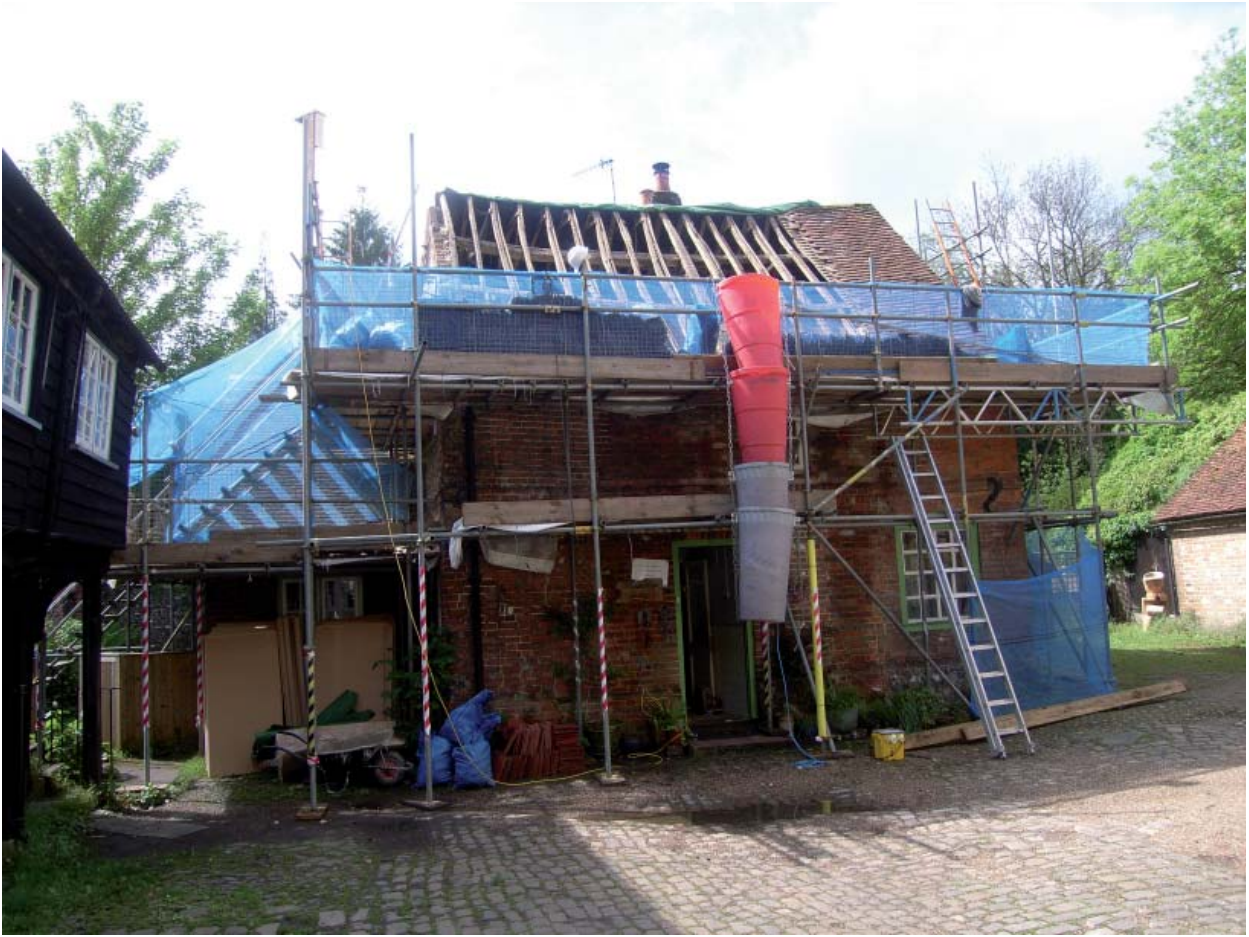
- 2.2.1 The current recording work at Black Boy Cottage focussed entirely on the roof structure and this work has not included any investigation of the building's interior or other exterior features, although the interior was inspected for exposed elements of the roof structure and these timbers taken into account. The roof structure was examined from the scaffolding platform outside the building (Pl. 1).

Plate 1: Black Boy Cottage, front (north) elevation

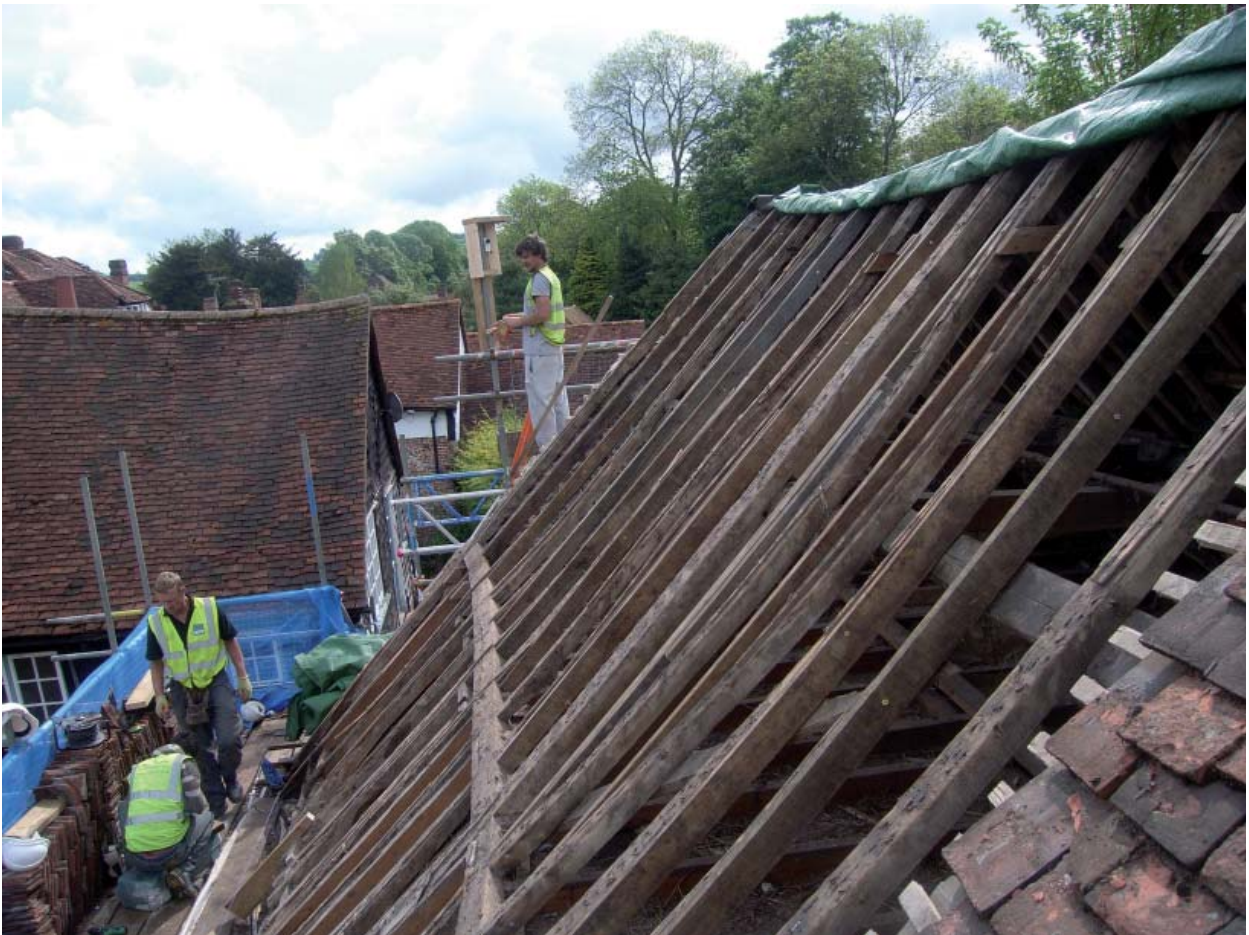
Plate 2: North slope of roof with unstripped area to the west

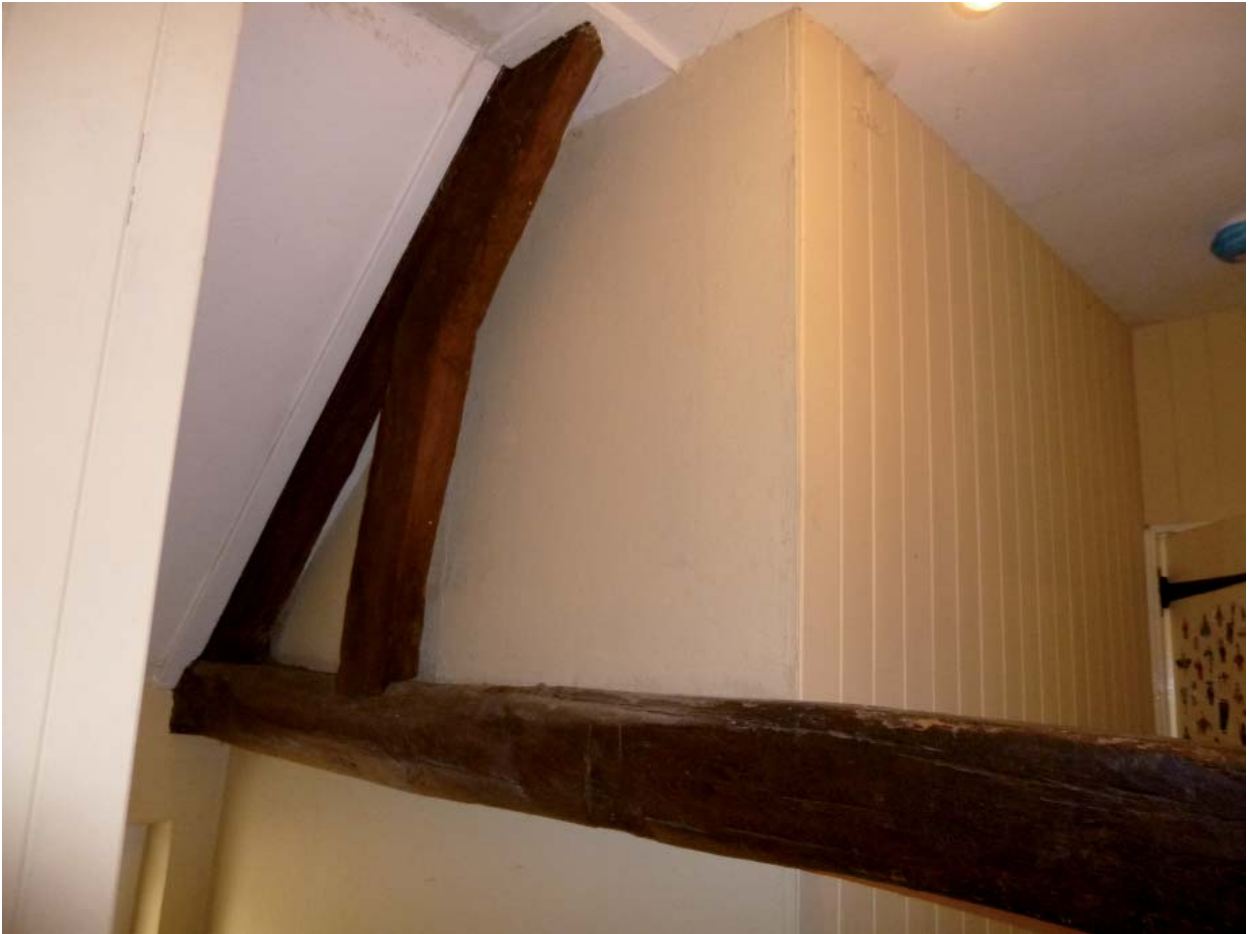
- 2.2.3 The roof consists of 16 pairs of common rafters, with a pair of principal rafters to the centre of the roof and a pair to each gable end, with two purlins to each slope (Pl. 2). The tie beams to either end of the building are visible in the bedroom walls, cutting across the casement windows, with the central tie beam cutting across the stairwell and landing, exposing the cranked principal at the northern end (Pl. 3); the same at the southern end barely visible against the chimney stack via the stripped roof. These trusses also have a low collar at the level of the lower purlin (Pl. 4). The collar to the central truss contains two empty mortices which do not correspond with the principal rafters, indicating further reused timber. On the landing, the central tie beam displays two shallow, and fairly doubtful, remnants of lap joints which may indicate previous use, or more likely, a former fixture.

Plate 3: Cranked principal of the central truss seen from the landing

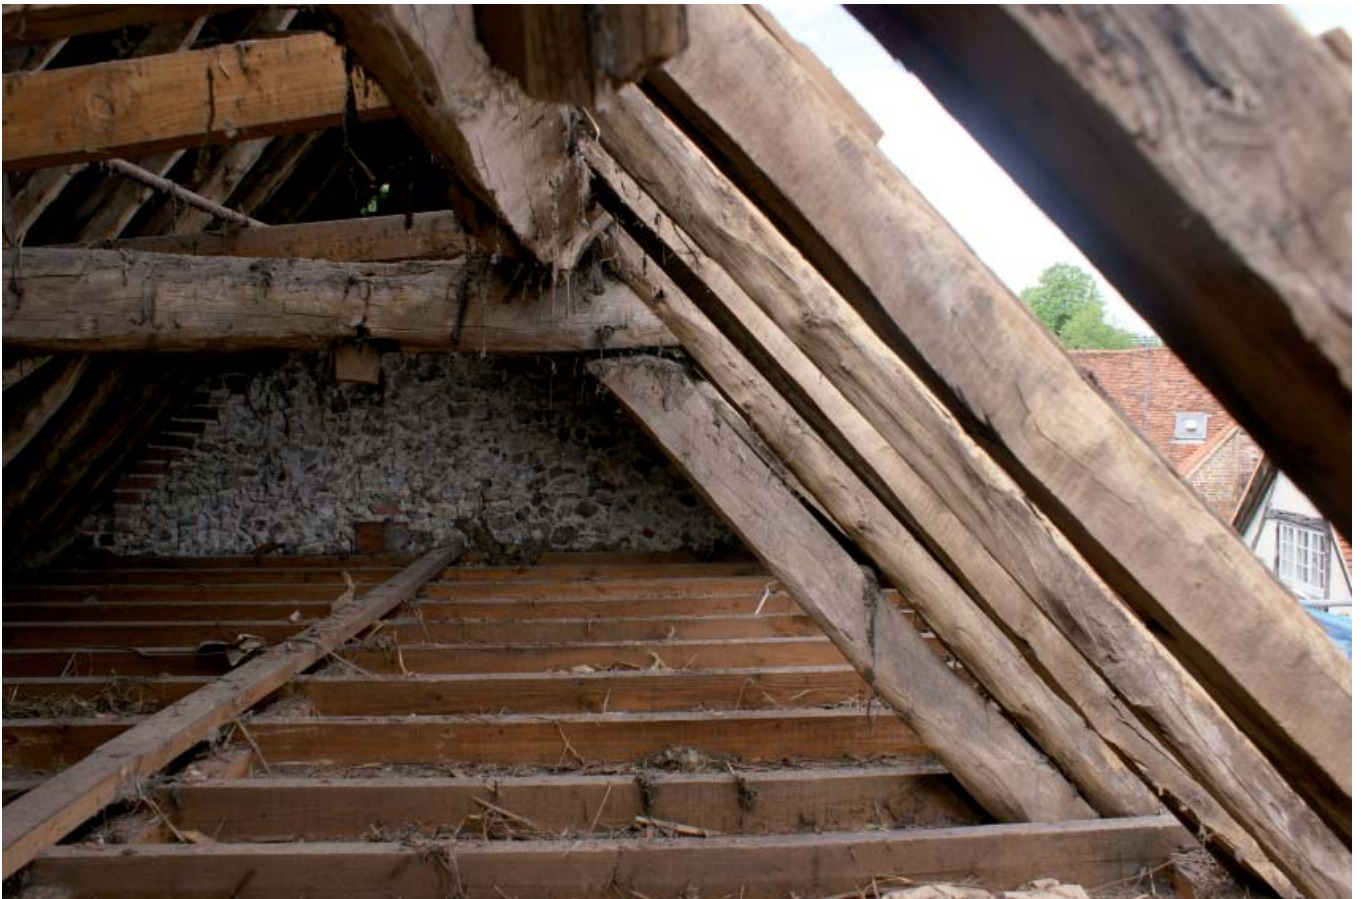
- 2.2.4 The aforementioned cranked principal rafter is a similar feature to the curved principal rafter in the roof truss of 32-33 Crown Court, also re-roofed within this programme of works. Although the truss was pictured in the VBS for Black Boy Cottage, the feature was not discussed in that report.

Plate 4: Collar and cranked principal of central truss (courtesy of Gary Marshall)

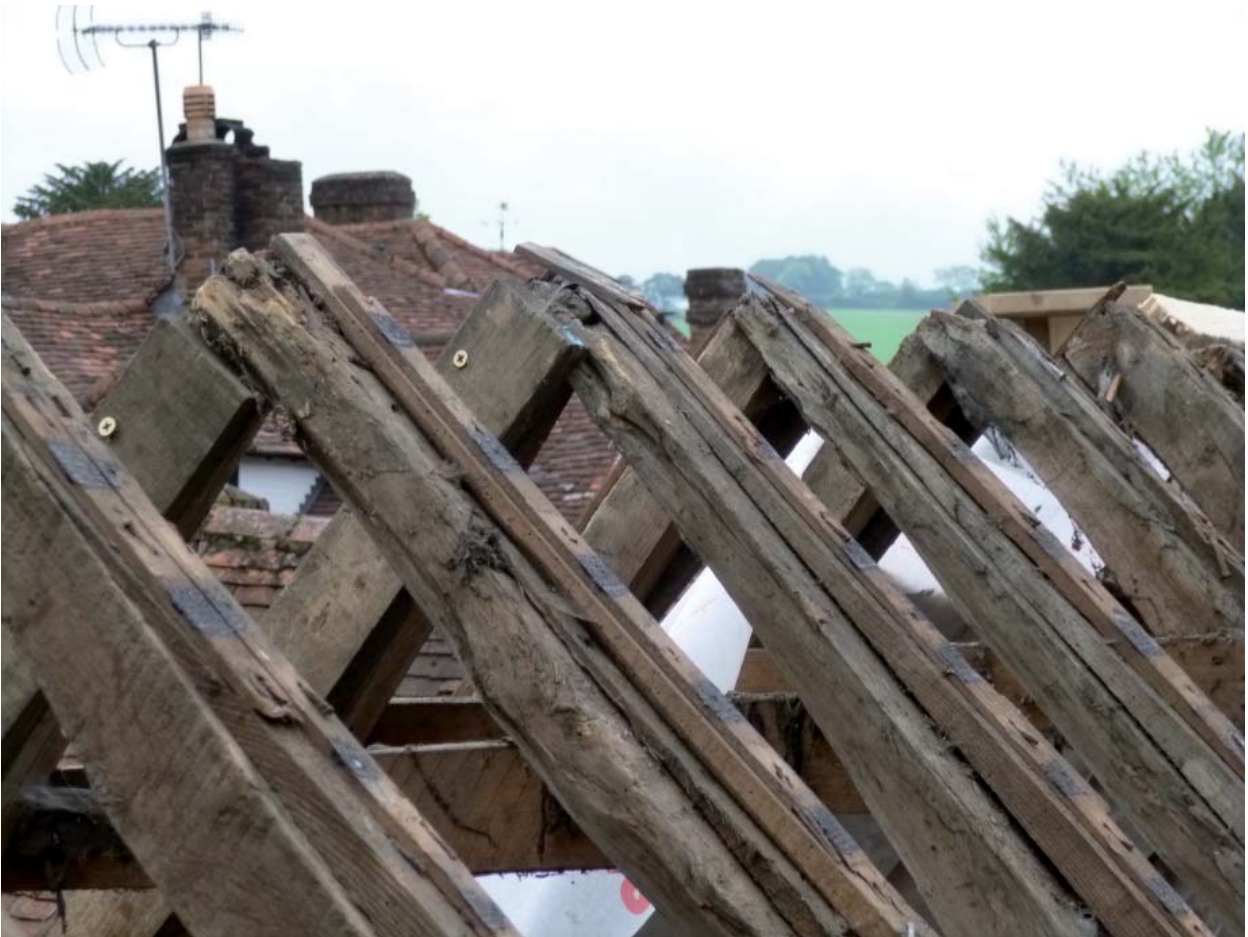
- 2.2.6 There is no ridge piece in the roof. The rafters are bridle-jointed at the apex and occasional pairs are also pegged, however, many joints have been reinforced by later timber and so the jointing method is often obscured or has rotted away. Thin collars were also fixed near to the apex during later works (Pl. 5). The common rafters are interrupted by the lower purlin, after which they continue to the wall plate where at least two phases of sprockets have previously created the eaves. The ends of the rafters have long-since rotted and been cut back to wall plate level; they are completely obscured in the south slope, however, the ends visible in the north slope indicate that they were notched over the wallplate in the same manner as the previous sprockets and the new sprockets. The wallplate does not appear to have been cut at all to receive the rafters (Pl. 6).

Plate 5: Apex joints and repairs

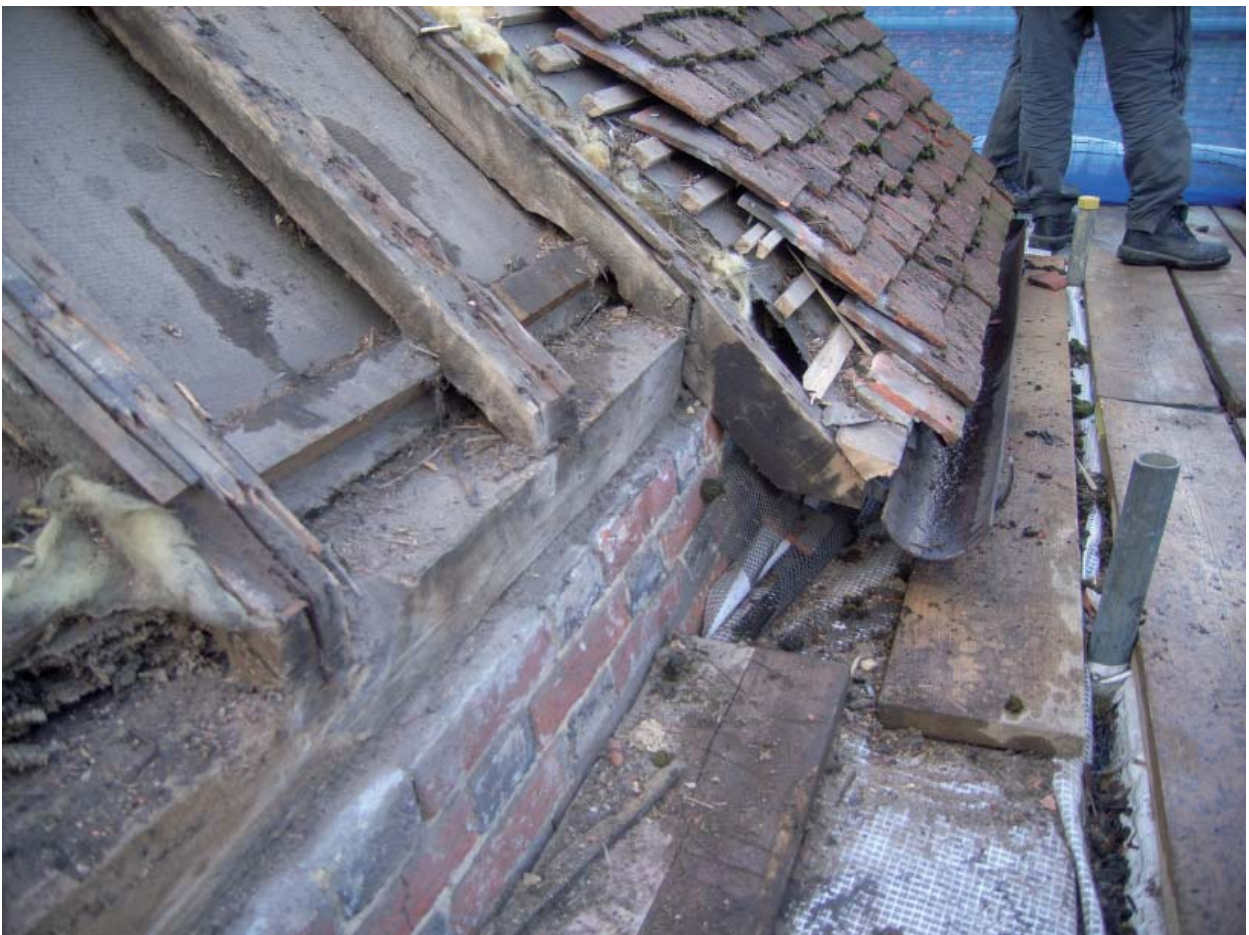
Plate 6: Rafter ends, wall plate and sprockets

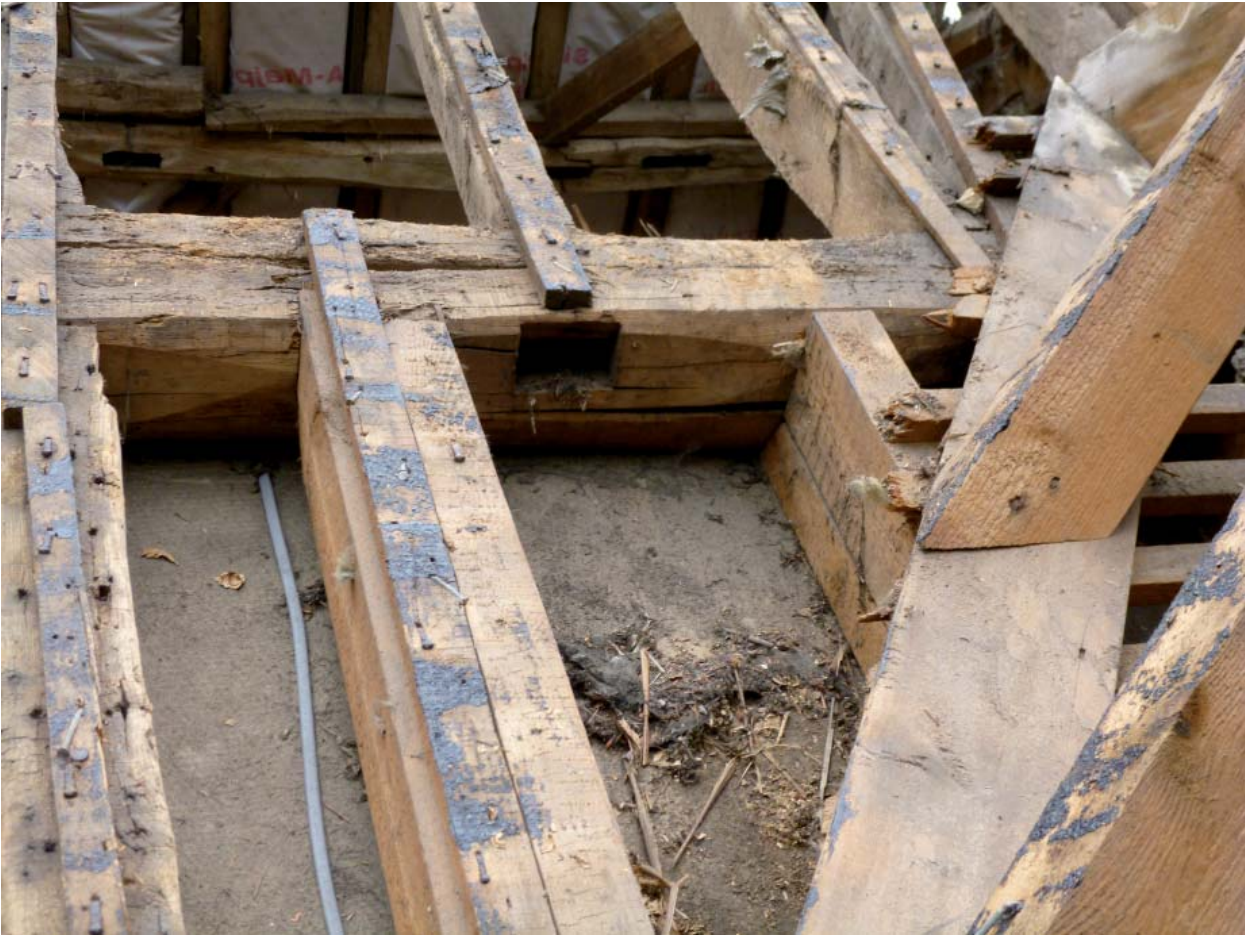
- 2.2.7 Many of the rafters have later thin strips of timber batten packing attached to their backs, and so the original method of jointing to the purlin is completely obscured. Occasional visible areas at the lower purlins indicate that they are mortice and tenoned and pegged; empty mortices are also visible in the soffit face of the lower purlin behind the dormer windows where the lower sections of the rafters have been removed (Pl. 7).

Plate 7: Empty mortise behind easternmost dormer

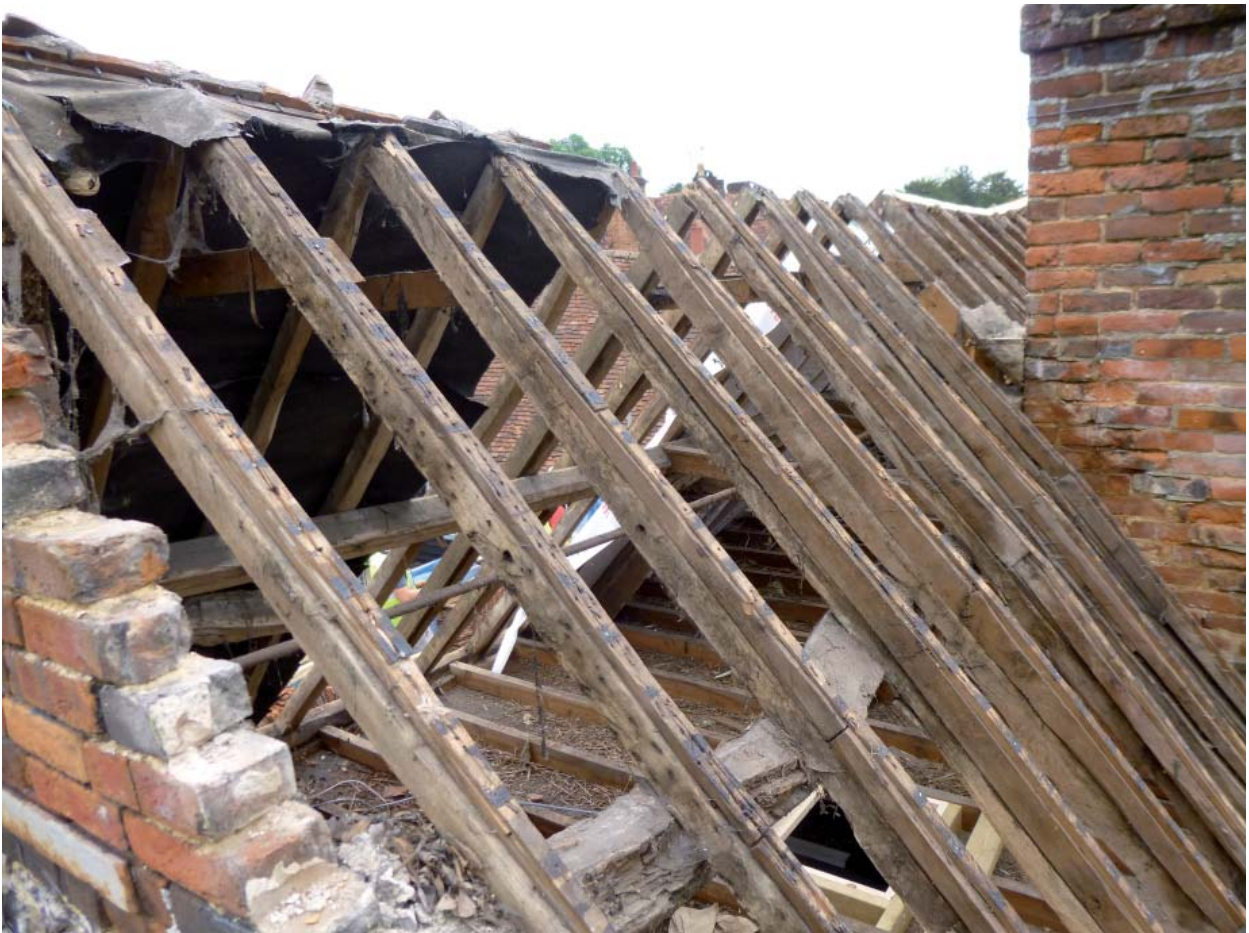
- 2.2.8 The rafters to the western end of the south slope have been heavily packed-out by adding bespoke shaped timbers to the backs [the upper-face] to counteract sag. Presumably, this packing was affixed during the RSA works (Pl. 8).

Plate 8: Packing to rafters on the south slope

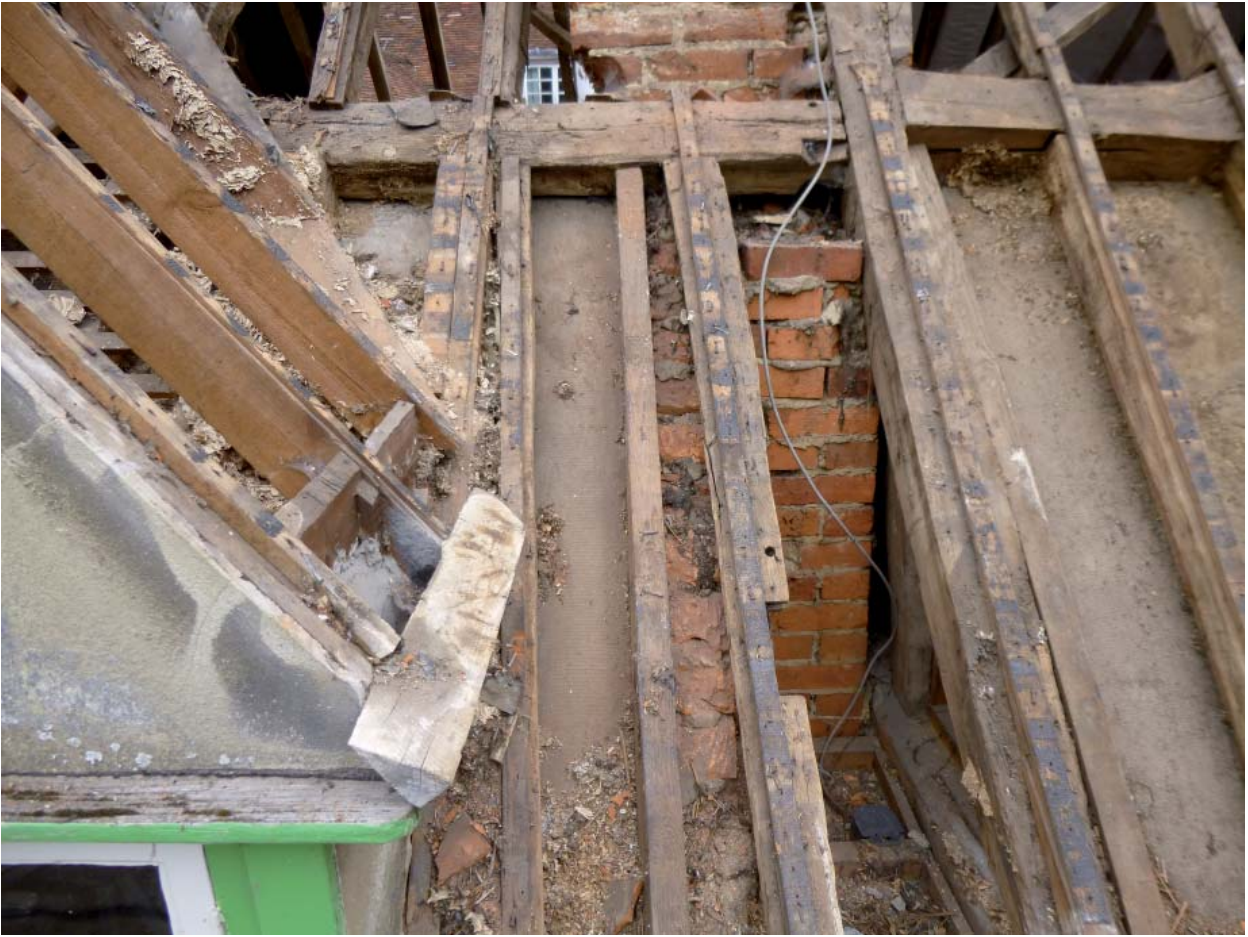
- 2.2.9 The majority of the rafters, although much patched-up, appear to have been new when the roof was constructed; any redundant notches etc. appear to have been made to join to, or allow for, other members which have since been replaced. The rafters to the western end of the north slope display several peg holes and notches which do not tie in with the current form of the roof and so these may be the exception and are reused. Two pieces of reused timber have been used to replace lower parts of the rafters either side of the westernmost dormer (Pl. 9).

Plate 9: One of the few reused portions of rafter

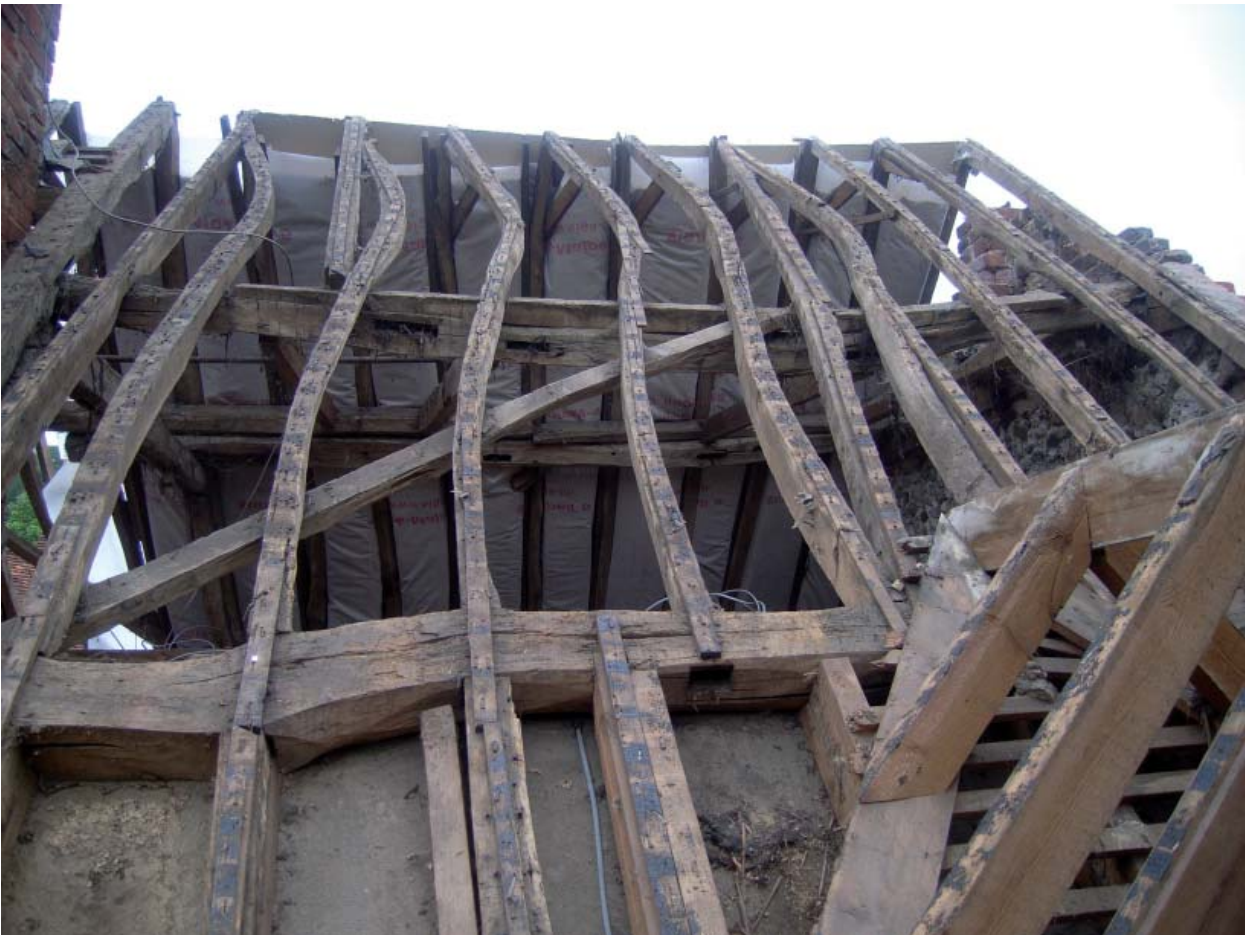
- 2.2.10 Several of the rafters are of split logs, many of which retain the waney edge to the underside. Six rafters to the eastern end of the southern side display the same distinctive 's' shape towards the top, indicating that they have been cut from the same piece of wood, although the differing thicknesses and shape to the underside make it difficult to deduce the shape of the original tree (Pl. 10).

Plate 10: 'S' shaped rafters

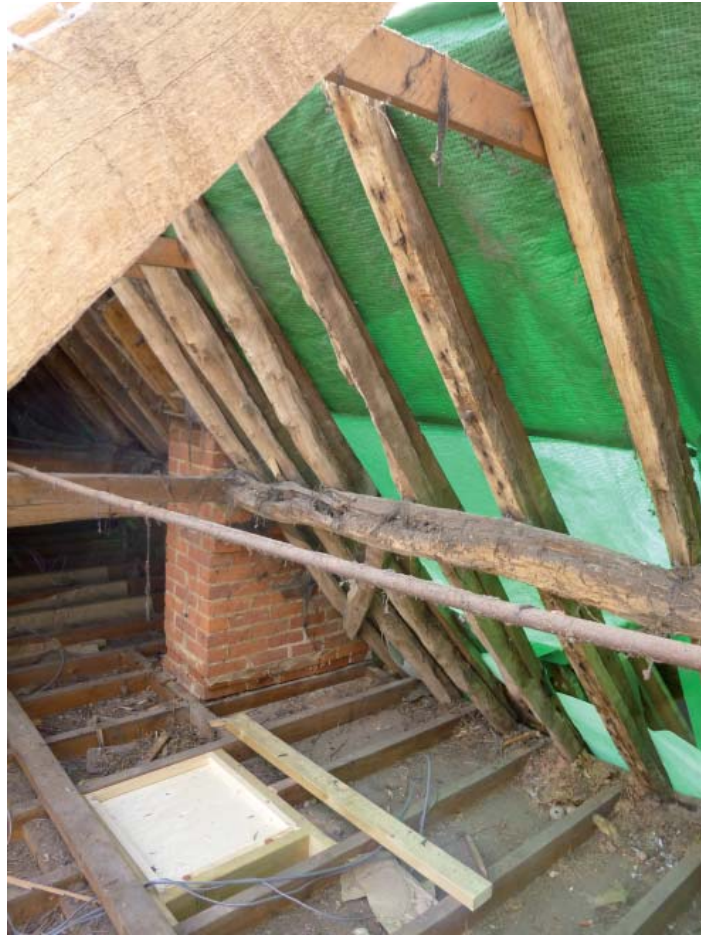
- 2.2.12 The iron bar connected to the cross-shaped straps in the gables is visible just above the level of the upper purlin (Pl. 11).
- 2.2.13 The wall plates are laid directly onto the brick walls and abut the principal rafters at either end.

Plate 11: Reinforcing bar visible in the roof space

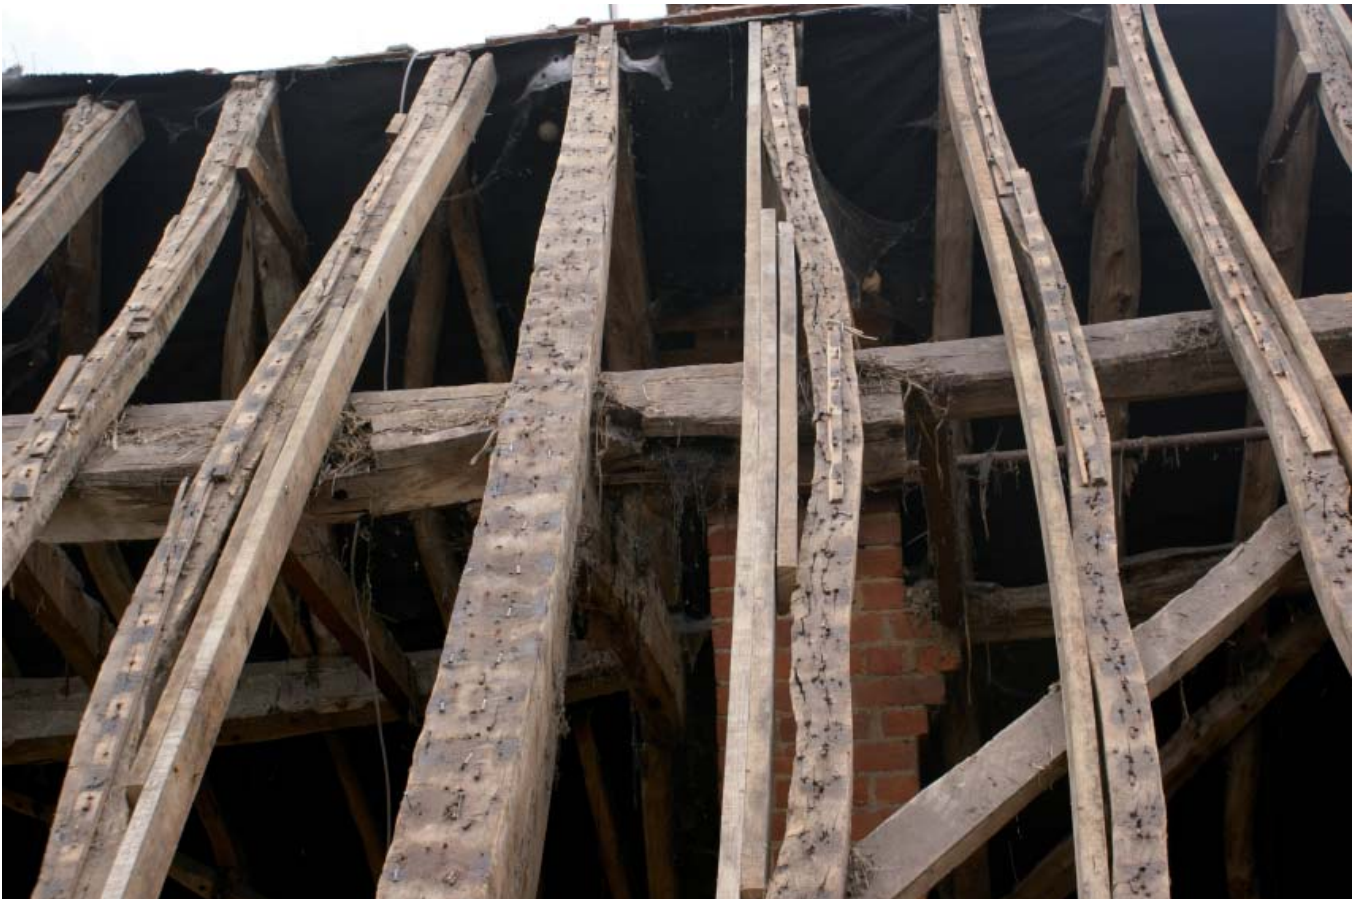
- 2.2.14 The ends of the purlins are built into the gables and the ends of the timbers exposed.
- 2.2.15 The upper purlins, although nominally through purlins, are made up from several pieces of timber, jointed with rough scarfs, peg holes are visible within the scarf joints, but it is not clear if these originate from a former use of the timber as they contain numerous empty mortices (Pl. 12). In the western end of the north slope, the original purlin has apparently rotted away towards the centre and a new purlin fitted, however, the remnants of the original now hang from the end built into the gable and long pegs, with the other end still in the rafters, project from the timber (Pl. 13). The western purlin on the opposite slope is also heavily rotted, but still remains in place and also shows an empty mortice from the timber's previous use. To the upper purlin in the south slope, the easternmost piece, scarfed to the next, also shows empty mortices from a previous use (Pl. 14).

Plate 12: Scarf of north slope upper purlin (courtesy of Gary Marshall)

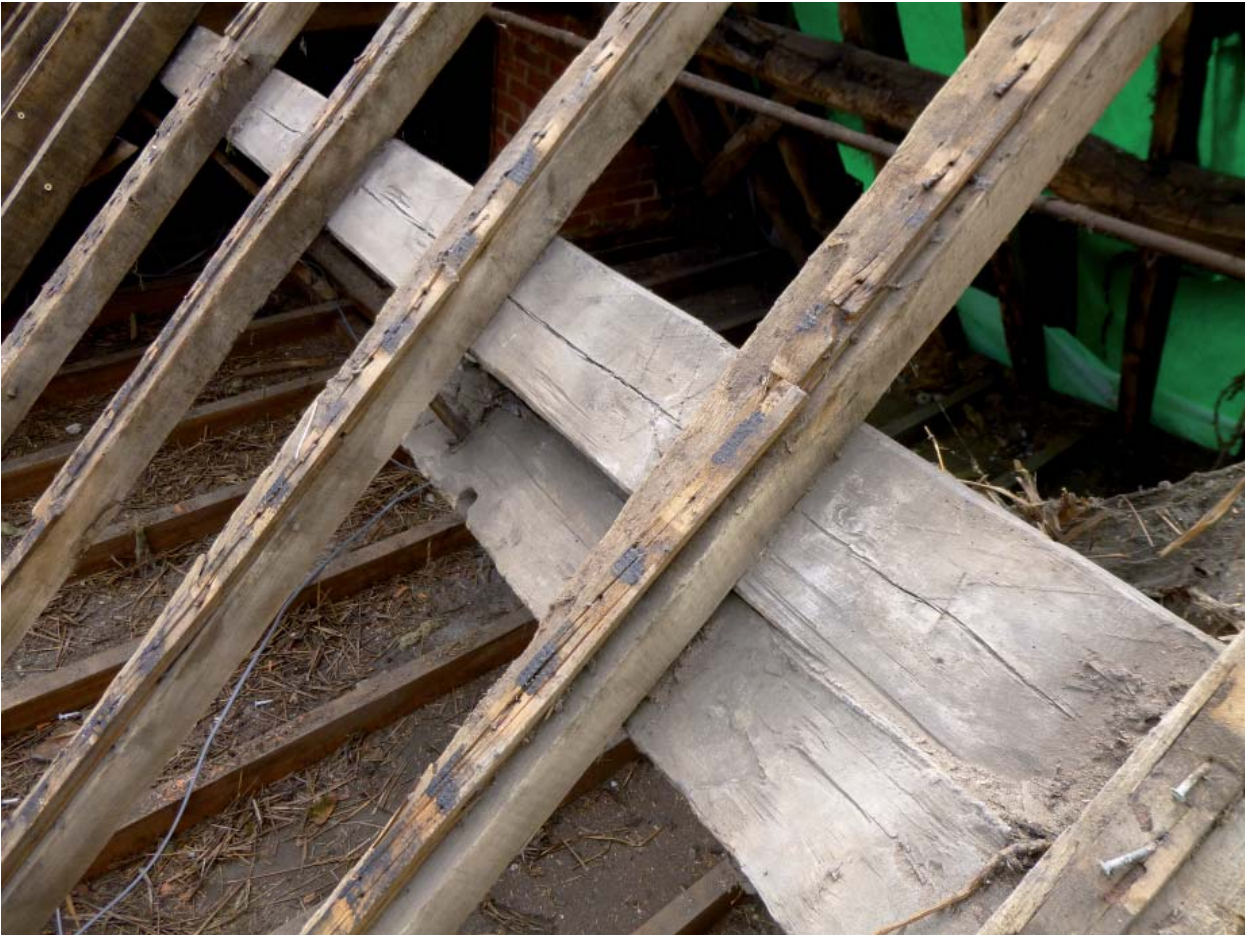
Plate 13: Redundant length of north slope upper

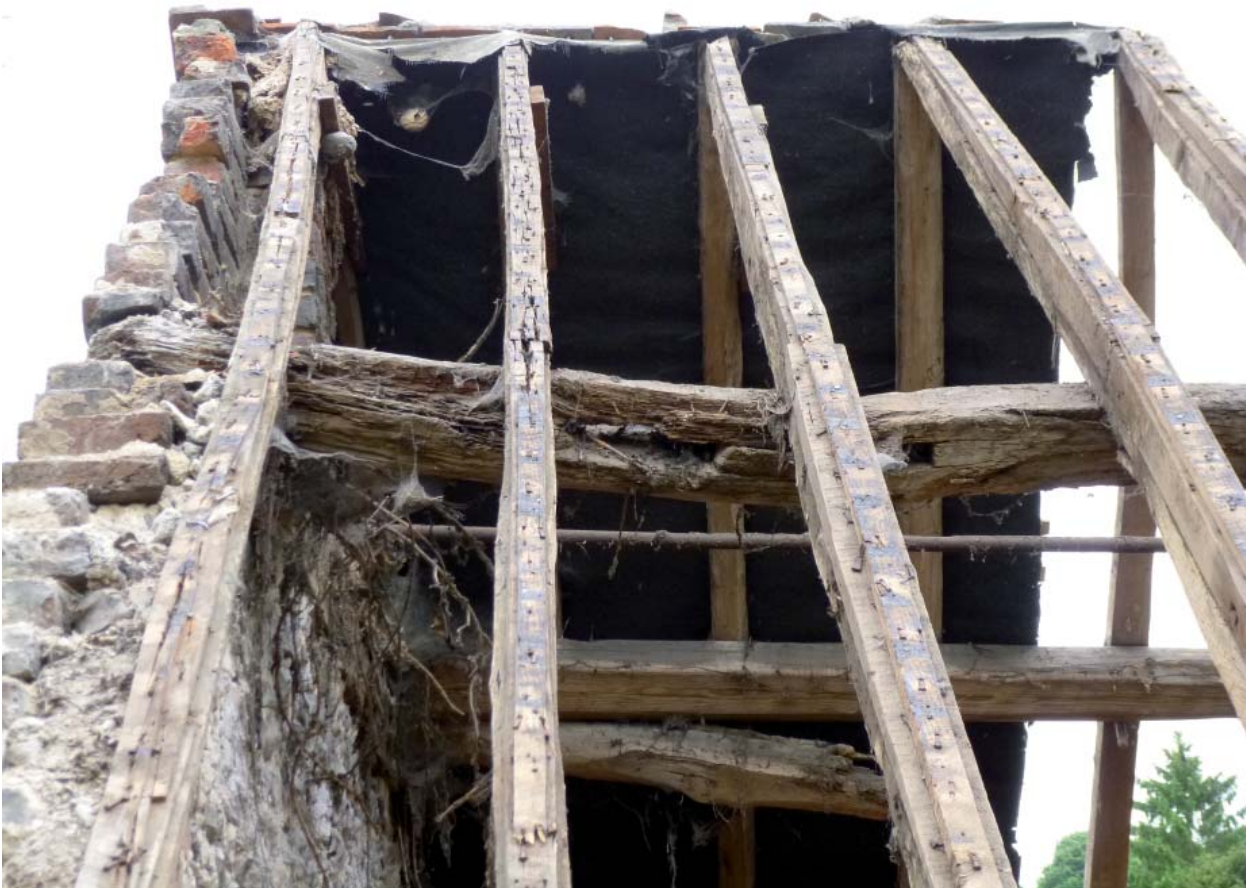
Plate 14: Rotted length of north slope upper purlin

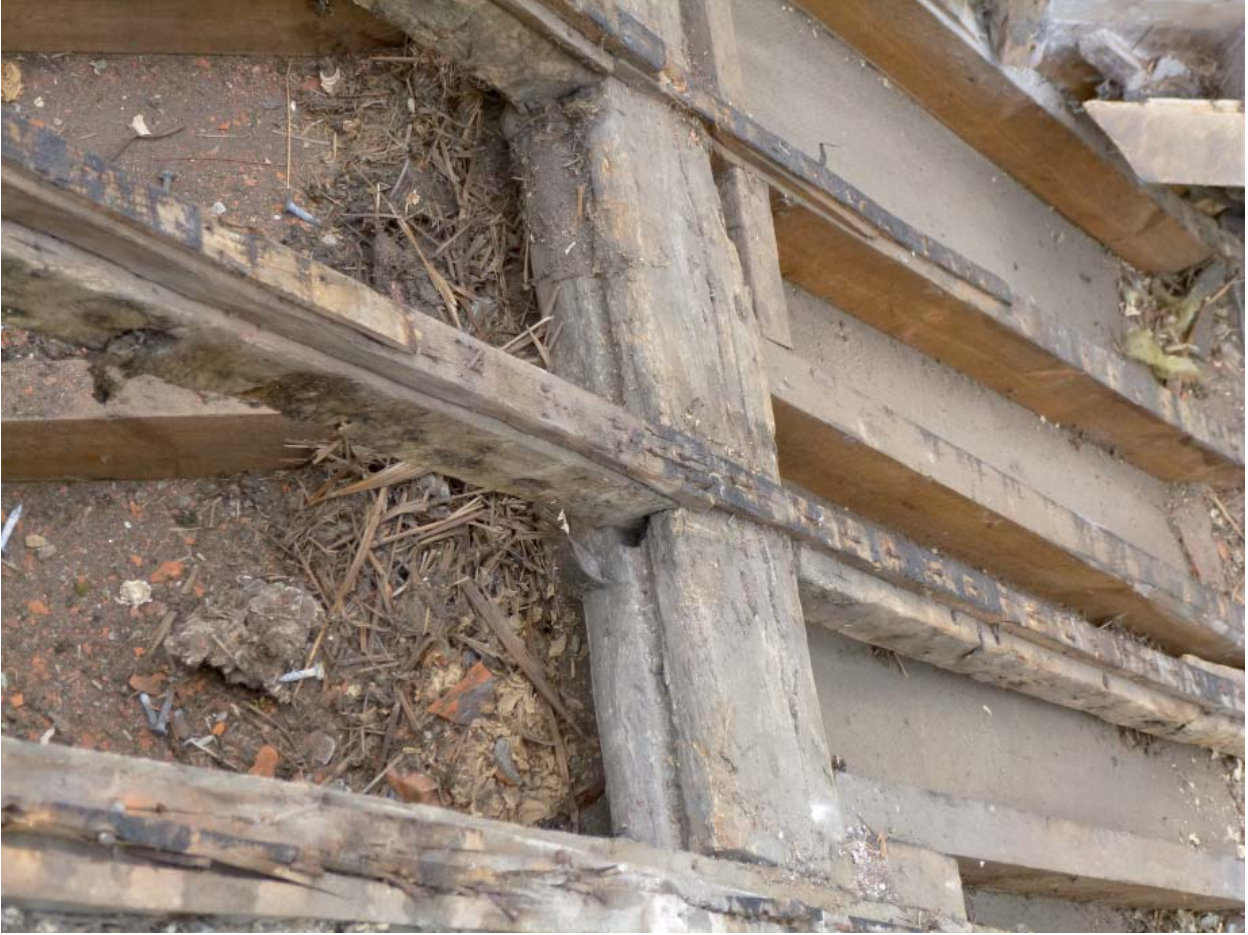
- 2.2.16 The lower purlin at the westernmost end of the rear slope has a stave slot to the now-top face, this would have held the staves in a wattle and daub panel in a wall frame in its previous use (Pl. 15). The empty mortices and peg holes indicate the location of the posts in this former usage.

Plate 15: Stave slot in south slope lower purlin

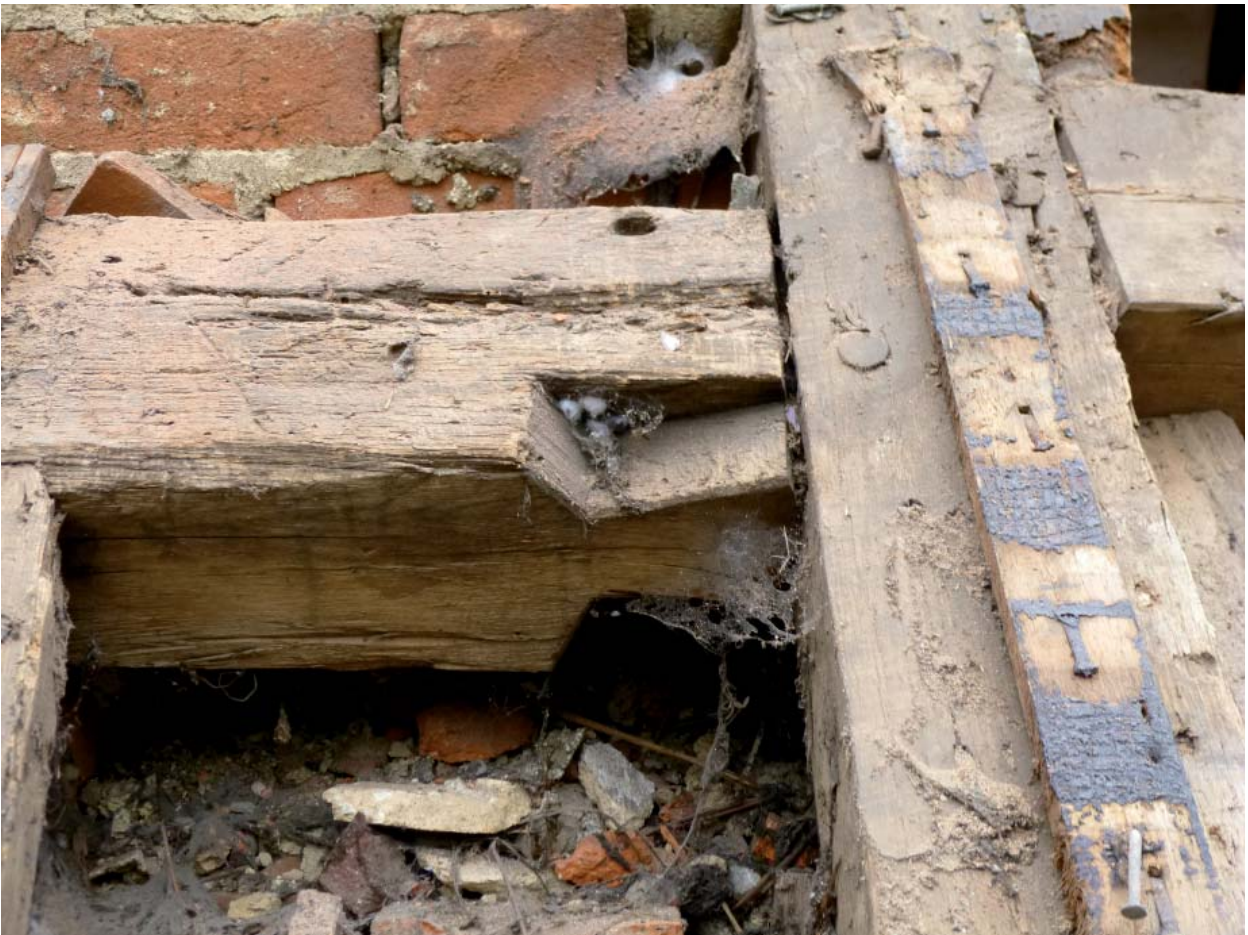
- 2.2.18 The same purlin which includes the stave slot also has the tail of a lap dovetail joint to the soffit face of the easternmost end, adjacent to the principal rafter (Pl. 16); a socket of a lap dovetail joint is included in the lower purlin at the easternmost end of the northern slope, partially obscured by the principal rafter at the gable. These appear to be of different sizes and so may not be related (Pl. 17).

Plate 16: Dovetail from a former use of the south slope lower purlin

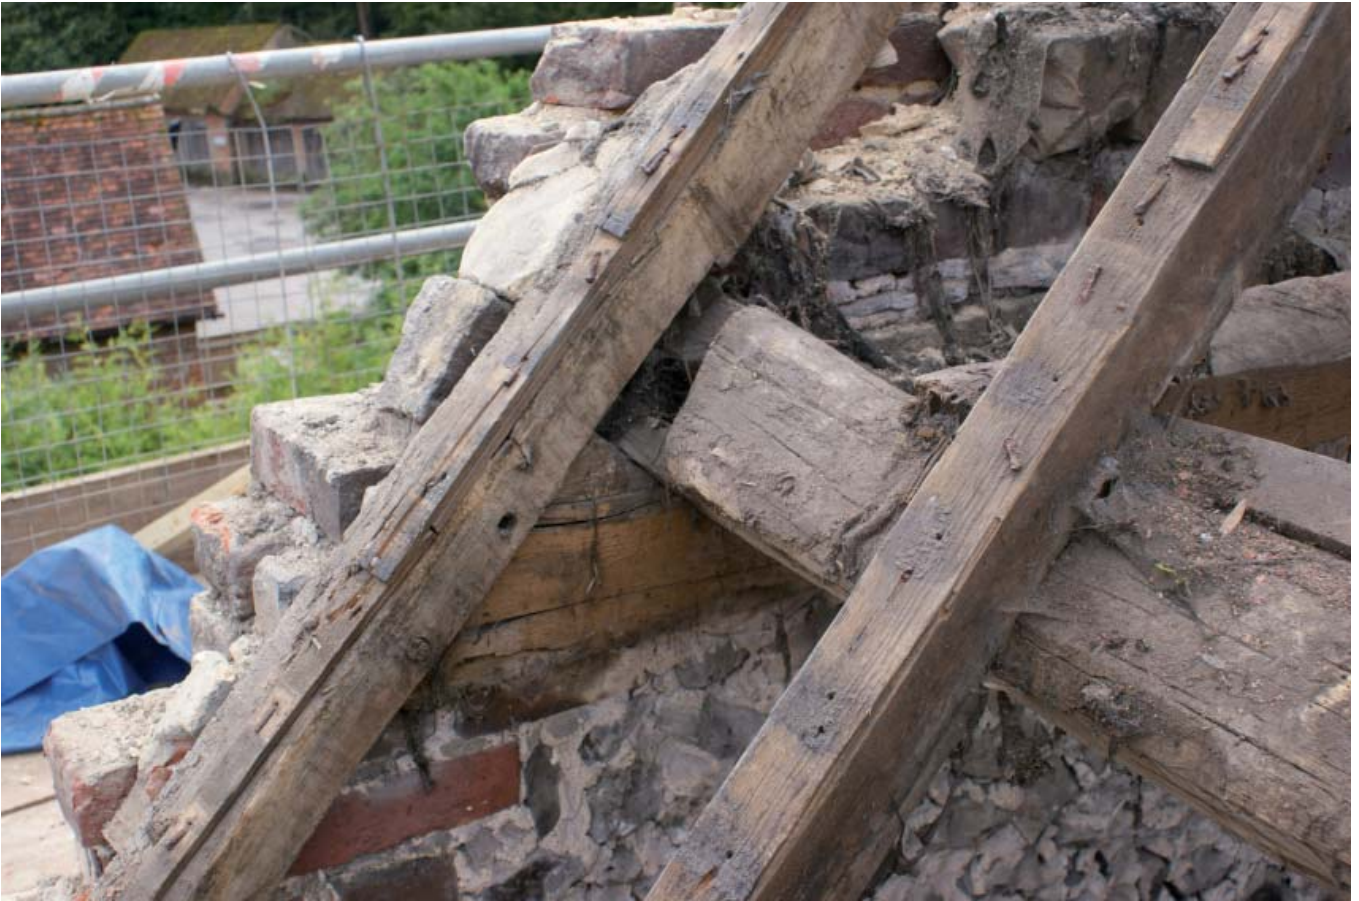
Plate 17: Dovetail from a former use of the north slope upper purlin (courtesy of Gary Marshall)
