Black Boy Cottage West Wycombe Village

Building Investigation and Recording

Client: National Trust

Black Boy Cottage, West Wycombe Village, Buckinghamshire
Report on Historic Building Investigation

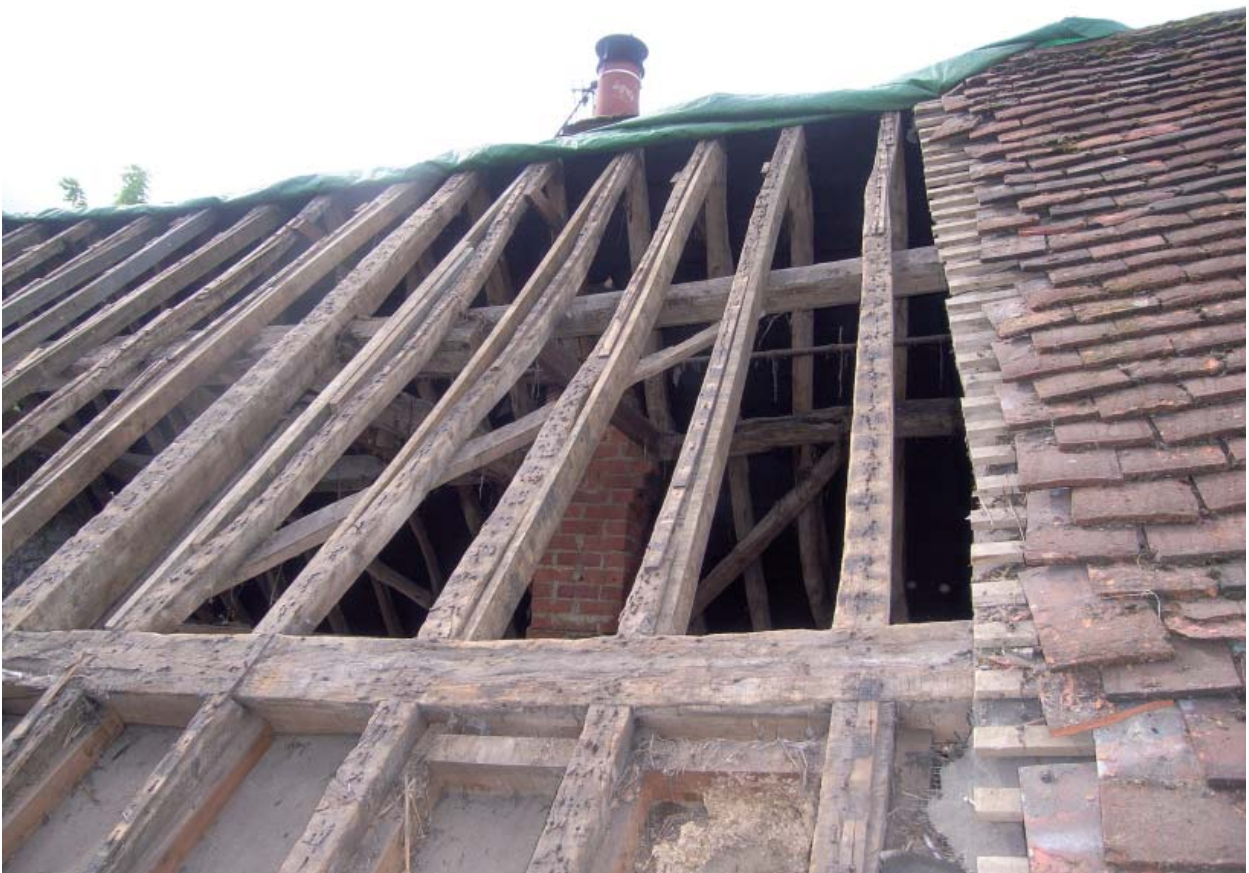
- 2.2.19 Windbracing appears to have been a later consideration and consists of one piece of scrap timber nailed to the underside of the rafters in the eastern end of the north slope and two similar braces to either end of the southern slope (Pl. 18).

Plate 18: Windbraces

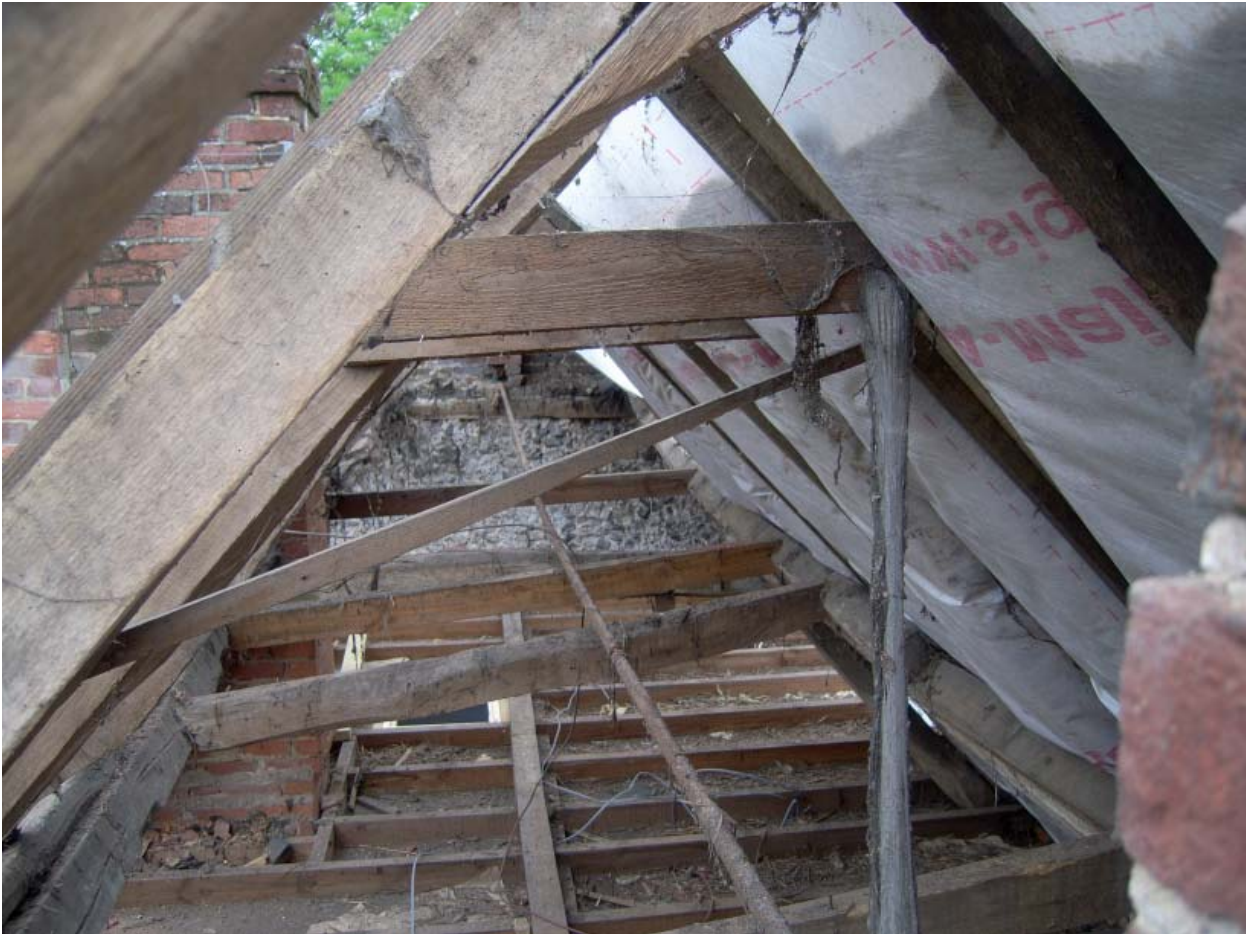
- 2.2.20 Several pieces of timber, appearing to be of different phases of work, have been added at varying angles to attempt to brace the upper purlins against each other and prevent them from bowing inwards under the weight of the roof (Pl. 19).

Plate 19: Braces between upper purlins

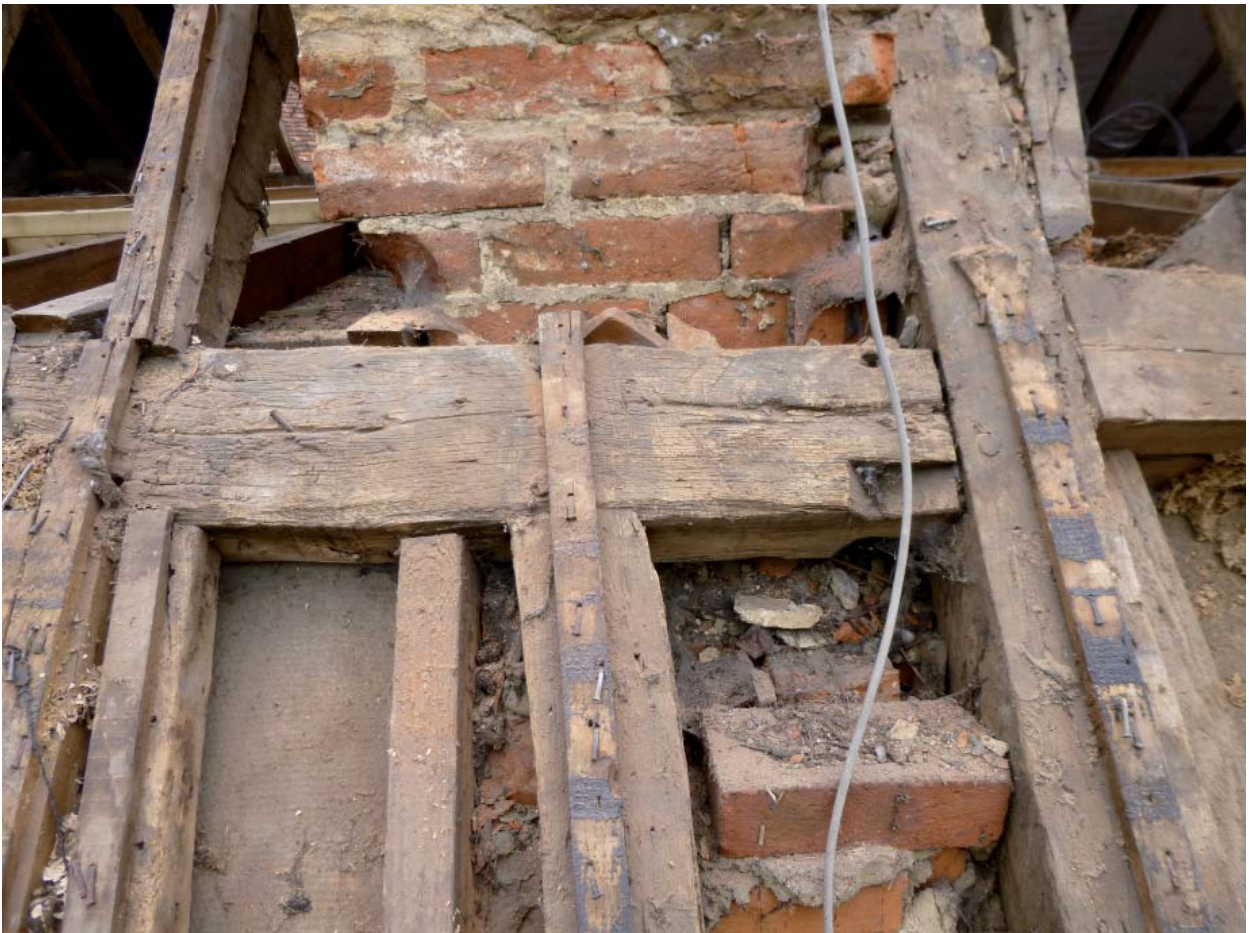
Plate 20: Degraded Carpenter's Marks on south slope

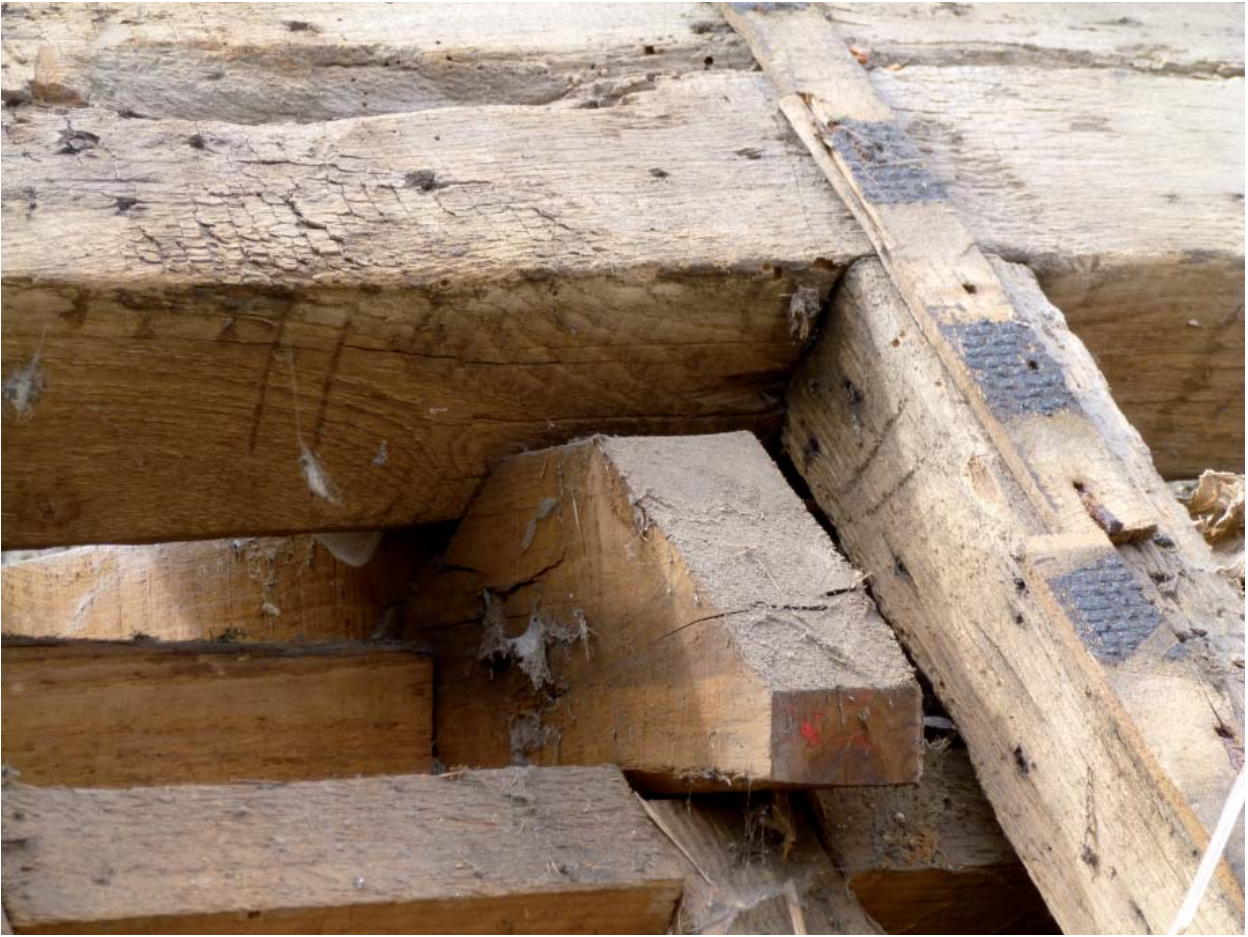
- 2.2.22 The carpenter's marks to the north slope consecutively number alternate sets of timbers from west to east below the lower purlin. The rafters above the lower purlin, however, have a less consistent system of marking which may point to more widespread recycling than the timbers indicate, however, this top face of the timber is heavily degraded in many places and is also obscured by the aforementioned battening or packing, and so the visible marks may well be incomplete (Fig 7, Pl. 21).

Plate 21: Carpenter's Marks on north slope

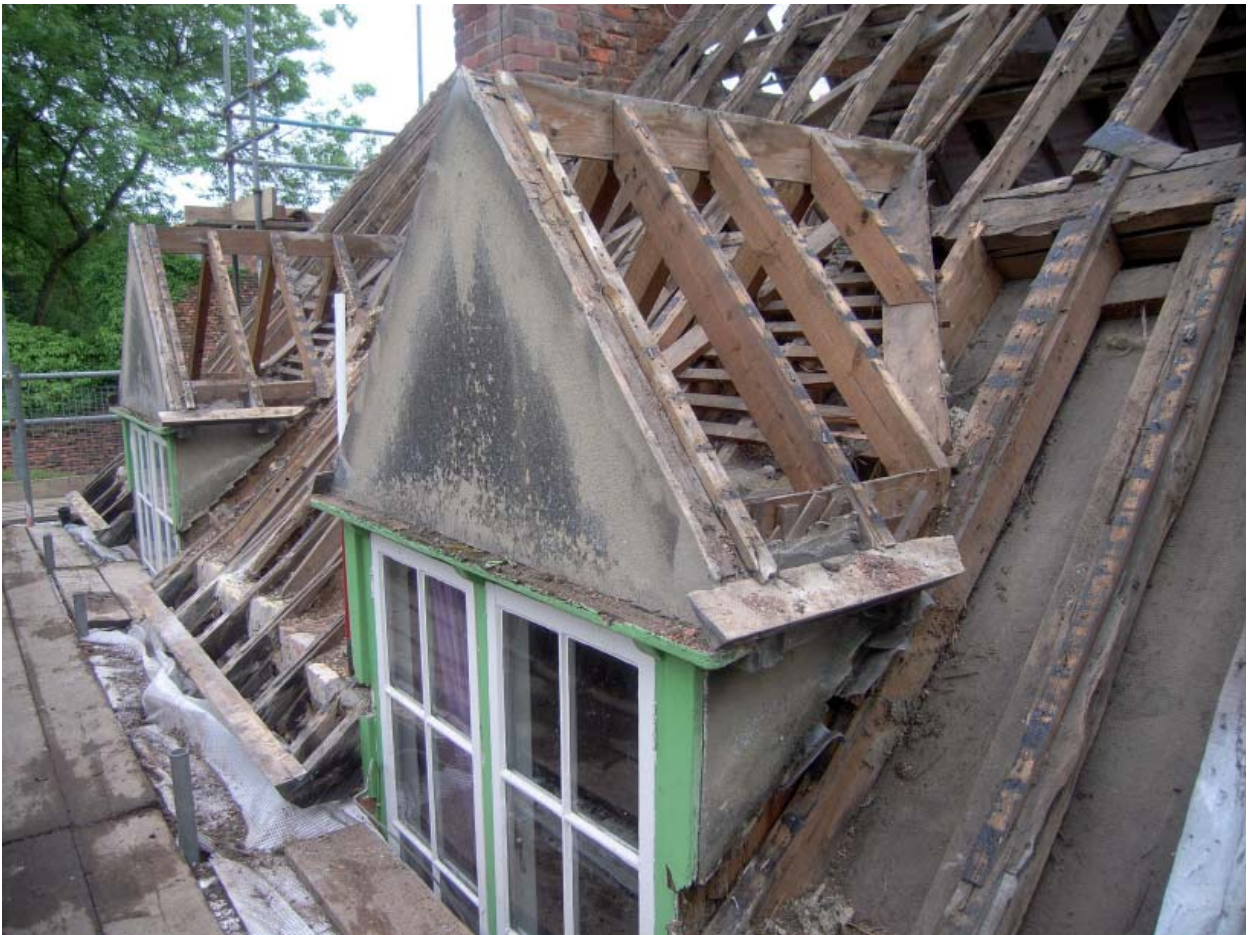
- 2.2.23 The dormer windows were installed during the RSA works and consist of softwood frames matching the timber used in the roof repairs and the construction of the first floor ceilings (Pl. 22).

Plate 22: Dormer windows
