Steps House West Wycombe Village

Building Investigation and Recording

Client: National Trust

Steps House, West Wycombe Village, Buckinghamshire
Report on Historic Building Investigation

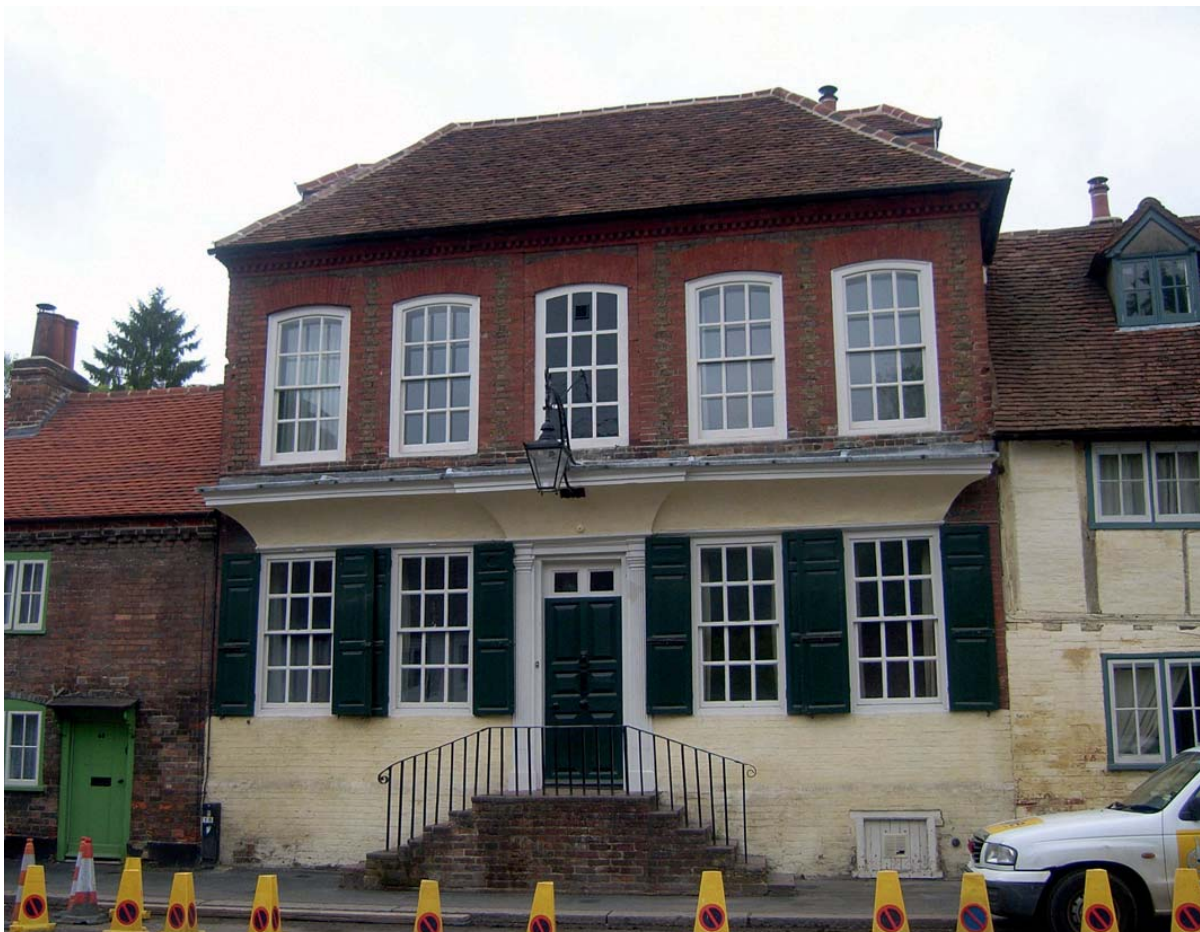
Plate 2: Steps House following re-covering of the roof, south elevation

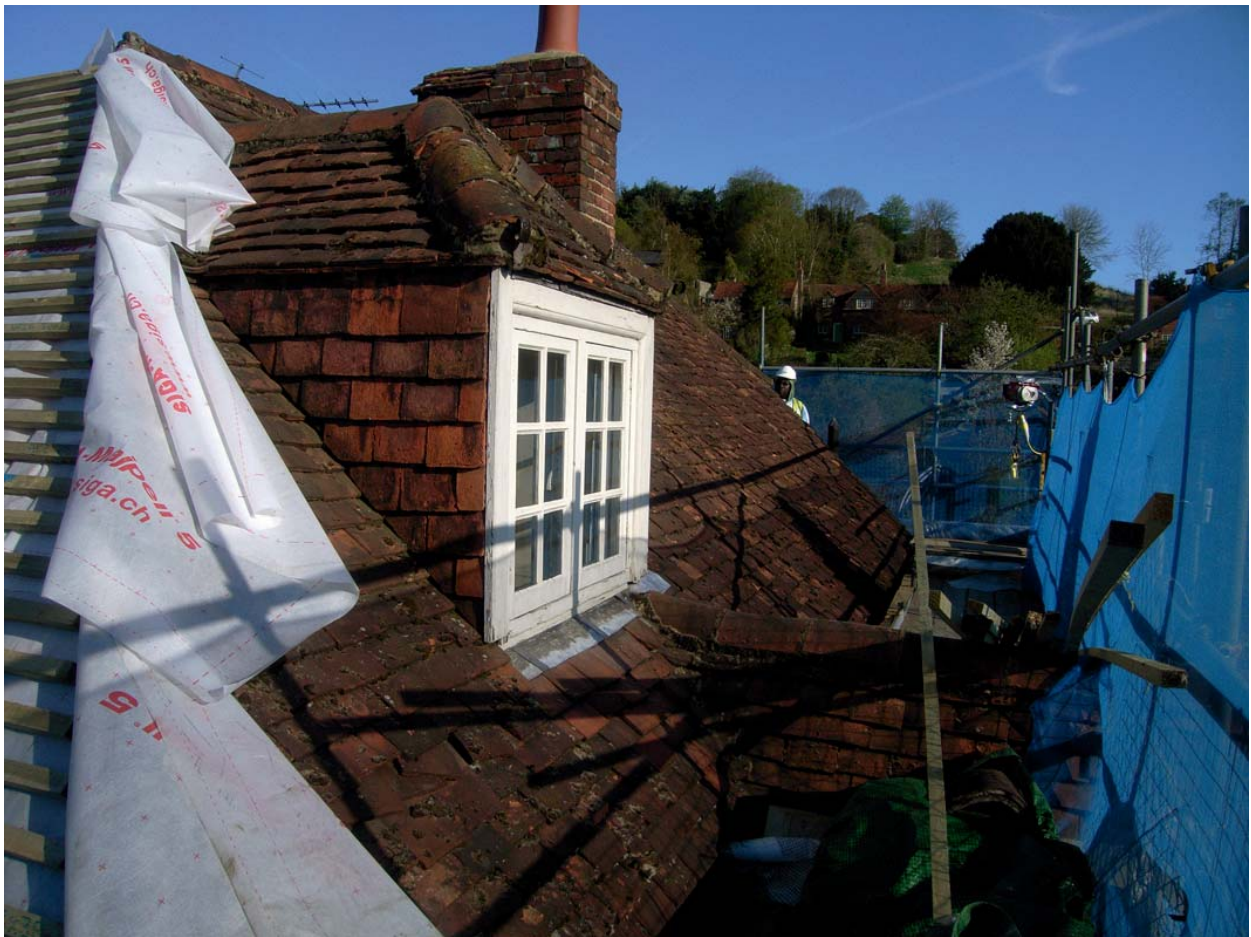
Plate 3: Dormer window in the east slope of the east wing

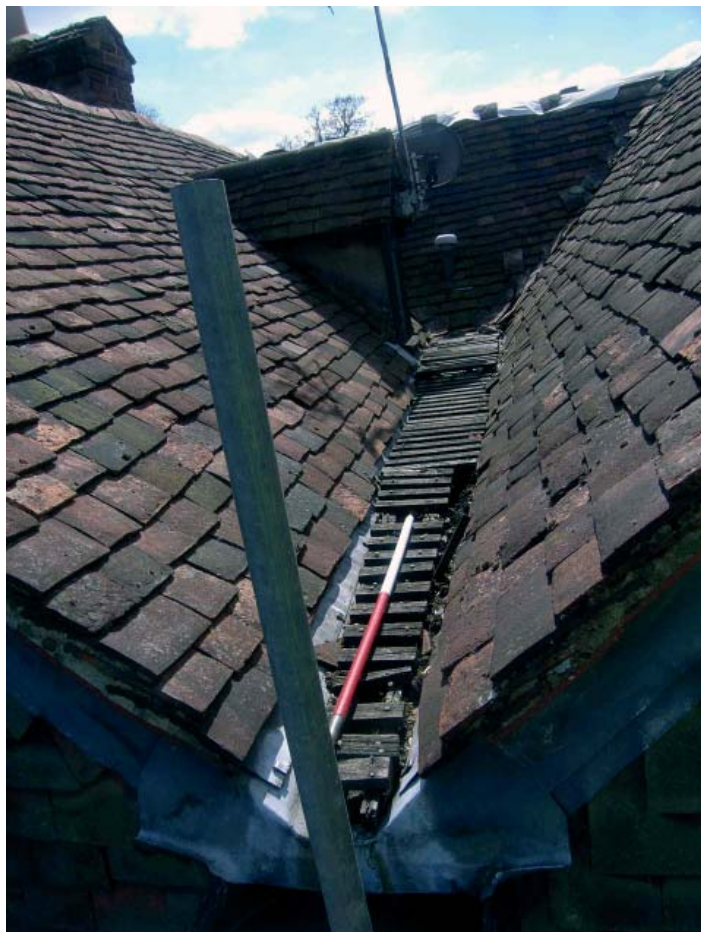
Plate 4: Dormer window/roof access in the valley between the wings

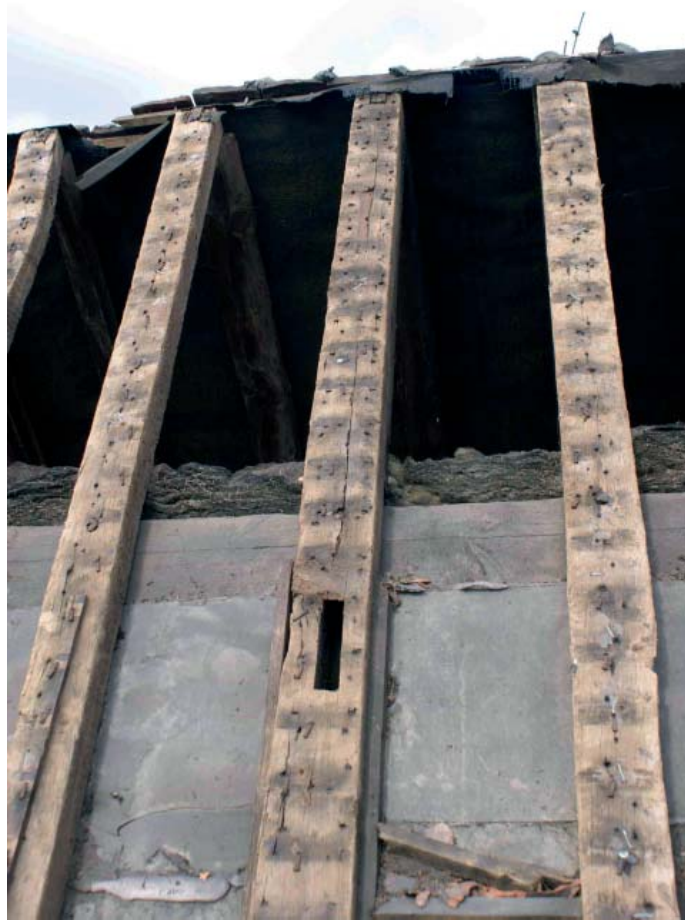
- 2.2.3 The roof of the southern, front, block consists mostly of jack rafters due to the hip and valley rafters to either end of the roof. A pair of principal rafters is in the centre of the roof with the collar now removed and the empty mortice visible (Pl. 5); the end of the tie beam is visible at the wall plate of the south slope (Pl. 6).

Plate 5: Empty mortice in the principal rafter in the south slope of the south range (courtesy of Gary Marshall)

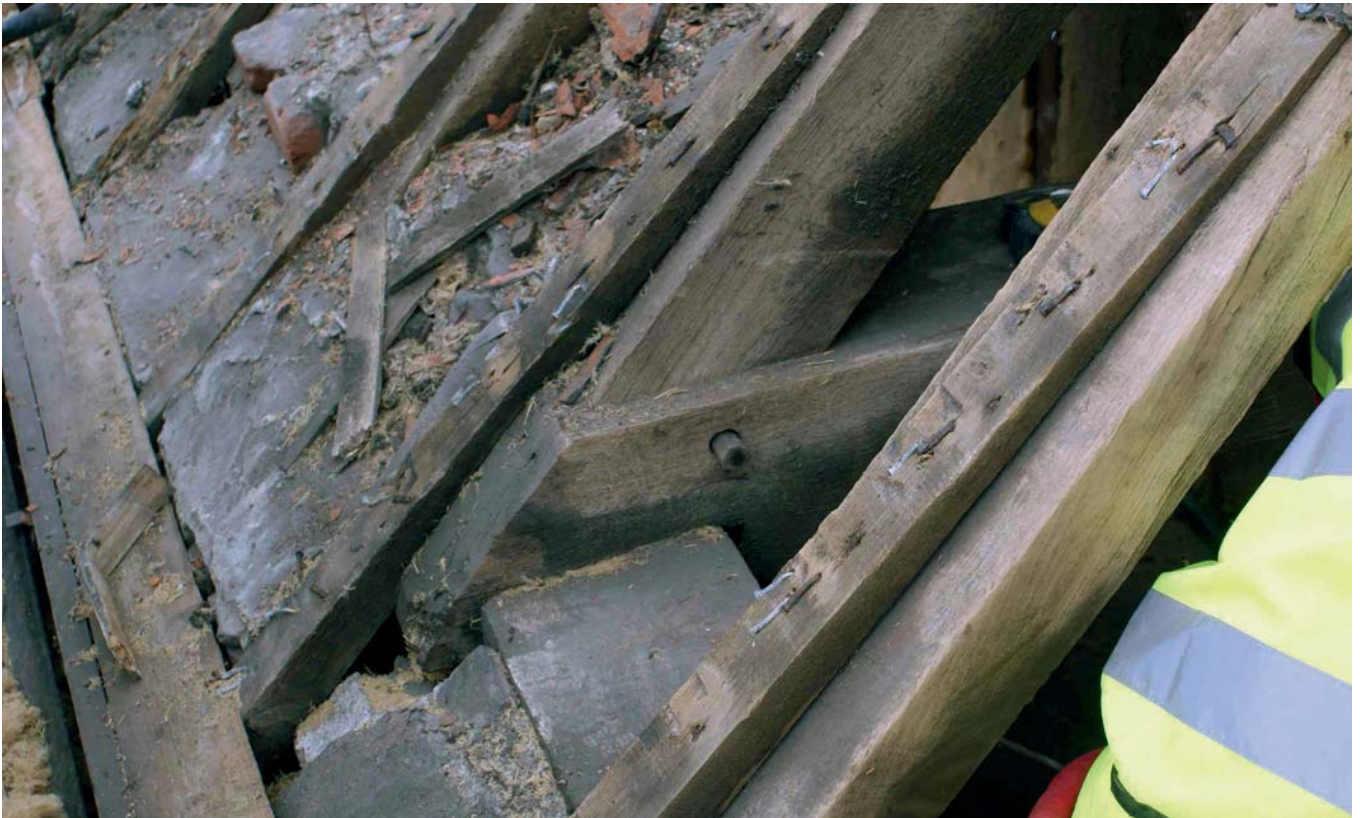
Plate 6: End of the tie beam in the south slope of the south range (courtesy of Gary Marshall)

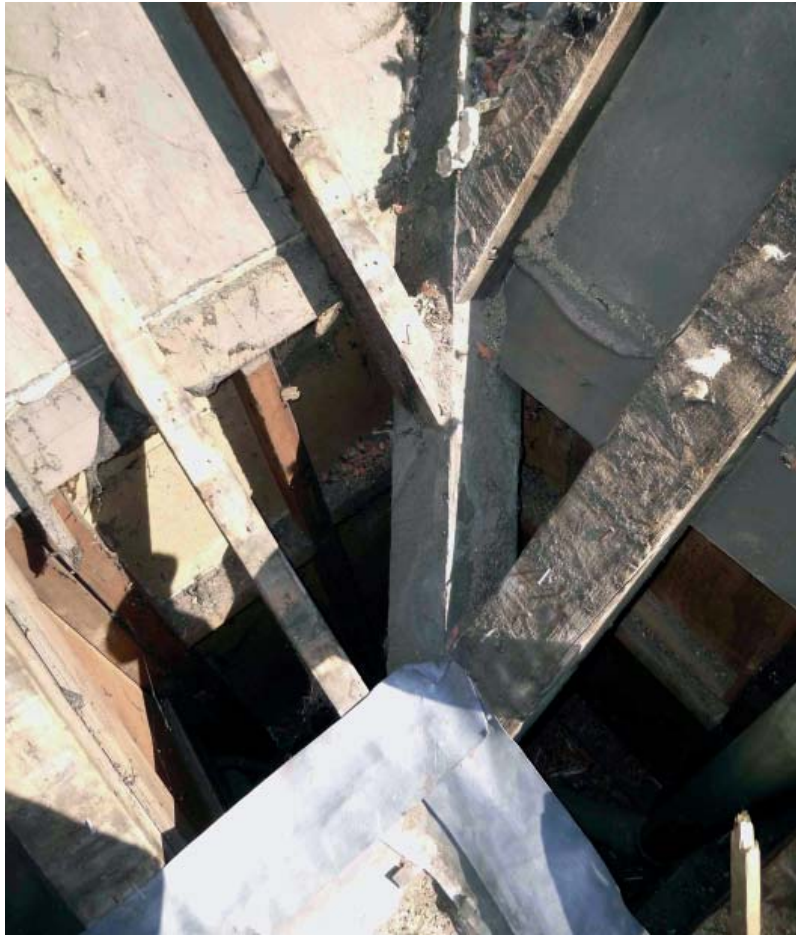
- 2.2.4 The two rear wings are of much the same construction, with eleven or twelve pairs of common rafters with a pair of principal rafters to the south of the chimney stacks. The rafters are partially obscured by the aforementioned leadwork in the valley (Pl. 7). The northern ends of the wings are half-hipped (Pl. 8).

Plate 7: Leadwork in the valley obscuring the rafter ends

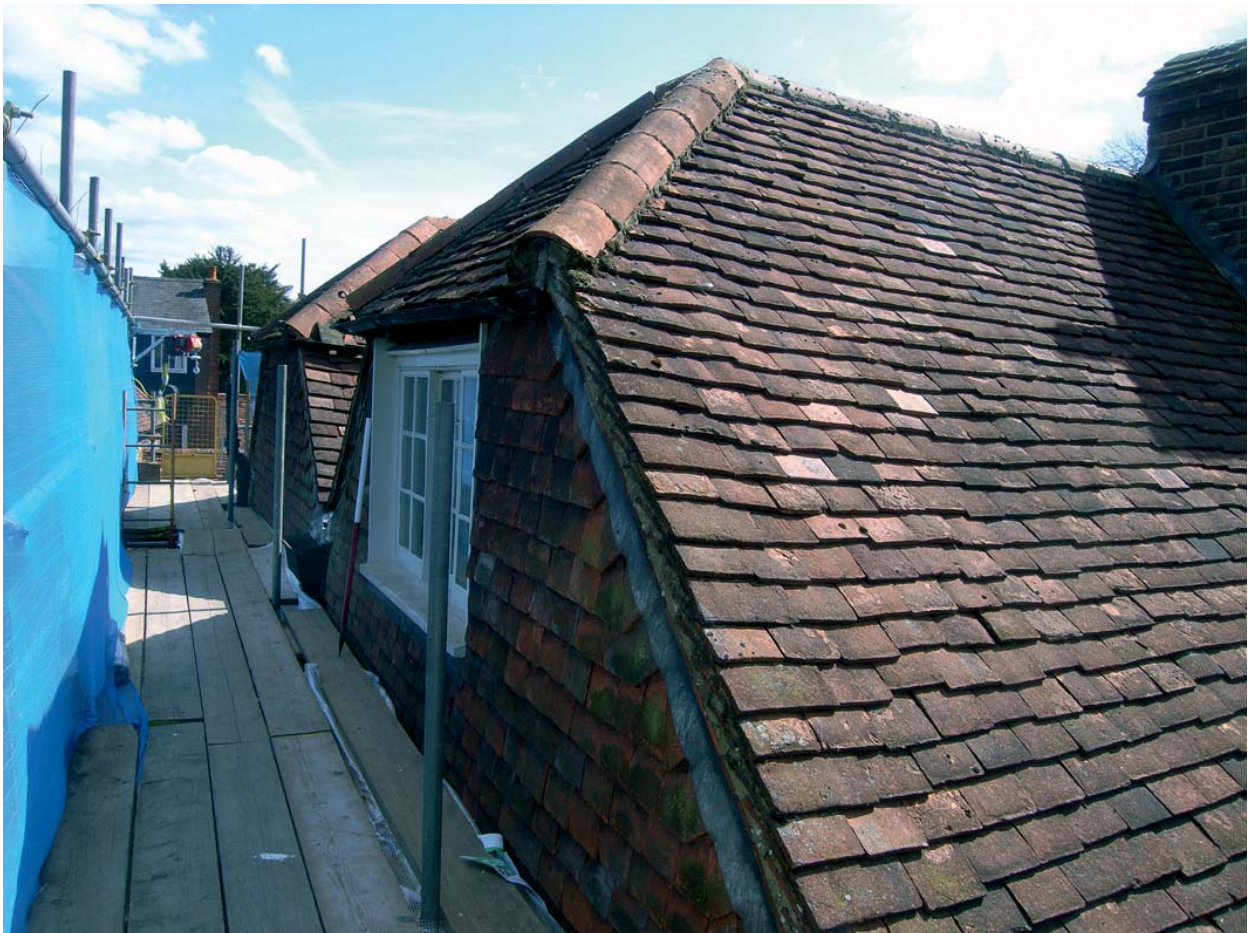
Plate 8: Half-hipped wings prior to stripping

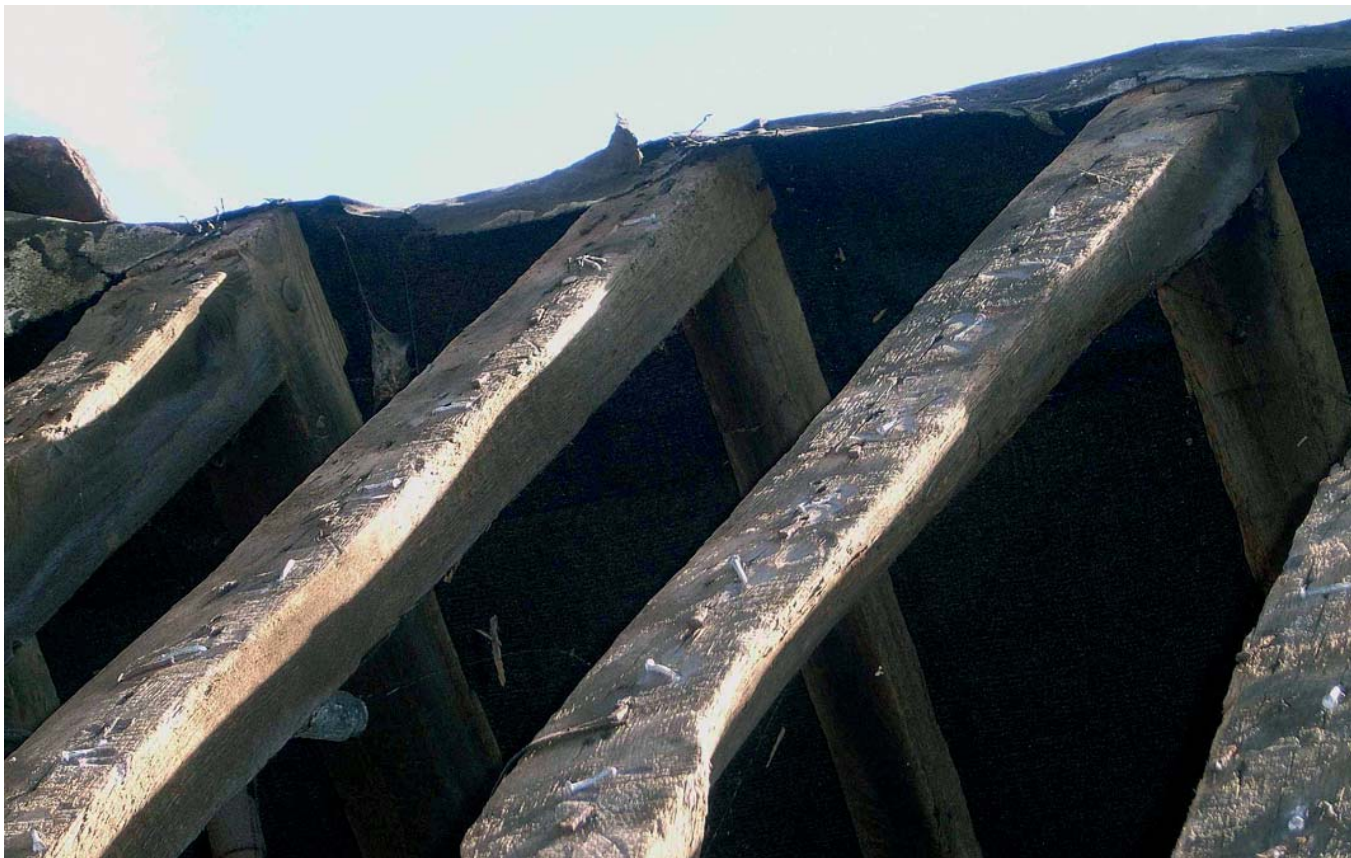
- 2.2.5 The rafters are bridle-jointed at the apex and some pairs are also pegged (Pl. 9). There is no ridge piece in any of the roofs, although a short piece of new timber and a reused rafter (probably a length of timber removed to allow for the dormer window construction) have been added later for support to the apex near to the chimney in the east wing (Pl. 10).

Plate 9: Example of rafter joints at the apex, west slope of west wing

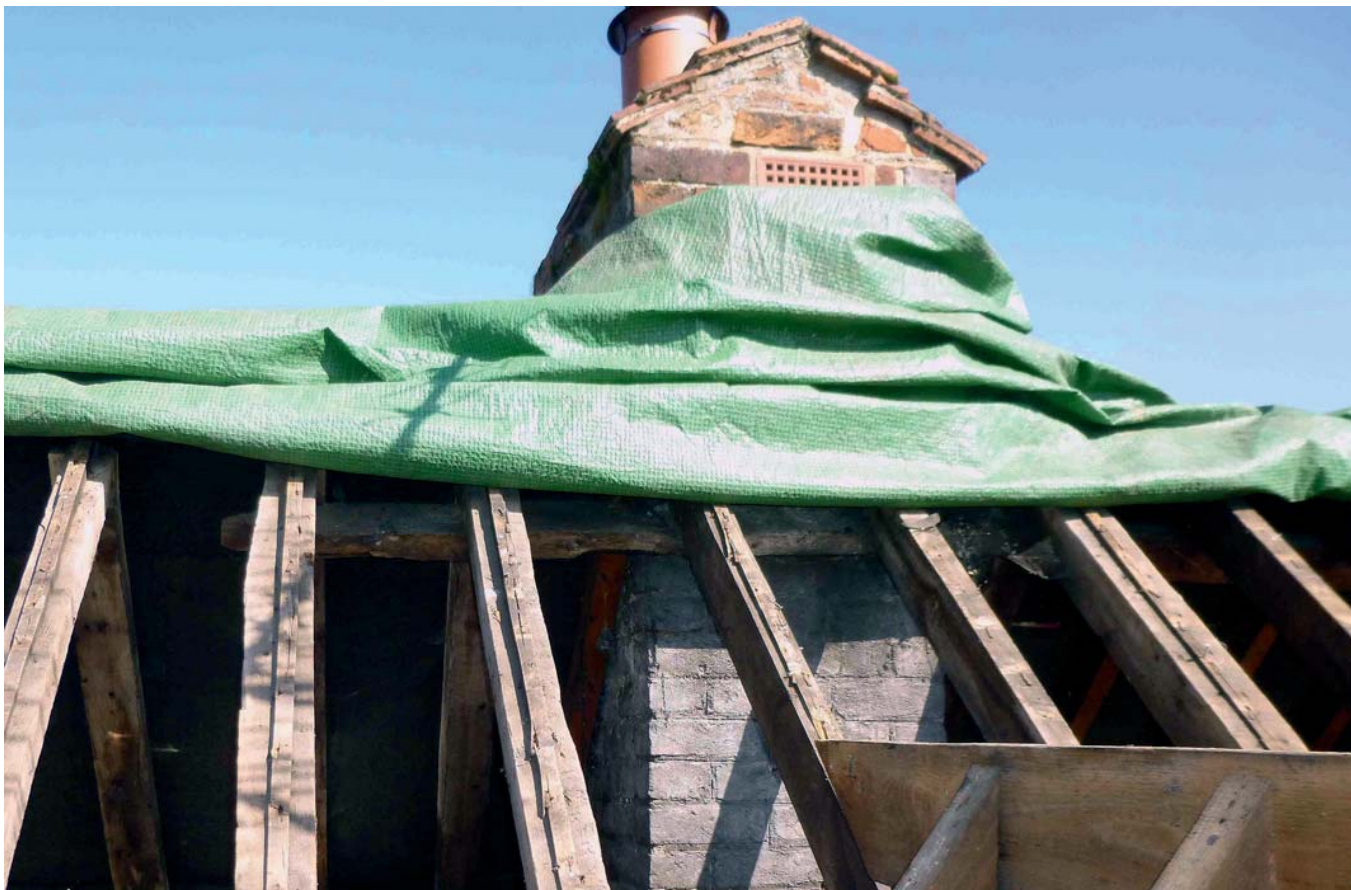
Plate10: Later support of the rafters at the apex next to the east wing chimney stack, west slope

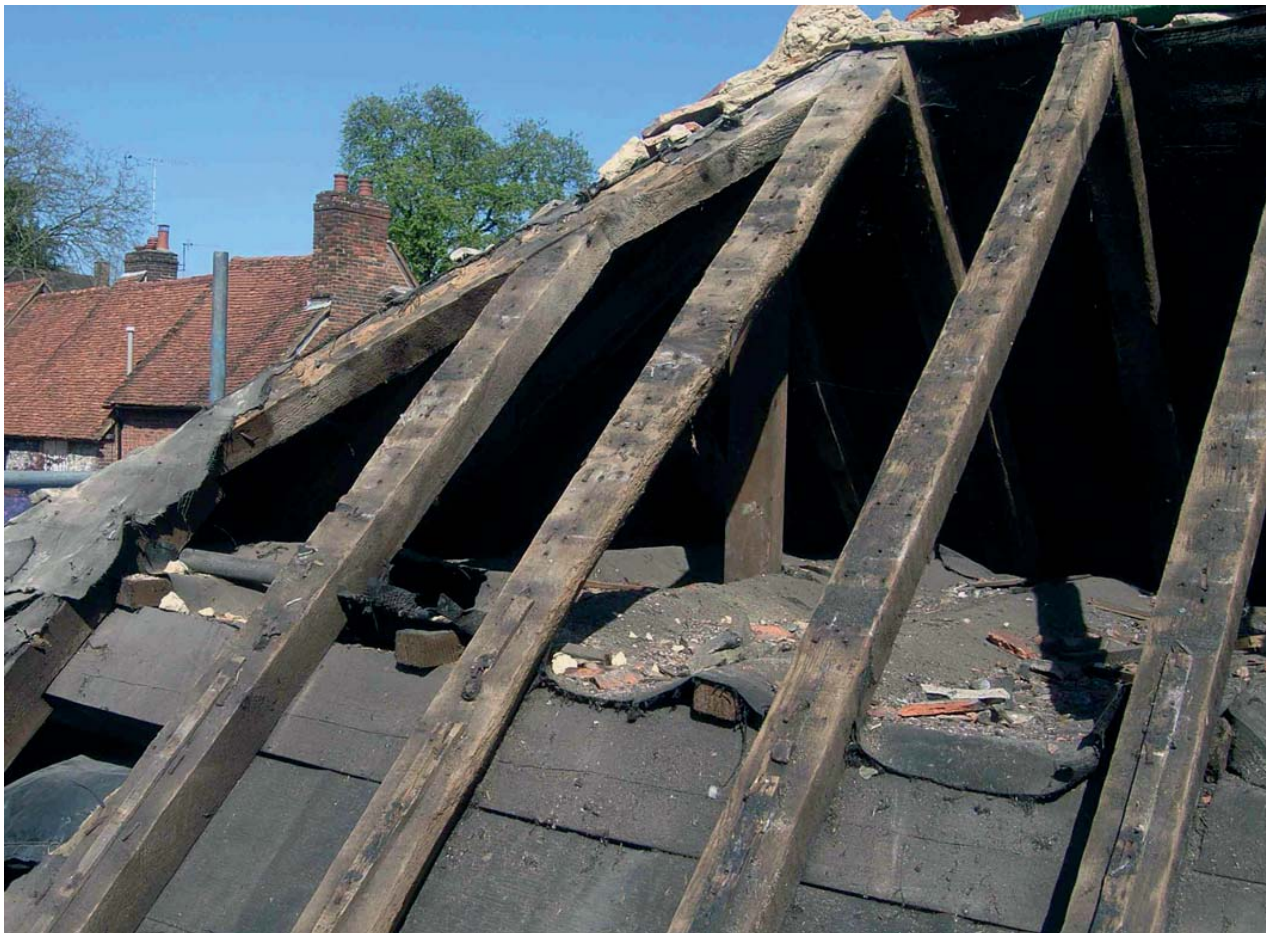
- 2.2.6 A single purlin supports the rafters to each slope. The rafters are pegged to the purlin with square wooden pegs to the rear wings (Pl. 11) and round wooden pegs to the front block. Some of these joints have been reinforced with large iron nails.

Plate 11: Example of the pegs attaching the rafters to the purlin, west slope of the east wing

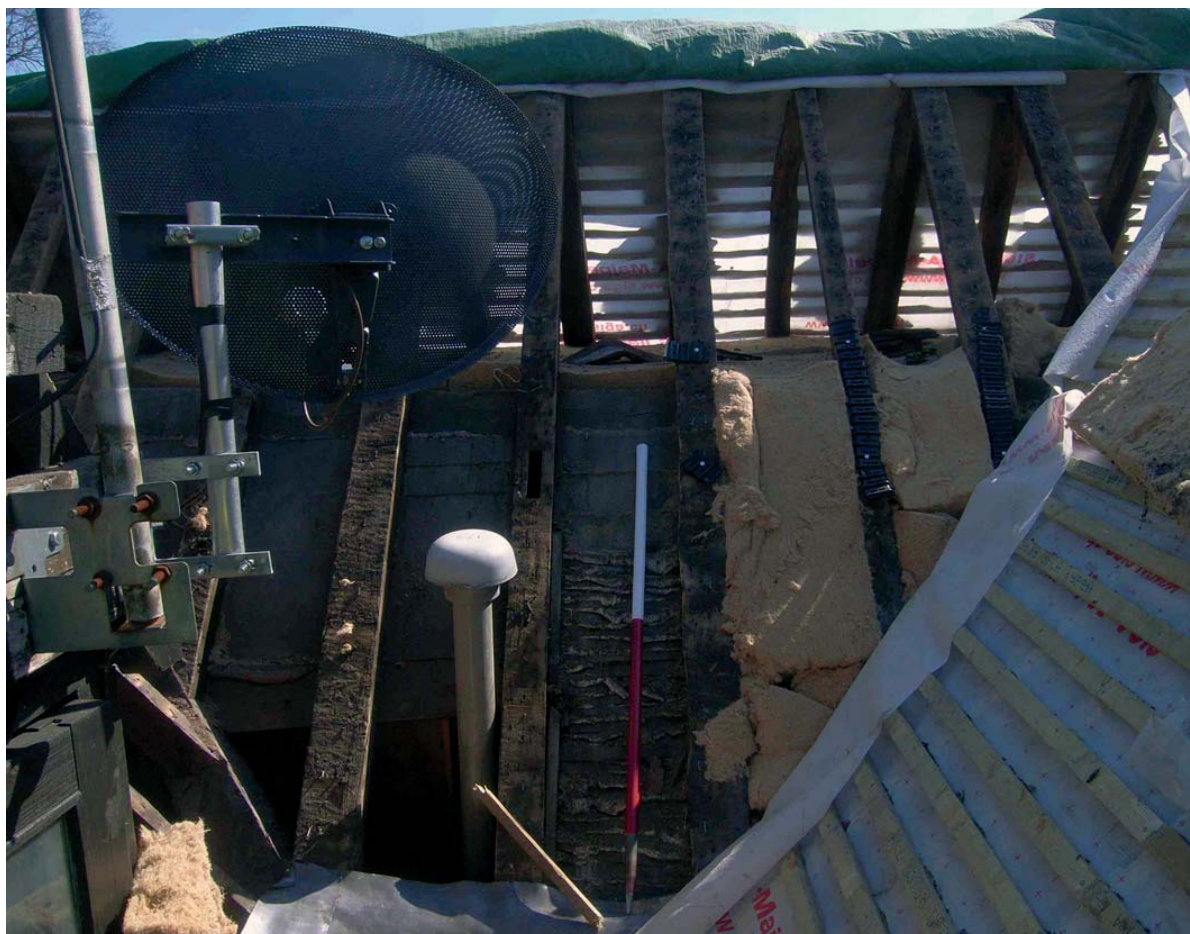
- 2.2.9 The principal rafters of the southern block have empty mortices (Pl. 12) following removal of the original collar; the same mortices in the wings have the tenons visible, however, the attic ceiling construction obscures any possible remaining collars (Pl. 13).

Plate 12: Empty mortice in the principal rafter in the north slope of the south range

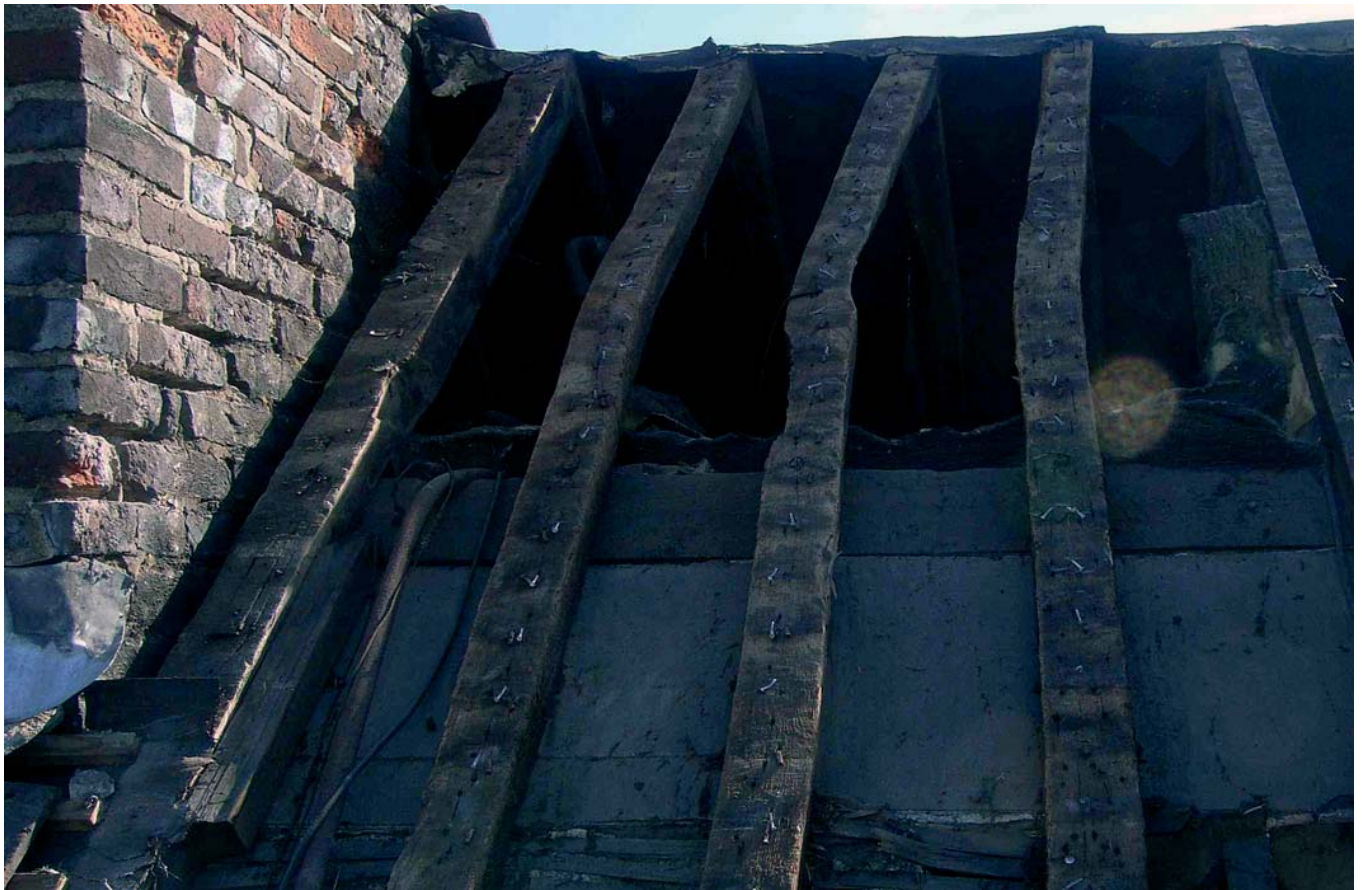
Plate 13: Tenon of collar visible but the collar obscured, west slope of the west wing

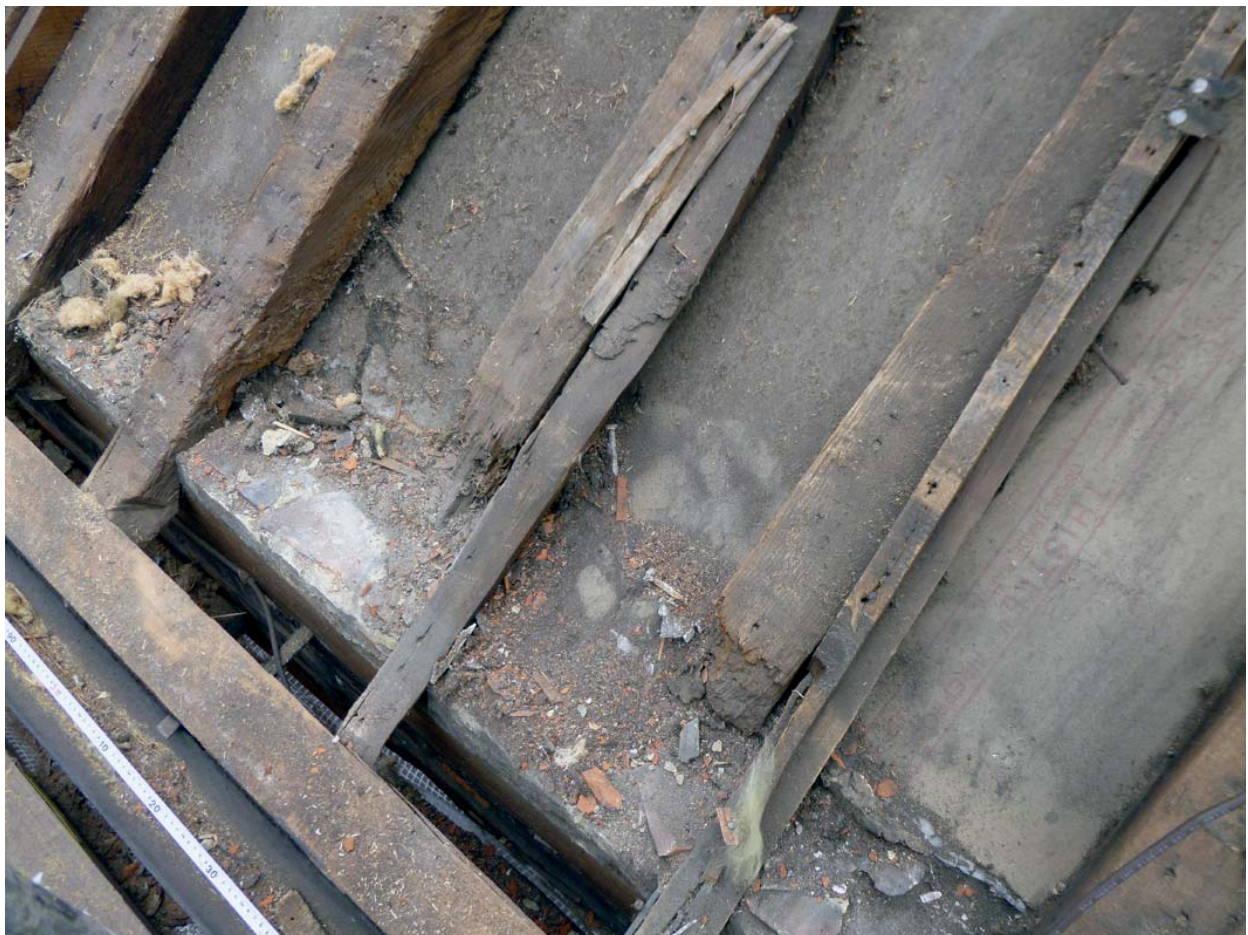
- 2.2.11 All visible areas of the roof display some repairs and reinforcement from additional timbers fixed to the sides of several rafters. Many of the rafters have been sawn off at the wall plate due to rot and sprockets have been fitted to support the eaves (Pl. 14). The original rafters were at least notched over the wall plate, but where the rafters have been sawn off at the eaves the wall plate has been mortared-over, obscuring any potential seating or indication of the method of jointing the two members.

Plate 14: Rot, reinforcement and sprockets, west slope of the west wing

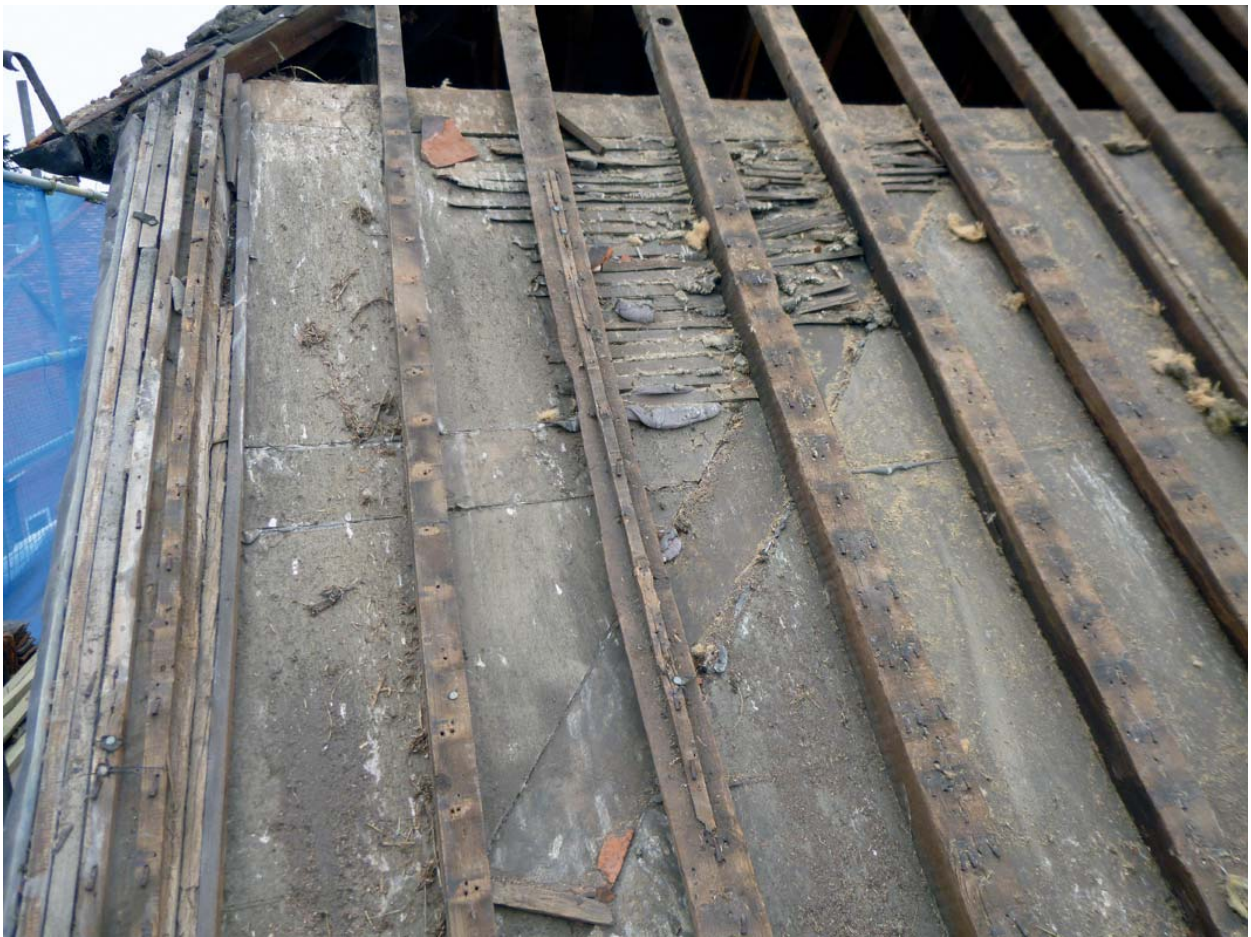
- 2.2.14 Only one windbrace is visible, bracing the westernmost slope between the principal rafter and tie beam and the purlin. All details have been obscured by the sheeting of the attic ceiling below, however, it has been fitted over the lath and plaster ceiling phase and so in all likelihood dates to the RSA works (Pl. 15).

Plate 15: Windbrace in the west slope of the west wing

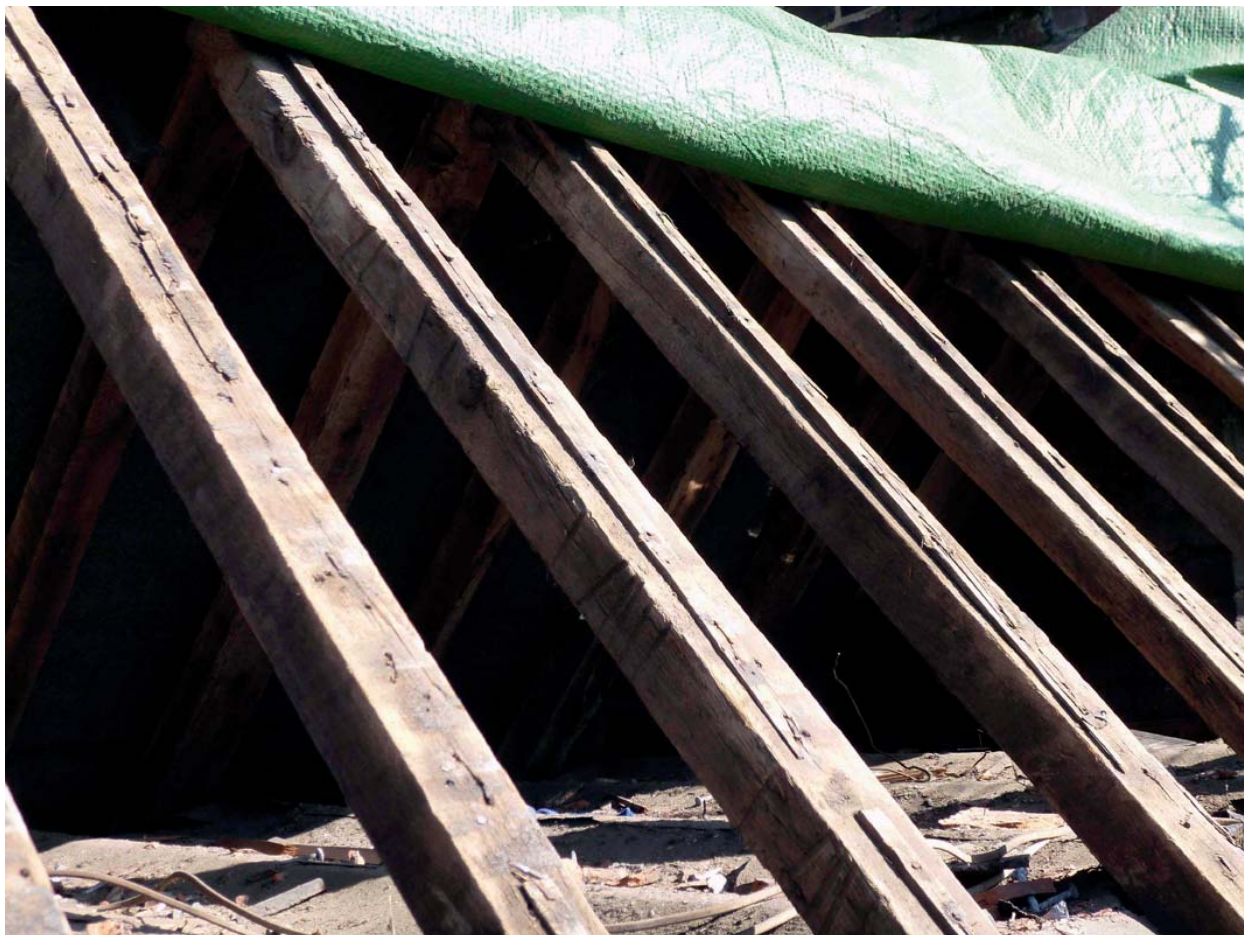
- 2.2.16 A few rafters display partial importer's marks (Pl. 16). Timber was imported in balks and sawn on site; the grooves appear to have been part of a tally or Roman numeral style of marking. Further investigation or analysis of the timbers may find where they originated.

Plate 16: Importer's marks, west slope of the east wing

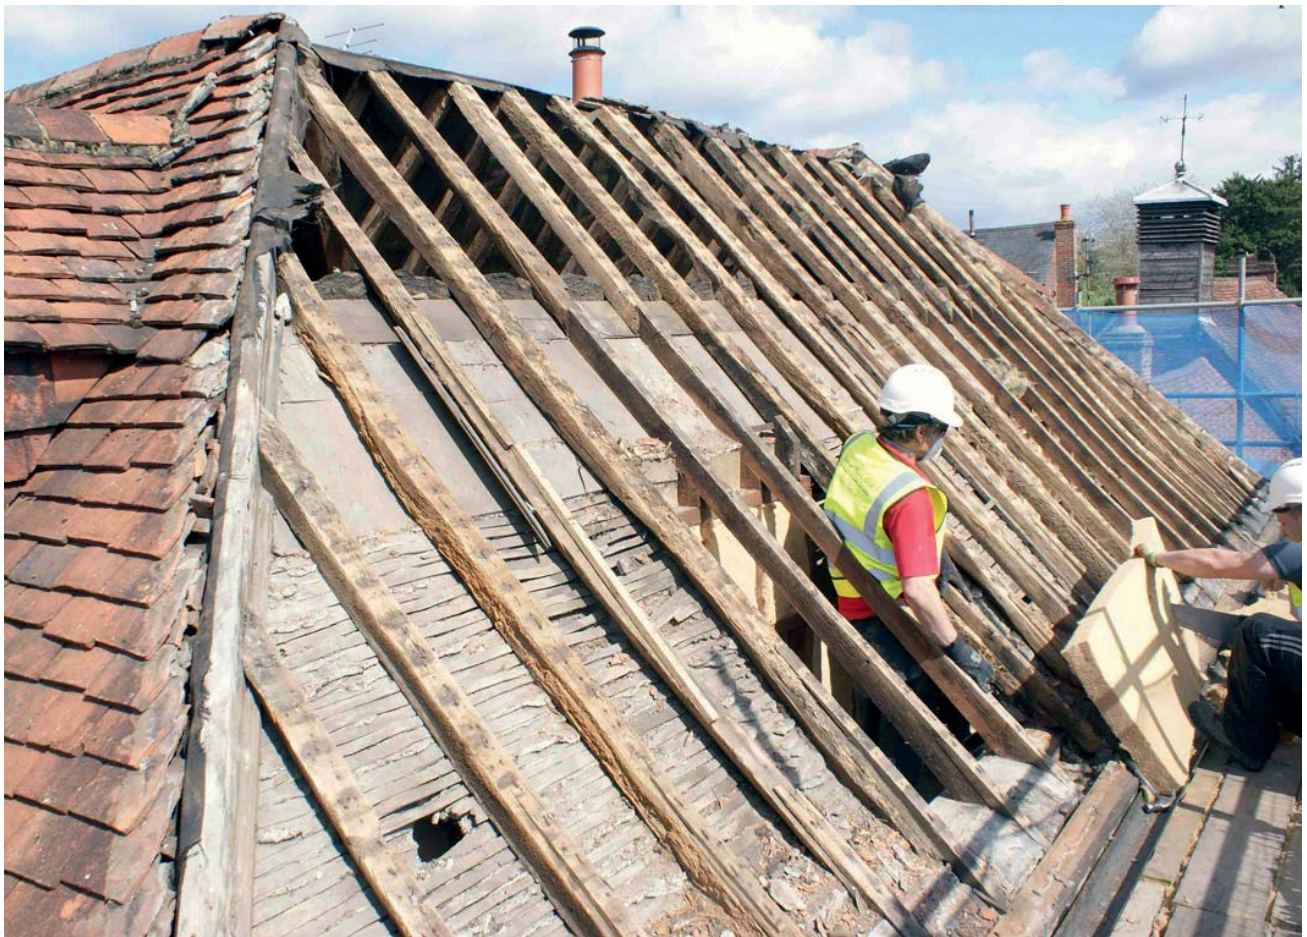
- 2.2.17 Repairs to the rafters in the southern, front, slope indicates that there were two dormers; as mentioned previously. One front-facing dormer remained until the RSA renovations when dormers were constructed to each side slope and the dormer to the front slope was removed (Pl. 17). The area from which the dormer had been removed at an earlier date does not appear to have been adequately made good at the time of removal as the timbers bridging the gap date from the RSA works (Pl. 18).

Plate 17: Replacement lengths of rafters to former dormer in the south slope, west end of the south range (courtesy of Gary Marshall)

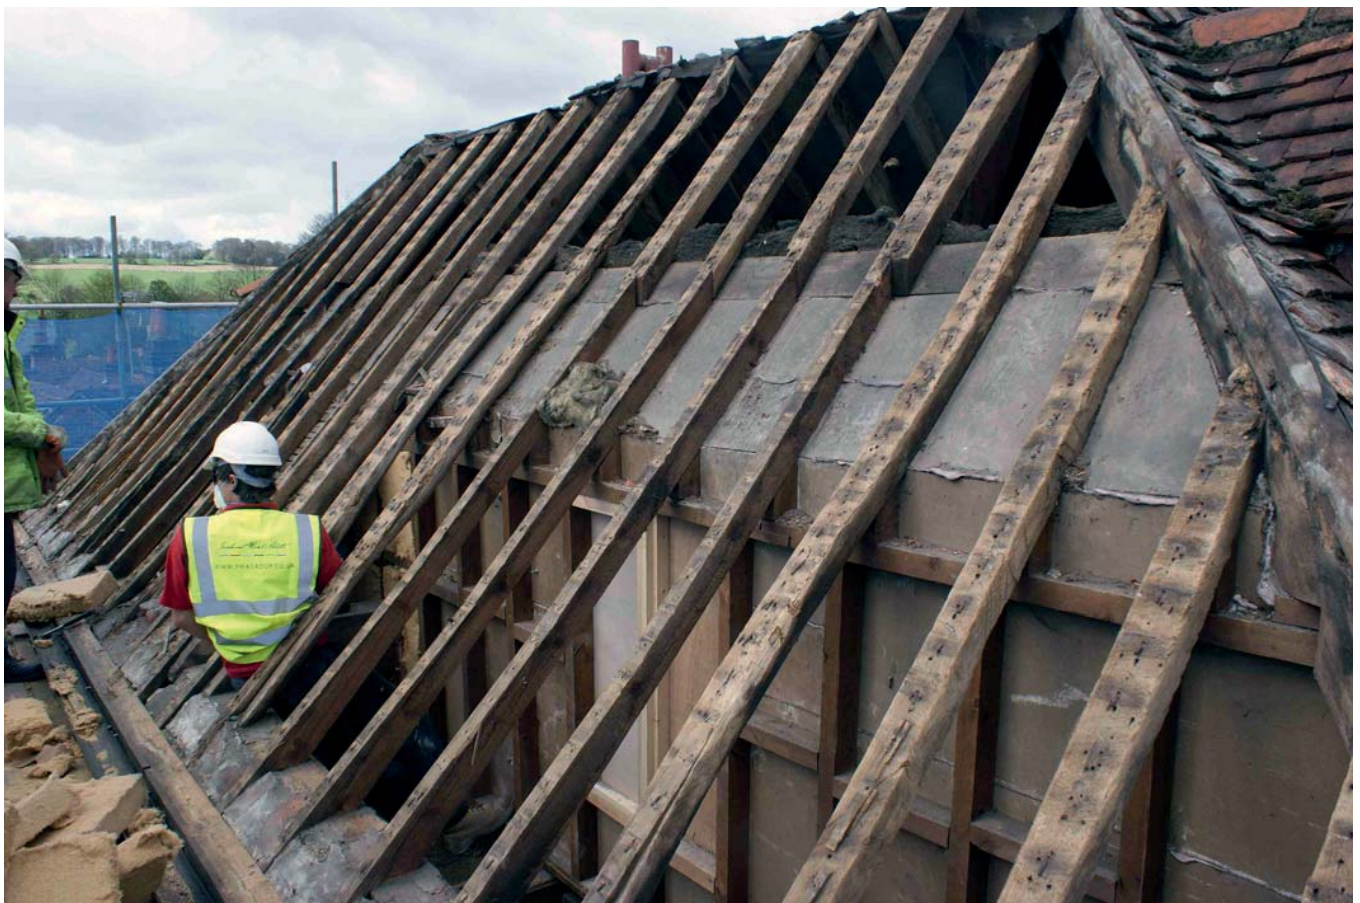
Plate 18: Replacement lengths of rafters to former dormer in the south slope, east end of the south range (courtesy of Gary Marshall)

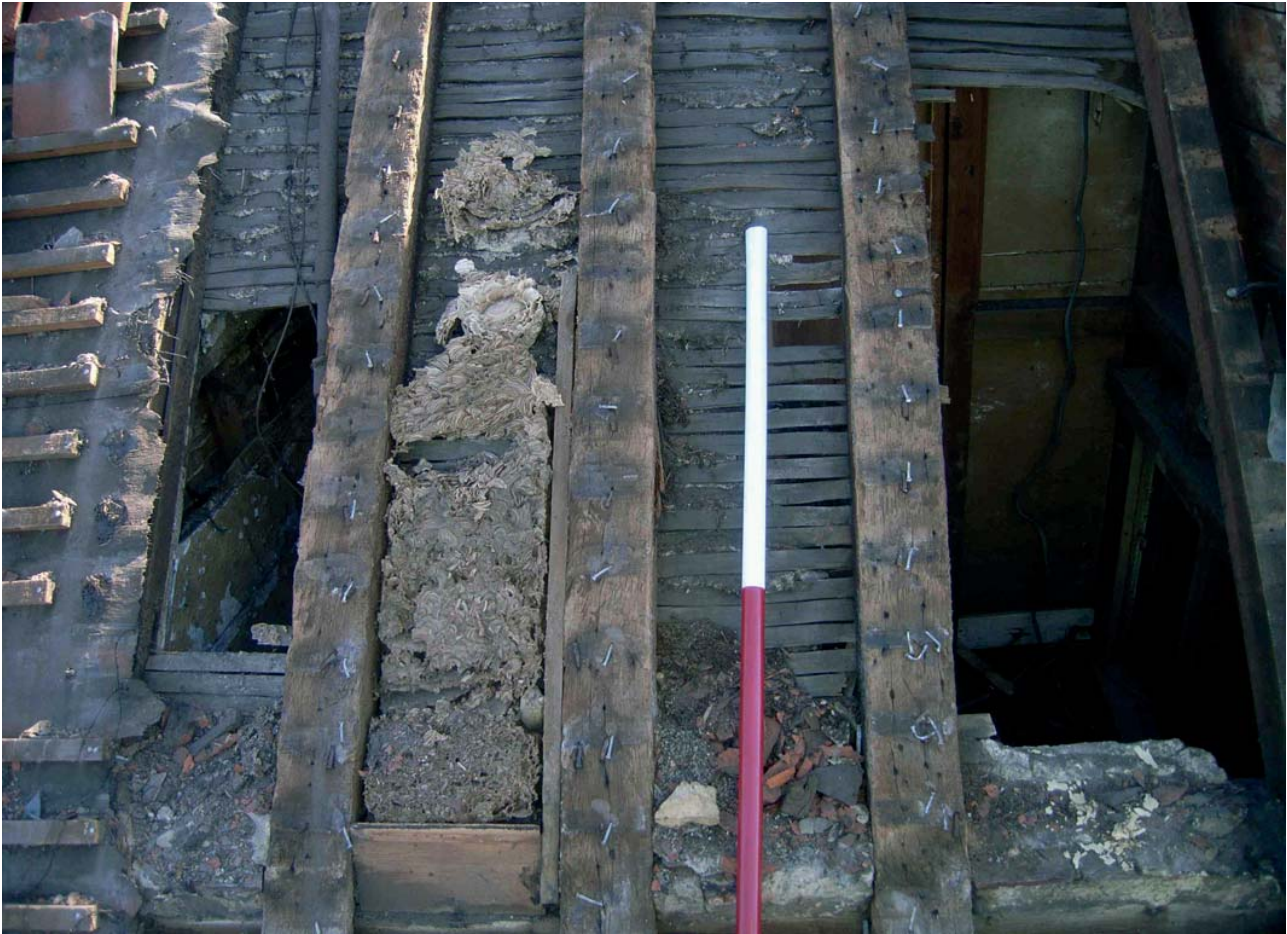
- 2.2.18 The original lath and plaster of the attic ceilings are visible in some areas of the roof, other areas display the later Thistle Fireproof Plasterboard fitted between the rafters. To the western wing, the attic room ceilings were reconfigured during the RSA works by boxing-in the eaves in order to create a barrier to the cold roof and also create a crawl-space containing the services. The previous wall plaster is visible in some areas (Pl. 19).

Plate 19: Original lath and plaster wall and ceiling and the RSA boxing-in of the eaves, west slope of the west wing
