# 57 and 58a High Street West Wycombe Village Buckinghamshire

## Historic Building Recording and Investigation

**Document Type:** Building Investigation and Recording

## Report on Historic Building Investigation

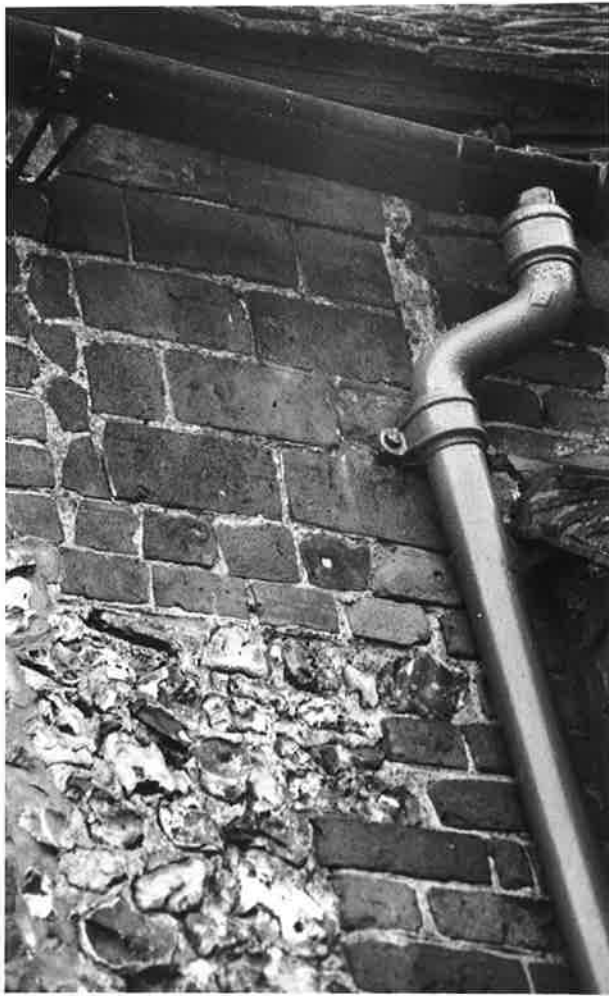
- 2.4.6 The rear elevation is formed of flint with red brick dressing including a horizontal band across the elevation. There is a clear straight joint between the main and west block fabric. There is a projecting brick buttress to the rear of no. 57 which rises to the first floor level.

DETAIL OF STRAIGHT  
JOINT TO REAR OF  
MAIN BLOCK. NO 58A  
R. 192 N. 25

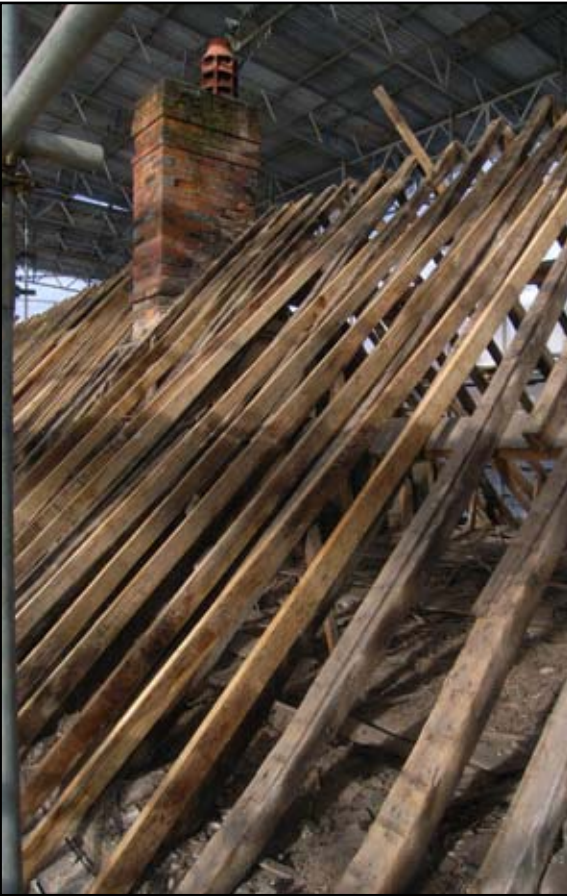
Plate 1: Main block north elevation roof timbers following removal of tiles

- 2.2.6 The rafters are primarily the same as seen in the west block roof structure, namely plain rafters bridle jointed at the apex with a wooden peg (Plates 1-11). However they are less uniform in appearance suggesting a slightly earlier date and also include several obvious reused timbers with empty mortices and notches. The rafters have varying sizes with cross section measurements of between 10 and 13 cms wide and 7 - 12 cms deep. As with the west block the carpenters markings are at the apex are Roman numerals scribed with a race knife, also with an additional line or tag to denote the rafters forming the northern half of the structure. The carpenters marks are not on all rafters and they do not all run sequentially indicating there has been reuse of the early roof timbers. The marks appear on the west face of the timbers indicating this roof forms a separate construction sequence to the roof of the west block.

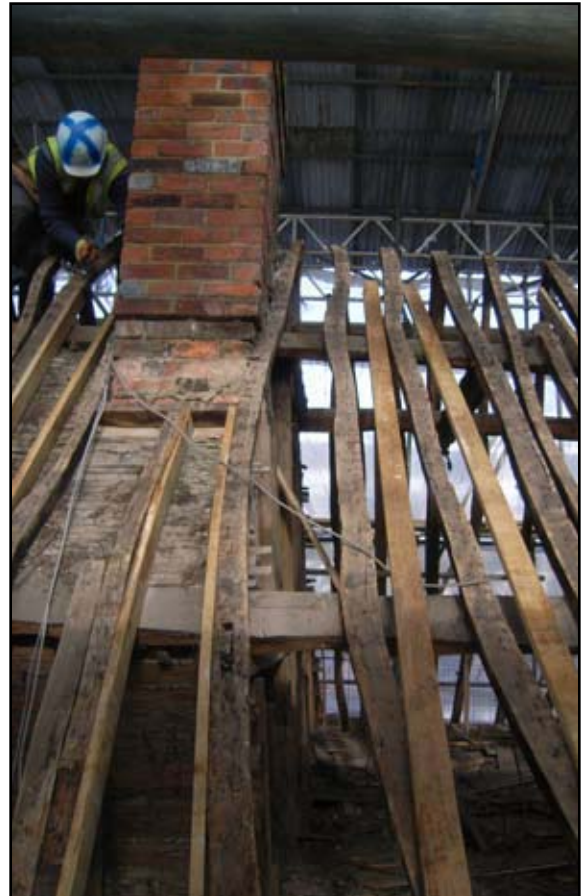
Plate 4: Northern elevation of main block roof timbers with central chimney and attic rooms lath and plasterwork

- 2.2.7 Within the roof space there is lath and plaster partition walling forming two attic rooms nos. 58/M and 57/K. The lower section of the lath and plaster structure is situated between 83 and 110cm away from the edge of the roof and is supported by short sections of timber posts. The lower section of wall is approximately 70cm high and the entire structure terminates approximately 70cm from the apex of the rafters. There are several reused timbers within the posts for the lath and plaster wall with truncated race knife inscribed carpenters or Baltic (transportation) markings.

- 2.2.8 The lath and plasterwork for the main block attic rooms terminates at the central chimney stack and within the lath and plaster covered stud wall adjacent to this stack is a door opening that has been blocked up with modern plasterboard. To the east of this, the roofspace is open and covered with debris, some of which is from the current building work, however most appears to relate to earlier phases. Amongst other general debris within the open roofspace there is a quantity of organic straw material, timber laths and

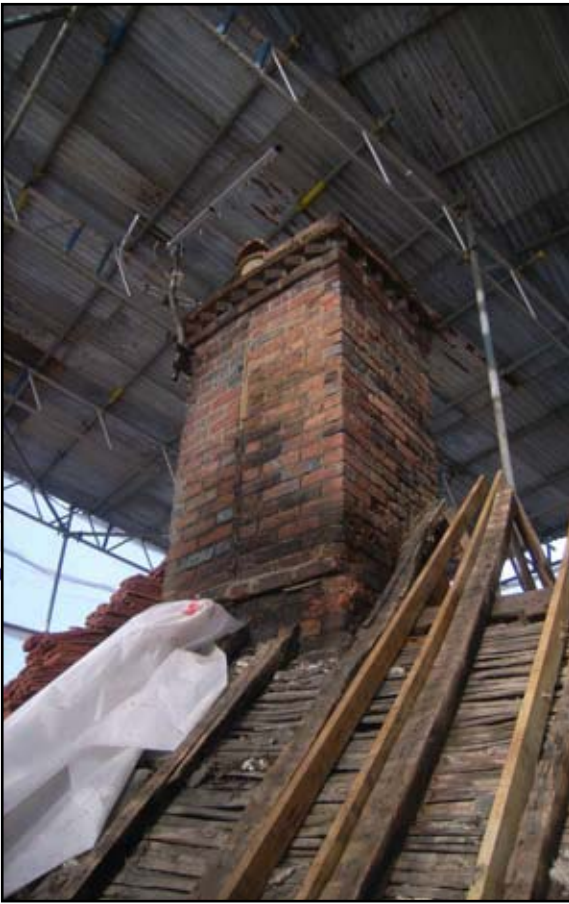
Plate 5: Detail of central chimney

- 2.2.5 **Main Block:** There is a change in the angle of the two blocks leading to some variation in the rafters at this point including a section of 20<sup>th</sup> century concrete and wire mesh infill to the north (rear) elevation. This main section of roof is the largest measuring approximately 9.35m in length on the north elevation and includes two attic rooms. The chimney at the west end is wider and longer than the adjacent stack and appears to be constructed of the same brick type as described above.

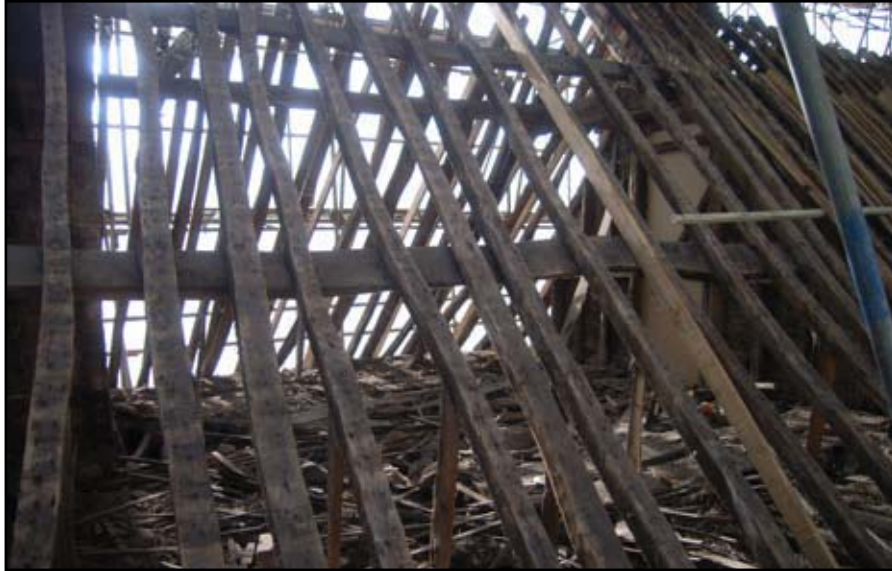
Plate 9: Detail of main block open roofspace showing debris

fragments of pegged tiles indicating the roof and its associated features have been repaired and altered at some point (Plate 9).

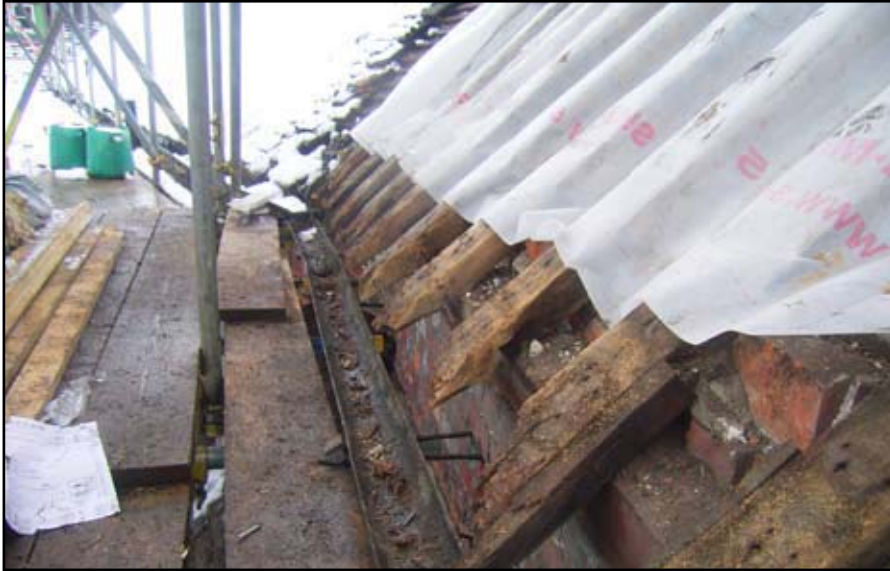
Plate 13: No. 58a notched rafter detail on north elevation

- 2.2.3 The roof timbers in this block are fairly consistent in size and in appearance with some timbers more modern in appearance, suggesting a later repair. There are carpenters marks at the apex of the timbers that have been inscribed on the east face using a race knife. The marks are in the form of Roman numerals and some of these have added scribed lines, commonly known as tags, which would normally be used to indicate the side of the building the rafter should be on - in this case the northern rafters have the additional markings. The numbering appears consistent suggesting these rafters form part

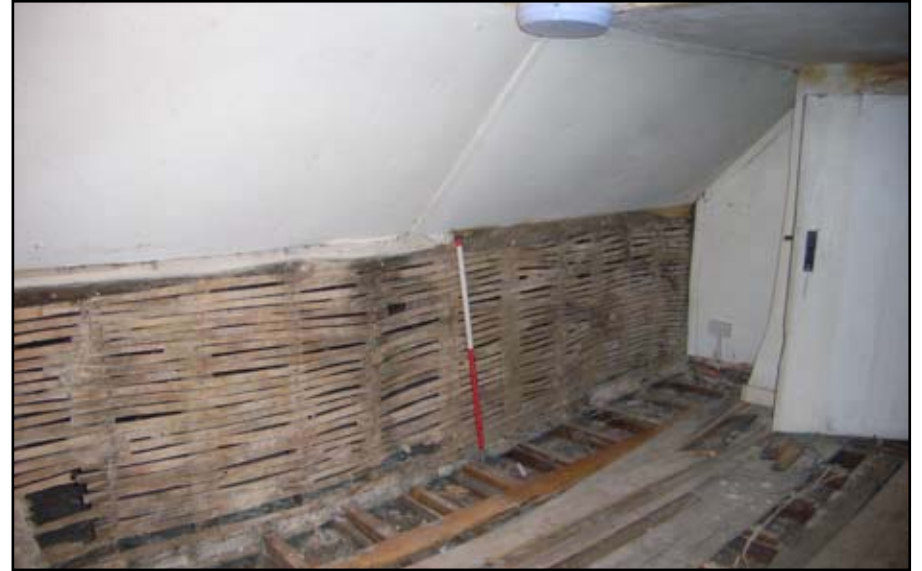
Plate 14: Room 58/M interior view, south elevation

- 2.3.1 During the works several floorboards were lifted within room 58A/M (plates 14 - 17). Beneath the floorboards, a central beam runs east to west through to room 57/K however it does not continue through to lobby/stair 58/L at the west end of the room but instead terminates approximately 35cm before this. At this west end of the beam numeric carpenter's marks can be seen running sequentially from I - IIII, these are scribed with a race knife and so it can be assumed the beam is not truncated but the west end of the room has been extended in some way. The joists measure 76 - 102 x 102mm and are laid at varying intervals of 330 - 381mm. Most joists have wooden pegs fixing the joist in place in the beam. Some joists have additional timbers in place which have been added, probably to correct the obvious sag of the floor in the central area.

- 2.3.2 As discussed previously in §2.2.7, the walls are of lath and plaster however there is modern board covering the upper faces. The north lower wall has mainly exposed laths with no plaster remaining (Plate 14) however early plaster remains on the south wall and this has been painted with a limewash (Plate 17). The plaster has a high horsehair content and is extremely friable. Modern board had been placed over this surface but was removed during the works. The ceiling plaster was not exposed and remained hidden beneath the modern board.

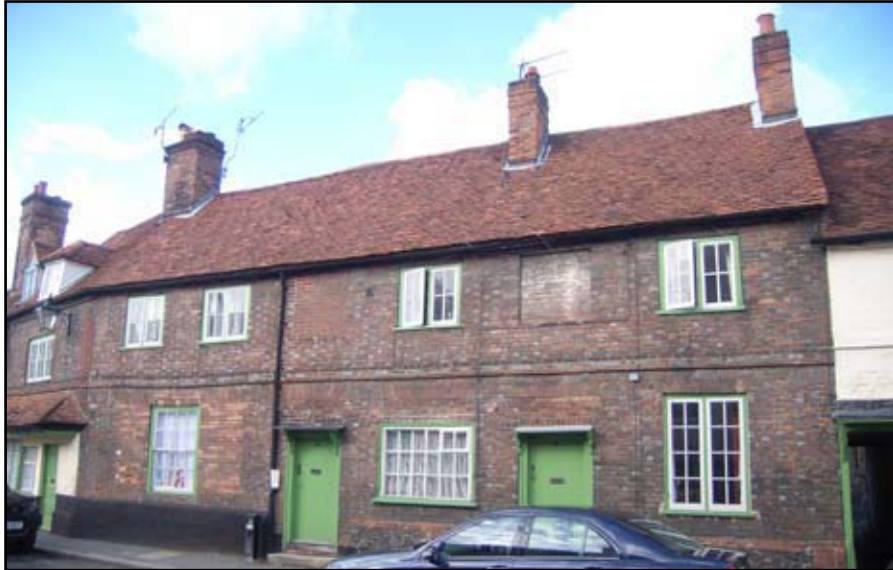
Plate 19: High street elevation prior to works

- 2.4.3 There is brick facing to the frontage of no. 57 and 58a which appears to date to the 18<sup>th</sup> century (Plate 19). This brickwork is predominantly in orange/red coloured brick laid in a Flemish bond with vitrified headers creating chequerboard effect. The brickwork of the upper floor projects outwards and at this point there are three courses of English bond.

- 2.4.4 The western end of no. 58a (the west block) has a set of adjoining windows on the ground floor with a hipped tile pentice over the windows and the adjacent door. The brickwork on the ground floor has been rendered and so we are unable to see the detail beneath, the current configuration is likely to be a later alteration, however. There is a high plinth which has been rendered and then painted black. The first floor has a solitary central window with header lintel and wooden casements within, this window is set lower than those of the main range indicating the difference in floor levels across both buildings. The window has red brick jambs and it is clear the lintel brickwork has been reset or repointed. There are two courses of projecting plain red brick headers beneath the eaves. An irregular section of brickwork adjacent to the main block façade is of plain red brick and possibly a later repair or addition.

- 2.4.5 An obvious straight joint separates the west and main blocks and the brickwork of the main block has a different level of course to the west block. The ground floor windows had segmental red brick lintels and the first floor had lintels of red brick headers. The larger range has a quantity of obvious alterations to the fenestration. On the ground floor, two former ground floor windows have been blocked and a sash window inserted leaving the prior lintels in situ. To the east of this the former entrance to no. 58 remains extant but is, however blocked from the inside of the property. This door was a later insertion in the position of a former window as the lintel is still visible. This section of frontage also includes two further blocked openings, one of which contains the current door to no. 57. The central blocked opening contains a wide multi-light window with small upper casement opening. The plinth at this point consists of flint rubble with brick dressing. The first floor contains two blocked windows, both blocked at different dates. Unlike the west block, on this section of the façade the overall appearance of the brickwork is less uniform suggesting this section of brickwork predates the west block.

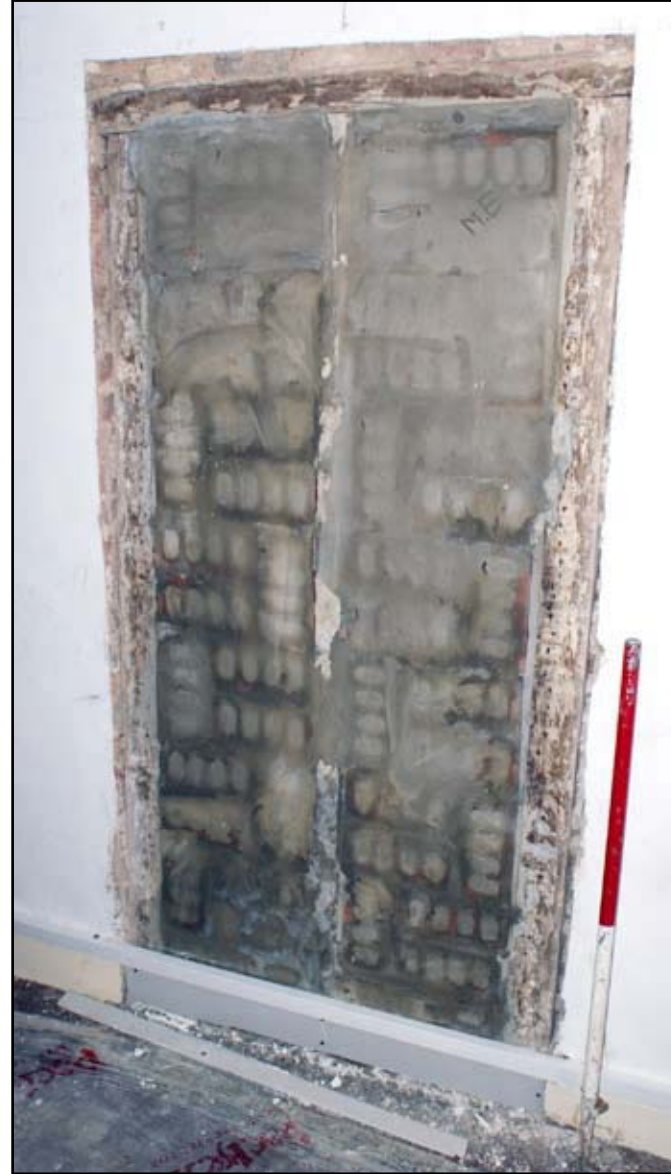
Plate 18: Blocked opening in room 57/1  
(photo: National Trust)

- 2.4.1 During the works a blocked internal doorway was revealed on the east wall of room 58a/J which formerly allowed access to the adjoining room 57/I (Plate 18). The doorway had simple pegged timber jambs and lintel and had been blocked with modern hollow bricks around a central upright timber with a grey/beige 20th century cement render over. The opening measured 75cm wide and was 183cm high. The amount of opening up exposed little of the surrounding partition wall however it was seen to be of brick construction, the bricks being a paler pink colour than seen elsewhere and with a sand coloured gritty textured mortar. There are some broken tiles used as fill above the lintel.

- 2.4.2 This doorway was presumably in use when the main and west blocks were divided into three separate properties, the larger area of the main block forming no.58, and was consequently blocked during works in the mid 20th century to convert the three dwellings into two different properties.
