No 32-33 Crown Court West Wycombe Village

Historic Building Investigation and Recording

May 2014

32-33 Crown Court, West Wycombe Village, Buckinghamshire
Report on Historic Building Investigation

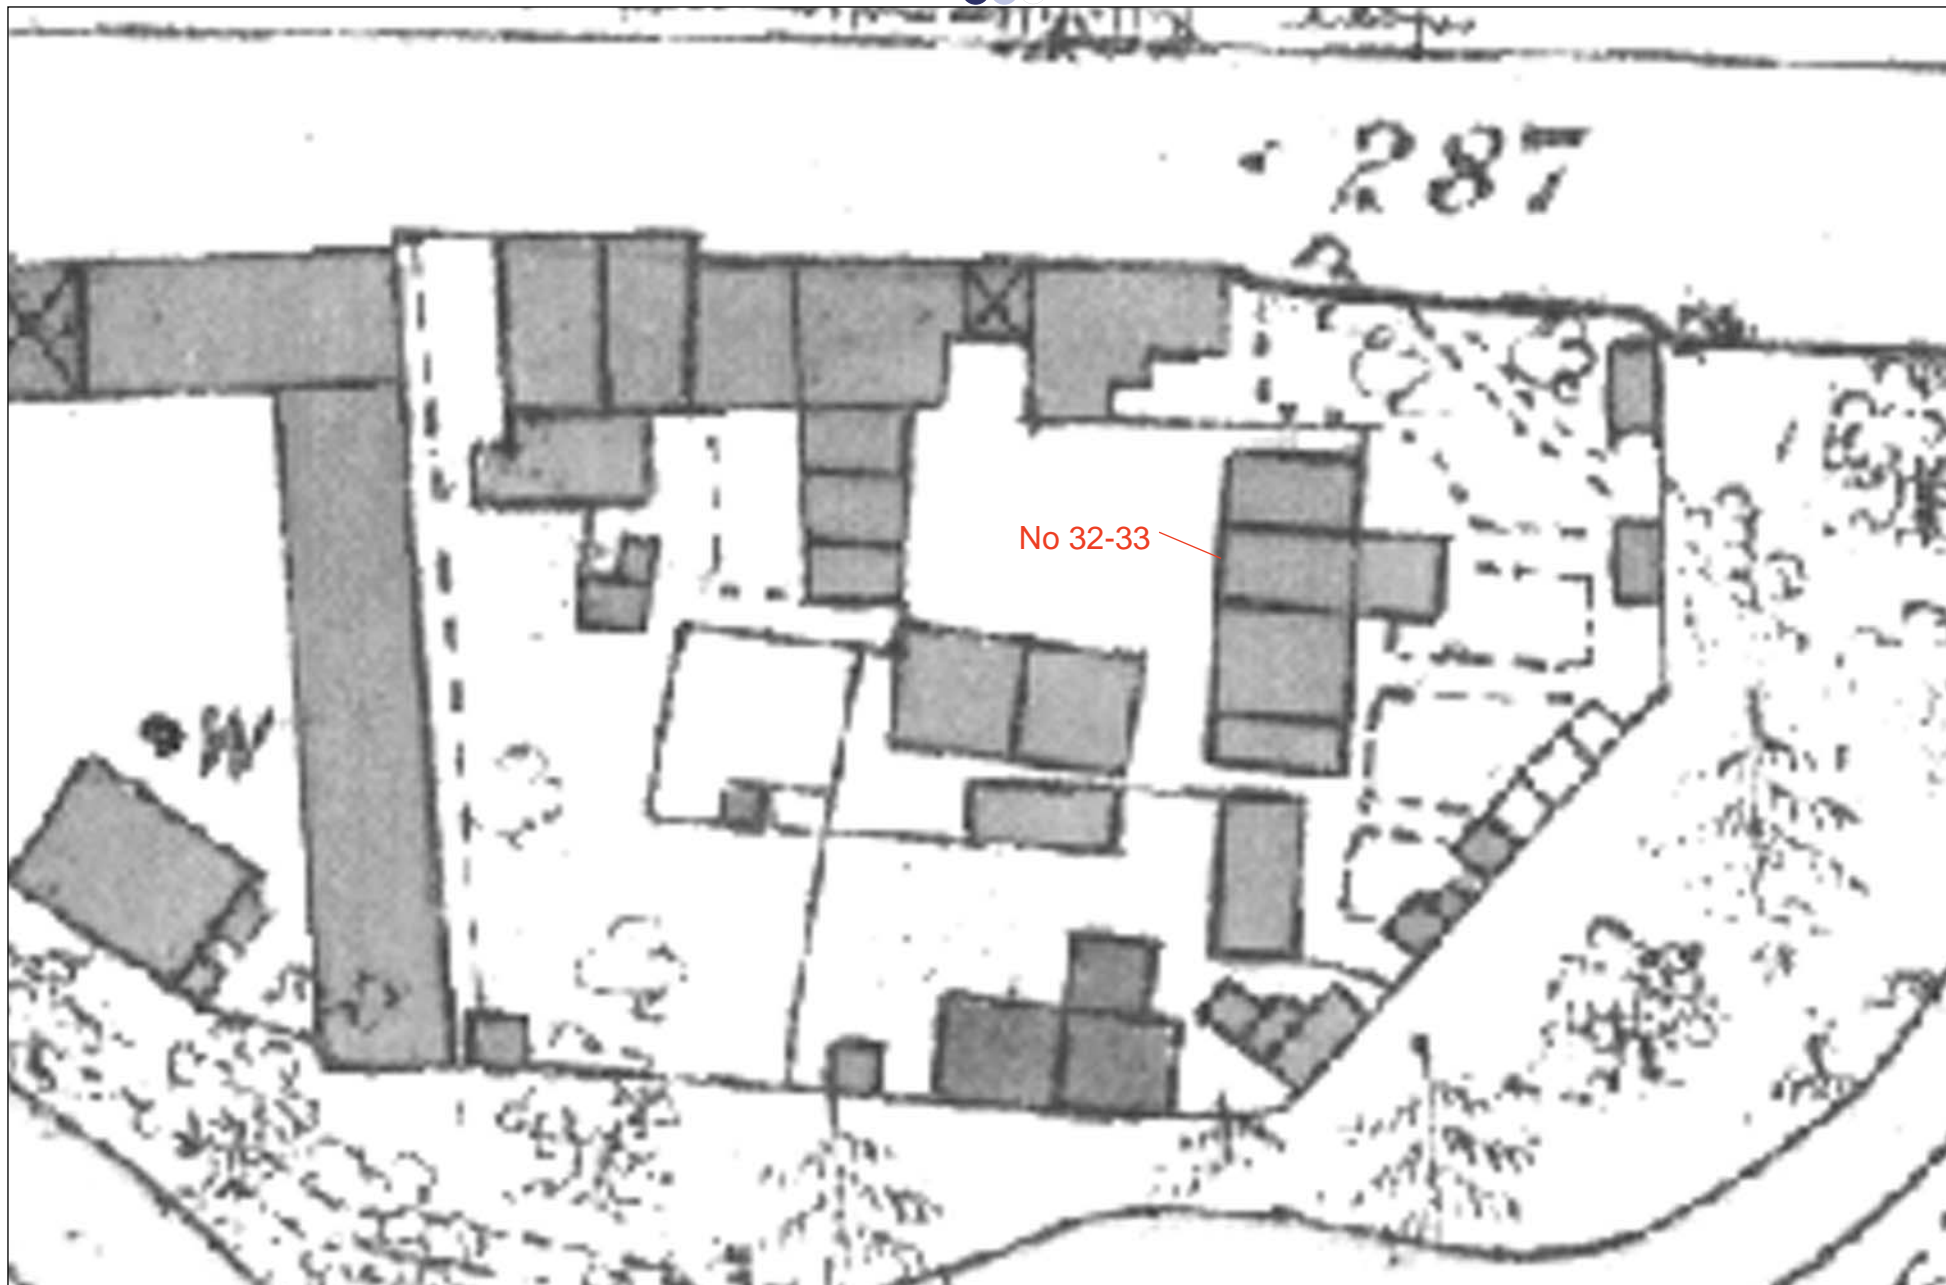
Figure 3: 1876 OS map (25 inch map)

- 1.4.11 The first edition OS map of 1876 shows the main rectangular plan building divided into four components (four properties?) and an extension to the rear of the block to north of centre. There is at least one outbuilding shown to the rear of the property, against the boundary wall to the east of the plot (Fig 3).

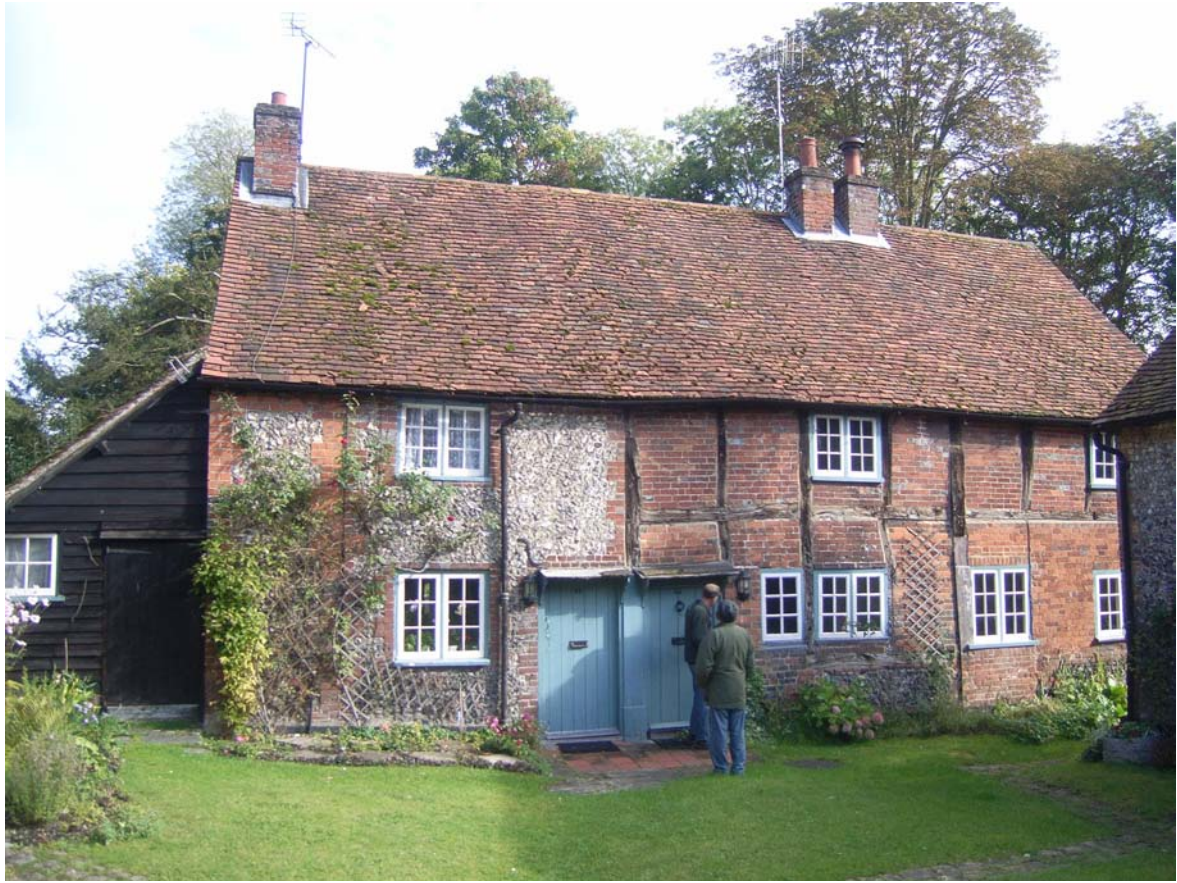
- 2.2.3 No.32-33 Crown Court is a two storey building with gabled, tile-covered roof. It is timber framed with flint rubble and red brick nogging (Plate 1). There are single storey, weatherboarded lean-to extensions at the northern and southern ends which were almost certainly constructed in the c.1930 refurbishment. These partly obscure the north and south elevations behind although the gables of each are visible. The gable of the *north*

- 2.2.4 The *west elevation* faces into the court and is an intriguing constructional patchwork that provides much evidence of alteration since its original construction (Plate 1). The main construction is a timber box-frame from which most of the framing survives in the central and southern bays with brick nogging infill from various phases and some sections of the framing replaced or altered. However, the northern bay of the west elevation (ie No.33) is constructed from flint with brick dressings and without any visible timber framing. The footprint of the building is believed to be primary and therefore rather than this flint bay being a secondary addition it is likely that it was also originally timber framed but this has been replaced by the flint. There are two distinct phases however to this flint and brick section of wall in the west elevation because although most of the bricks are a dark red colour and relatively thin those in the upper part of the northern third of this bay are an orangey red colour and slightly larger. There is a clear straight joint between the two types of brick approximately 1.4 m south from the northern end of this wall, and it is likely that in this northern area the original timber framing remained in-situ after the rest of this bay was rebuilt in flint (late 18th/early 19th century?), but then this section was also rebuilt in brick/flint, probably in the late 19th century. It is interesting to note that most of the brickwork at the northern corner of this wall is the same dark red as further to the south and it is only the uppermost c.13 courses that are formed from the later orangey red brickwork.

Plate 1: General view of west elevation

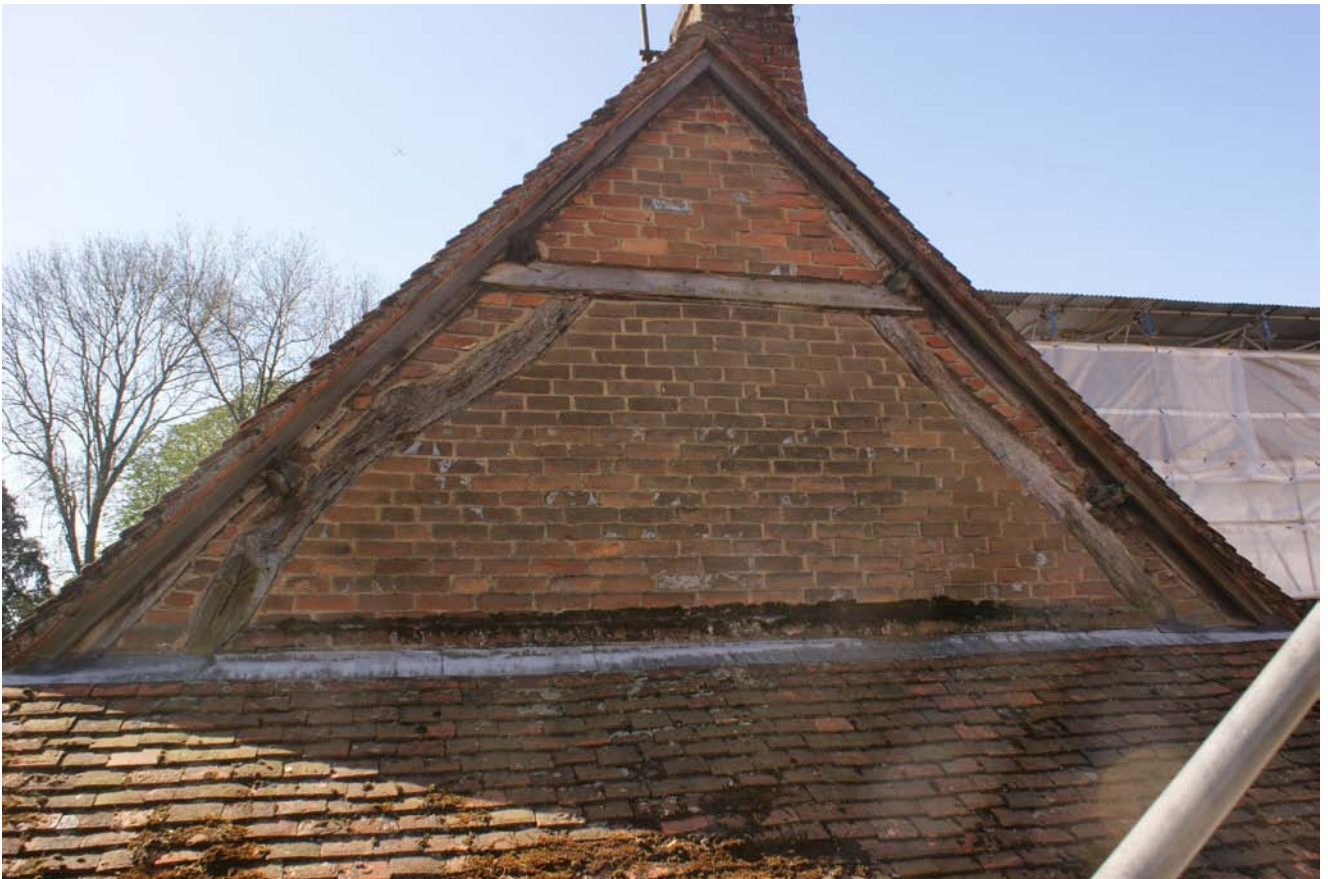
elevation has a pair of heavily weathered, curved timbers visible that it has been speculated could be surviving cruck blades (discussed further below – see Plates 2, 25). These timbers are jointed to a collar although this is hidden beneath a protective board probably added in the c.1930 works. The brickwork within this gable is different below and above the collar but both sections appear to be of probable 20th-century date. The gable of the *south elevation* is formed from probably 20th-century brickwork.

Plate 2: Gable of north elevation above 20th-century lean-to

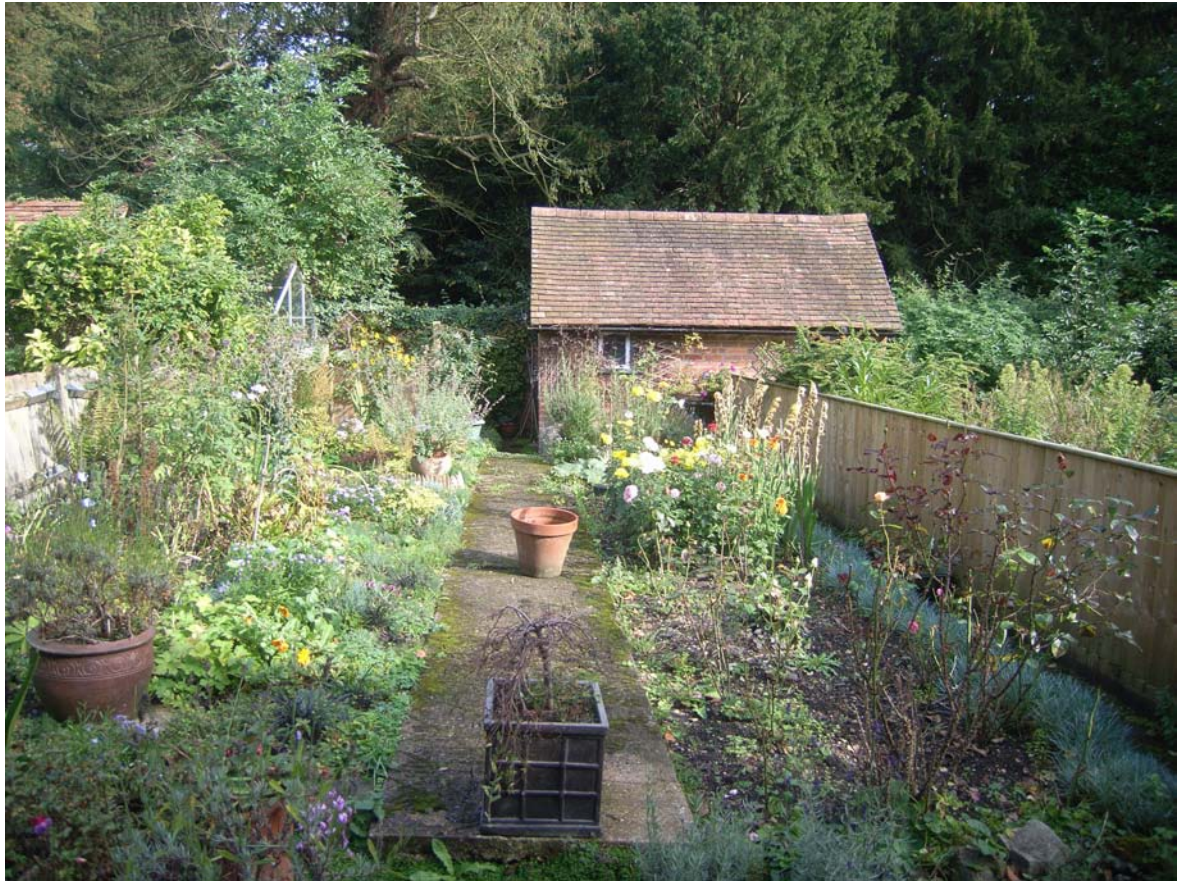
- 2.2.7 It is worth noting that there is a well-built brick outbuilding at the end of the garden of No.33 (Plate 3) and a small weatherboarded outbuilding in the garden of No.32. These have not been investigated in the current project but they are a feature of houses in West Wycombe village.

Plate 3: Outbuilding in garden

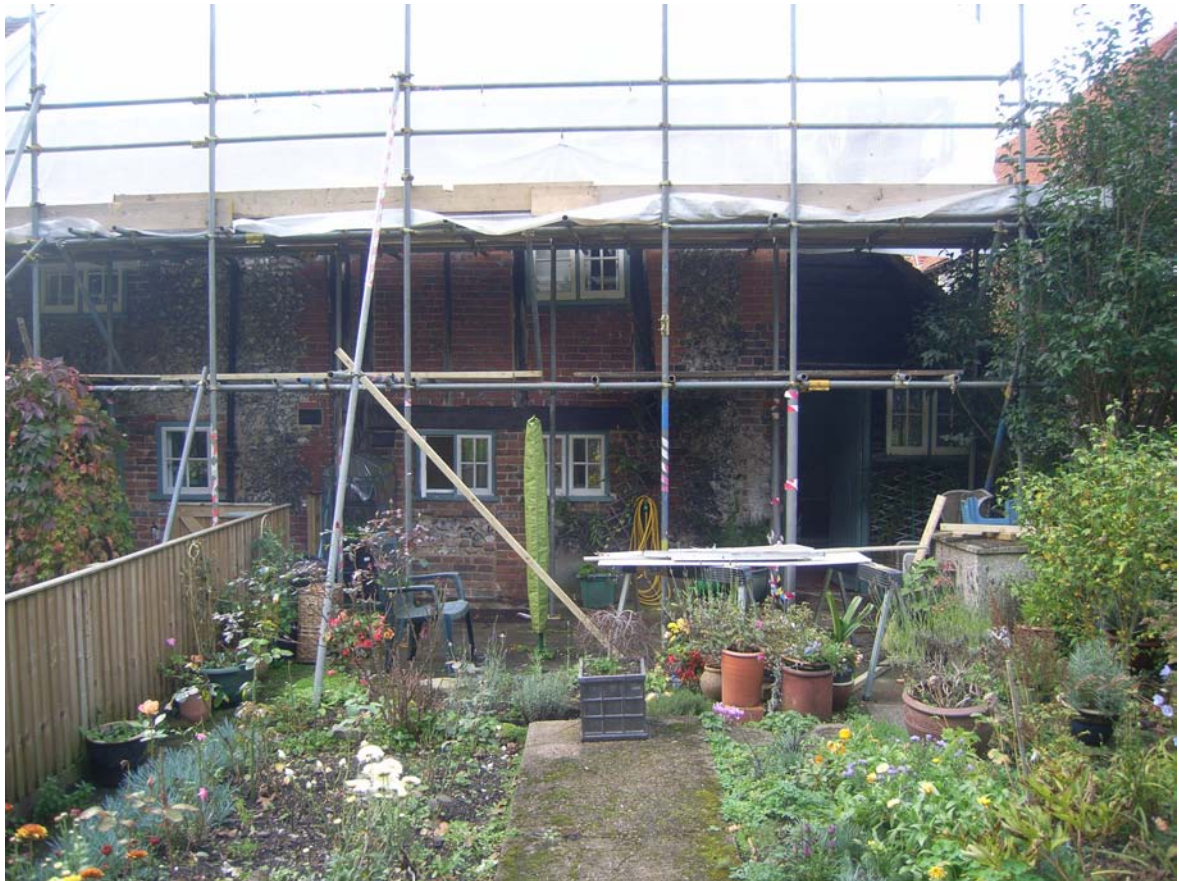
- 2.2.6 The *east elevation* (rear) of the building was also timber framed but it has now been much altered and the wall of No.32 appears to have been virtually entirely rebuilt in brick and flint. Some of the historic framing does survive in the northern bay, (ie the wall of No.33) including two full height posts at the south-east corner of No 33 (the junction with No.32). There is also a mid rail which acts as a lintel over the window although this is covered by a modern protective board. Beneath this lintel the brickwork has all been rebuilt (probably 1930s) but the brick nogging above is older and looks very similar to brickwork exposed inside in the chimney stack (probably 18th or early 19th century date). The lower part of the corner post has been removed beneath the mid rail in probably early 19th century brickwork (bricks c.6.5 cm tall)

Plate 4: East elevation beneath scaffolding

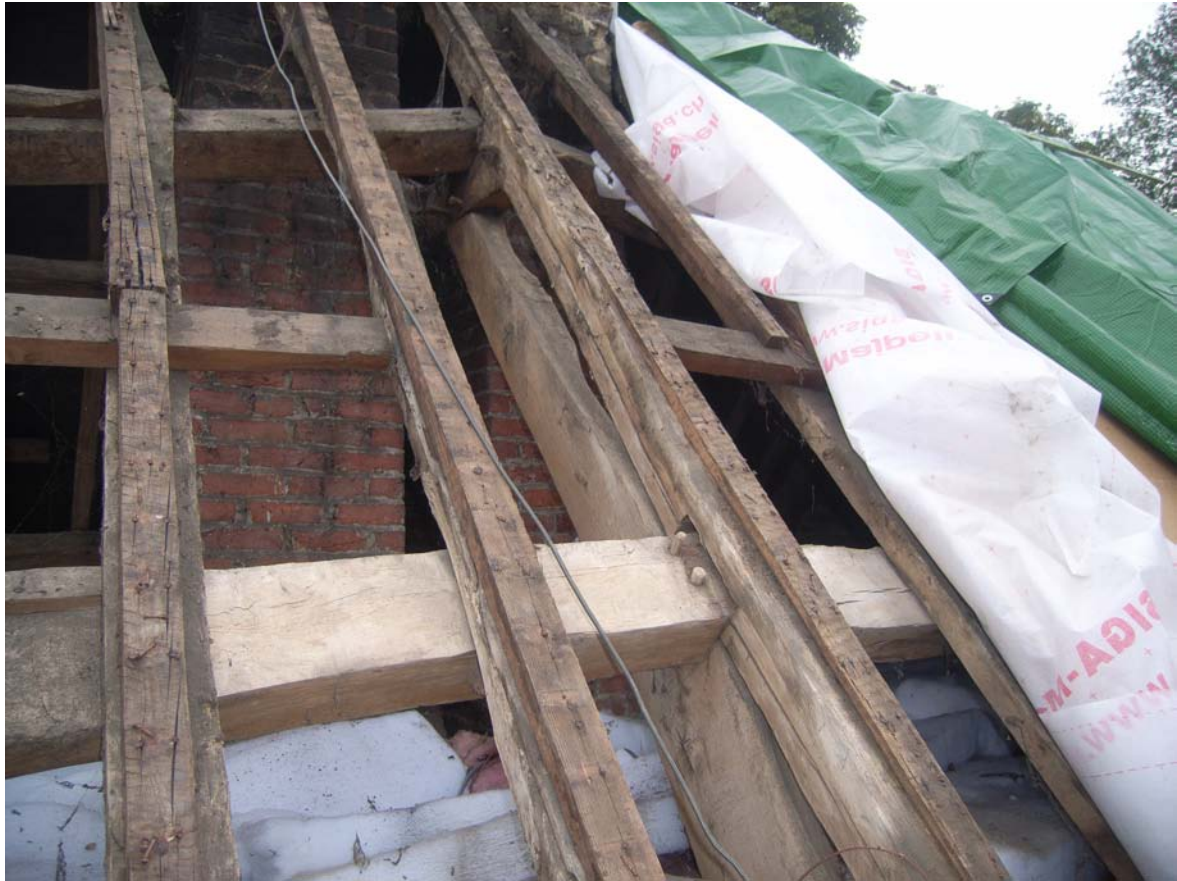
Plate 11: Truss 2 detail, west slope

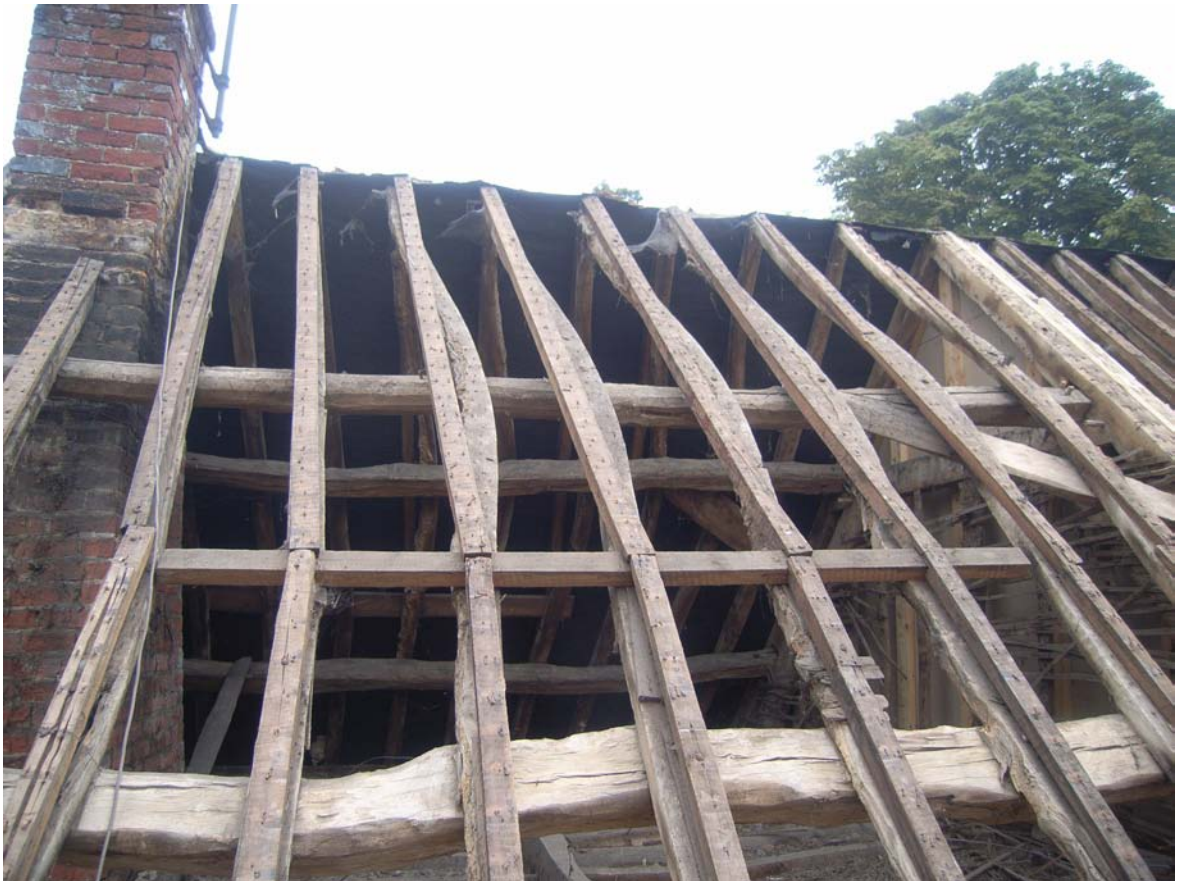
- 2.3.13 In the northernmost bay there are straight **windbraces** to each slope beneath the upper purlin and immediately to the north of Truss 3 (ie the other end of the bay to empty mortices referred to above – Pl. 14, 15, 20). There are also similar straight wind braces to each slope at the southern end of the building (Pl. 5) but there doesn't appear to be any evidence of further windbraces in the other bays and this occasional use of windbraces rather than uniformly along the building is a feature that has been previously noted in other buildings at West Wycombe.

Plate 14: West slope of north bay

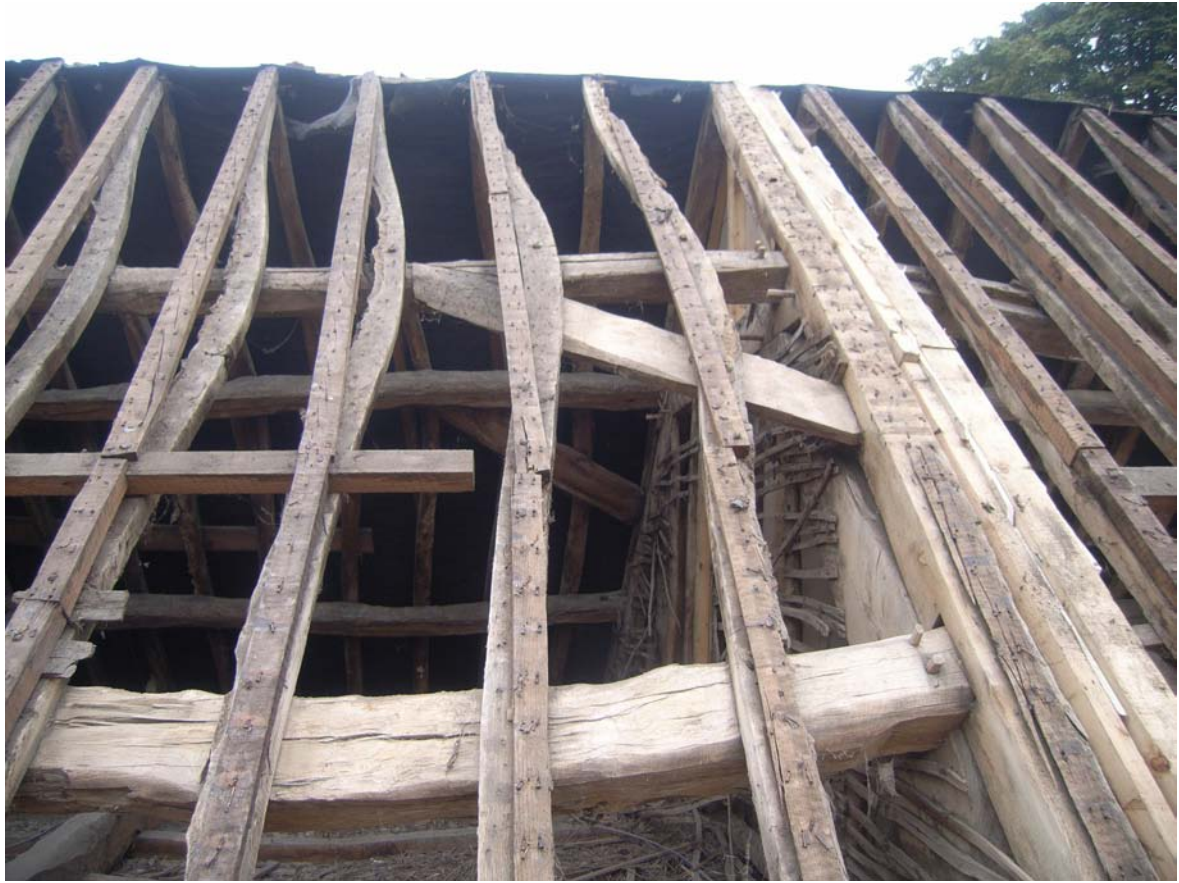
Plate 15: West slope of north bay

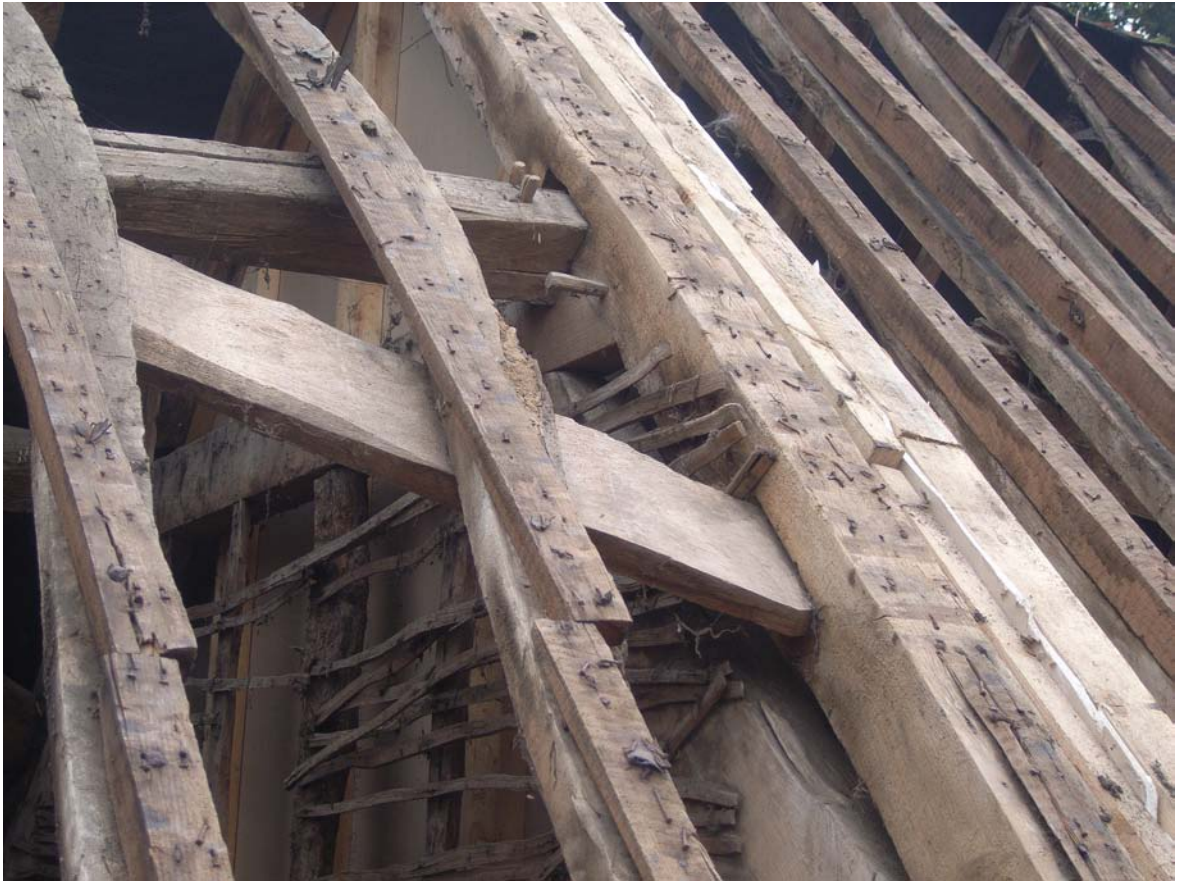
Plate 17: Wind brace in north bay, west slope

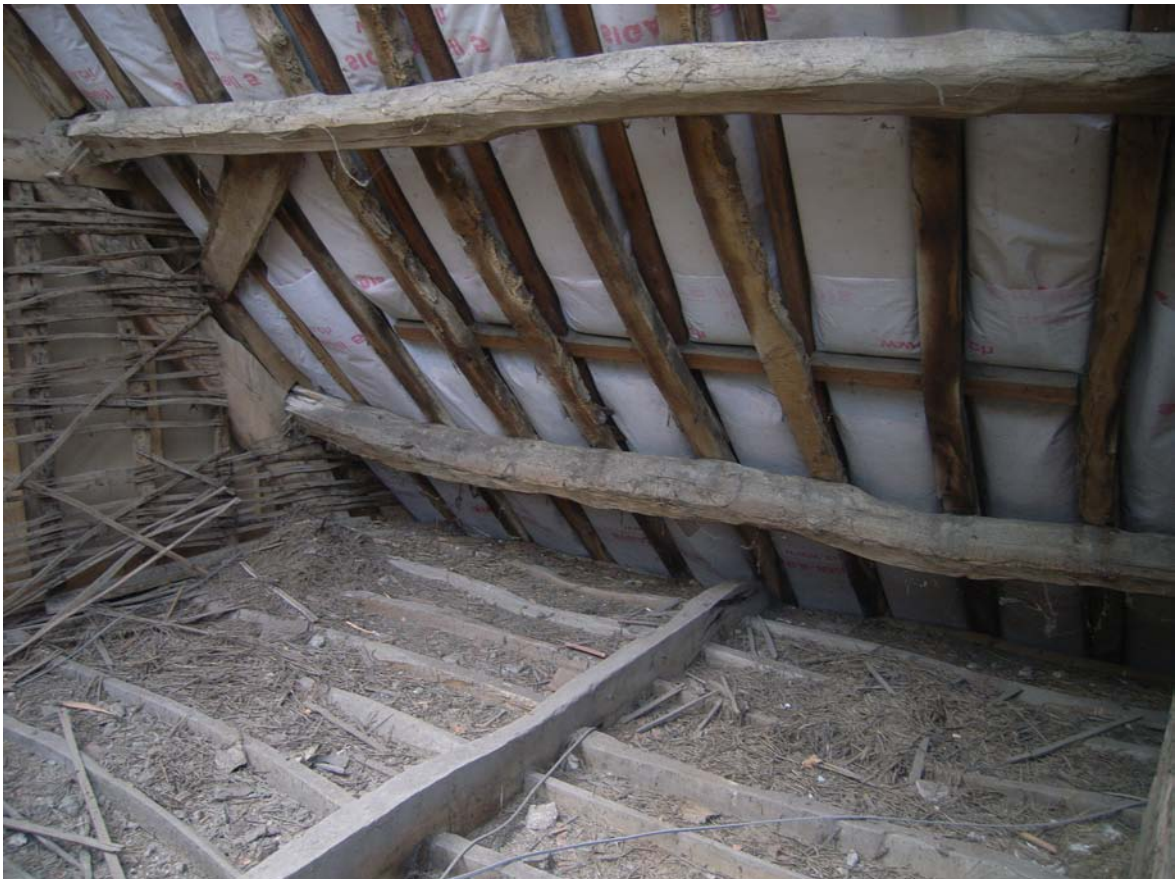
Plate 20: Northern bay roof space looking south-west

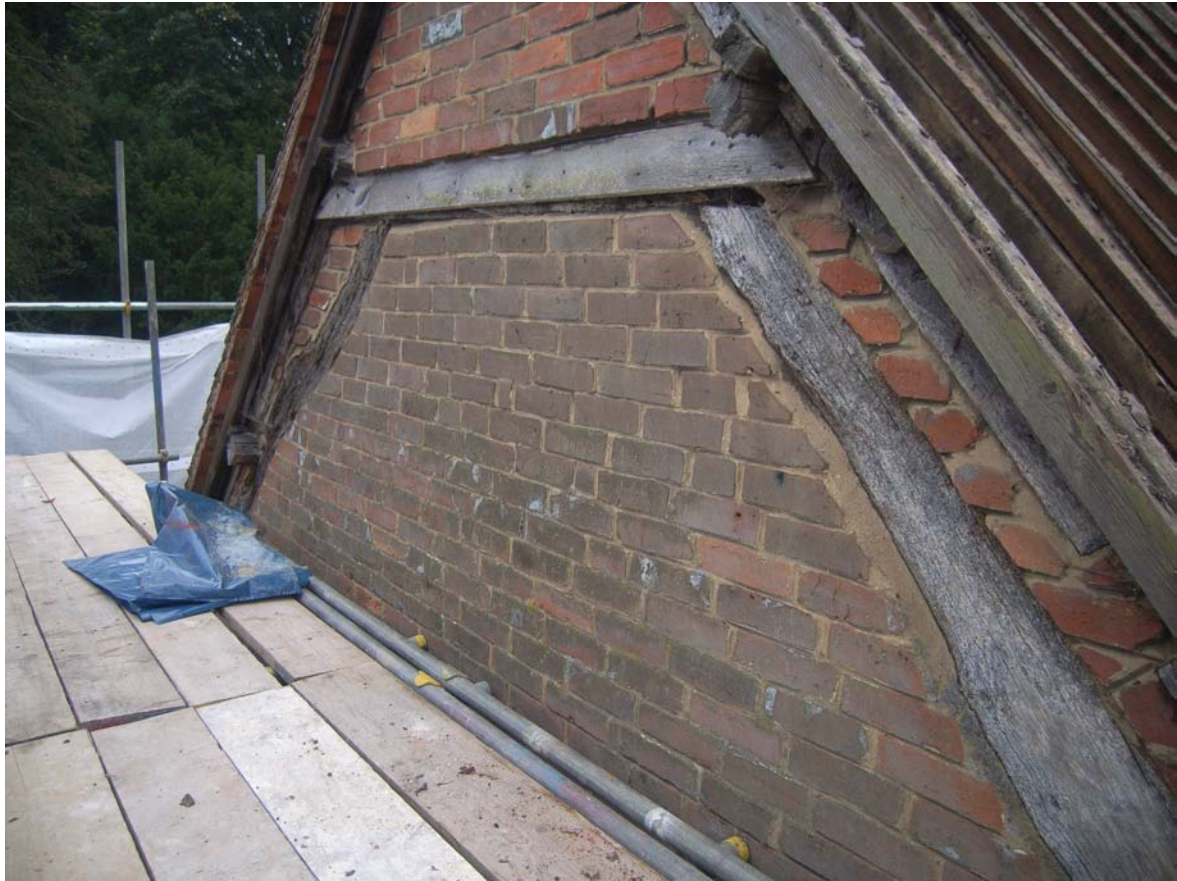
- 2.3.4 Curved inner principals are a characteristic feature of a particular roof form found widely in this general area (South Oxfordshire, Buckinghamshire, Berkshire) with a particular concentration in the Wycombe district. Studies of this roof type suggest that the earliest examples are from the mid 17th century but they are most commonly found in the mid to late 18th and they can be found in 19th century buildings (Clark, 2004). The curved inner principals in this building vary in size but they are c.24 cm tall x 11 cm wide.

- 2.3.5 It is possible that these curved members are partially surviving crucks from a greatly altered former hall but there should be some evidence to suggest that the cruck blades formerly continued down towards the ground prior to the secondary insertion of the tie-beams. Unfortunately the junction between the curved inner principals and tie-beams in each truss are obscured by slightly raised ceiling and insulation so it was not possible to closely examine this area.

Plate 25: Curved inner principals (or crucks) in northern gable

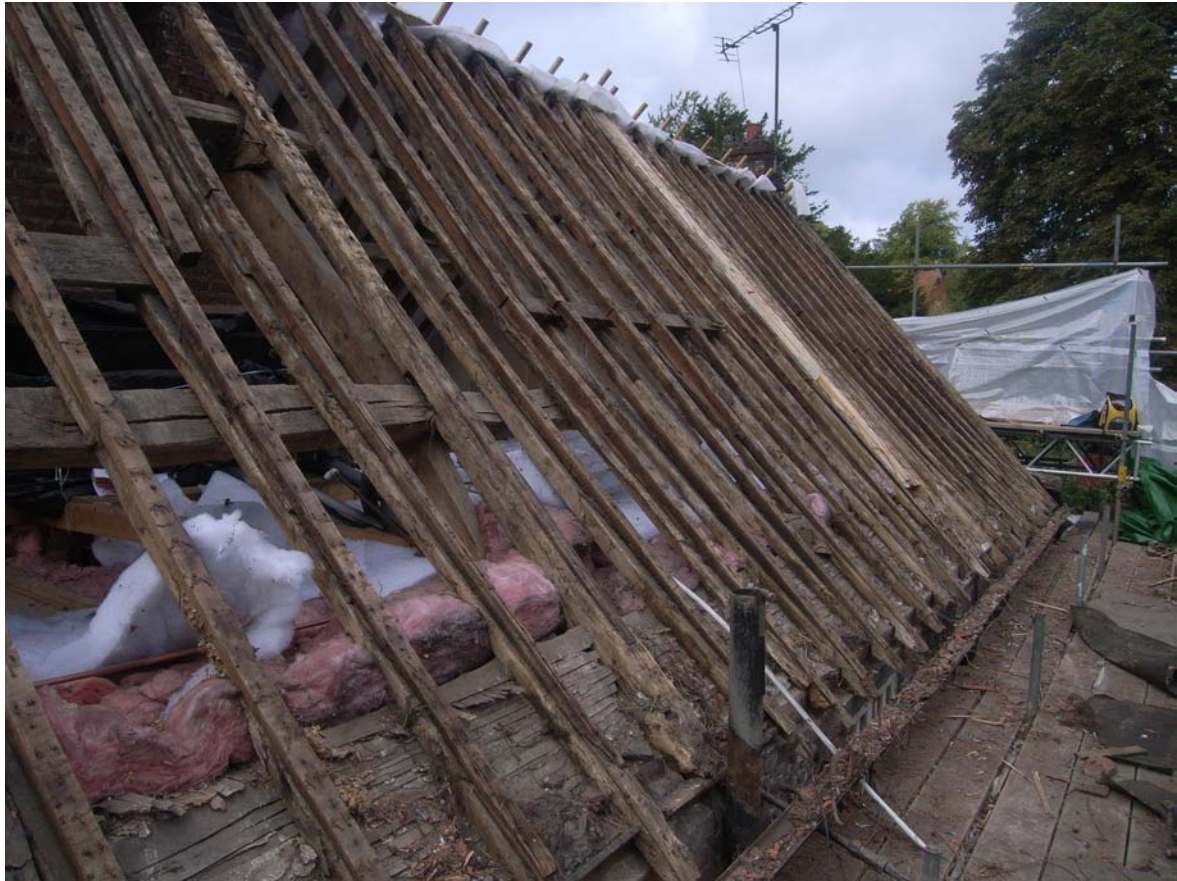
Plate 28: Southern bay roof space, west slope

- 2.3.9 The ceiling in the southern bay (Bay 1) is largely obscured by modern insulation but the ceiling appears to be modern and there are fragments of newspaper apparently from 1965 within this. The purlins in Bay 1 are held apart by a spreader beam with 'birds mouth' notched ends (Plate 28).

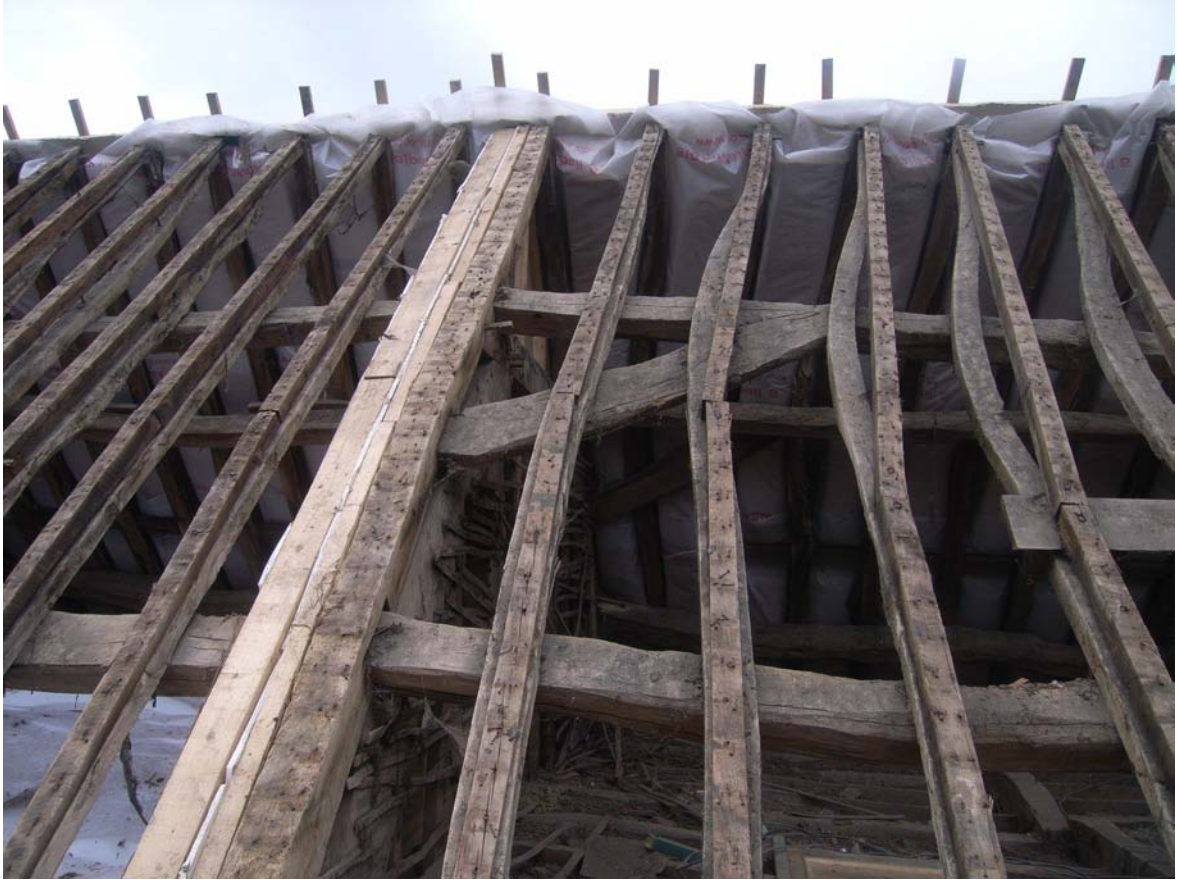
Plate 31: East slope wind brace in northern bay

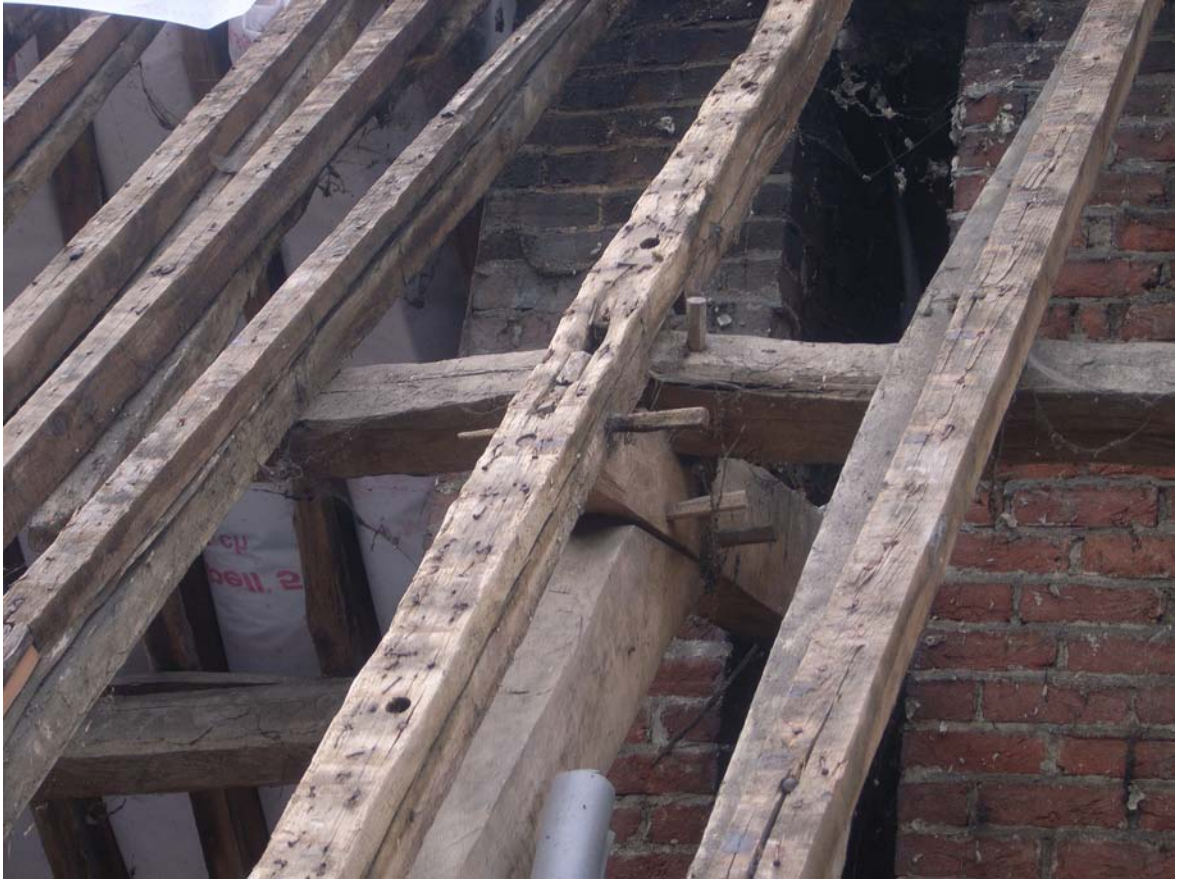
- 2.3.6 The upper purlins are clasped between principal rafter and the collar. The purlins appear to be scarfed immediately to the north of each truss with two pegs adjacent to the principal rafter/curved inner principal.

Plate 35: Detail of collar, clasped purlin and curved inner principal

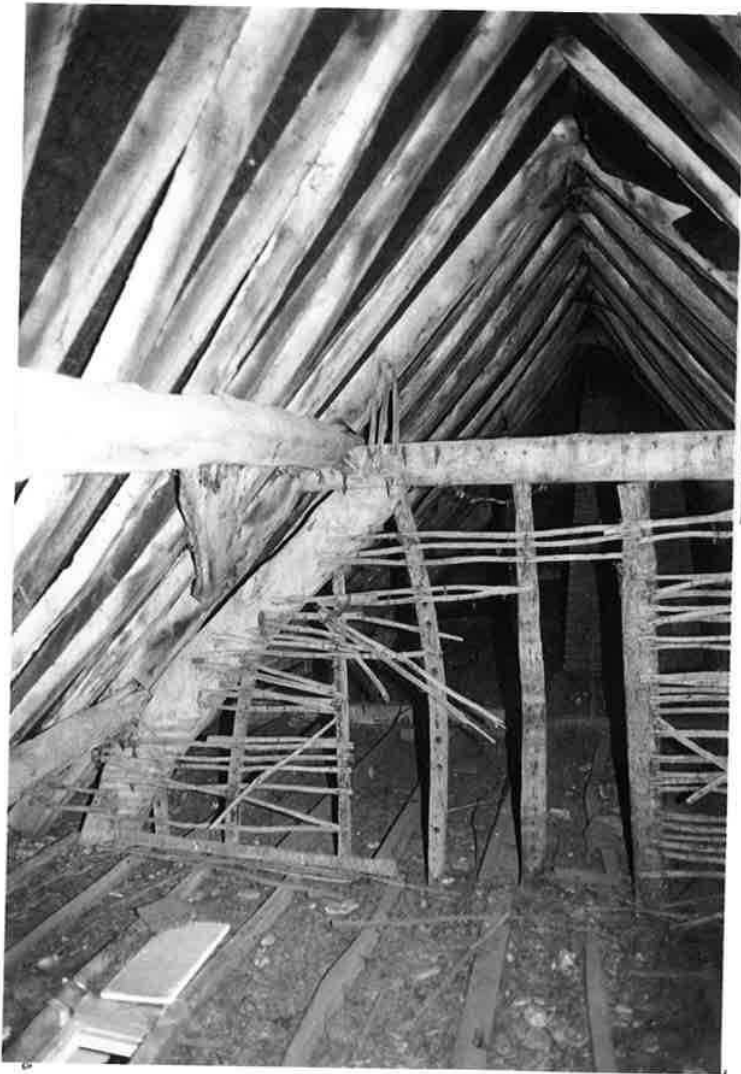
INTERNAL ROOF STRUCTURE
LOOKING SOUTH SHOWING
REMNANT OF EARLIER
CRUCK TRUSS.
R. 251 N. 23.
