Buildings 007 and  
Buildings 112  
RAF Northolt  
Hillingdon  
Greater London

Historic Building Recording  
and Investigation

December 2007

Client: Defence Estates

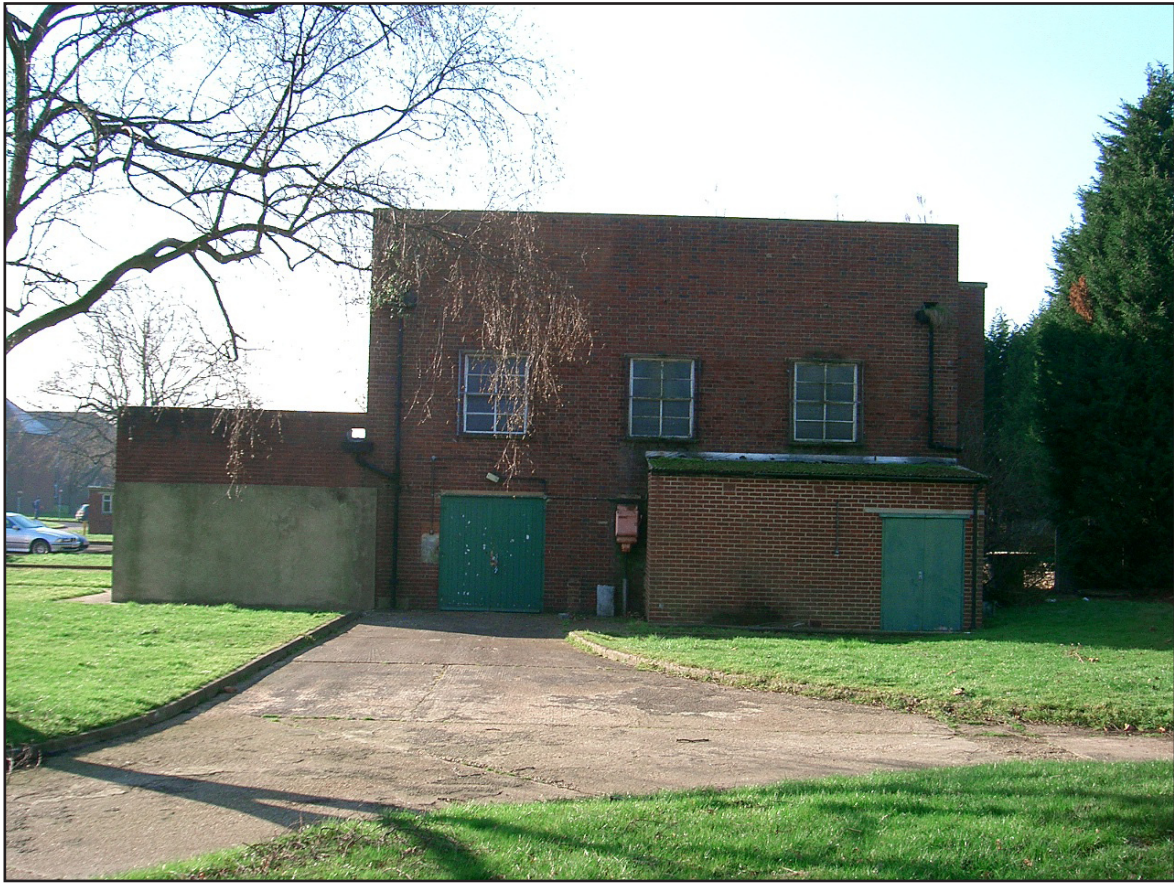
Plate 1: Building 007 - South West Facing Elevation

5.3.2 The **south west facing elevation** (Plate 1) has a row of three clerestory windows, each with two four-pane tilting casements and white painted metal frames with concrete lintels and sills. The south-eastern half of the elevation at ground floor level is now covered by Extension 2 while to the north-west of this is a double door (timber slatted doors with a reset sandstone lintel). There is a light fitting above the mortar repairs over the doorway. An isolator electric box with timber supports is found to the south east of the door. There is a patch of brickwork repair to the south east of the doorway which seems to be associated with the footprint of a possible earlier structure such as a lean-to. This may have been connected to Extension 2 which was a secondary addition. There are two large down-pipes with hoppers at either end of the elevation which provide drainage for the flat roof.

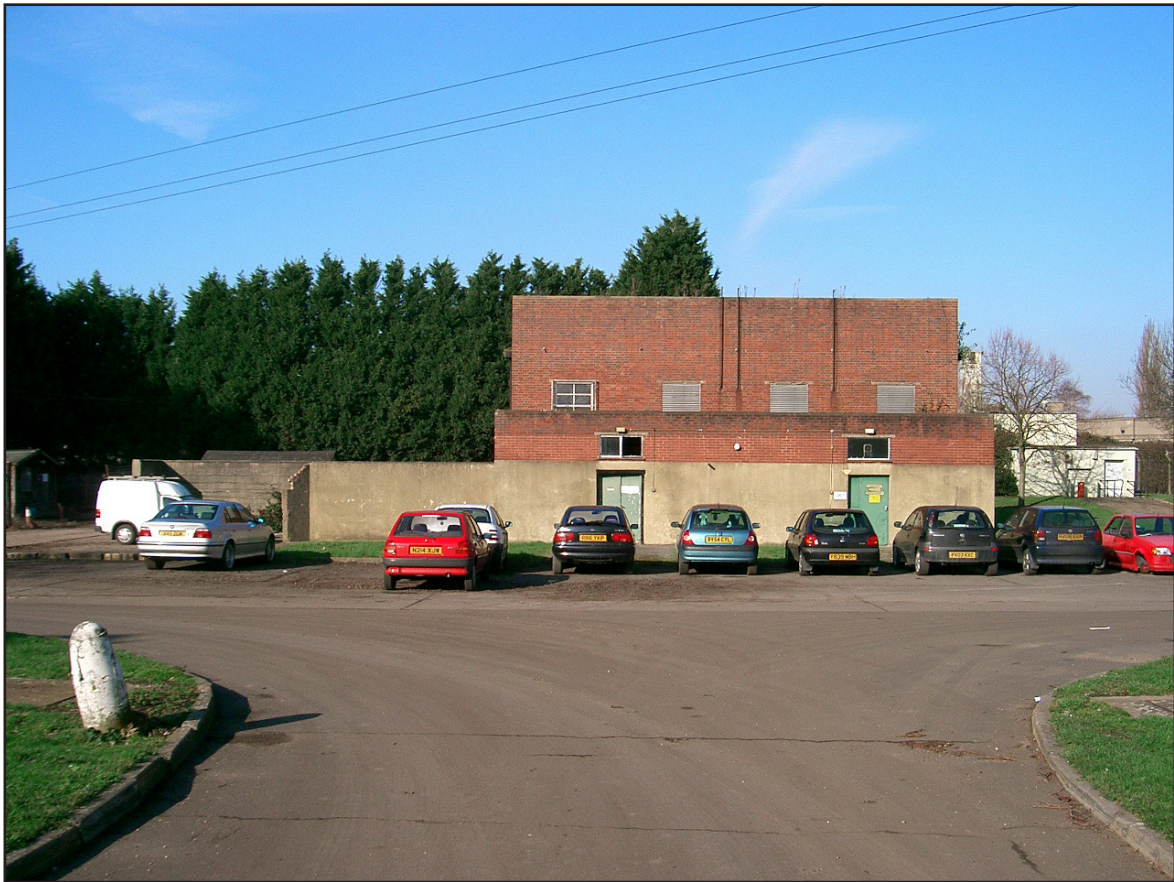
Plate 2: Building 007 - North West Facing Elevation

5.3.3 **The north west facing elevation** (Plate 2) is substantially obscured by Extension 1 which is located across the lower part of the elevation. There are four clerestory

openings in the main elevation of which the three to the south west have ventilation shutters. The remaining opening has a metal frame window the same as those in the south west elevation. Three down-pipes can be seen running from the join of the extension to above the parapet and coping.

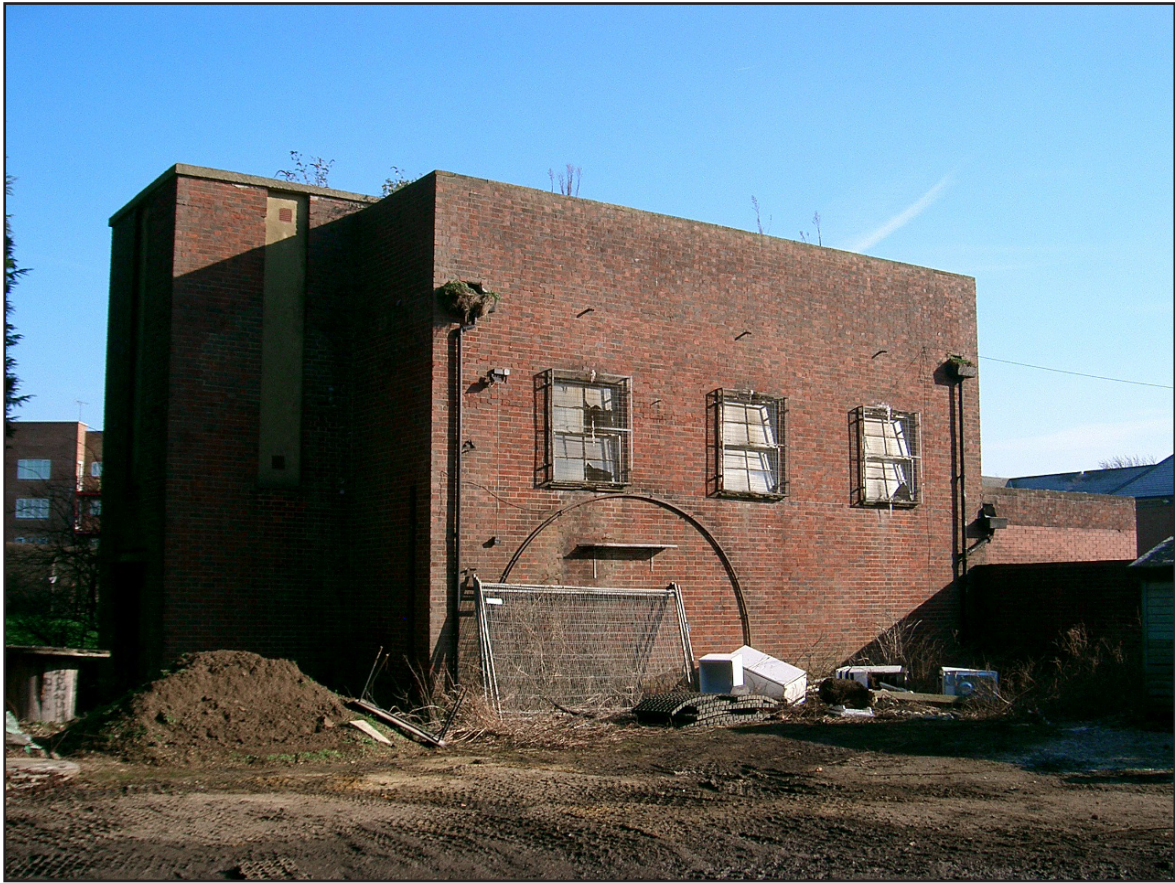
Plate 3: Building 007 - North East Facing Elevation

- 5.3.4 Three clerestory windows as seen in the south west facing elevation are also present on the **north east facing elevation** (Plate 3), as are the two down-pipes and three smaller pipes. The pipe to the southern corner has been replaced in order to accommodate the roof drainage pipe from Extension 1. To the south eastern end is a semi-circular fixing where a corrugated iron Nissen type hut would have been fixed. It is approximately 4.7 metres wide and a metal shelf can still be seen attached to the main wall. There is no door into the main build from this structure, and no sign of its footprint.

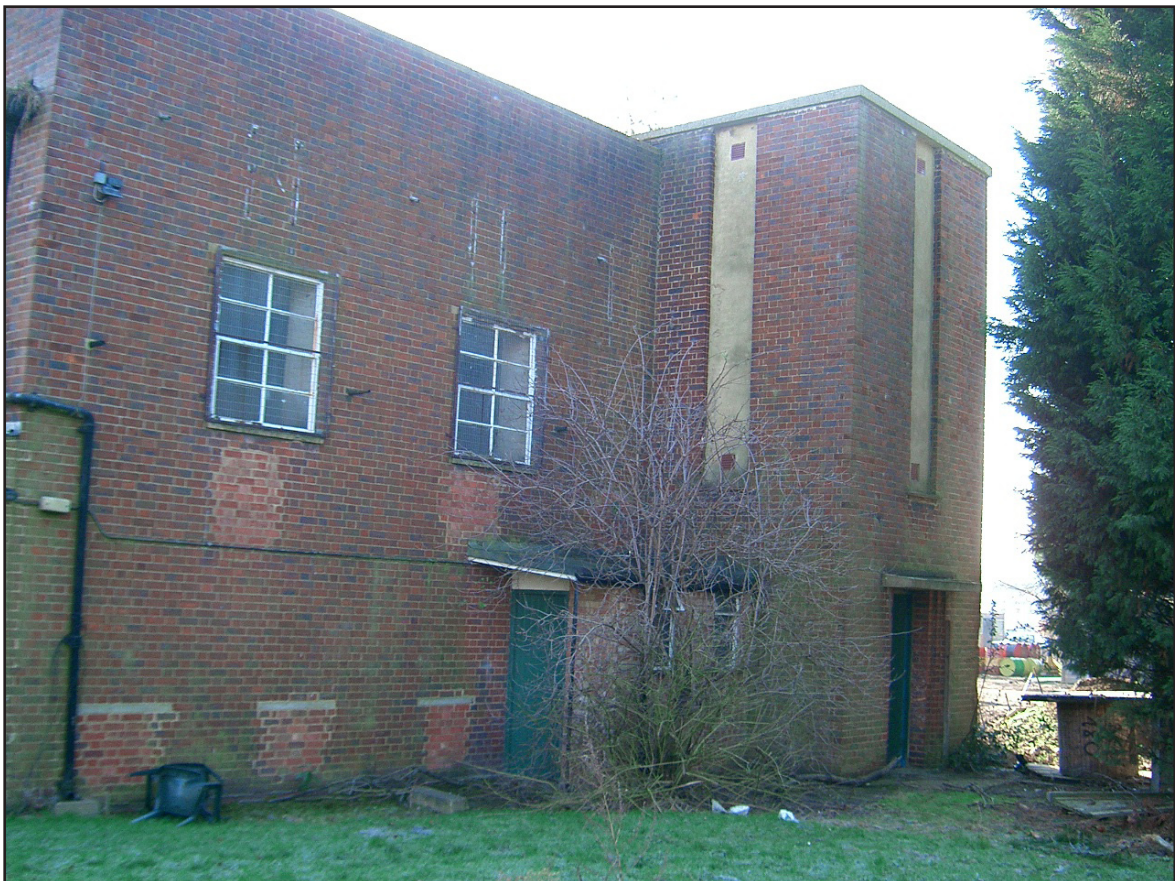
Plate 4: Building 007 - South East Facing Elevation

- 5.3.5 The **south east facing elevation** (Plate 4) is somewhat dominated by the square-plan 'tower' which projects from it towards the eastern end. This has now been much reduced in scale so that it projects only slightly above the main roof but it would originally have been approximately twice its current height. A aerial photograph survives in *The Battle of Britain Then and Now* (p. 247) dated May 1942 showing the whole airfield and although the view is very small it is possible to see Building 007 together with the tall tower. However, this surviving 'tower' would not have been the chimney. It would probably have been a water tower while the chimney itself, which would have been a similar height as the tower, would have been adjacent to the tower and had its base inside the building. Evidence of the chimney is discussed below in the internal description. As referred to above *British Airfield Buildings* (Innes) shows several similar examples of heating stations at other airfields and the same arrangement of coupled tower and chimney (slightly taller than the tower) can be found at RAF Kirkbride, RAF Upwood and RAF Oakington.

- 5.3.6 There are two clerestory windows to the south west side of the tower as seen in the other elevations. In the wall above the windows are metal fixings and below each window is a patch of paler brick in-fill. At ground level there are another three patches of in-fill with small concrete lintels above. These patches probably indicate where fittings associated with the building's original function were housed. Three small roof drainage pipes can be seen protruding from the level of the roof just below the parapet as seen in the other elevations. Extension 3 is built into the corner where the tower and main build meet.

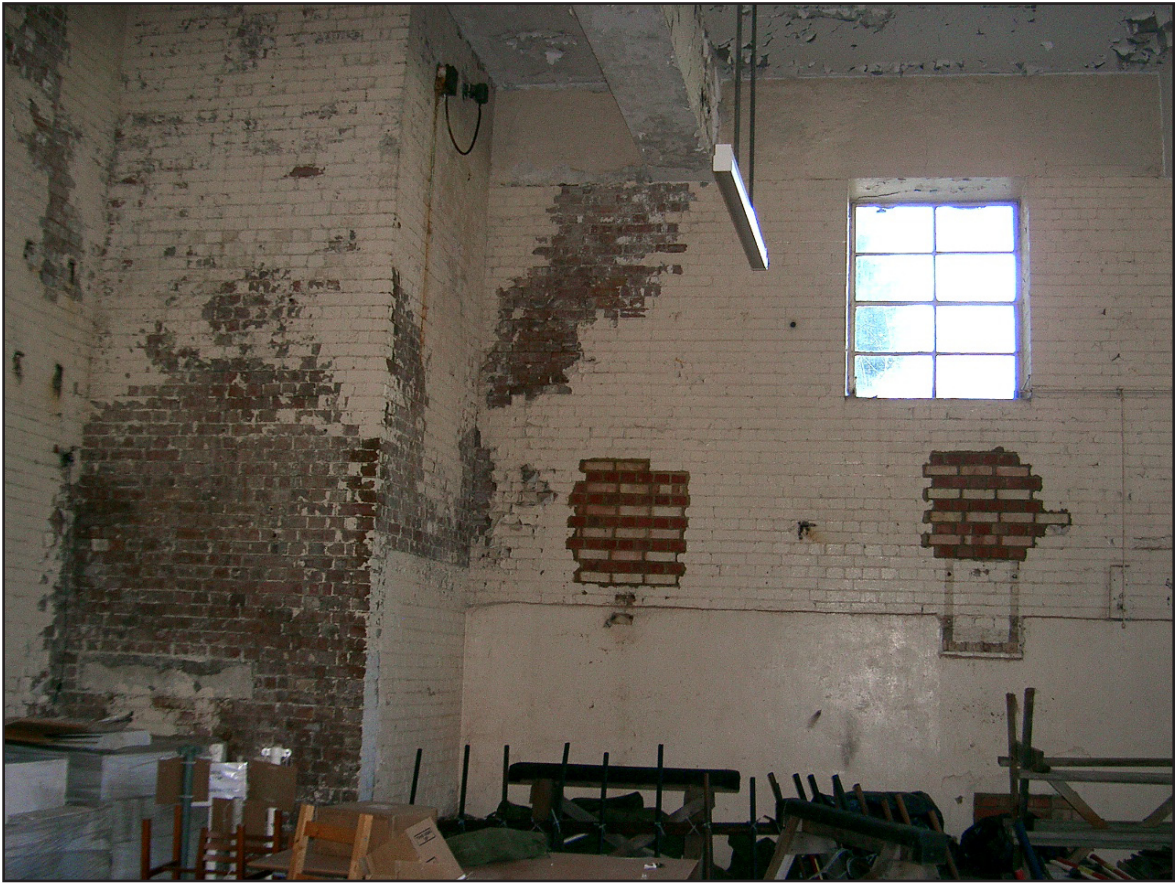
Plate 5: Building 007 - Room A (Main Build Interior)

- 5.4.1 The interior of the main building divides into two main rooms each of which is the full width of the building and is double height up to the flat concrete roof. The larger room (A) occupies the three south-western bays of the building (Plate 5), while the smaller room (B) is a single bay wide and faces north-east (Plate 6).

5.4.2 The larger room would presumably have housed the main boiler and other plant and at the eastern corner is a separate square plan structure which is the base of the truncated chimney. This is immediately adjacent to the tower which projects from the footprint of the building and as discussed above both structures would originally have been approximately twice the height of the main building. A low former opening in the north-west face of the chimney has been blocked but this is where smoke would have been carried from the boiler into the chimney. The plant has all now been removed from the hall and it is now only used for very basic storage. The walls are all of white-painted brick (English bond) other than a rendered band along the south-east wall and several former openings which have been in-filled with brick but not painted over. At least some of these openings would presumably have had pipes passing through the walls. The interior of the building is plain and non-decorative, reflecting the utilitarian nature of the structure and evidence of the former use of the building survives in small truncated iron brackets in the wall and the partial imprint in the floor from former plant. There are two blocked doorways in the north-west wall which would have linked through to Extension 1 (possible coal store). One of these former openings has been blocked recently so that it is bare brick while the other has been painted over.

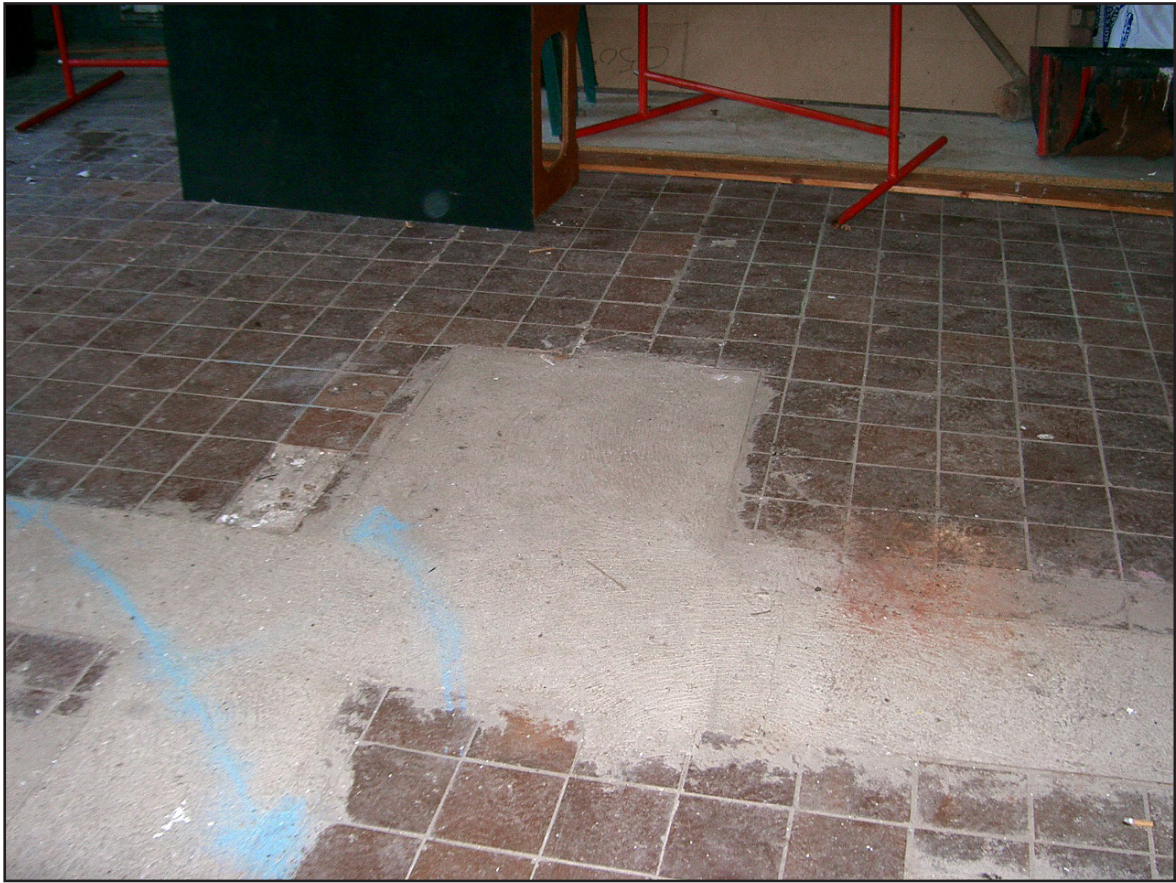
Plate 7: Building 007 - Interior Floor

5.4.3 The floor is covered with square brown tiles measuring 15cm × 15 cm, except in areas where equipment would have stood which is exposed concrete (Plate 7). The ceiling is a painted concrete slab on the surface of which is the imprint of the former shuttering boards. The ceiling is strengthened by two deep concrete beams (Plate 8). There is tile skirting around the base of all the walls.

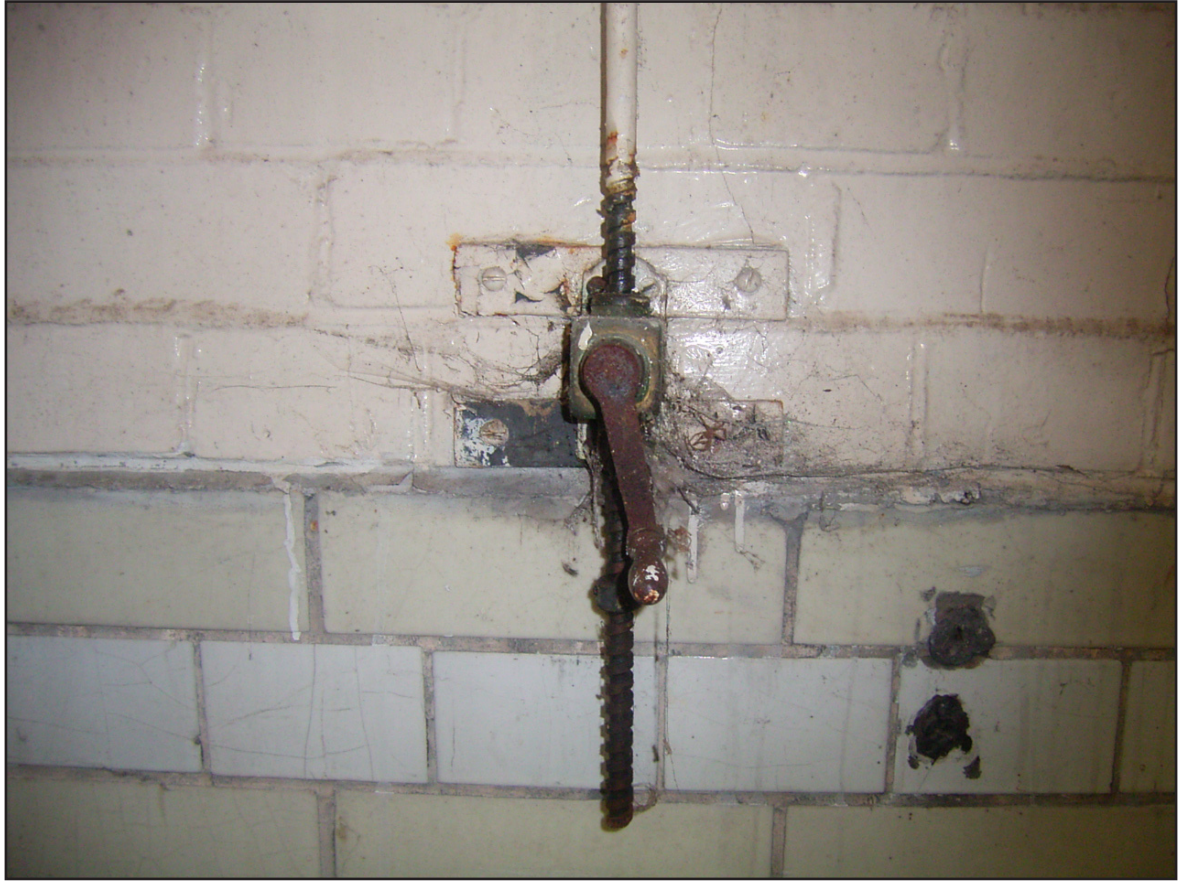
Plate 9: Building 007 - Original Window Fixtures

5.4.4 One minor feature of interest in the smaller room is a device for opening the high window in the north-east elevation. This consists of a long vertical rod fixed to the casement and with a screw and handle fixed to the wall at the base (Plate 9). There is a vertical plank door between the rooms with attractive long hinges. This room has cream-coloured glazed bricks (English bond) forming the lower 17 courses around each of its walls.

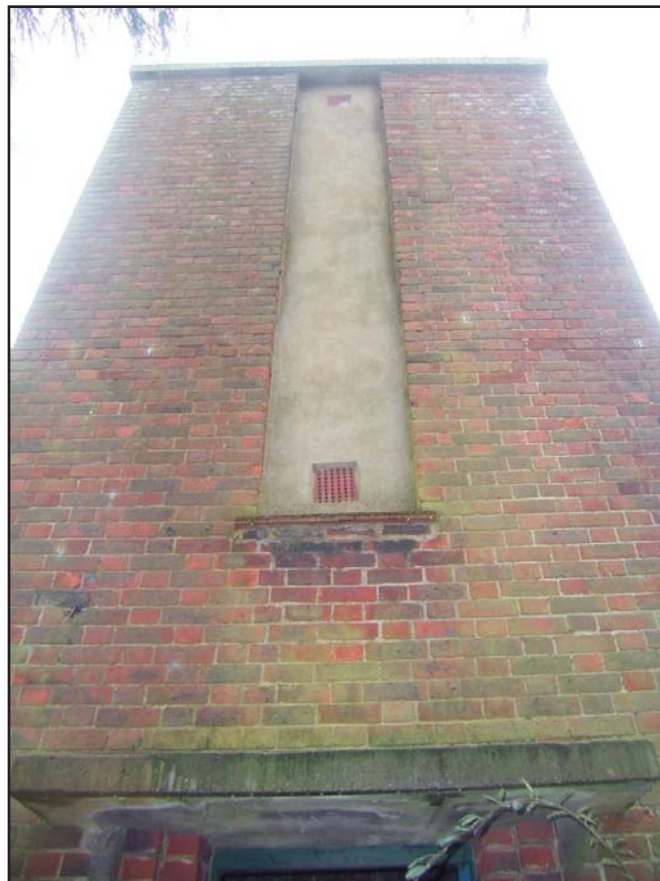
Plate 10: Building 007 - Tower

5.5.1 The tower (Plate 10) projects from the main building's south-eastern elevation. It presumably held a large water tank at a height enough to generate pressure for use in the heating system. As referred to above it would probably originally have been twice its current height and it would have been adjacent to a chimney immediately within the footprint of the building. The tower is not bonded into the main building but it must be primary.

5.5.2 When it retained its full height the tower would have made the building more visually impressive and it is the one part of the building which has some limited architectural pretension. This is partly shown by the tall panels to each of the external elevations which would have been windows but have now been blocked. These start approximately 13 brick courses above door height and stretch all the

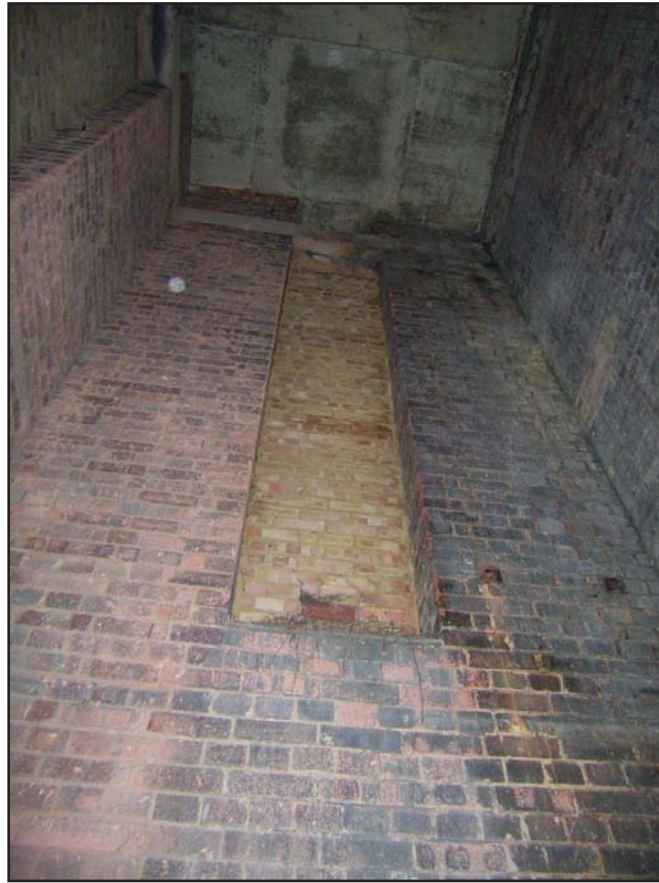
Plate 11: Building 007 - Tower Interior

way to the top but they would have continued up in the tall primary tower (see Plate 11). The simple architectural detailing is also shown in stepped bricks to the jambs of the doorway in the south-east elevation (Plate 12), and a small concrete porch over the same opening.

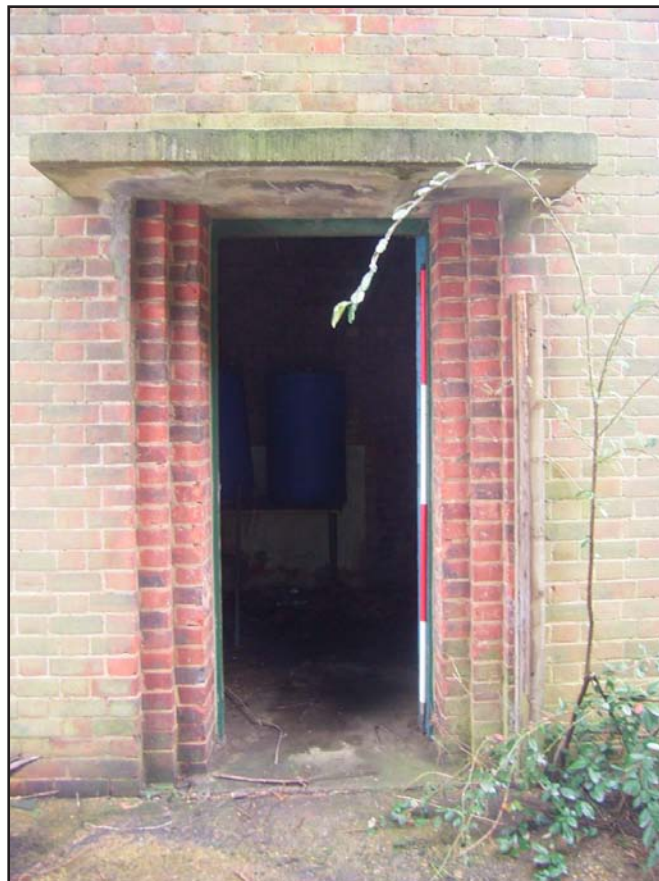
Plate 12: Building 007 - Tower Doorway

5.5.4 The doorway into the tower is recessed with stepped brick jambs and has a large cantilevered concrete lintel. It has a timber door frame and the door itself is slatted on the front and back.

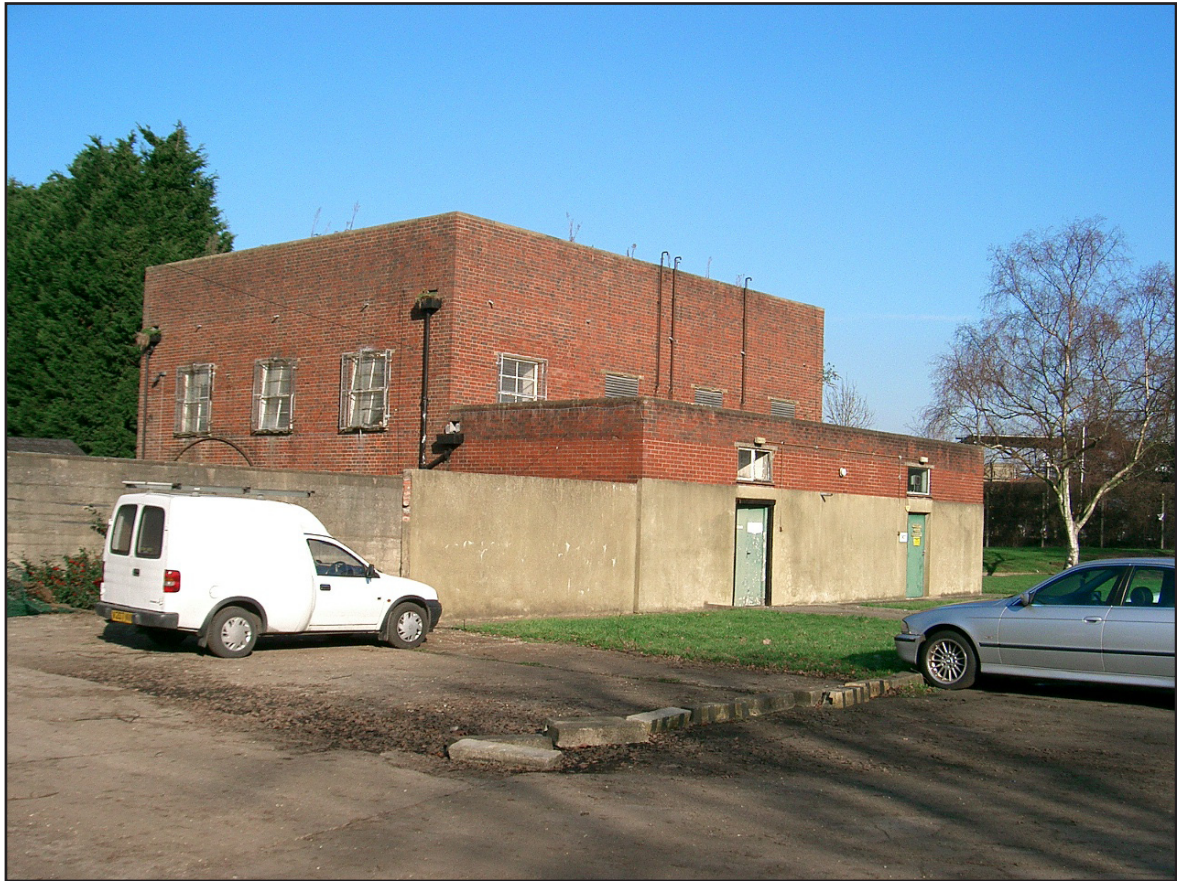
Plate 13: Building 007 - Extension 1 Exterior

5.6.1 This is single storeyed and is approximately half the height of the main build (see Plate 13). It may originally have been a coal store but has more recently been used as a respirator test facility. It has three rooms, C, D, and E, as shown on Figure 3. Like the main the main build it also has a flat concrete roof behind a brick parapet but the lower two-thirds of the elevations are rendered. The brickwork above the render is all stretcher bond but there is a distinct difference in the colour of the bricks which form the parapet (c.8 courses) to those which face the main wall (c.10 courses). This may be due to a slightly different brick type (e.g. non-load bearing) being used for the parapet as compared to the main wall or the lower part may have been cleaned and re-pointed. There are no fixings to suggest the presence of a structure. Within the parapet at each intersection with the main build are lead lined drain holes with metal down-pipes. The bricks measure 21.8 cm × 6.5 cm and arris to arris measures 29.2 cm. Although the brick bonding is different to that of the main building, the structures are keyed together and they are almost certainly both primary. The aerial photograph dated 1942 referred to above in *The Battle of Britain Then and Now* appears to show this extension.

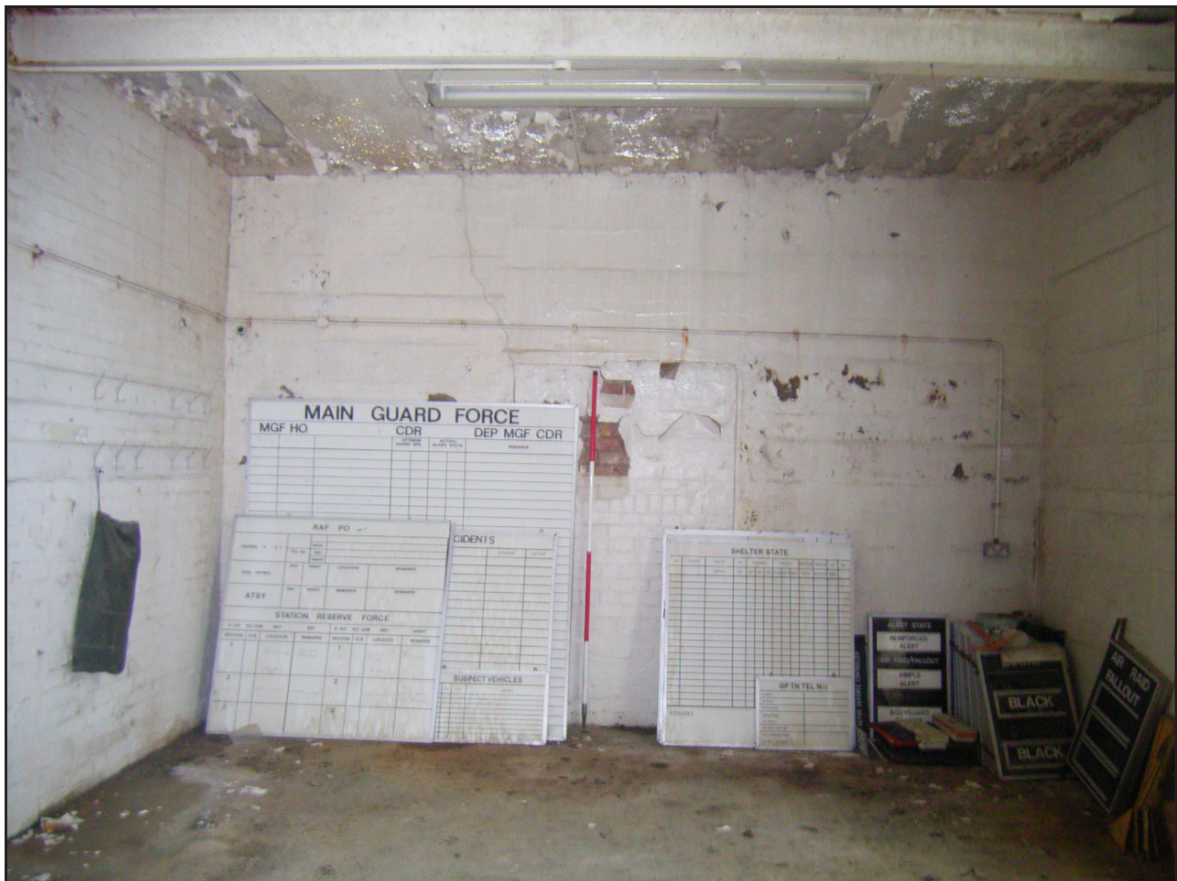
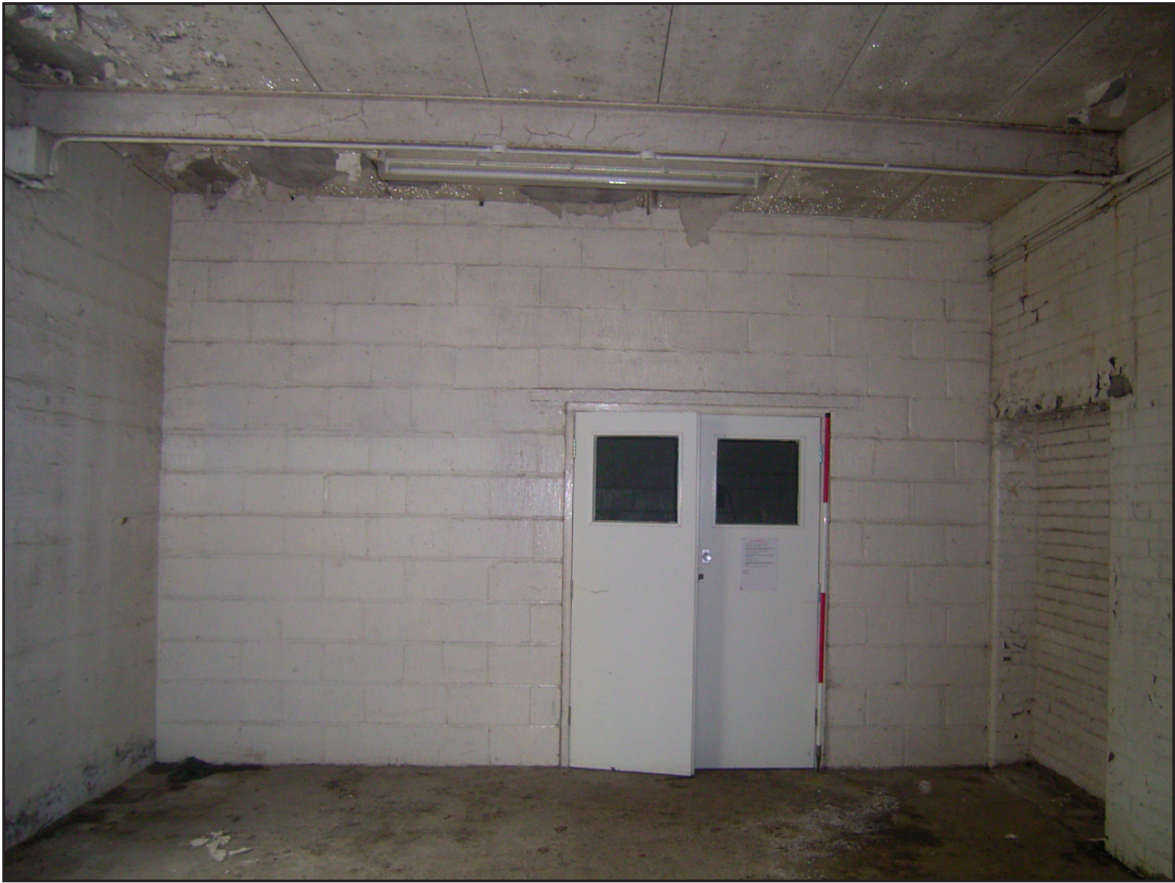
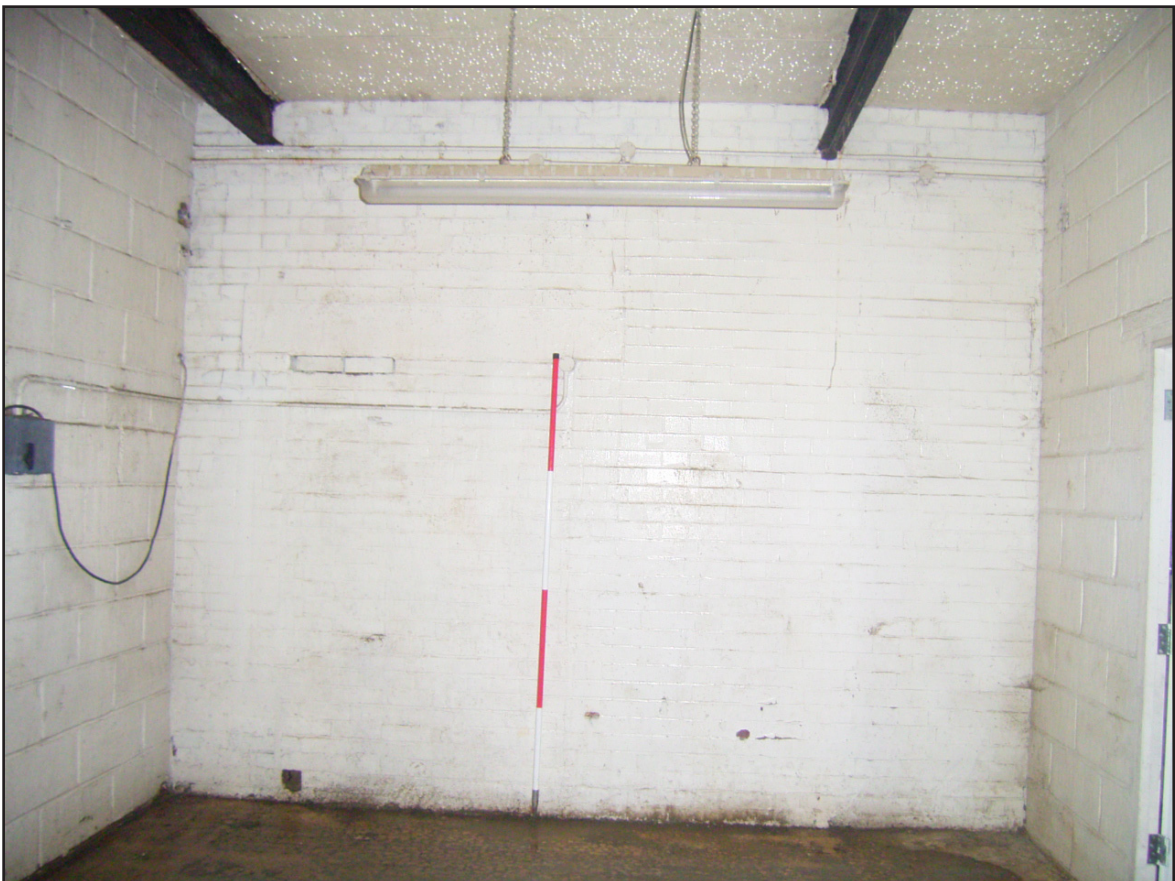
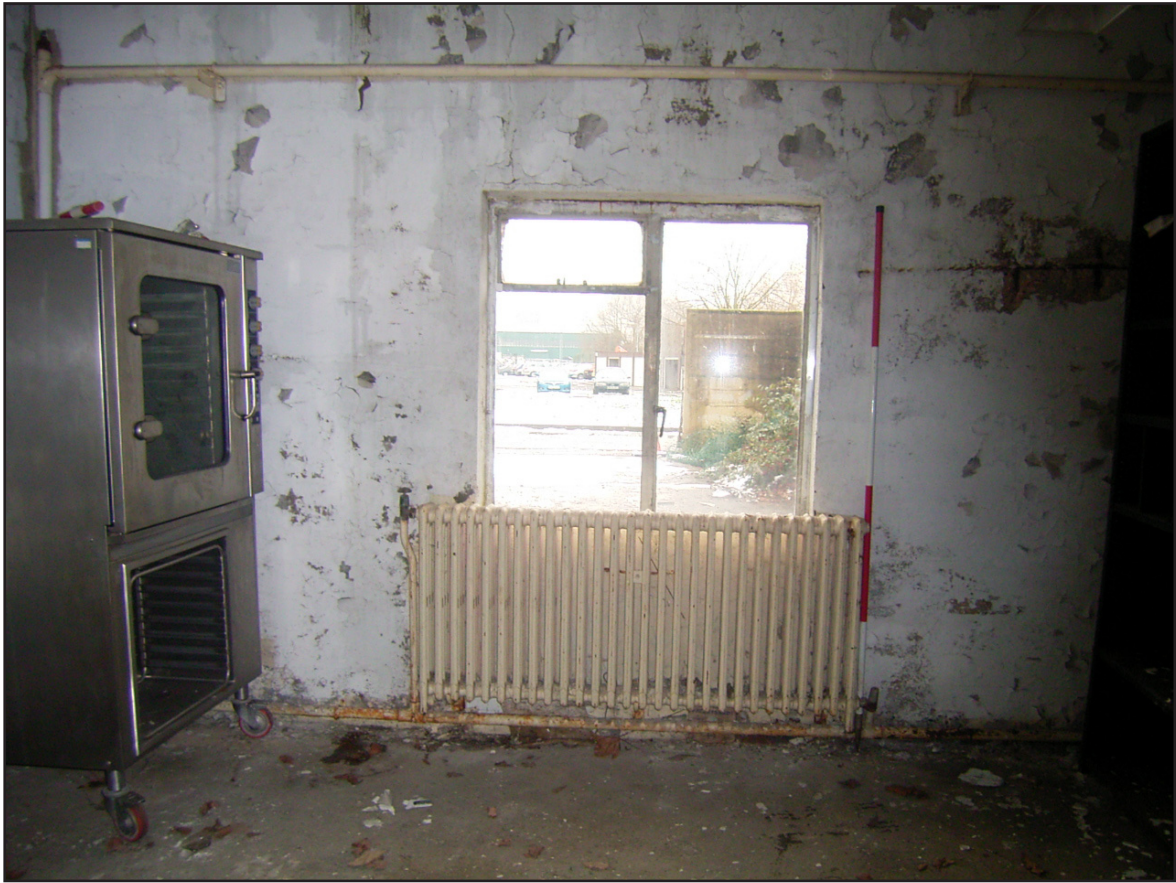
5.6.4 The interior consists of three rooms (C, D, and E) divided by breeze-block walls. Rooms C and D were used as a respirator facility and they each have blocked doorways which would originally have provided access into the main build from the outside. The floors are concrete and there are fixings for central heating pipes and radiators. Rooms C and D can be seen at Plates 14 to 16, Room E can be seen at Plate 17.

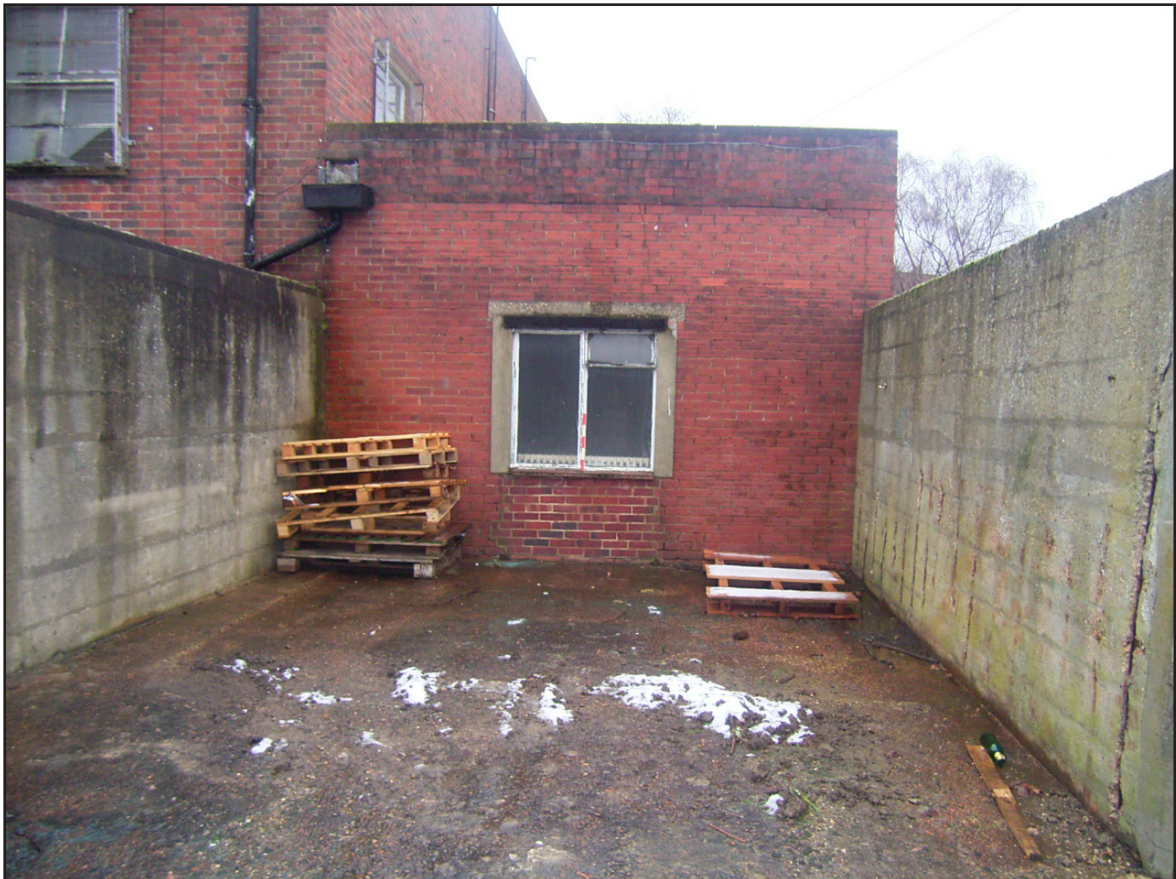
Plate 18: Building 007 - External Storage Area

5.6.5 From this extension there are two walls projecting to the north east which form an external enclosure/storage area (Plate 18). These walls are both of reinforced concrete and red brick construction and are rendered the same as the extension. This enclosure would have originally been accessed through a door in the north east elevation of Room E, but this has been blocked and a window inserted.

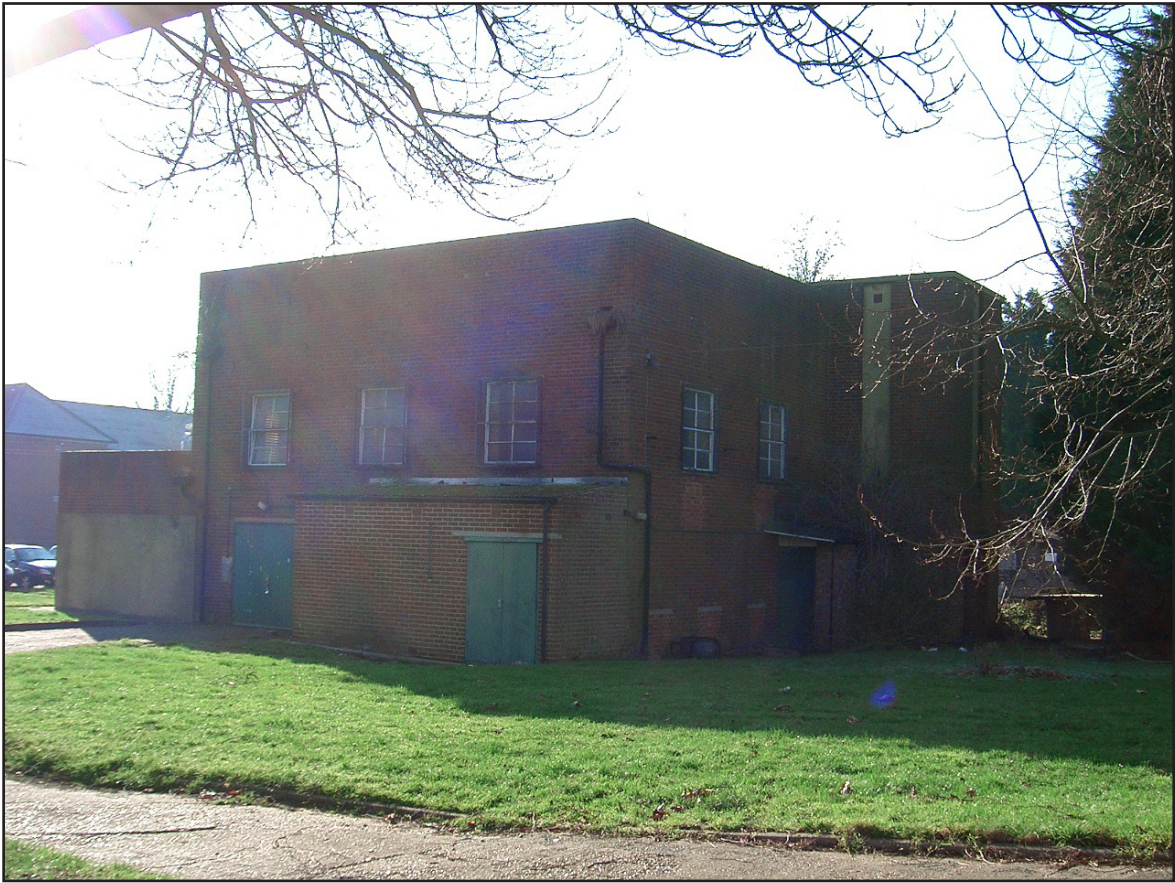
Plate 19: Building 007 - Extension 2 Exterior

5.7.1 This is a smaller single storey extension projecting from the southern half of the south-west elevation (Plate 19). It has a shallow pitch, corrugated metal-covered roof and has red-brick (stretcher bond) walls. The bricks measure 21.5 cm × 6.2 cm × 10.5 cm and arris to arris they measures 28.1 cm. The brickwork is bonded into the main building and there are several vents located to all sides of this extension. A light switch is present next to the door which was locked at the time of investigation.

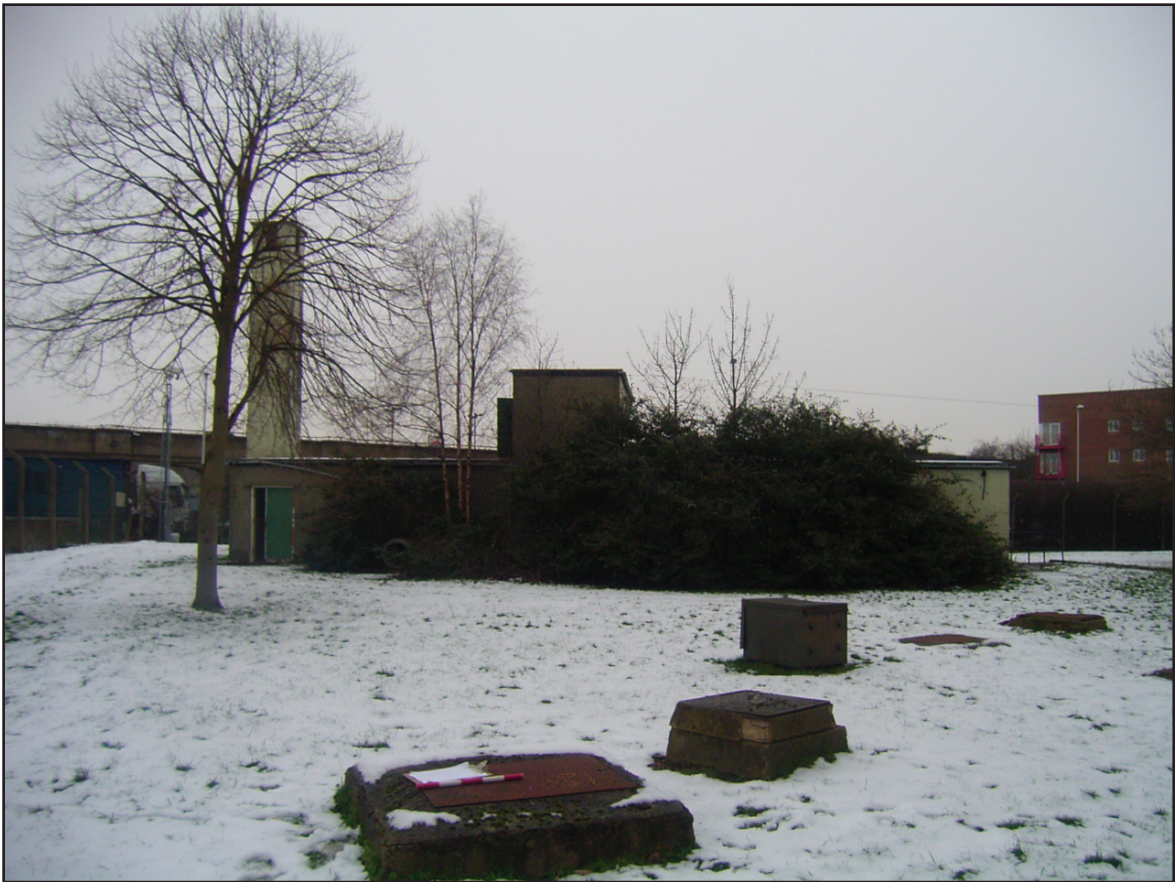
Plate 24: Building 112 - North East Facing Elevation

6.3.4 The **north east facing elevation** (shown at Plate 24) has a plain doorway at the east end through which decontaminated personnel would have exited the building. To the west of this is a concrete pipe (c.65 cm diameter) which passes through the wall at ground level and projects c.1.7 m beyond the face of the wall. Much of the rest of this elevation is obscured by vegetation but towards the west end are further hatches through which contaminated clothes would have been passed into bins.

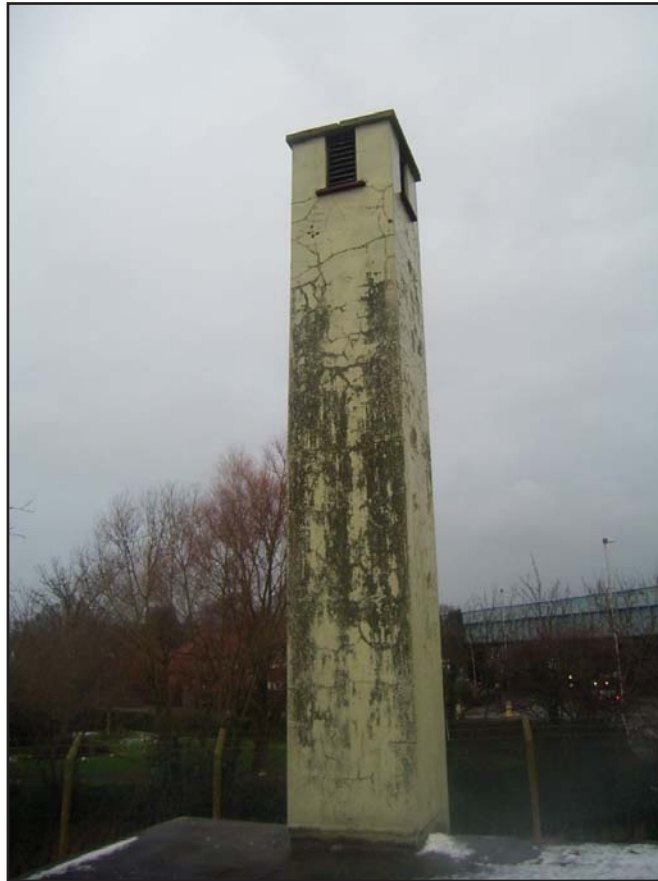
Plate 25: Building 112 - Air-Intake Shaft

6.4.3 At the south east end of the building a tall air-intake shaft (Plate 25) which would have supplied fresh air to the facility in the event of an incident. The small chimney on the south west side of the facility was associated with a boiler room which would have provided hot water and heating to the building.

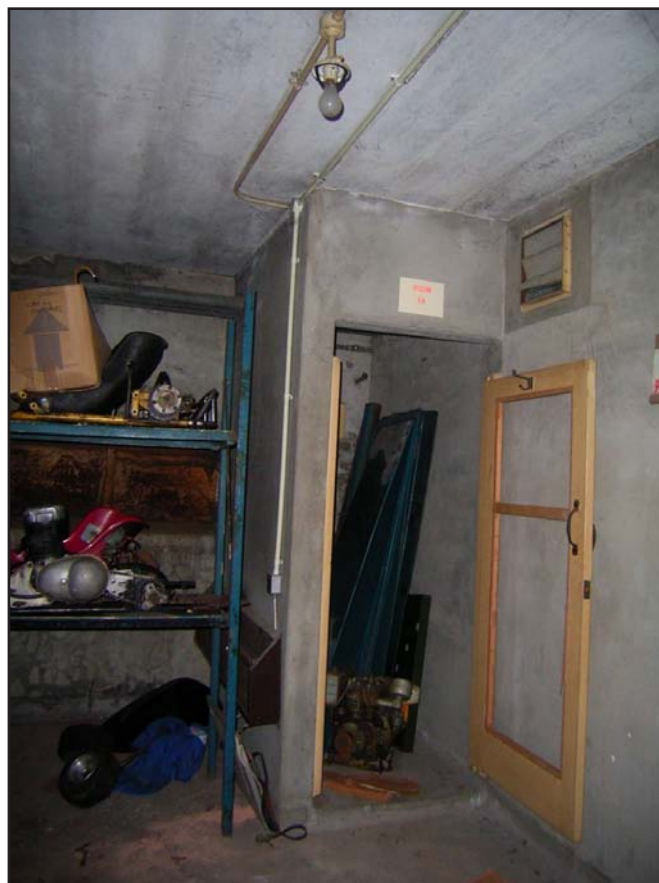
Plate 26: Building 112 - Room 1 & 1a

- 6.4.5 **Room 1a** is located in the eastern corner of Room 1 as shown at Plate 26. The pipe-work and floor base suggest that this room originally contained a shower unit. It appears that this was associated with the decontamination areas. The door is recent and is missing panes of glass.
