Buildings 007 and  
Buildings 112  
RAF Northolt  
Hillingdon  
Greater London

Historic Building Recording  
and Investigation

December 2007

Client: Defence Estates

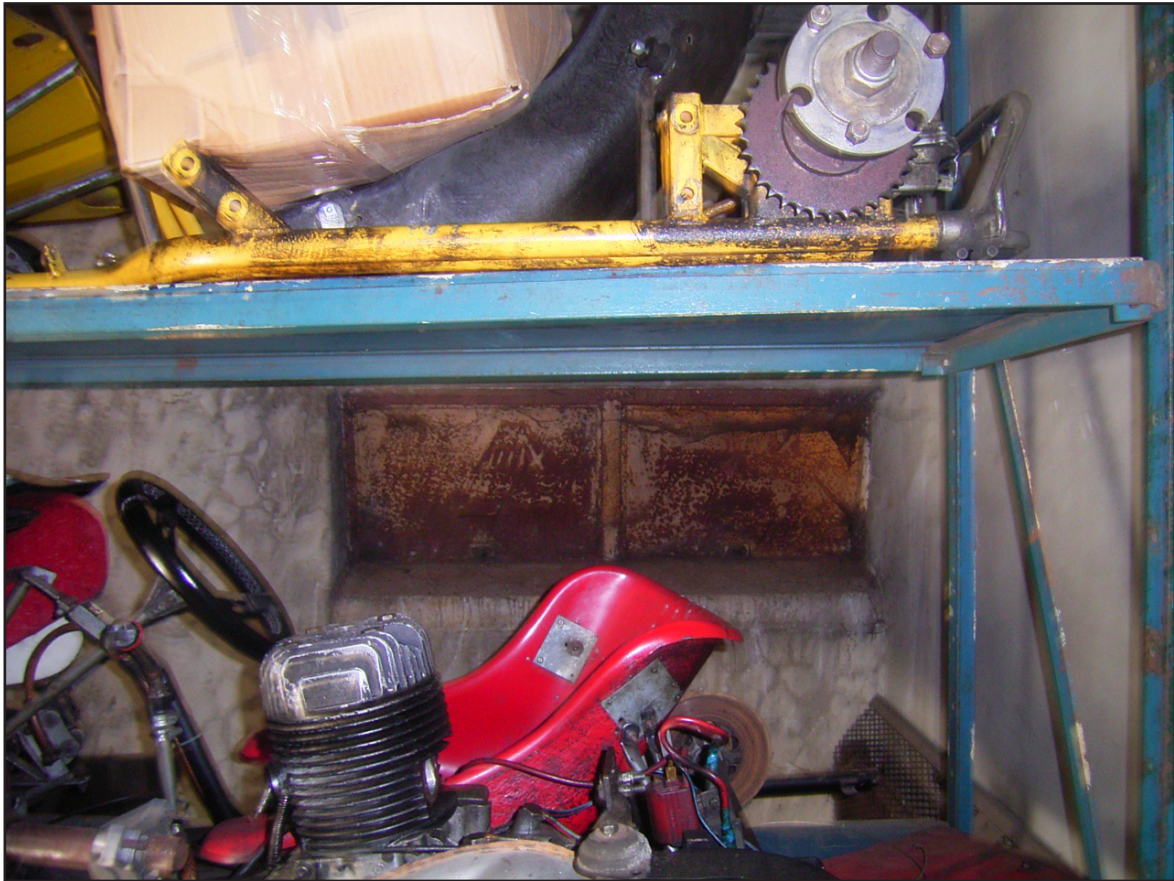
Plate 27: Building 112 - Contaminated Clothing Hatches

6.3.4 The **north east facing elevation** (shown at Plate 24) has a plain doorway at the east end through which decontaminated personnel would have exited the building. To the west of this is a concrete pipe (c.65 cm diameter) which passes through the wall at ground level and projects c.1.7 m beyond the face of the wall. Much of the rest of this elevation is obscured by vegetation but towards the west end are further hatches through which contaminated clothes would have been passed into bins.

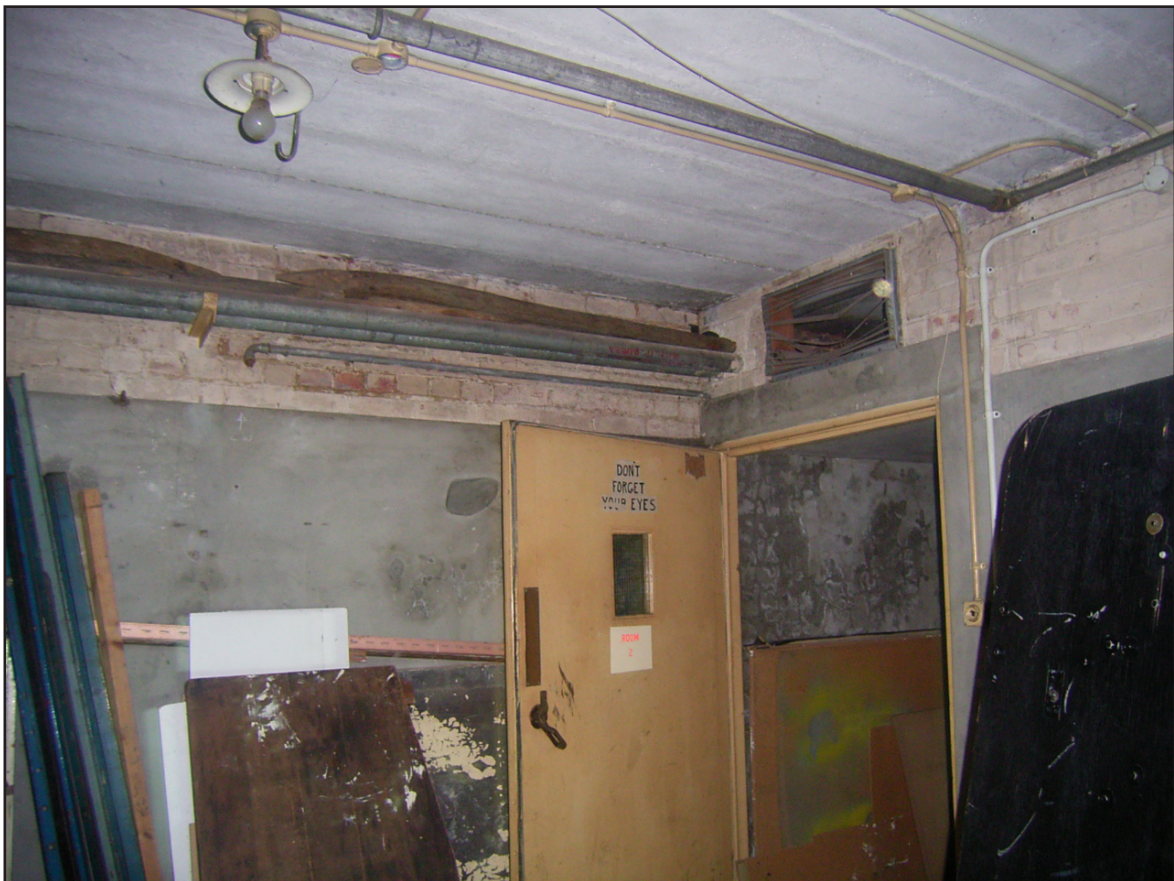
Plate 28: Building 112 - Room 2 Looking Through To Airlock in Room 1

- 6.4.6 **Room 2** is a large room which is rendered on all elevations with some exposed brickwork of about seven courses at high level (Plate 28). The brickwork is stretcher bond. There are high level extraction vents and pipe-work, a wall heater, and a wooden serving hatch which connects to Room 3. The doorway is too large for a modern door so extra wood panels have been inserted either side of the jambs (Plate 29). This room seems to have served as the bleaching area. The remaining rooms of the building would have comprised of various dressing and waiting areas, a boiler room, and an air conditioning plant. These have since been significantly altered to serve as the fire training facility.

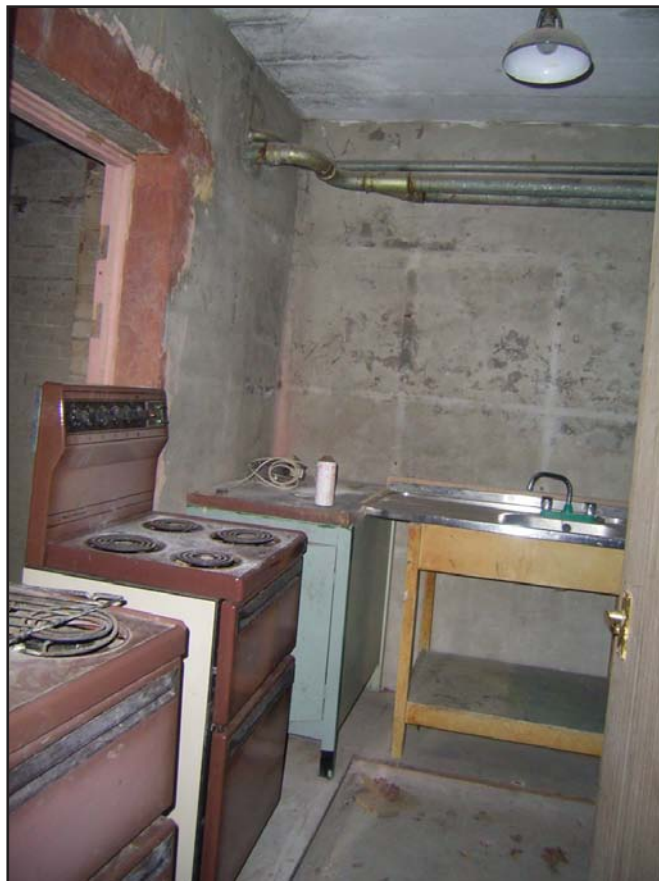
Plate 30: Building 112 - Room 3

- 6.4.7 **Room 3** may originally have been a bleach store or a shower room but it is now a kitchen area with associated cupboard fittings which are raised off the floor on wooden plinths (Plate 30). The doorway has areas of recent rebuild in concrete blocks to the side. This area is not rendered. The serving hatch which connects to room 2 appears to cut into the wall rendering so it probably post-war alteration. The hatch opening has a concrete sill, lintel and jambs. A doorway connects to Room 7.

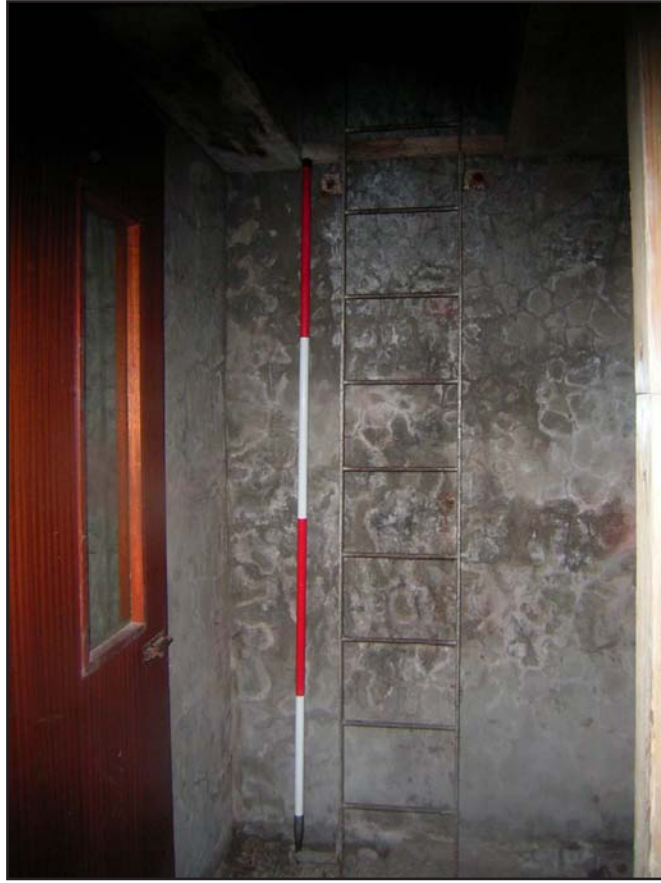
Plate 31: Building 112 - Room 4

- 6.4.8 **Room 4** is a small enclosed area with a metal ladder allowing access to the roof space above (Plate 31). There is a small ground level opening to the adjacent 'training course'. The room is rendered as elsewhere with a timber ply opening to the roof space.

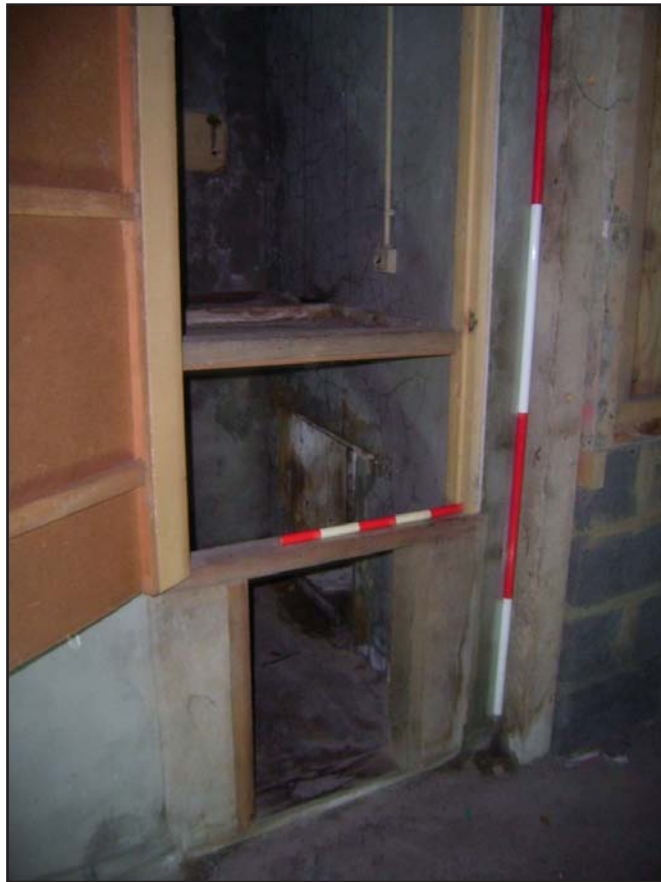
Plate 32: Building 112 - Room 5

- 6.4.9 **Room 5** seems to have been a large cupboard (Plate 32). It has a high level horizontal plywood division to reduce the height of the training passage below. The door has been cut through with another ground level entrance to the training passage.

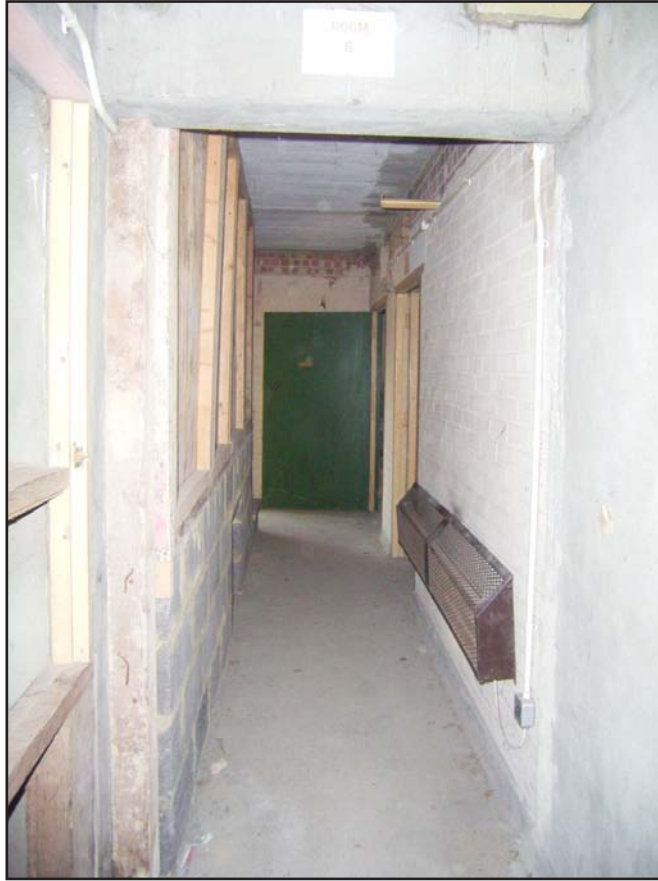
Plate 33: Building 112 - Room 6

- 6.4.10 **Room 6** is a corridor leading from the rear entrance to Room 2 (Plate 33). The walling is on one side brick in a stretcher bond which is painted cream and not

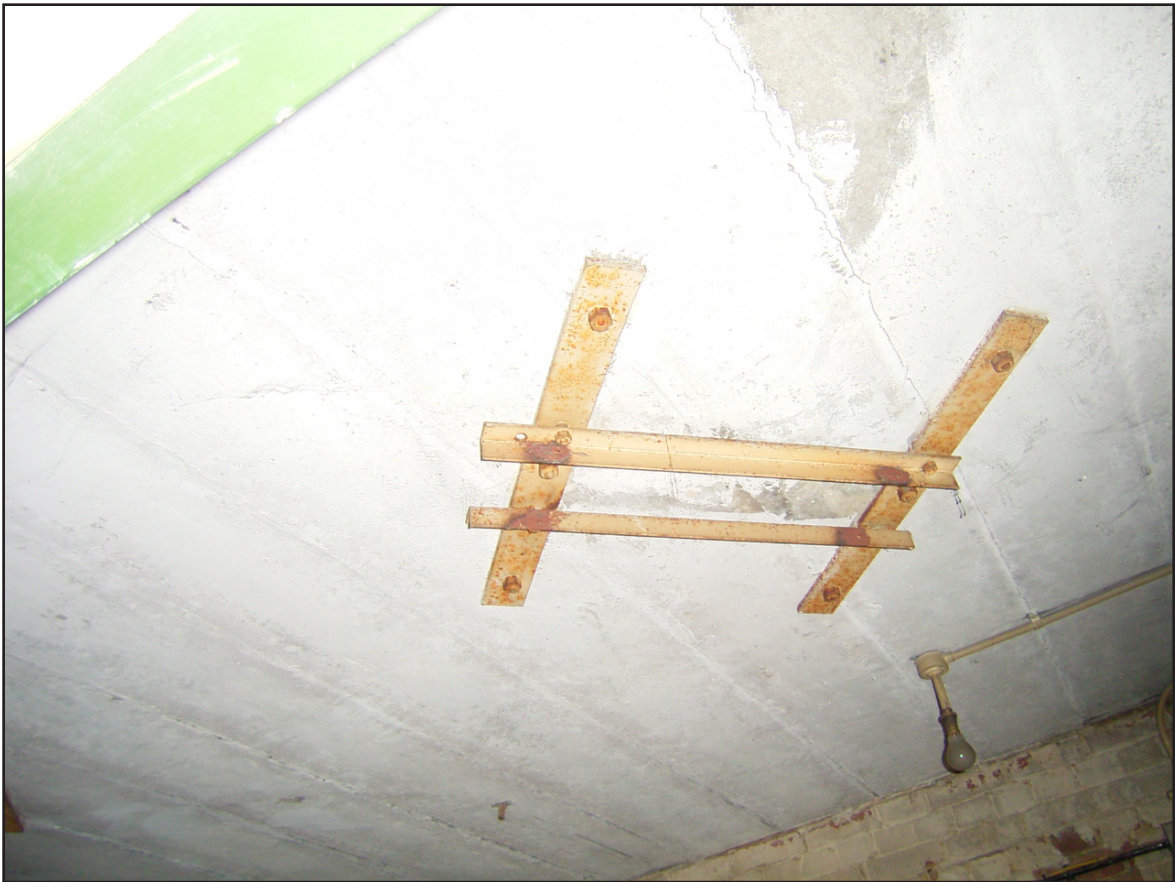
Plate 36: Building 112 - Original Fixtures

- 6.4.15 Some of the fixtures such as door handles and other fittings seen inside Building 112 appear to be original. Examples of these can be seen at Plates 36 & 37.
