## George Vaults, 35 High Street, Rochester

### ARCHAEOLOGICAL ASSESSMENT OF MEDIEVAL CELLAR

Oxford Archaeological Unit  
August 1998

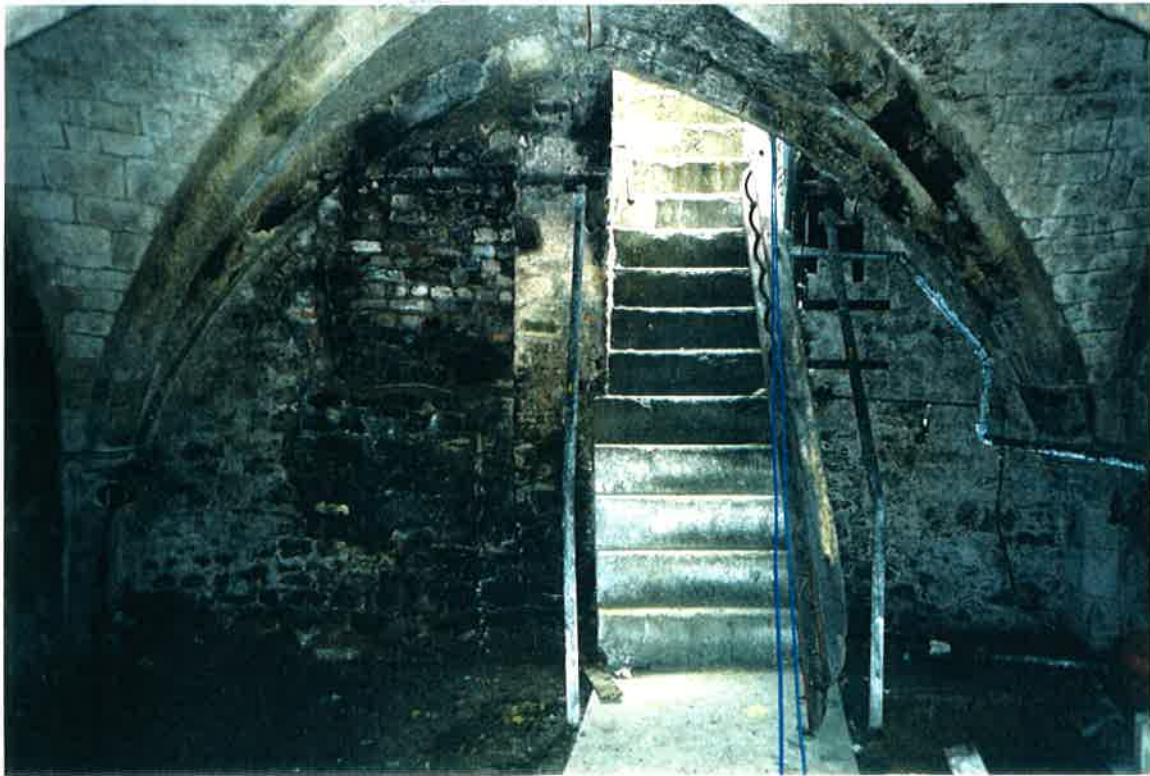
Fig. 2 George Vaults, North Wall

The entrance in the north wall, which is one of the principal objects of inquiry, is through a high door cut through the end of the vault, approached down a steep concrete stair with flanking brick walls; the entrance, if not the steps, was in the same place in 1900. The north wall of the cellar has medieval stonework at the sides and base which must represent the end of the original building. The upper centre of the wall has been disturbed for two later openings, one of which is the present entrance to the cellar. The entrance is on the east (right) side of a central pier of brick and stone, and has concrete steps descending from a high sill; on the west (left) side is a recess with a brick back and an area of stone blocking or repair below it, while both openings have brickwork in their jambs. Neither of these is likely to have been an original door or window, but they may represent successive means of access, or a door and window, or the central pier may only date from the creation of the present stair (perhaps in the 19th century).

- access at the north end could be modified to make a fire exit without damaging the medieval fabric;
- access could in the long term be achieved though use of original door openings in the east wall into the adjacent premises;
- reopening of the street entrance, and careful conservation (possibly restoration) of the pavement lights would be of benefit for the appreciation of the true character of the medieval cellar;
- reopening of the side lights would appear to be a different matter, as their blocking may carry foundations of the side walls of the building.

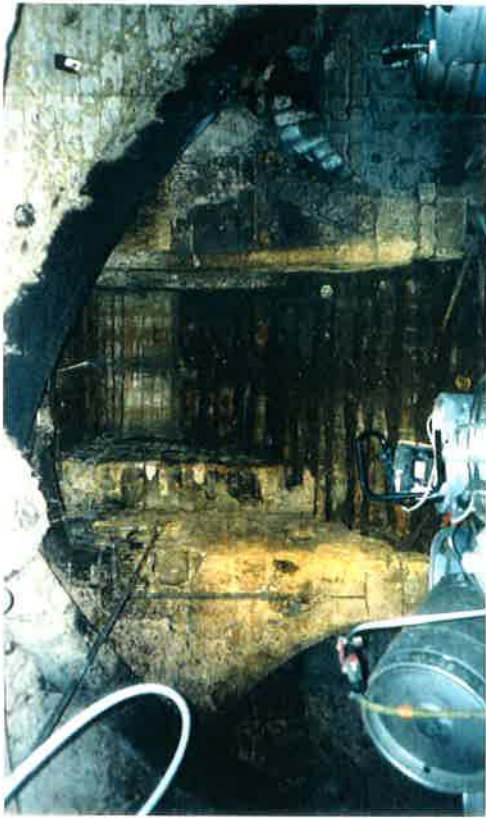
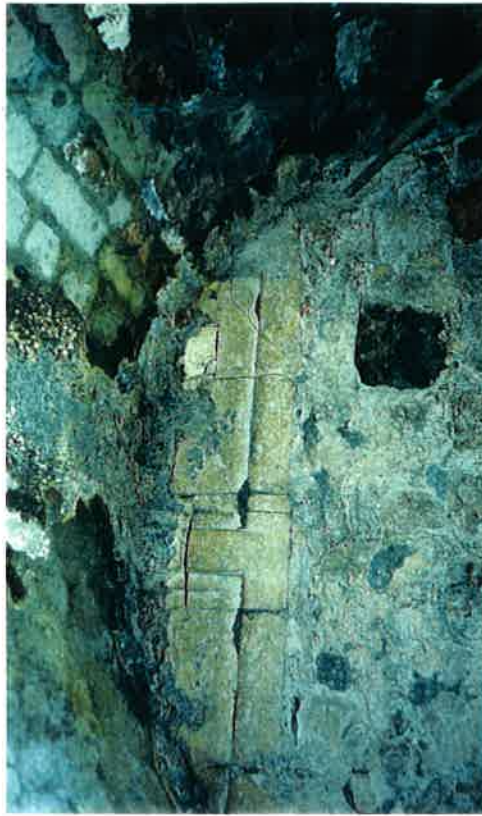
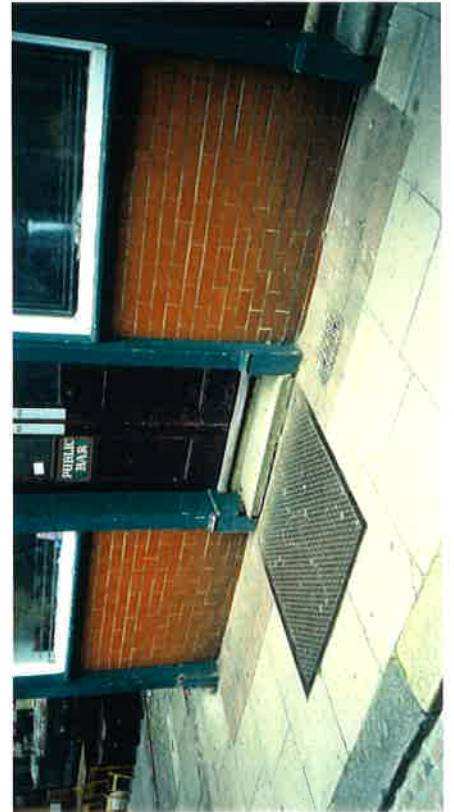
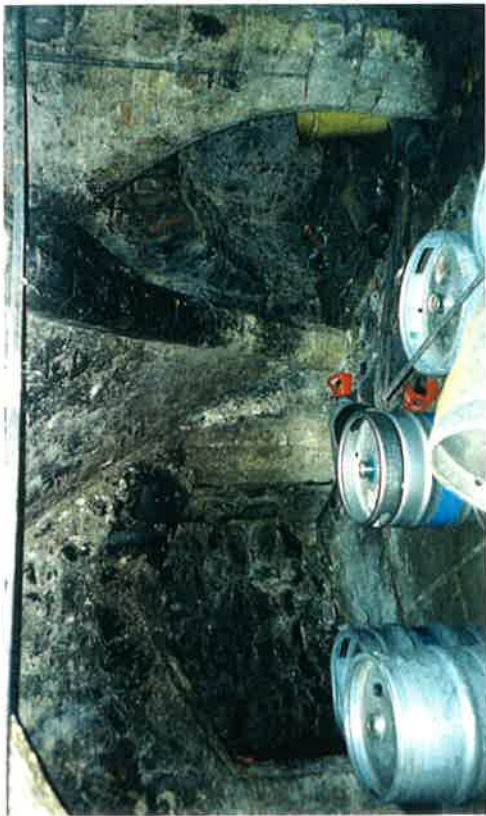
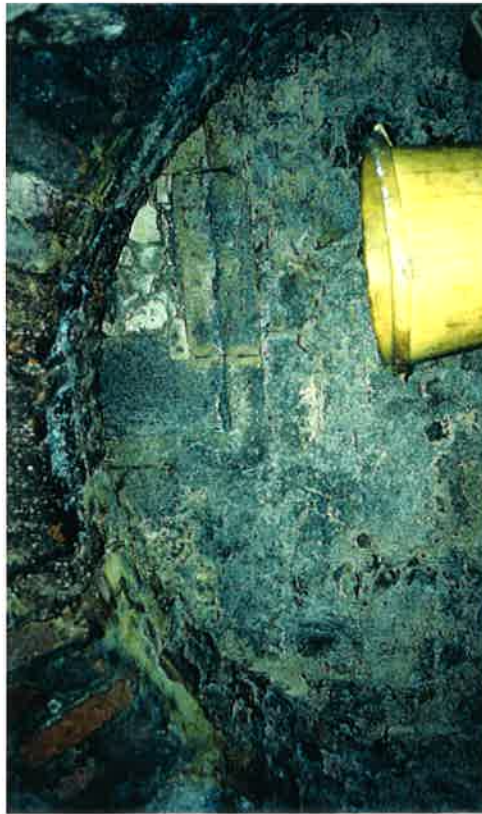
Fig. 3 George Vaults: Features in South Wall

In the centre of the south wall is an arched entry to the street, with an original segmental arch beneath the centre of the vault, a stone jamb set behind it marking the extent of the medieval building, and a brick-lined passage rising to the street, with a flight of brick steps. It is likely that the medieval street level was up to a metre lower than at present, but the cellar will have been part buried. On either side of the door is a pointed arch of stone fronting recesses that are partly filled with brick arches, but have stone back walls with the sills of original stone windows. These are well made in ashlar, and have a mullion and sloping rear face, with an rebate round the edge of each opening. These can be interpreted as windows taking light from the street (and correspond with infilled paving in the street), with wooden shutters closing on the rebates, and upper lights like the windows in the west wall must have had.

- the vault should be repaired and generally conserved by the most appropriate and archaeologically sensitive means;
- the infilled step at the south end should be removed, having due consideration of the archaeological potential of the exposed walls (and the filling material);
- the cellar should be properly ventilated, sensitively conserved, and brought into use.
