# Knole Cellars in Stone Court Sevenoaks Kent

**Building Investigation  
and Record**

# Knole Cellars in Stonecourt, Sevenoaks, Kent

*Building Investigation and Record*

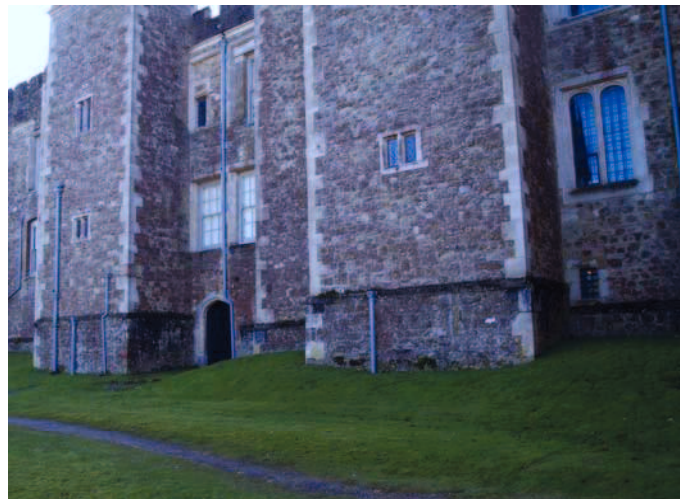
Situated under the north range of Stone Court, the cellar is a long low room approximately 30 m by 4.7 m and 2.5 m in height. The cellar is entered by the staircase at the east end, and a door in the centre of the north wall, which opens to the exterior. Although there is evidence of partition walls, the only separation currently in place is an open timber trellis structure midway along the room.

The walls are constructed of coarse stone blocks, possibly green sandstone or Kentish Rag, and are rendered with a thin lime plaster throughout. The doors within the cellar are simple pointed arches, but the stonework is good and the edges have been carefully chamfered, indicating that, while this might not be a room of high status, it was certainly of some importance. On the external north wall, the ground level is significantly above the internal floor level, but it falls away sharply to the north.

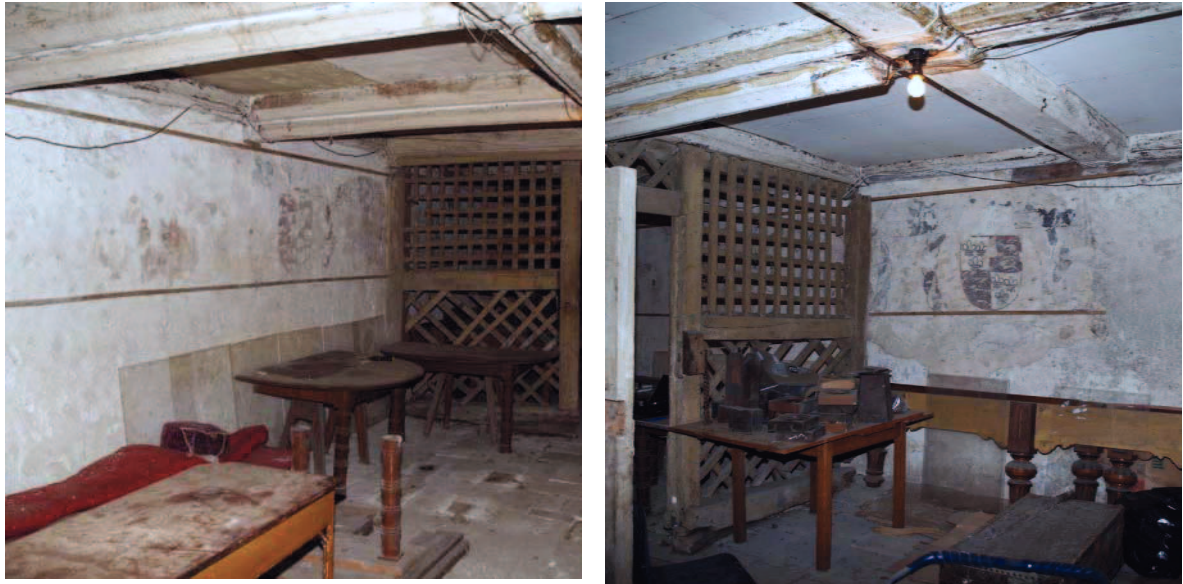
By far the largest area is the section in the centre of the south wall showing four large coats of arms surrounded by mantles, over which runs an elaborate freeze.

On the eastern end, are the Tudor Royal Arms, with the Lions of England and the fleur-de-lis of France, quartered. Above the shield there is a crown with a cross on one side, sitting on a green striped band, while the whole coat of arms is surrounded with a twisted or plaited mantle.

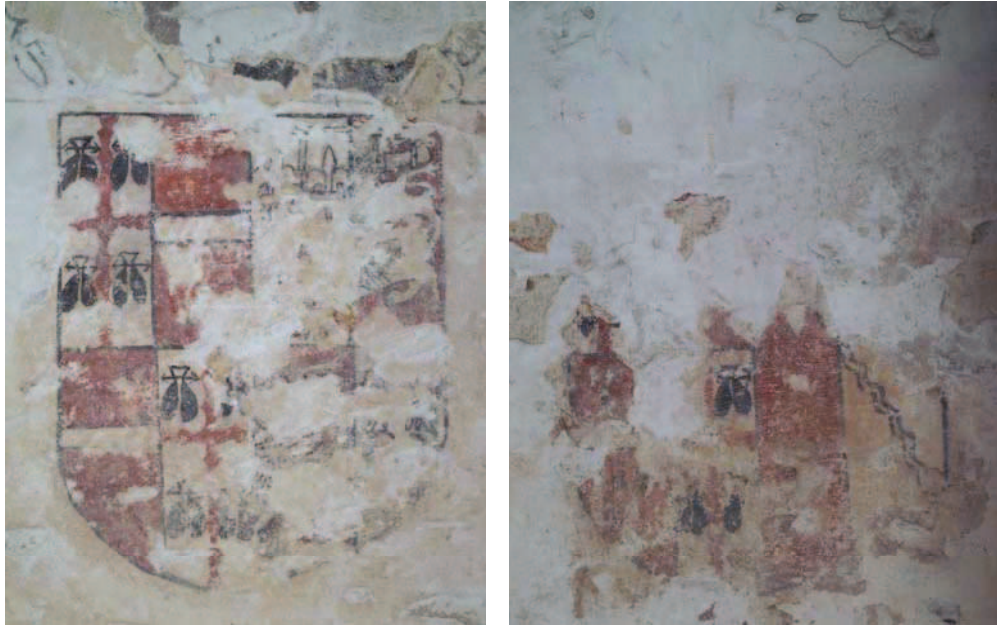
Further to the left, the third shield is the arms of Thomas Bouchier, combined with the Tudor Royal Arms. The upper part of the shield is not visible, and so it is not clear if there is a further hat above it. However, as with the other arms, it is surrounded by a fragmentary plaited mantle.<sup>2</sup>

Finally, further to the east, there is a very fragmentary set of arms, which again includes those of Thomas Bouchier, combined with the arms of Cambridge. These may have been the arms of Isabel Bouchier (d.1483), the granddaughter of Edmund Langley, Earl of Cambridge, who was married to Bouchier's brother, Henry. No hat is visible, but fragments of the mantle can be seen on the surrounding plaster.<sup>3</sup>

Above all the coats of arms runs a frieze, containing motifs reminiscent of the type of northern European grotesque work, which was beginning to influence English painting in the late 15<sup>th</sup> or early 16<sup>th</sup> centuries. The way in which the paintings have been uncovered makes the relationship between the frieze and the heraldic decoration confusing. However, it is clear in raking light that the frieze is on a later layer and therefore postdates the coats of arms.

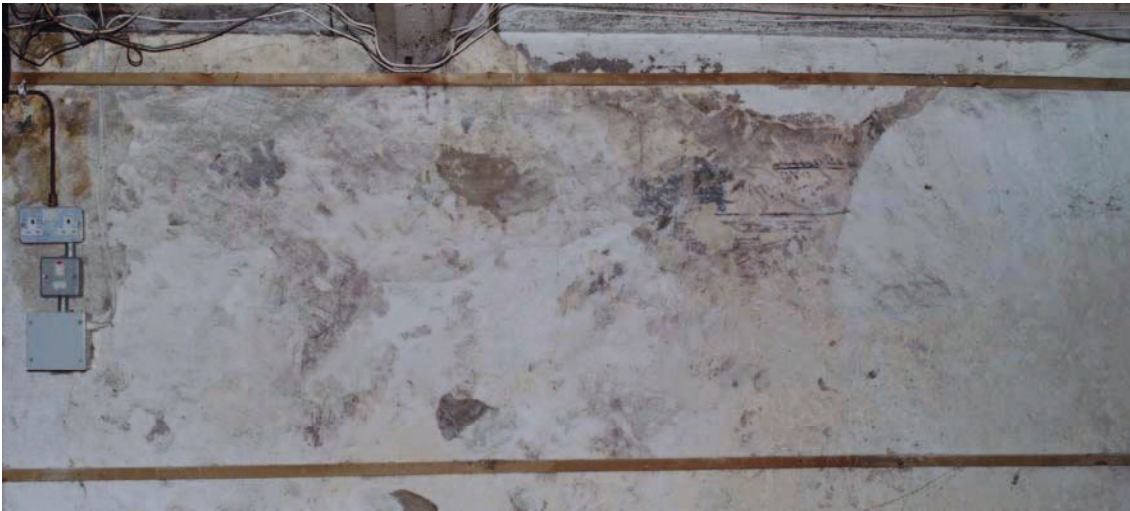
On the scene to the left, a figure, apparently of a bishop, kneels in prayer. This has previously been identified as the Martyrdom of Thomas Becket, but very few details are apparent and it is not clear that this is the case.

To the right, there is a figure, which appears to be Christ with a crossed nimbus, covered with flecks of vermillion blood. The figure stands or kneels within a round arched niche, the spandrels of which are decorated with a foliate motif, typically found in 15<sup>th</sup> century timber roofs. Above this is a band of linear decoration with small circular motifs, which runs into the frieze. The uncovering has been undertaken in such a way that the junction between the two paintings is not clear, and they may easily be misinterpreted as the same scheme. A little further to the right, a small fragment of a plaited mantle, similar to those around the arms, can be seen.

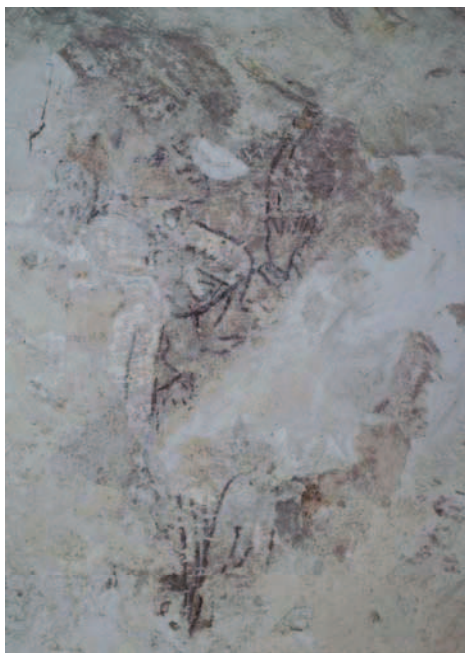
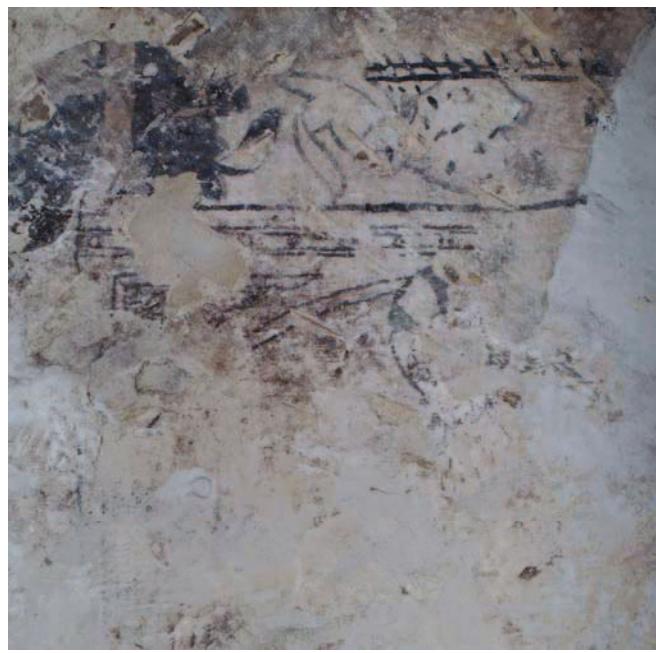
The subject matter is unclear. However, the kneeling bishop faces right towards the scene of Christ. It therefore appears possible that the figure of Christ is a Man of Sorrows with the bishop praying to him. It is possible that this is a representation of Bouchier himself as donor. However, further iconographic research needs to be undertaken in order to clarify the details. It is also clear that further painting survives beneath limewash, and it is possible that uncovering would reveal more details.

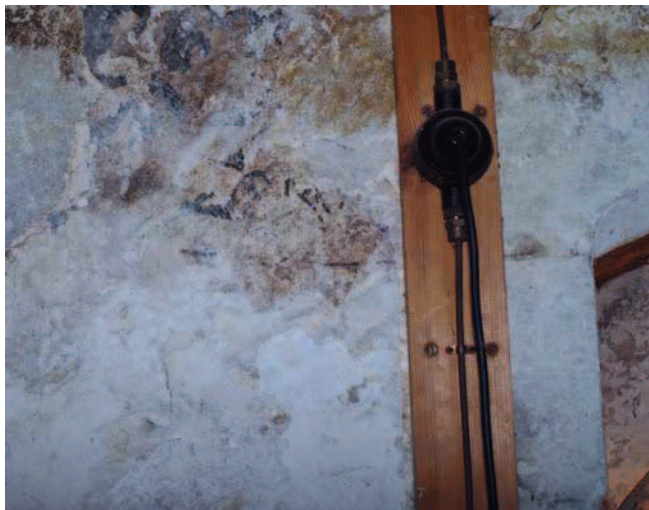
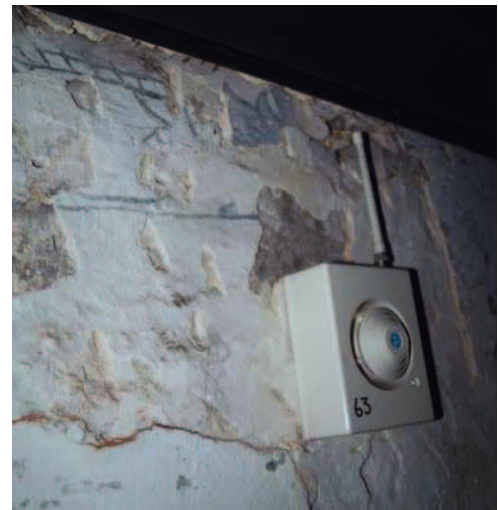
Although a detailed investigation of the plaster on the walls of the western part of the cellar was not undertaken, it appeared, from losses in areas of exposed masonry, that the painted plaster did not extend beyond the Royal Arms, which appears to be the western most section of the painting. This coincides with a change in decorative detailing of the ceiling beams, which are far more elaborate, towards the east of the cellar (in the painted area) and are less ornate in the unpainted area towards the west.

The implication is that the cellar was originally divided into two rooms, one of which was used for social or formal events, and decorated accordingly, while the other was far plainer. It should be noted that this is speculation based on the visible evidence, and a far more detailed investigation of the plaster to the west would be necessary in order to confirm this.

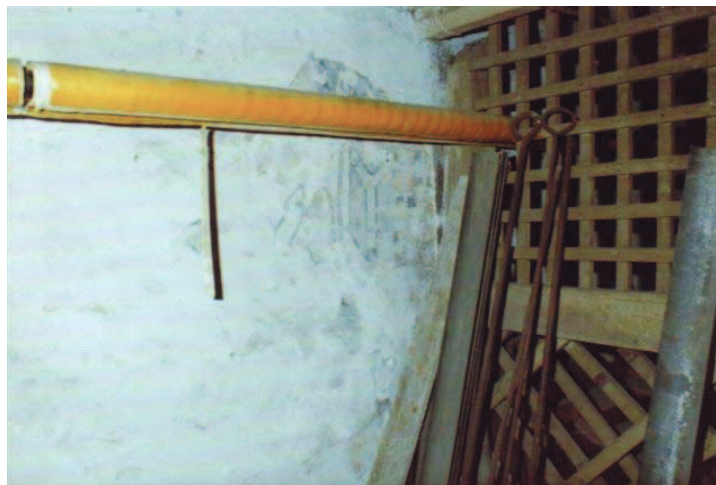
An examination was carried out by E. Clive Rouse, in 1977. At the time the paintings were obscured by heating pipes, which have subsequently been removed.<sup>6</sup> In 1979, Rouse carried out a two day programme treatment assisted by Madeline Katkov. This involved uncovering and repairing some areas and was apparently intended to lead to further work, which never took place.<sup>7</sup> It appears that, in order to expose the heraldic painting, any surviving later painting below the frieze, was removed.

At some point after this date, wooden batons with sheets of Perspex were screwed into the wall above and below the main areas of exposed painting, in order to prevent mechanical damage.

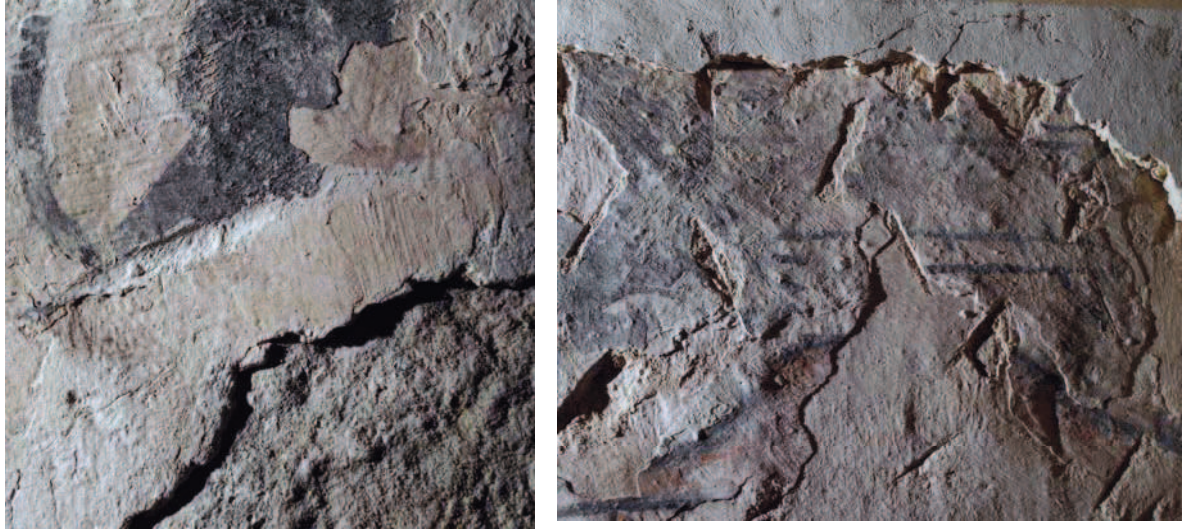
The early plaster has been keyed widely, prior to the application of the later lime and hair plaster. In some areas, these key marks are stable and on the Royal Arms they have been repaired with a fine lime plaster, presumably during Rouse's intervention.

In many areas the hair plaster was in a vulnerable condition and, while this layer is not historically significant, there is a risk that falling areas could pull away some sections of the painted plaster.

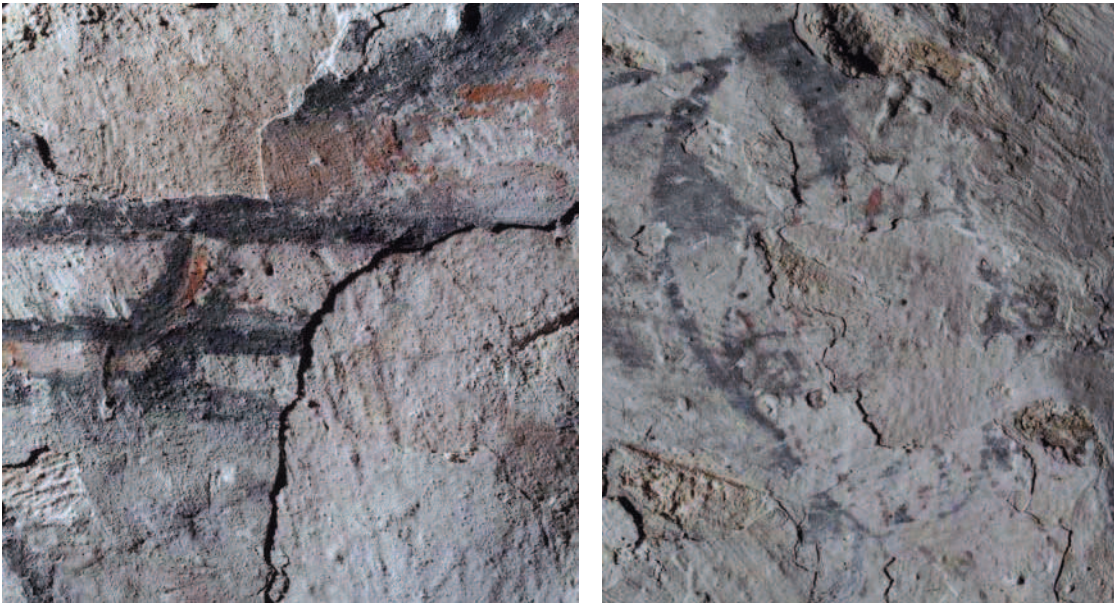
However, there are numerous areas of delamination between the paint layer and the ground, generally, but not always, on the painted frieze. Typically, on the edges of some major areas of loss, there is separation between the later and earlier paint layers, which leads to delamination and flaking. While much of this is historic, there are some areas on the paintings where this type of deterioration is active.

There appears to have been some discolouration of the pigment, typically with the lead and vermillion paints, both of which appear to have darkened. This is most notable on the arms of the cardinal and also on the drops of blood on the face of Christ.

The condition of the painting varied considerably. While some areas were stable, there were significant sections which were unstable and vulnerable to further loss. While the location of the painting and the Perspex covers reduces the risk of mechanical damage, it is recommended that limited emergency treatment is undertaken on these areas to prevent further loss. In conjunction with this, the alarm sounder on the east wall should be relocated to an unpainted surface.

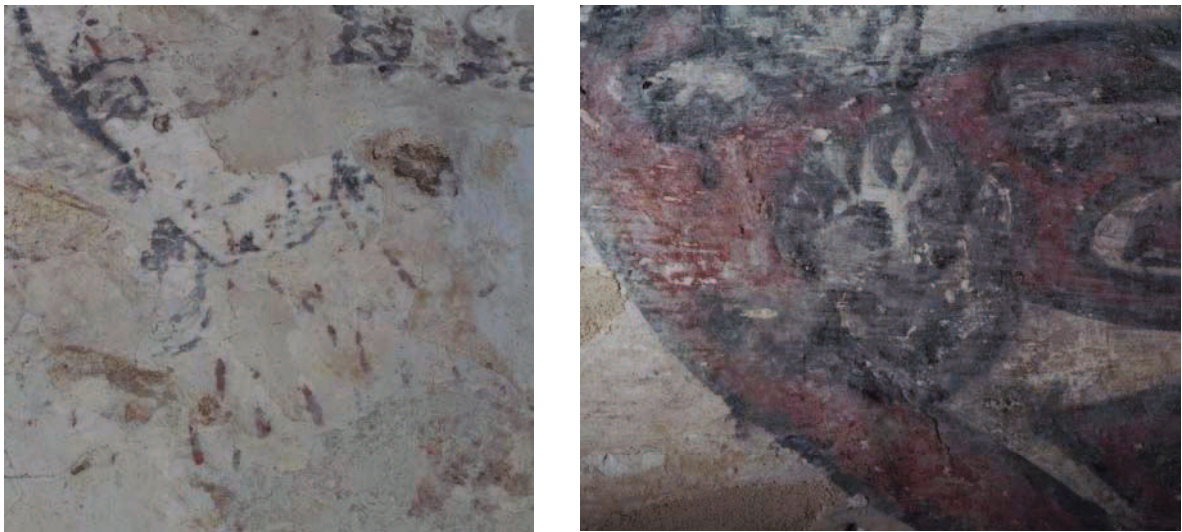
It was noticeable that on the lower baton, behind the Perspex, there was an accumulation of fragments of limewash, paint, dust and, in some areas, small pieces of plaster.

Ideally, the Perspex covers and wooden baton should be removed. It is possible that the Perspex is contributing to a deleterious microclimate in front of the painting and both it and the batons are highly disfiguring. However, this would also require measures to be put in place to protect the painting from mechanical damage. It is difficult to see how this could be achieved if the cellar continues to be used for ad hoc storage of furniture and other materials.

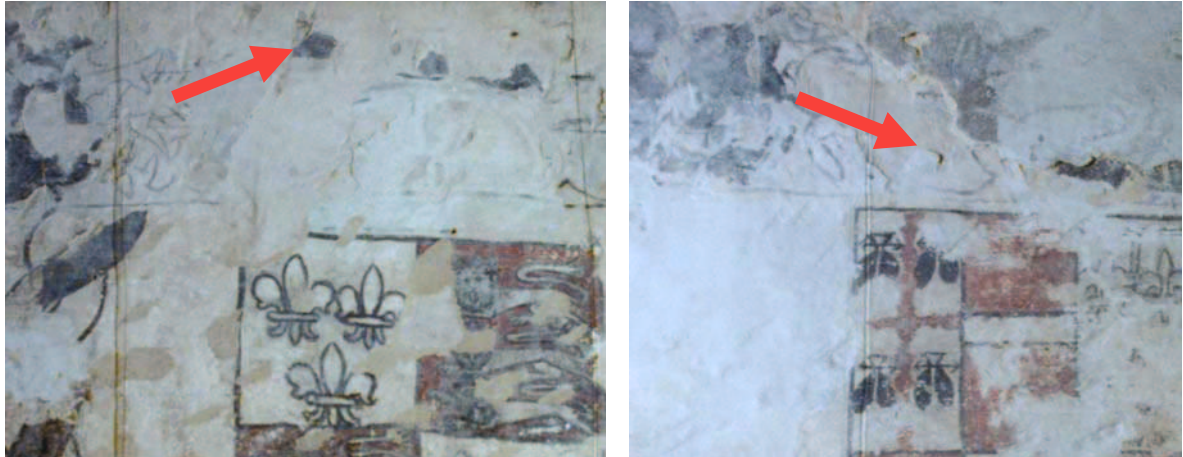
Images taken by Katy Lithgow in 1996 show the paintings, covered with the Perspex sheets, in a similar condition to today. However, there are at least two small areas where paint loss appears to have occurred. Both of these are in the frieze, rather than in the earlier layer, and are in areas where the painting is still very unstable.

The flakes of limewash and plaster on the lower baton also suggest that deterioration is active, albeit relatively slow.

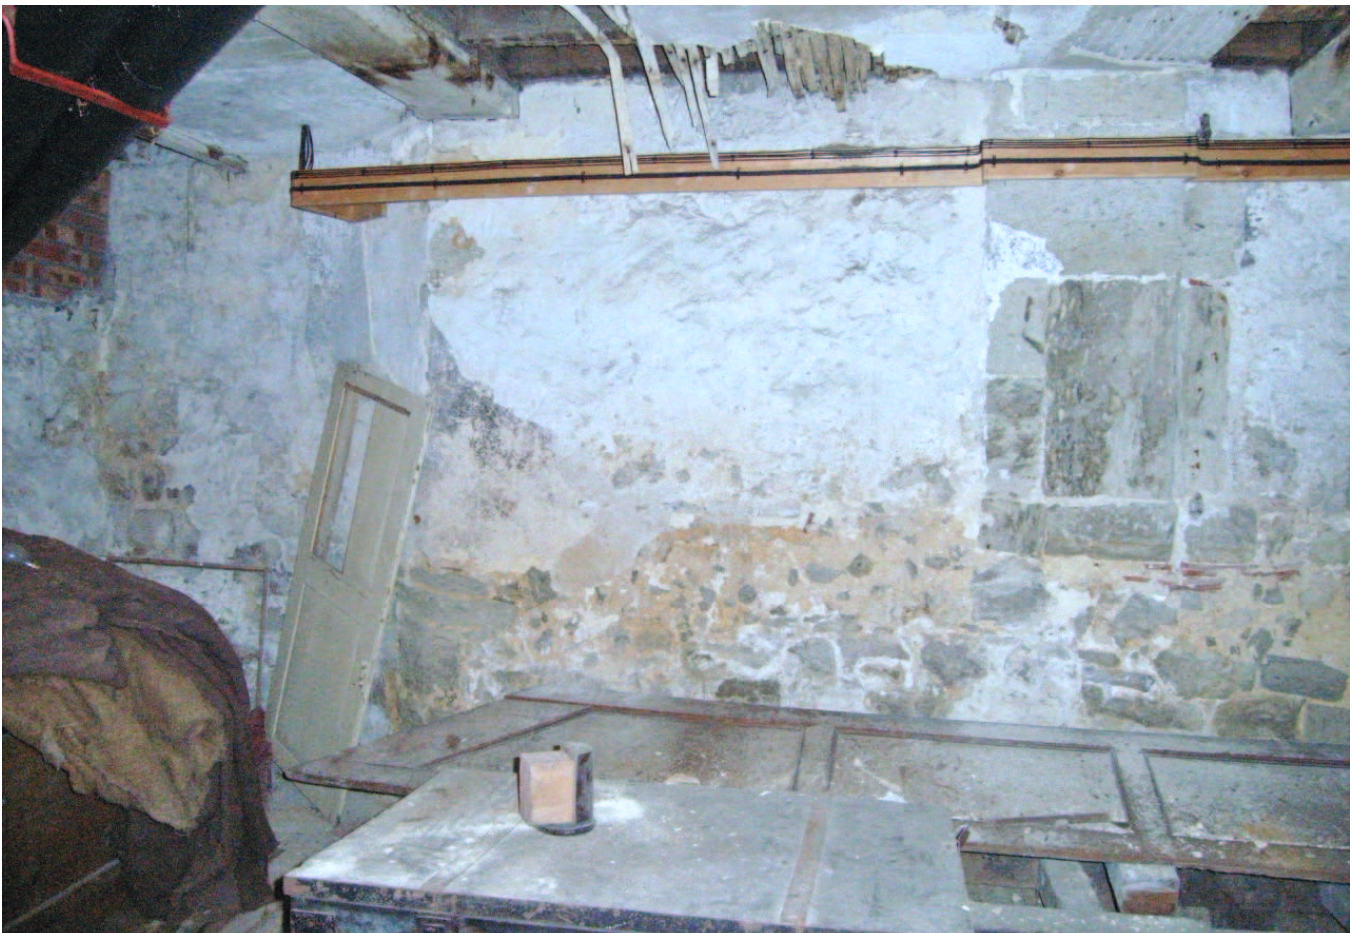
Plate 2: South wall of Area 1

- 3.2.2 *The Buttery stair?* The walls in the south east corner of the room show traces of an ascending line, possibly the imprint of a stairway, which appears to meet at a landing, and has a surviving stone door jamb on the south wall (Plate 2). Below this line, the wall is bare and above it, the wall is plastered, indicating a former floor level above that of the present floor. The jamb retains its rebate and pintles but is the only surviving side of a door once projecting into the room (with access gained from east to west). To the west of this is a large horizontal timber and a straight joint indicating a blocked opening, of uncertain function. The door jamb is most likely to be the remains of a door into the cellar on a stair descending from the Buttery (the 1741 may indicate a stair at this point), and later replaced by the present stair down from the Kitchen passage along the east and north walls.

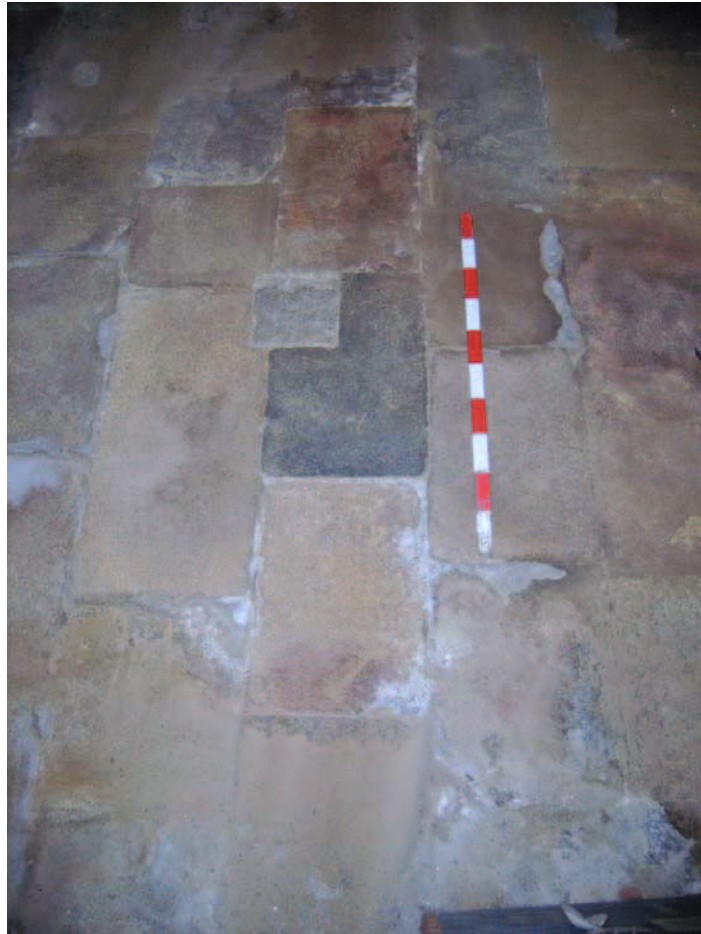
Plate 3: Flagstones in Area 1

The stones are varied, but include some Purbeck Marble paviments (purchase of such stones are included in the early 17th-century accounts). Some small square flagstones at regular intervals were probably laid to support posts (Plate 3). Hollowed stone drains run around the edges of the floor (at about 60 cm inside the east wall, 85 cm to south and 75 cm to west). The channel by the north wall runs down the diagonal corridor leading to the main cellar area, where it drains into a soakaway at the end. There are large timber barrel holders against the south wall, and others elsewhere in the cellar, traditionally constructed of mortised and pegged timbers.

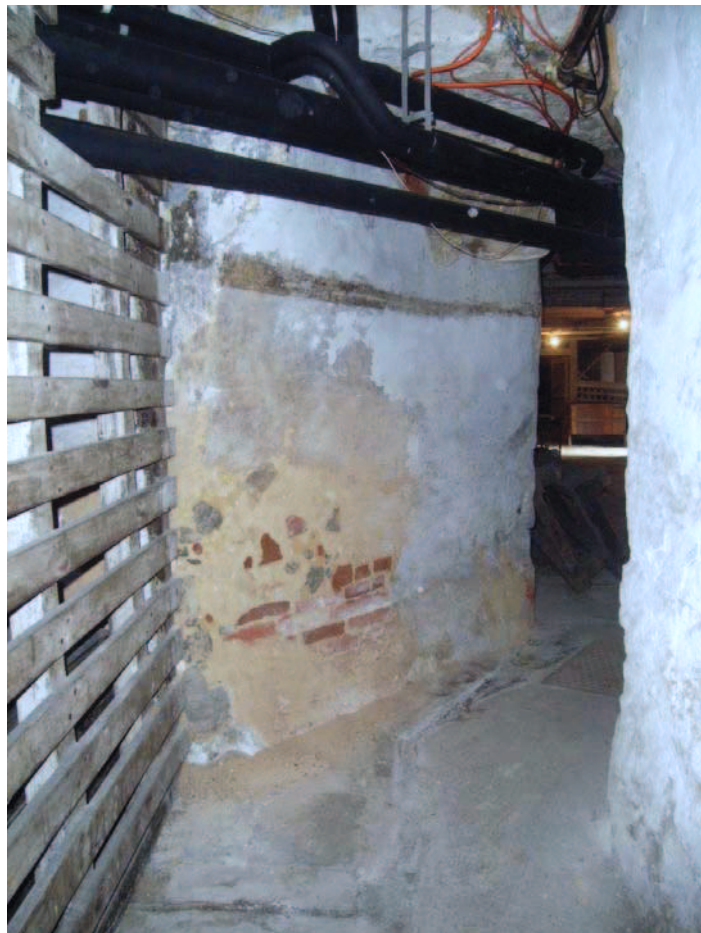
Plate 4: Passage leading from Area 1 to Area 2, facing west

- 3.3.1 *Access:* Area 2 is the east end of the main cellar area. It is accessed through the diagonal passage opening in the south east corner that leads from the Kitchen Lobby stairs and the Buttery. There is a small niche for a lamp in the diagonal passage on the right hand side as you enter Area 2 (Plates 4 & 5).

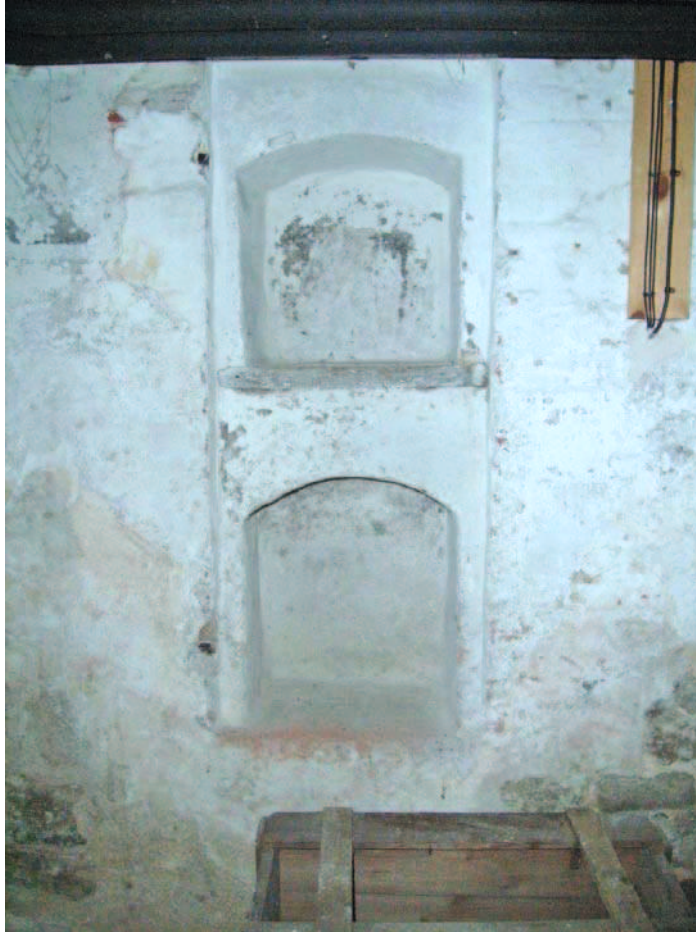
Plate 7: Cupboards in east wall of Area 2

- 3.3.3 The east wall features two shallow recesses (Plate 7), one above the other, with a square rebate and pintles for cupboard doors (possibly for holding precious vessels or liquors). In bay 3 of the south wall, there is a stone doorway, which gives access to a small wine cellar (See 3.6). The south wall also features a series of partially surviving medieval wall paintings, which are discussed further below.

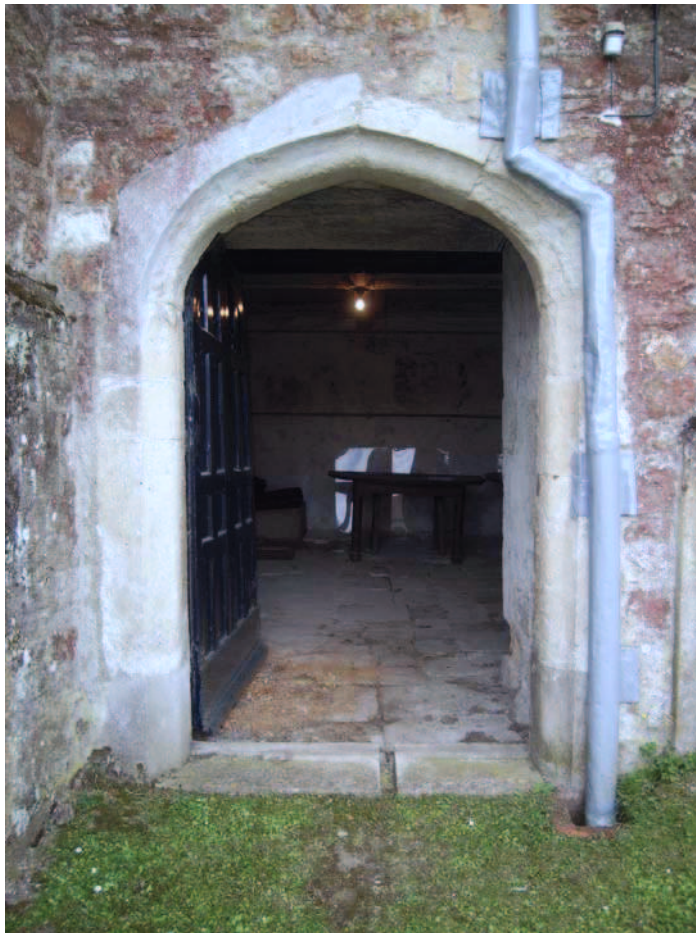
Plate 8: Doorway leading from Queen's Court to Area 2 of Cellars

- 3.3.4 *North Door:* The north wall of Area 2 has a large door to the courtyard and three evenly spaced windows to the right. The doorway has a pointed arch and a curved ogee chamfer running into the jamb (Plate 8). There are pintles on the east side of the doorway and bolt sockets on the other. The lintel soffit of the doorway is supported with four large planks. The plasterwork on the west side of the shallow doorway passage has been scratched with rough graffiti, including a shield with what appears to be a 'T' inside it. The door itself, is a large wooden panelled door, painted black. This door to the courtyard led directly towards the brewery, and was the largest means of access to the cellar.

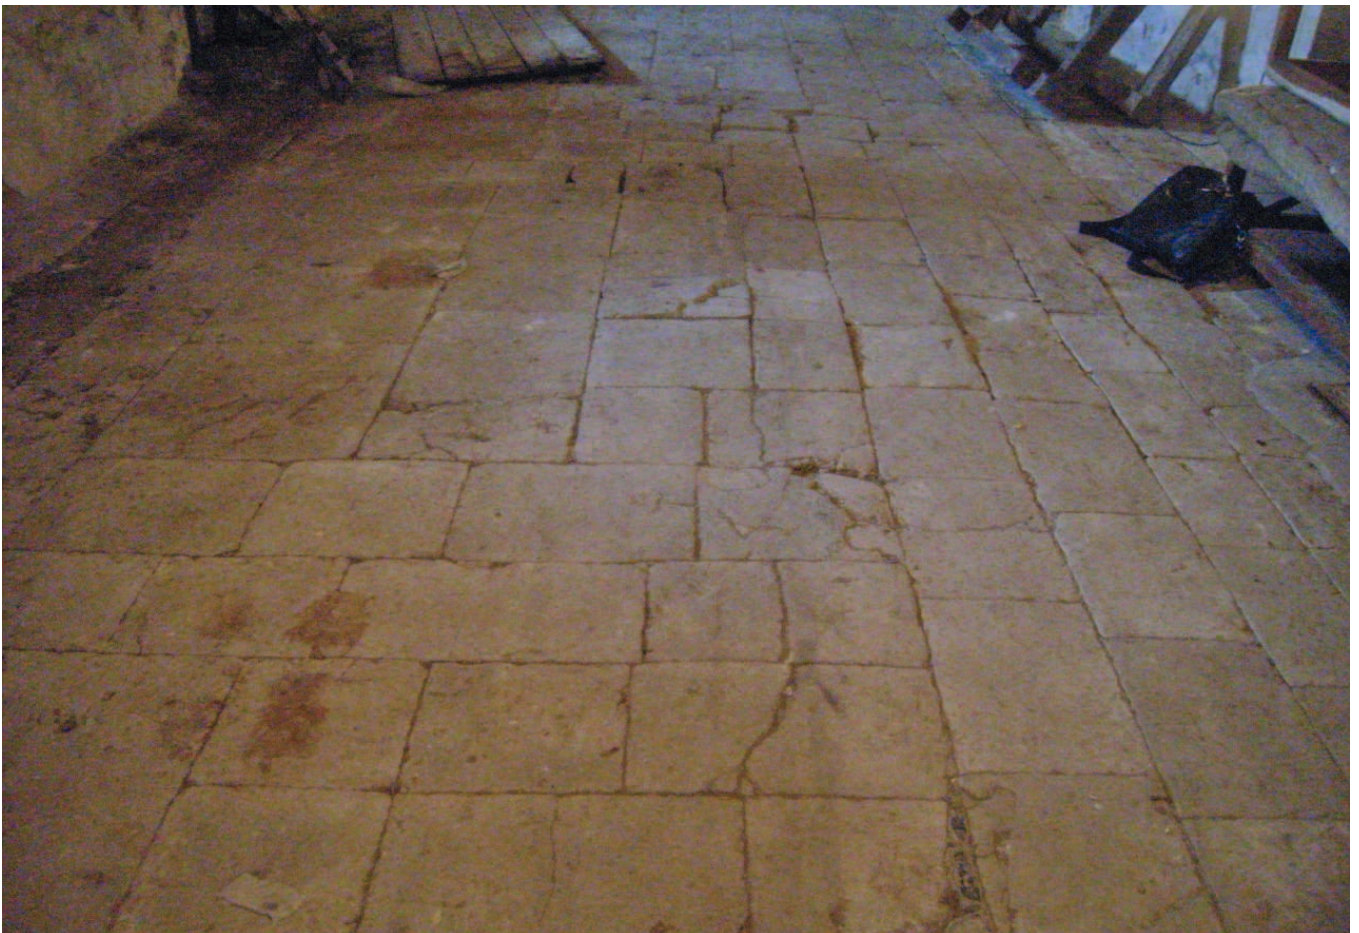
Plate 10: Flagstone floor in Area 2, facing east

- 3.3.6 *Floor:* The floor of Area 2 is of flagstones, which run broadly east to west in rows and is cambered in the centre with a slight hollow on the north and south sides for drainage. The paving stones on average measure around 45 x 30 cm, with larger stones up to around 75 x 45 cm (Plate 10). The south drain is 75cm from the wall, and the north drain is 50cm from the wall. The north drains curves outwards and arcs back in as if to continue out through the doorway in the north wall (Plate 11). However, at this point, the drain has been truncated by modern repair work between the doorway and the south wall opposite, where a manhole has been fitted and some concrete has been set down (the manhole is dated 1957). Besides this intervention, no obvious phasing can be detected in the floor of Area 1, which may all be contemporary and perhaps dates from the 17<sup>th</sup> century.

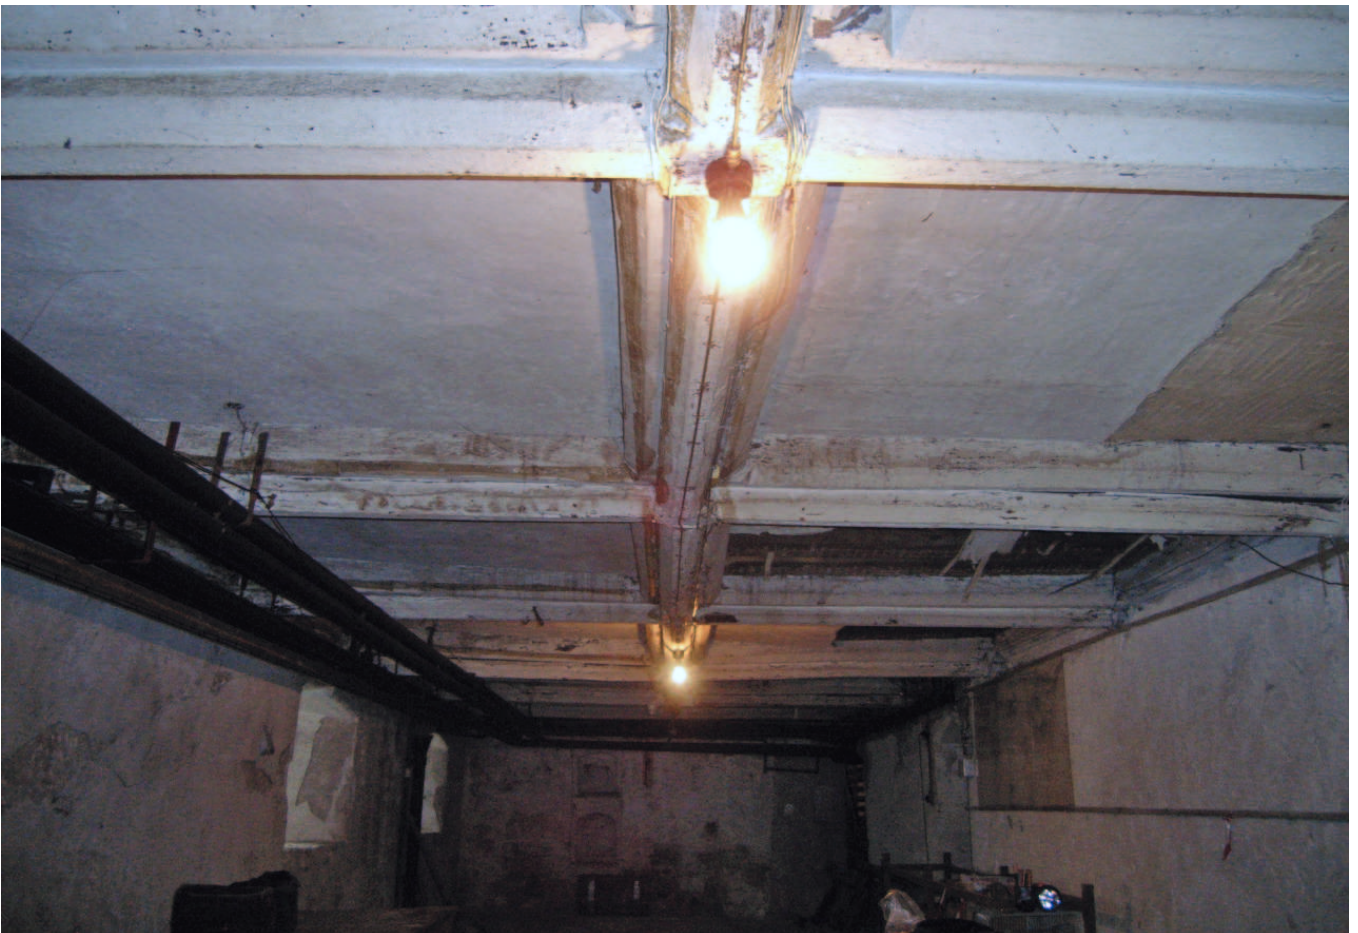
Plate 12: Roof Structure in Area 2, facing west

- 3.3.10 The carpentry throughout is of high quality and has been loosely dated by Hewett to the 15<sup>th</sup> century (1400-1510).

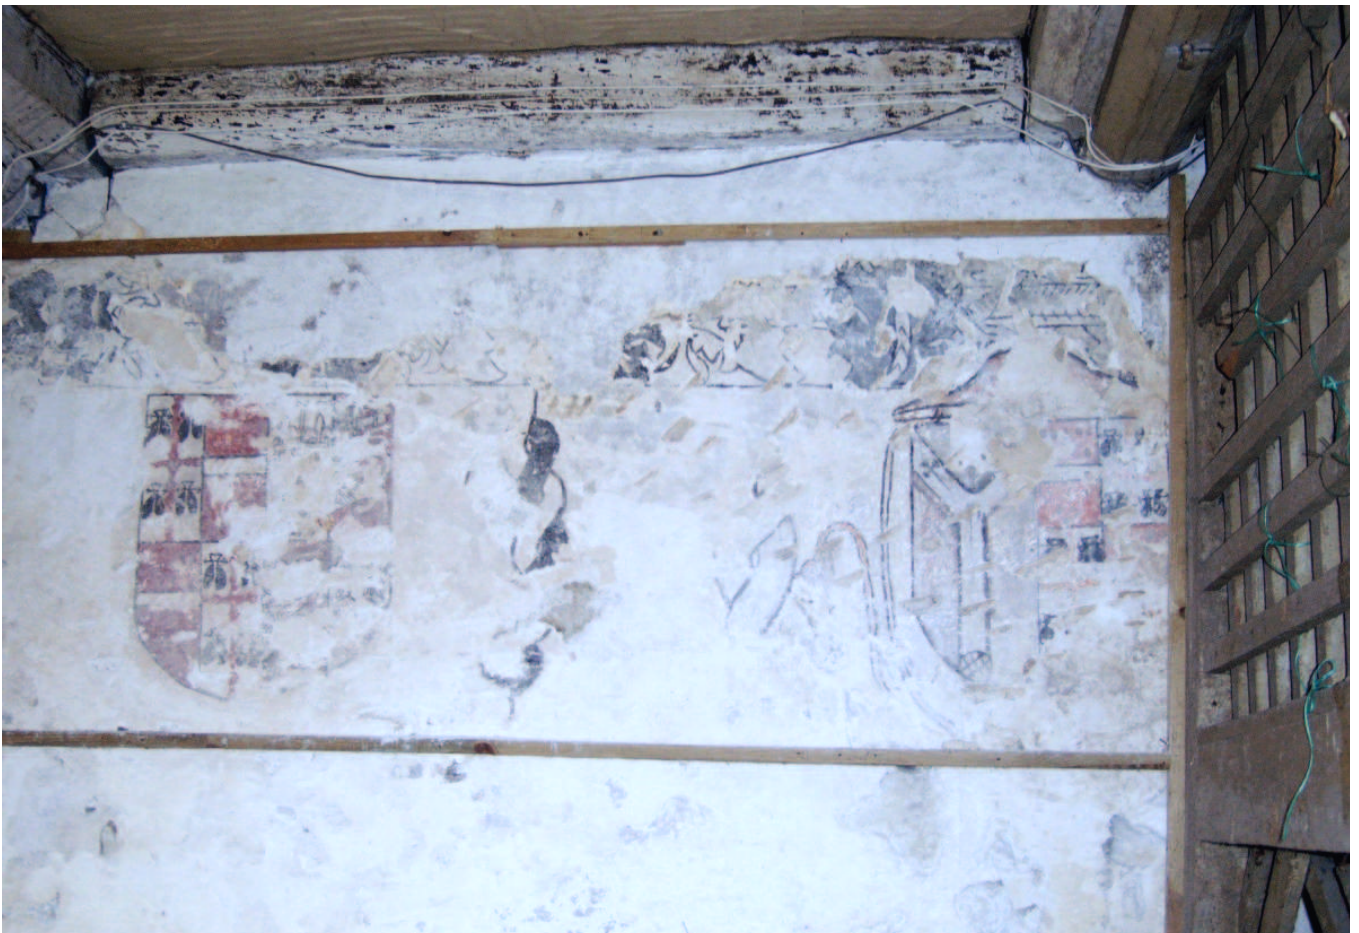
Plate 22: Medieval wall paintings in Area 2

3.5.1 The south wall of the main cellar space retains a frieze above large heraldic displays and some figurative scenes (Plate 22 & 23). It is painted onto plaster and although in poor condition, some of the figurative work and heraldic devices can be identified. It was found that the paintings were restricted to that part of the cellar where the ceiling is more ornate than the rest: the seven west bays of Area 2 and the eastern most bay of Area 3. This is a further indication that this part of the cellar was more formal and of a higher status than the other areas.

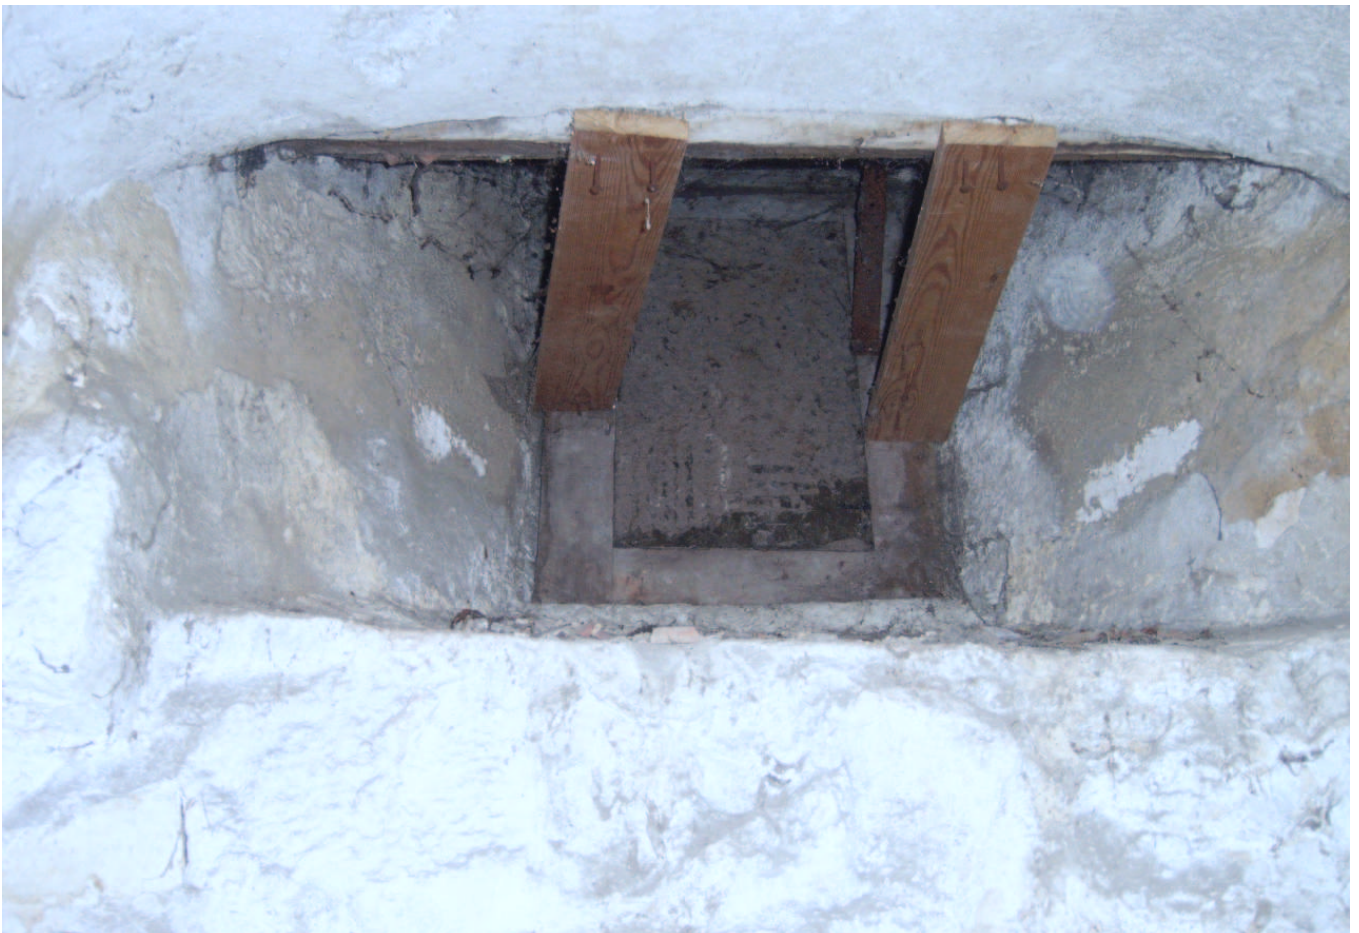
Plate 34: Blocked window at the end of passage in Area 4, facing east

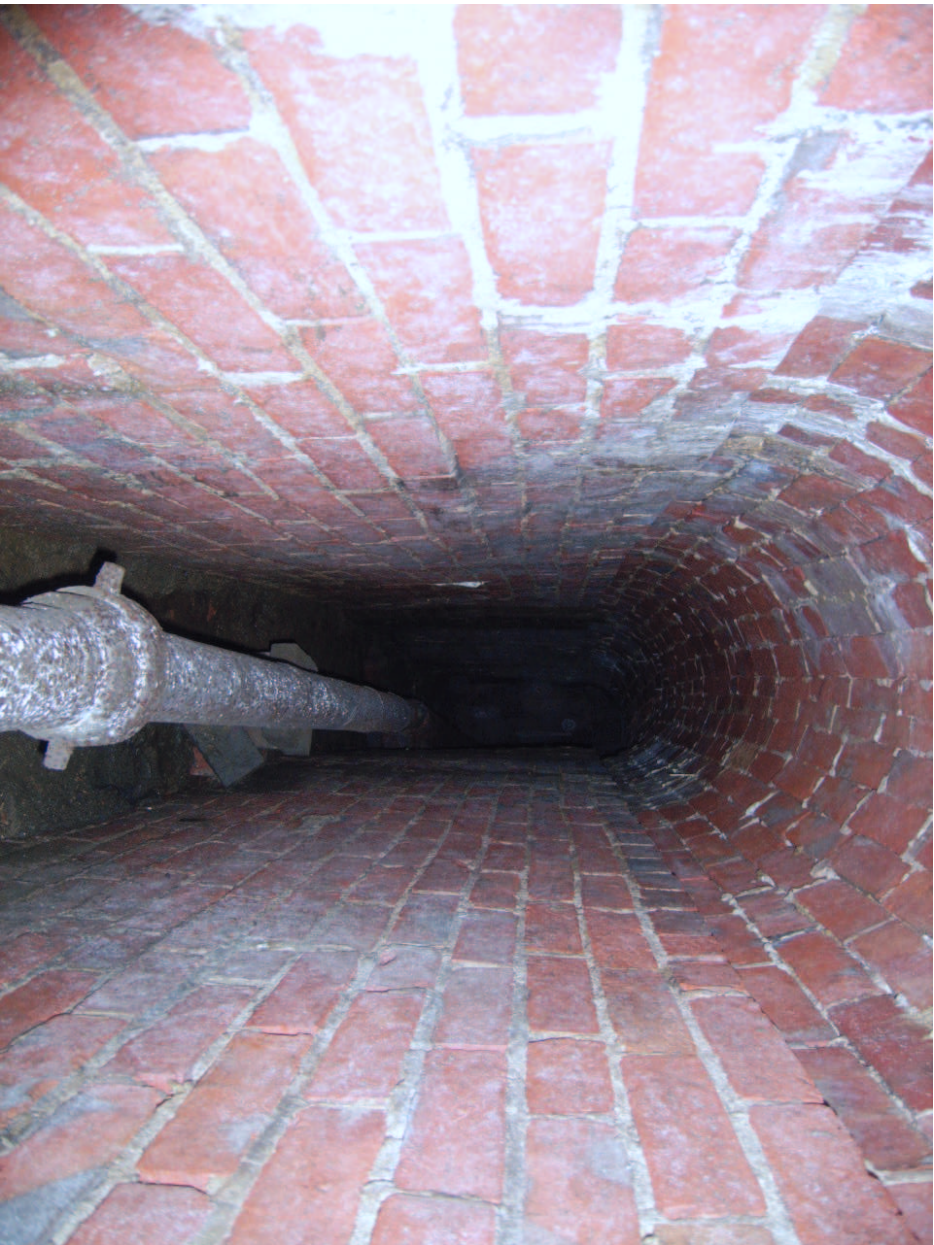
Plate 35: Drain running from east side of Area 4 under Stone Court
