Greys Court Oxfordshire

**Historic Building Analysis
Phase II:
Internal works, the floor
structures and associated
historic fabric**

**PHASE II: INTERNAL WORKS, THE FLOOR STRUCTURES
AND ASSOCIATED HISTORIC FABRIC**

**Oxford Archaeology
April 2010**

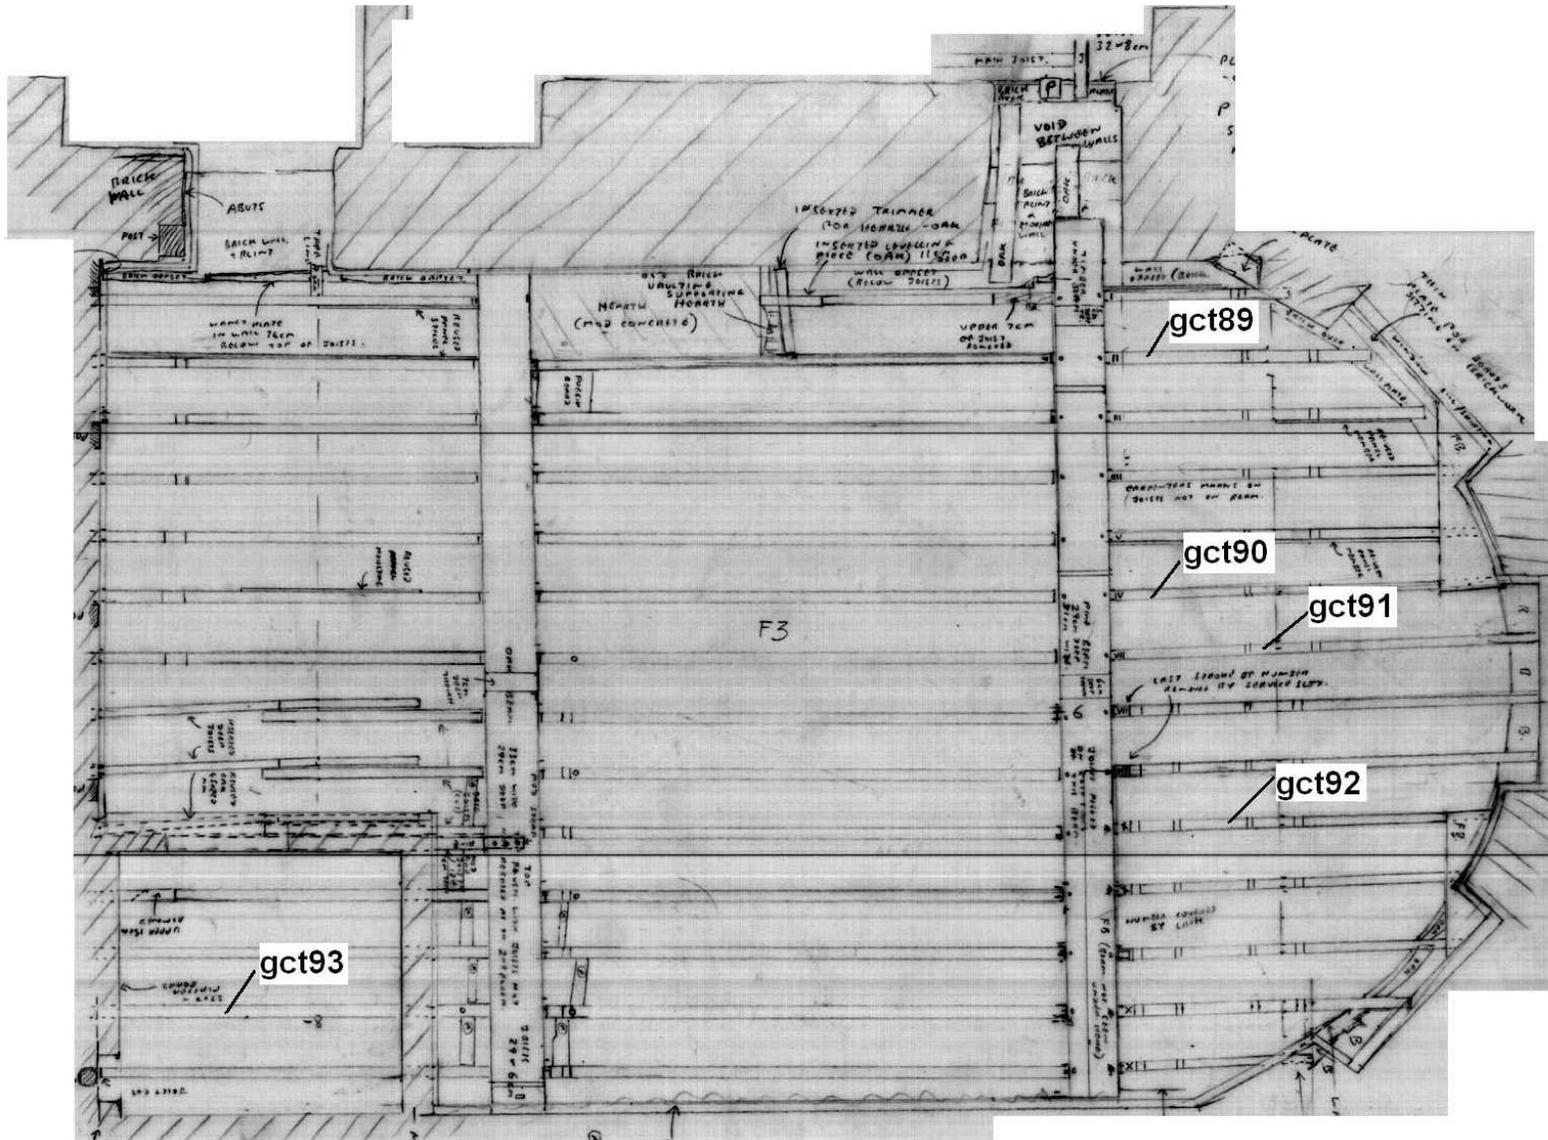
Figure 4: Room F3 floorplan, showing some of the timbers sampled for dendrochronology

A joist further toward the south end of Room F3 was also sampled, and found to have been felled in 1557-1589. A single joist in Room F4 was sampled and found to have been felled in winter 1574/75.

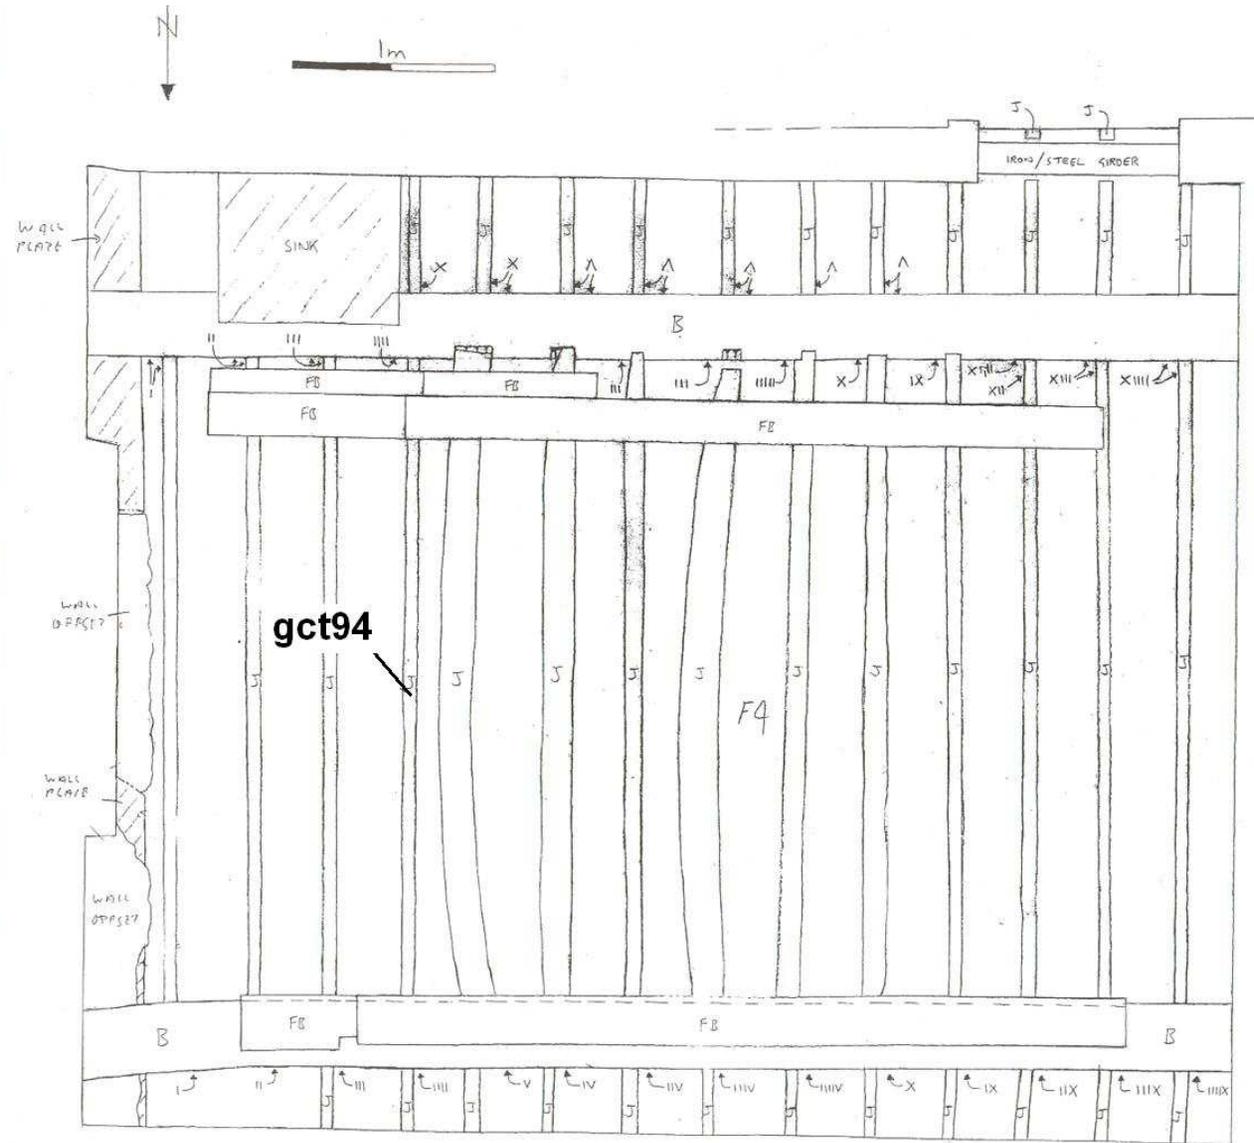
Figure 5: Floor plan of room F4, showing the timber sampled for dendrochronology

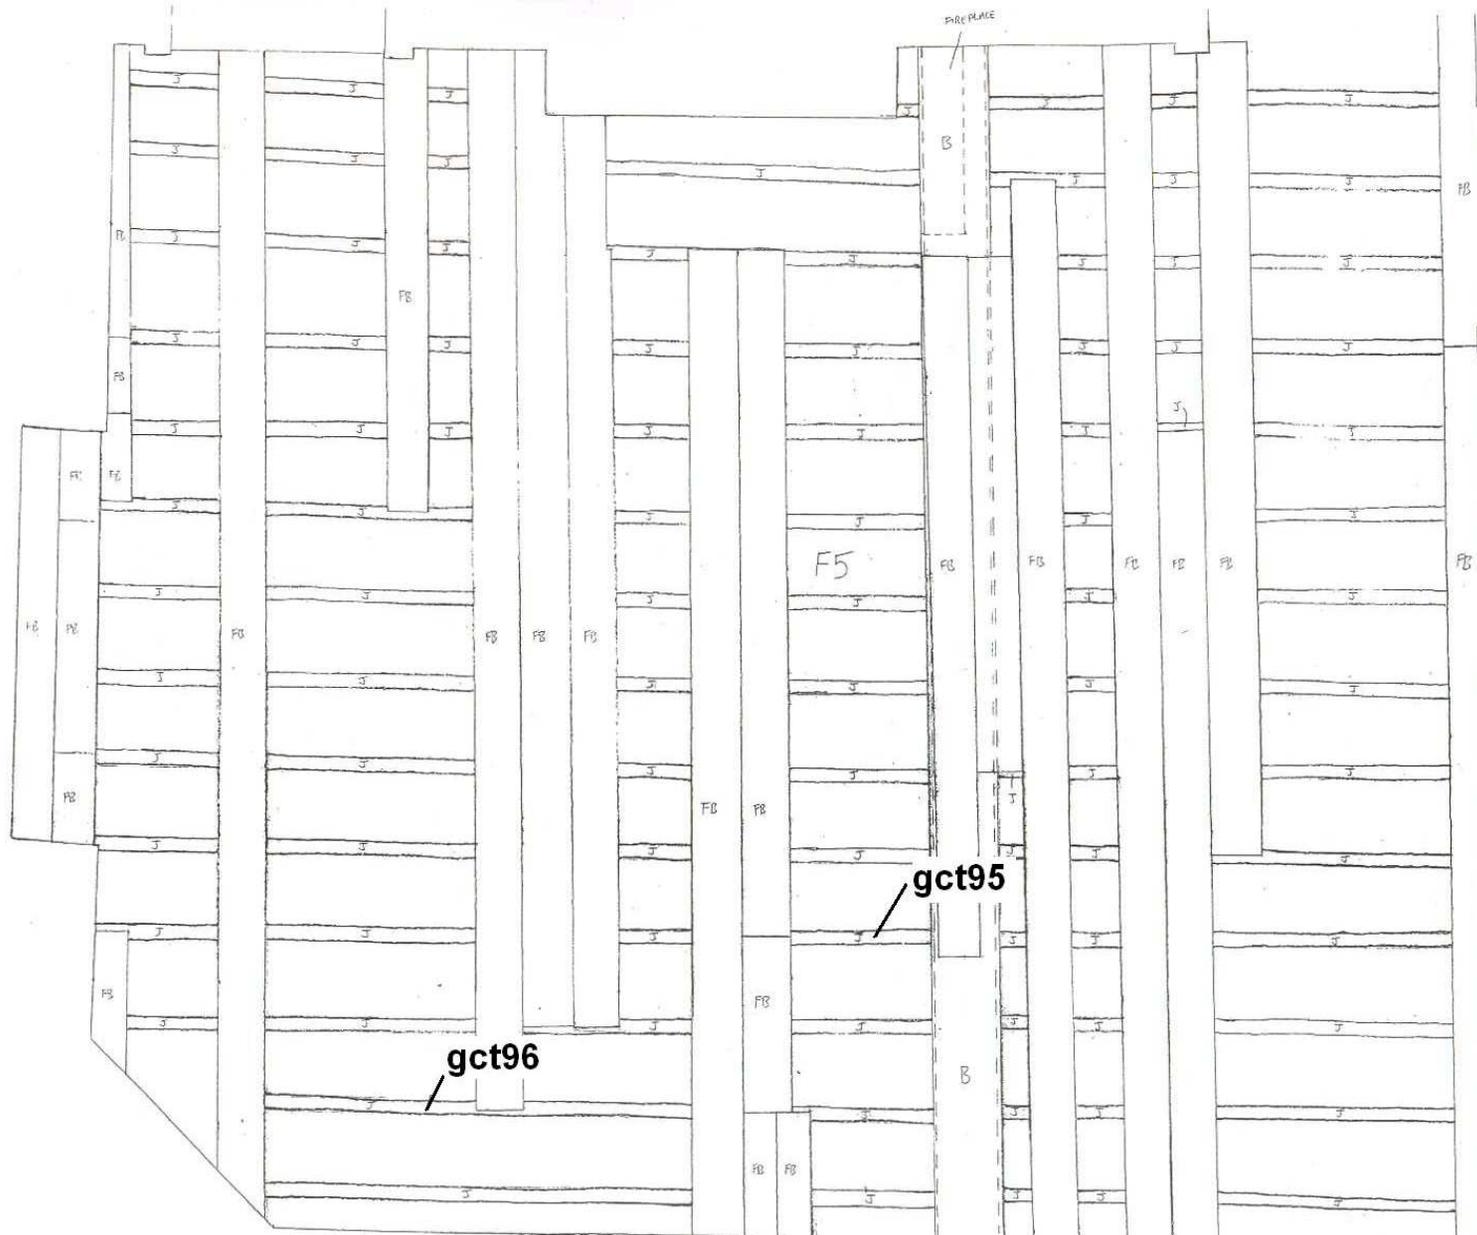
Figure 6: Floor plan of room F5 showing the timbers sampled for dendrochronology

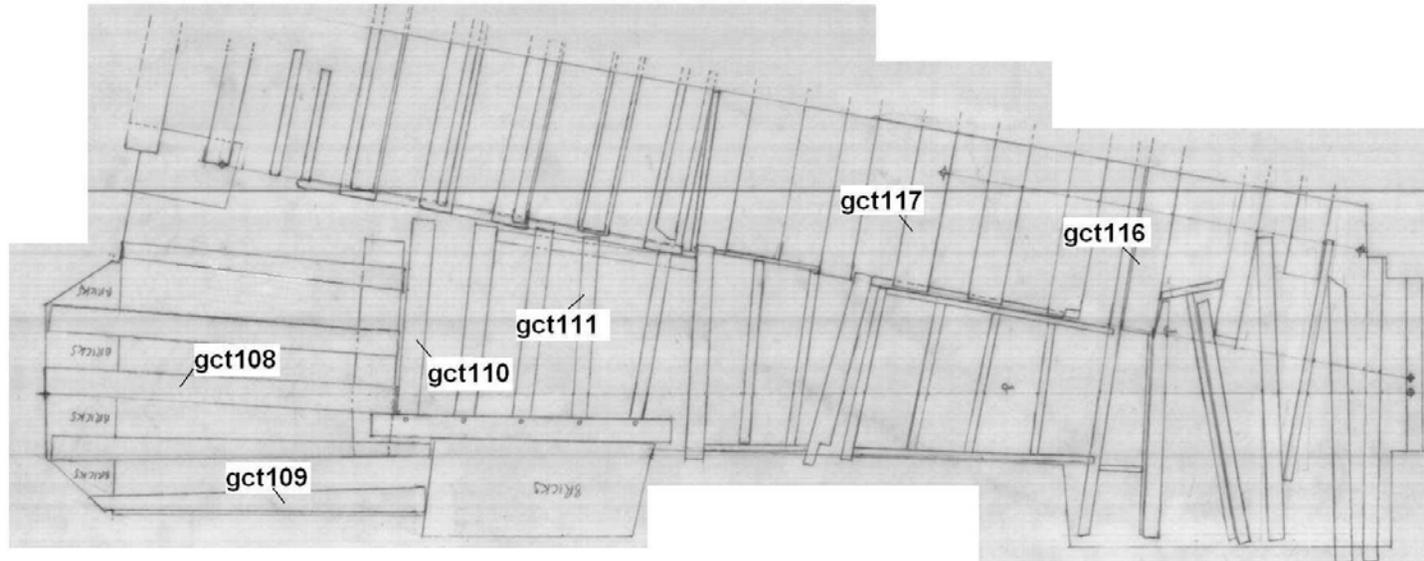
Figure 8: Floorplan of the lower floor to room F6, showing timbers sampled for dendrochronology

Three timbers from the floor of F6 dated against **GREYSCT4** ($t = 5.7, 7.0$ and 4.0 respectively). One was found to have been felled in winter 1757/58 and two in winter 1758/59. This phase is seen again in the joists to the north extension bay window, the timbers having been felled in winter 1756/57.

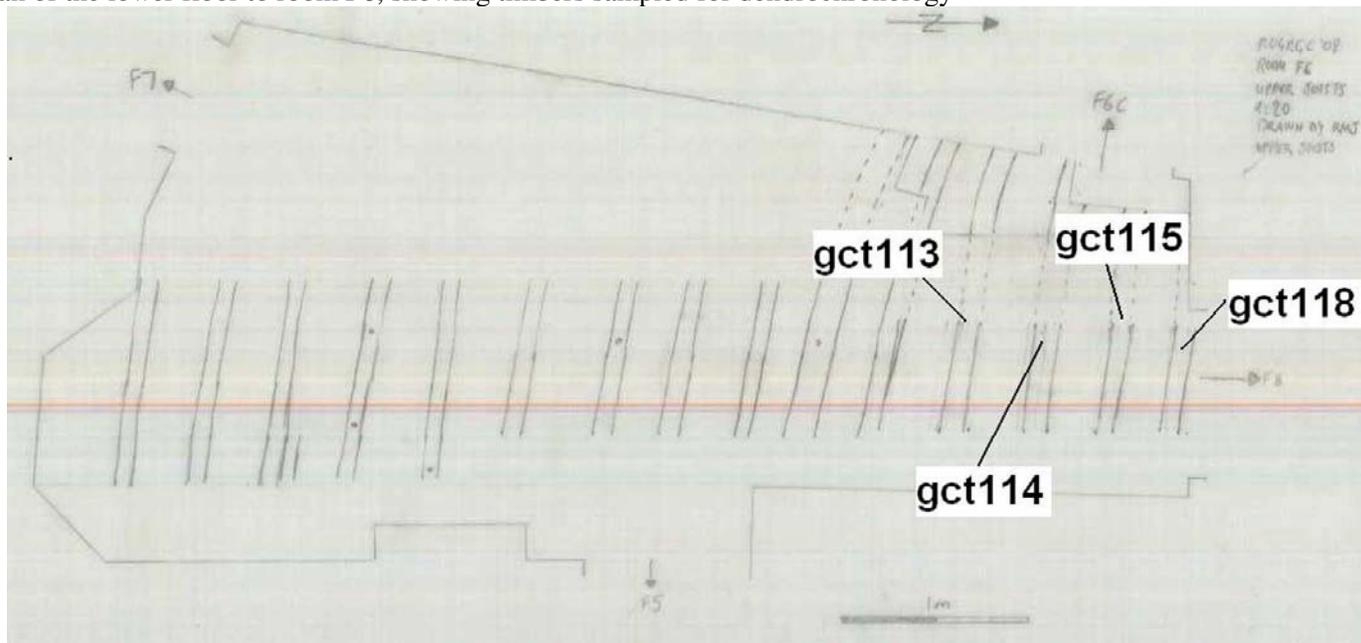
Figure 9: Floorplan of the upper floor level to room F6, showing timbers sampled for dendrochronology

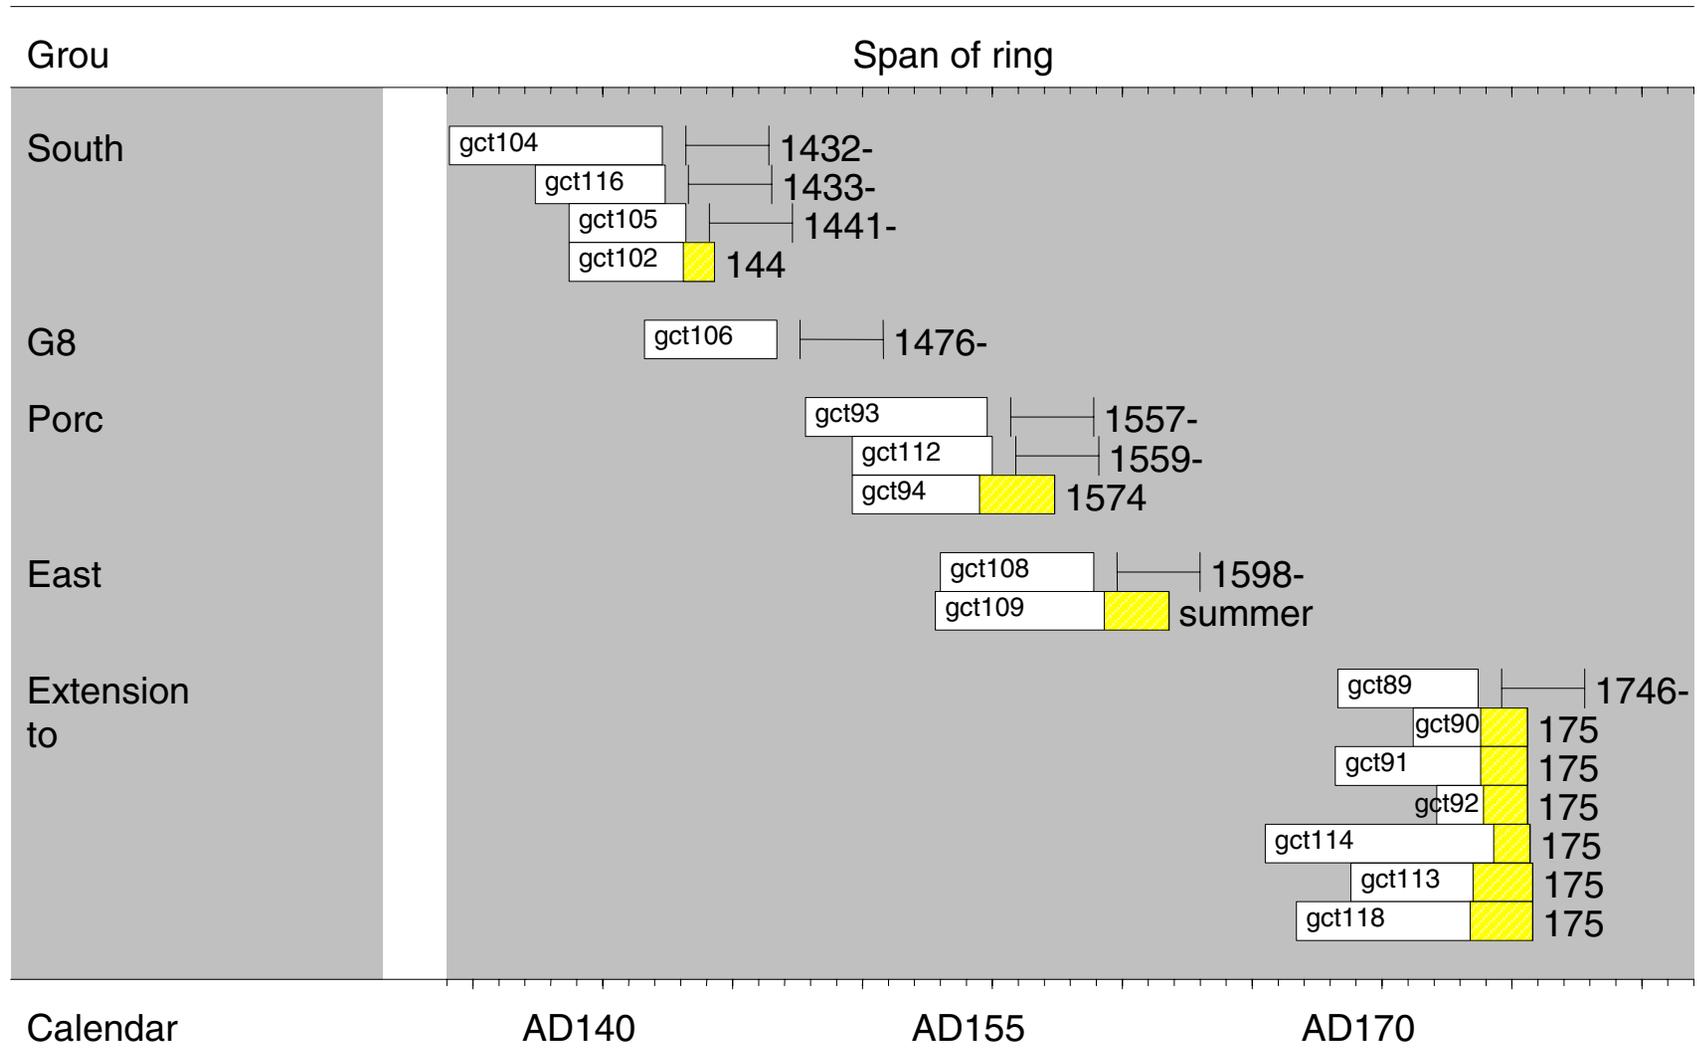
Figure 10: Bar chart showing the relative positions of overlap of the dated samples with their felling dates or date ranges, yellow portions of the bars represent sapwood rings

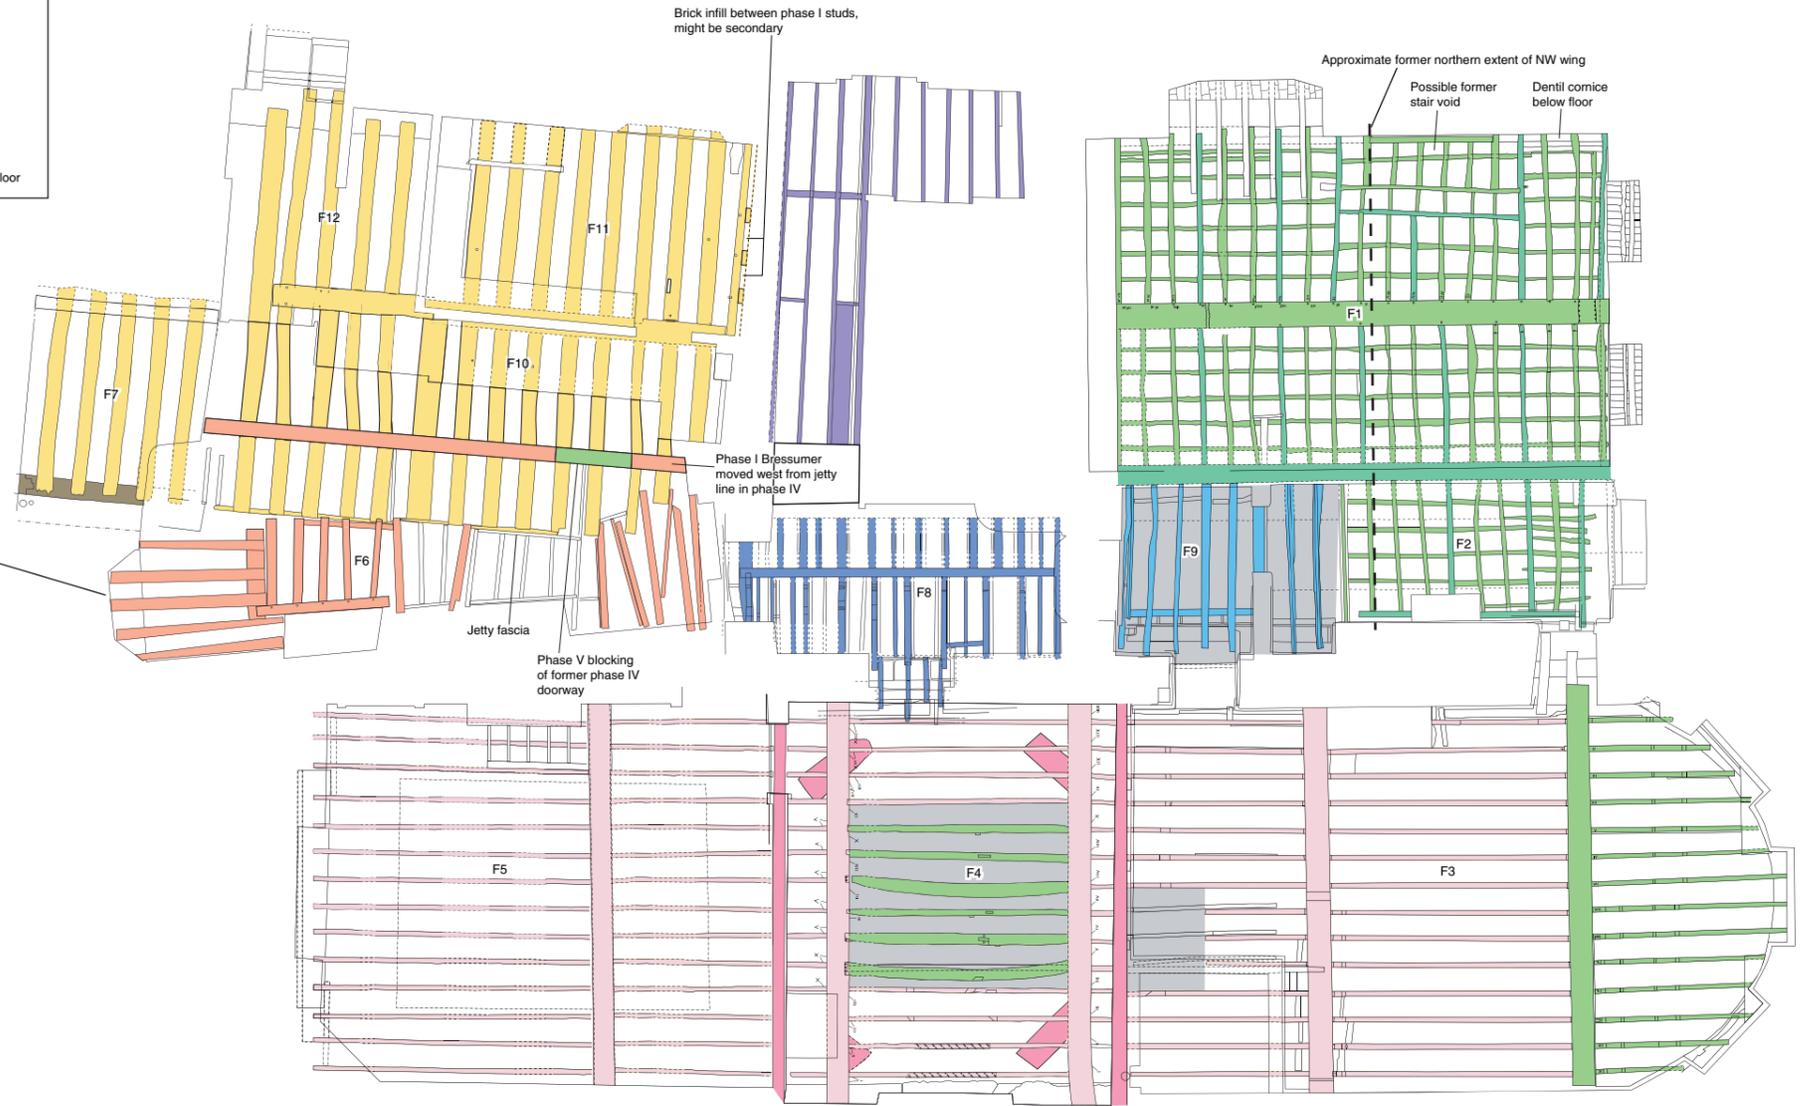
Figure 8: First floor phasing

Phase I, 1450-51	
Phase II, 1574-6	
Phase III, c.1570s	
Phase IV, c.1620	
Phase V, 1759-60	
Phase V, 16th-Century timbers re-used	
Phase VI, 18th-Century	
Phase VII	
Phase VIII, late 19th to early 20th-Century	
Phase X, 1930s insertions	
Former voids or areas where floor timbers have been removed/replaced

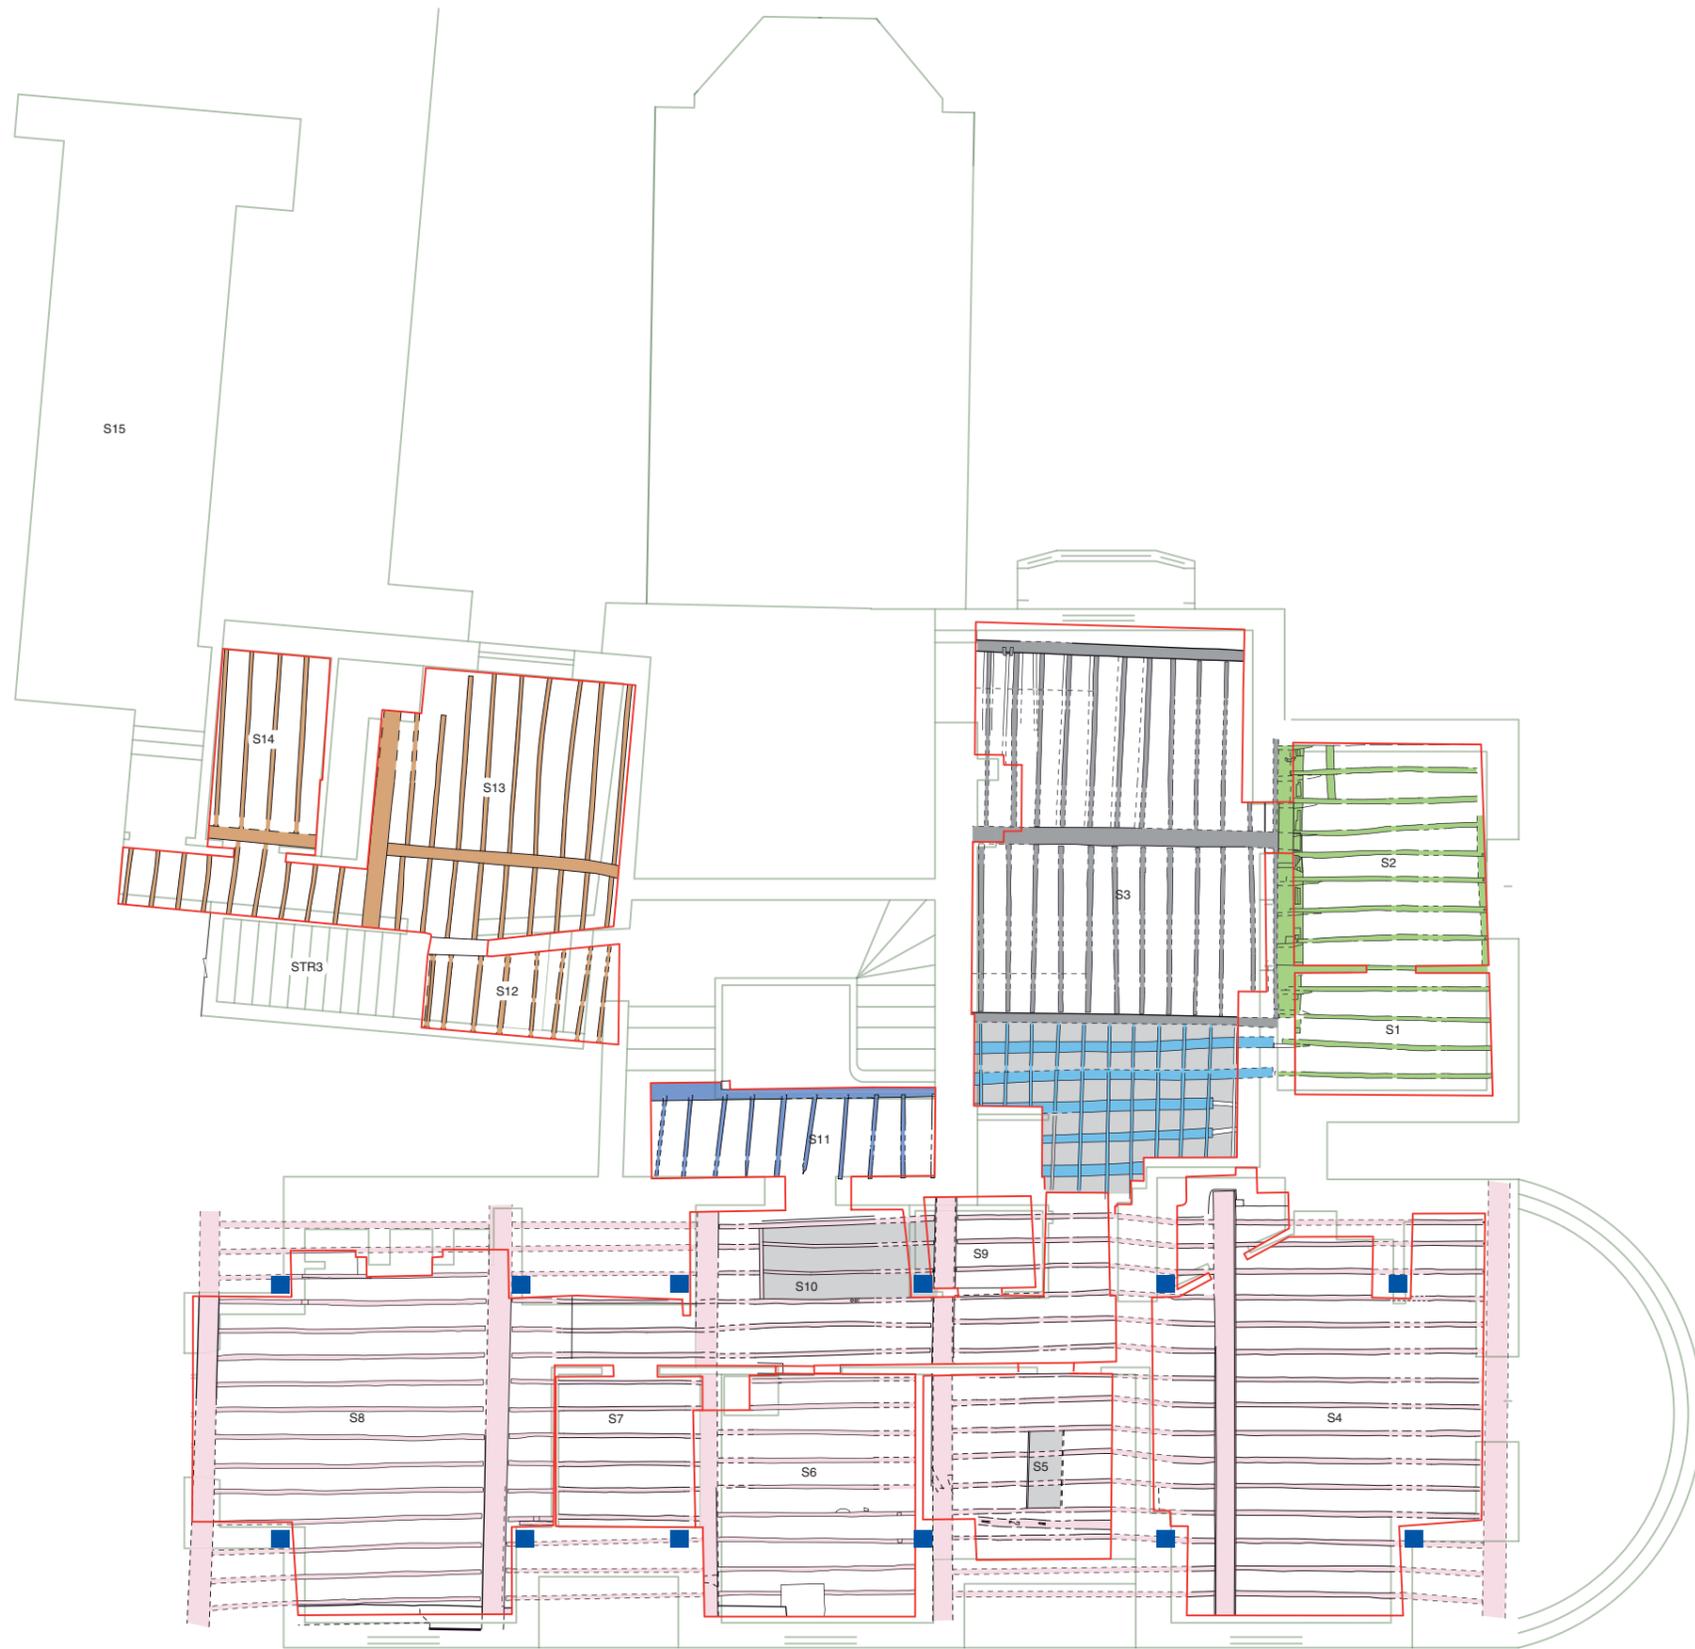
Greys Court, Oxfordshire	
Phase II, 1574-6	
Phase IIa, 1574-6	
Phase V, 1759-60	
Phase VI, 18th-Century	
Phase VII	
Phase IX	
Former voids or areas where floor timbers removed/replaced	
Approximate positions of Queen posts in roof trusses	
<p>1:100</p>	
<p>Figure 9: Second floor phasing</p>

- 3.4.28 S9 is a cupboard space divided off from the lobby area S10; the floor structure here consisted of the west end of a principal joist with common joists joined to either side (Plate 63). Two of the joists on the south are the two replacements filling the former stair void in S10 mentioned above. The south partition of S9 is located where it is due to the existence of a Queen post and interrupted tie beam of the roof structure there. Indeed the entire room partitioning of the second floor has largely been dictated by the position of the roof structure and this is illustrated on Figure 9.

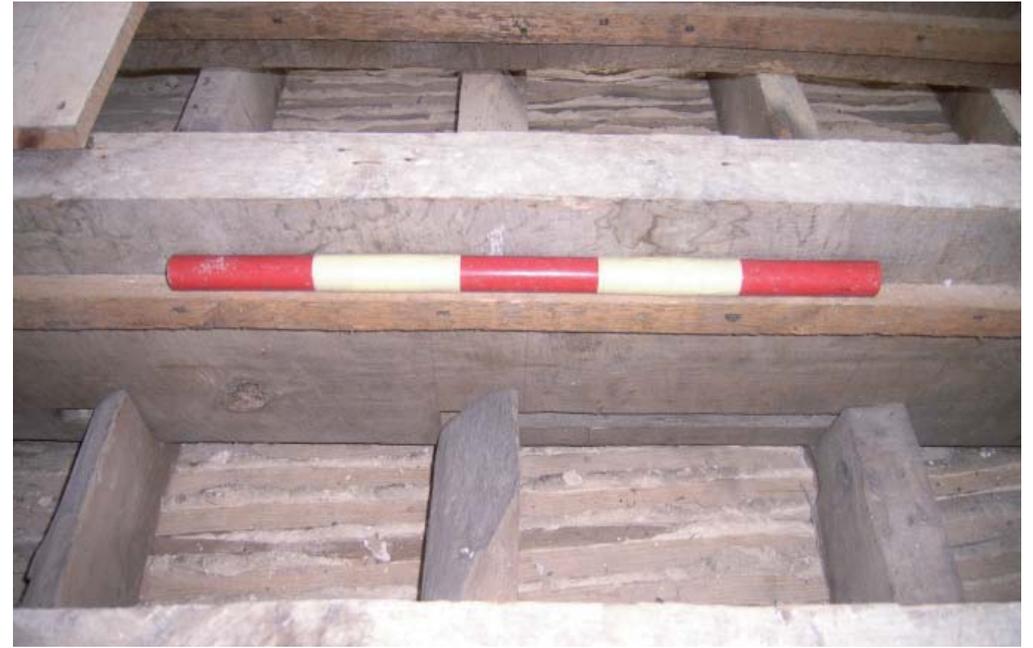
Plate 18: Example of chase or 'sliding' tenon in F1

- 3.8.25 Another feature in the floor of some interest is the use of chase (or 'sliding') tenons which are found in the sides of a number of full depth floor joists to house the ends of ceiling joists. These were common features used widely in the 18th century and they allowed ceilings to be added after the main floor structure had been constructed. One end of the ceiling joist would have been inserted into a conventional mortice in a floor joist and the other end would have been slid sideways into a long chase tenon (Plate 18).

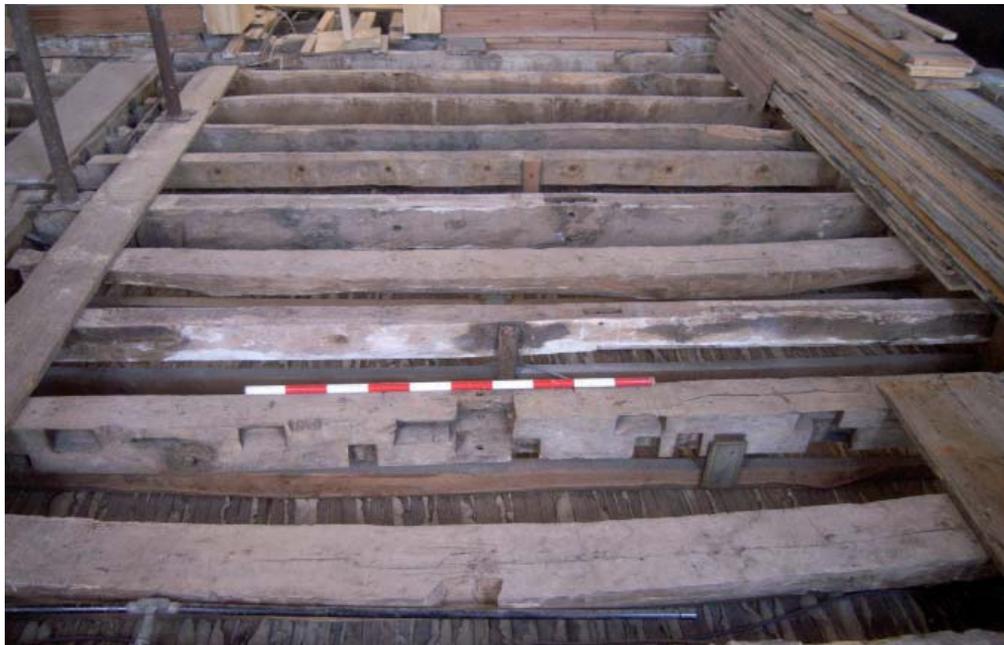
Plate 31: General view of floor in F4 looking west

- 3.8.32 F4 forms part of the continuous first floor of the east range and essentially forms part of Phase II (detailed above) but in the central section there are 6 joists (5th to 10th from east wall) which are insertions and there are double sets of thinner joists (a floor joist above a ceiling joist) rather than the full depth joists found elsewhere in the range. Constructional similarities with other works undertaken in Phase V suggest that this insertion probably dates from the 18th century (Plate 31).

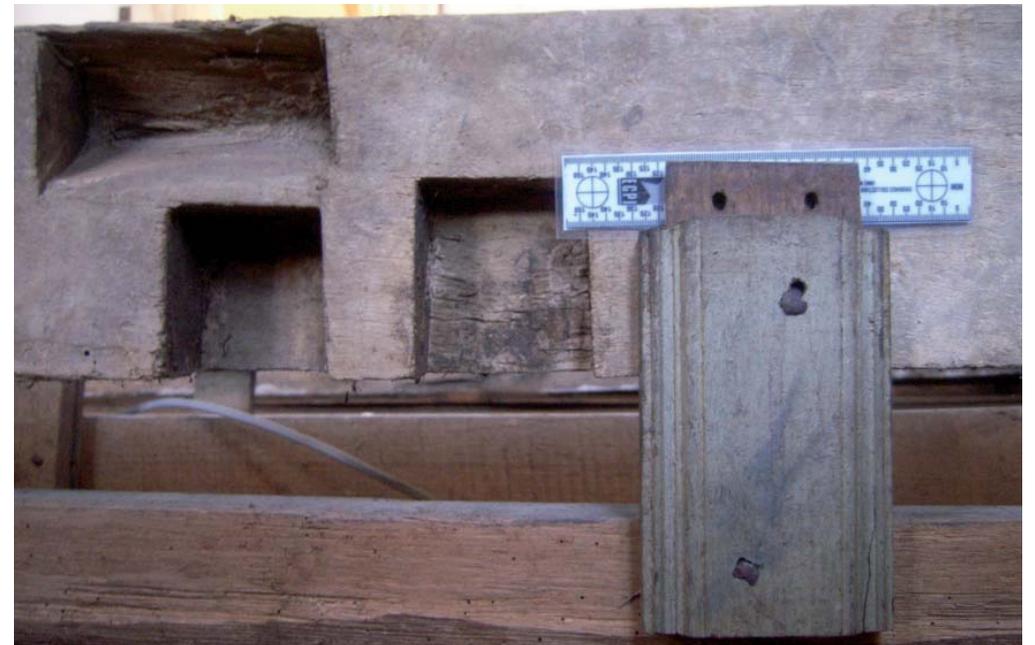
Plate 32: Detail of reused beam in F4

- 3.8.35 The fourth joist from the east has mortices in the south end of the west face which may relate to a structure by which stairs from below would have been secured. One of these mortices (near the south end of the joist) is for a diminished haunch over a standard tenon, similar to others found elsewhere in the building in the current works, which suggests that one of the original joists was reused and inserted east to west from this joist parallel to the principal, perhaps to create a landing area along the edge of the stairs. There are also three conventional mortices north of this in the joist which could have been for attaching further joists or for fixing elements of the putative stairs or other structure that was here (Plates 32-34).

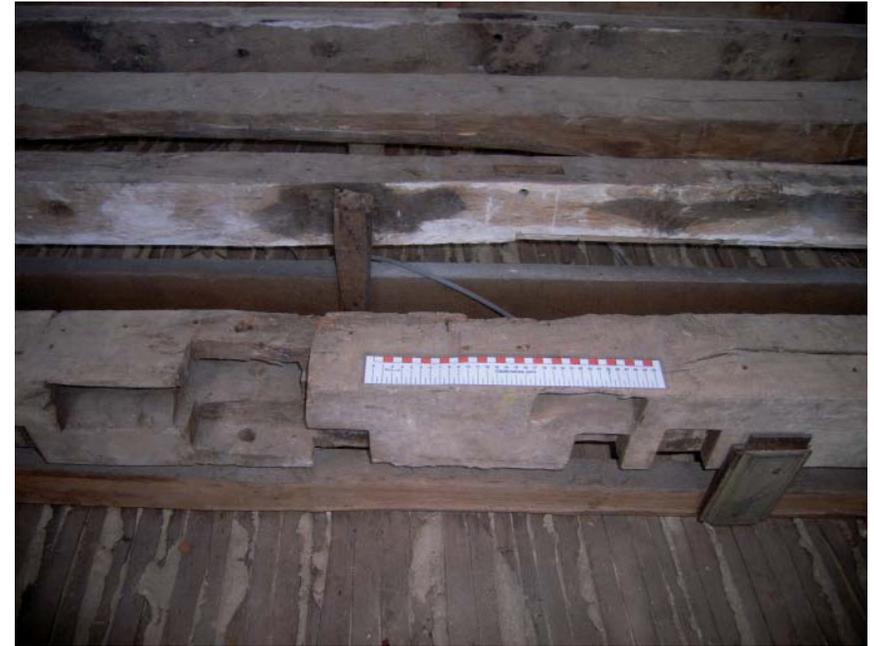
Plate 34: Detail of member in F4

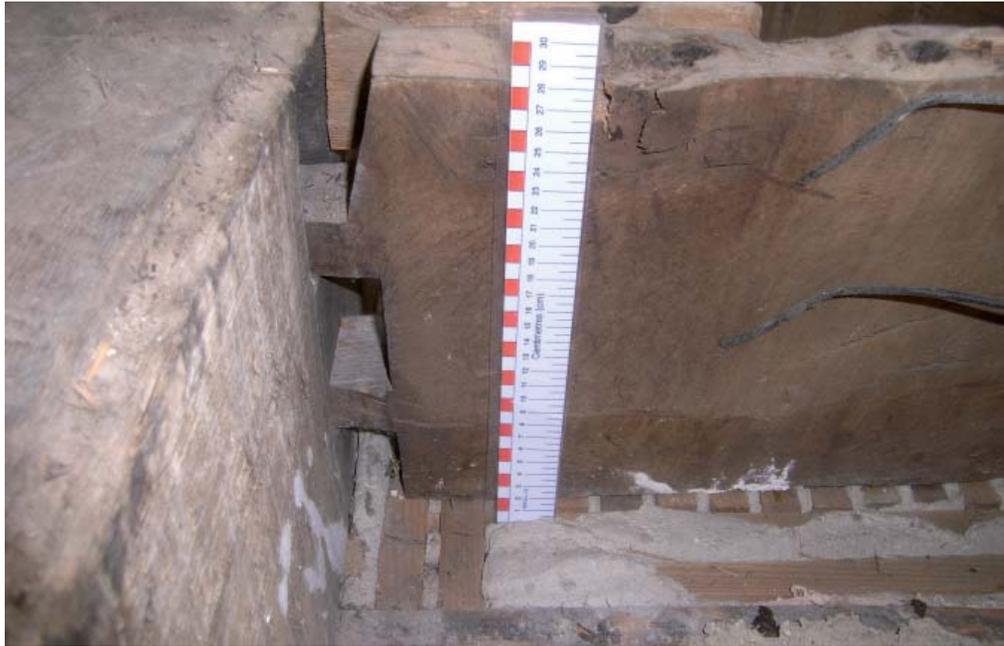
Plate 37: Detail of double-tenon joints in F5

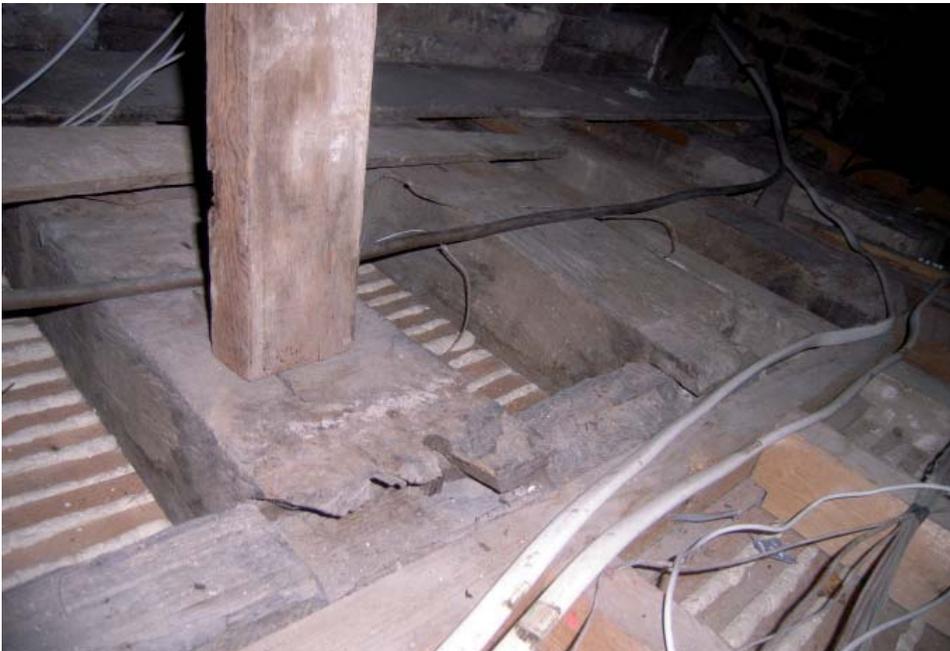
Plate 43: Medieval jetty rafters and bressummer below F6 looking north west

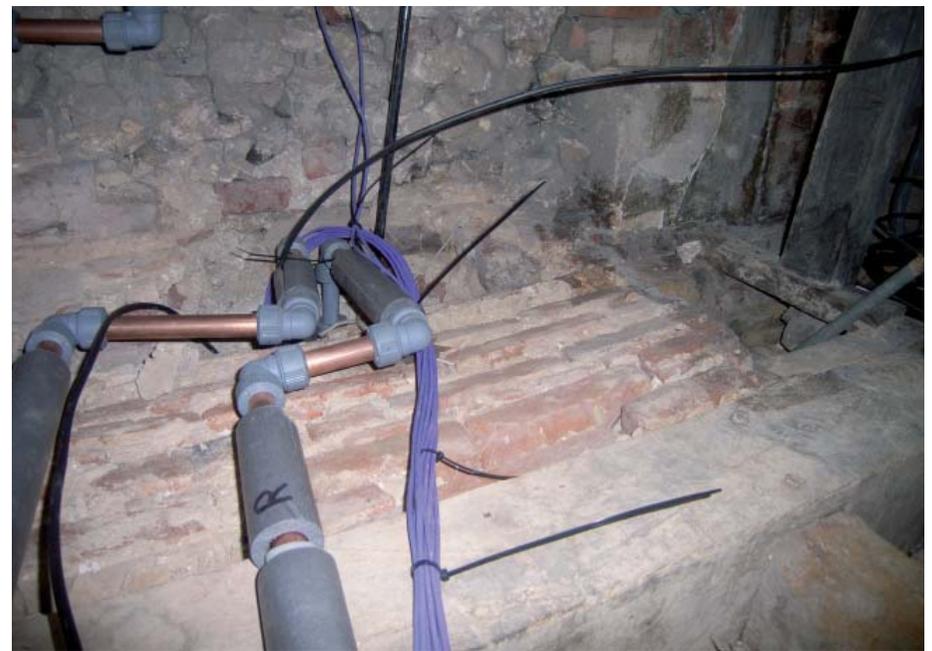
Plate 44: Top of brick arch in south wall of 16th century wing abutted by timbers of possible former link now part of lower floor of F6 looking east

3.7.7 North of the section of floor abutting the brick arch is an area of modern (20th-century) repairs to the ceiling below (i.e. when this was no longer a floor, and then further east a series of probably 17th century joists. These

were probably added at the same time as the dated porch floor was added at the south end of the room and have been included in this phase but no joists in this part of the floor or in the section abutting the brick arch have been tree-ring dated. There are empty sockets in the brickwork of the east wall in the floor void where former joists have been removed and replaced with the modern ceiling support timbers.

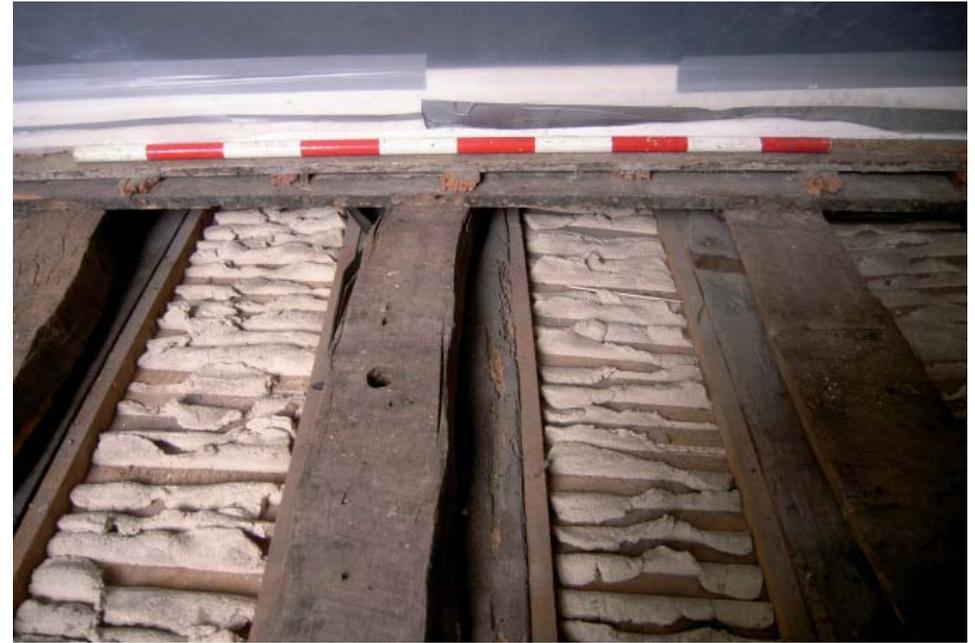
Plate 54: Joists and double floorboards (lower boards doweled) in F11 looking east

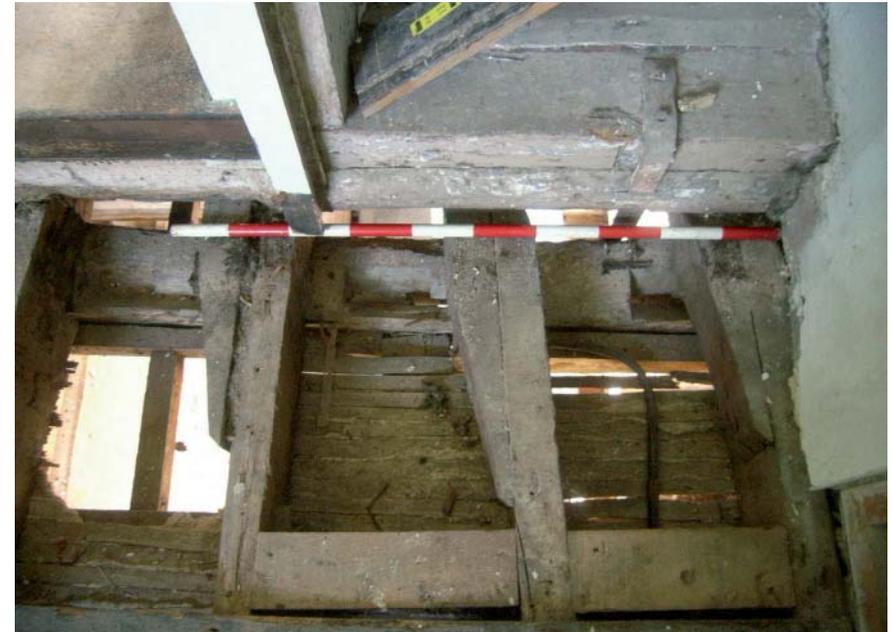
Plate 56: Detail of reused plate and joists strapped to 18th century truss room S2 looking south

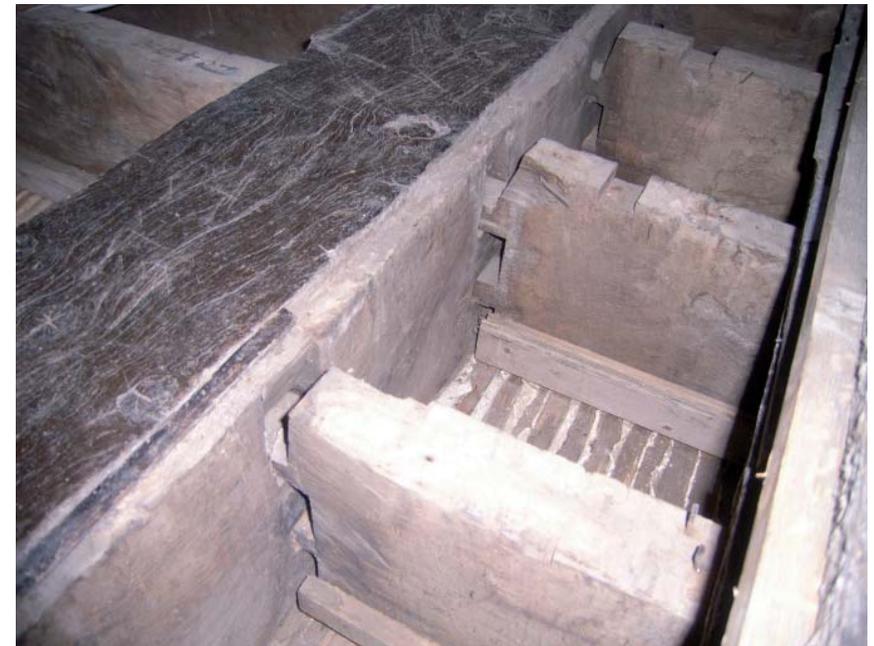
Plate 60: Detail of double-tenon joints in S4

- 3.4.24 The joists span the spaces between the beams and are joined into the beams by a double tenons at either end consisting of a diminished haunch tenon above a standard tenon, which was not unusual by this date (Plate 60). The joists needed to be as deep or nearly as deep as the beams in order to allow application of ceilings which covered the joists and the beams. Thus fine decorated plaster ceilings could be created within a room without the ceiling area being broken up by a beam or beams as often occurs in lower status or older ceilings.

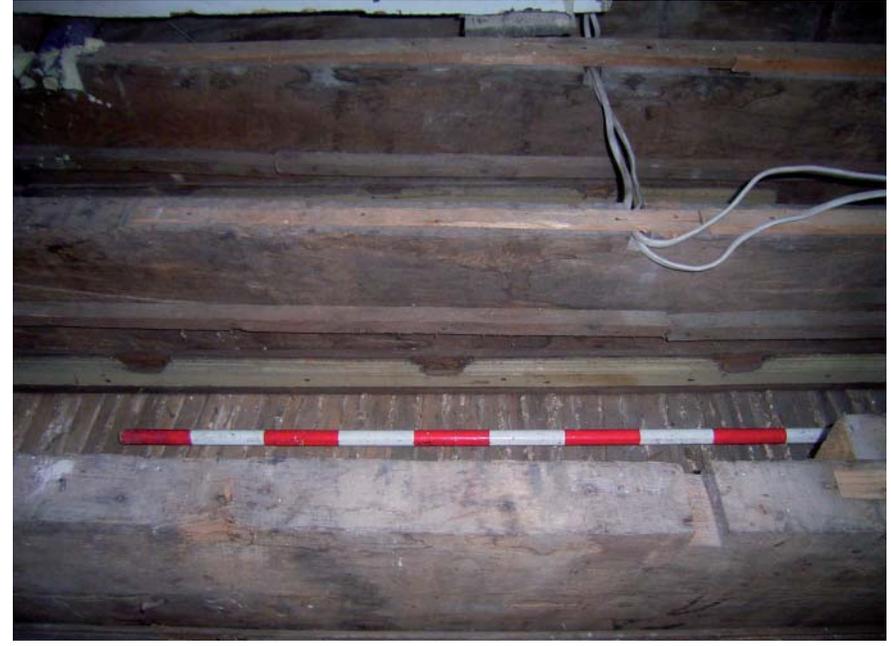
Plate 62: Joists in S8 showing reuse of moulding bars from panelling looking west

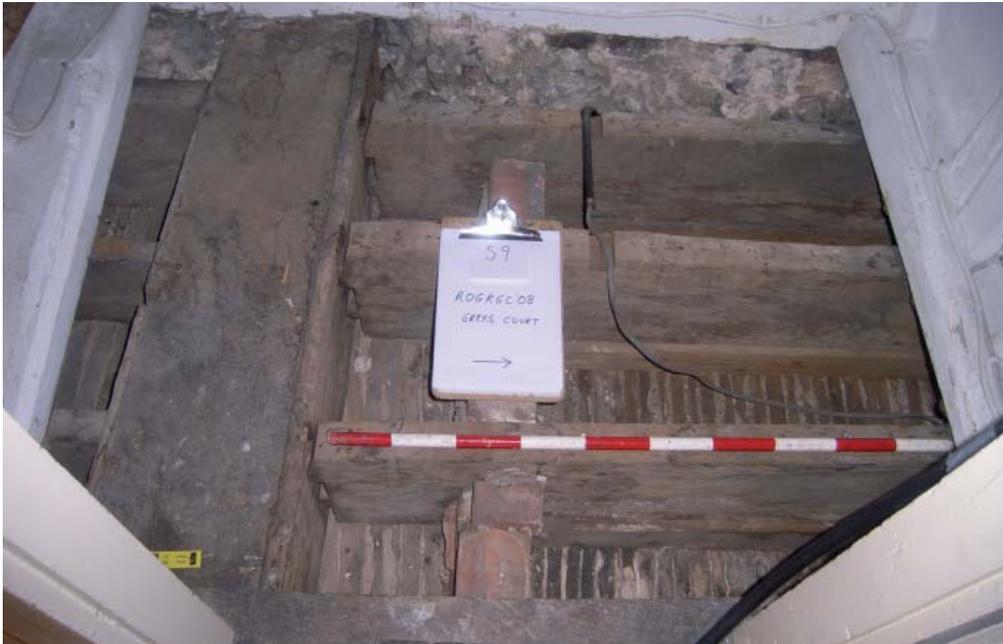
Plate 63: Joists in S9 looking west
