Greys Court Oxfordshire

**Historic Building Analysis
Phase II:
Internal works, the floor
structures and associated
historic fabric**

**PHASE II: INTERNAL WORKS, THE FLOOR STRUCTURES
AND ASSOCIATED HISTORIC FABRIC**

**Oxford Archaeology
April 2010**

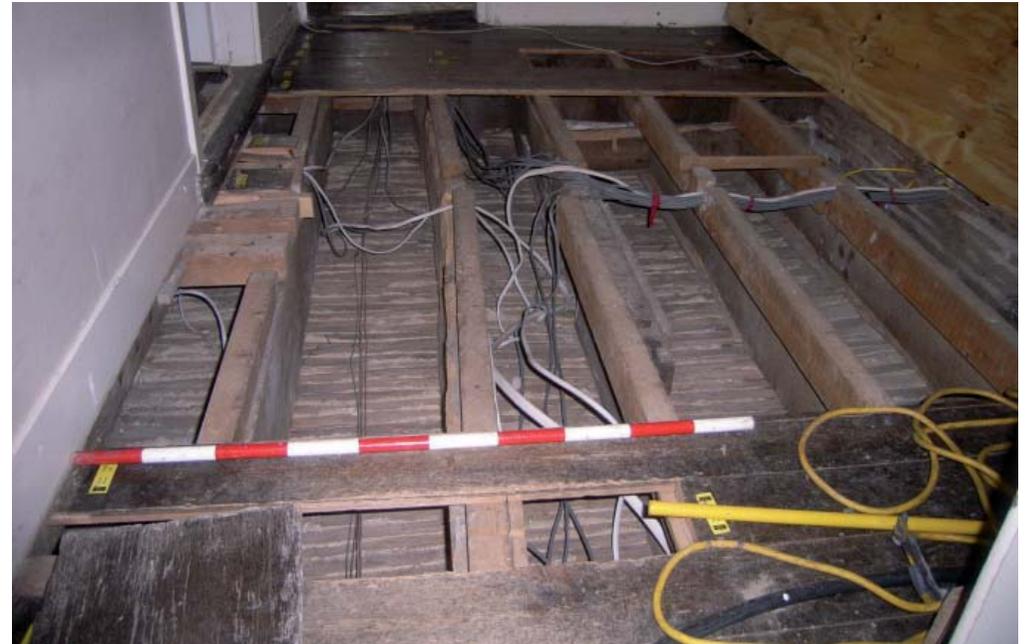
Plate 64: View in S10 looking south

- 3.4.27 Similarly in room S10 large sections of the primary second and third joists from the west wall were removed. The south ends of these two joists measuring about 0.5m in length remained *in situ* and had a thin trimmer attached to their ends. The trimmer retained traces of lath and plaster. The north parts of the joists right up to the next beam to the north appear to have been removed and later replaced with two slightly narrower replacements (Plate 64). Removal of the two joists and insertion of the trimmer would have given a north-south oriented rectangular opening of approximately 1m x 2.5m which would give enough space for a small stair down to the first floor. There is no visible evidence of attachment of any stair structure. However it is possible that the empty mortices left in the beam when the two primary joists were removed were utilised for this purpose. These are now being used by the

- replacement joists therefore any evidence there is concealed. Also the joist on the east side of the opening has been reduced in two areas; at its north end adjacent to the beam the lower part of the beam 14cm deep by 1m long has been removed and at the south end of the opening the upper part of the joist of the same dimensions has been removed. The reasons for this is almost certainly connected with the opening and but the precise function of these two slots and how they relate to the construction of a former stair is unclear.
