# ROYAL VICTORIA MILL DARTFORD KENT

HISTORIC BUILDING RECORDING

# ROYAL VICTORIA MILL, DARTFORD, KENT

## HISTORIC BUILDING RECORDING

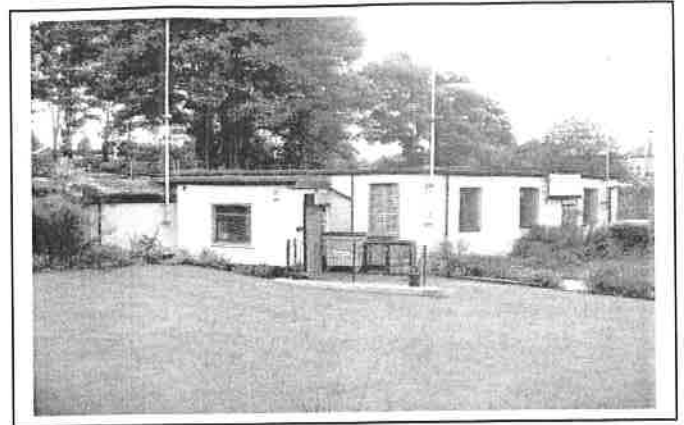
**Plate 6:** Former mill viewed from north-east

3.3.1 The *north elevation* (Pl.6) is covered with a thick cement render with 'ashlar' grooves and a small section of this render was removed to reveal red brickwork. The elevation has three windows each of which has eight lights, a softwood frame, a tiled sill and appears to be of early 20<sup>th</sup>-century date.

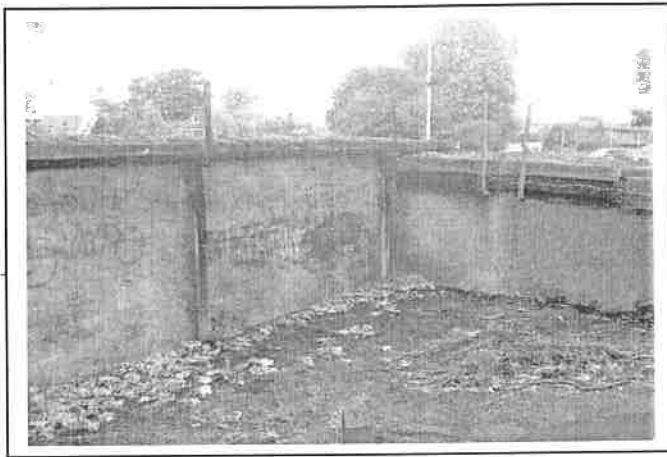
**Plate 7:** East wall of former mill (to left) and rear face of front wall of former mill house

3.5.1 As referred to above in the historical background section and map analysis there was formerly a small group of buildings adjoining the mill to the east (including the mill house) and sections of the front (north) wall from these buildings survive. Two sections of the front wall survive with a northwards step between them from two historic buildings. The recessed section of wall,

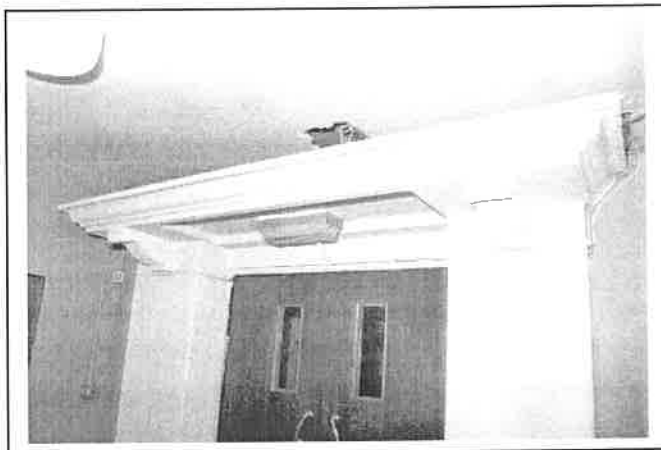
**Plate 8:** Bracketed porch (now internal) probably added in C20th

3.4.2 Another feature of some interest, although not apparently significantly historic, is a large bracketed stone porch (Pl.8) over the original doorway at the north-east corner but which has now been enclosed by a small 1990s extension (see below). As referred to above this doorway, where carts would have been loaded from above, would have been largely hidden by the overhanging floors above and it appears unlikely that an attractive architectural feature such as this would have been located at this hidden utilitarian doorway. Although the historic photographs are not totally conclusive they also suggest that there was no such porch in the early 20<sup>th</sup>-century and it appears that it was added in the mid 20<sup>th</sup> century.

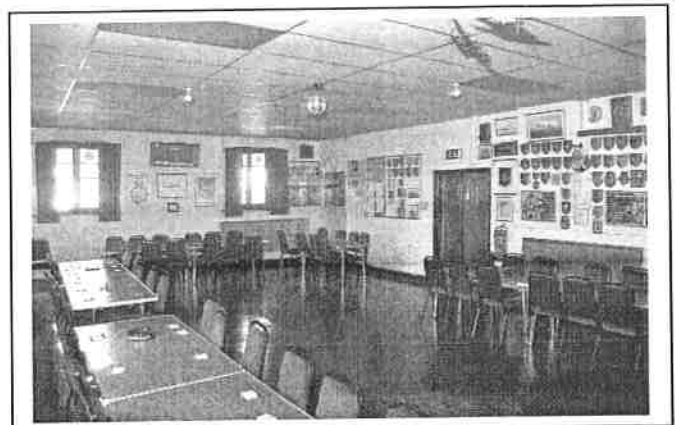
**Plate 11:** Interior of hall

3.4.1 The interior has been substantially altered in the 20<sup>th</sup>-century post-mill phase of the building and only limited evidence survives from the building's historic phases. The internal plan divides east - west into two main areas: to the west half is an open hall (Pl.11) and to the east are several smaller areas providing utility spaces. The surfaces, decoration, and visible features in the western hall all appear to date to the mid 20<sup>th</sup>-century (or later) and there are no visible features of historic significance. The eastern half contains features of more interest although it again has been substantially redecorated in the later 20<sup>th</sup> century. The feature of greatest historic interest is the enclosed former mill stream within the kitchen which is represented by an up-standing ledge (c.1 m high by c.1m wide) now covered with a stainless steel work top and modern tiles. There also survives three relatively historic doors to rooms in the western half of the structure (to the kitchen and toilets) with ovolo-section glazing bars probably of late 19<sup>th</sup>-century date.
