WADHAM COLLEGE FRONT QUAD, OXFORD
ARCHAEOLOGICAL AND PHOTOGRAPHIC RECORD IN ADVANCE OF ALTERATIONS

OXFORD ARCHAEOLOGICAL UNIT
MARCH 2001

| NMR DATA | |
|---|---|
| SITE NAME | SOUTH RANGE, FRONT QUAD |

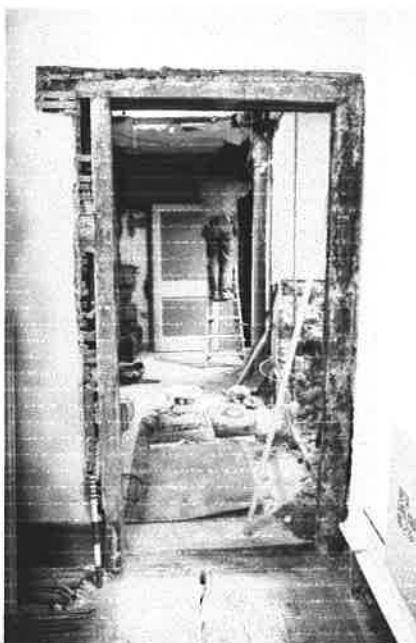
Plate 5: Reopened historic door, east wall of the JCR

3.1.2.2 During the opening up for a new door to the 'New Pantry' to the south side of the east wall of the JCR the wooden frame of a former door was rediscovered (Plate 5). This door is shown on the 1848 college plan giving access to a Scouts room.

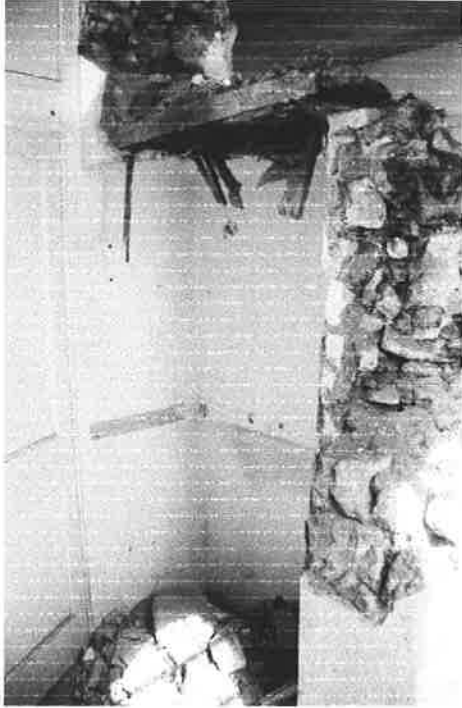
Plate 7: Blocked doorway in former Scouts room at east end of south range

The new lift for wheel chair access was inserted at the east end of the south range behind Stair 4. In the 1848 plan of the college the area is marked as a Scouts room. A number of structural observations were made in the east wall of the room prior to and during its partial demolition. The recess seen in the plan to the north of the wall was a blocked doorway (Plate 7). The blocking was of modern materials and the door itself post dates the 1846 plan, but is visible on the 1939 plan. The internal partition wall was seen to be constructed of limestone rubble with a core mortar of red/brown earth, with the wall surface pointed with lime mortar. This wall was seen to be of a separate construction to the ashlar walling of the exterior wall (Plate 8). The rubble wall had also truncated the eastern splay of the window with the resultant squared jamb shown correctly on the 1939 plan in Figure 1. The rubble wall, however, is likely to be of the initial 1610-13 building phase and the difference in build suggests that the external shell of the building was constructed as a separate stage of the building process with high quality materials

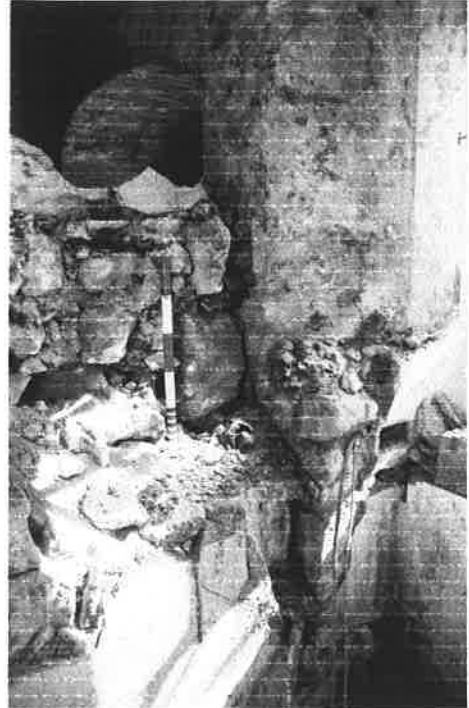
Plate 8: Straight joint between external ashlar construction and rubble internal partition wall, location as Plate 7

and that later the internal partition walls were constructed with poorer materials.
