EXETER COLLEGE HALL
ARCHAEOLOGICAL WATCHING BRIEF

OXFORD ARCHAEOLOGICAL UNIT
MARCH 2001

NMR DATA	
SITE NAME	THE DINING HALL
ADDRESS	EXETER COLLEGE
TOWN	OXFORD
PARISH	OXFORD
COUNTY	OXFORDSHIRE
NGR	SP 51457 06350
LISTED STATUS	GRADE I
VISIT/SURVEY DATE	9TH-14TH APRIL 1997
OAU SITE CODE	OXEXCO 97

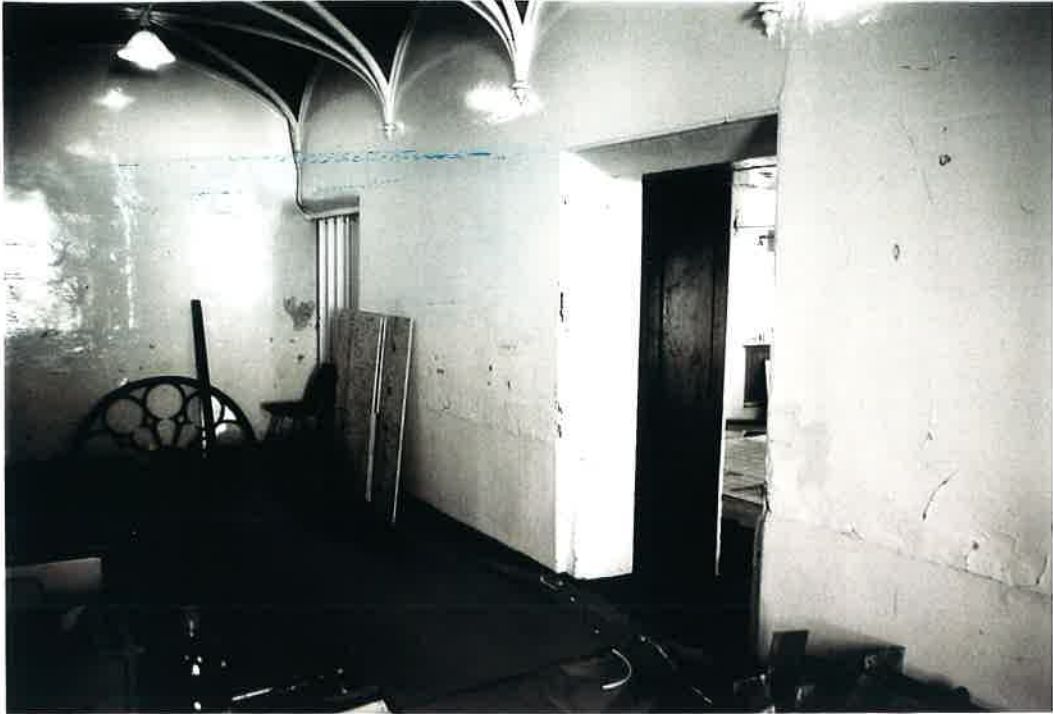
Plate 1: Screens Passage: existing doorway and area of investigation

- 4.1.1 The new doorway is 66 cm south of the existing original stone doorway which leads from the Dining Hall Entrance passage to the Servedy (Figure 2 and Plate 1). The new opening has been designed to match this door. An area of wall from the original northern door to the southern extent of the new opening was to be demolished giving a total investigation area of 188 cm in width by 203 cm on the east and 209 cm on the west in height. The wall had an overall thickness of 89 cm. Described below are the layers that made up this thickness.

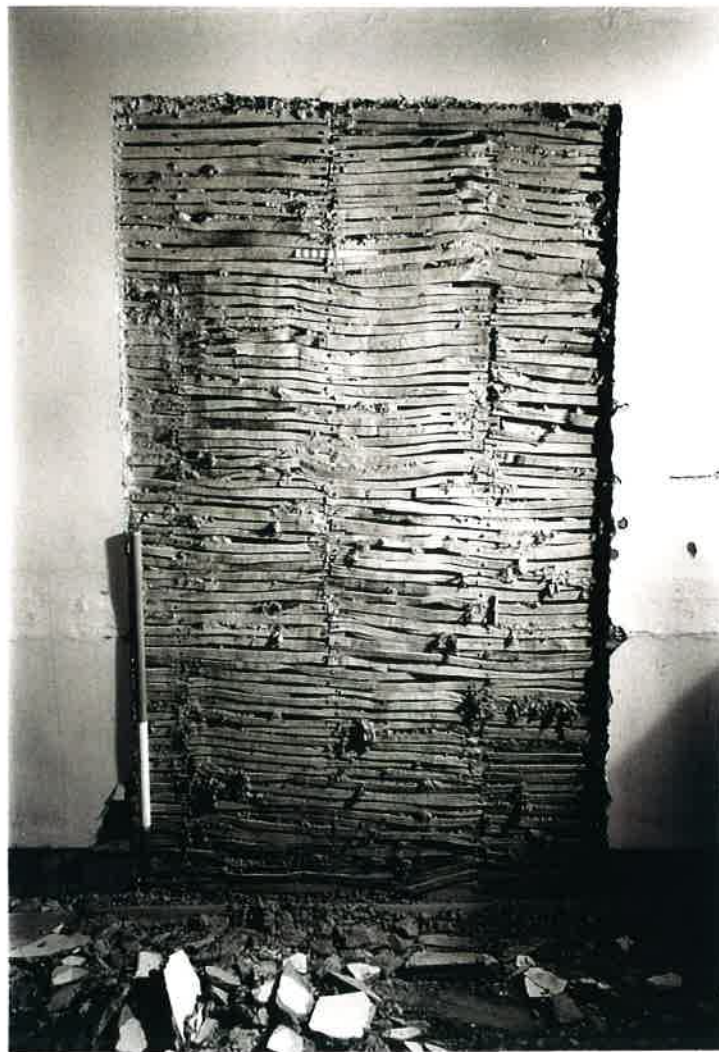
Plate 2: East side - Lath and stud base for plaster surface

- 4.2.3 Part of the current plaster surface on the eastern side of the new opening is attached to the stone wall by the means of a lath and stud frame work (Plate 2 & Figure 3). The studs that were removed measured on average 7 cm wide by 2.5 cm in depth, the height of the studs was not discovered as they were sawn off at upper extent of the investigation area, 203 cm from the modern floor. The studs were housed in recesses that cut through the limewashed plaster surface (4.2.2) and the stone wall (4.2.1). This brought them flush with the earlier plaster surface. Wooden dowels were inserted into drilled holes in the stone wall (4.2.1) and the studs were nailed to these wooden dowels and so attached firmly to the wall. The studs were spaced roughly every 36 cm with a smaller gap between them near the existing door. Figure 3 shows the grouping of lath attachments. The normal pattern was for a block of laths, c.50 cm by 77 cm wide, to span three of the studs being attached to the outer most two. The block arrangements alternated like brick work ensuring that a strong framework was maintained (Figure 3). The oak riven laths were closely spaced to form a key for the lime plaster and nailed onto the studs with handmade nails (0.8 cm heads, 2.5 cm tails). The laths continued below the modern floor level suggesting that the original floor level was lower than the present one.

- 5.3 The eastern side of the wall was originally finished with a lime mortar skim applied directly onto the stone blocks. This surface was whitewashed with a black pigmented wash covering the skirting area of the wall. At a later date a new plaster surface was put up on a framework of studs and laths. The studs were recessed into the wall to provide a secure fixing of the new wall surface, to ensure that the wall was not thickened too much by the new surface and to correct for the leaning in the stone core of the wall. The channels that were cut to recess the studs went through the older plaster layer and cut into the stone itself. This layer in turn failed along the lower and most vulnerable area of the wall and was replaced with a modern grey concrete known to be very hard wearing. The concrete was put on over the lath and stud work but had its own metal gauze acting as a key.

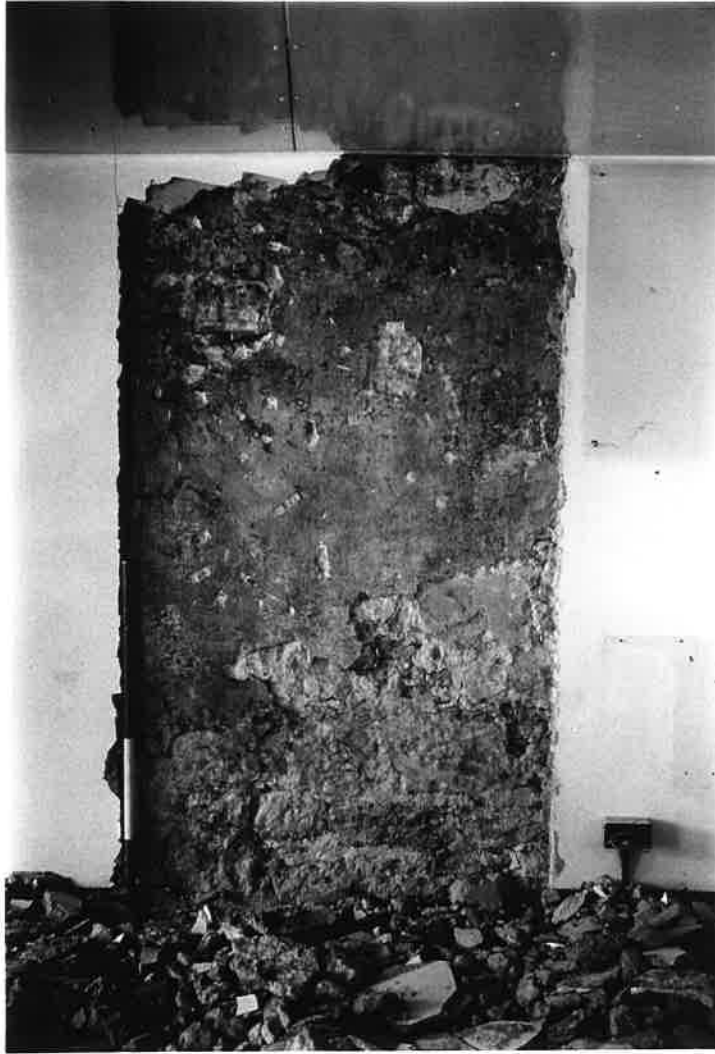
Plate 6: West side - Plastered and washed surface

4.3.2 Applied directly onto the rubble wall was a layer of lime mortar 1.5 cm thick. This layer was covered in a substance that was greyish, purply blue when dry but brown when wet. Although it seems likely that it was a pigmented limewash it may have been a layer of dirt. Beneath this coloured layer there was evidence of white wash. The plaster was very strong, a creamish white colour with no visible inclusions. Also present was a different type of lime mortar/plaster. It was cream in colour with red hair seen in clumps and a very small amount of rounded pebbles 0.5 cm in diameter. The relationship between the two mortars is unclear. At the upper area of the wall the haired type seemed to be applied over the white inclusion free type but then over the bottom half of the wall the haired type was directly applied to the wall surface. Neither seemed to go all over the surface area being investigated. The haired type may be an undercoat to the white inclusion free type although they often appeared to have the opposite stratigraphic relationship. To the northern edge of the wall by the replacement quoins an area of surviving paint work was exposed. The area measured 6 cm wide by 80 cm in length. The pattern was made up of two shades of brown paint; an undercoat of dark beige with an upper coat of swirling brushed lines in dark brown. Under this finish other colours could be seen; a dark red umber, dark blue green and a light bright green. The green colours appeared to be applied directly onto the stone work. The plaster finish and the paint remains did not extend onto the new quoins (Plate 6).

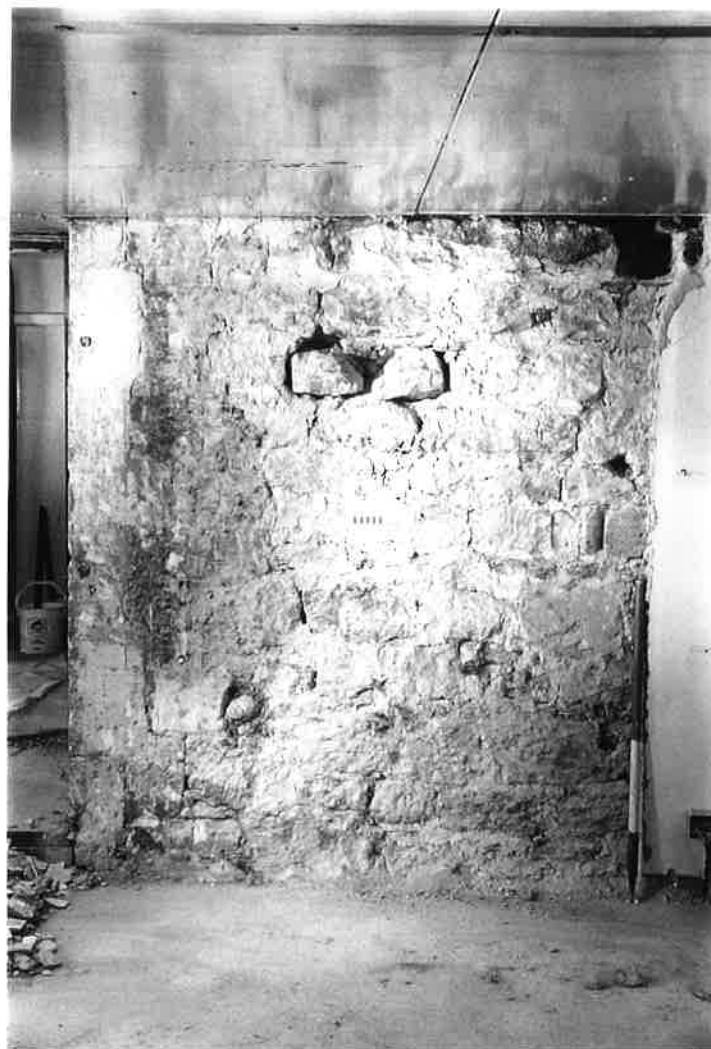
Plate 7: West side - Coursed rubble wall surface

4.3.1 The wall elevation that was revealed on the western side of the new opening was made of coursed limestone rubble (Plate 7). Twelve courses were revealed mostly of light grey limestone but with some pieces of a honey yellow colour. The stone pieces varied in size from 34 cm x 24 cm to 21 cm x 11 cm. Most of the stone had been roughly faced with some diagonal tool marks visible. There was some evidence for reused masonry; one piece of stone was well faced with fine vertical tooled strike marks another piece of stone was worked and appeared to be from a decorated boarder of some sort (Plate 8). The matrix of the wall was white lime mortar with a small amount of sand and grit inclusions. Its application was quite rough with the mortar overlapping the stone edges in an attempt by the builders to create a smoother wall surface. Both vertical and horizontal joints were up to 3 cm in thickness and varied considerably. The ashlared quoins to the northern extent of the wall have been replaced and were of a whiter colour than the rest of the wall. At a height of 200 cm above the modern floor level the wall face stops. Its upper course forms a horizontal ledge extending 18 cm into the core of the wall. At this depth into the wall core a new wall face continues upwards (Plate 9). The wall had several fixing dowels in its build, three along the bottom of the exposed area presumably for a former skirting board and vertically down the northern wall extent quoins possibly for a fixed door surround or wooden rails or fittings of some type.

- 5.4 The western side of the wall was of coursed rubble with some evidence of the reuse of stone. The northern quoins of the wall were replacements. The rubble surface was originally faced with a lime plaster skim applied directly onto the stone. In some areas there appears to be patching or use of a different kind of mortar with hair as an inclusion. This surface may have a pigmented lime wash covering it but no skirting detail was observed. To the northern extent of the wall an area of brown paint surface was observed. Directly above this layer a thick coat of modern pink cement was applied presumably relating to the modern use of the room as a kitchen area.

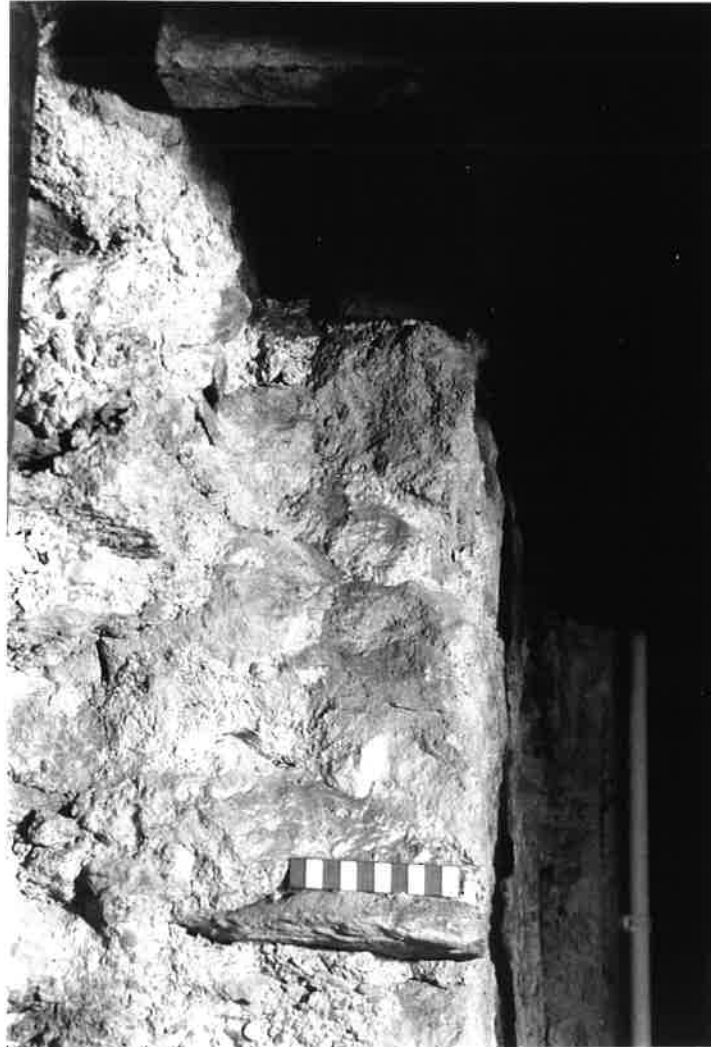
Plate 9: West side - Joist holding ledge

- 5.2 As described above the western side of the wall is stepped back at a height of 200 cm above the current floor level. This stepping of width forms a ledge of 18 cm on which the joists of the current first floor rest. The wall was therefore designed to carry the load of a floor and shows that there was a further building to the west of the screens passage at the time of wall construction, believed to be 1618. The door to the north of the new opening must have provided the link between the two areas. This suggests that the 1701-3 build of the range in which the servery is situated is a replacement. Alternatively the wall through which the new opening is being built may relate to the 1701-3 building phase.
