# 2-4 London Street, Reading Berkshire

BUILDING INVESTIGATION, RECORDING AND  
ARCHAEOLOGICAL WATCHING BRIEF

OXFORD ARCHAEOLOGICAL UNIT  
NOVEMBER 2000

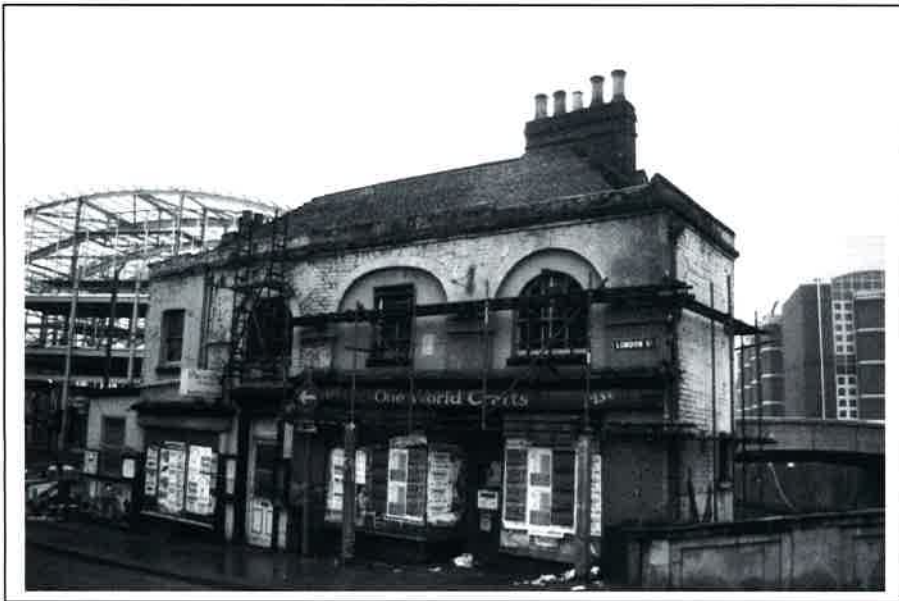
**Plate 3:** Street (east) elevation

- 3.1.2 The **street (east) elevation** (Plate 3) had the remains of blind arcading with impost bands at first floor level to the three northern bays, largely truncated at ground floor level by the early 20<sup>th</sup>-century glass shop front to No 2. The central arch was slightly

depressed and surrounded a square-headed sash window which contrasted with the semi-circular sashes and arcade arches in the flanking bays. The arcading remained intact for its full height in the left hand bay enclosing a classical doorcase around the wide front door to No 4. In contrast to the arcading in the three northern bays the southern bay had flanking recessed walls rising to the simple cornice and parapet which extended across the whole elevation. The southern bay had a four-pane sash window at first floor with a cambered brick lintel, above an open plate-glass shop front at ground floor. As detailed above (see 2.3.4) there is the possibility that the blind arcading was a secondary feature added to the building shortly after 1840. The glass-plated shop fronts are known to have been added after c.1900.

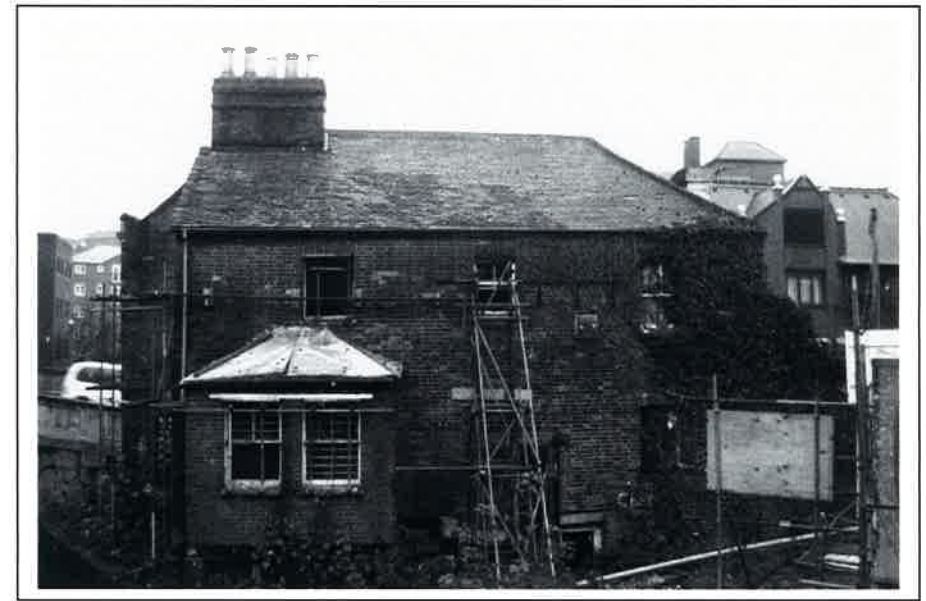
**Plate 4:** Rear (west) elevation

- 3.1.3 The **rear (west) elevation** (Plate 4) was plainer and unpainted unlike the other three elevations. Each of the three bays towards the south had a first floor sash window beneath segmental brick lintel, the fourth bay having been removed by the secondary step in the building's plan. At ground floor there was a similar window in the southern bay and two doorways in the central bay leading to the cellar and ground floor. The northern bay had been obscured by a single storey brick projection added in the late 19<sup>th</sup>-century, with two sash windows in its west face. The flashing partially survived of a lean-to which adjoined this projection to the south and which enclosed the ground floor door. A large, secondary, iron tie-bar anchor, consisting of a horizontal member and three verticals, was located towards the centre of the first floor and a circular cast-iron tie bar plate was at the northern end, immediately adjacent to the projection. An extra brick course had been added immediately beneath the wall plate in the northernmost 2 m of the west elevation suggesting that the primary wall immediately beneath the wall plate was sagging and therefore an extra course was inserted as a measure to prop up the roof.

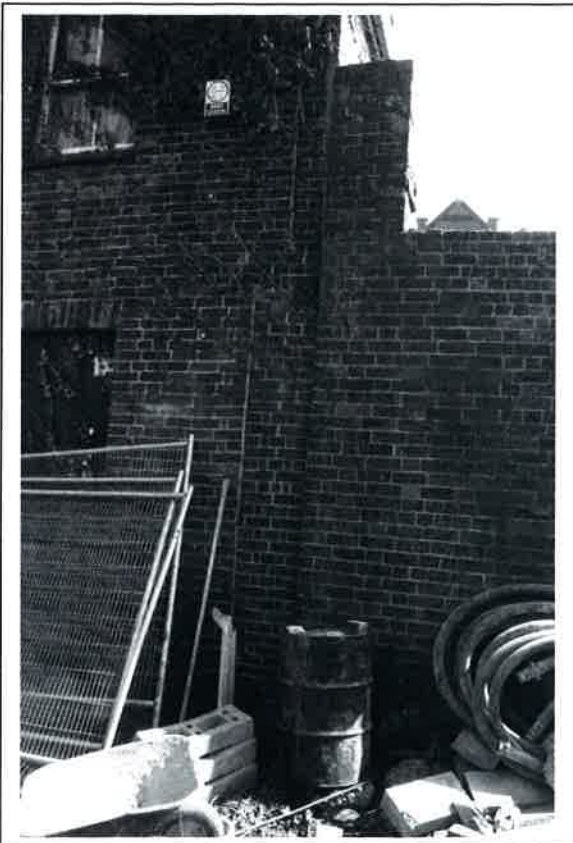
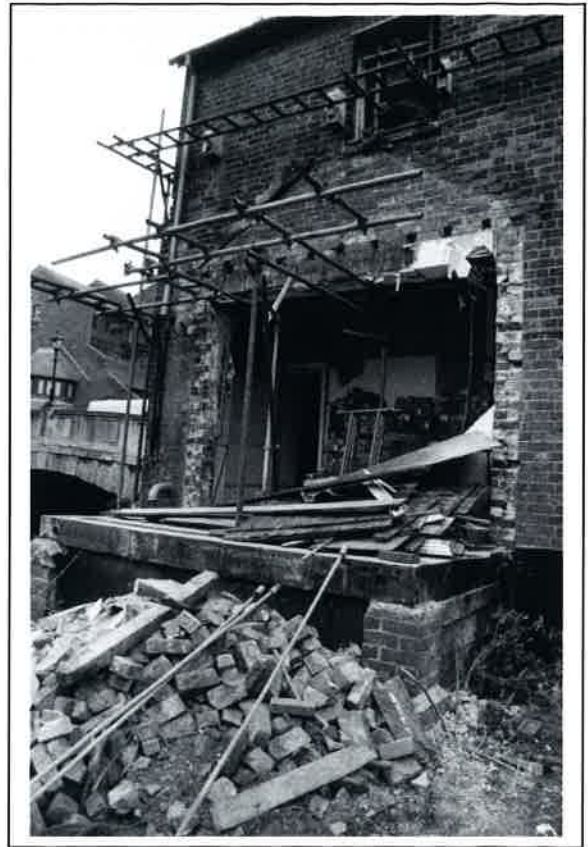
**Plate 9:** Straight joints at south-west corner of primary building, visible after removal of ivy

**Plate 8:** Outline of secondary bay which projected from west elevation after demolition

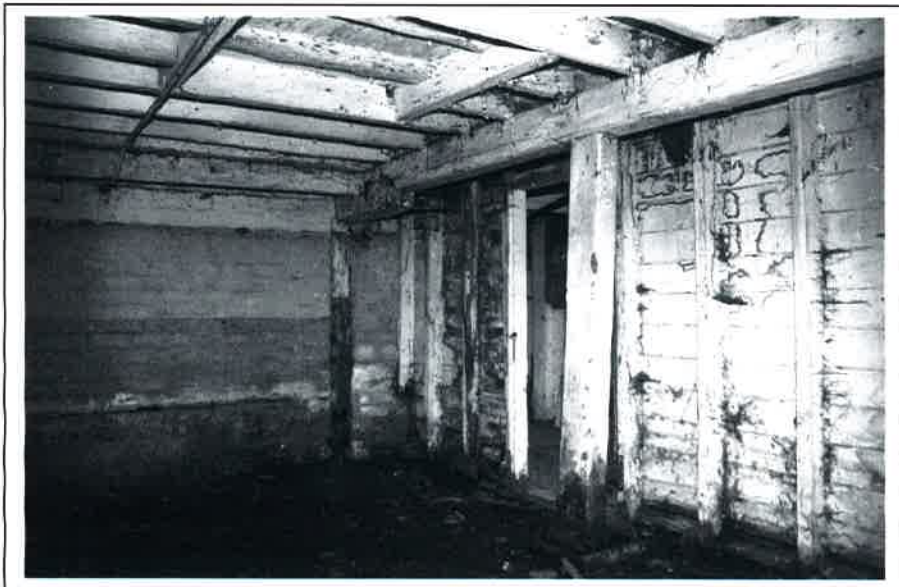
**Plate 13:** View within C2 from north-east showing trap-door and rough scarf in main beam adjacent to secondary brick cross-wall

- 3.3.5 Room C2 (Plate 13) was on the east side of the central third of the building and was divided from C1 by a secondary (late-19<sup>th</sup>-century?), single skin brick wall with 3 horizontal timbers tying the wall together. The western wall was formed by a possibly late-19<sup>th</sup>-century stud partition immediately to the west of the principal joist which extended along the spine of the building. The beam was supported by a simple, rectangular-section softwood post on a brick base, and it had a rudimentary stepped scarf 75 cm to the north of the southern wall shared with C1. The 20 cm step in the principal joist created by the scarf allowed a slightly greater head height within the main part of the room (2 m to underside of the ground floor boards). An apparently-primary hatch (c.1 m x 1 m) survived towards the centre of the room which consisted of two long flat joists supporting a covering board. The hatch appeared to be the same date as the primary floor boards which survived in situ beneath the secondary floor within G2.
