# Chapter 6

## The Late Roman Villa Complex (Phase 4)

by David Miles, Simon Palmer, Alex Smith and Grace Perpetua Jones

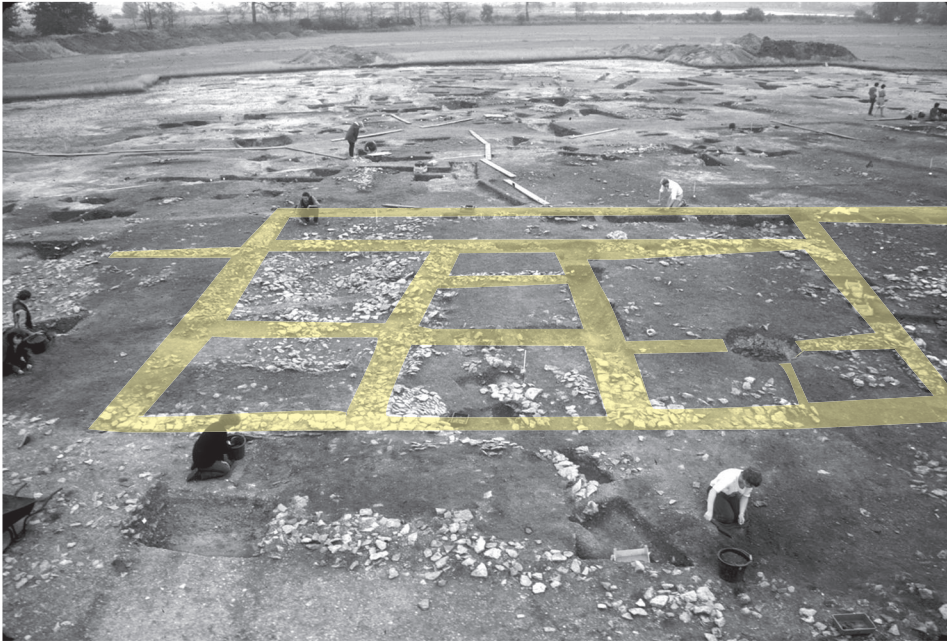
Plate 6.1 Late Roman villa (B 8) looking east

The successor to Building 7 was rectangular with stone foundations, originally measuring 13.5 x 9 m in Phase 4a. It was aligned NNE-SSW, and the entrance is likely to have been situated in the middle of the eastern side, leading into Room 5/6, which was partitioned in a later phase. This entrance room/corridor was flanked by two larger rooms (4 and 7; both *c* 5 x 4.5 m) and led towards a range of three smaller rooms at the rear (1, 2 and 3). The structure partially overlay Building 7, seeming to utilise some of the existing walls in its structure, but extended further north. Footings, where they were best preserved, ranged from between 0.6 to 0.7 m wide and were of a mortared random rubble construction made up of small (0.1 m) pieces of limestone. They were of variable depth, deepest on the west side (719/1556) where they ran along the top of Phase 2 ditch 2502. The north and south sides had the shallowest footings, the former just resting on the gravel surface, and the latter largely untraceable, except for a fragment on the south-west corner (1591).

Extant walling survived only on the western side, apart from a surviving fragment of wall 2107 reused from Building 7. The wall was of coursed and faced limestone blocks with a more random mixed rubble infill. The stone was mortared. All the walls had been robbed down to the old ground surface, but some lengths had been completely removed, including the foundations, notably a large section of one of the internal walls between Rooms 4 and 5/6. The foundations of the eastern wall (880) survived along much of its length.

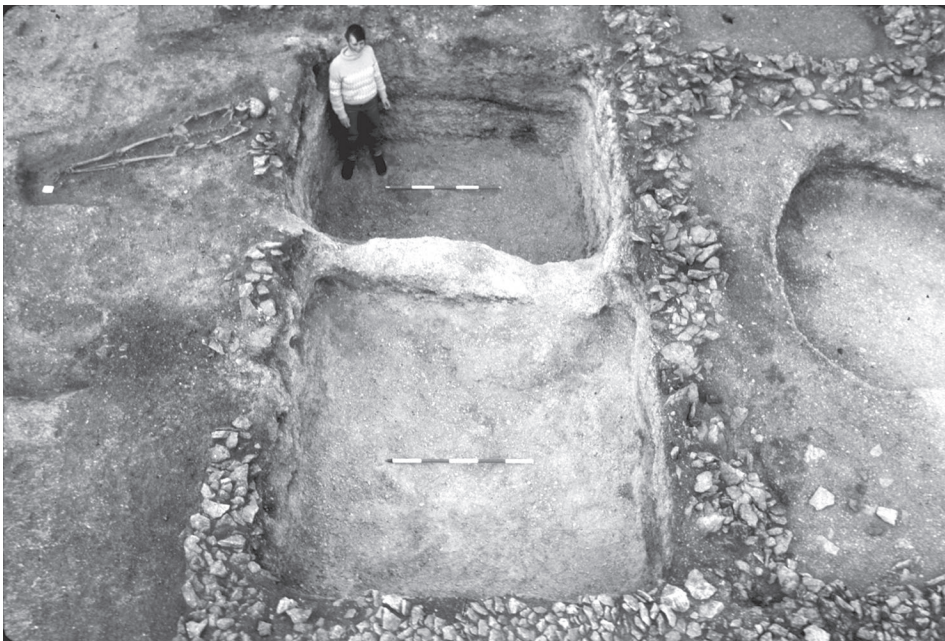
Plate 6.2 Sunken chambers in B 8

(see Pl. 6.2). Chamber 1909 was the most northerly and largest in area, 2.5 m square and 0.8 m deep (see section 120, Fig. 6.8). The north-east and west sides were all near vertical, cutting down on the inside edge of the structural walls. The south side was more uneven with a tongue of gravel extending into the centre of the chamber, perhaps marking the position of steps down. Traces of clay were found on the floor, suggesting a clay lining. The fill suggested a rapid process of infilling, but gave no clear indication of function or duration of use. No evidence for the revetting of the gravel sides was forthcoming. Finds were few and appeared to be mainly building debris. Two coins dated AD 330-5 and AD 350-400 were recovered from the top fill and over 2.5 kg of pottery was found spread throughout the layers, providing a general 4th-century date. Other finds included 1.6 kg of tile, building stone, nails, a bone gaming piece/venerer (Fig. 6.17, no. 24), vessel glass, a whetstone and 145 animal bone fragments. The character of the infill and the lack of any deep later silting over the top may suggest the chamber was infilled prior to the abandonment of the building.

Separated from 1909 by a small gravel causeway was the smaller but deeper chamber 1969 (see section 121, Fig. 6.9). This measured 2.5 x 2 m and was 1.5 m deep, a depth comparable to some of the waterholes elsewhere on site. Like 1909, it was vertical sided and flat bottomed, although there was no indication of steps. The fill contrasted to 1909, in that the lower 0.5 m appeared to have silted during use. It consisted of a series of layers and lenses of clay, silt and gravel but with no organic matter in evidence. Finds included two Roman coins, from the lower part of the infilling, dated to AD 335-41, and AD 345-53. Other finds included large numbers

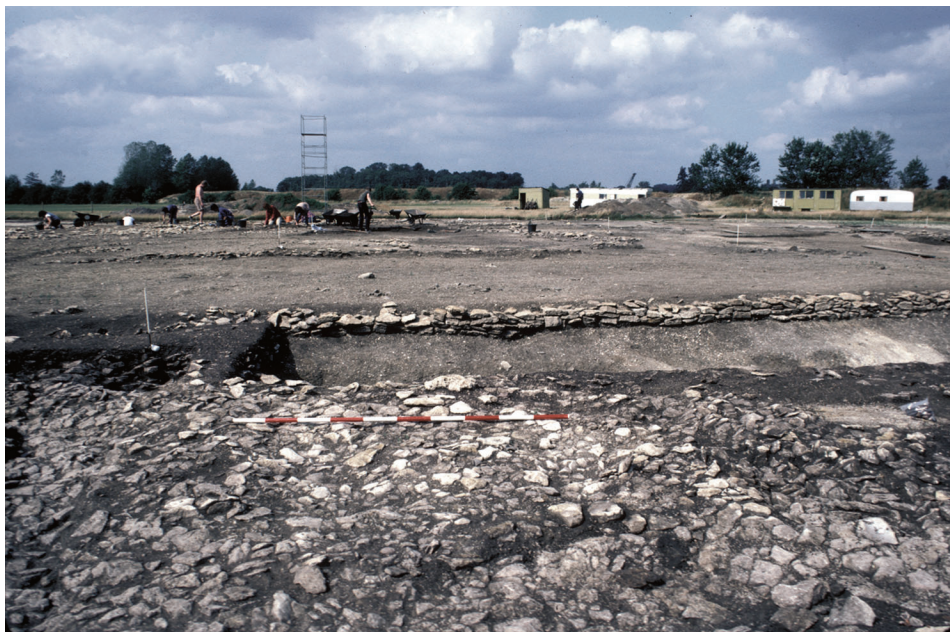
*Plate 6.4 Enclosure E 22 looking north*

The latest Roman phase is marked by a large sub-rectangular enclosure ditch E 22 (501), clearly visible on aerial photographs, which was roughly concentric with the inner enclosure E 21, but covered a much wider area (c 50 m across). The ditch on average was between 1.5 and 3 m across and 0.6 to 1.2 m deep and the inner edge was marked by a shallow shelf (see section, Fig. 6.11). On parts of the southern and western sides of this shelf a narrow dry stone wall survived up to three courses (see Pl. 6.4). There was an apparent gap in the wall of c 5 m on the southern side, on the same line as the entrance to the inner enclosure. The wall was faced only on its outer edge, the inner face being left ragged, and had an approximate width of c 0.4 m. The upper fill of ditch 501 was distinctive, being an alluvial deposit up to 0.3 m in depth. Finds from within this layer included sherds of 13th-century pottery and a coin dated 1205-15. Roman finds from the lower levels ranged from a small number of domestic items (bone pin, copper alloy thimble and pendant (Fig. 6.18, no. 41), brooch, querns and vessel glass) to building debris. Just 16 kg of pottery and 5 kg of ceramic tile were recovered from all of the enclosure sections, along with over 2000 animal bone fragments, largely unidentifiable fragments but including sheep, cattle, horse and a little pig.

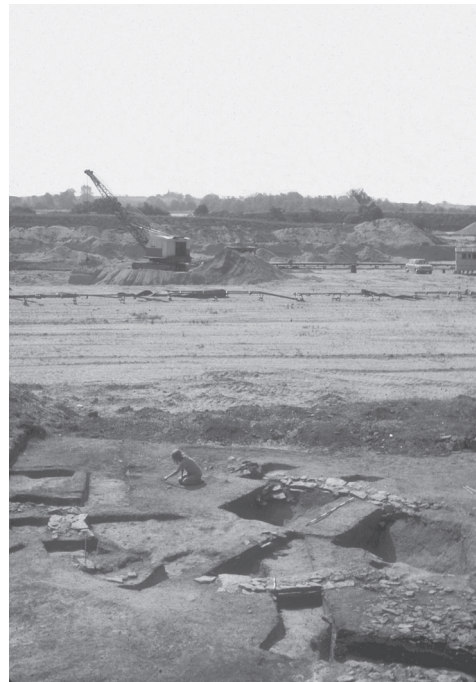
Plate 6.5 *The late Roman shrine looking south-west and with gravel workings in the distance*

A roughly rectangular area (c 180 m<sup>2</sup>) was excavated just off the north-east corner of Trench 13 (see Fig. 6.3), which exposed a circular masonry building interpreted as a shrine, along with an associated cobbled path (Fig. 6.12). The shrine was sited on an island of silts and clays, which fell away to the north into the palaeochannel. The structure comprised three wall arcs (2023, 2024, 2025) and stretches of robber trenches (2035, 2036) outlining a circular building with an internal diameter of approximately 6 m. The wall foundations were an average of 0.7 m in width where preserved, and were two courses deep, of flat limestone slabs with shaped faces to give smoothly curved inner and outer foundation faces. The core of the foundations was of

solidly mortared rubble. The wall footings laid on this foundation were preserved only on wall arc 2024, the northern wall, and a very short section on the east end of wall arc 2023, forming the south wall of the building. These wall footings were 0.55 m wide and also two courses thick, made up of slabs smaller than those used for the foundation, but also with inner and outer wall faces shaped. The core of the wall was again of mortared rubble. The walls and foundations were set into shallow trenches about 0.45 m deep (from modern ground level) and varying from 0.8 to 1 m wide where preserved between wall arcs 2024 and 2025 along the north-east line of the building (section 66, Fig. 6.12). The limestone slabs for the foundations and wall footings are of Cotswold limestone, while all the rest of the stone and cobbles are local material.

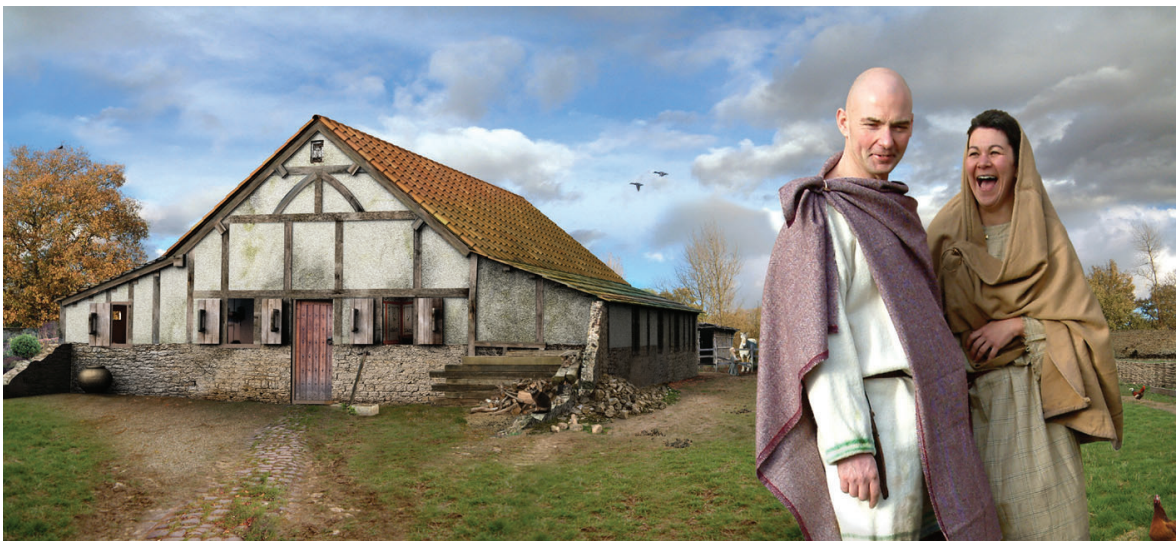
Plate 6.8 Reconstruction of late Roman villa

Later developments in the villa structure considerably altered the patterns of internal human dynamics. The addition of Room 8 to the south-eastern section of the main building and the continuation of its outer wall down towards B 9 effectively unified the two buildings in an architectural sense, creating what would appear to be an open 'courtyard' between them (Fig. 6.5). A possible gateway and corridor restricted access into this central space, from which there was presumably access into both of the buildings. It is possible that this was connected with a greater need for security and
